Description: Engine/Transmission Driveability Issues

Vehicles: Windstar, Freestar, Monterey

From: Kulkarni, Arvind (A.)
Sent: Wednesday, May 25, 2005 10:49 PM
To: Fang, Andy (A.); Stodola, Robert (R.J.); Tigchelaar, Doug (D.G.)
Cc: Nasar, John (H.S.); Cordeau, Roger (T.); Hearn, Mark (E.)
Subject: Analysis of CQIS data of water leak into PCM

V229 Wipe Cowl Module – Water Leak Paths

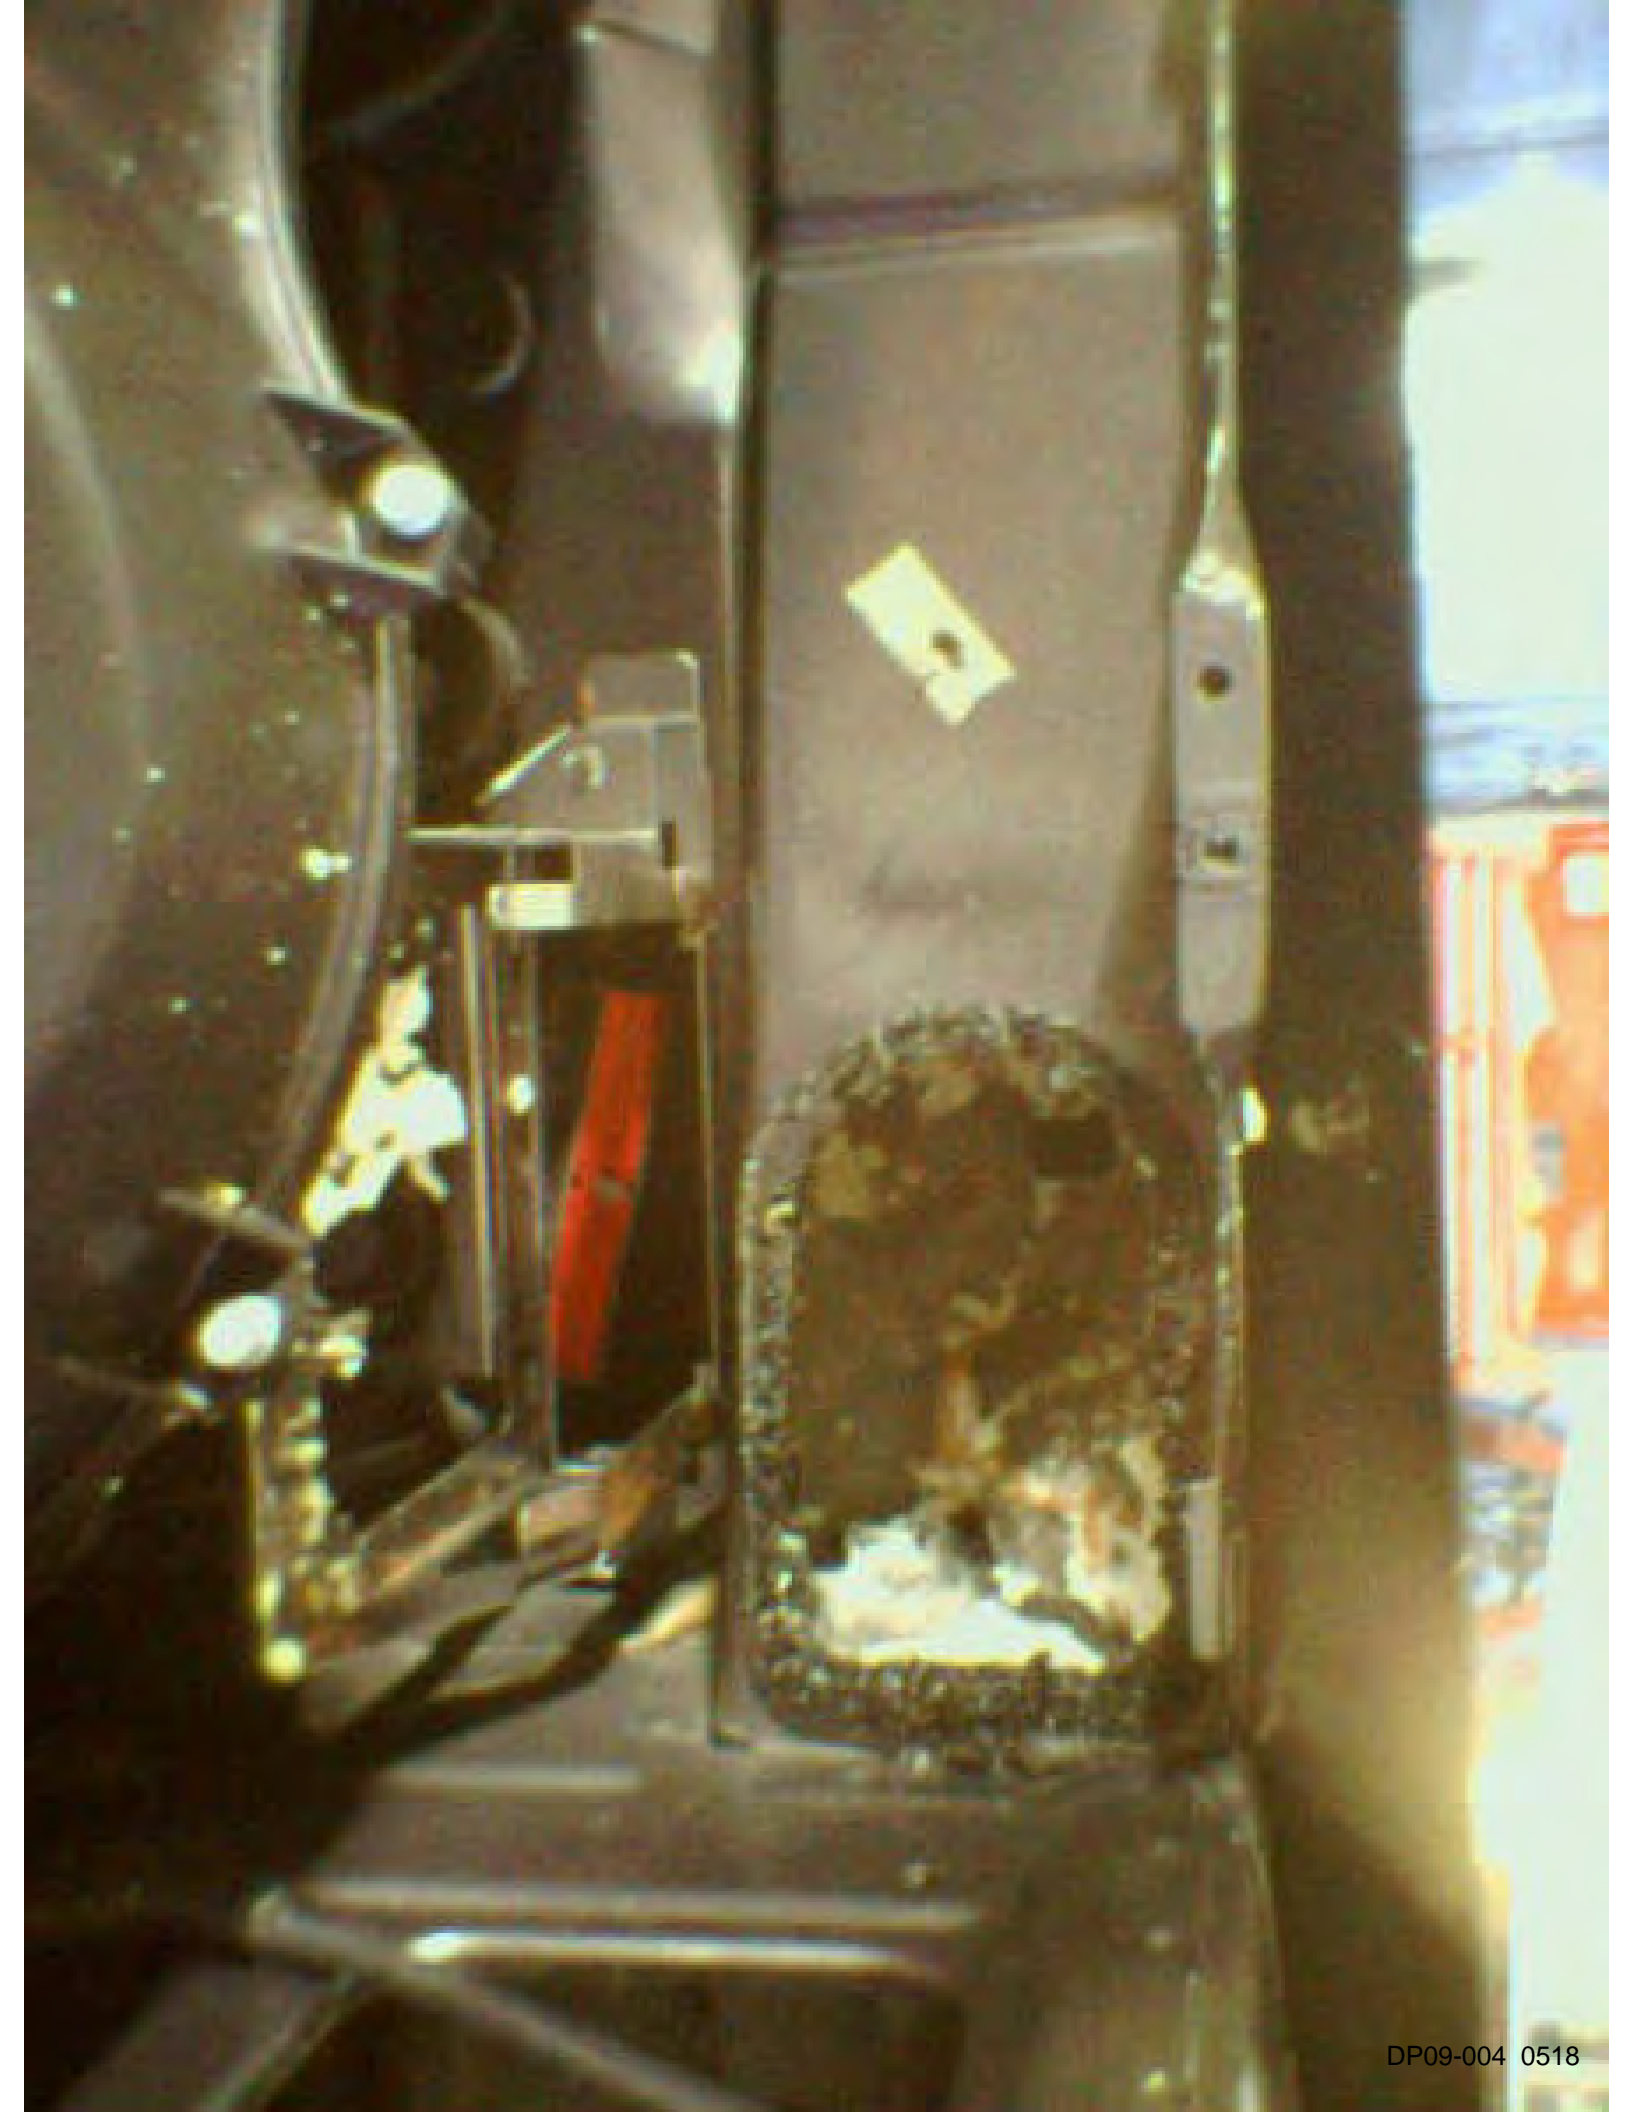
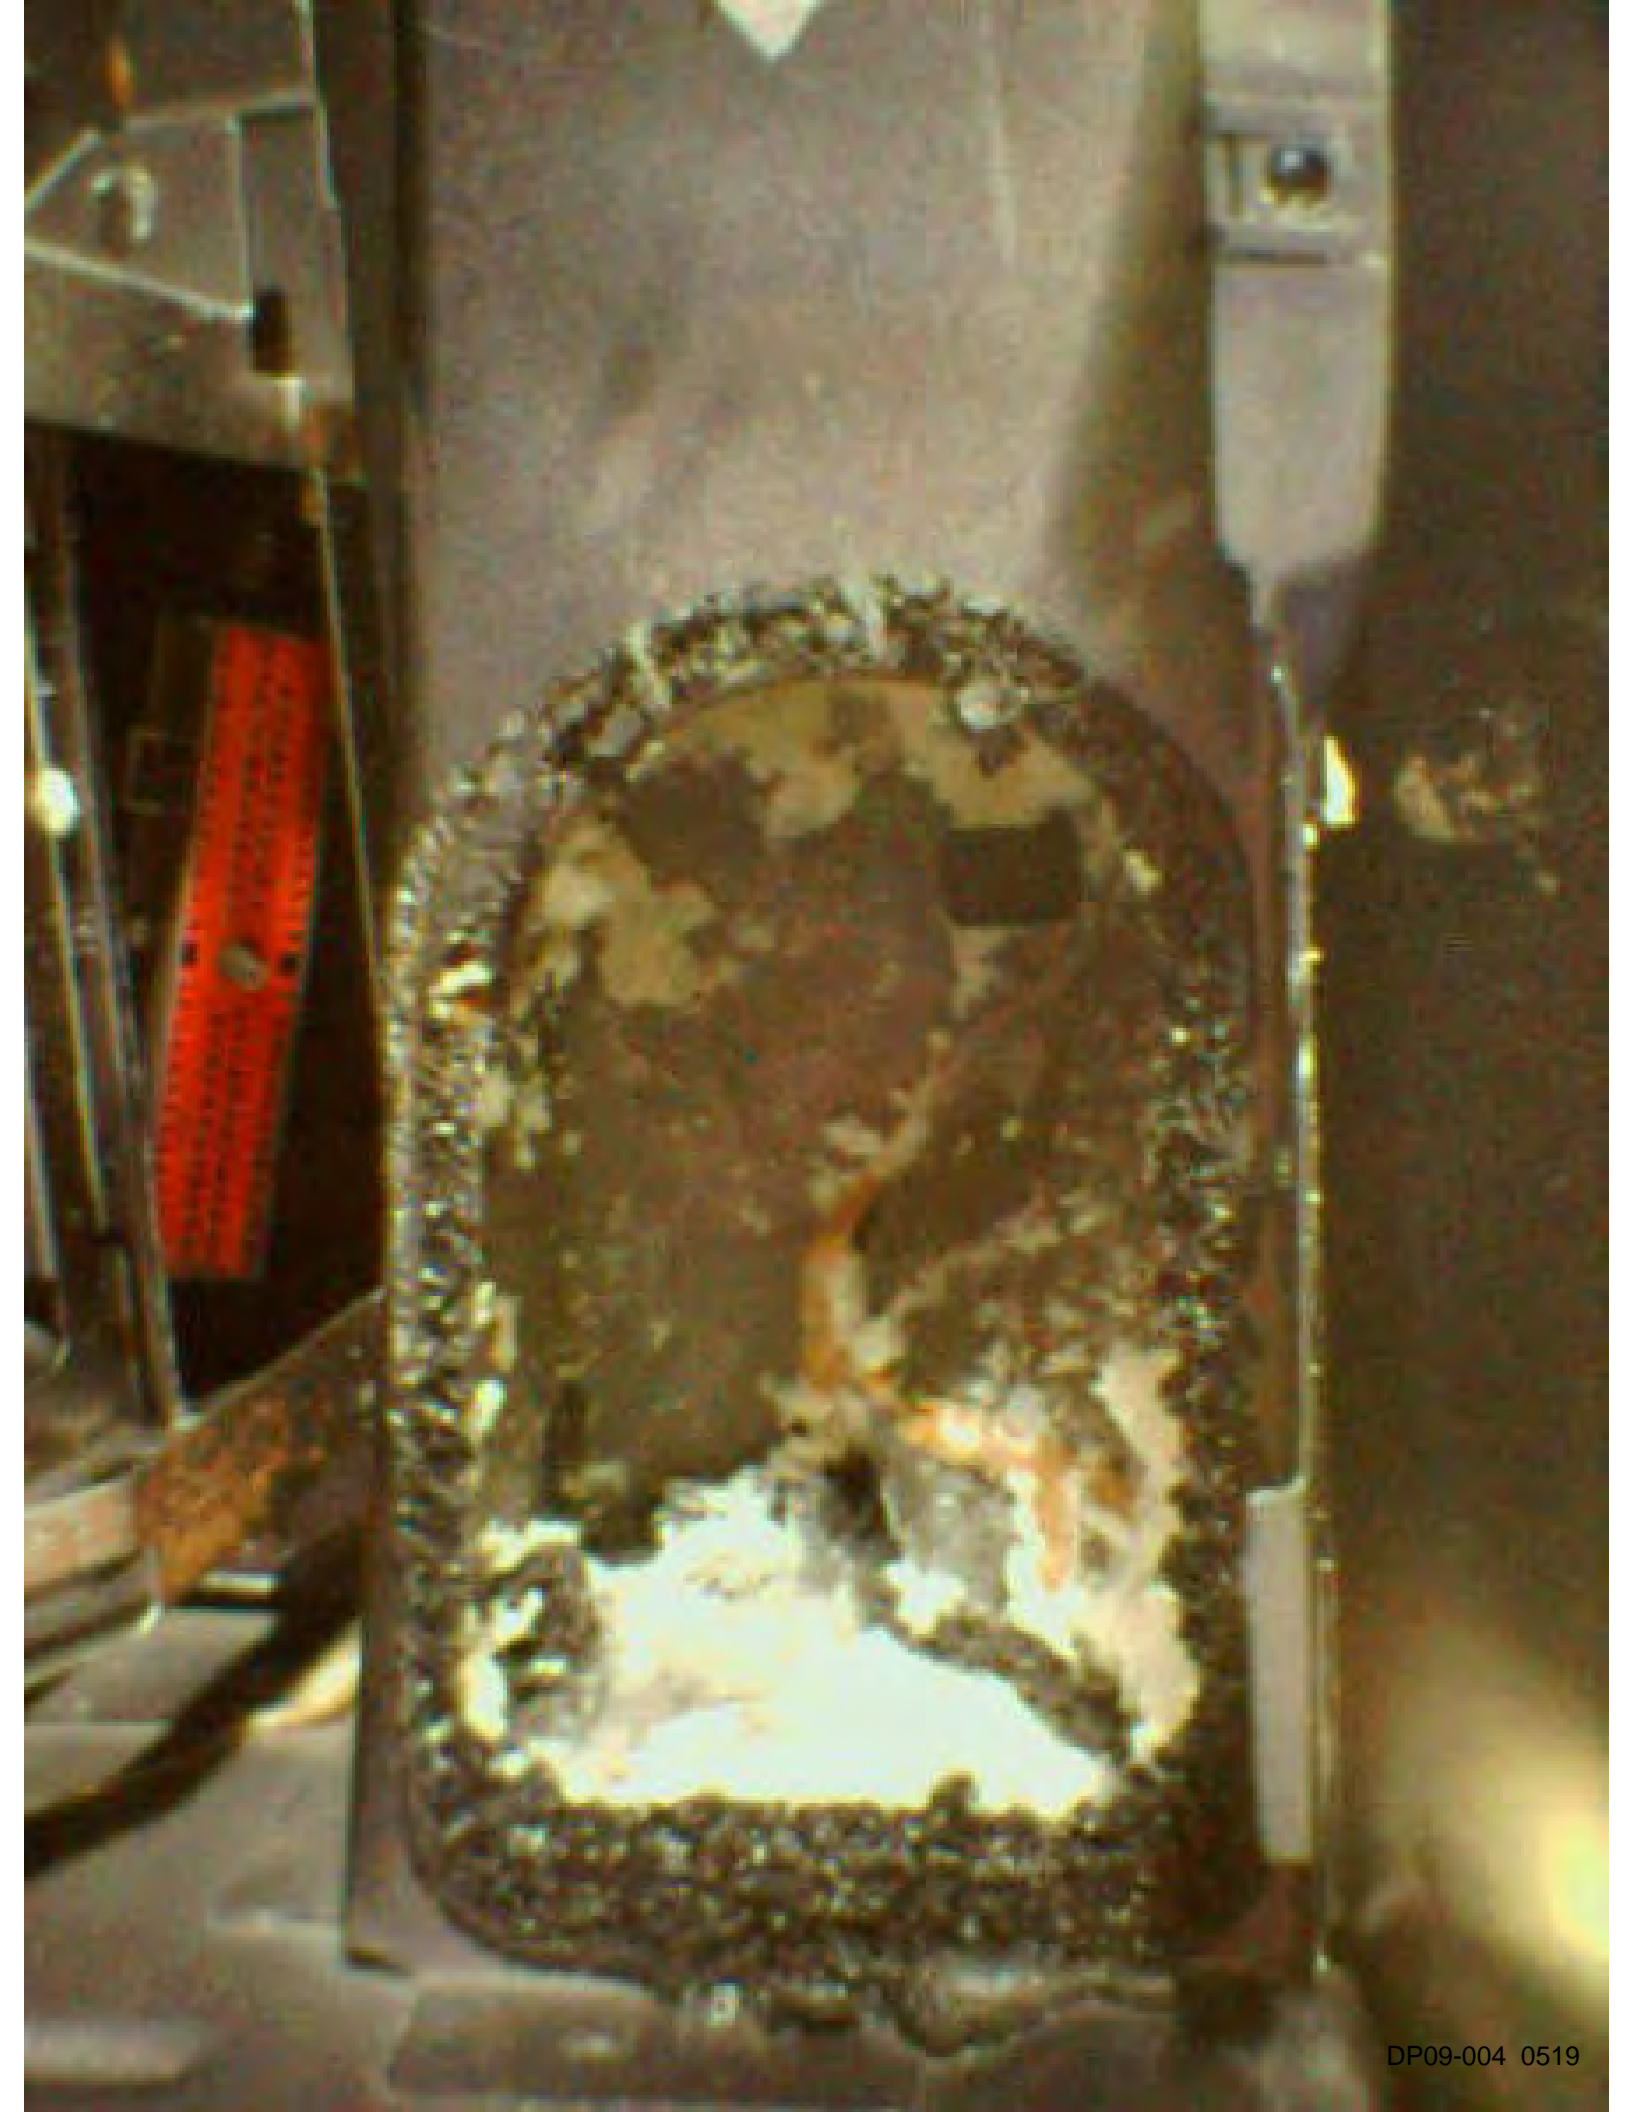
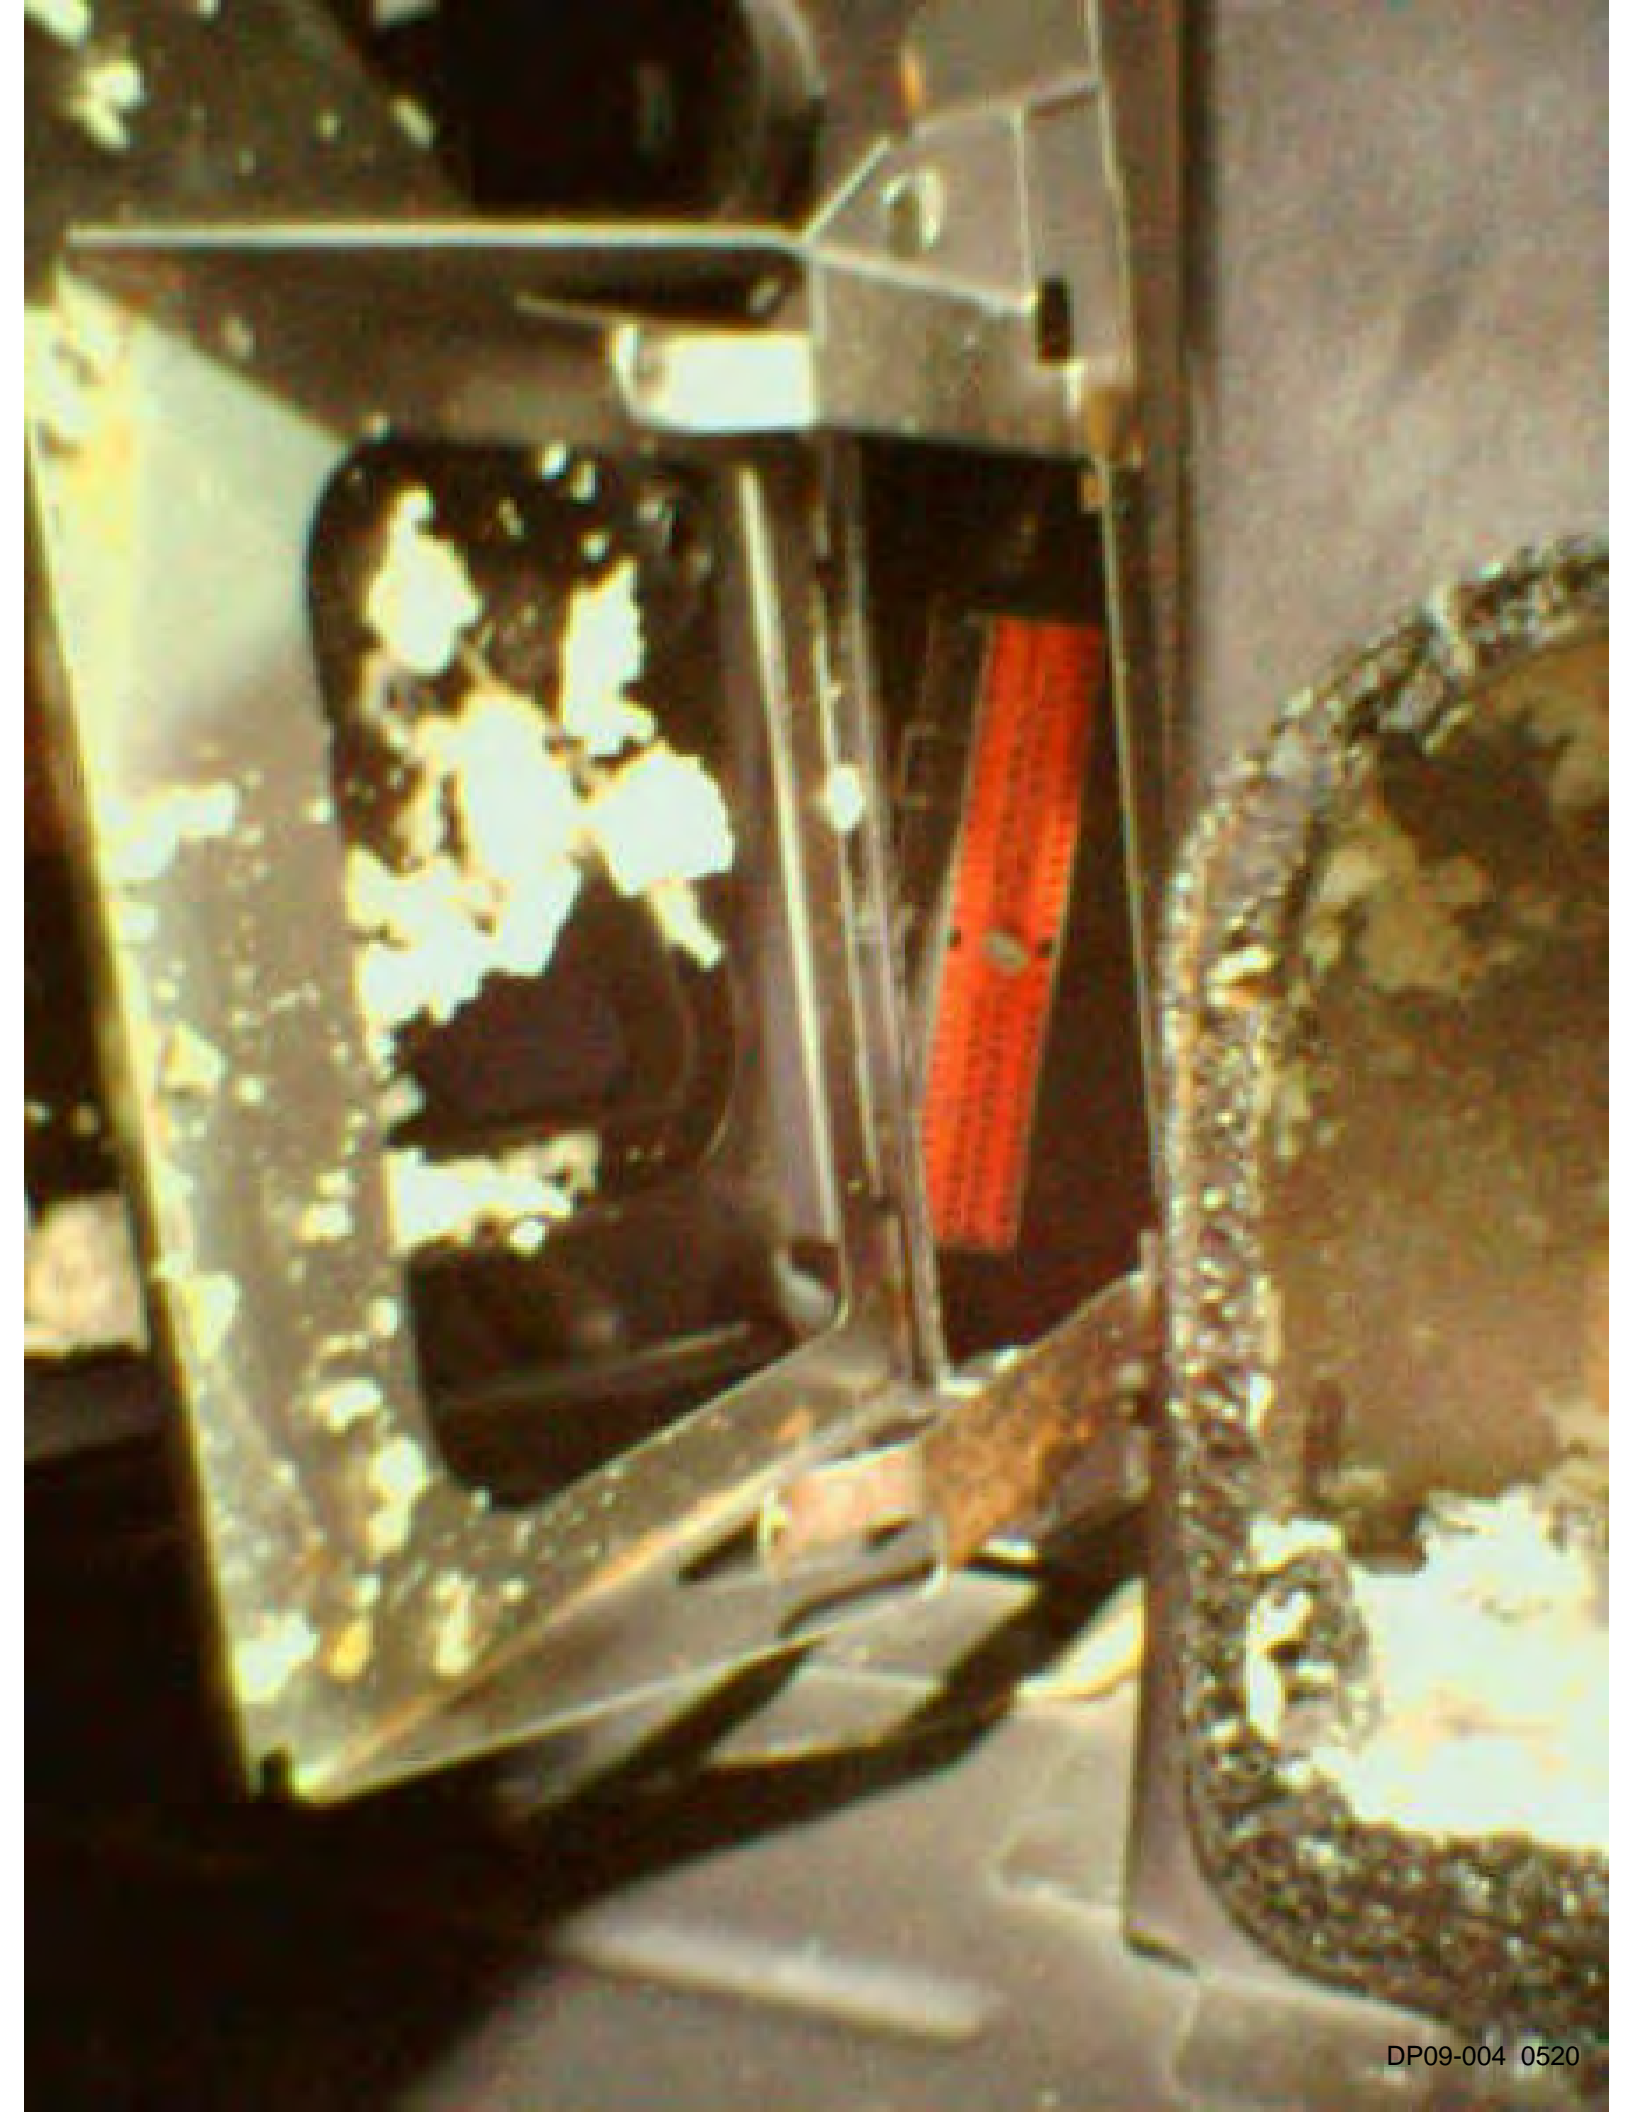
Craig Davis spoke to you about this Freestar. It has an ongoing water leak into the PCM. The dealer followed the TSB for water leaking issue and it continued to fill the PCM with water.

I had the dealer remove the dash, as suggested by Craig, to determine where the leak originated. The attached photos show the water is coming through the frame. Can you offer any guidance?

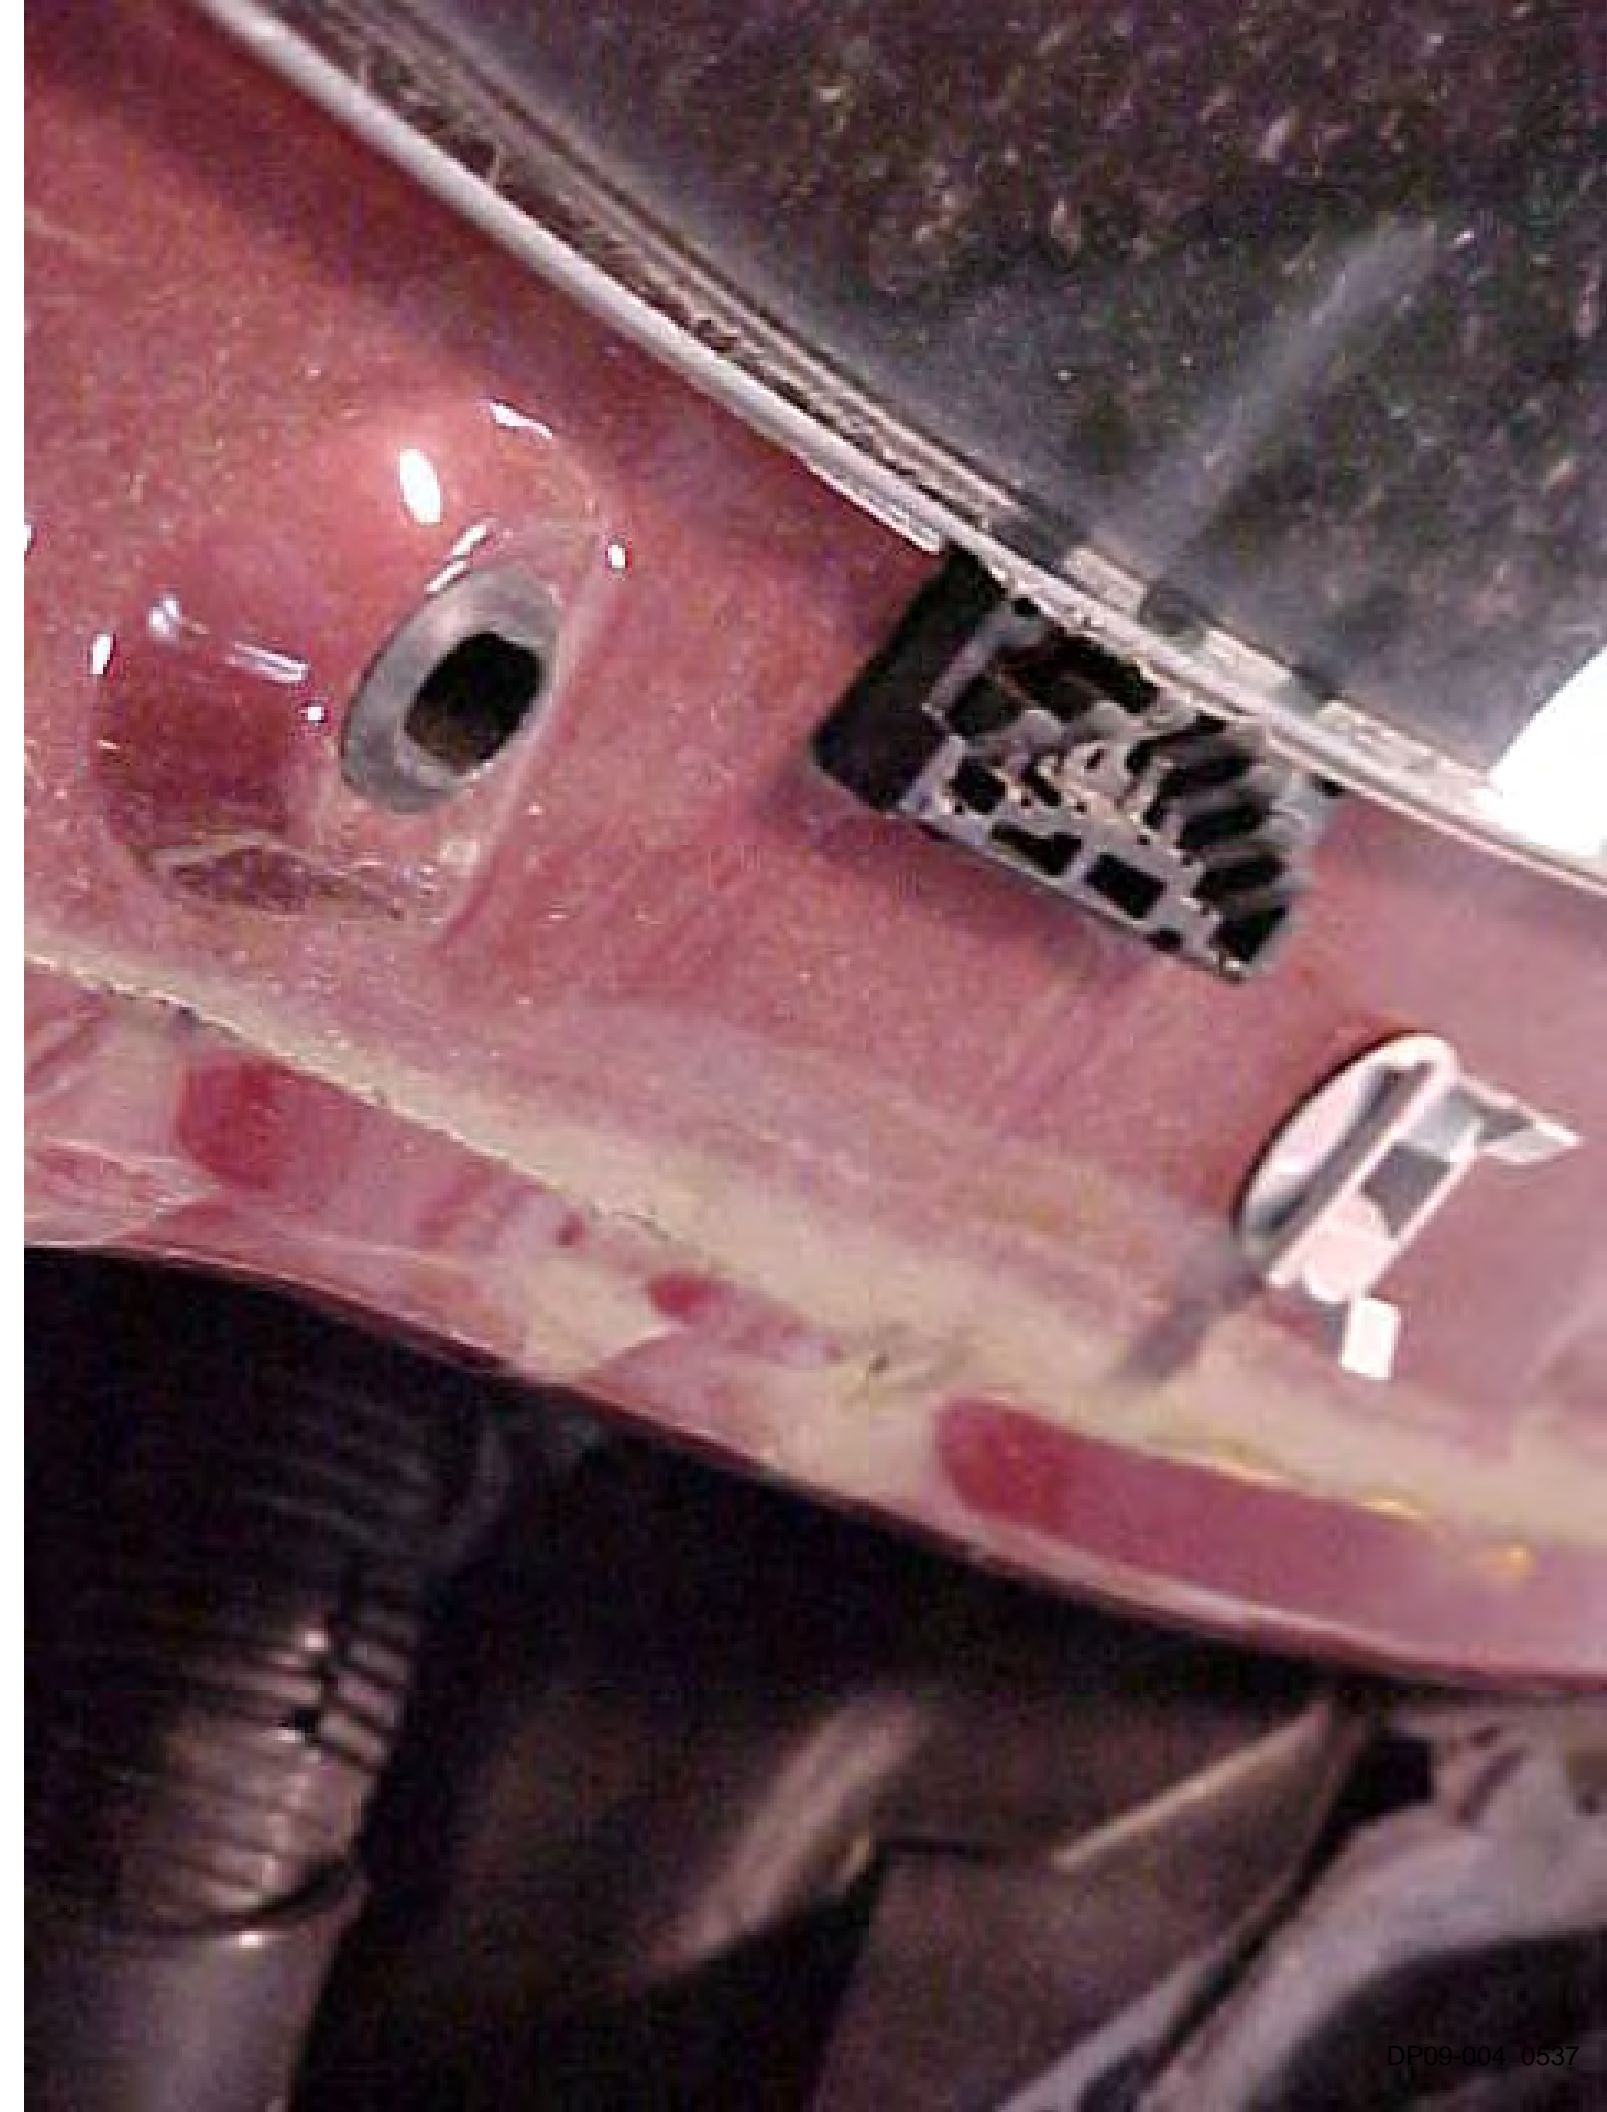
here are the attached pic on our discussion this morning tom oslick day ford 412-856-0600

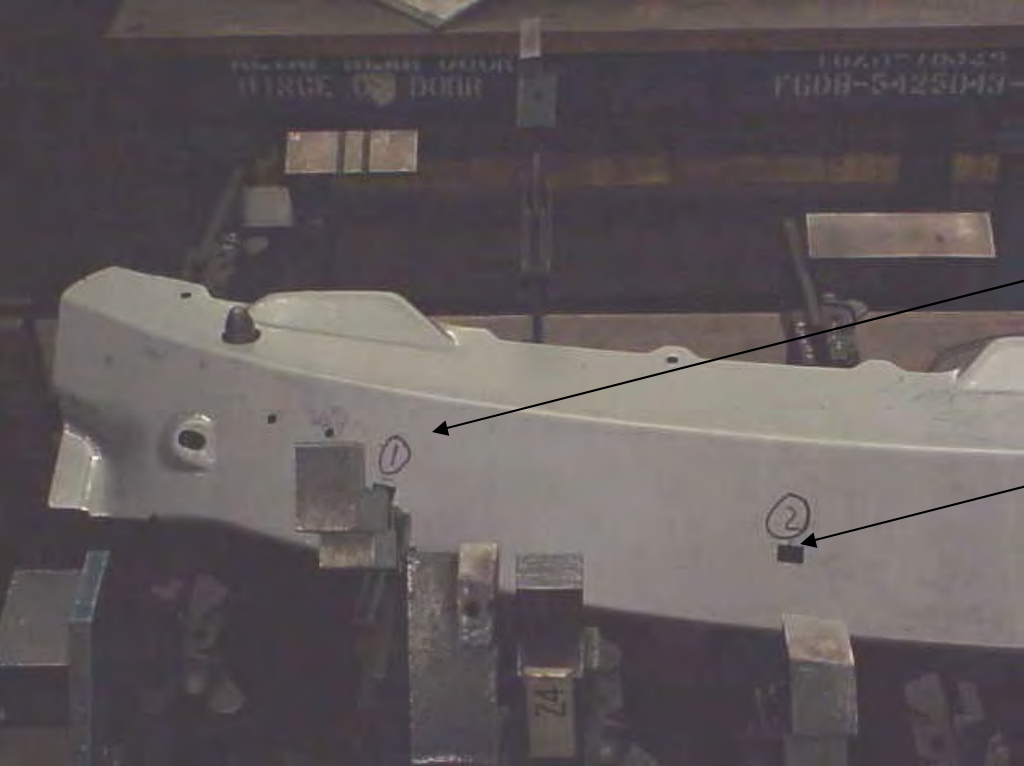
Hole 1

Hole 2

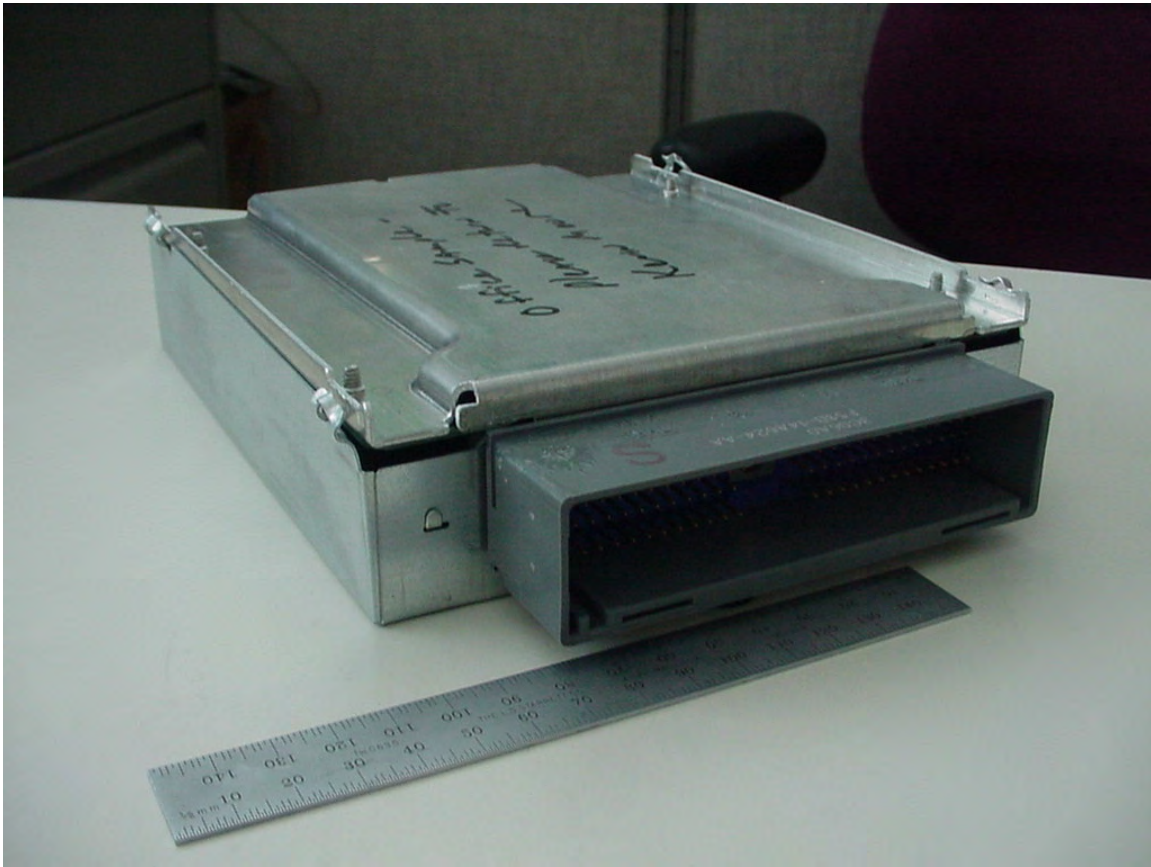
The V229 module was designed as a non sealed sheet metal module. There was no provision made for a sealing path, thus this module can not resist water intrusion. The interface of the mating parts is variable, in some cases a butt interface is formed, in other cases clearance is designed between the adjacent features.

Figure 1. The V229 module with the cover slightly open to show the butt interface of the cover, the base, and the connector.

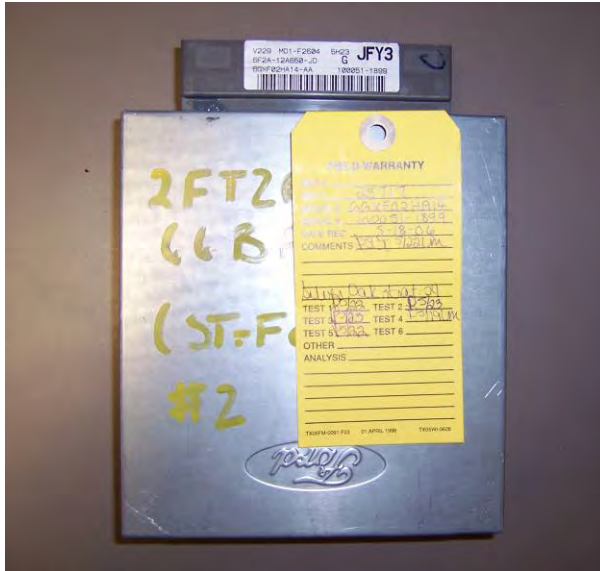
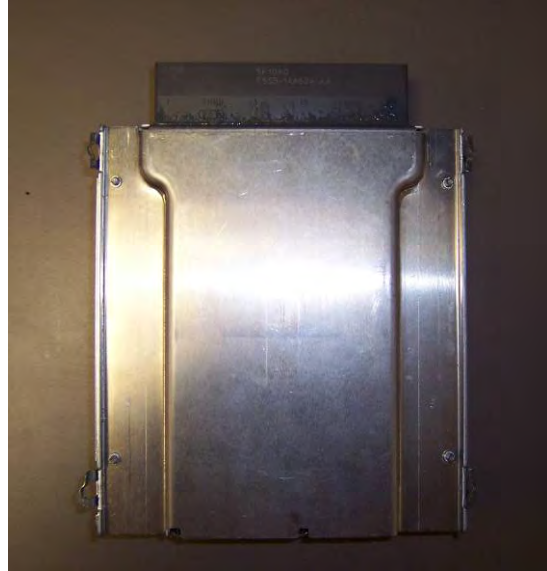
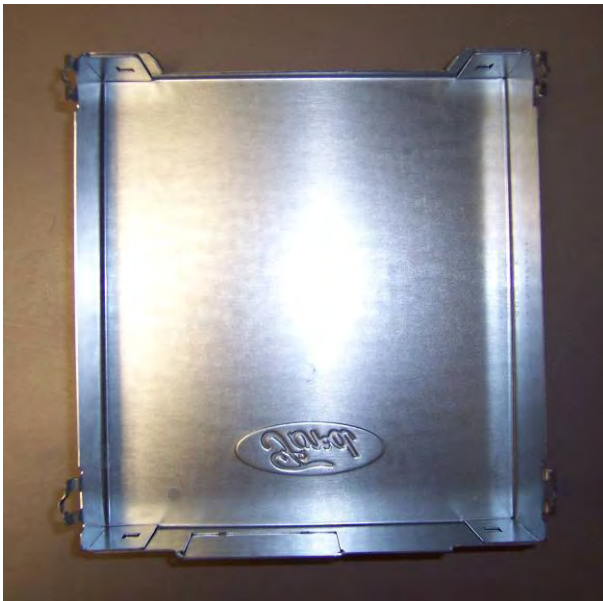
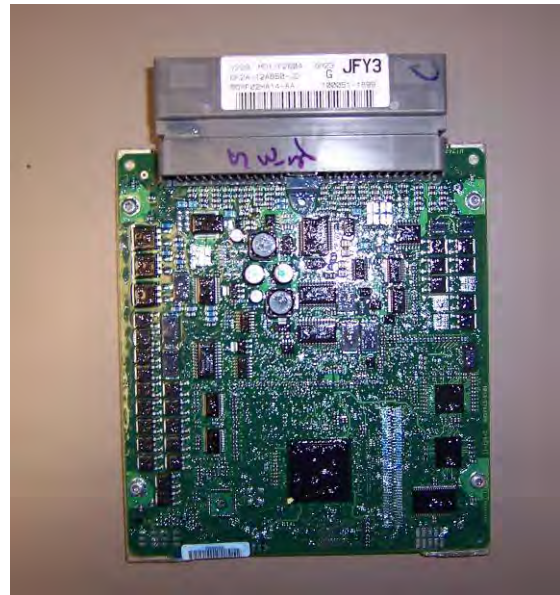
100051-1899 (St. Felician, Quebec)

- Test Results:
Upload – PASS
Suit Case Test – PASS
Reflash – PASS
Quality Ambient (+25 deg C) – PASS
Quality Cold (-40 deg C) – PASS
Quality Hot (+125 deg C) – PASS

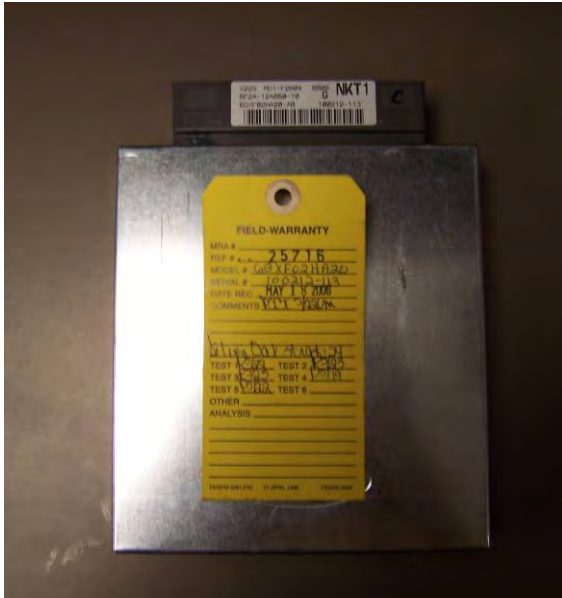
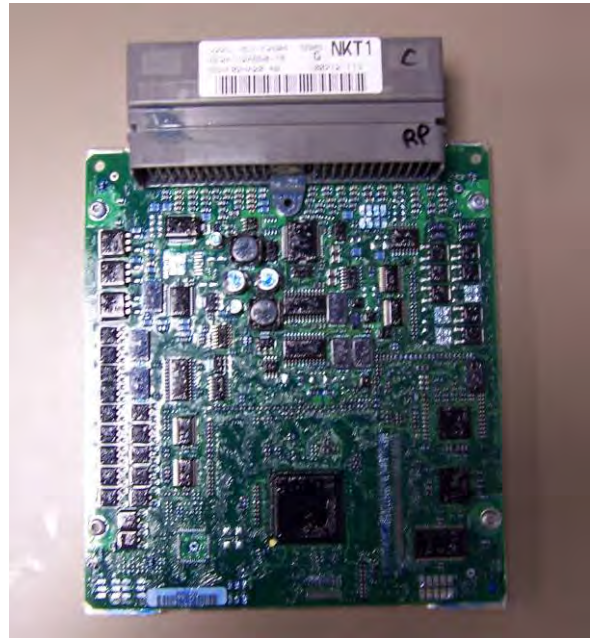
100212-113 (Newport News, VA)

Test Results:

Upload – PASS

Quality Hot (+125 deg C) – PASS

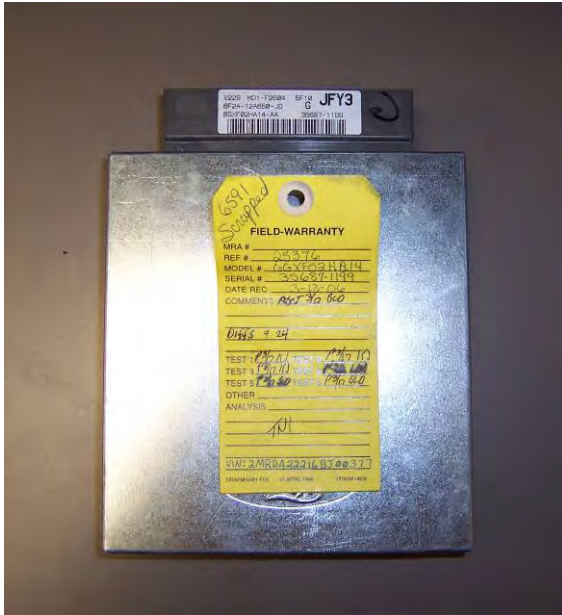
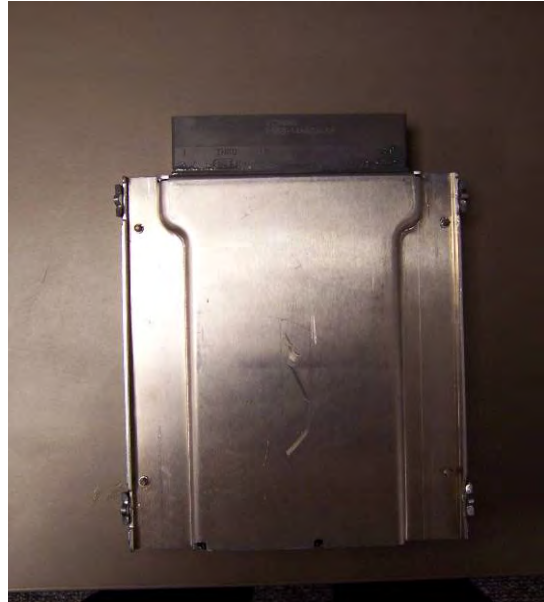
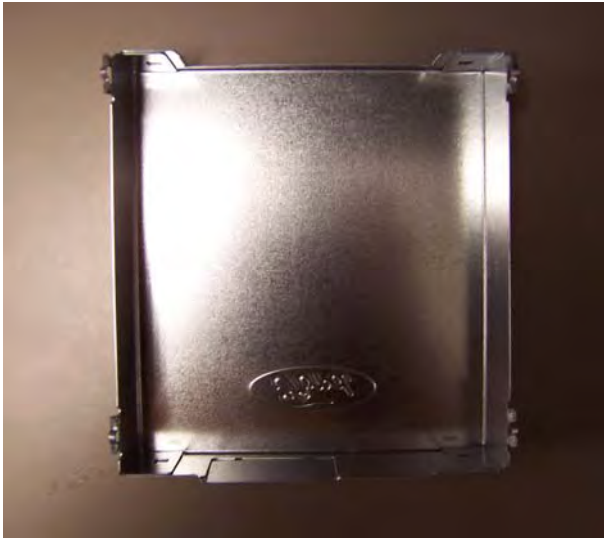
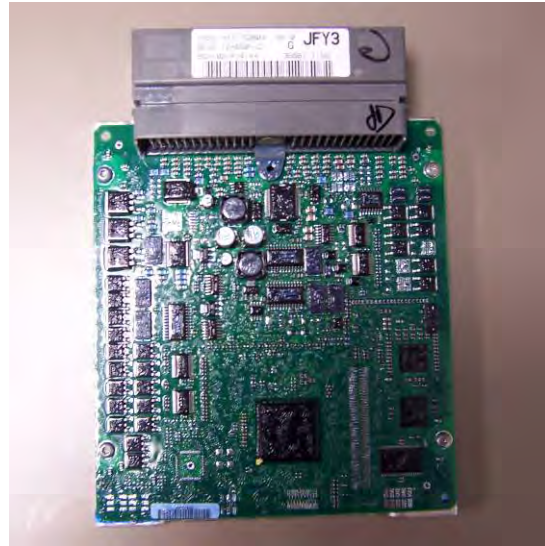
35687-1199 (Vin 2MRDA22216BJ00377)

Test Results:

Upload – PASS
