Description: Engine/Transmission Driveability Issues

Vehicles: Windstar, Freestar, Monterey

From: Kulkarni, Arvind (A.)
Sent: Wednesday, May 25, 2005 10:49 PM
To: Fang, Andy (A.); Stodola, Robert (R.J.); Tigchelaar, Doug (D.G.)
Cc: Nasar, John (H.S.); Cordeau, Roger (T.); Hearn, Mark (E.)
Subject: Analysis of CQIS data of water leak into PCM

V229 Wipe Cowl Module – Water Leak Paths

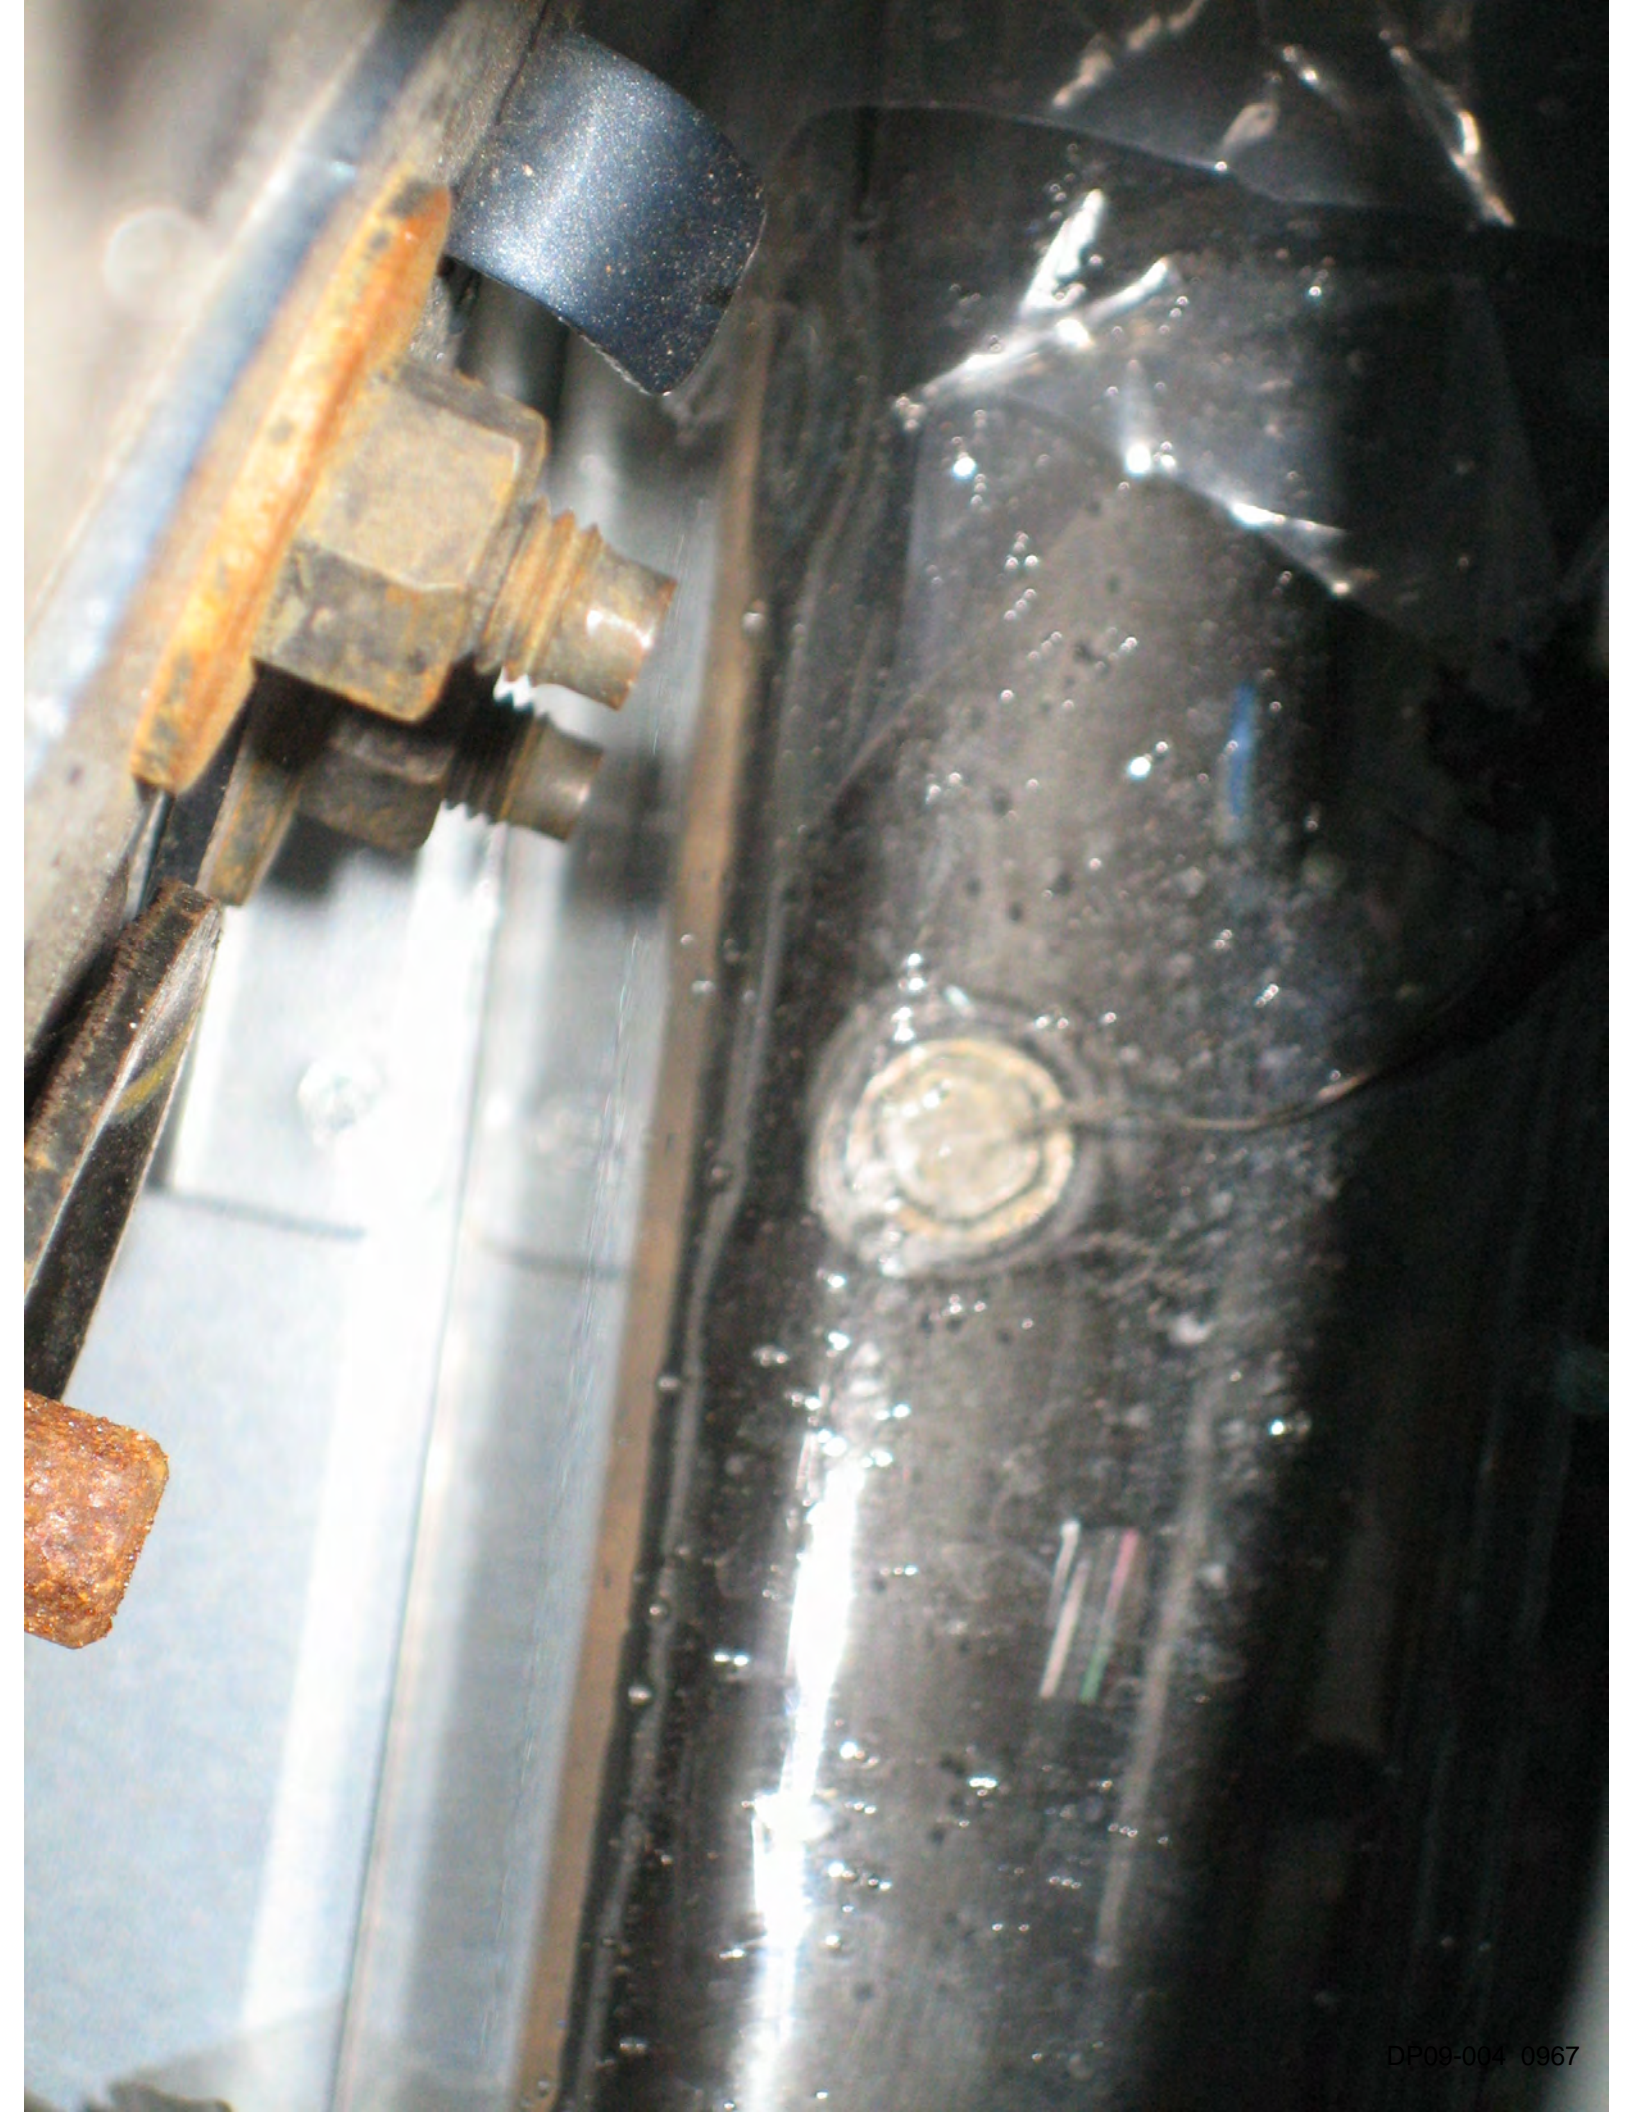
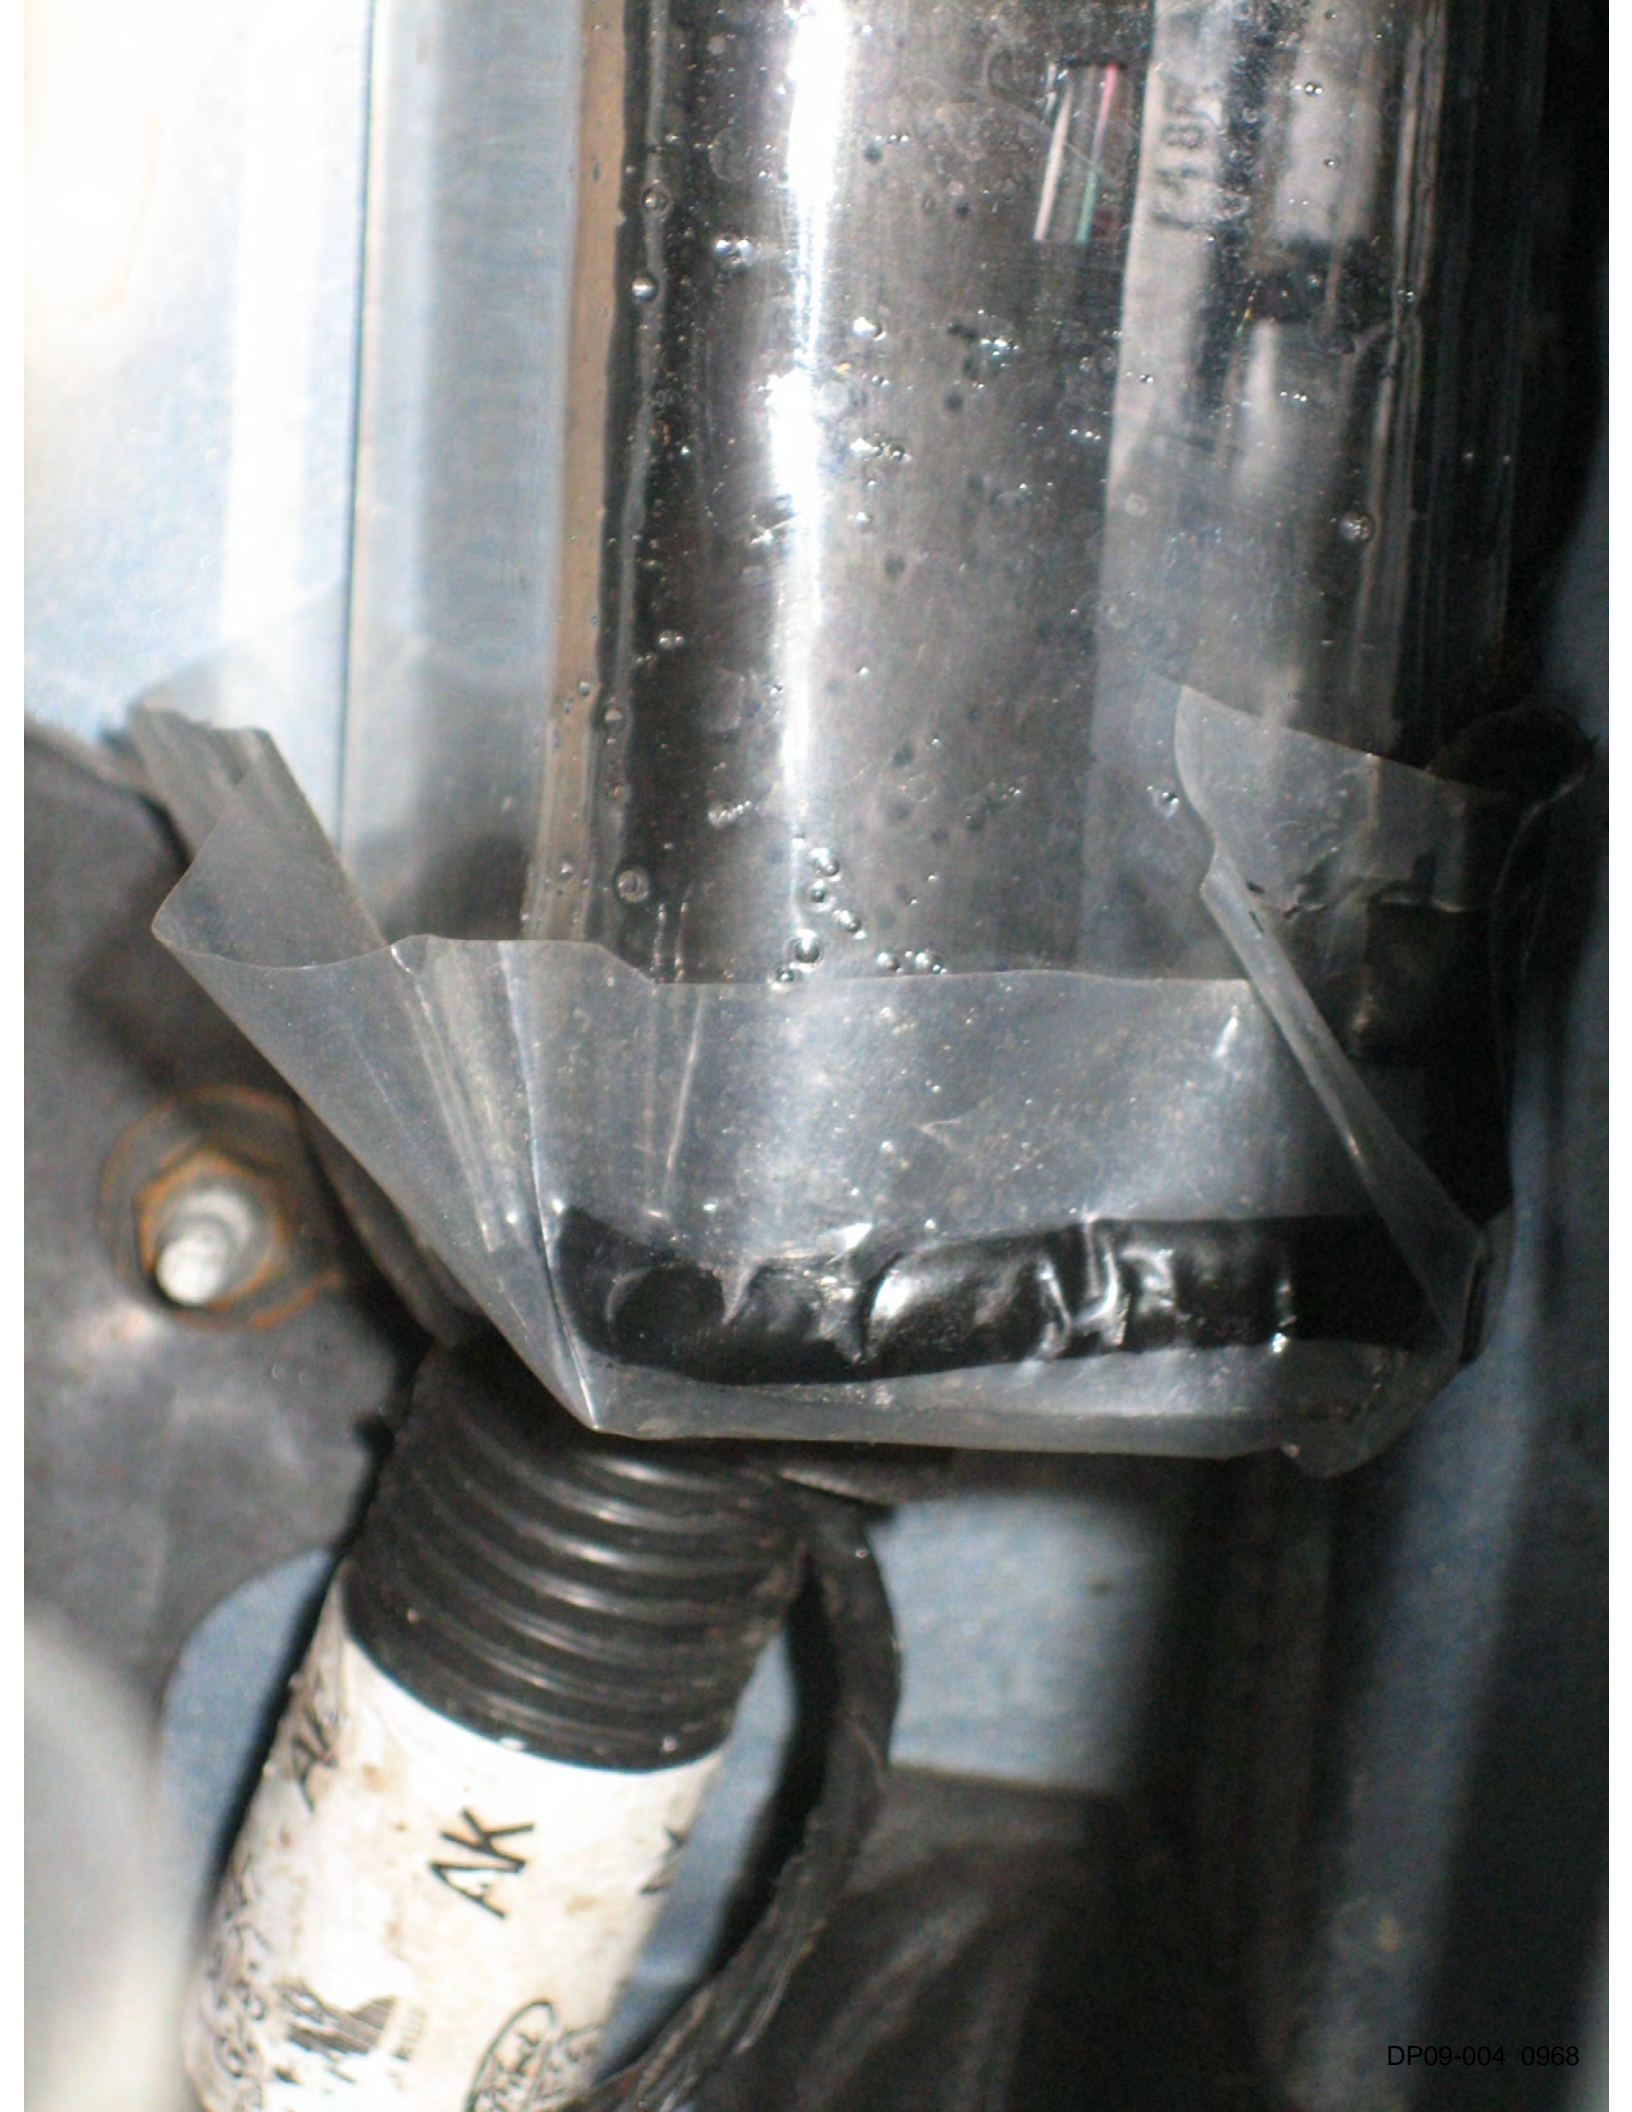
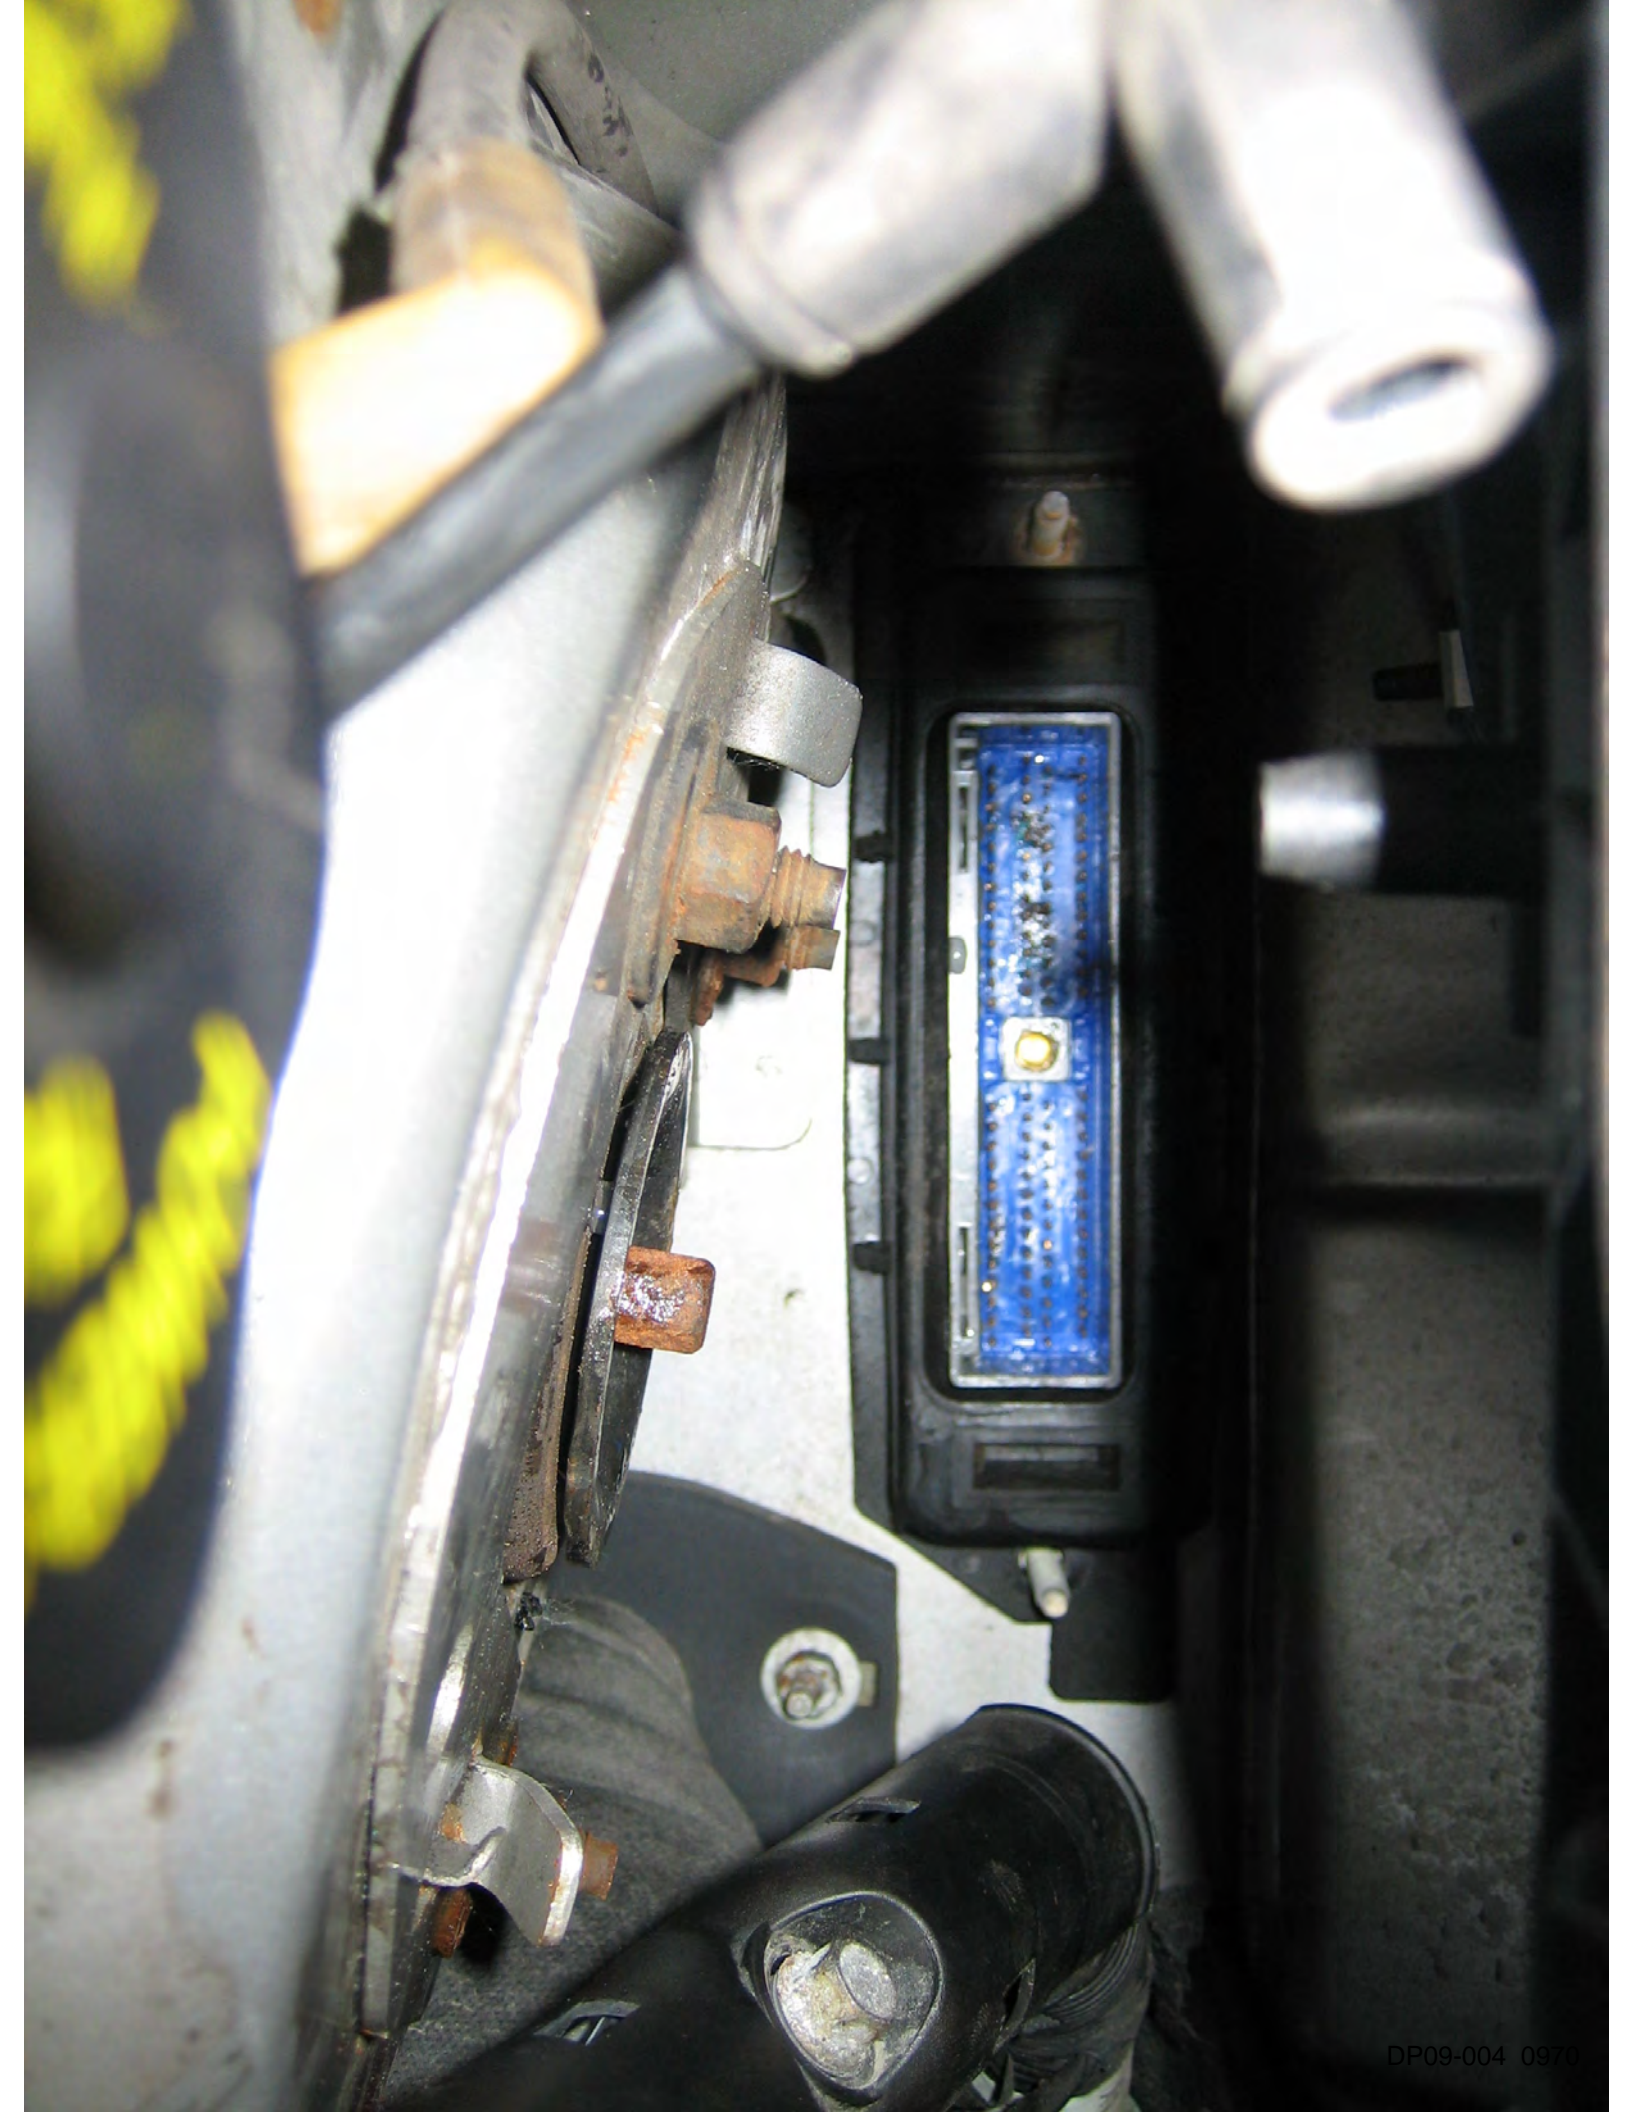
John, as per our conversation earlier here are the digital pic's of the three Freestar's with repeat water intrusion into the PCM. All vehicles have had repeat repairs for water intrusion, also you will notice a make-shift umbrella for the PCM installed by the sublet trim shop. The tech stated all cowls have had the TSB performed and water continues to enter connector. When the PCM was disconnected and removed large amounts of water flowed out, further neither showed any excess amount of foam sealant around the fender/bulkhead joint. All three of the vehicles are presently at Gorno Ford in Woodhaven MI, located on Allen Rd.
