From: Jimmy Lee [JimmyL@DDCC.COM]
Sent: Friday, October 03, 2003 11:19 AM
To: Placha, Diana (D.B.)
Cc: David Faeth; Iarsumi@exedy-us.com; Jeff Cline; KusamizuK; Sean Kawamura; Koji Akita; Mike Berry
Subject: MPI investigation 1991

Re: Ford P/N: E6SP-7F466-AA, Insert-Trans. Converter Cover (MPI P/N: W1818)
Response to QR 925305.

Re: C11578386 G8D#35881 4F50N Differential Failure in Vehicle Durability

Re: C11565485 G8D#34605 4F50N Pump Drive Plate Failure

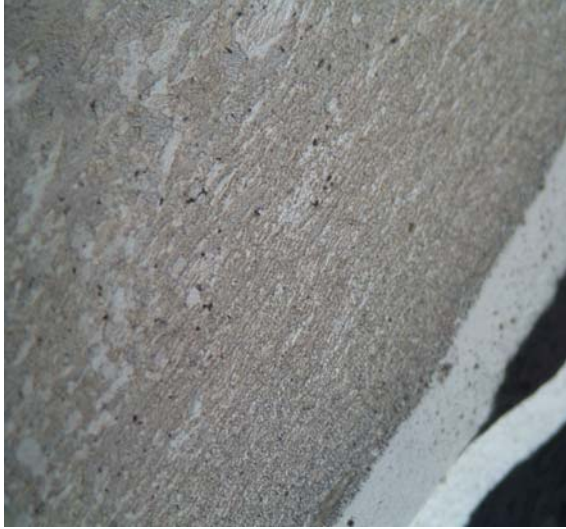
Fig. 1, **Acceptable** – 70,000 Miles Durability Test

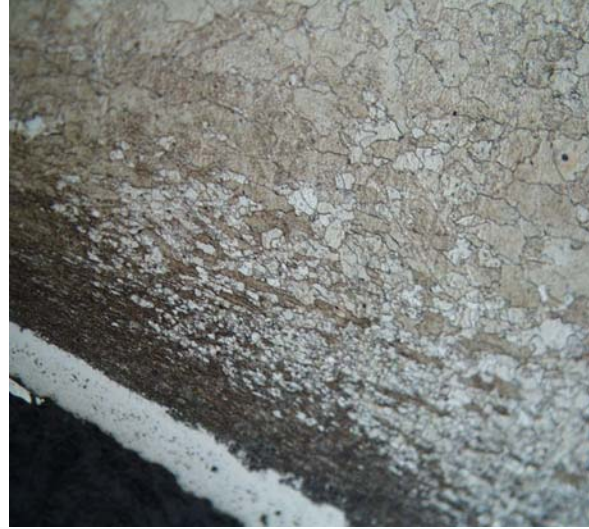
Fig. 2, **Acceptable** Nitrotec Case.

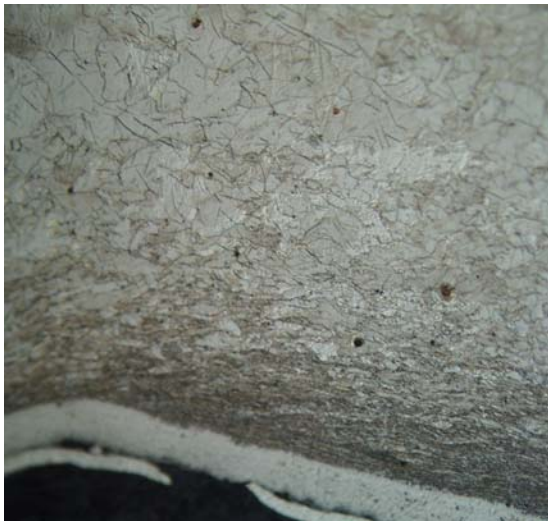
Fig. 3, **Unacceptable** – Nitride Needles Cooled)

5. DZ (diffusion Zone) case evaluations are to be made at 200X magnification on each part looking for abnormalities and "nitride needles". Record on the Shop Order whether Nitride Needles were observed or not. If Nitride Needles are observed, place the job on QC Hold and contact your supervisor for disposition.

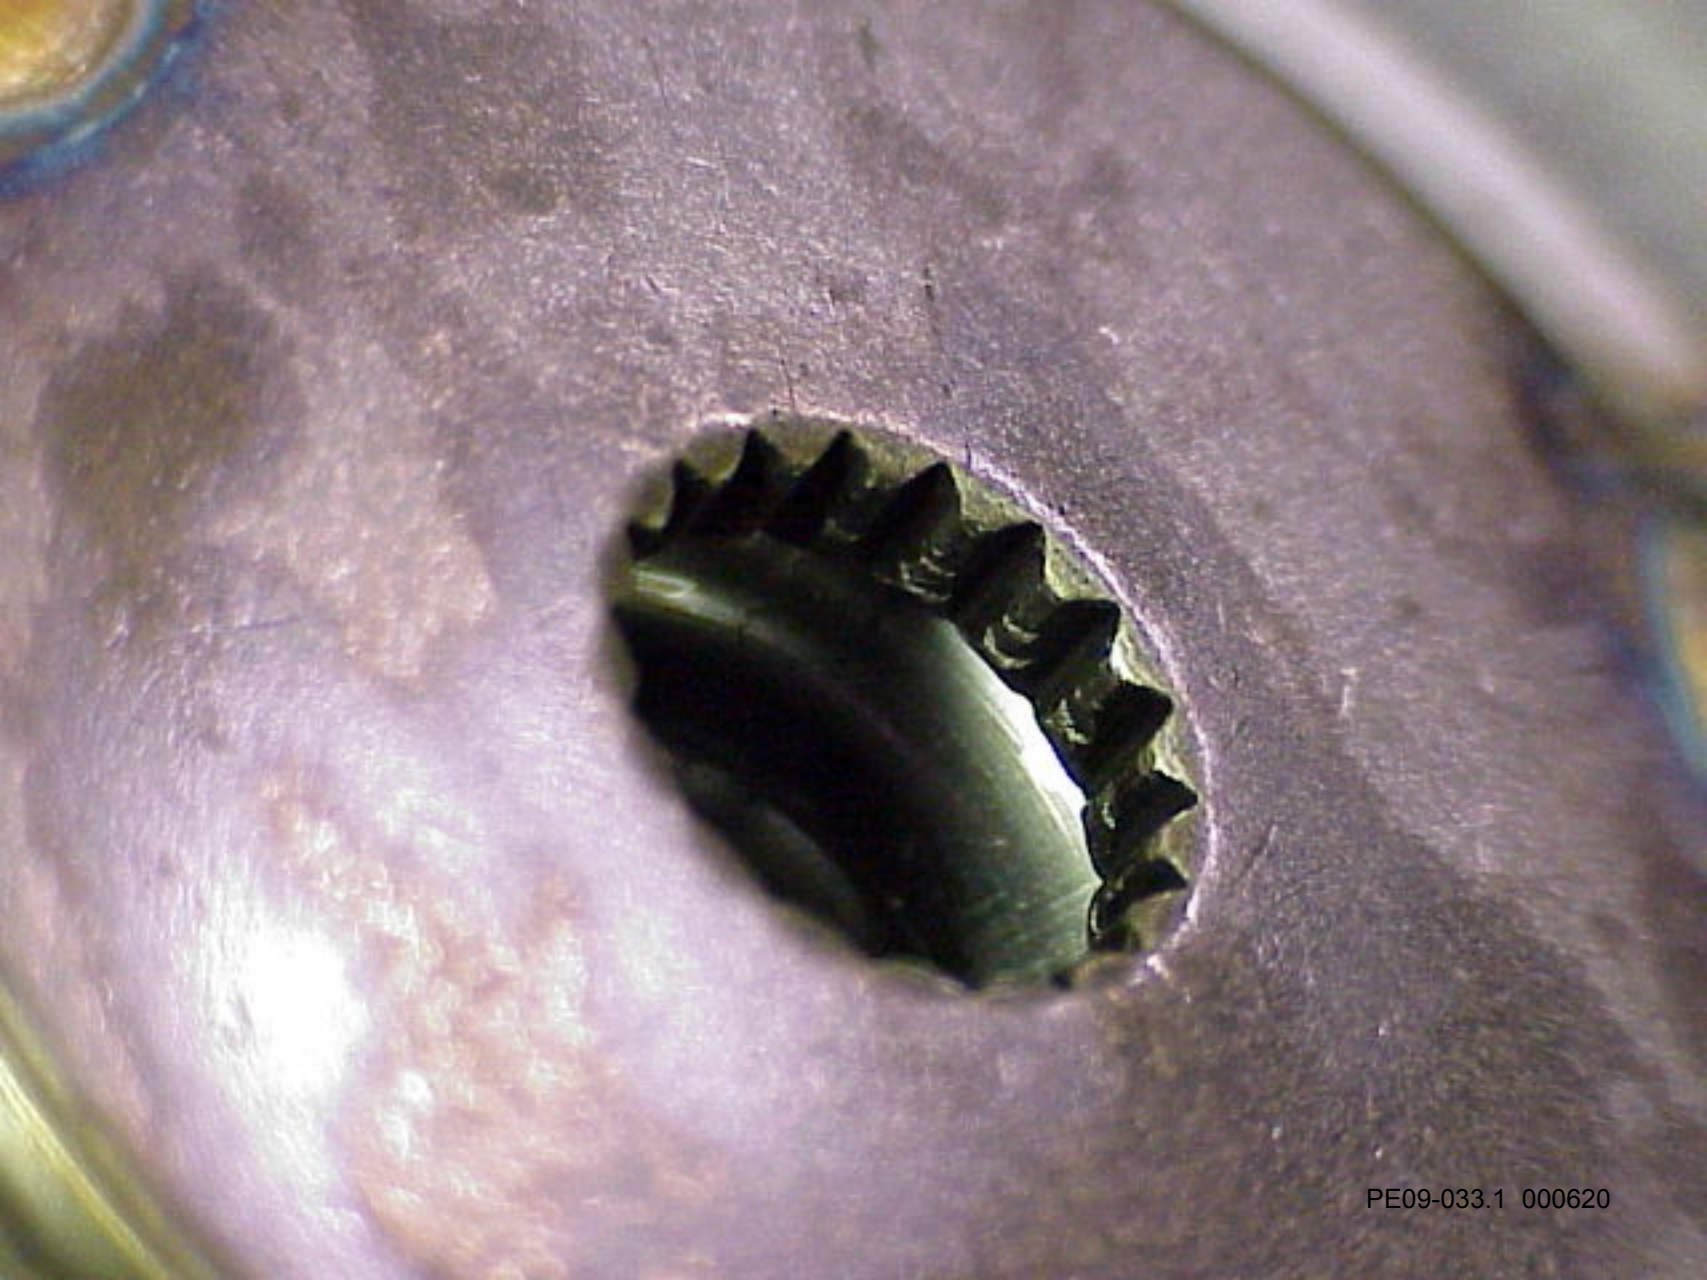
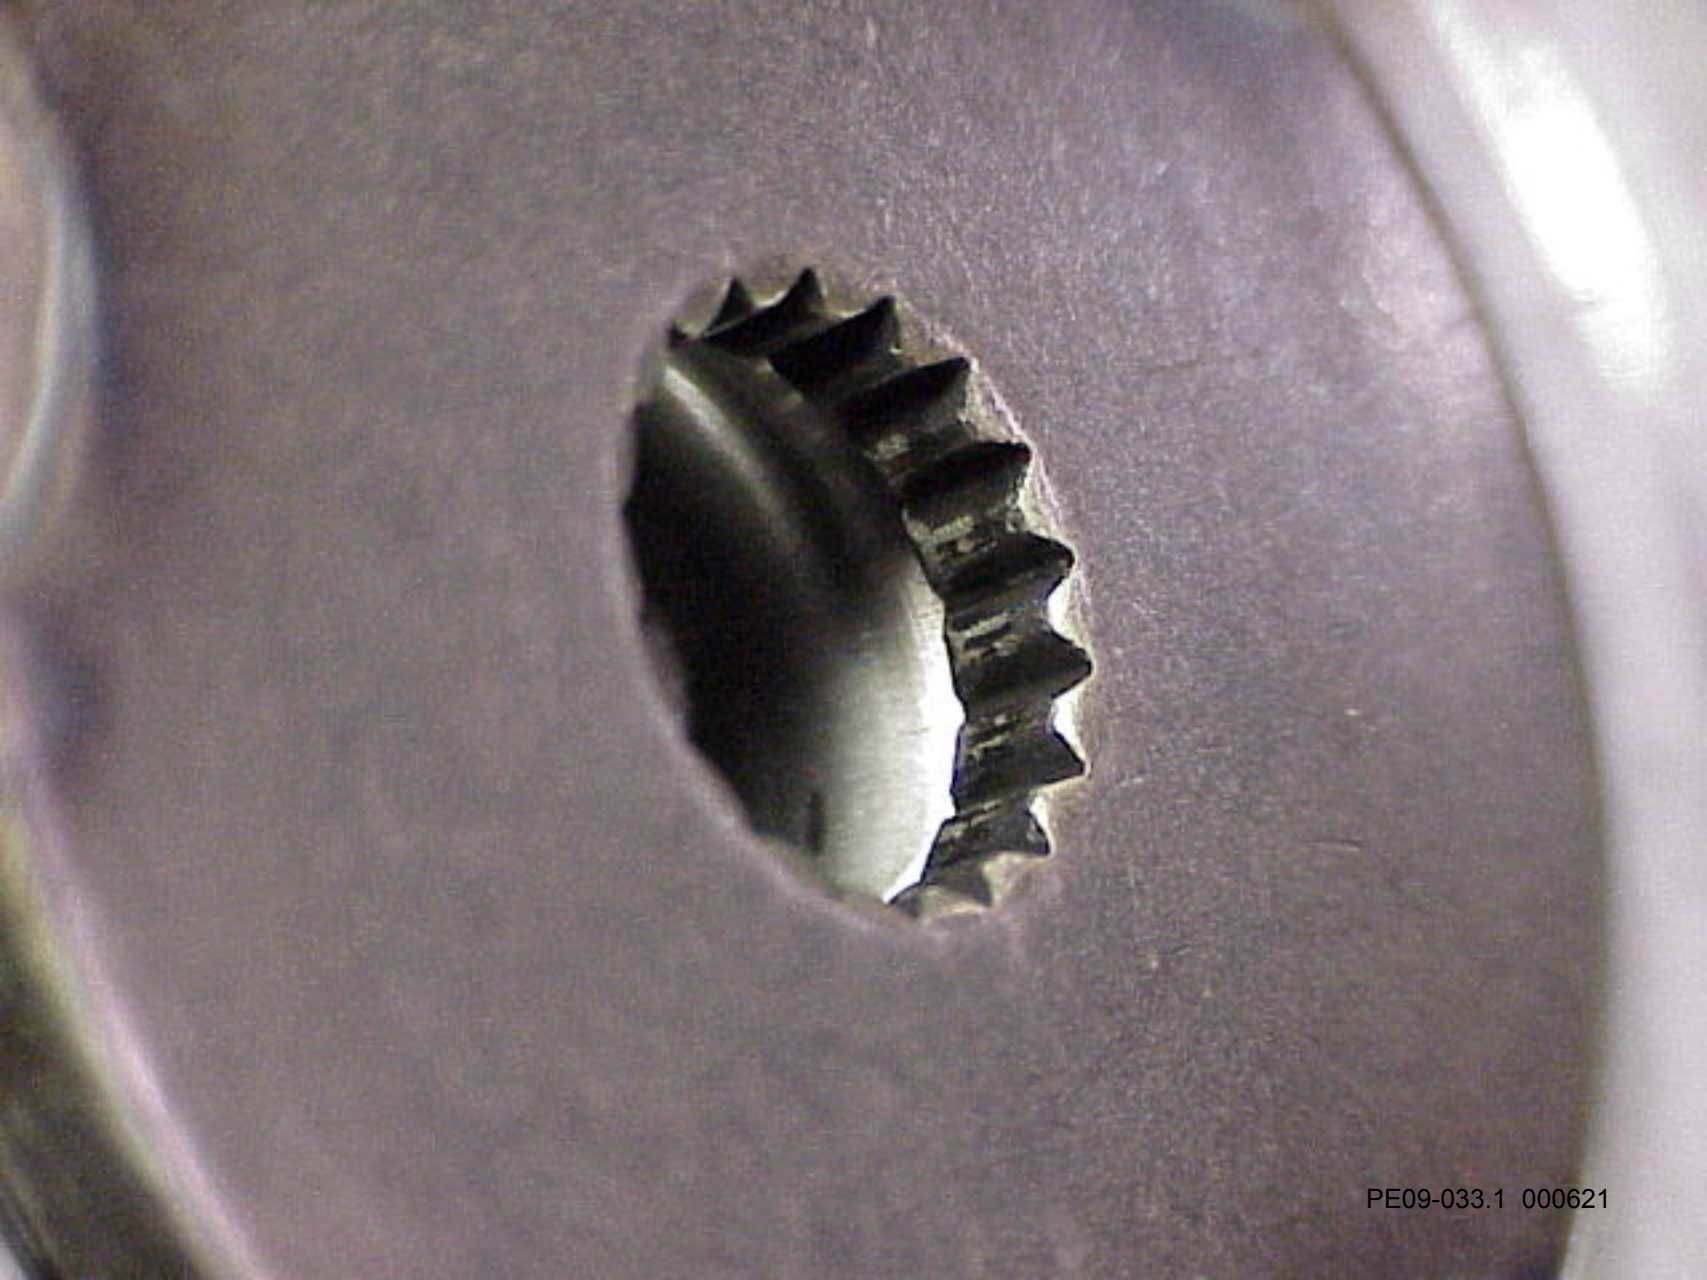
of tearing can be and is limited on this part. We do not feel that the print tolerance (70%) is exceeded on the part in the photo.

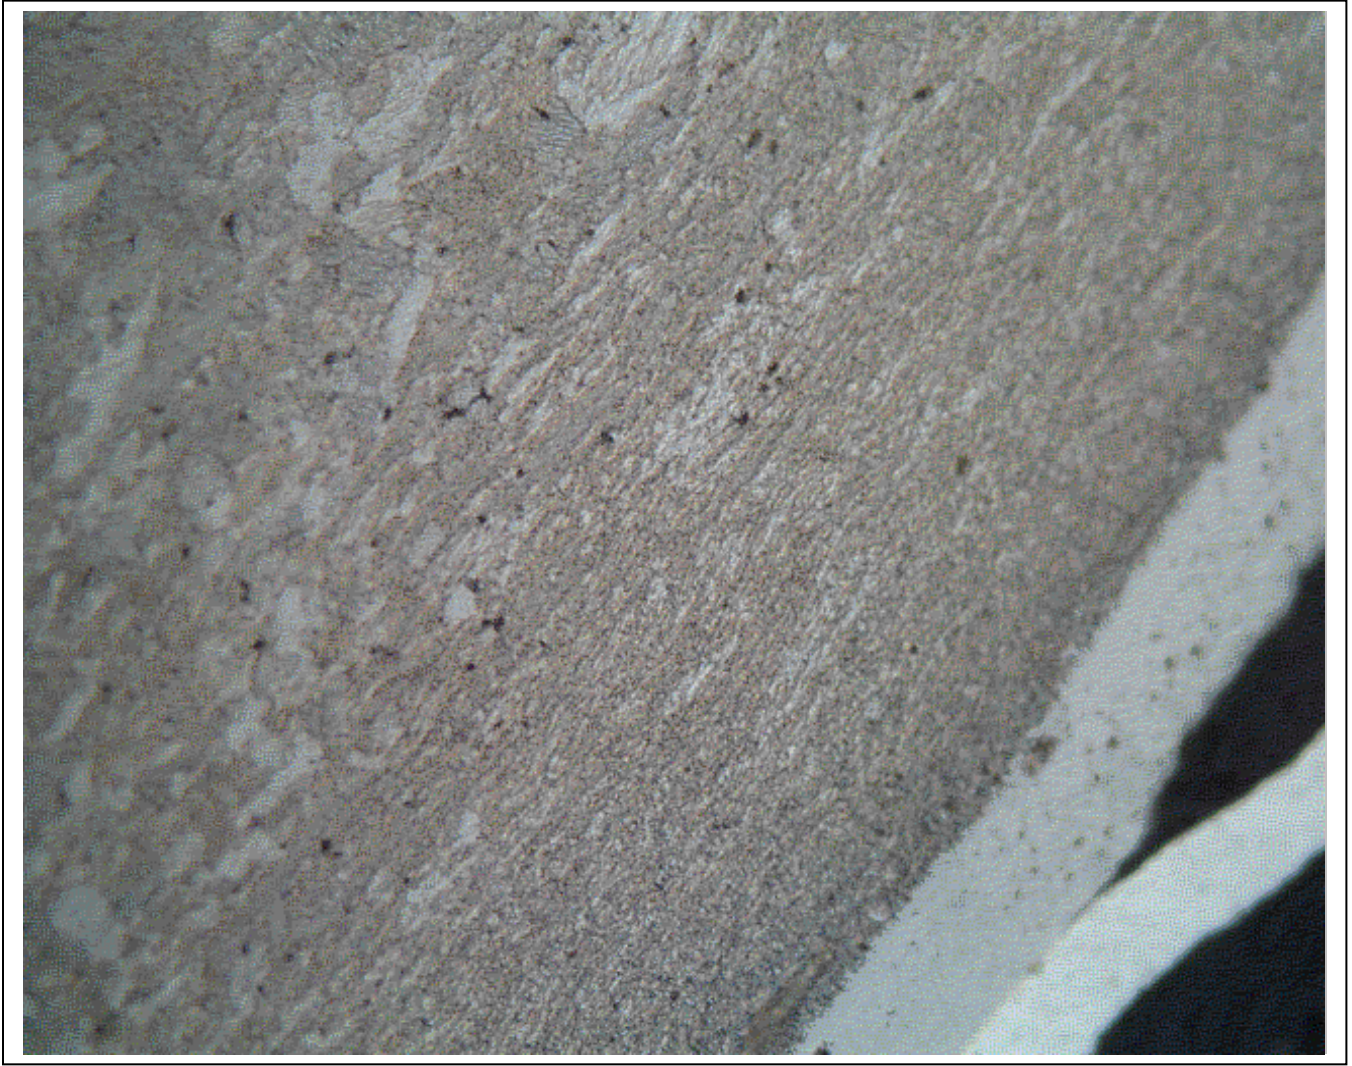
MPI Pic #2 passed 69,544 miles 500X

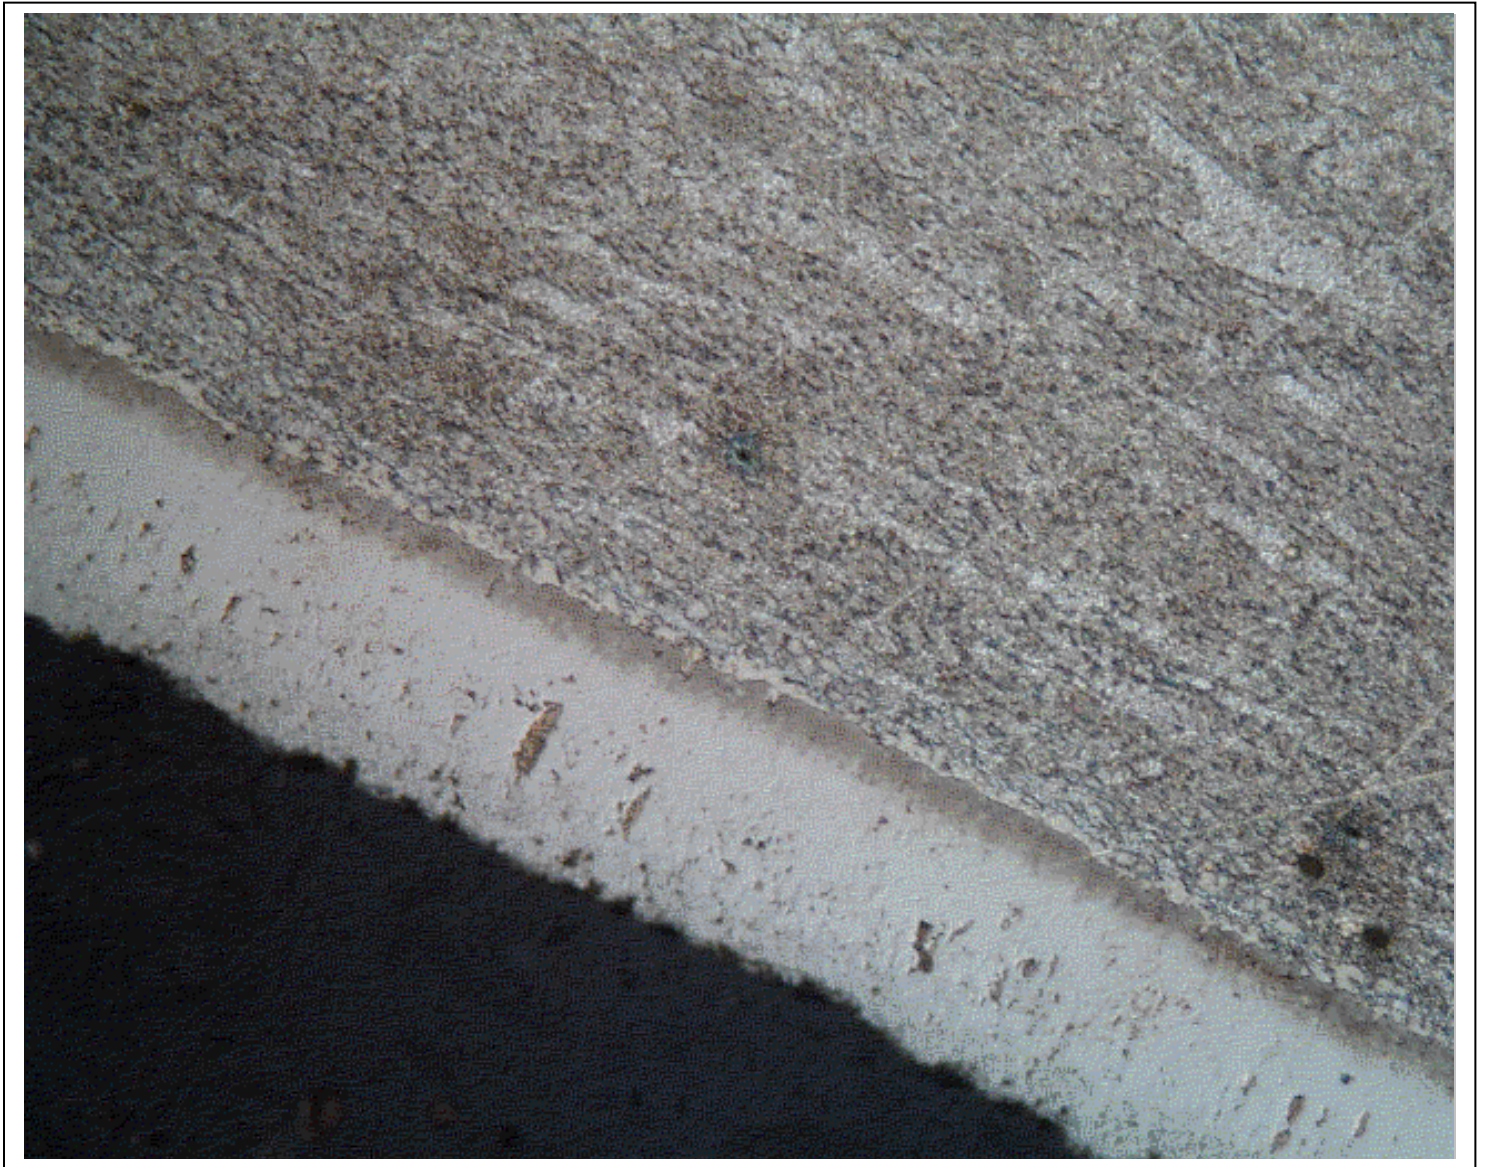
MPI Pic #4 current production 10-03 500X 400F

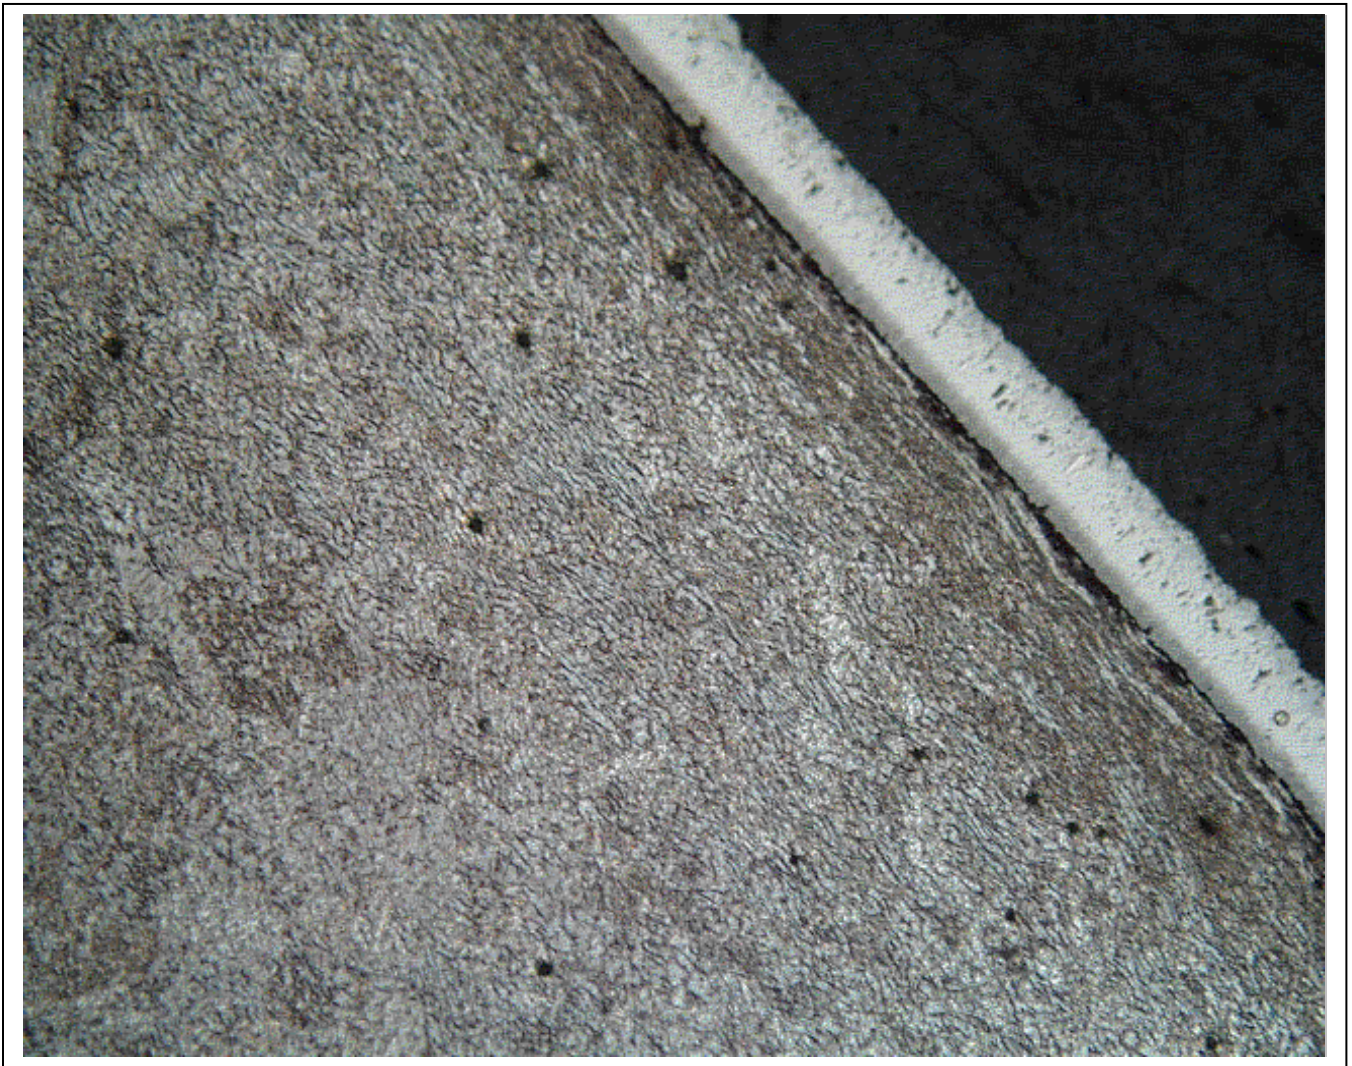
MPI Pic #7 current production 10/03 200X 600F

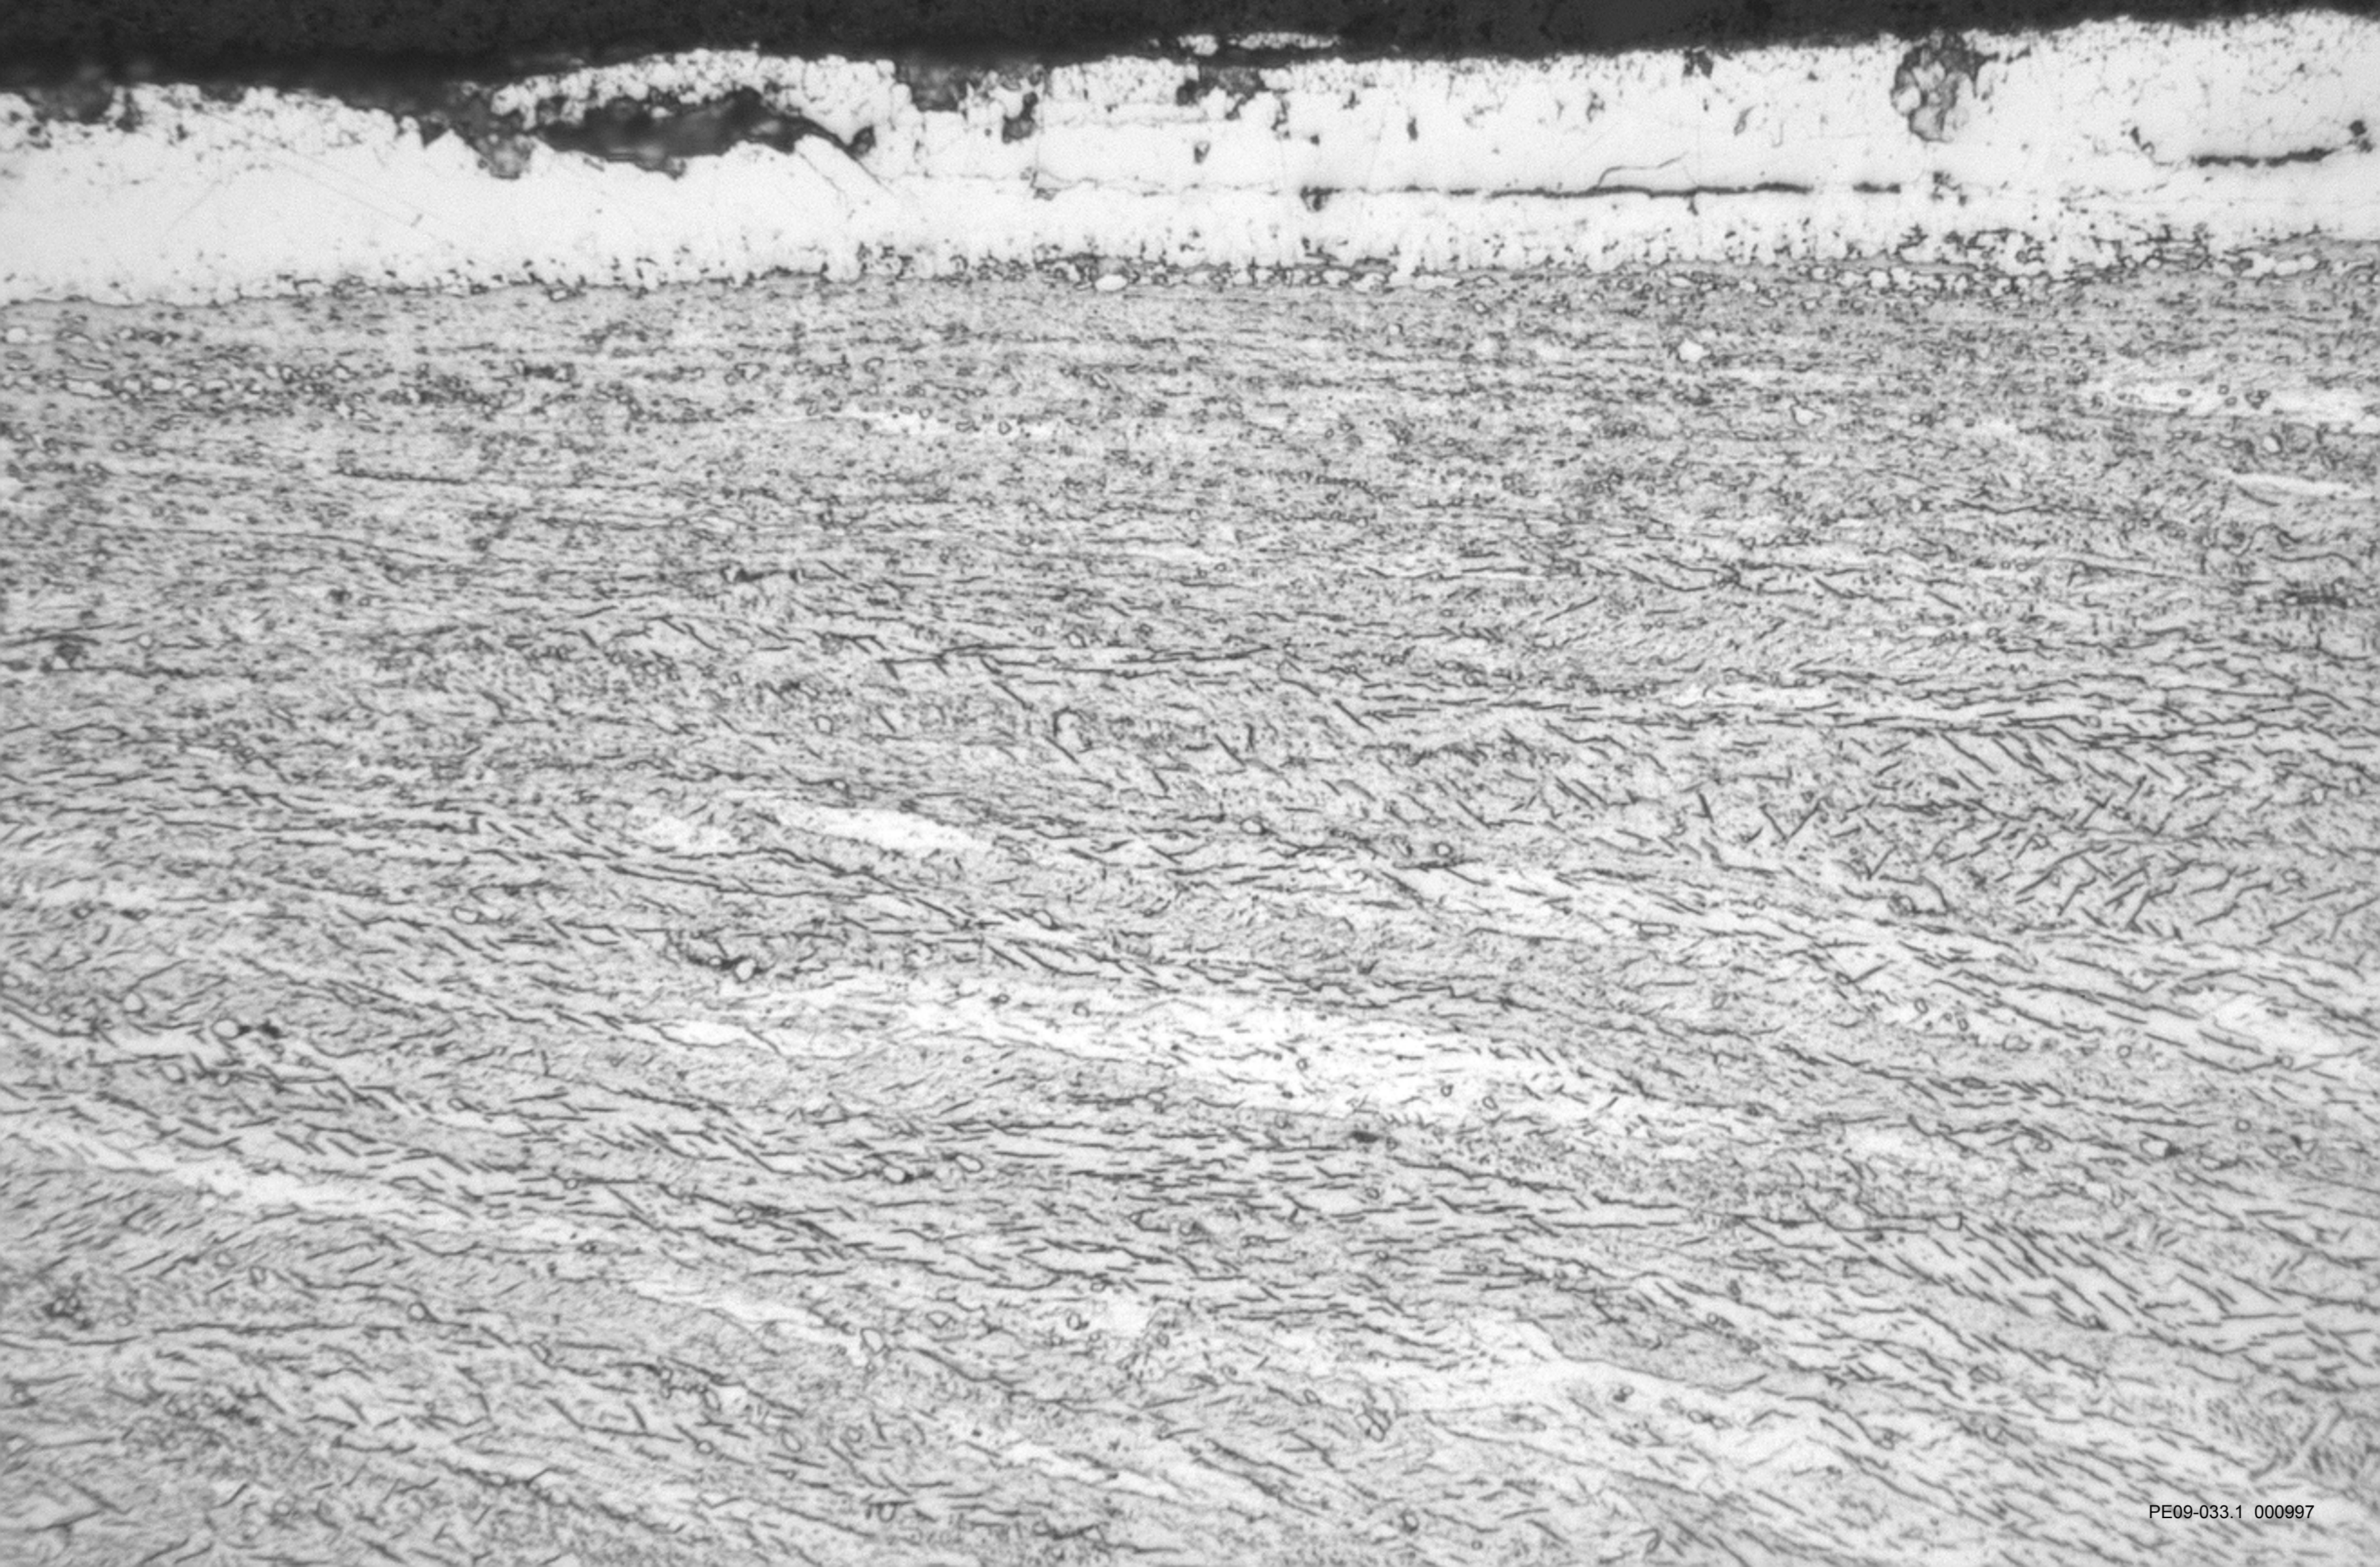
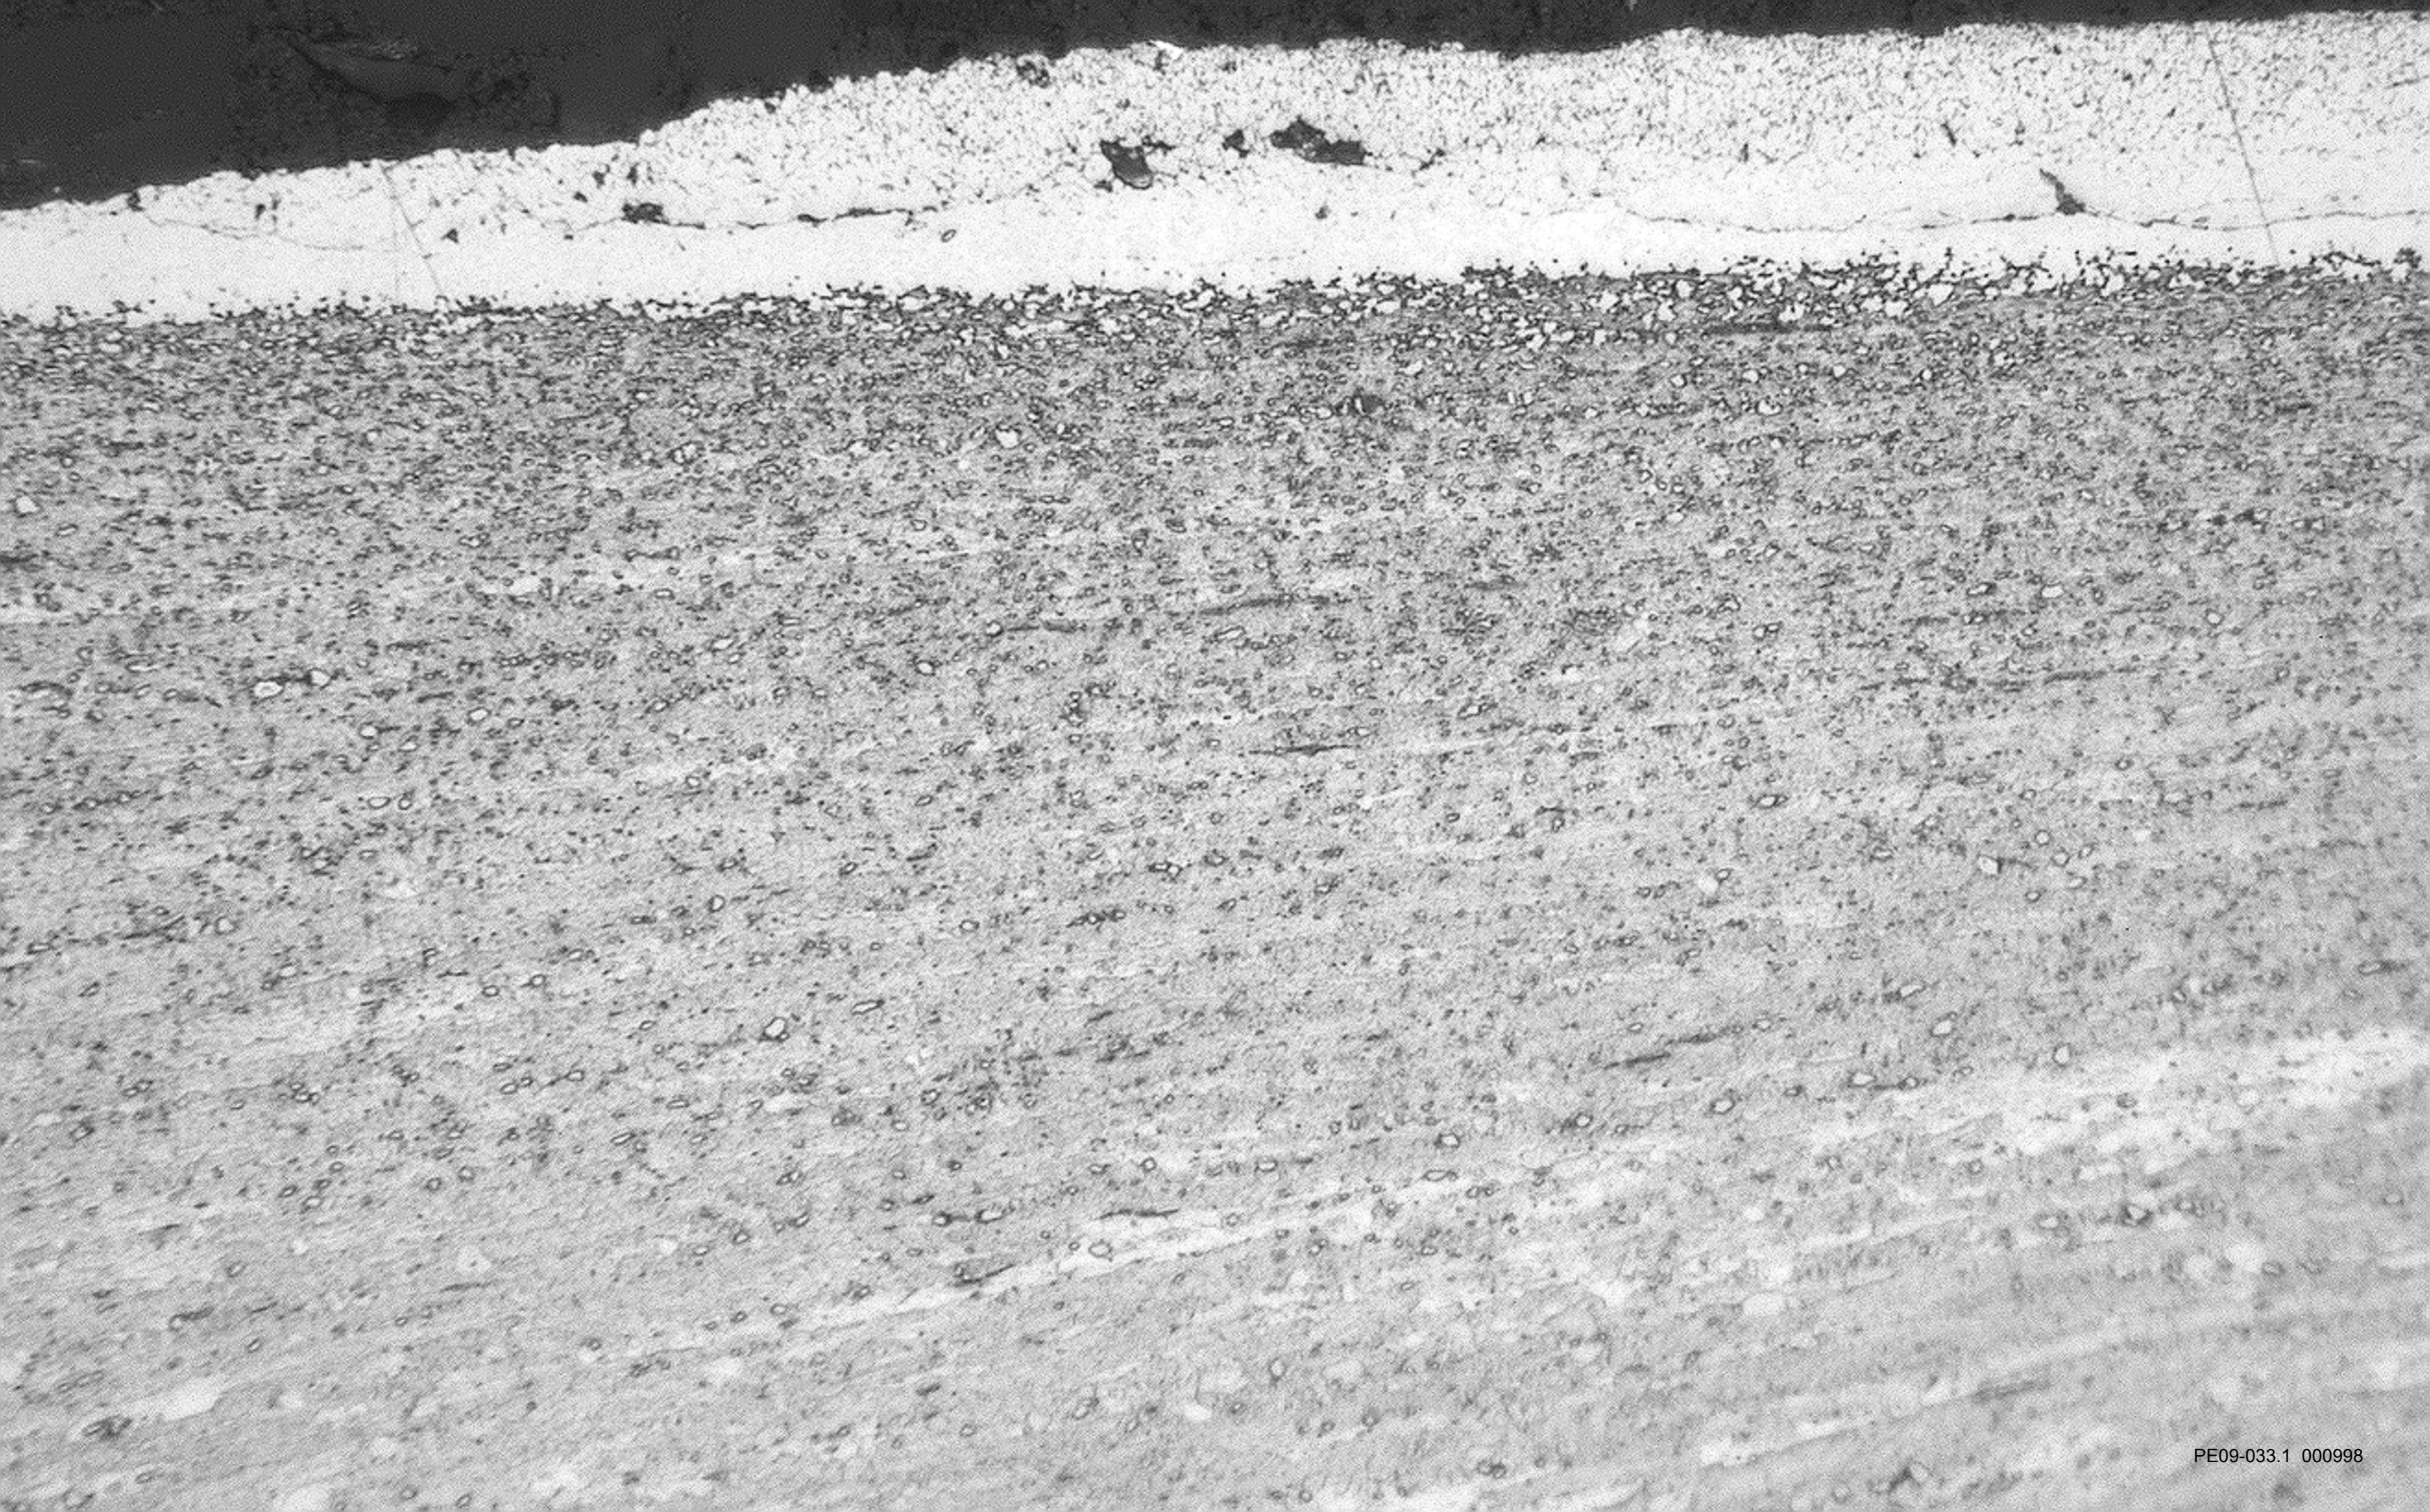
Here are the photos that depict nitrite needles vs. no needles. Sample 1 is the failed part and Sample 4 is a un-used vintage part. According to Joel, a new un-used part from the same build date as the failed part has case structure and hardness similar to Sample 1. As soon as I receive the photo from Joel I'll forward it to everyone.
