From: Jimmy Lee [JimmyL@DDCC.COM]
Sent: Friday, October 03, 2003 11:19 AM
To: Placha, Diana (D.B.)
Cc: David Faeth; Iarsumi@exedy-us.com; Jeff Cline; KusamizuK; Sean Kawamura; Koji Akita; Mike Berry
Subject: MPI investigation 1991

Re: Ford P/N: E6SP-7F466-AA, Insert-Trans. Converter Cover (MPI P/N: W1818)
Response to QR 925305.

Re: C11578386 G8D#35881 4F50N Differential Failure in Vehicle Durability

Re: C11565485 G8D#34605 4F50N Pump Drive Plate Failure

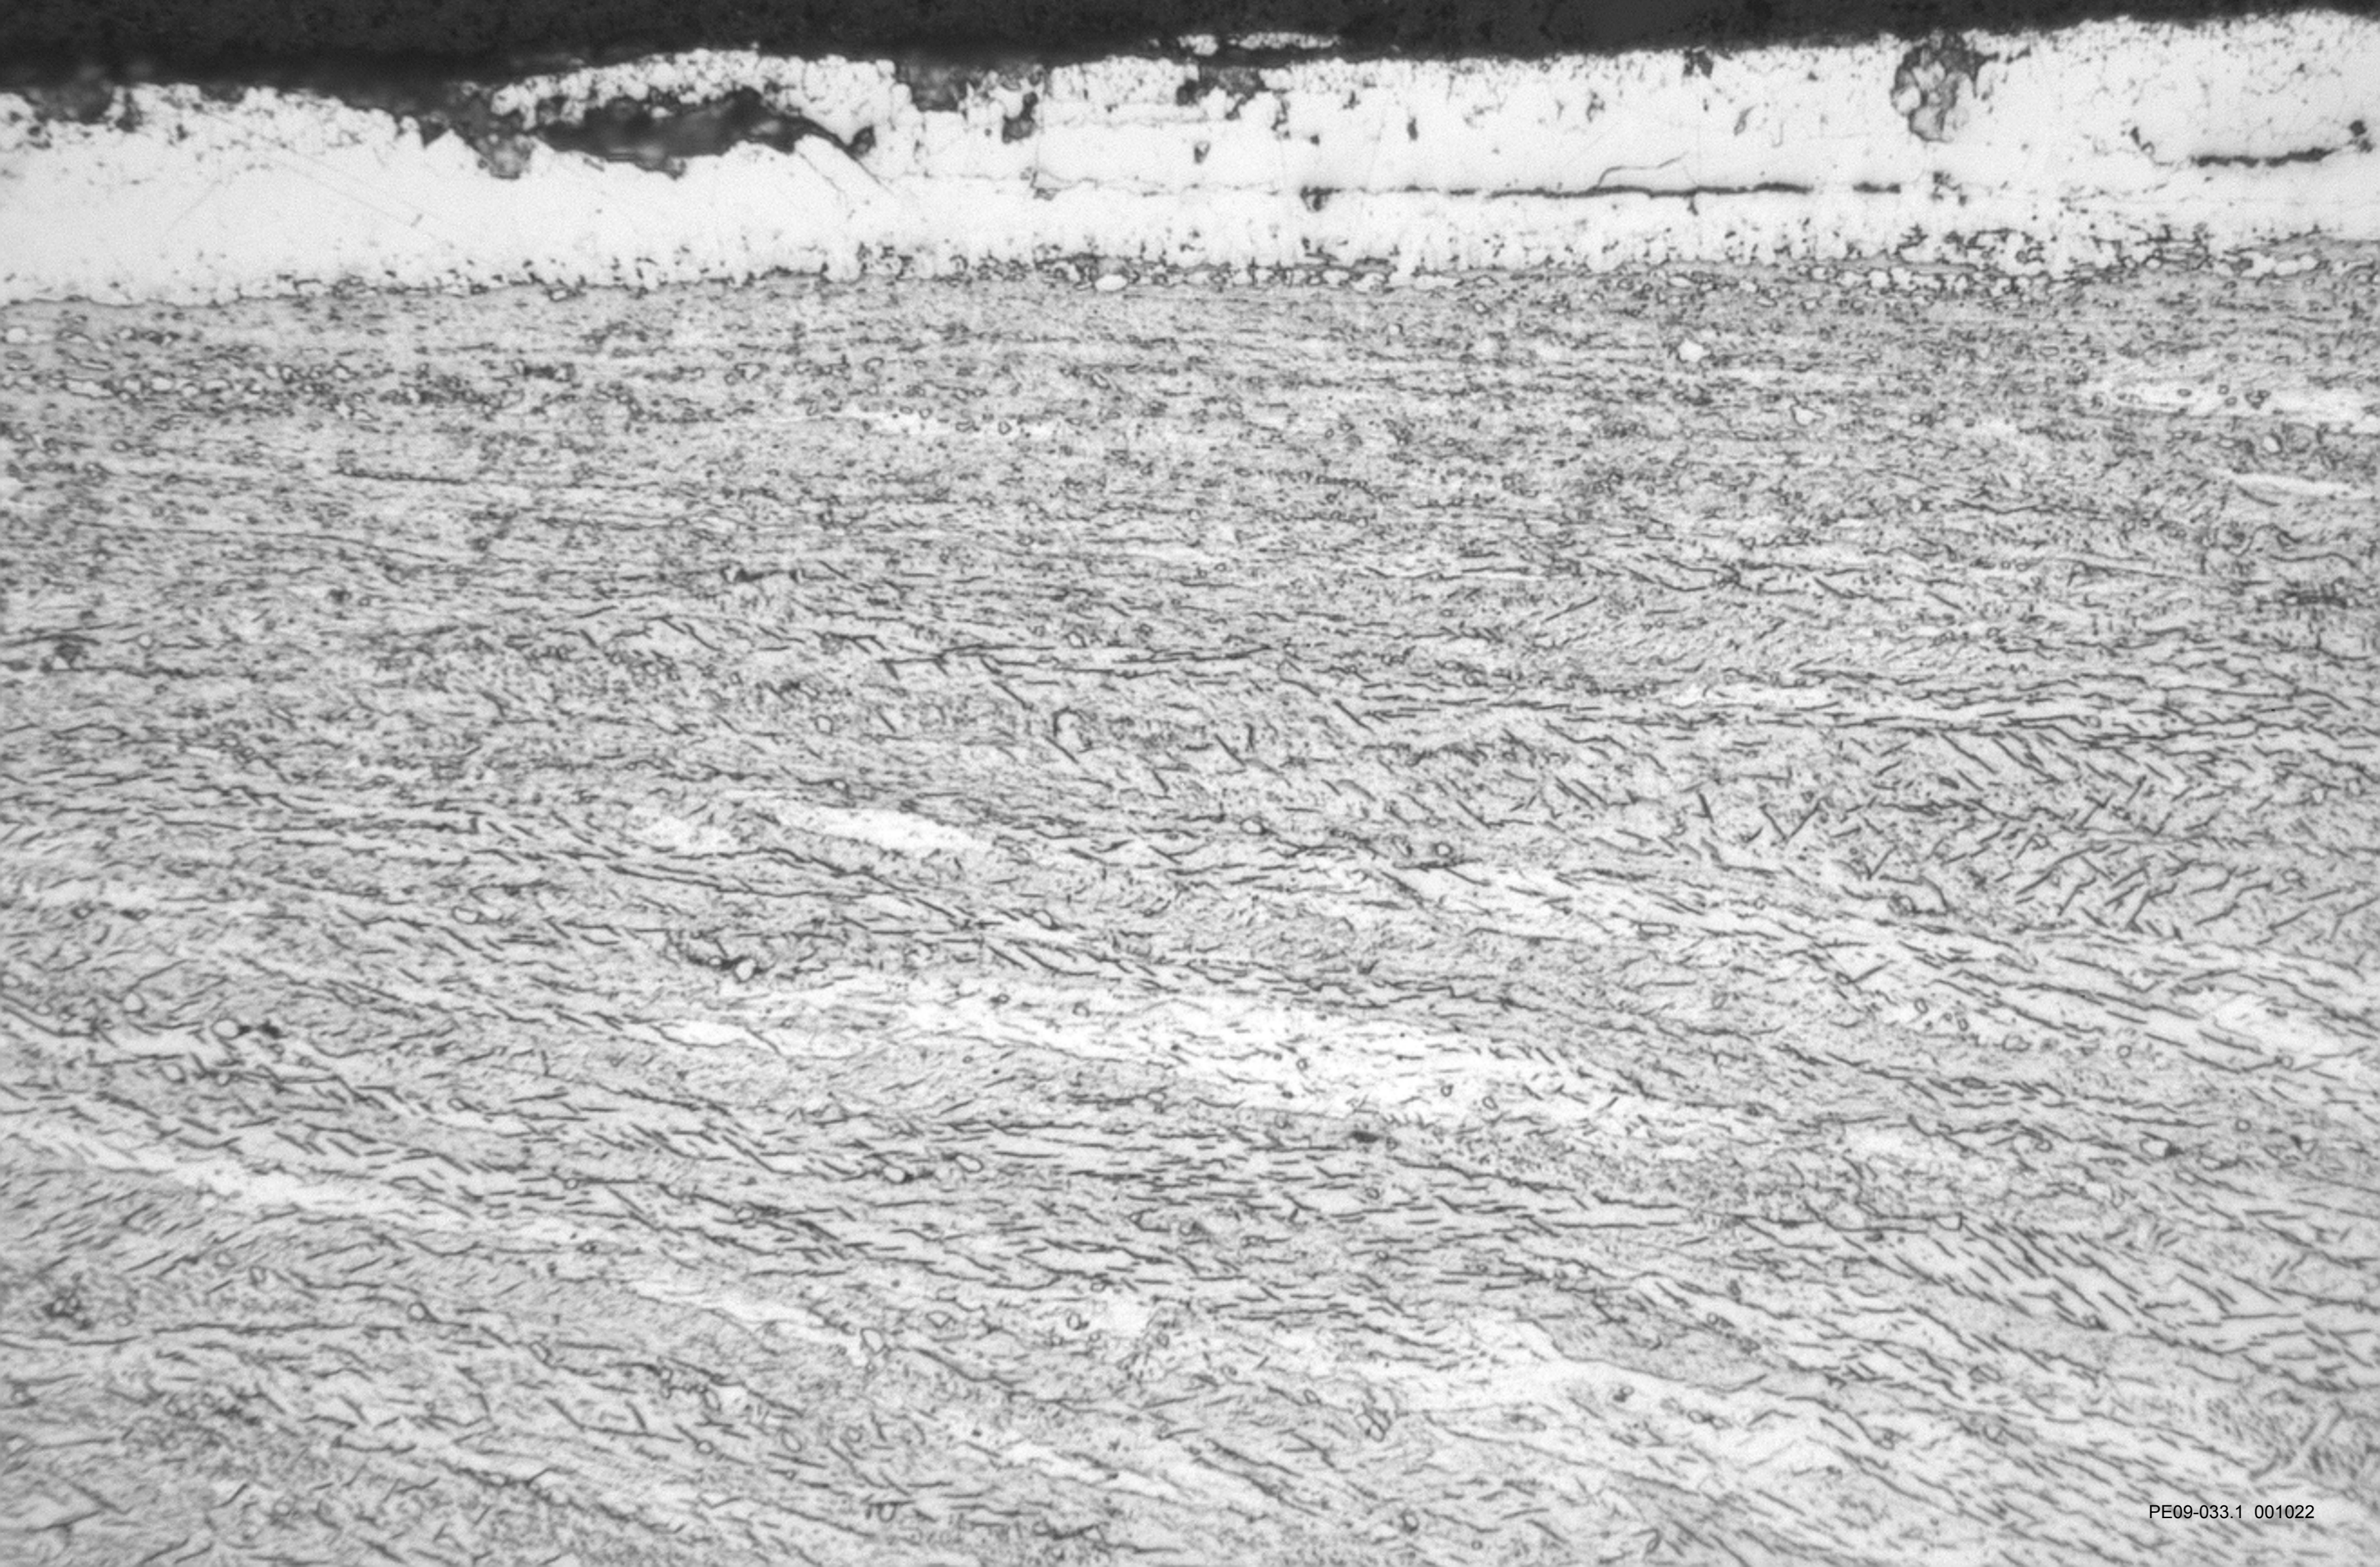
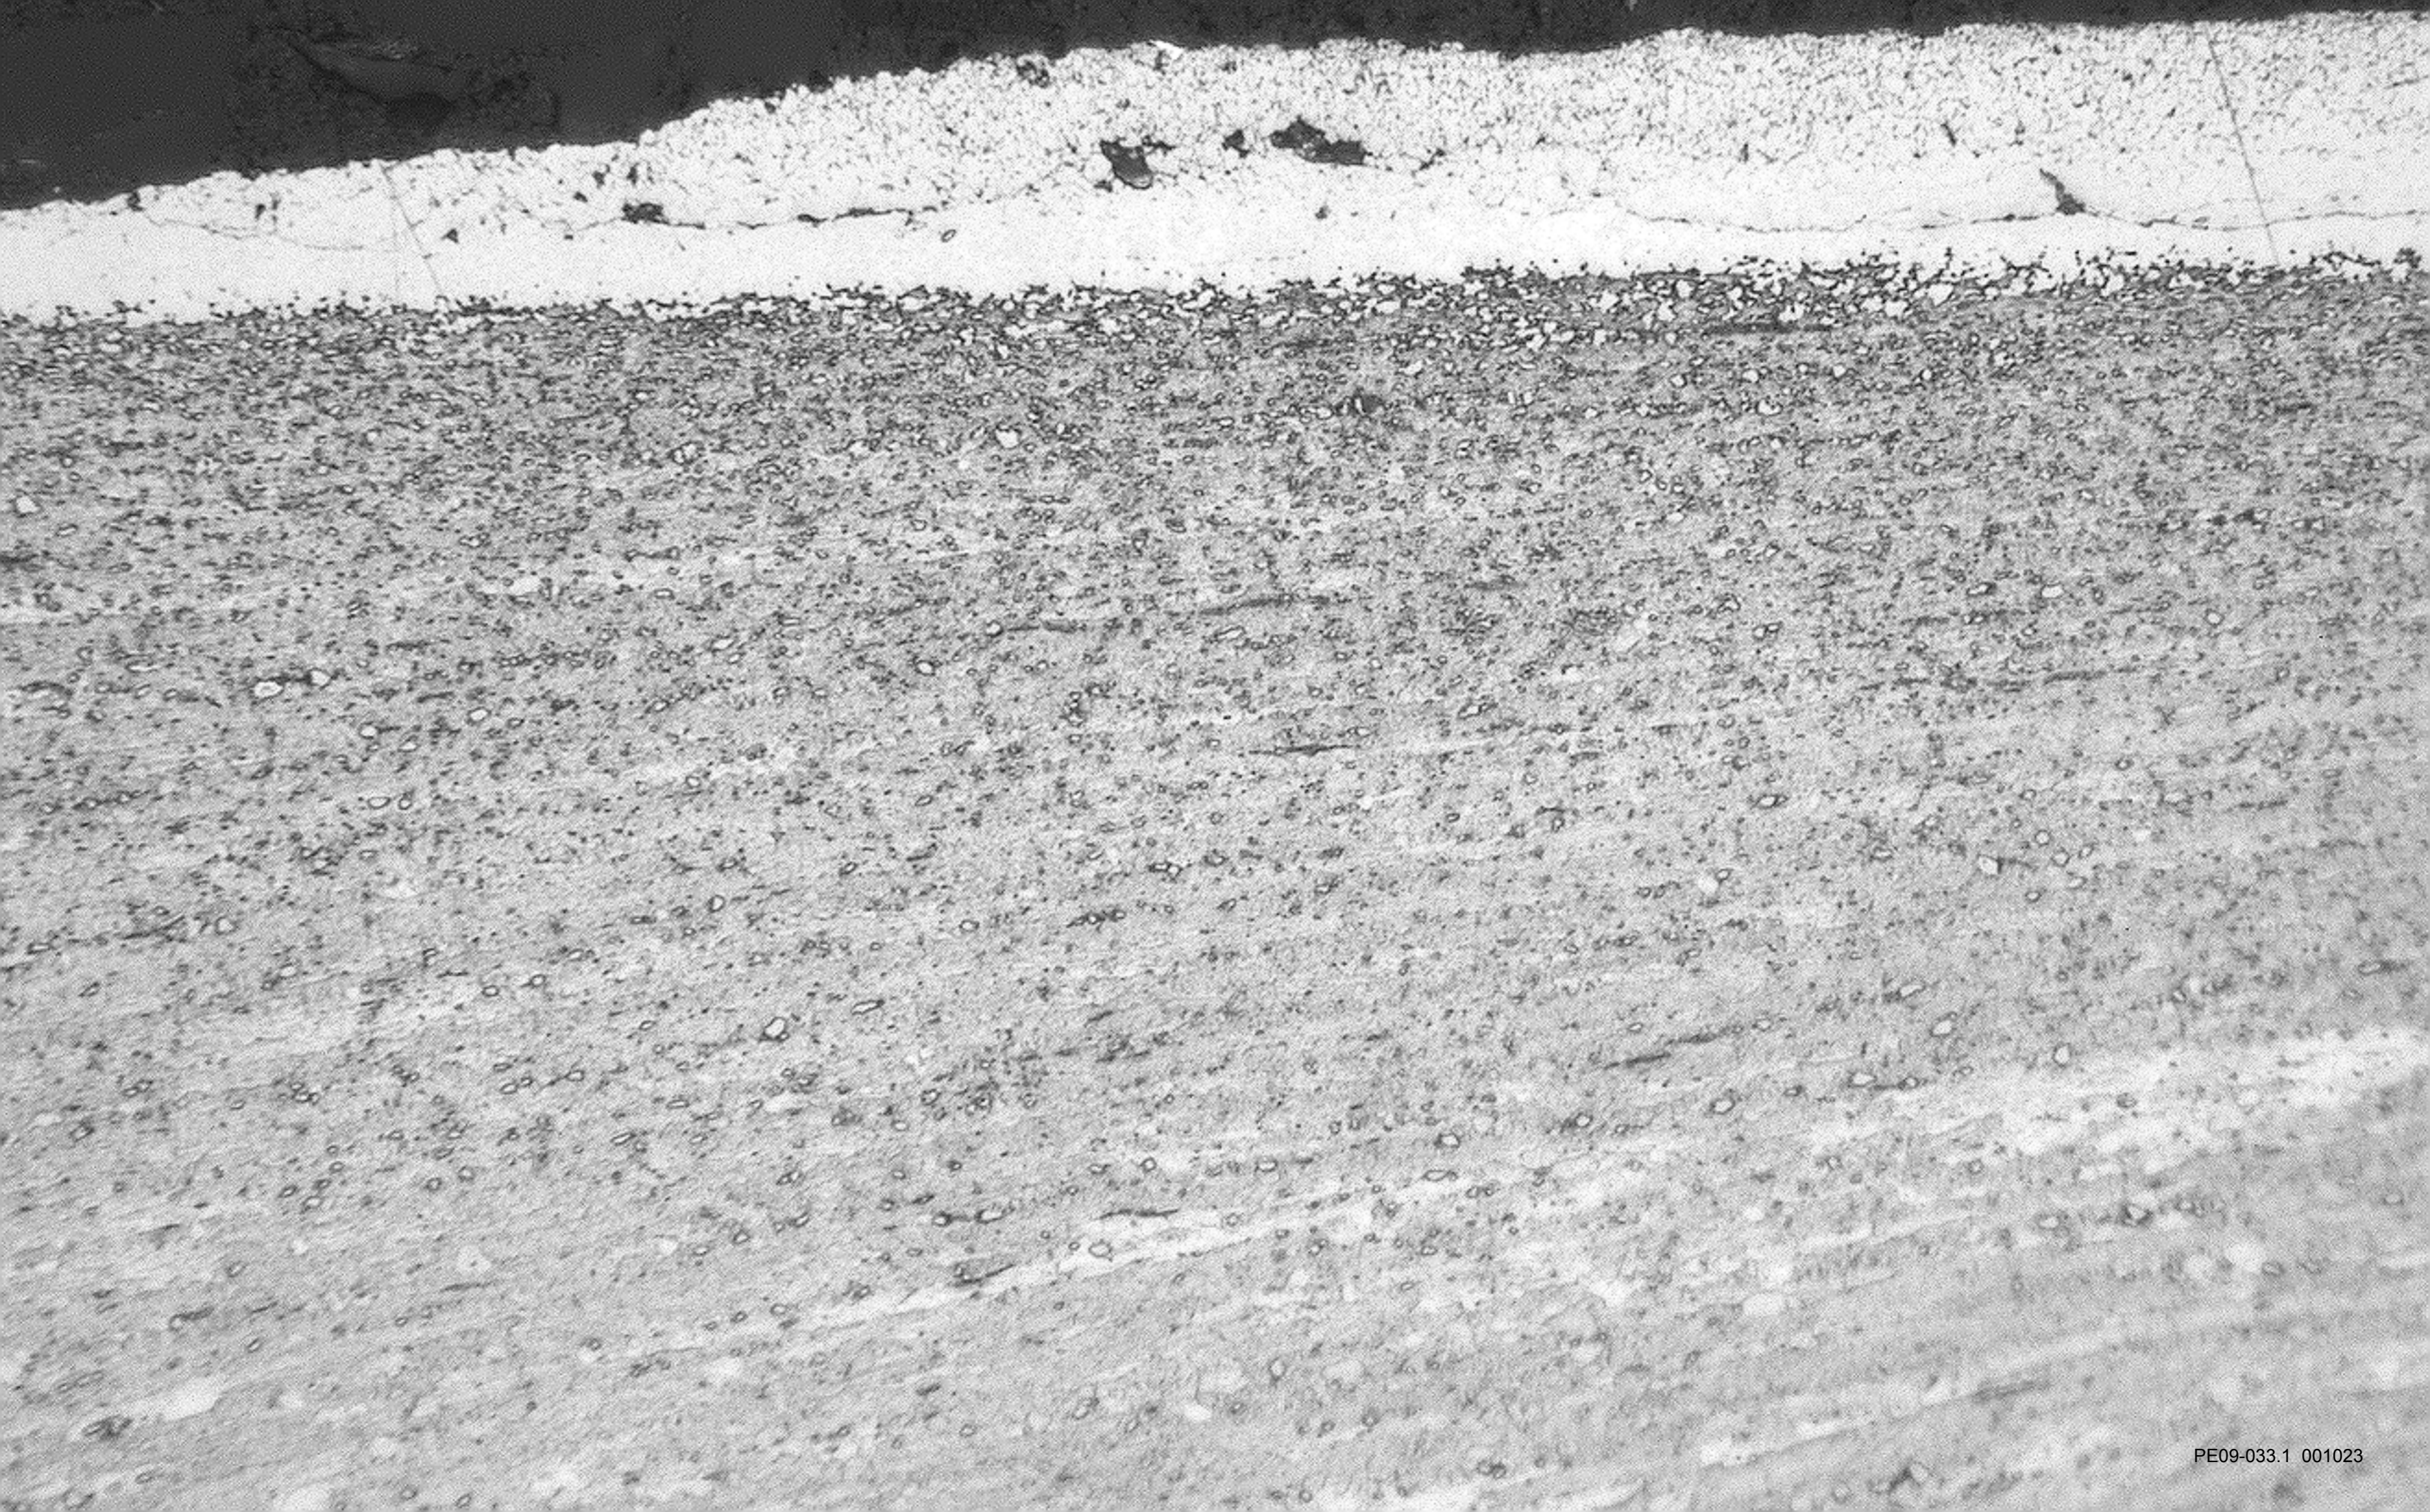
Diana,
These photos were on the w drive already. Sample 1 is the failed sample. Sample 4 is the Vintage. Please give me a call if you would like to discuss them further. Would you like me to post a sample 3 photo (I probably should before the meeting). It will take a little while to do that, I'm tied up with another project.

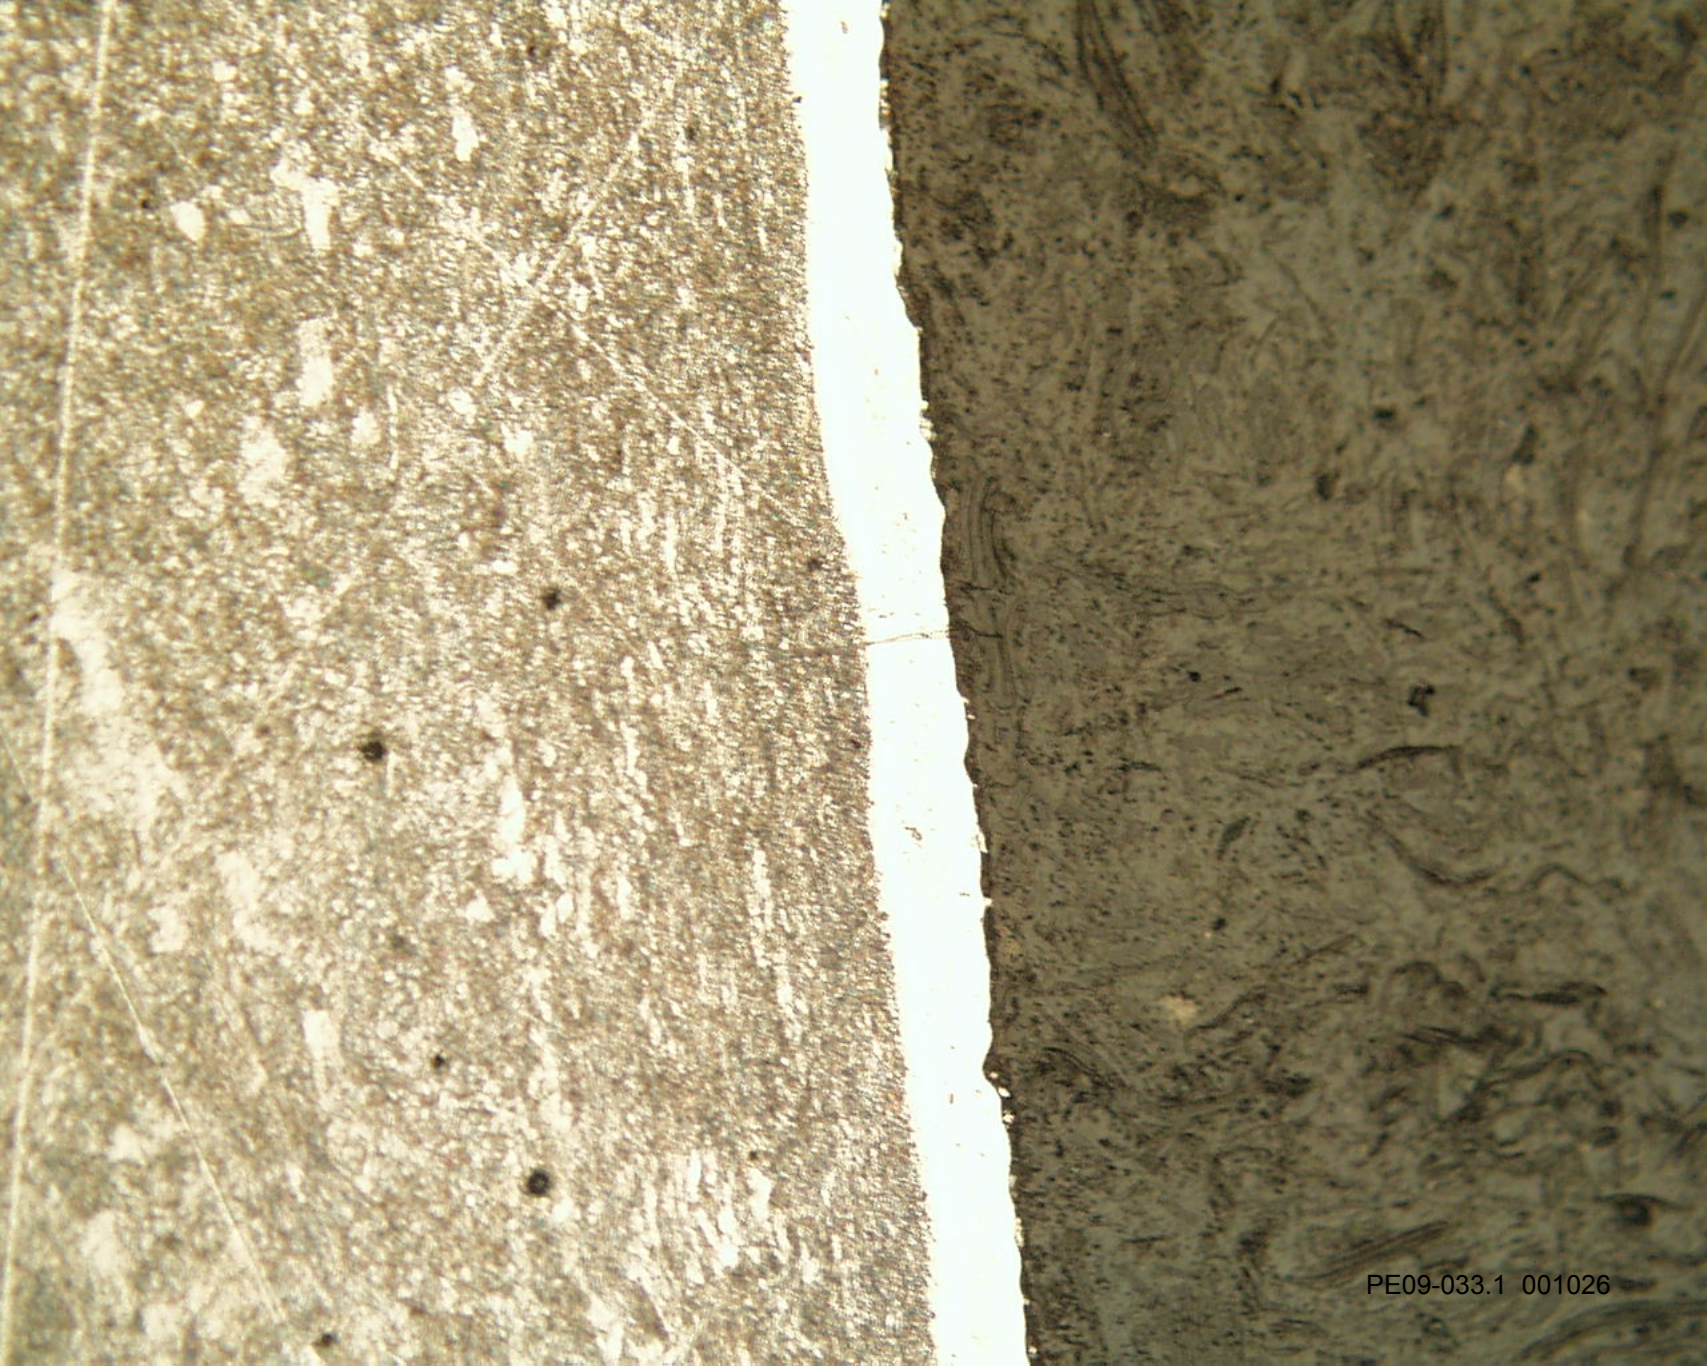
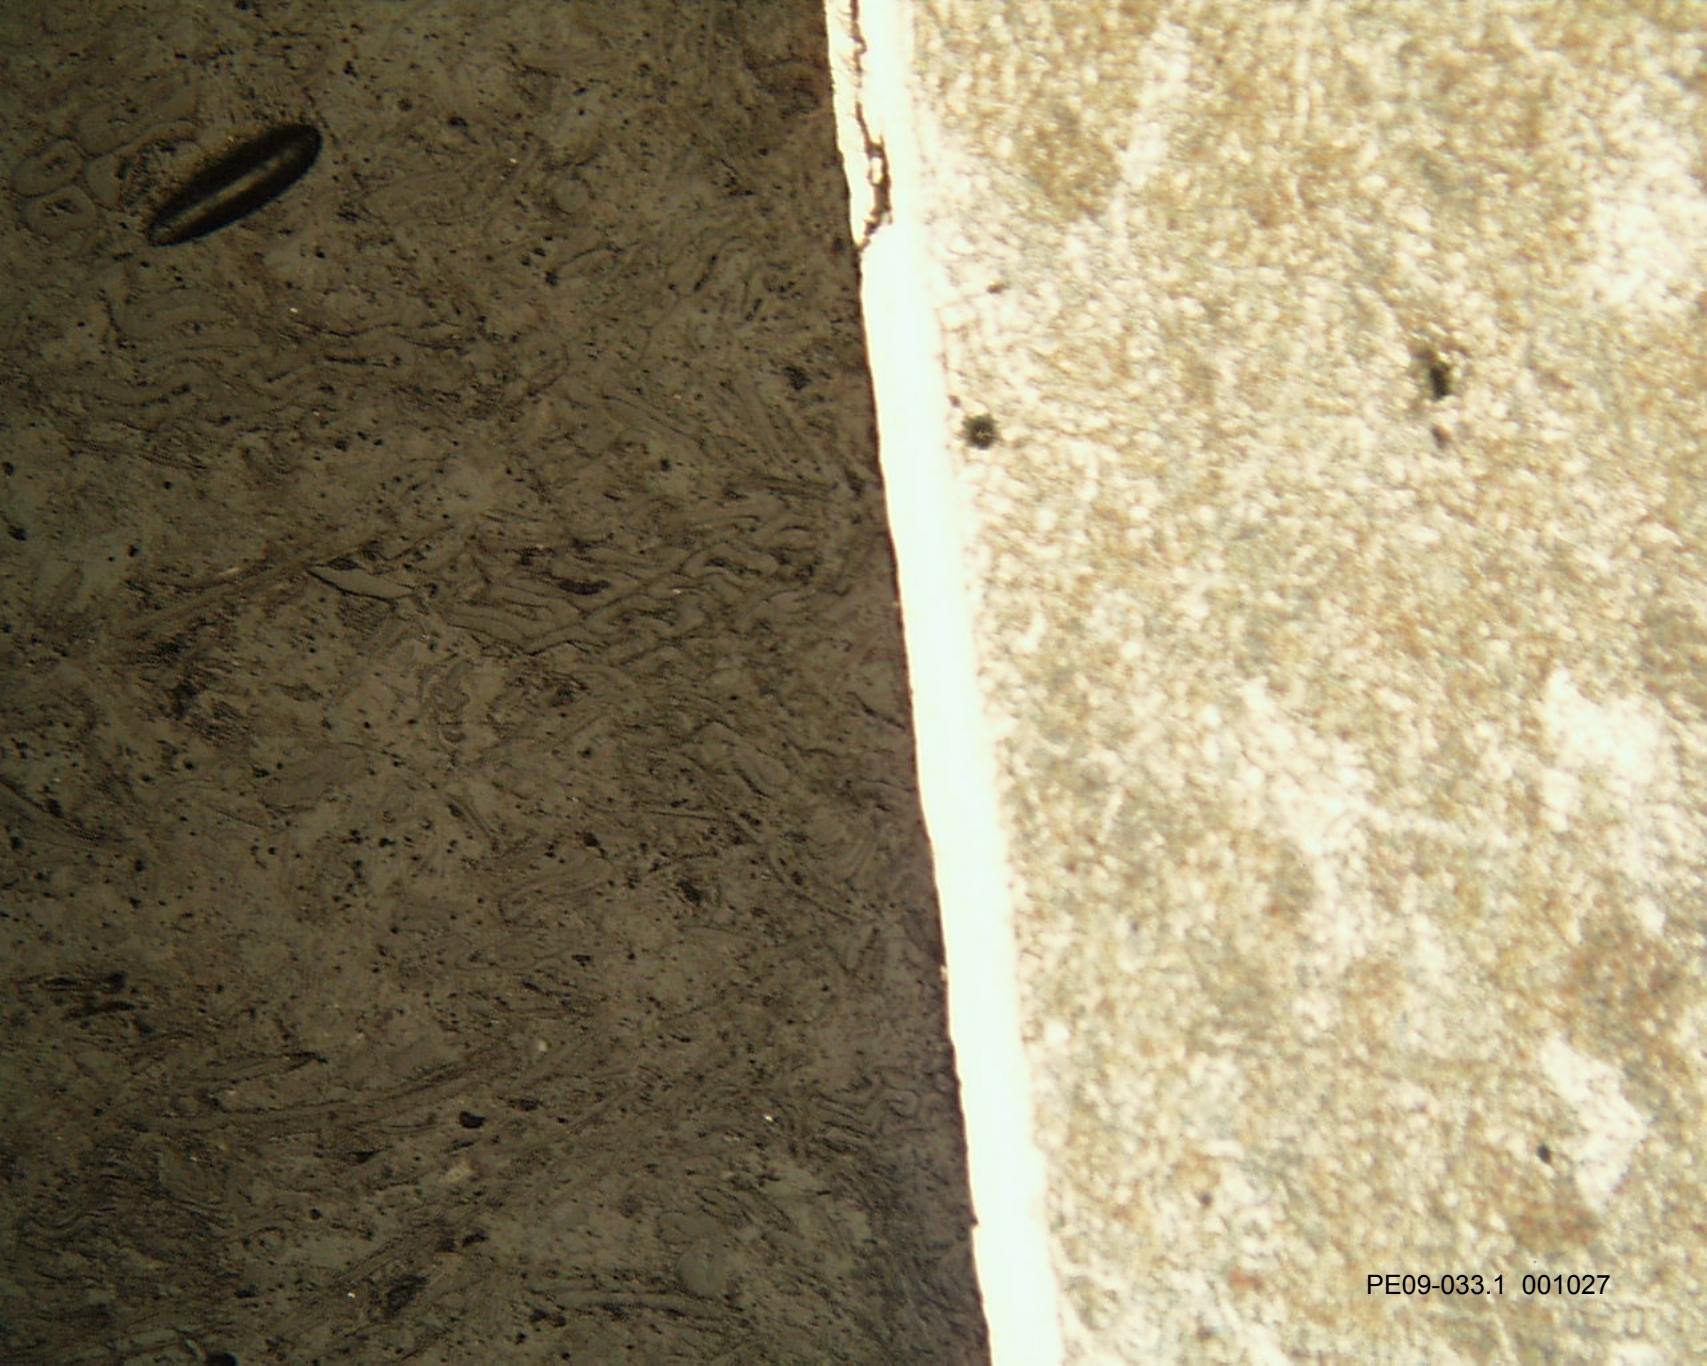
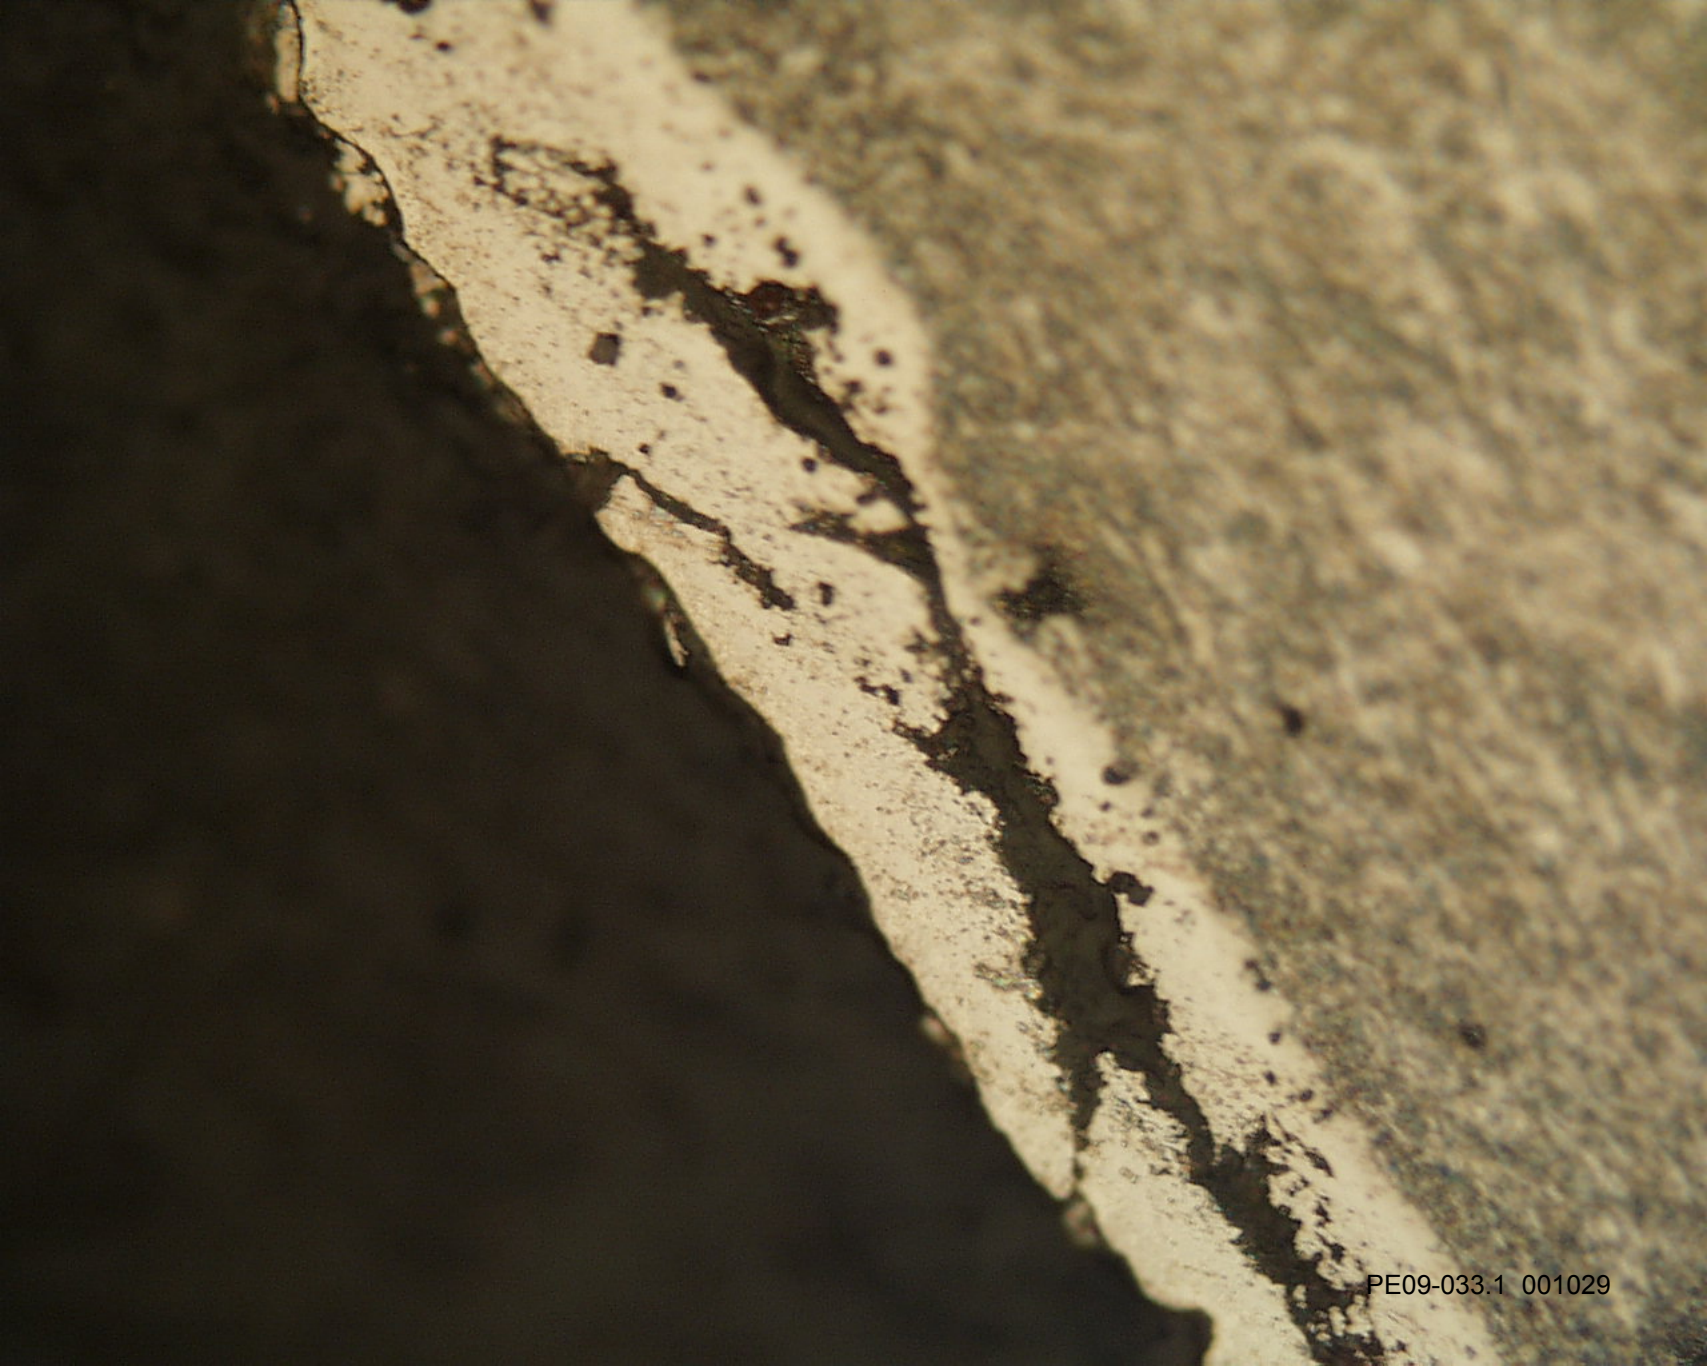
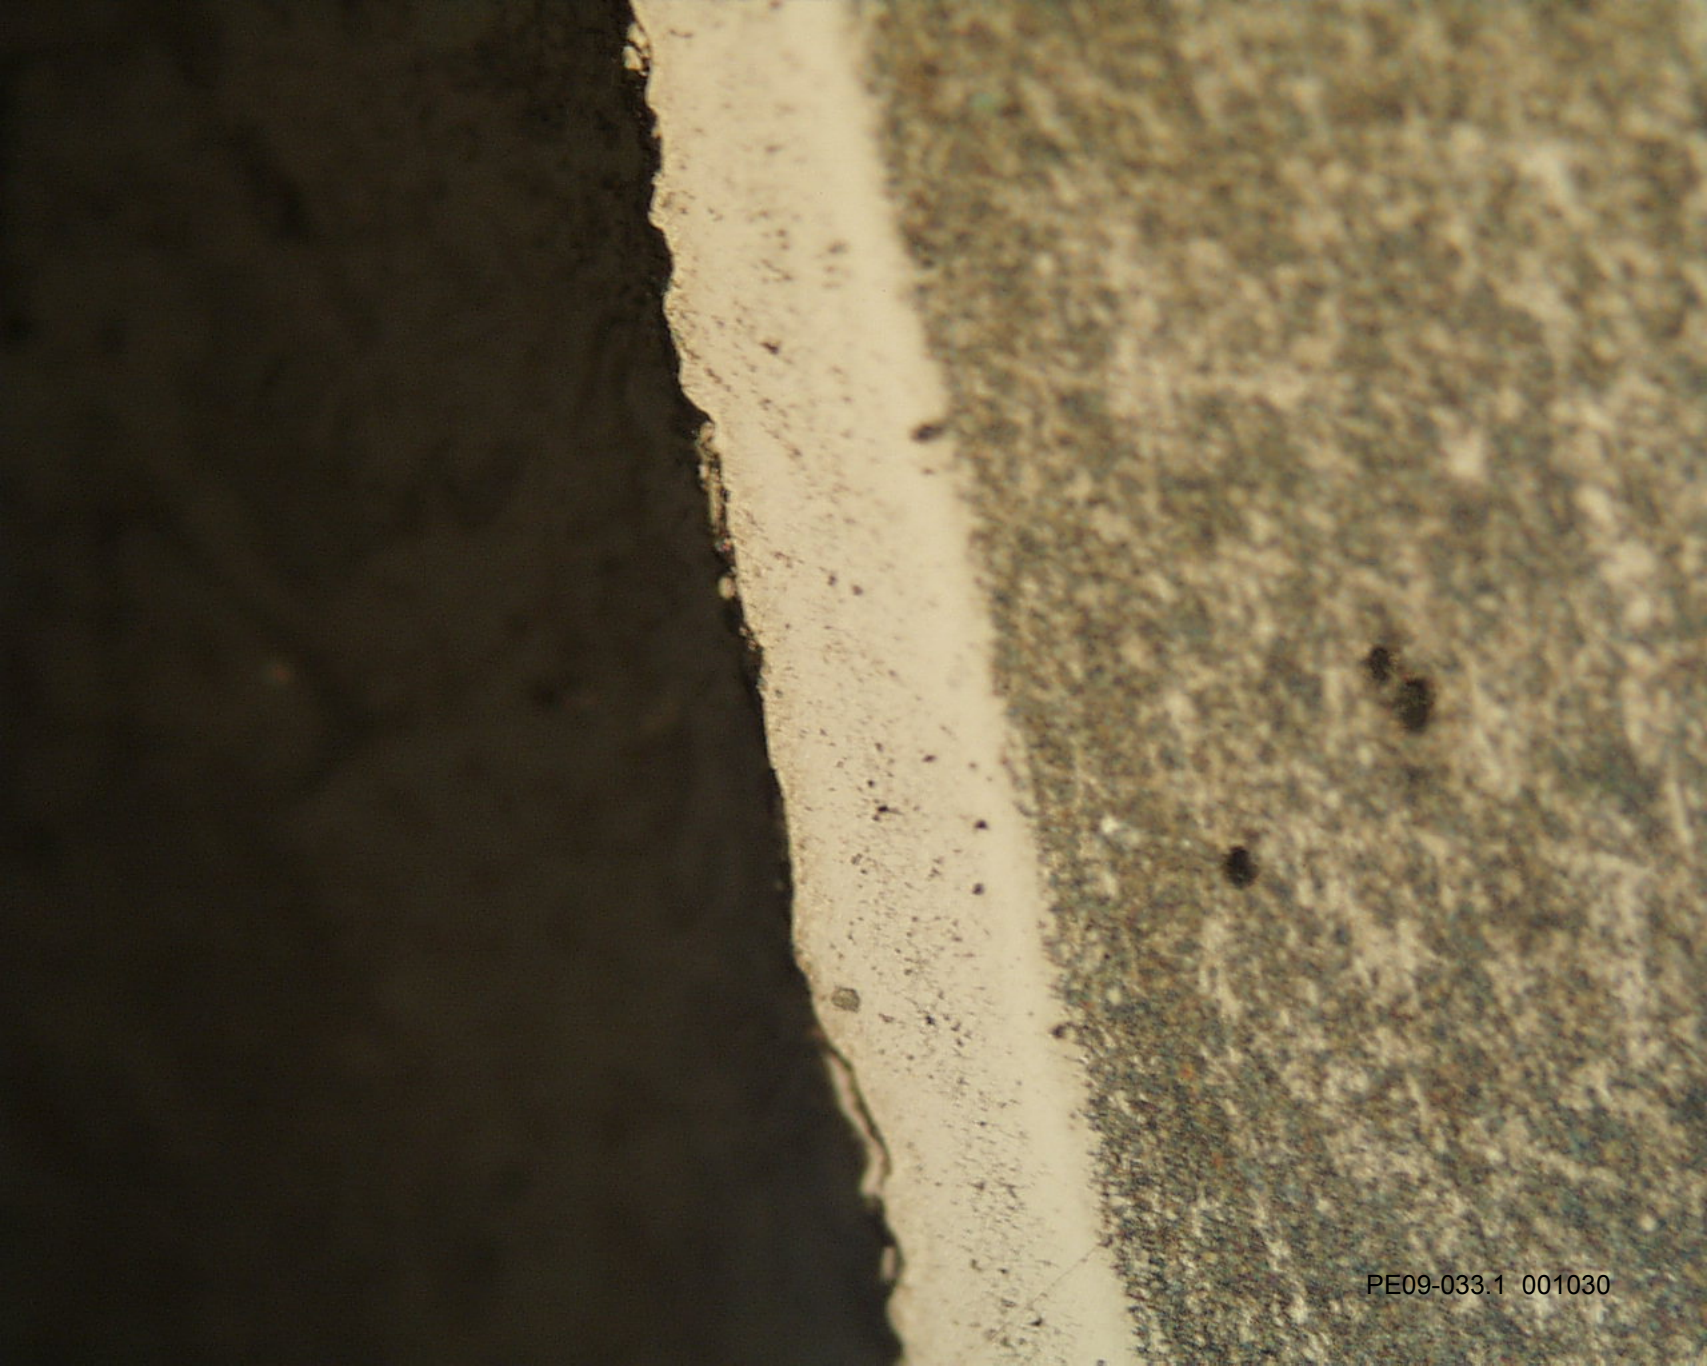
The attachments are pictures of mounts made of nickel plated inserts. I will check my e-mail Monday morning, but will be out of the office all day Monday. Rick and I will be at FPM for the 1:00 Eastern time conference call.

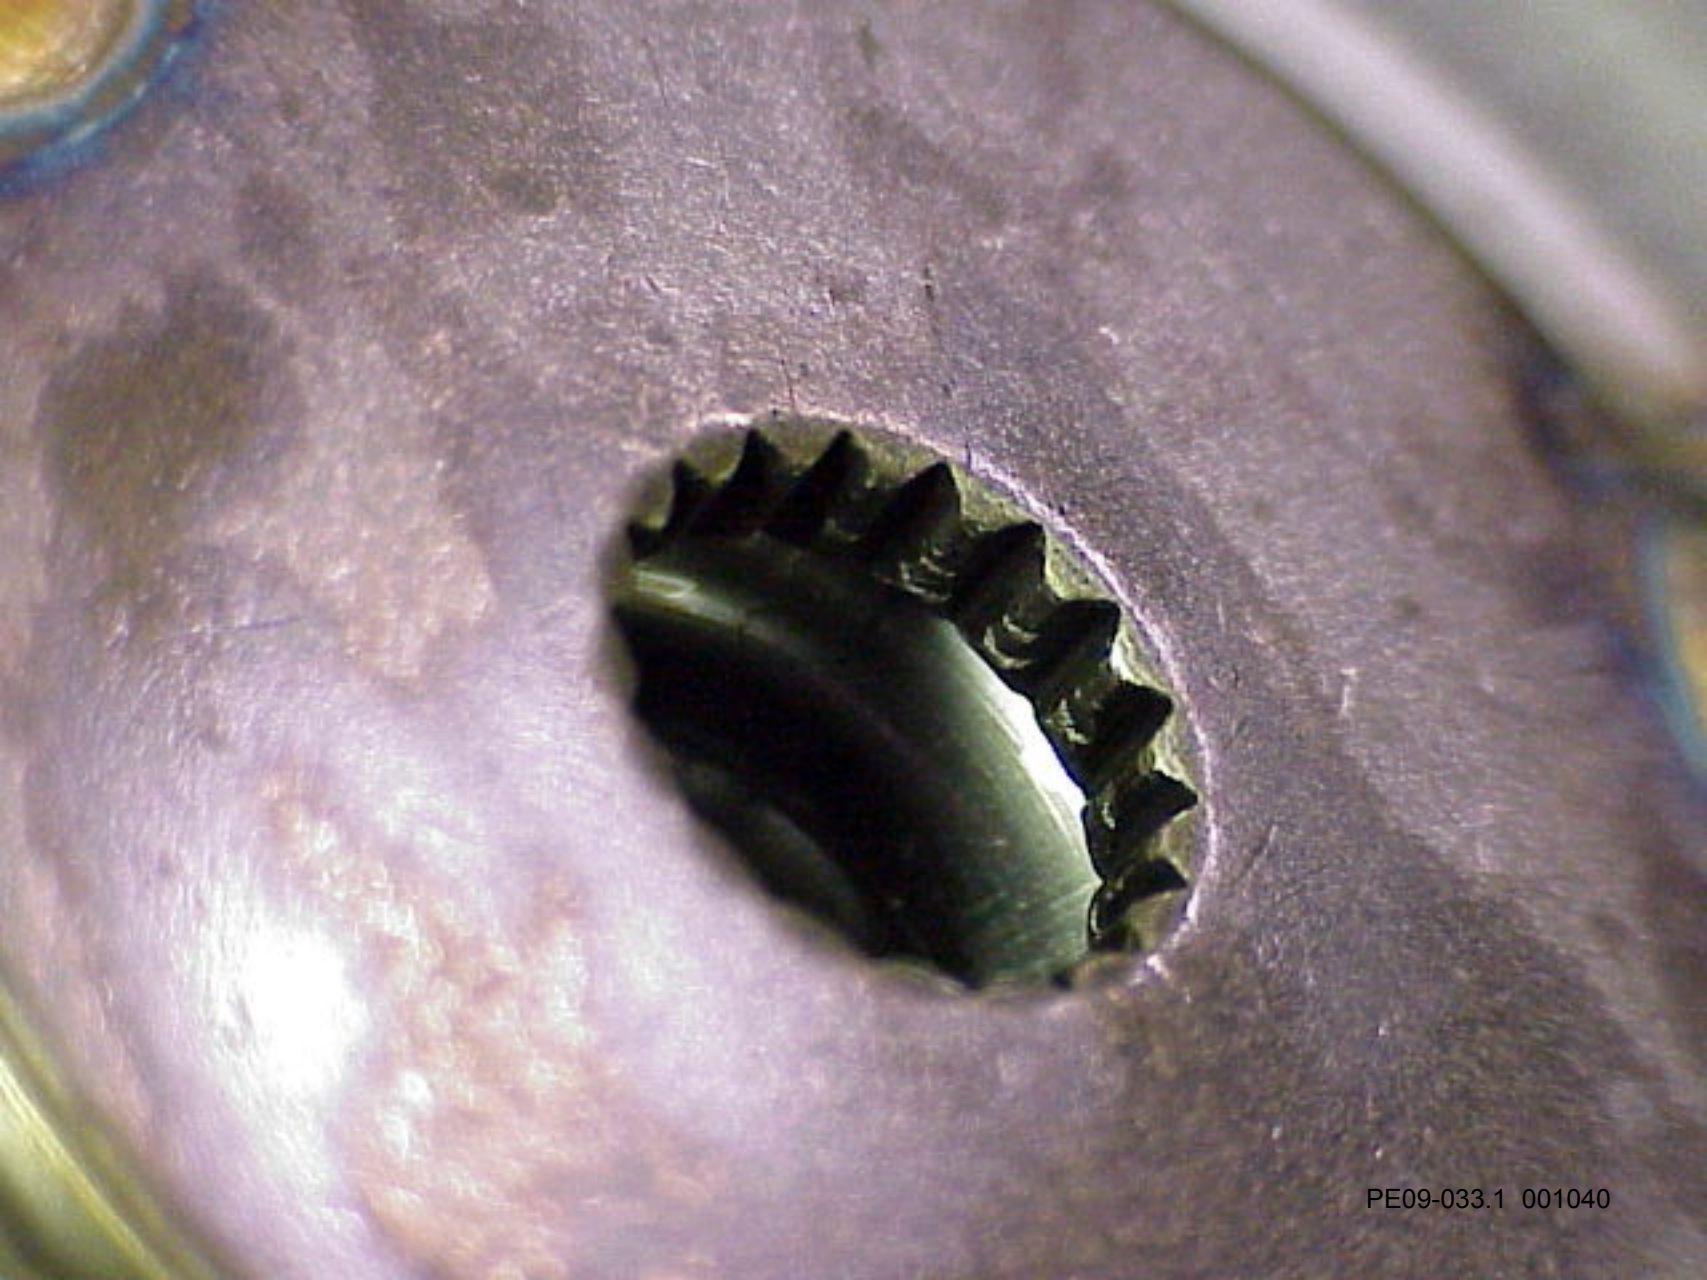
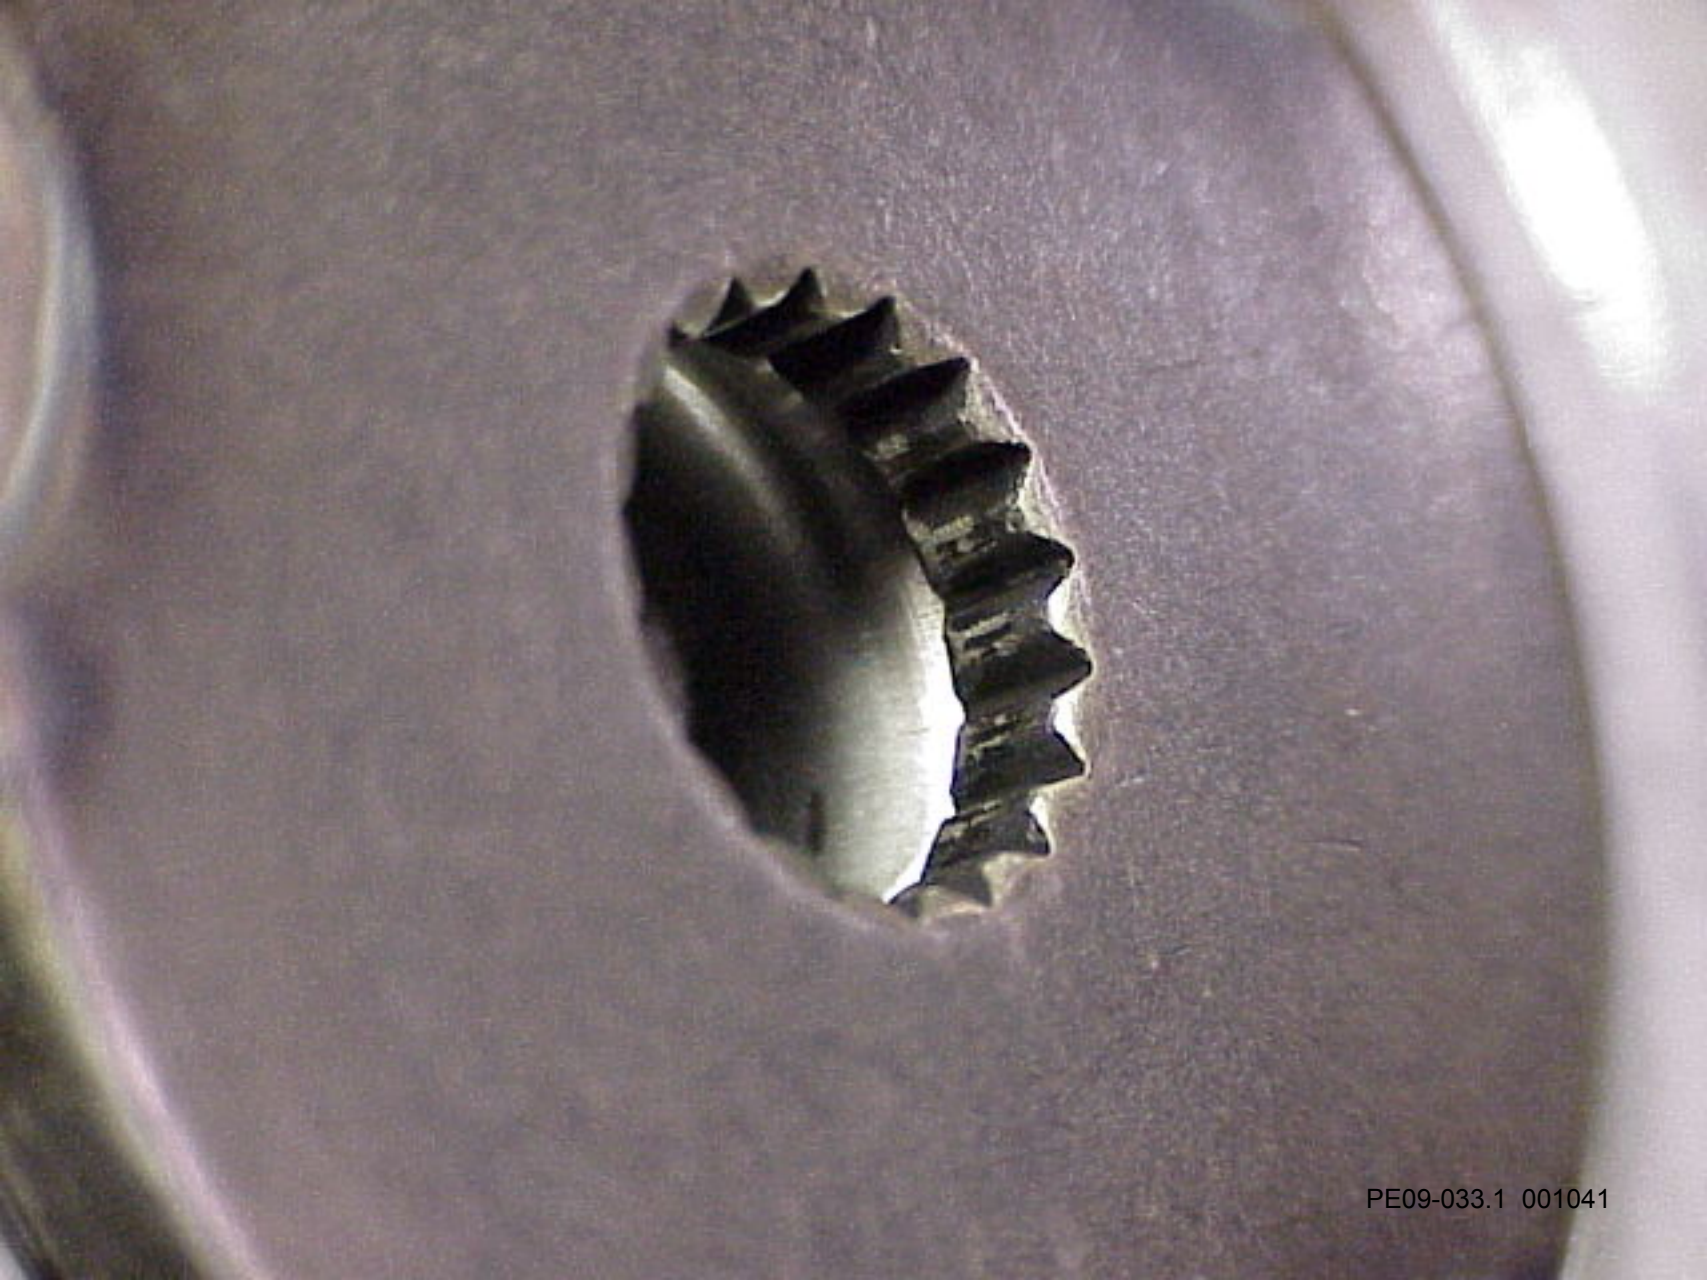
of tearing can be and is limited on this part. We do not feel that the print tolerance (70%) is exceeded on the part in the photo.

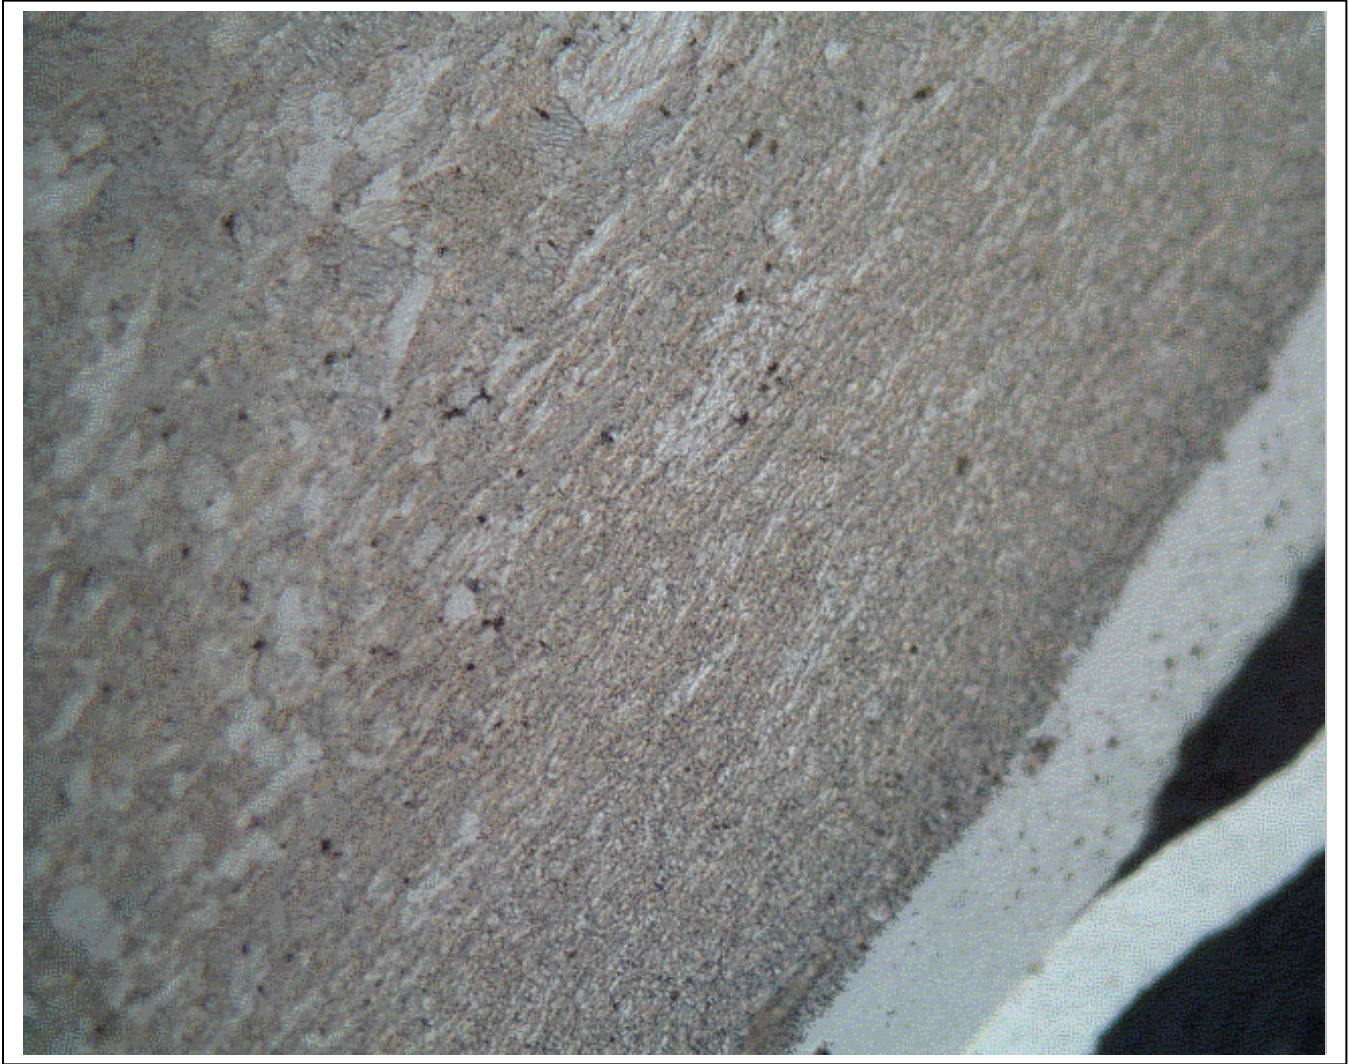
MPI Pic #2 passed 69,544 miles 500X

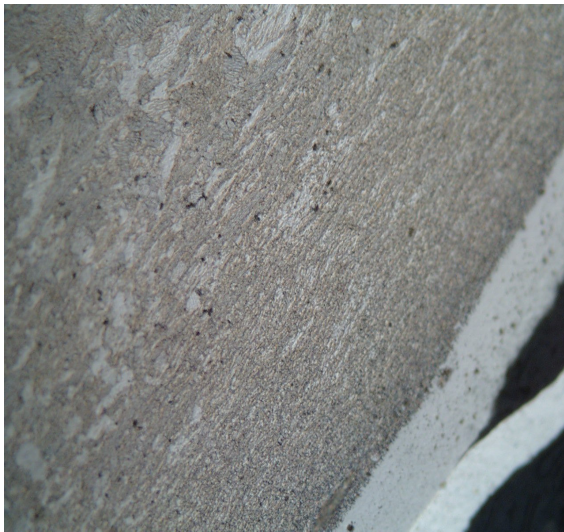
Fig. 1, **Acceptable** – 70,000 Miles Durability Test
