# Net Meeting Summary Sheet

**Issue:** ABS Module and/or harness damage after FSA 07S51

**Vehicle:** Escape

**Model Year(s):** 2001 and 2002

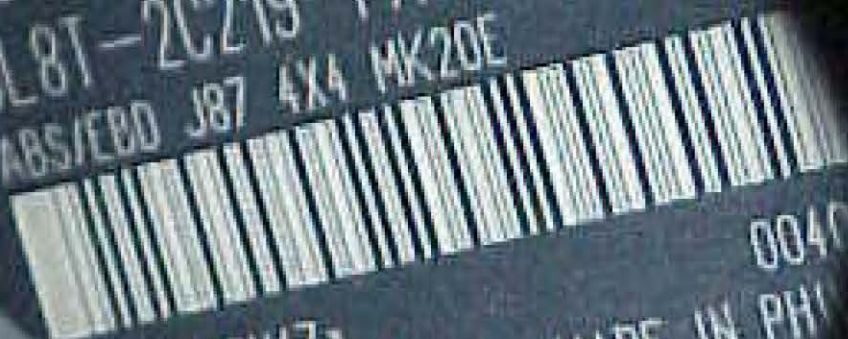
Controller  
5L8T-2C219-FA  
ABS/EBD J87 4X4 MK20E

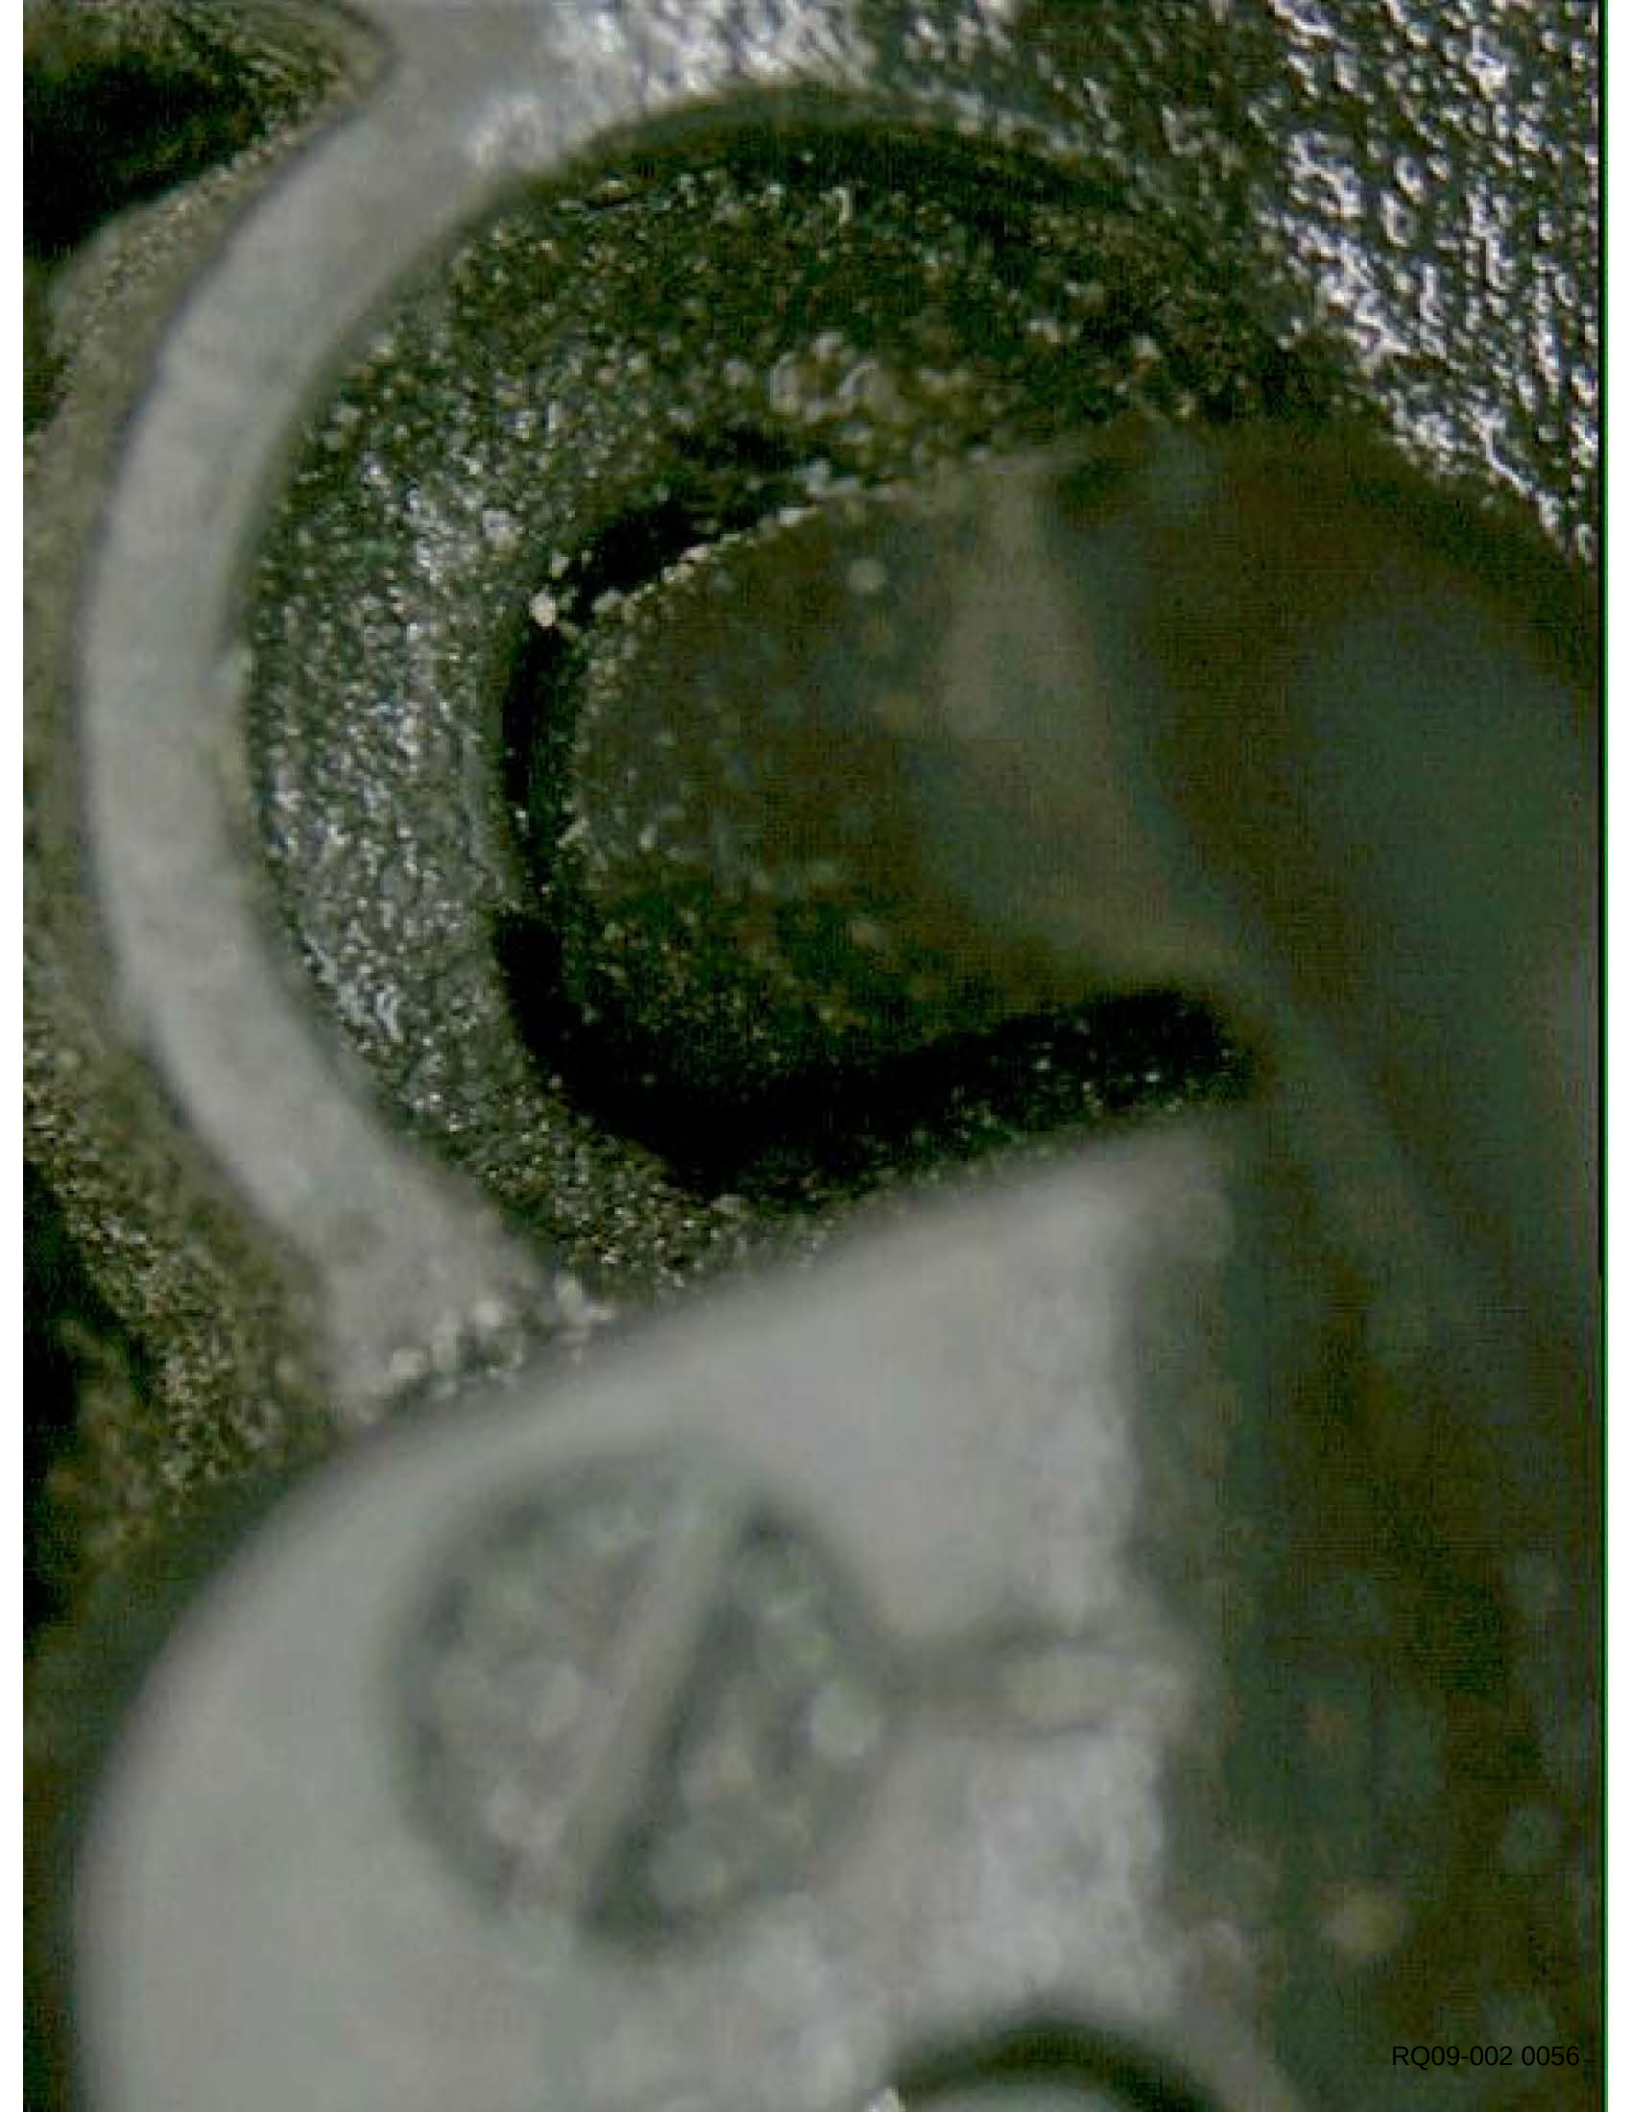
Pin Eroded & Broken Off

**Dendrites**

**Corrosion**

Black dendrite growing  
between pins 24 - 25

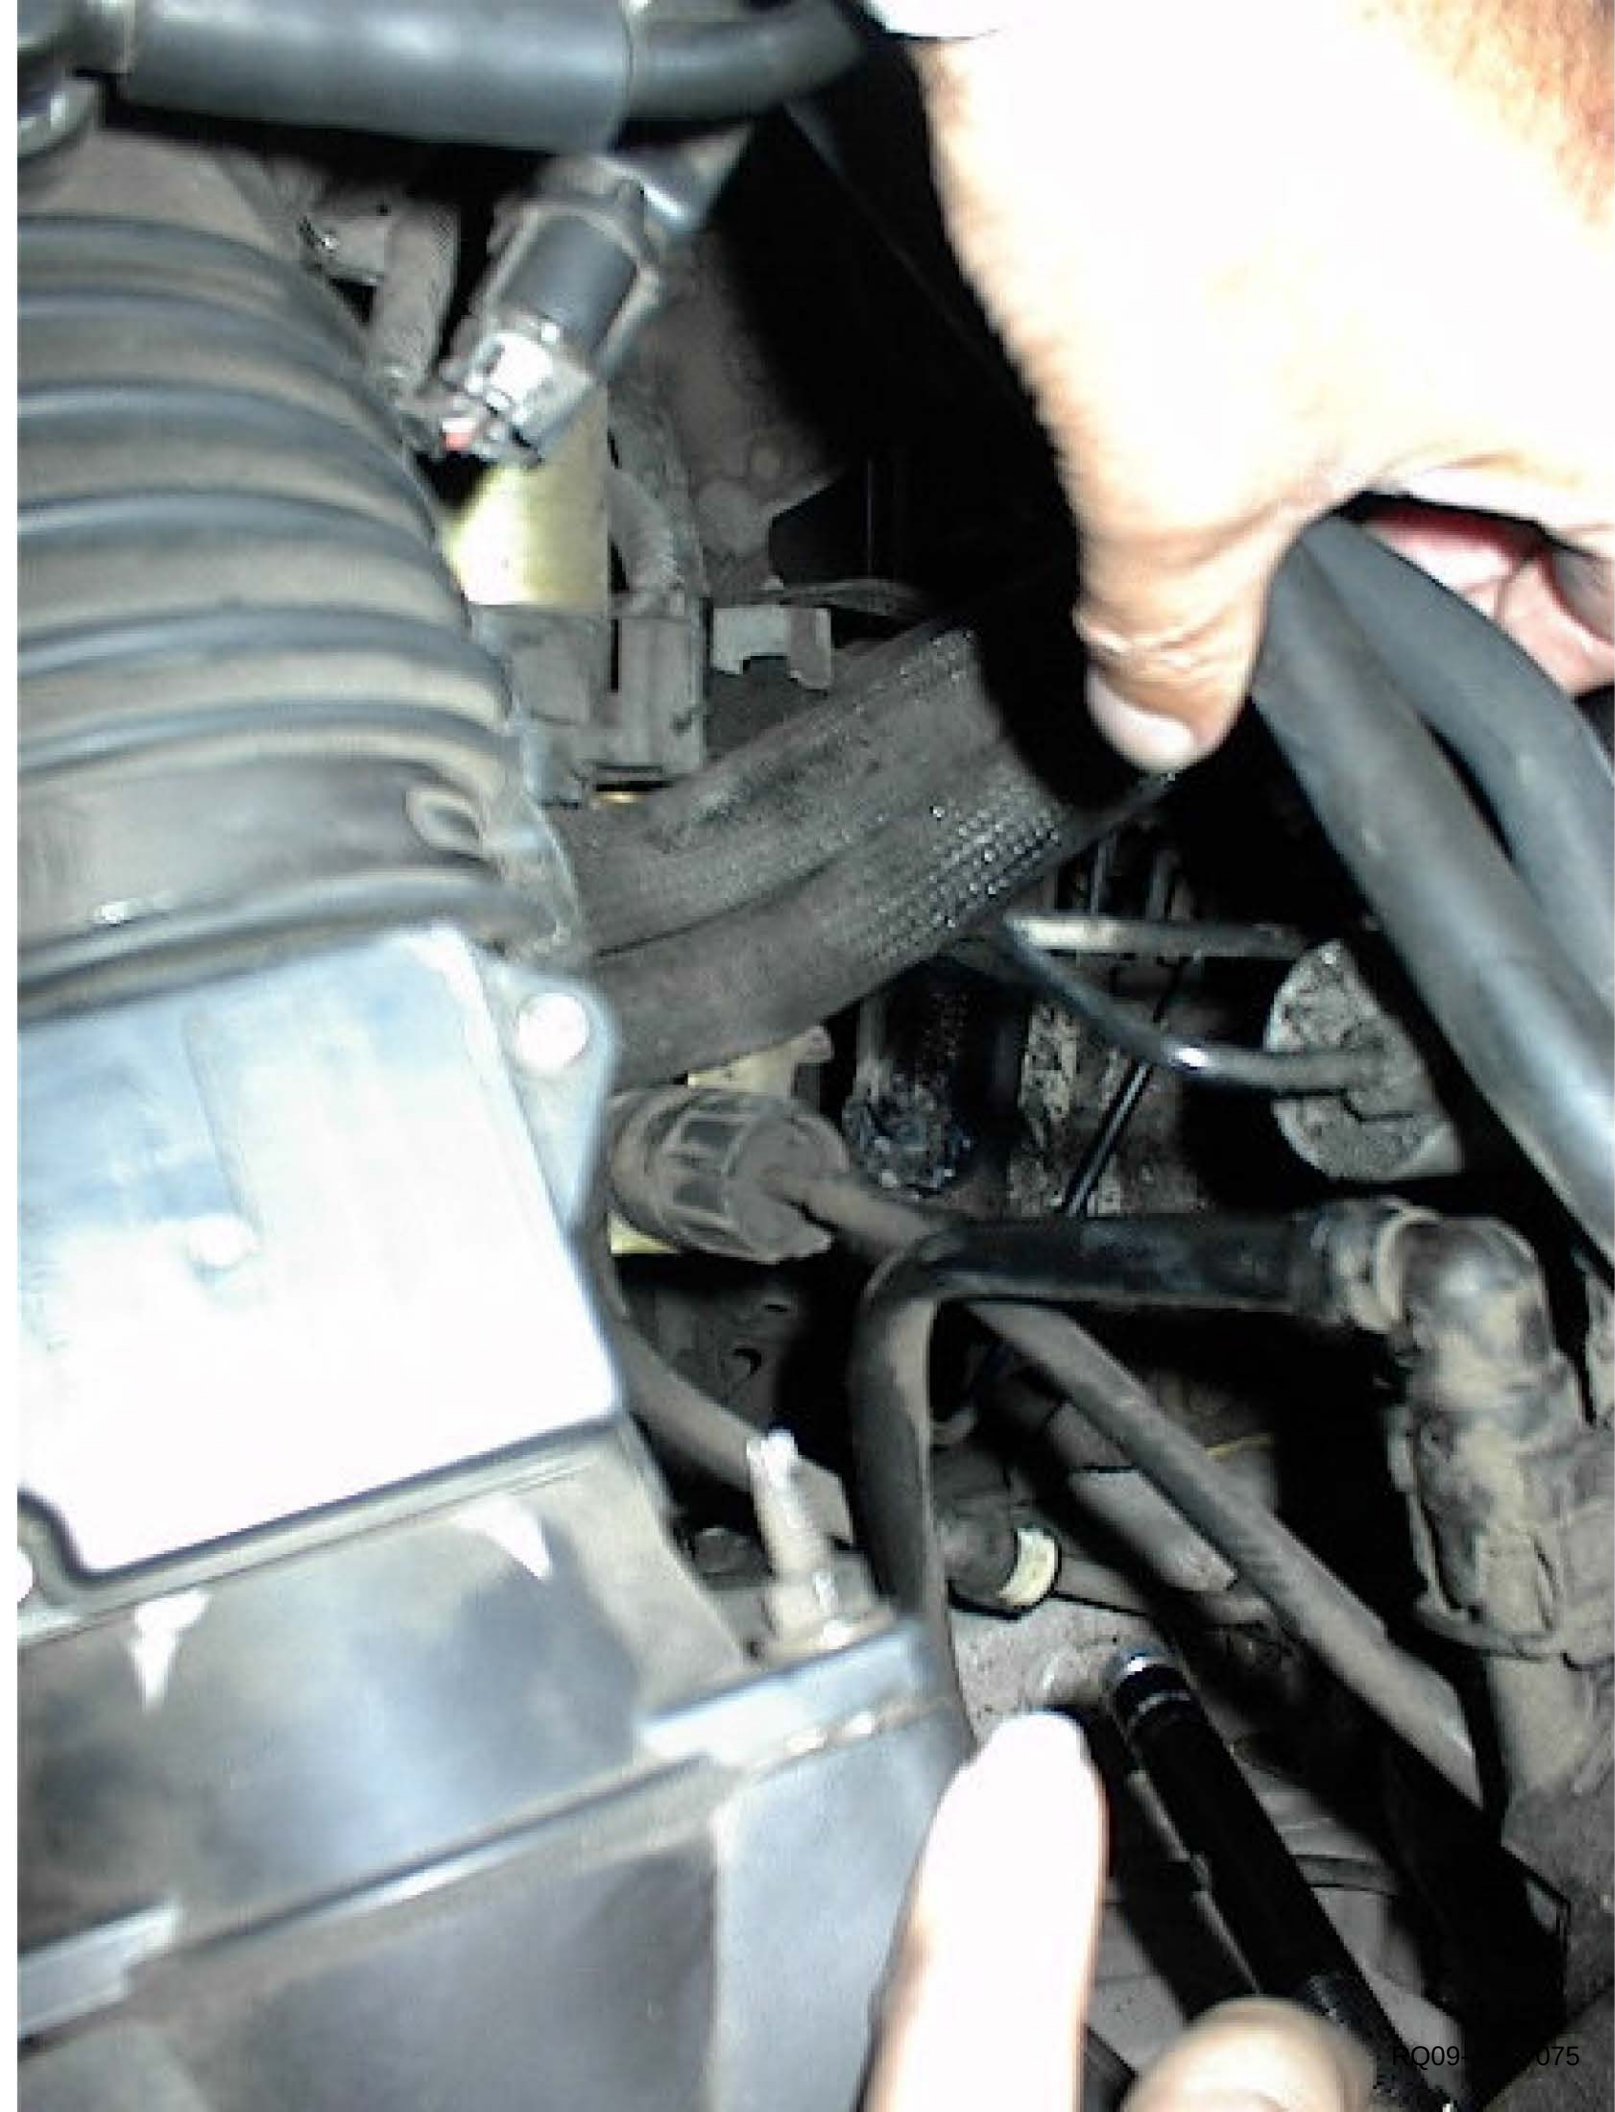
Please find attached the photos of the damage caused by shorting internally in the ABS module. The parts to repair this condition is as follows.

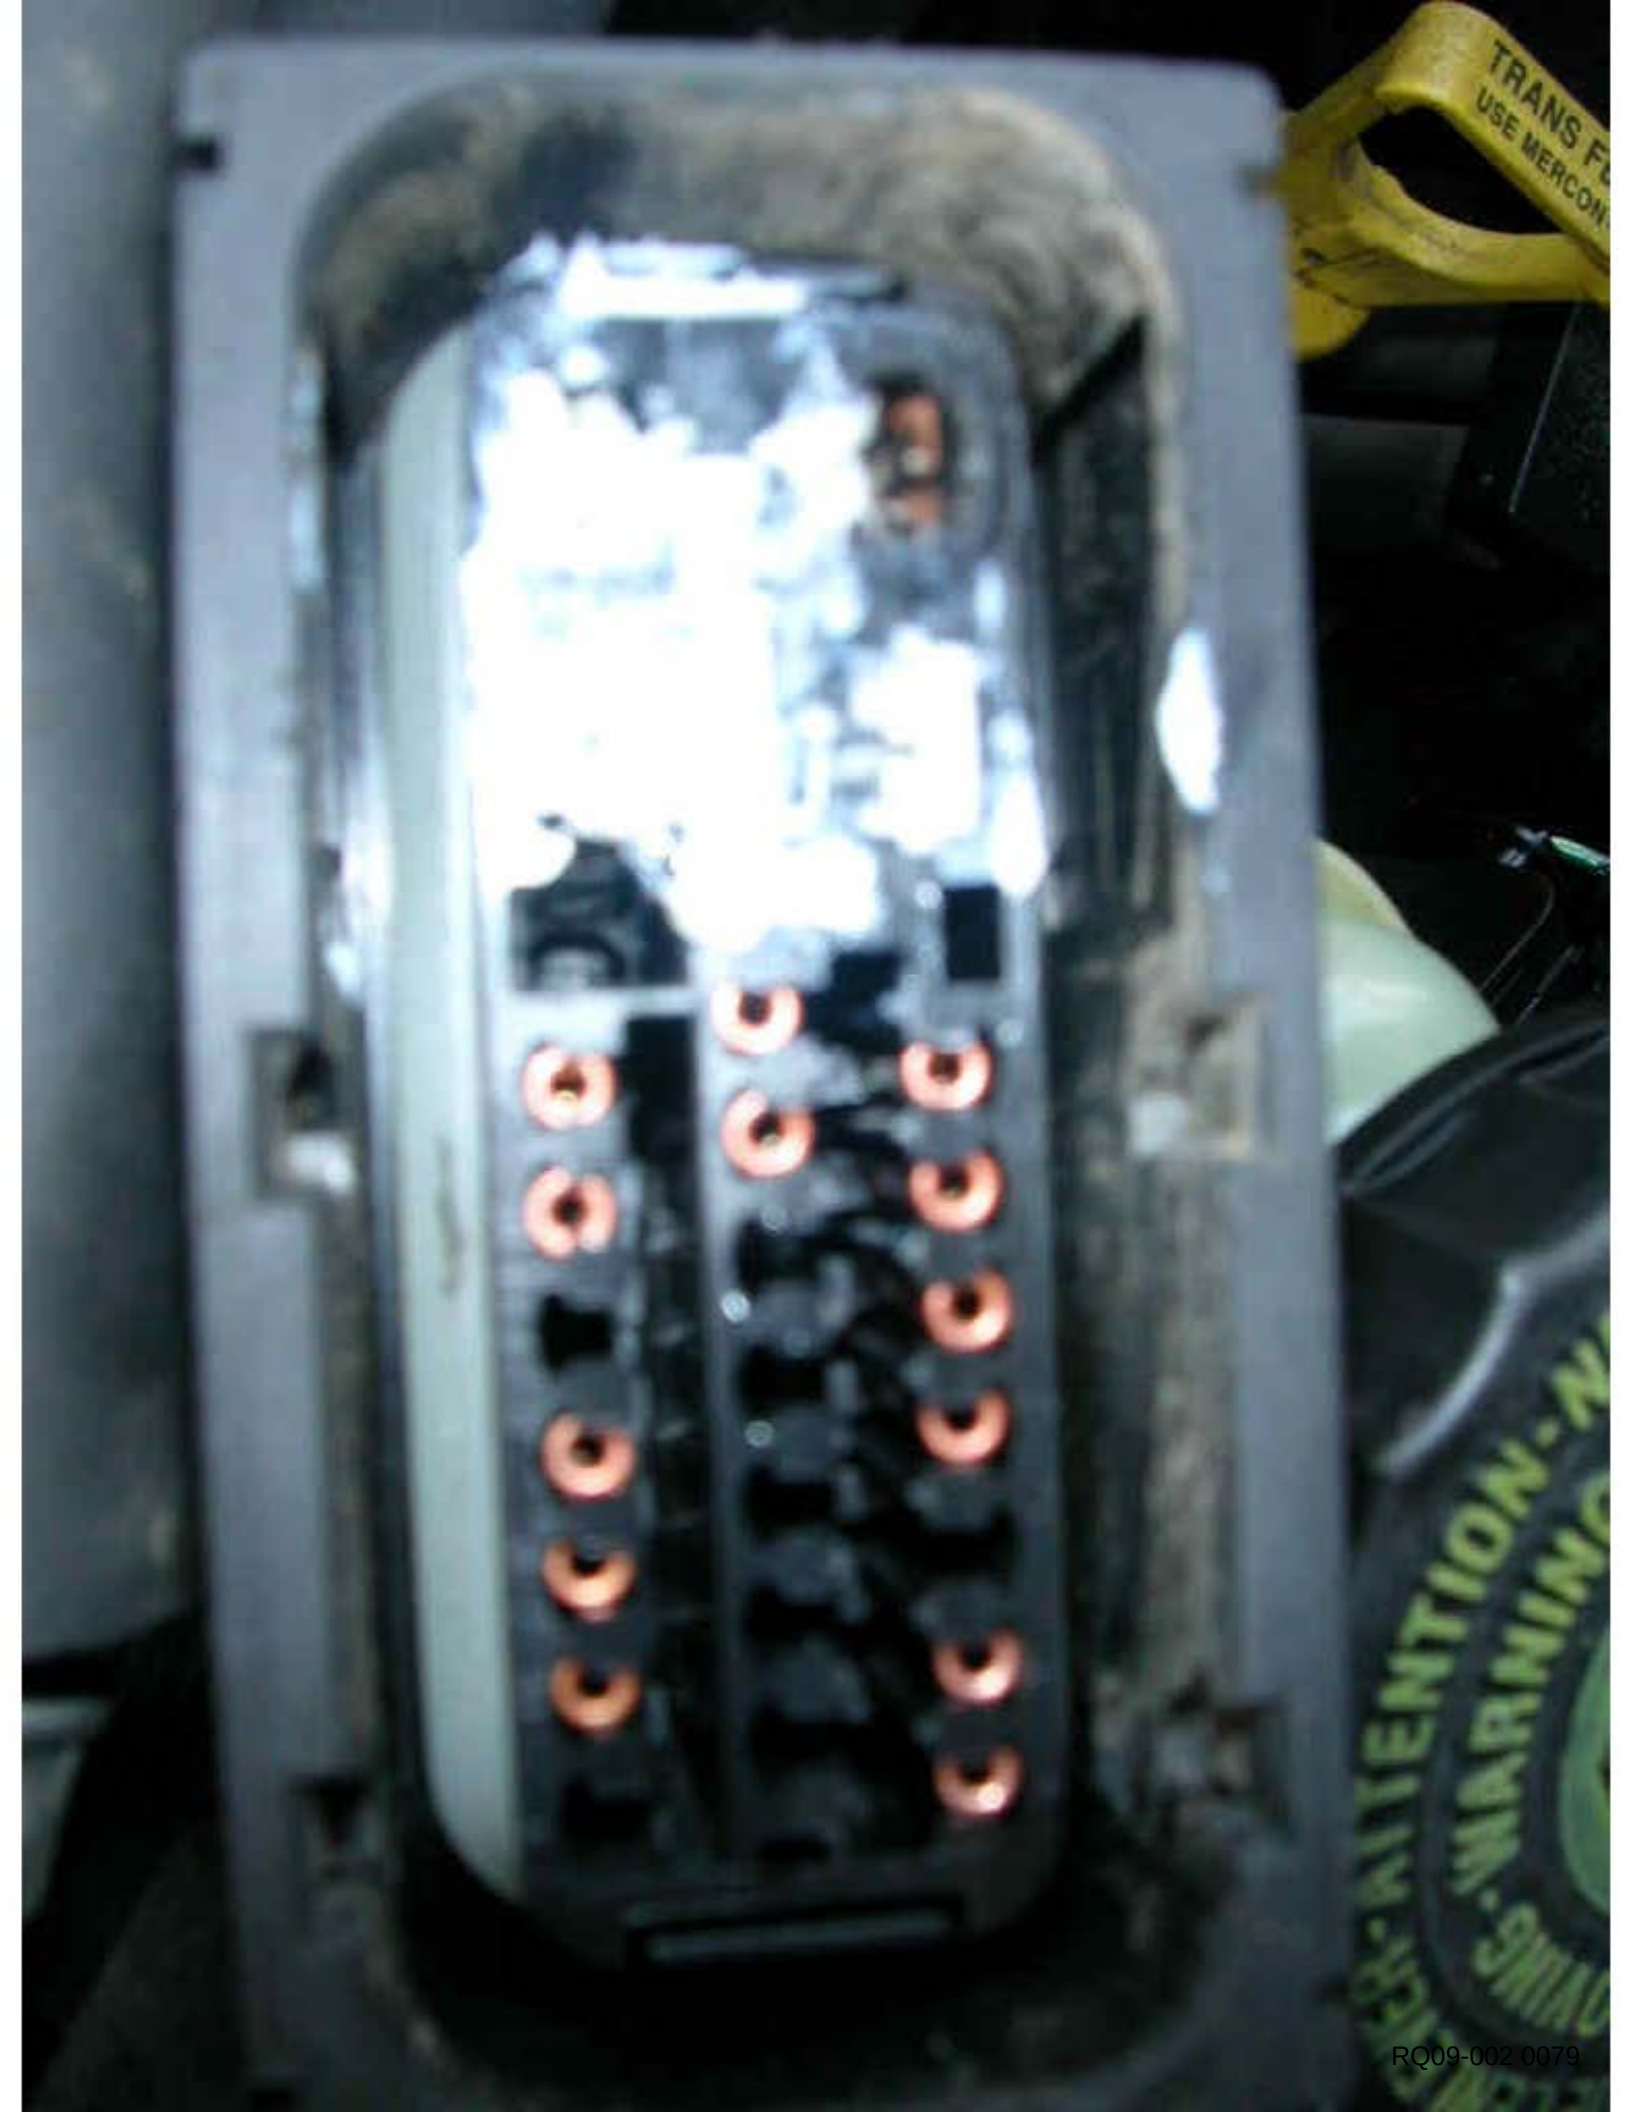
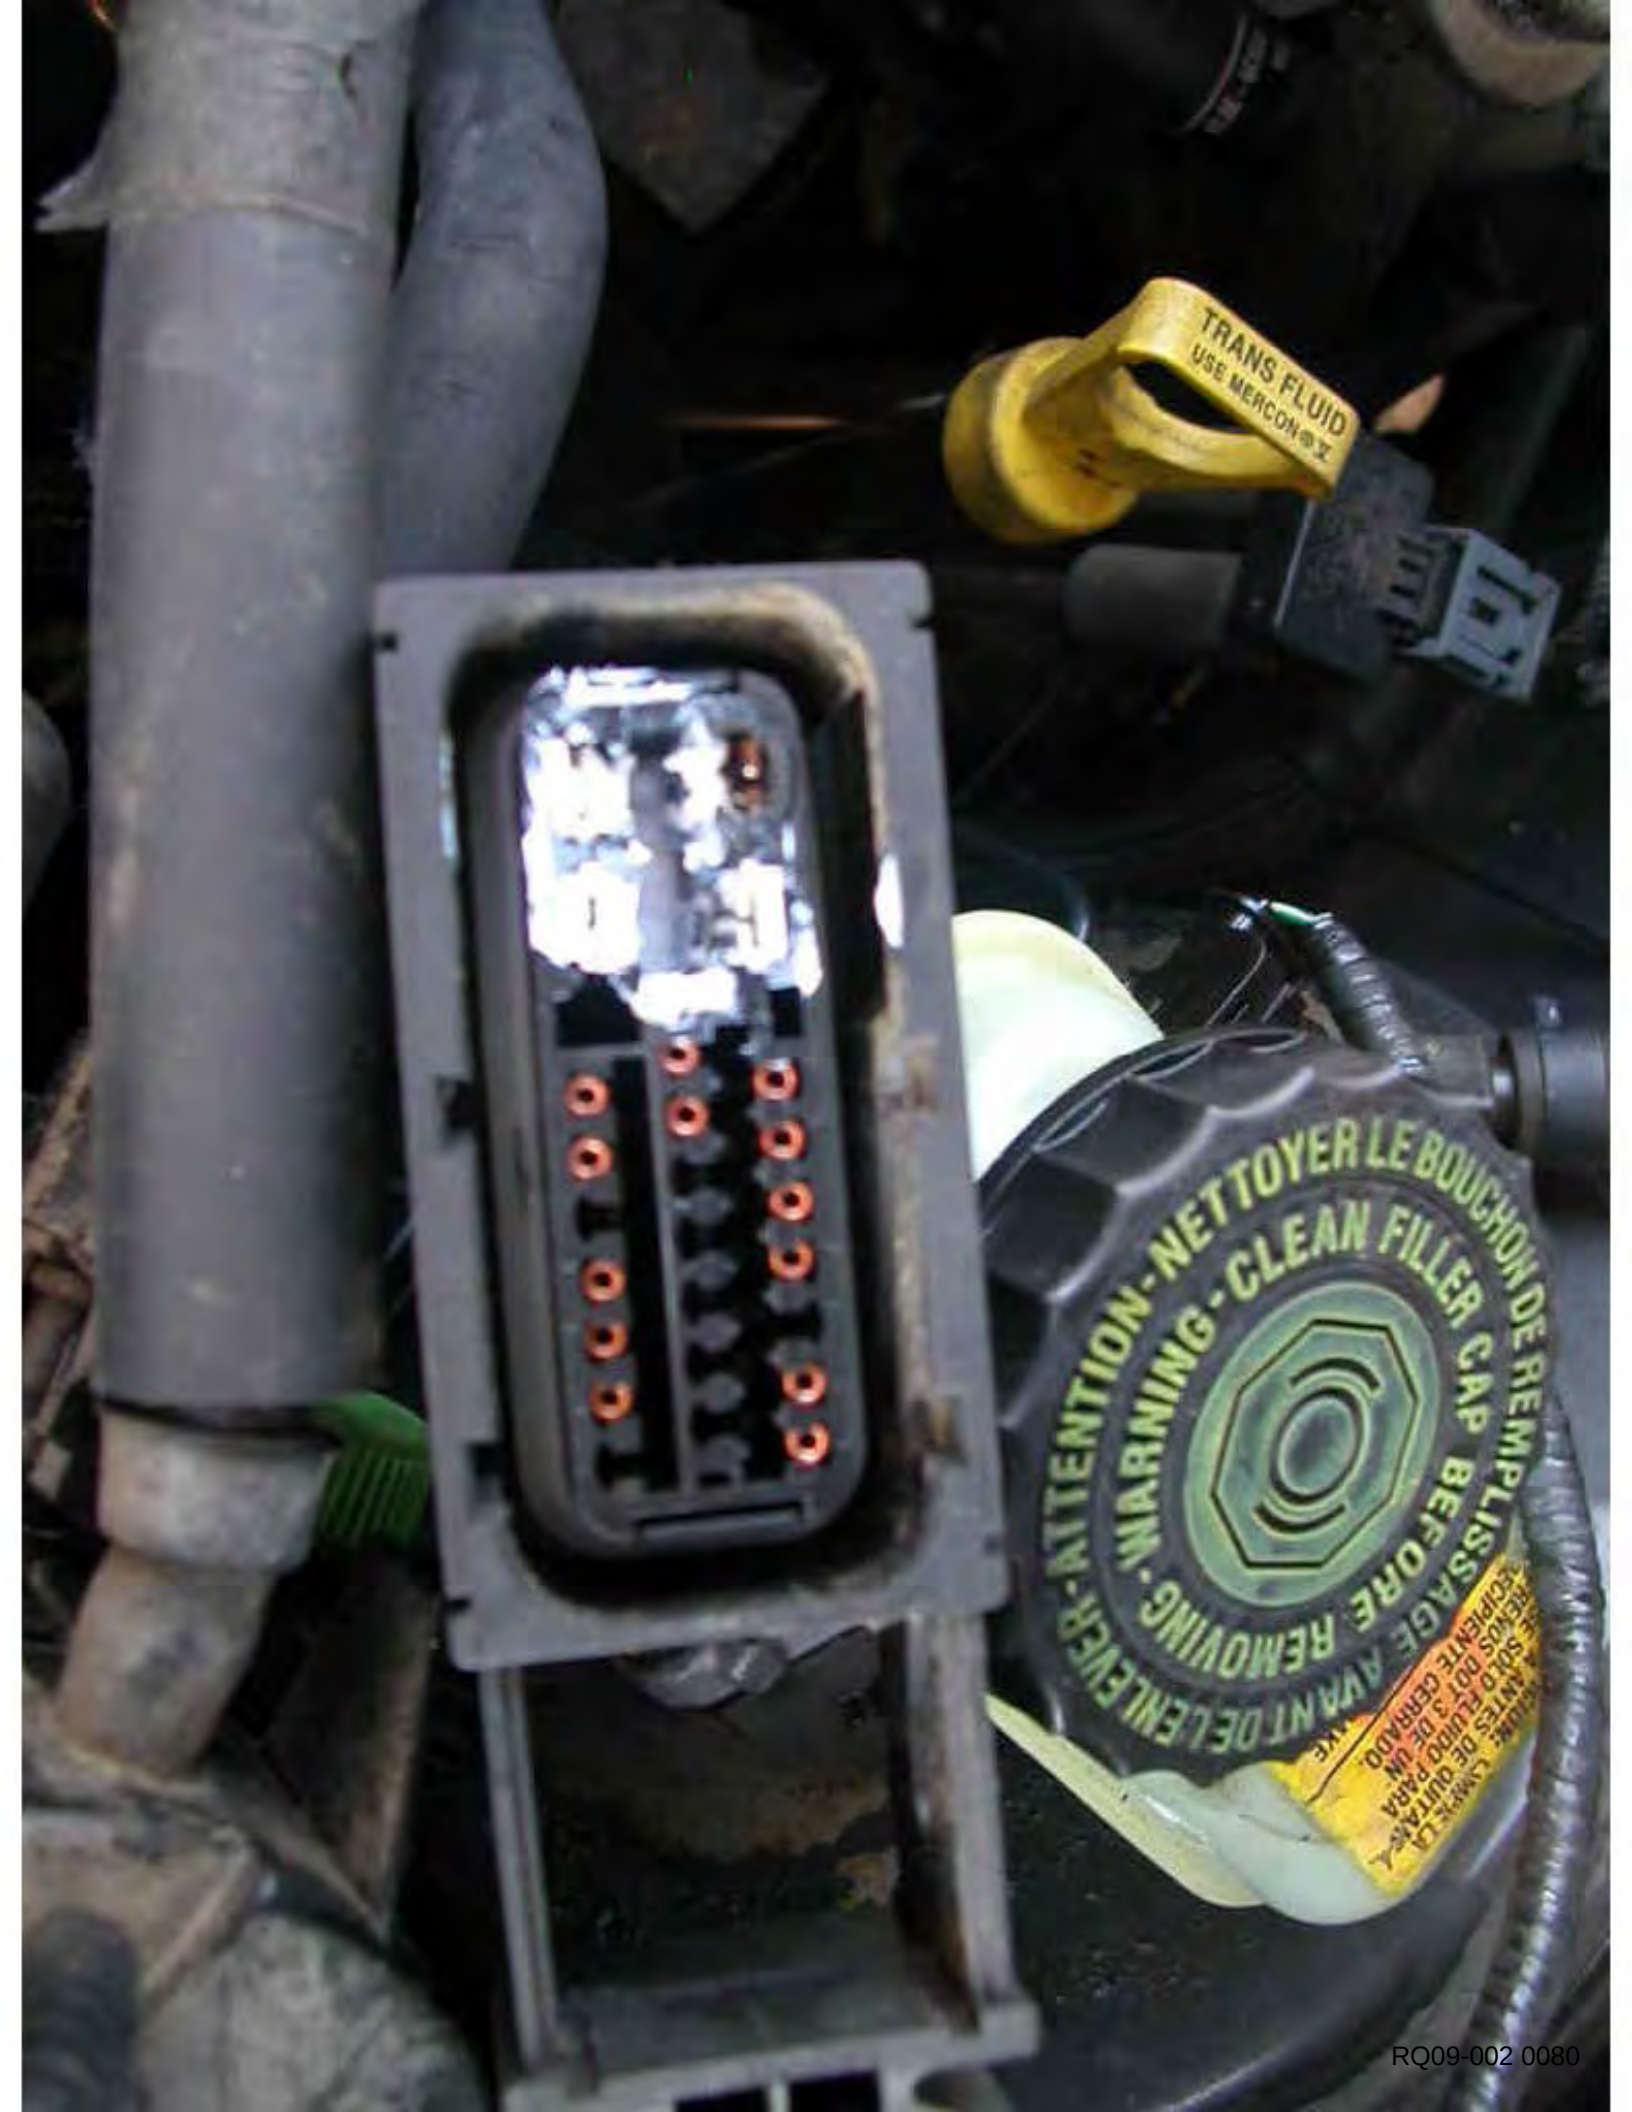
This one to me appears that they installed grease in a corroded pigtail. I am basing that on the fact that it got hot, but there are no pins left in the module at all. I can see some green corrosion on the smaller pins that did not get any grease on the extreme left of the picture.

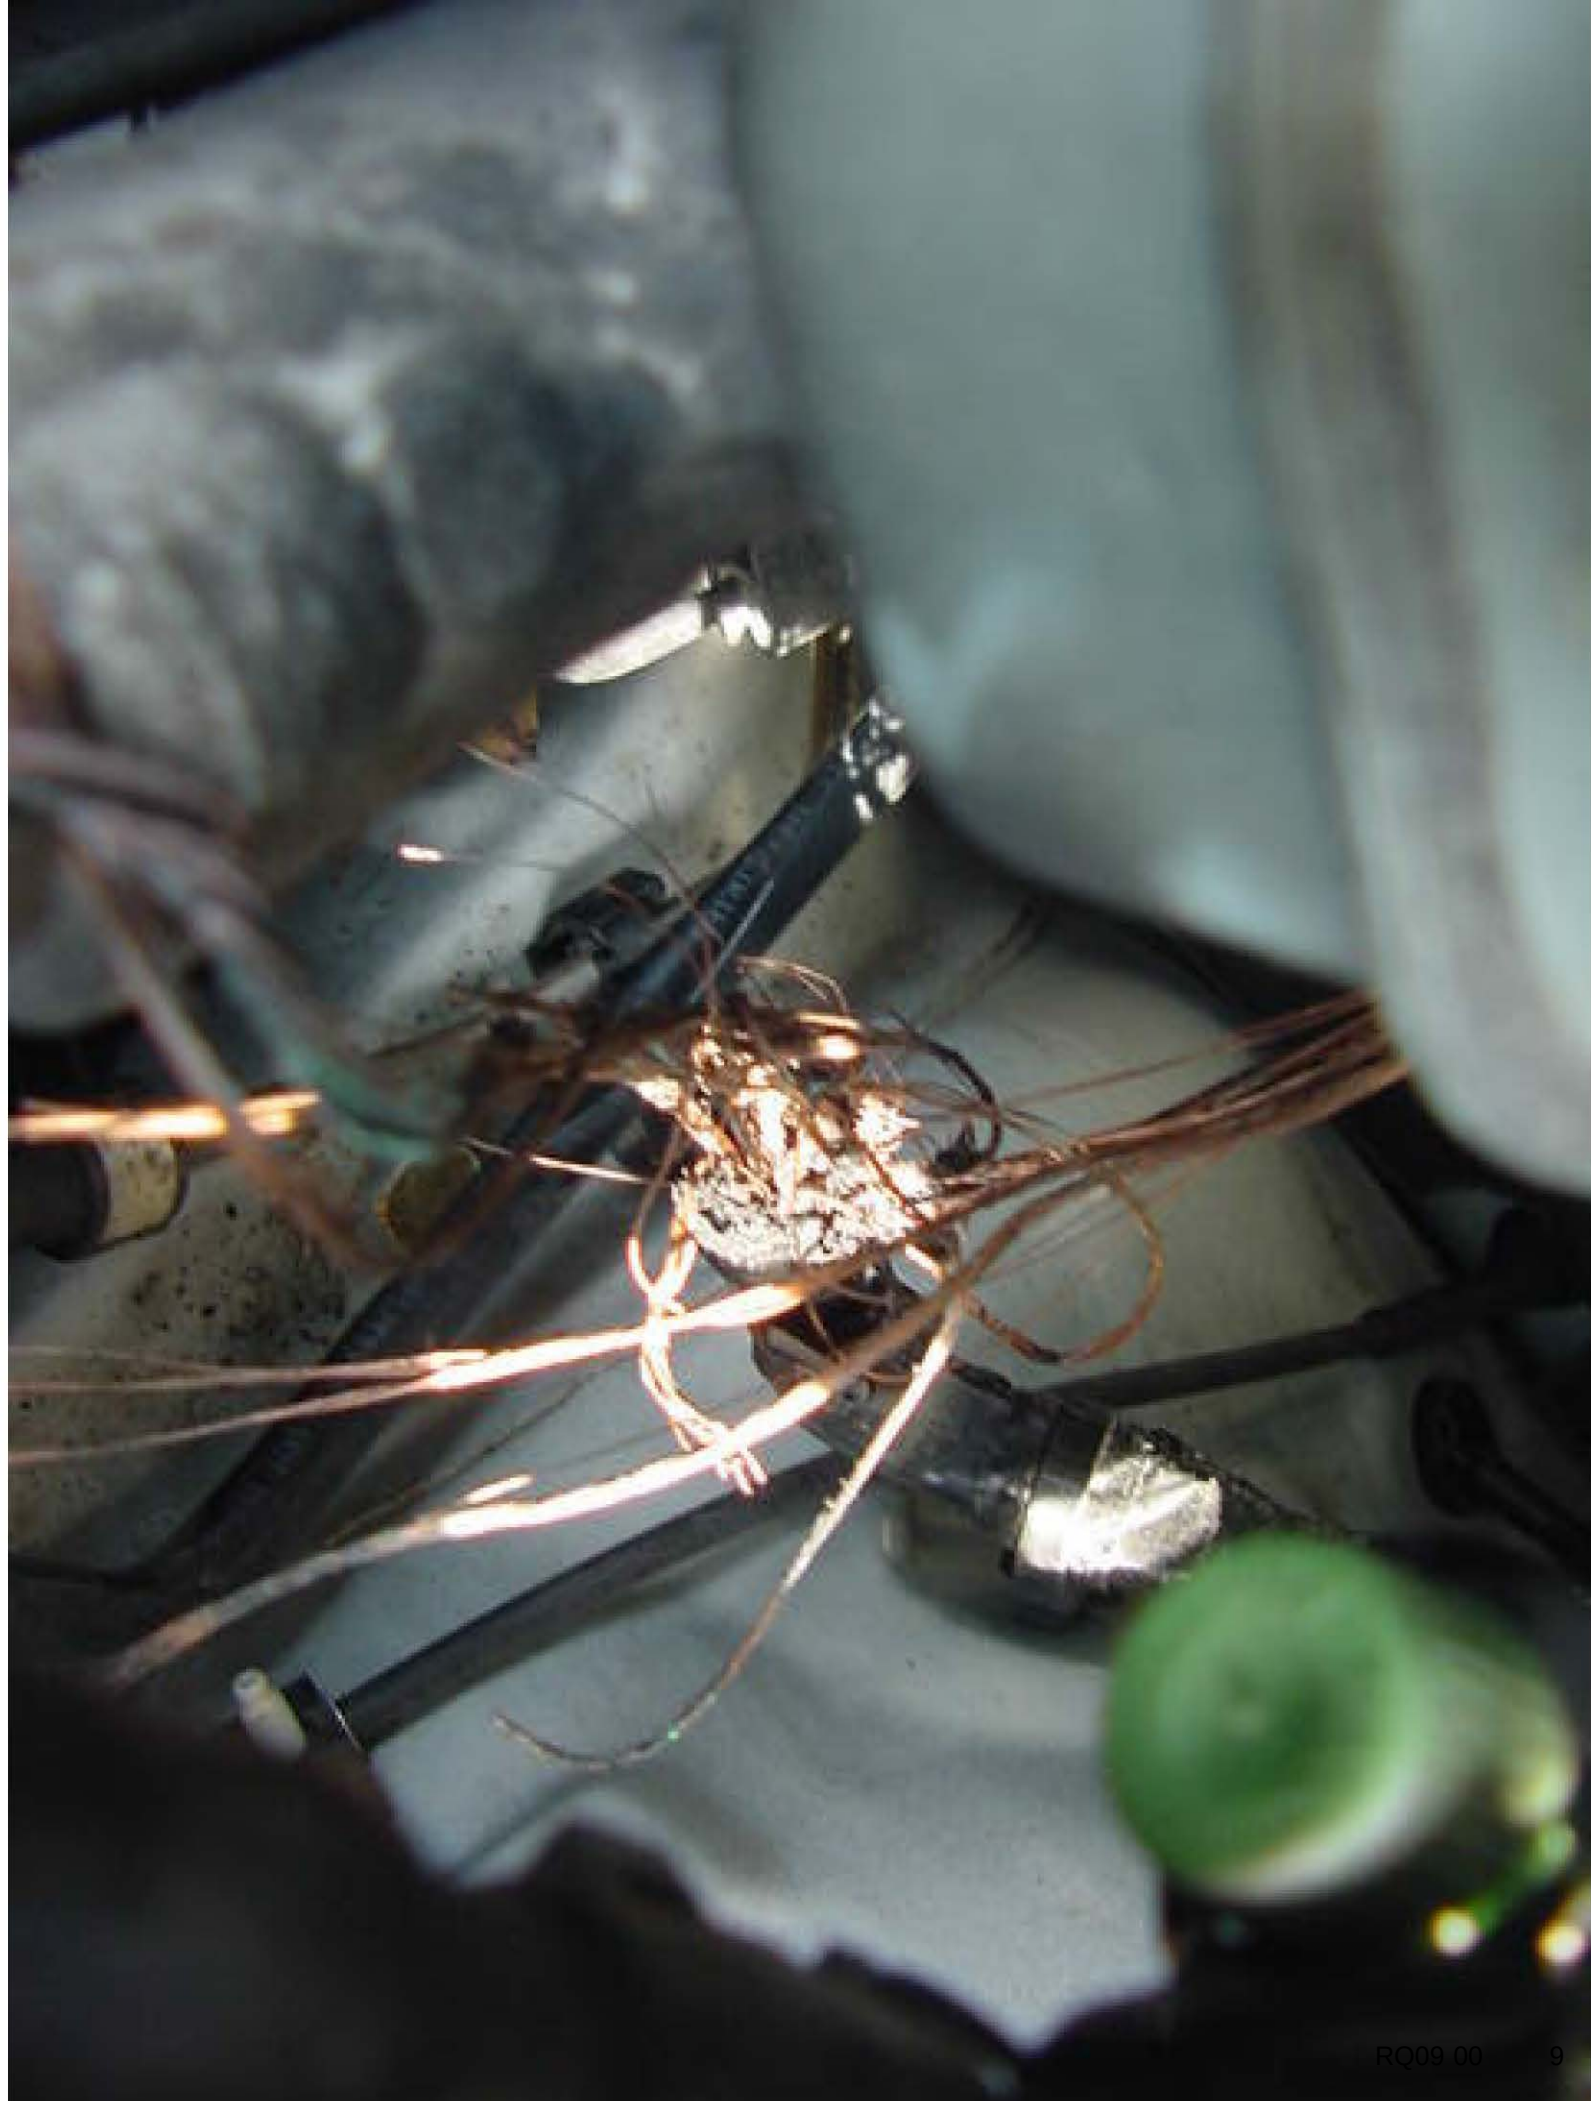
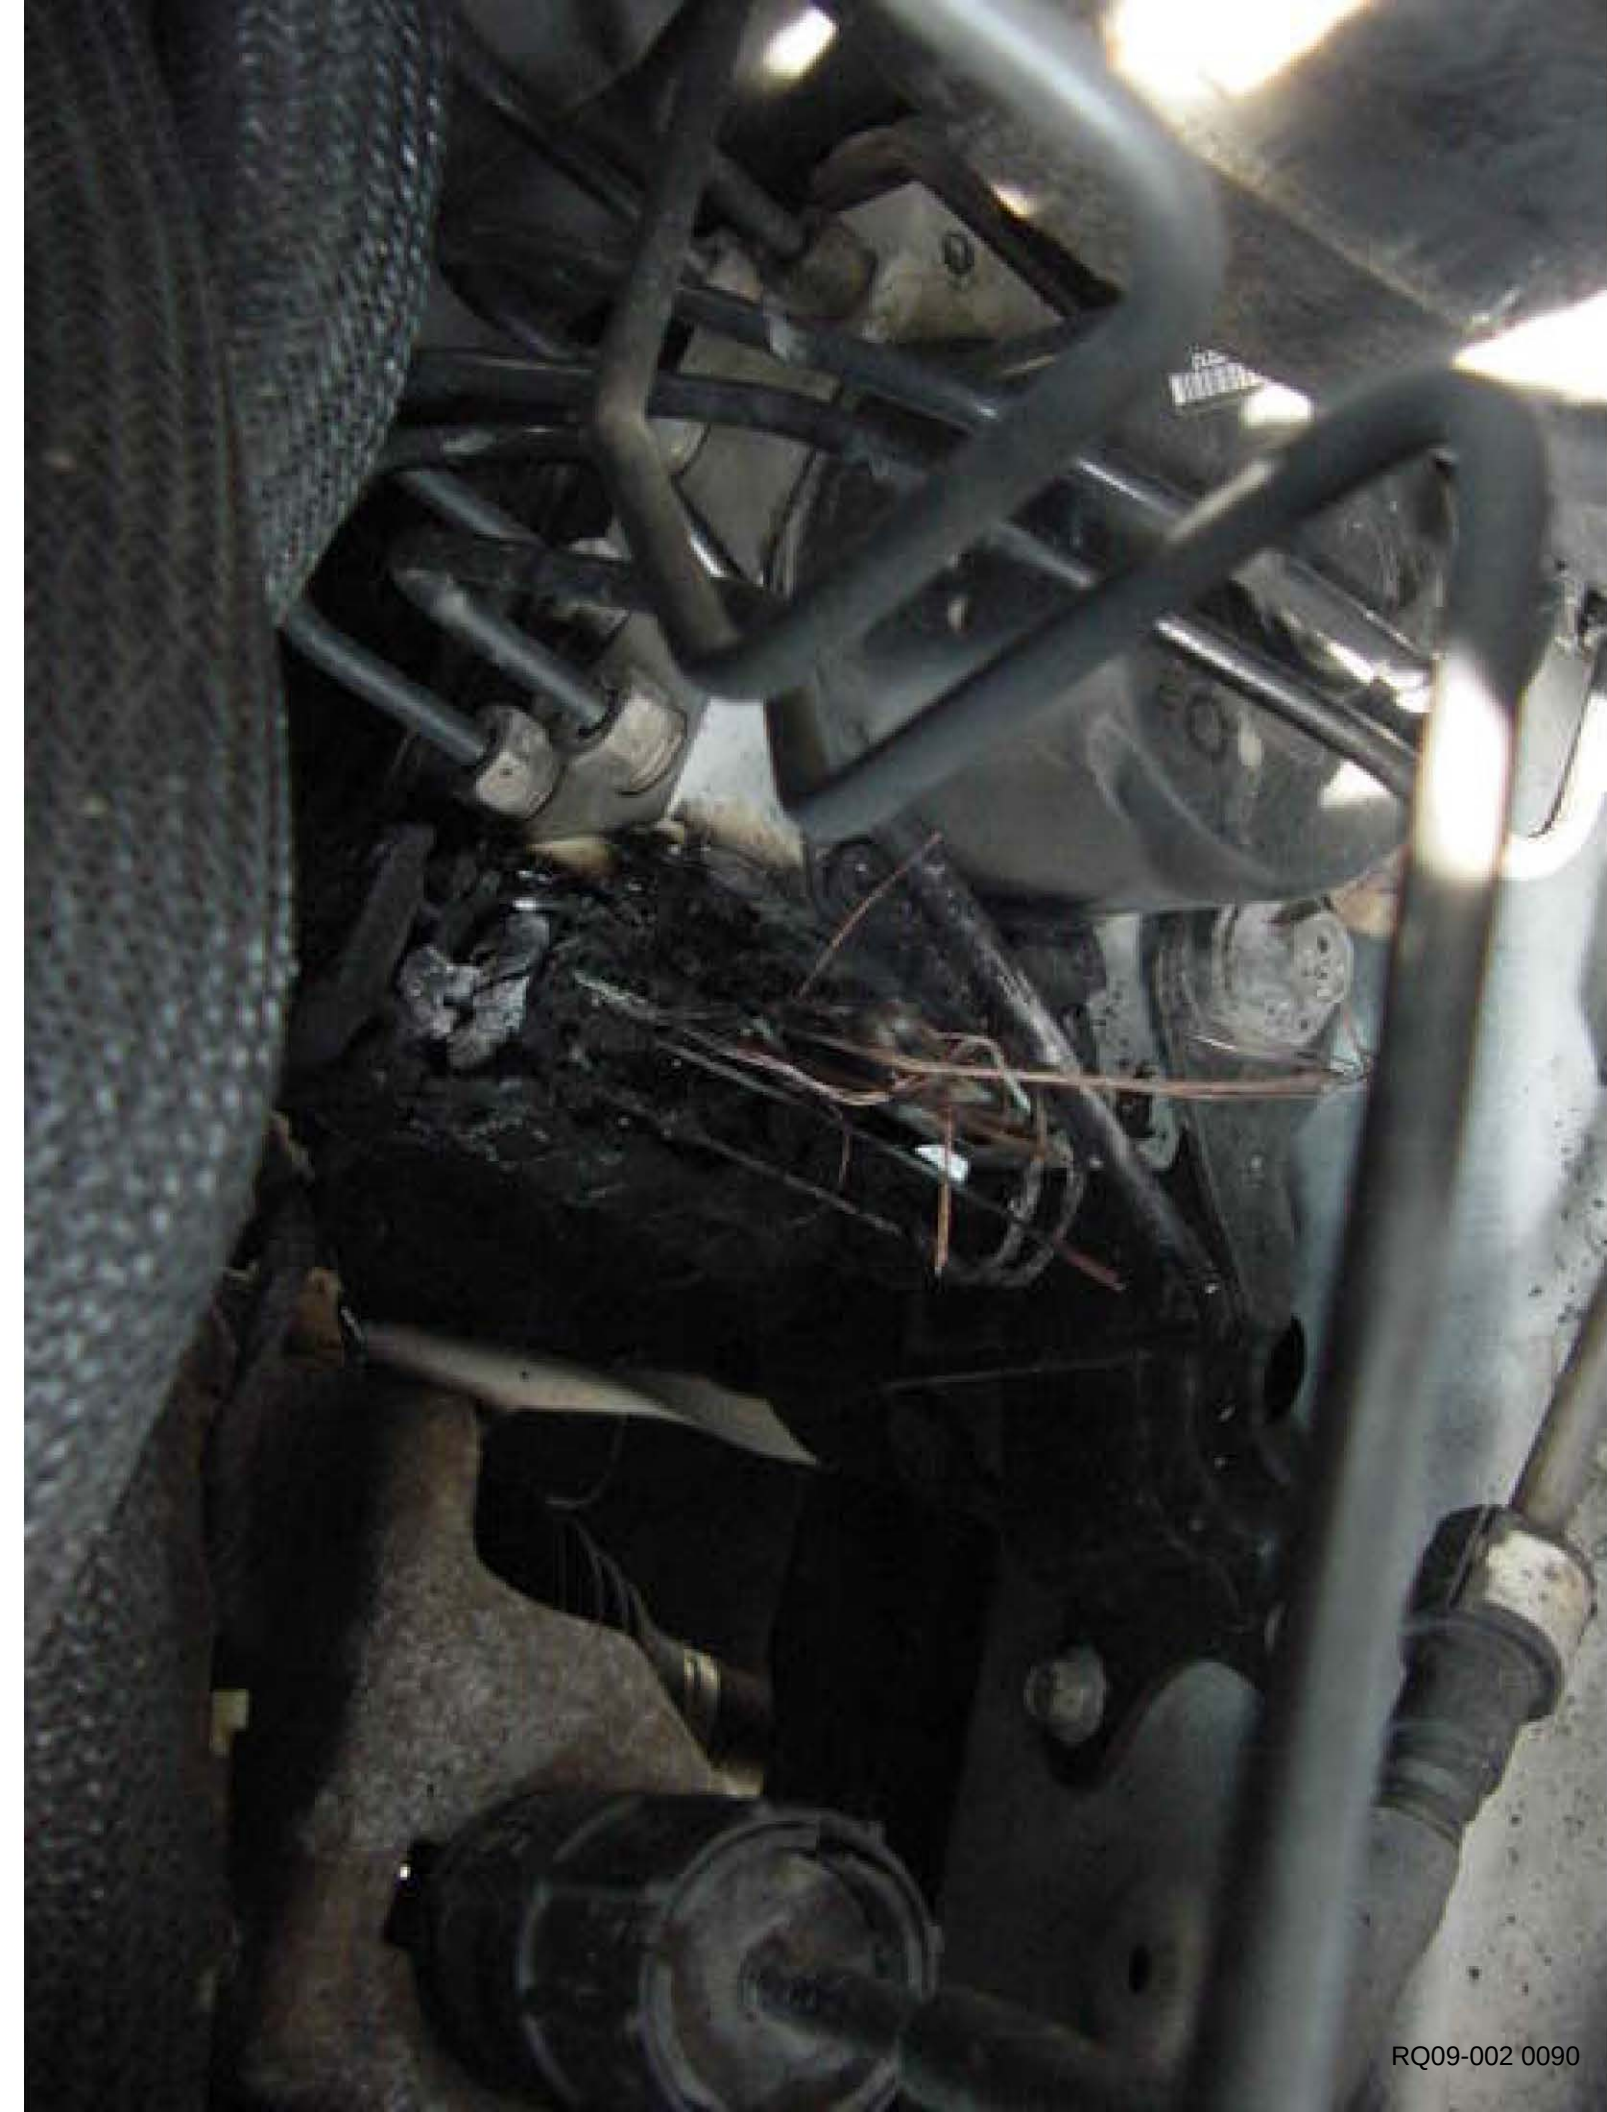
Photos for proof of damage to 2002 Escape VIN # 1FMCU04182KB66855. P&A - 03676.
