# Net Meeting Summary Sheet

**Issue:** ABS Module and/or harness damage after FSA 07S51

**Vehicle:** Escape

**Model Year(s):** 2001 and 2002

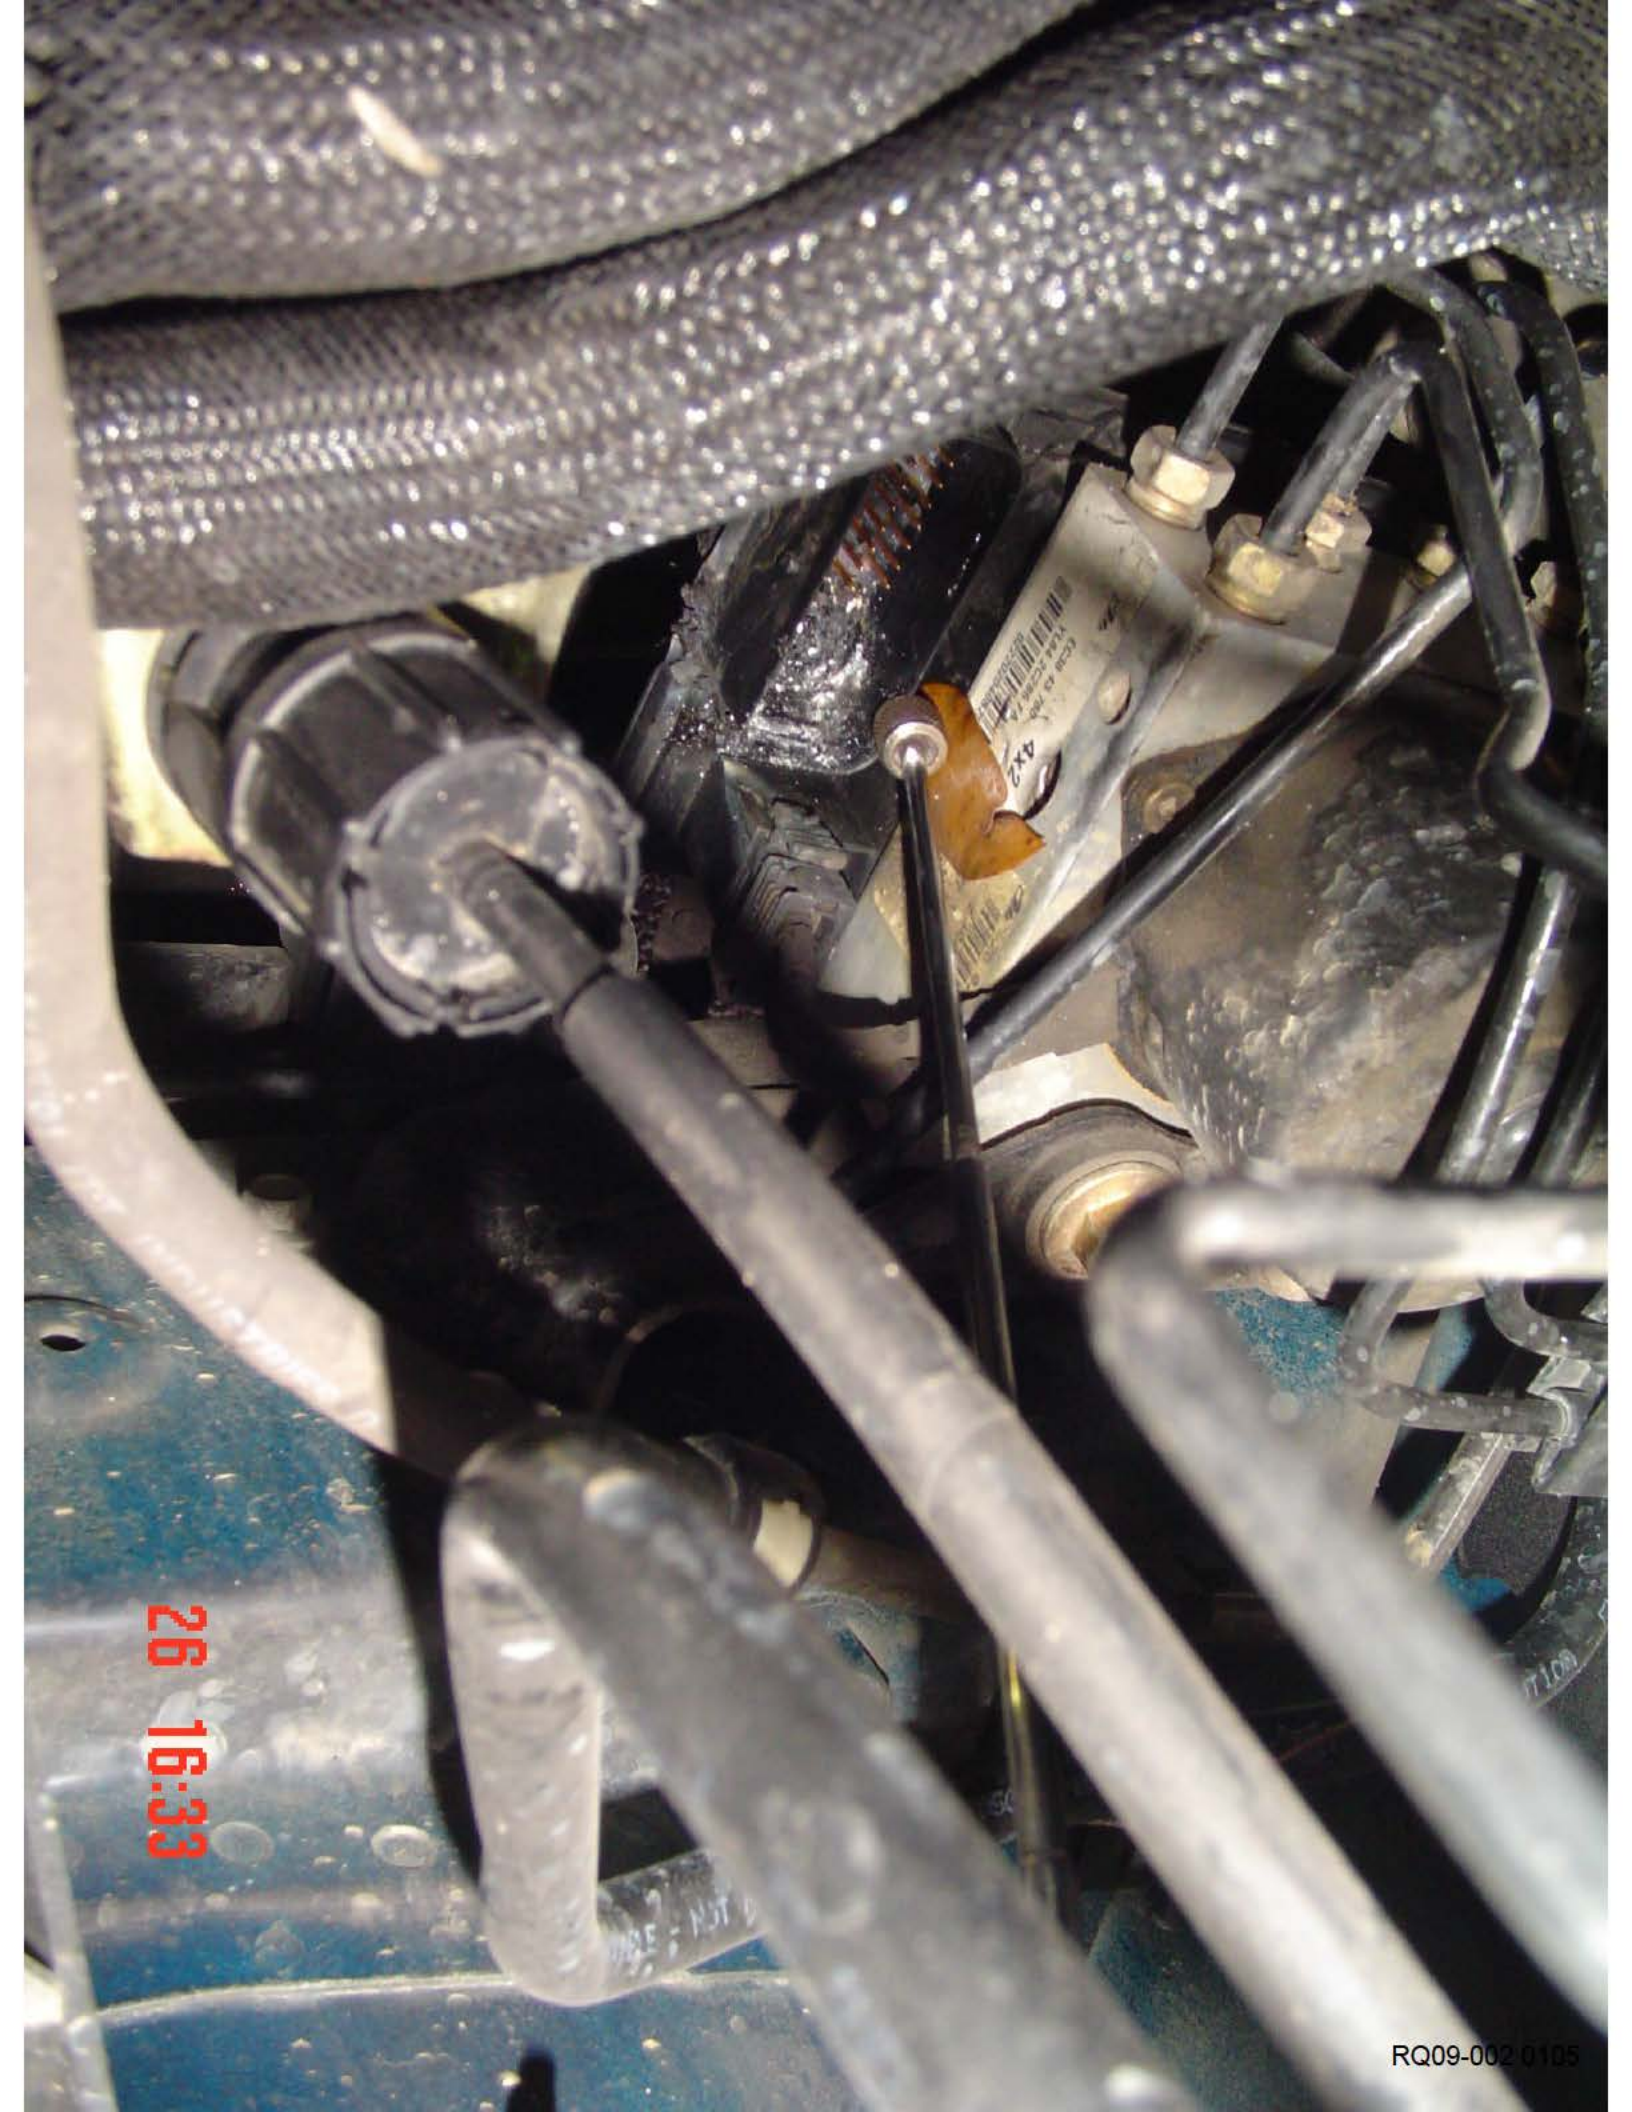
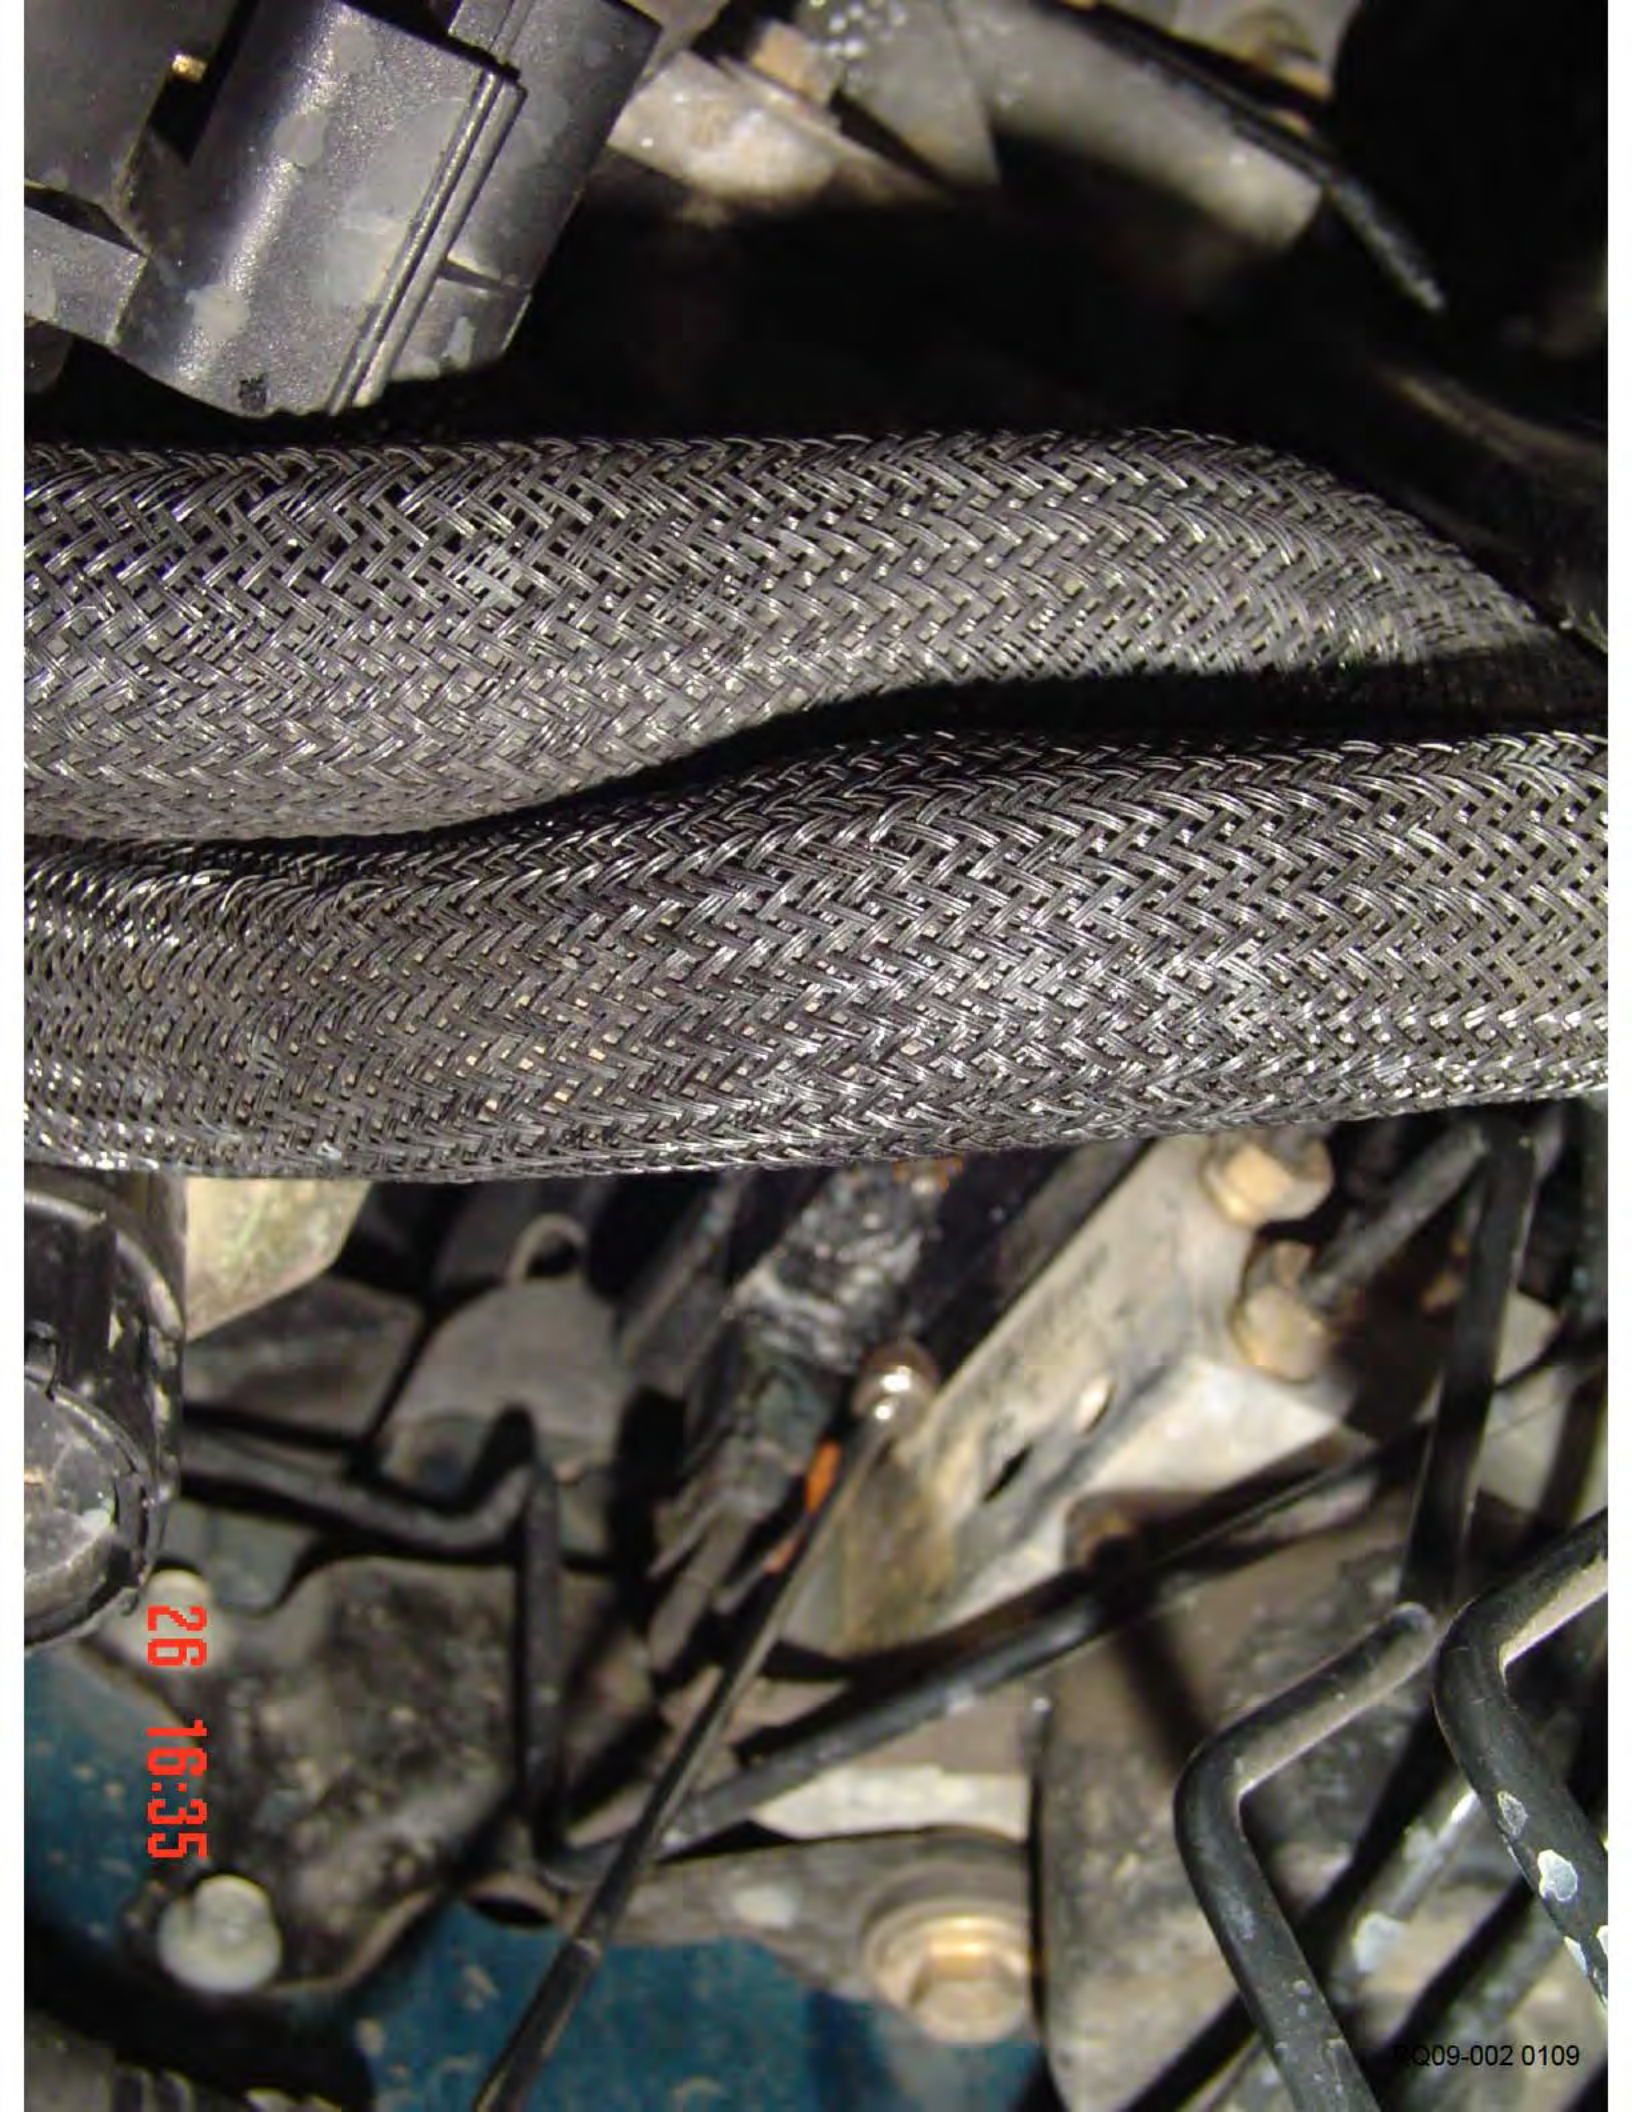
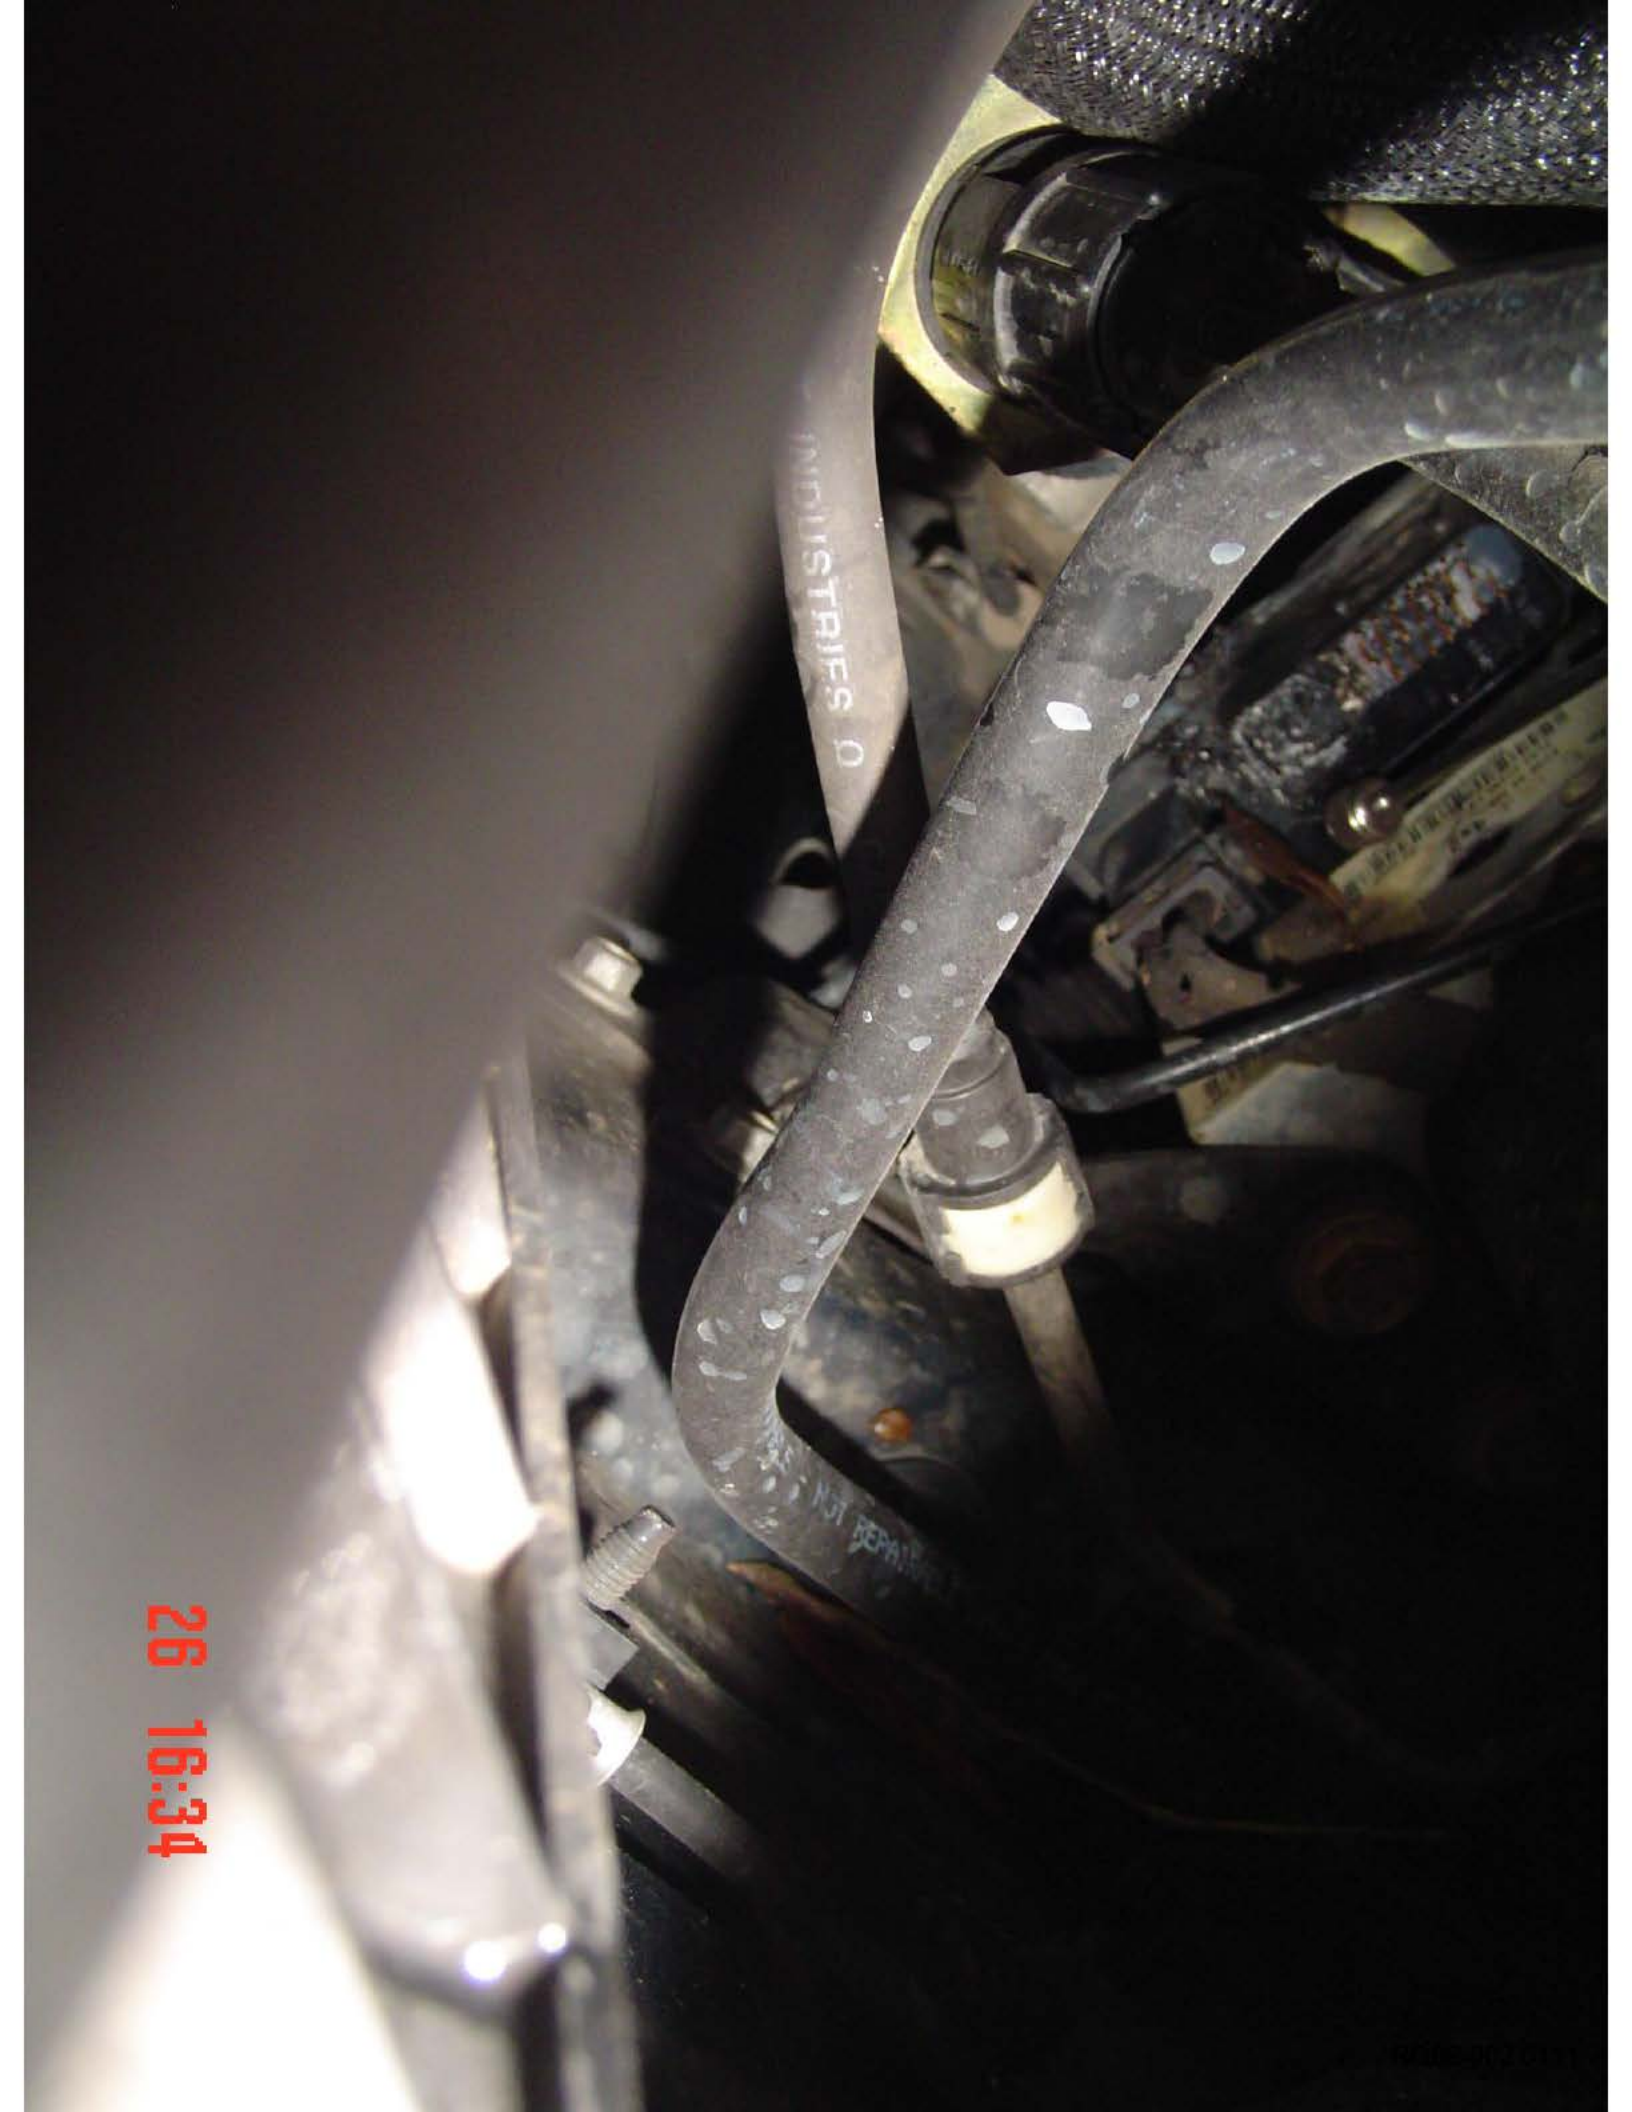
Tech Lonnie Melvin asked me to e-mail the attached pictures to you

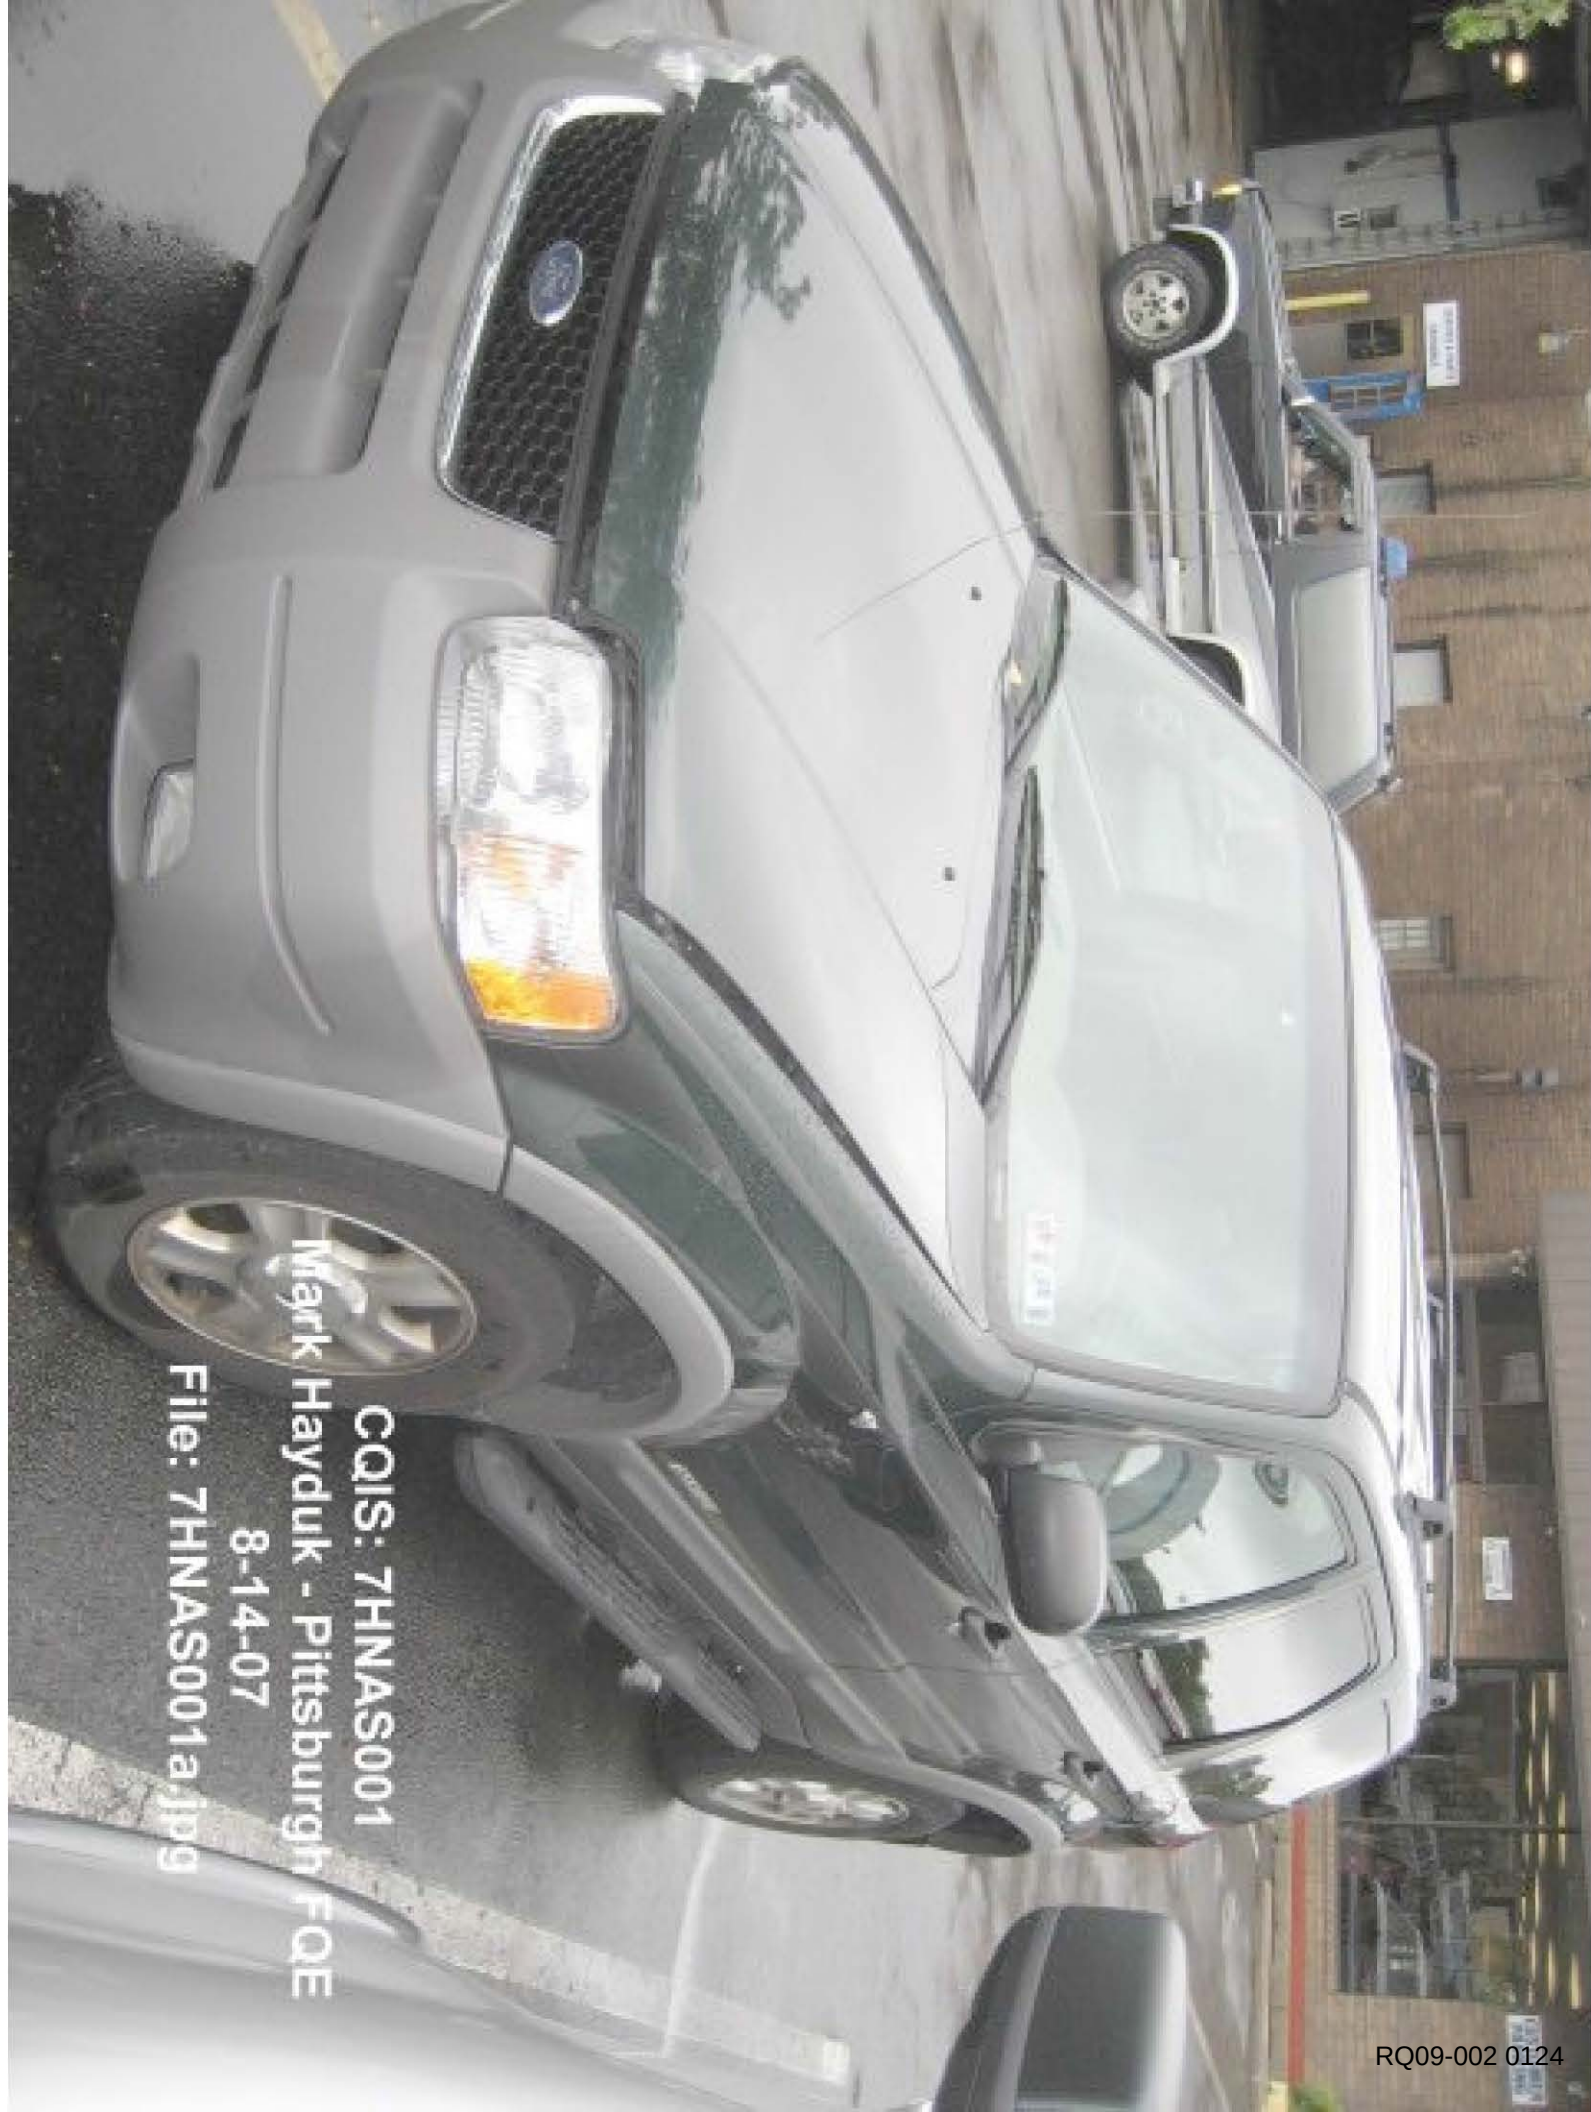
**TECH/C** **08/14/2007 08:34AM MARK HAYDUK MSS - FCSD - CQD - FQE**  
 CUST. STATES THAT THE VEH. WAS DRIVEN TO AN APARTMENT COMPLEX TO DROP OFF SOMEONE. THE CUSTOMER LEFT THE VEHICLE RUNNING WHILE THEY WENT INSIDE. WHILE THEY WERE INSIDE AN APARTMENT, SOMEONE NOTICED SMOKE COMING OUT FROM UNDER THE HOOD AND THEY CALLED THE FIRE DEPARTMENT WHO  
 APPLIED FIRE RETARDANT. THE VEHICLE WAS TOWED TO THE DEALER. FQE FOUND THAT THE CONNECTOR TO THE ABS MODULE WAS BURNT AND APPROX. 6" OF THE WIRING GOING TO THE ABS MODULE WAS BURNT. THERE WAS YELLOW FIRE RETARDANT RESIDUE FOUND UNDER THE HOOD. THE VEHICLE WOULD START AND IDLE SMOOTHLY BUT THE SHIFTER WOULD NOT COME OUT OF PARK DUE TO THE BRAKE LIGHTS BEING INOP. FSA 07S51 WAS PERFORMED ON 5-1-07 AT 83,533 MILES. THE CUSTOMER INDICATED THAT FOR SOME TIME, APPROX. A YEAR OR SO, THE BRAKE LIGHT WOULD COME ON AT TIMES AND THEY FOUND THE BRAKE FLUID LOW IN THE MASTER CYLINDER. THE DEALER INSTALLED A NEW BRAKE RESERVOIR CAP - THE CUSTOMER BELIEVES THAT THE NEW BRAKE FLUID CAP WAS INSTALLED WHEN THE DEALER PERFORMED FSA 07S51. THE HCU, ECU AND WIRING PIGTAIL ARE BEING CHANGED AS AN ASSEMBLY AND RETURNED TO MARK TUNEFF (SE&SE). PHOTOS. ATTACHED. MARK HAYDUK - PITTSBURGH FQE - 724-413-9113

CQIS: 7HNAS001  
Mark Hayduk - Pittsburgh FQE  
8-14-07  
File: 7HNAS001a.jpg

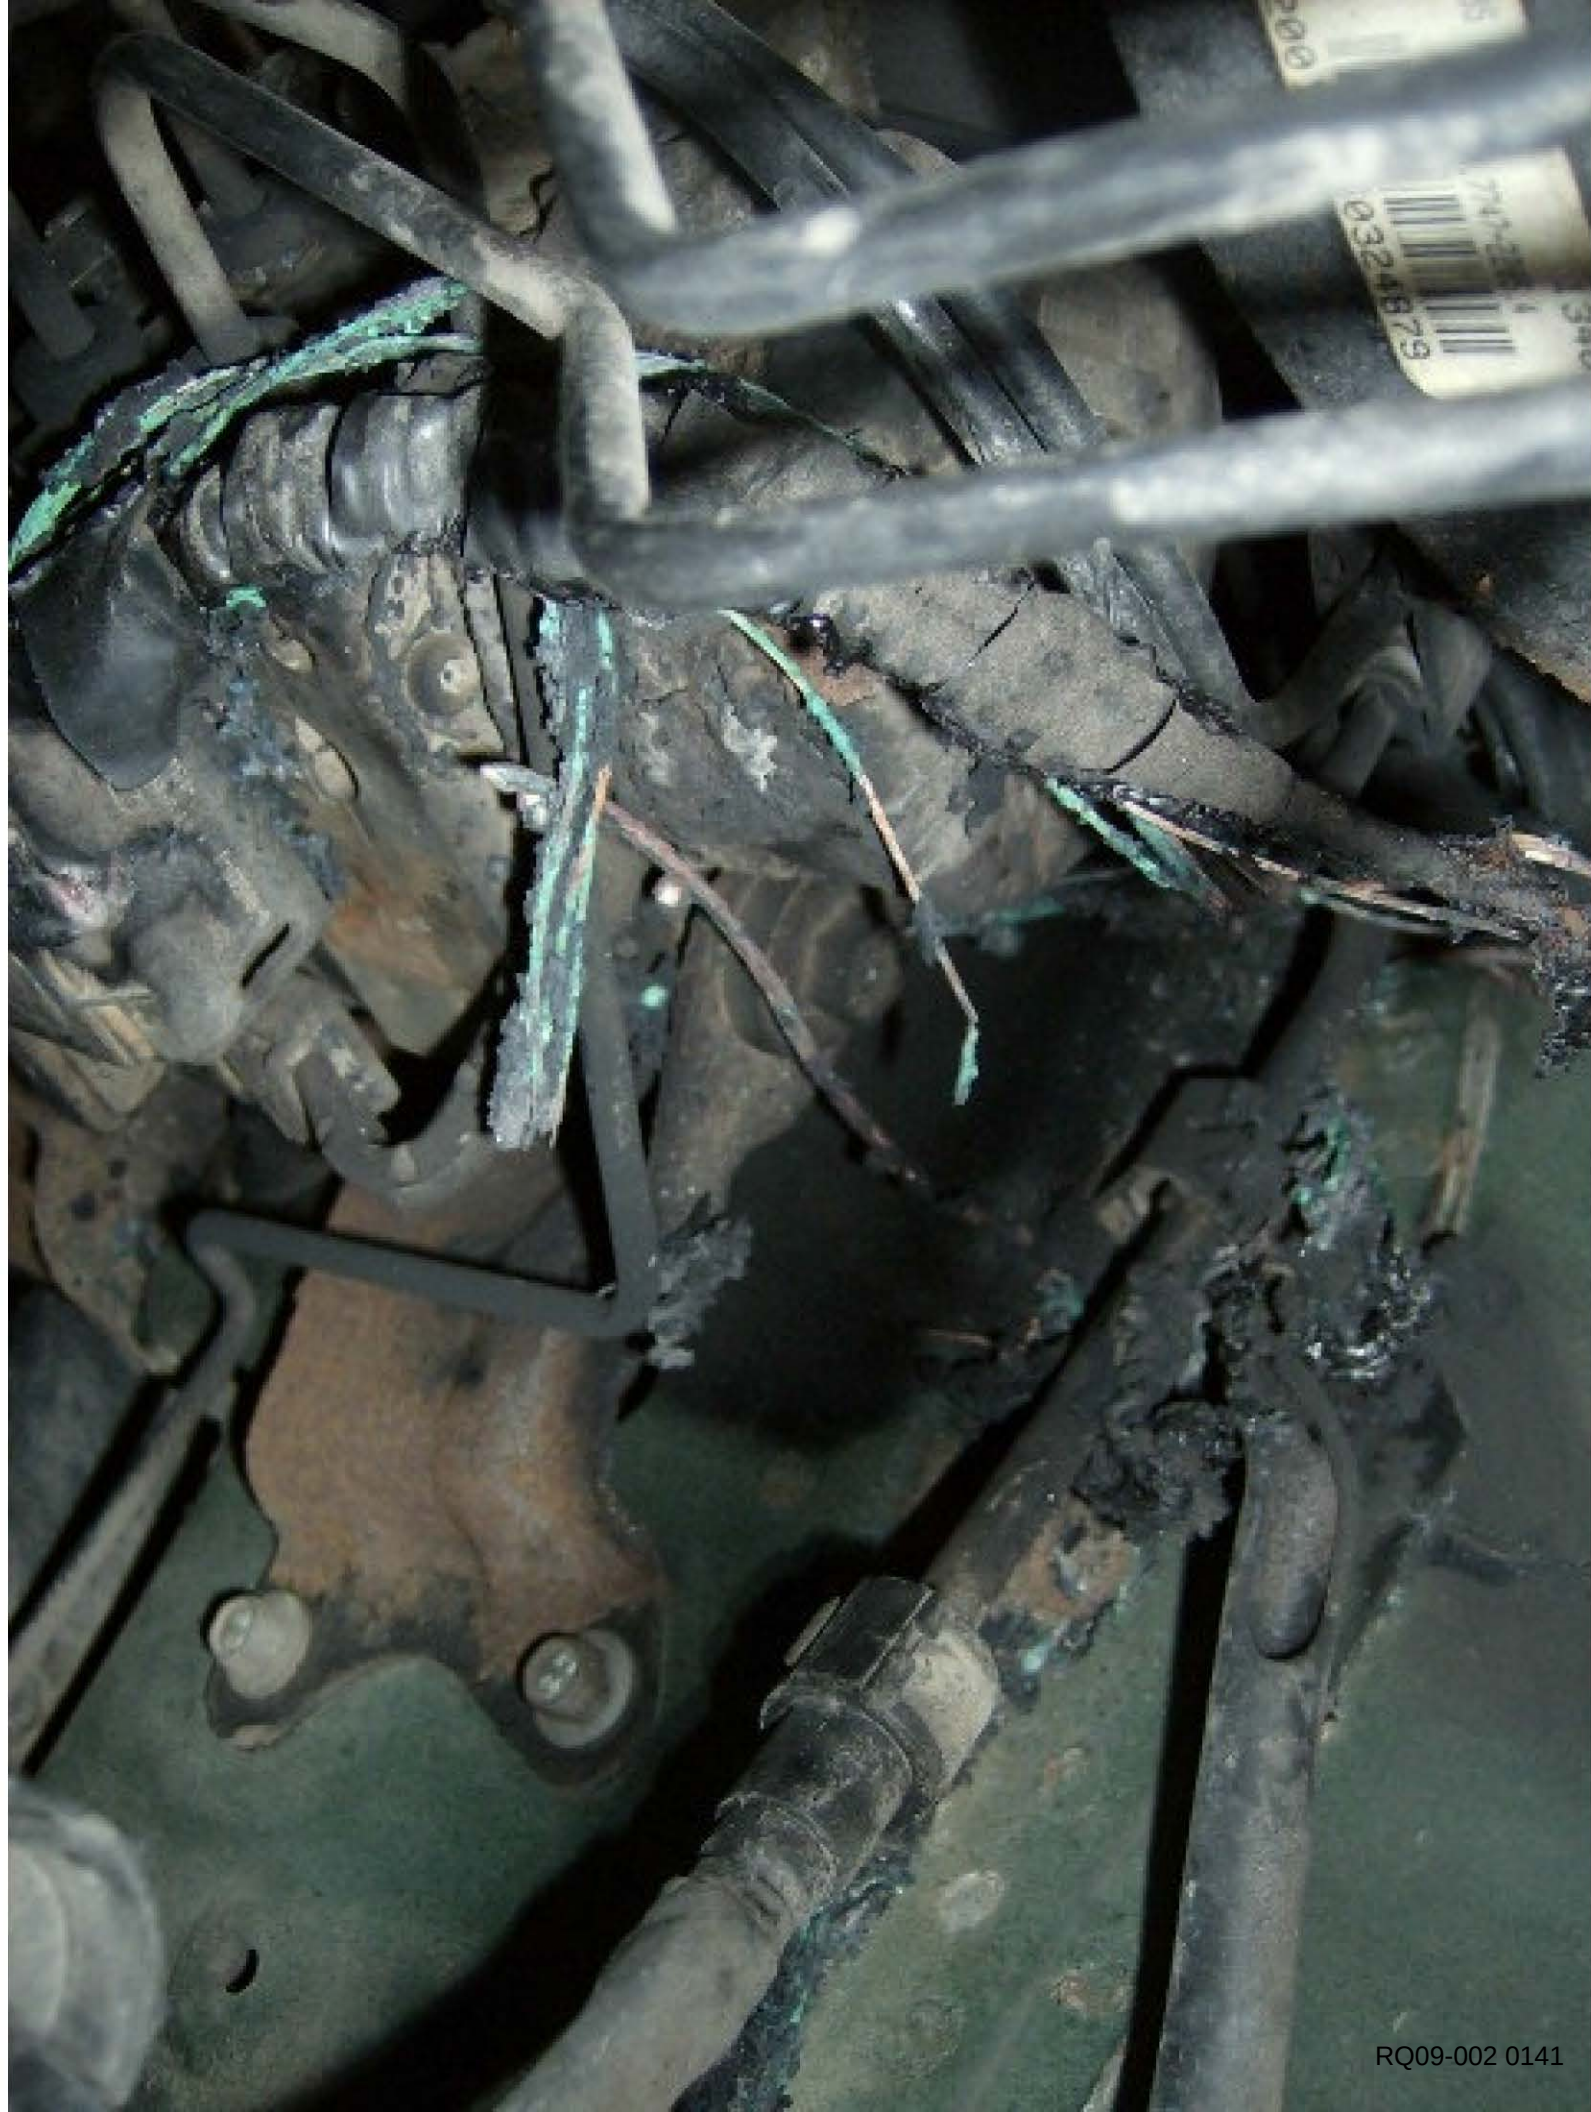
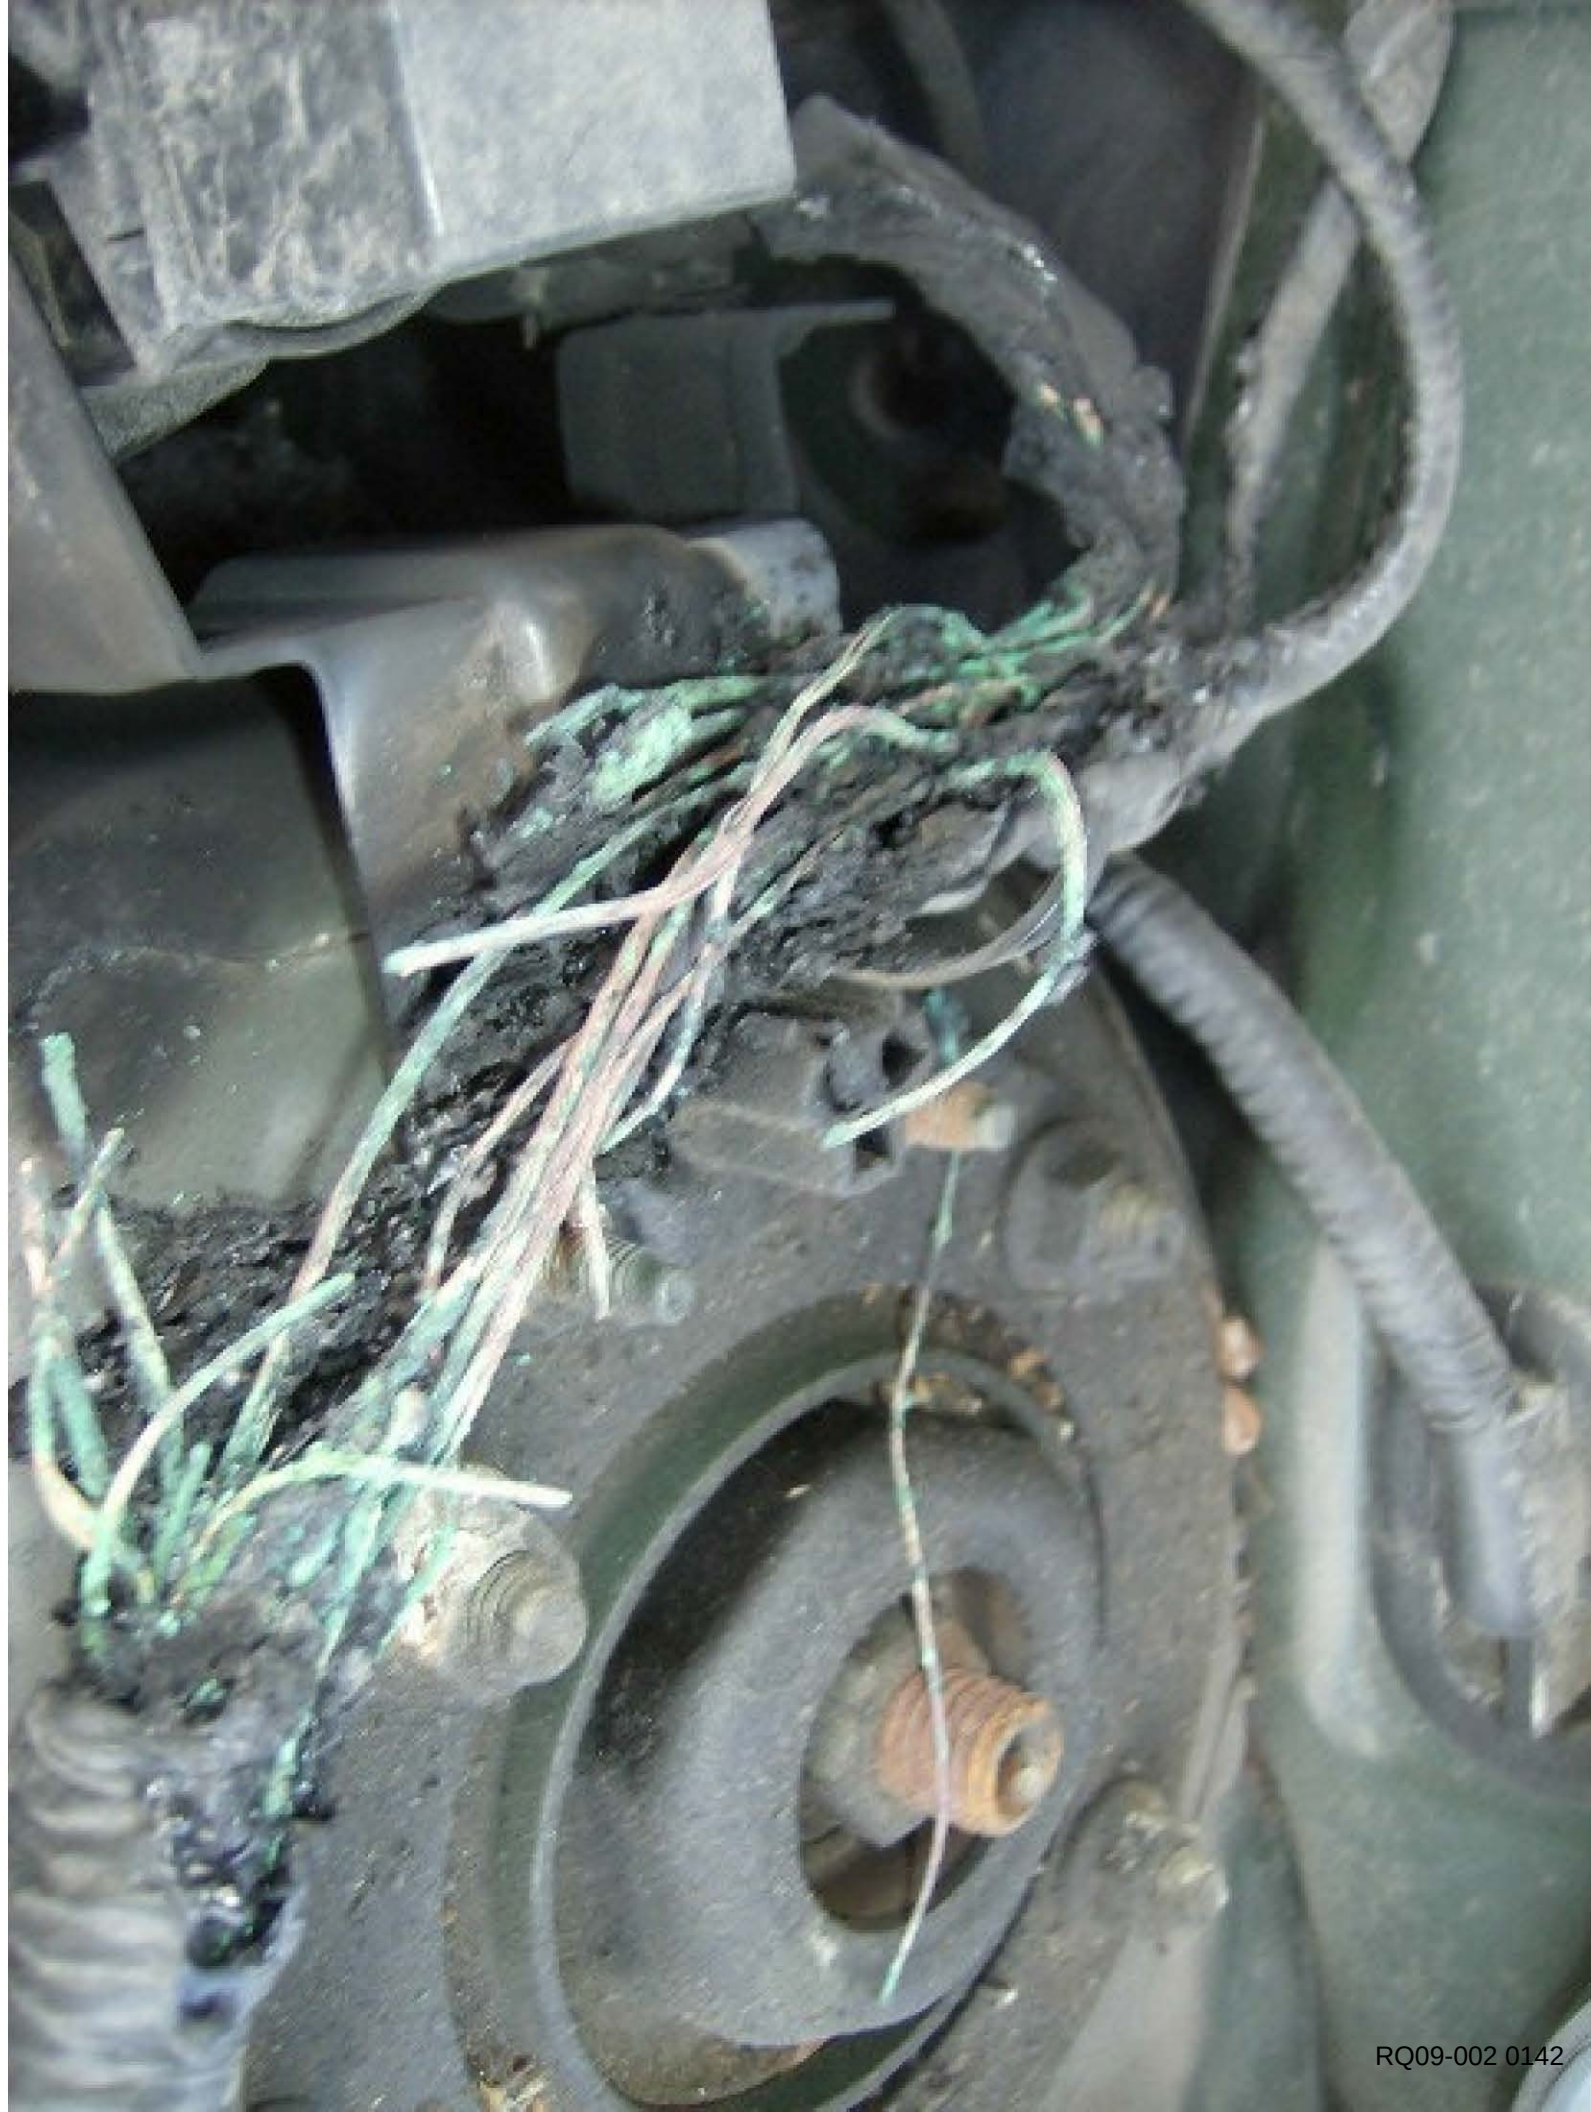
vehicle originally in with ele damage at dside headlamp...possible aftermarket wiring? cust decline repiars, and took vehicle also had labor op a performed..

vehicle came back with thermal damage seen above.

Dealer's Request...: Related Damage  
Dealer's Concerns.: VIN#1FMYU04192KB53585 HAD LABOR OP A REPAIR ON 4-12-07 AND WAS TOWED  
IN TO DLR WITH FIRE DAMAGE TO ECU, HCU, POWER DISTRIBUTION BOX AND  
WIRING HARNESS THAT LEADS TO PDB. DLR TO ASSEMBLE COMPLETE ESTIMATE TO  
FAX AND E-MAIL PICS. DLR HAD NO DETAILS OF FIRE, DATE, EMERGENCY  
RESPONSE, INJURY, PROPERTY DAMAGE OR DAMAGE CLAIM SUBMITTED TO INS.
