# Net Meeting Summary Sheet

**Issue:** ABS Module and/or harness damage after FSA 07S51

**Vehicle:** Escape

**Model Year(s):** 2001 and 2002

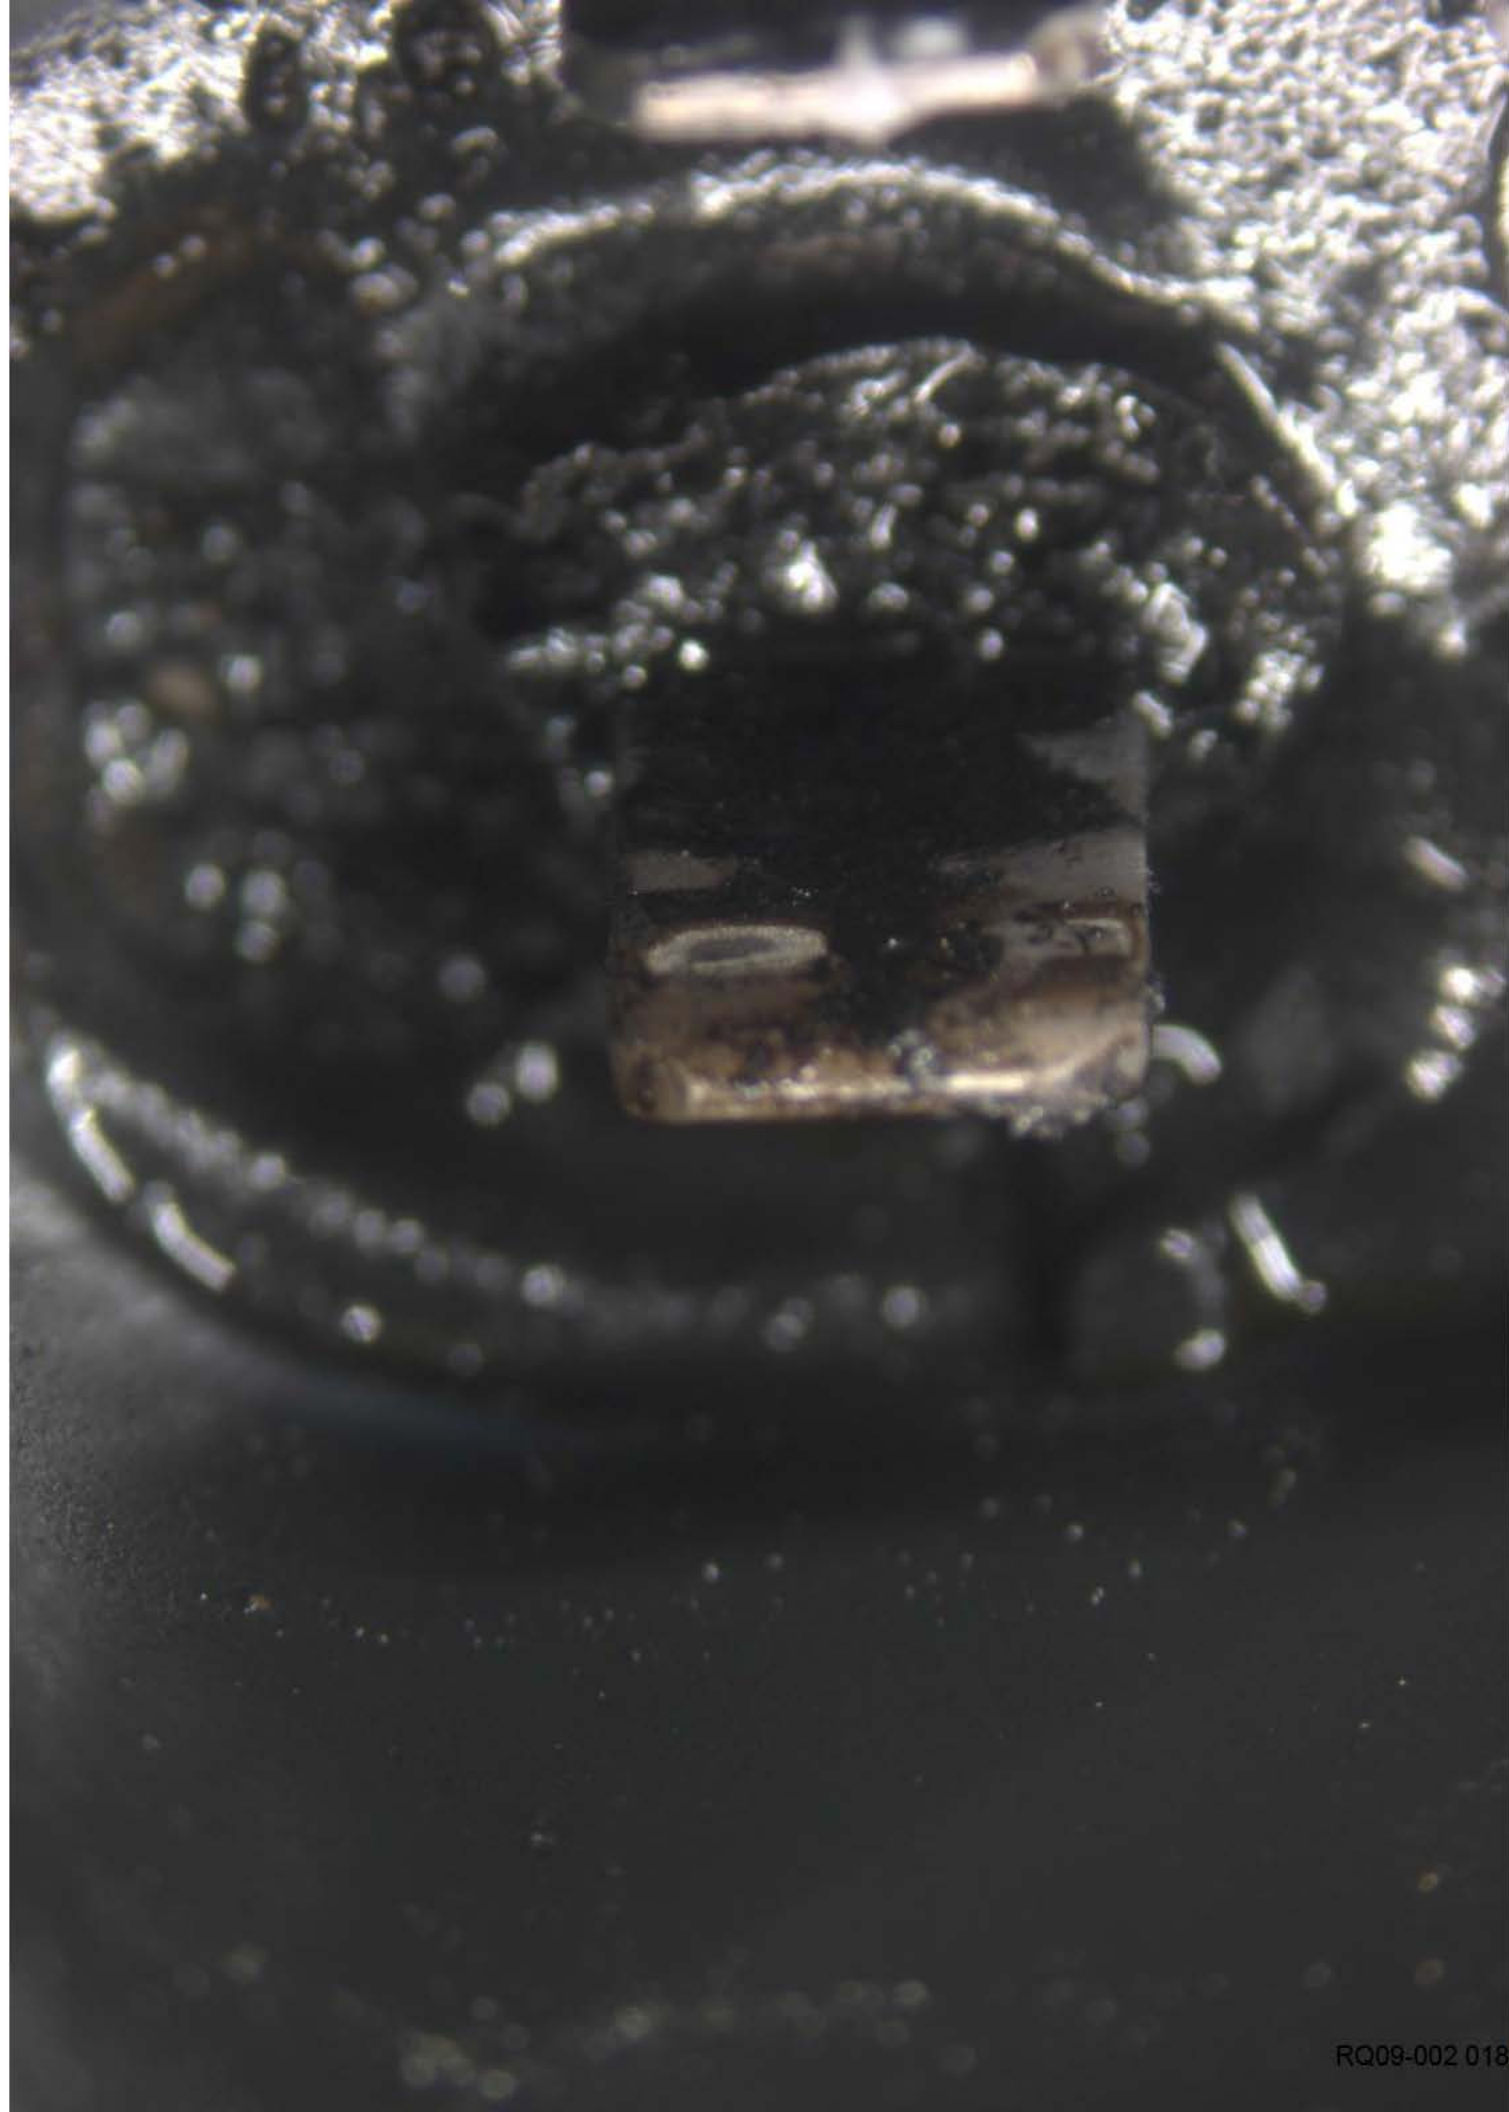
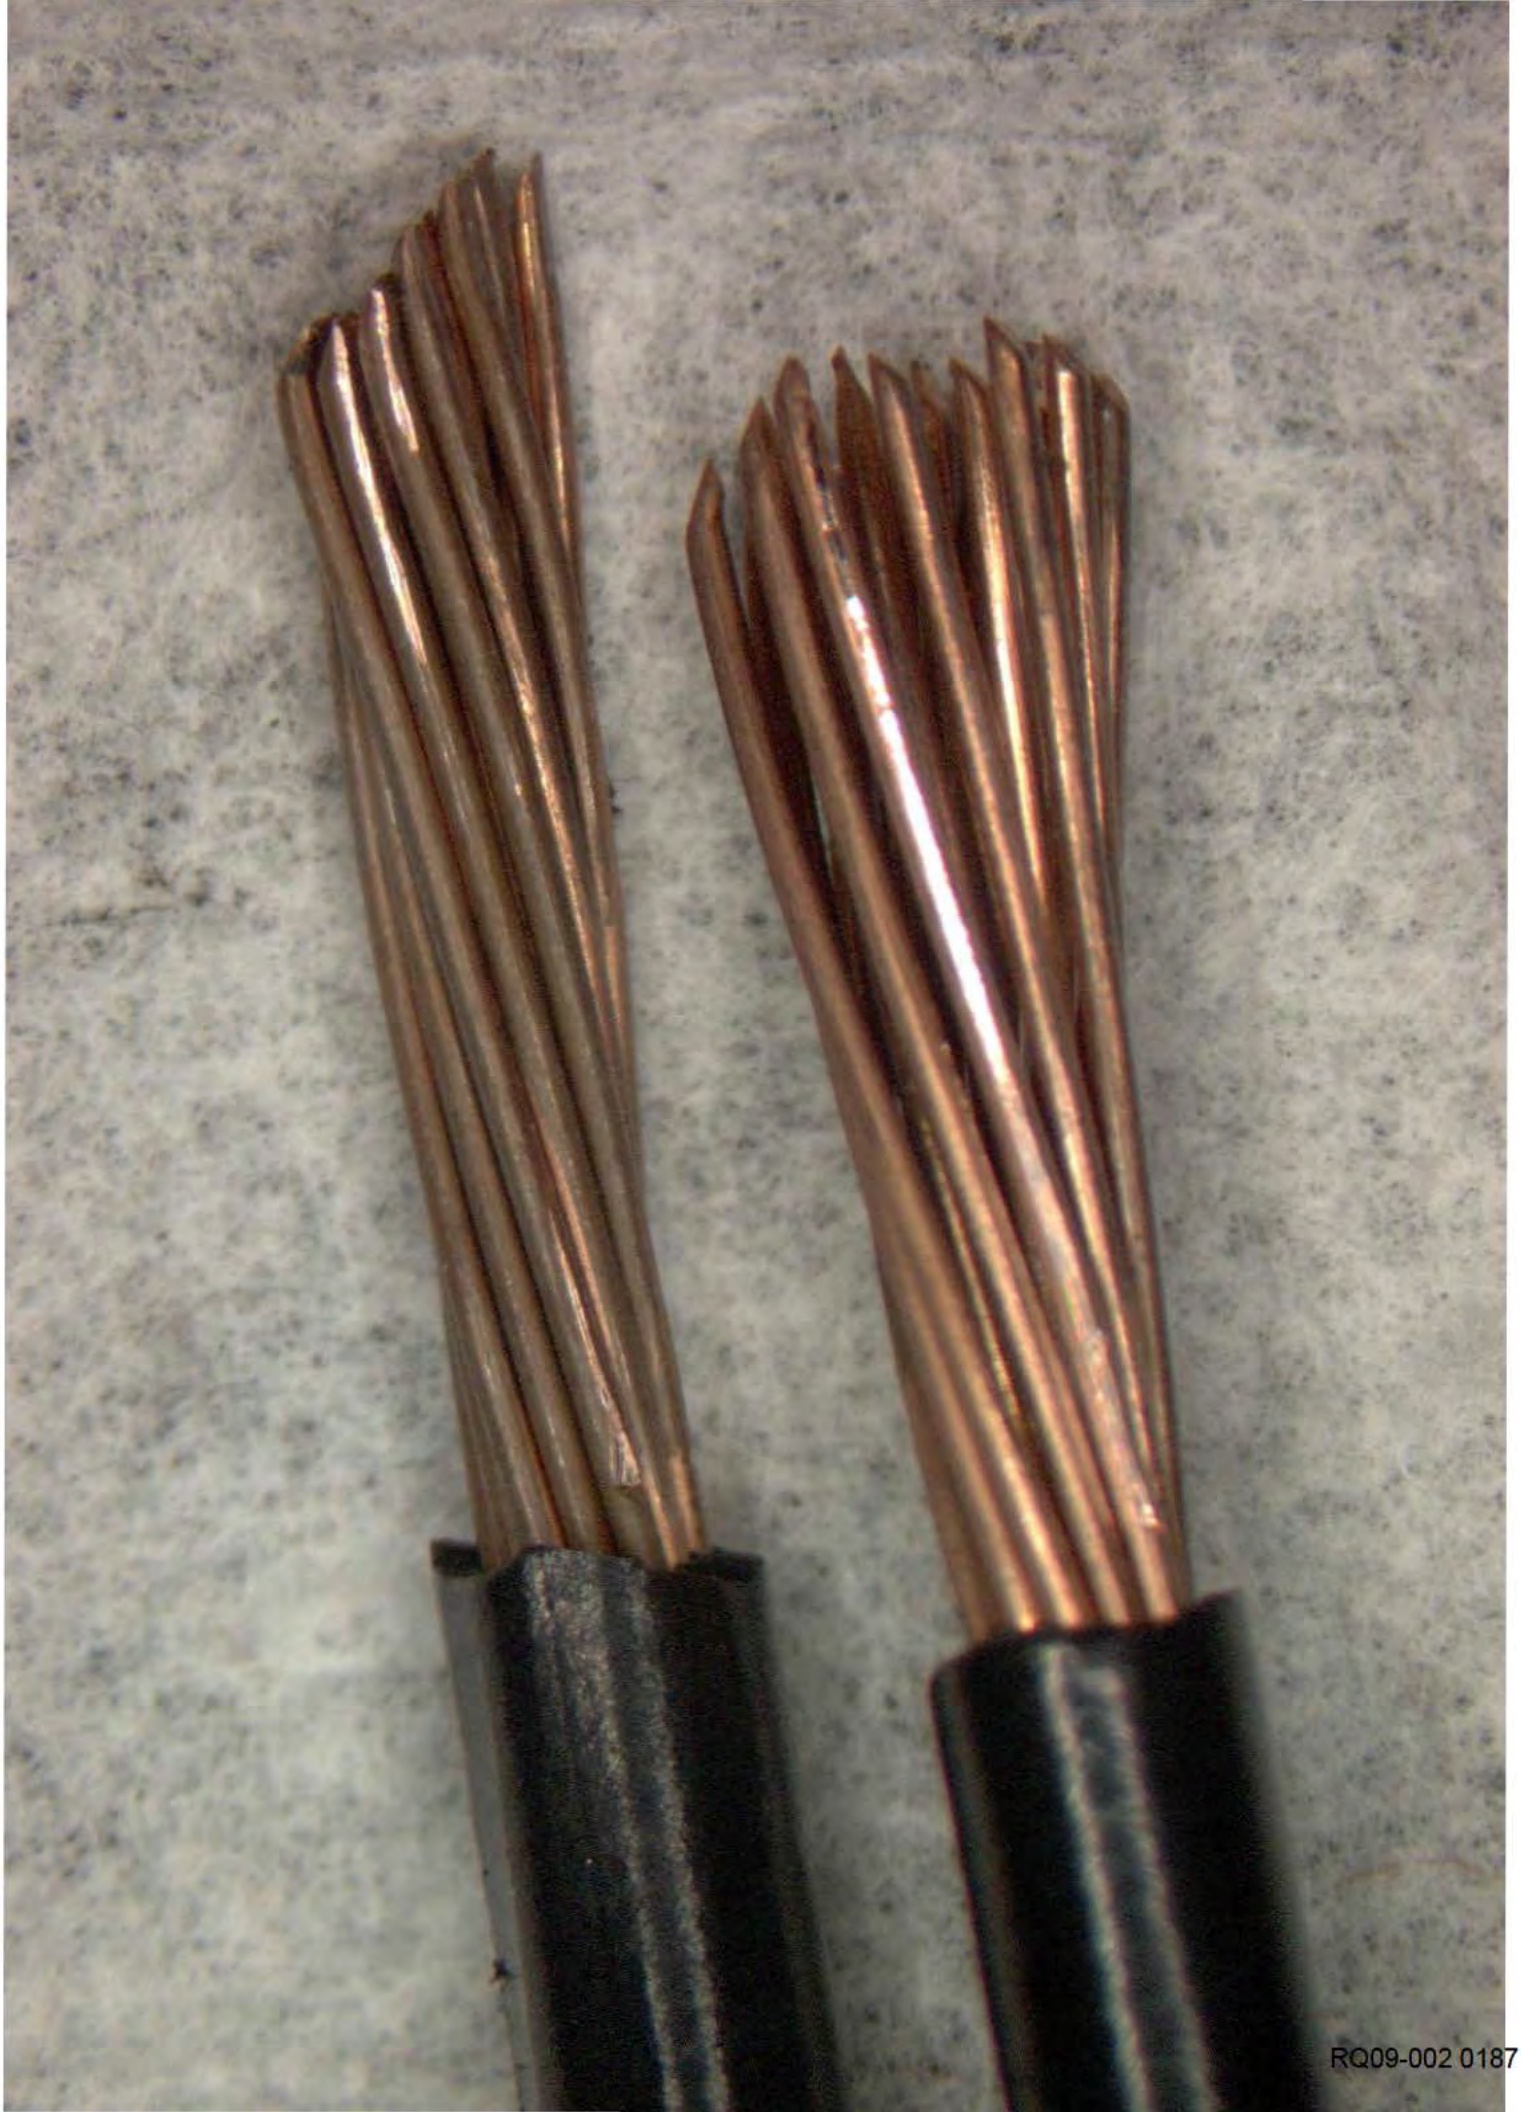
What I did NOT see: Blue or green corrosion that would indicate a conductive path between the terminals. Strong evidence of fluid on the wire strands.

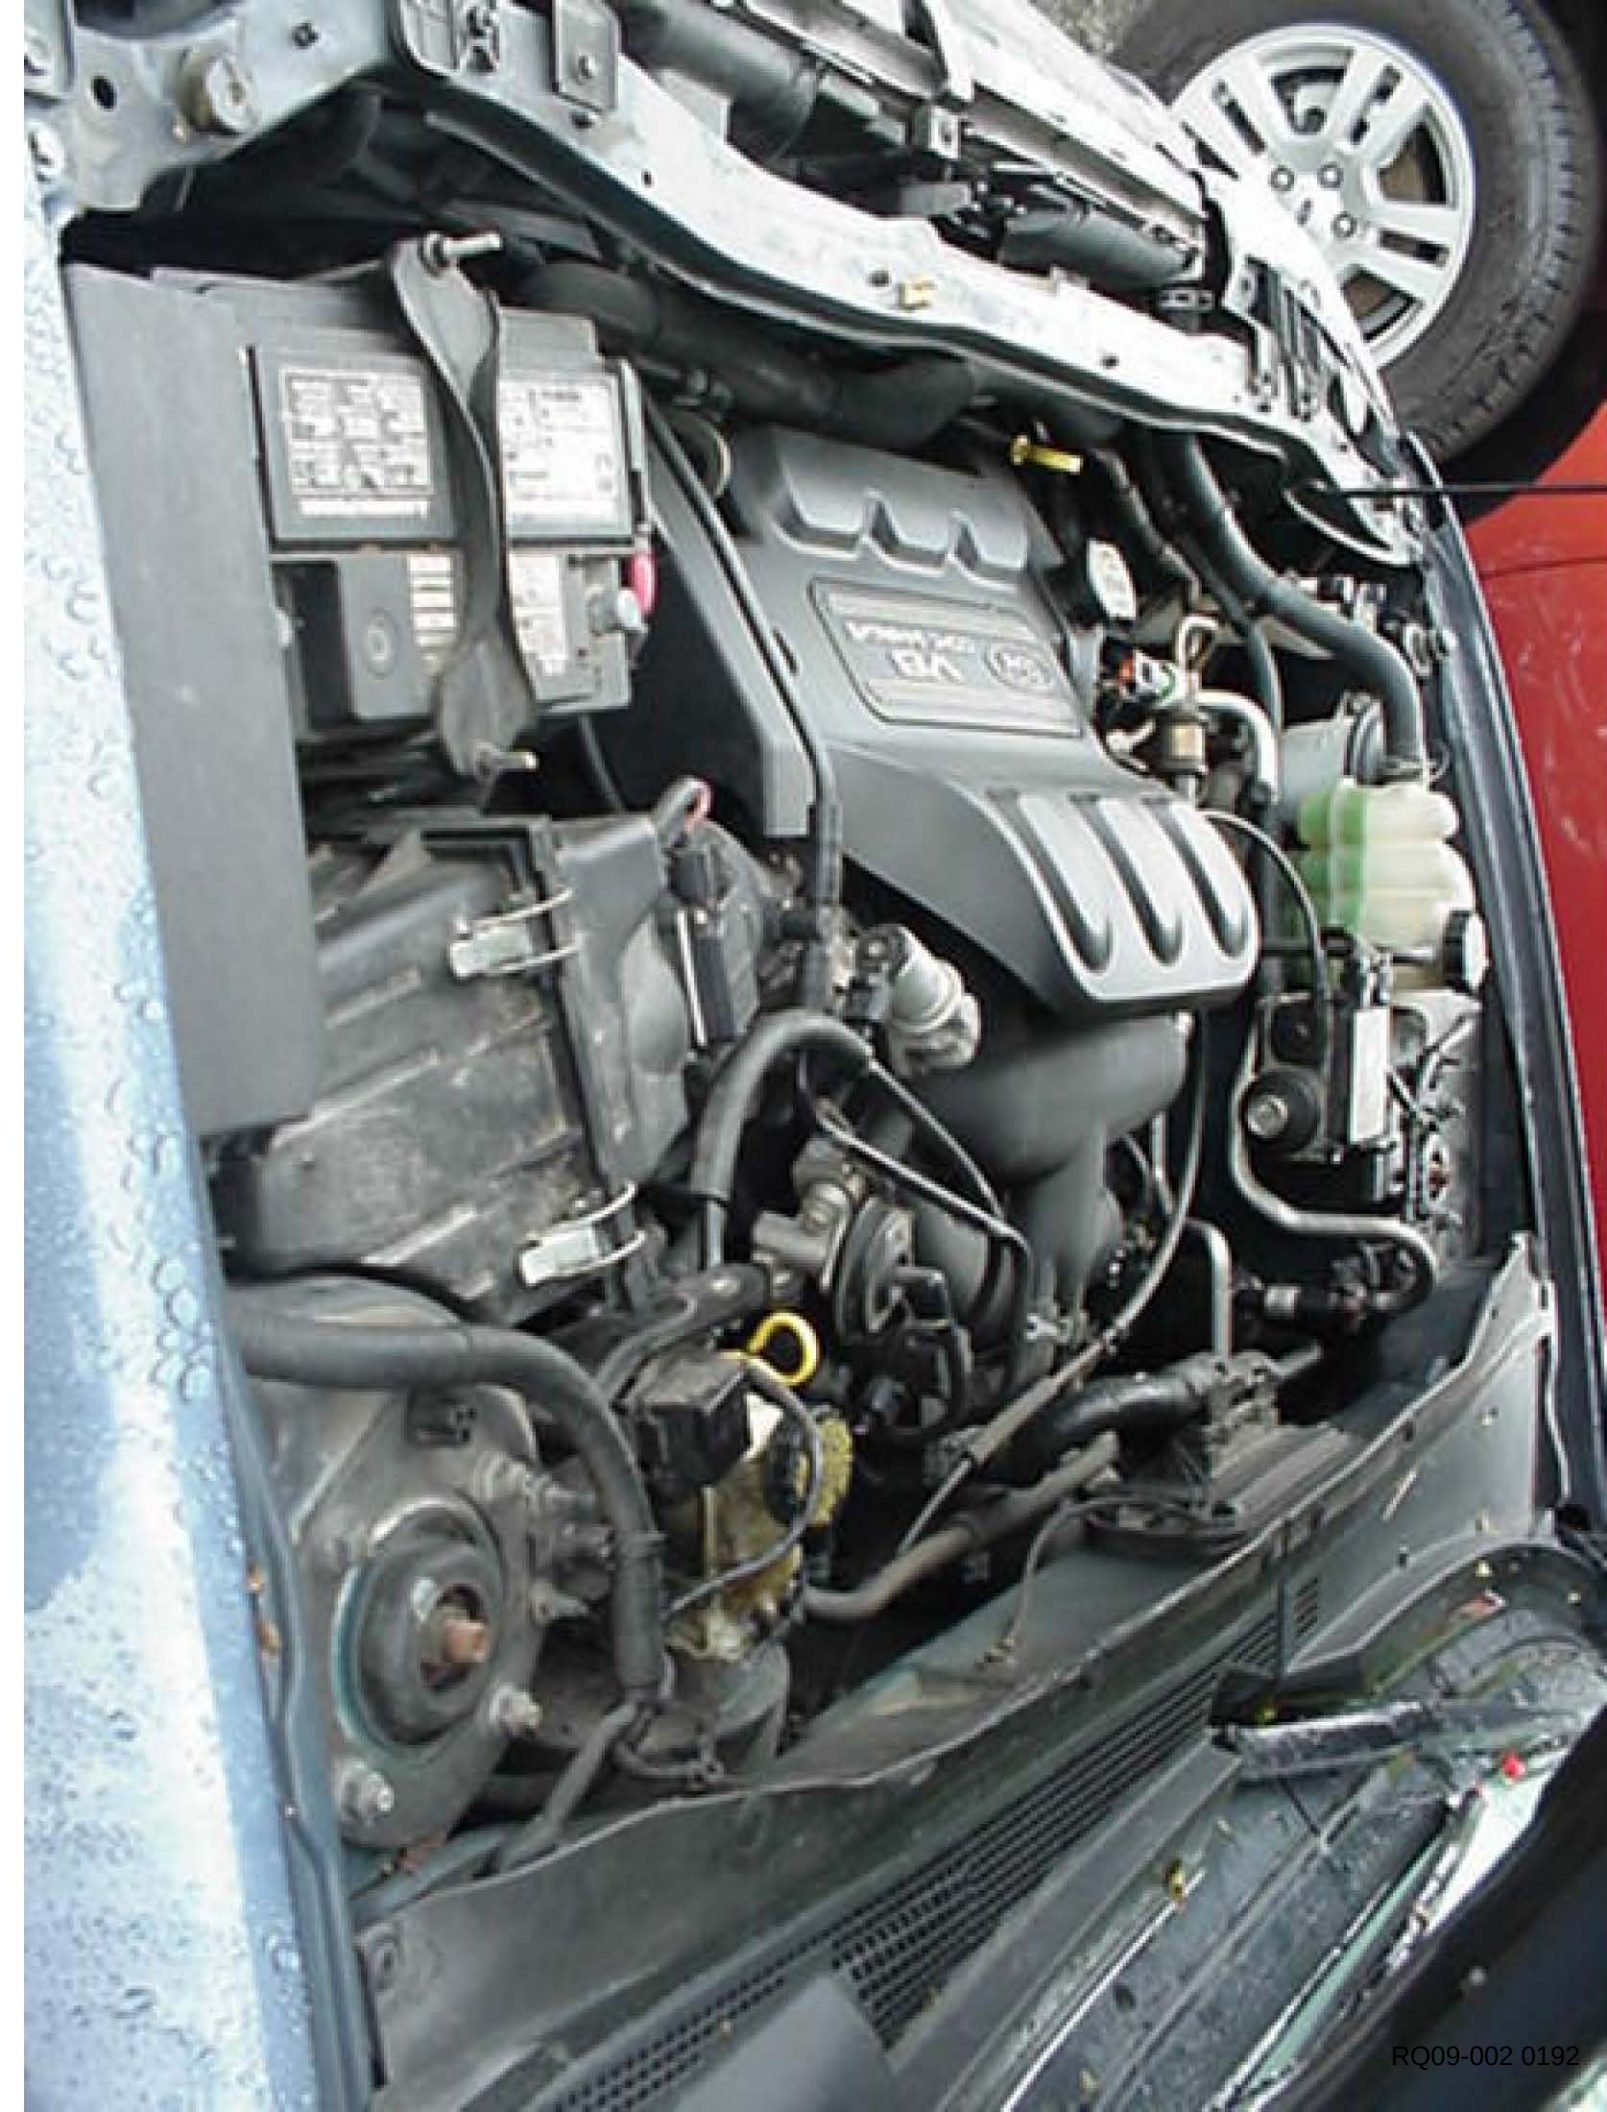
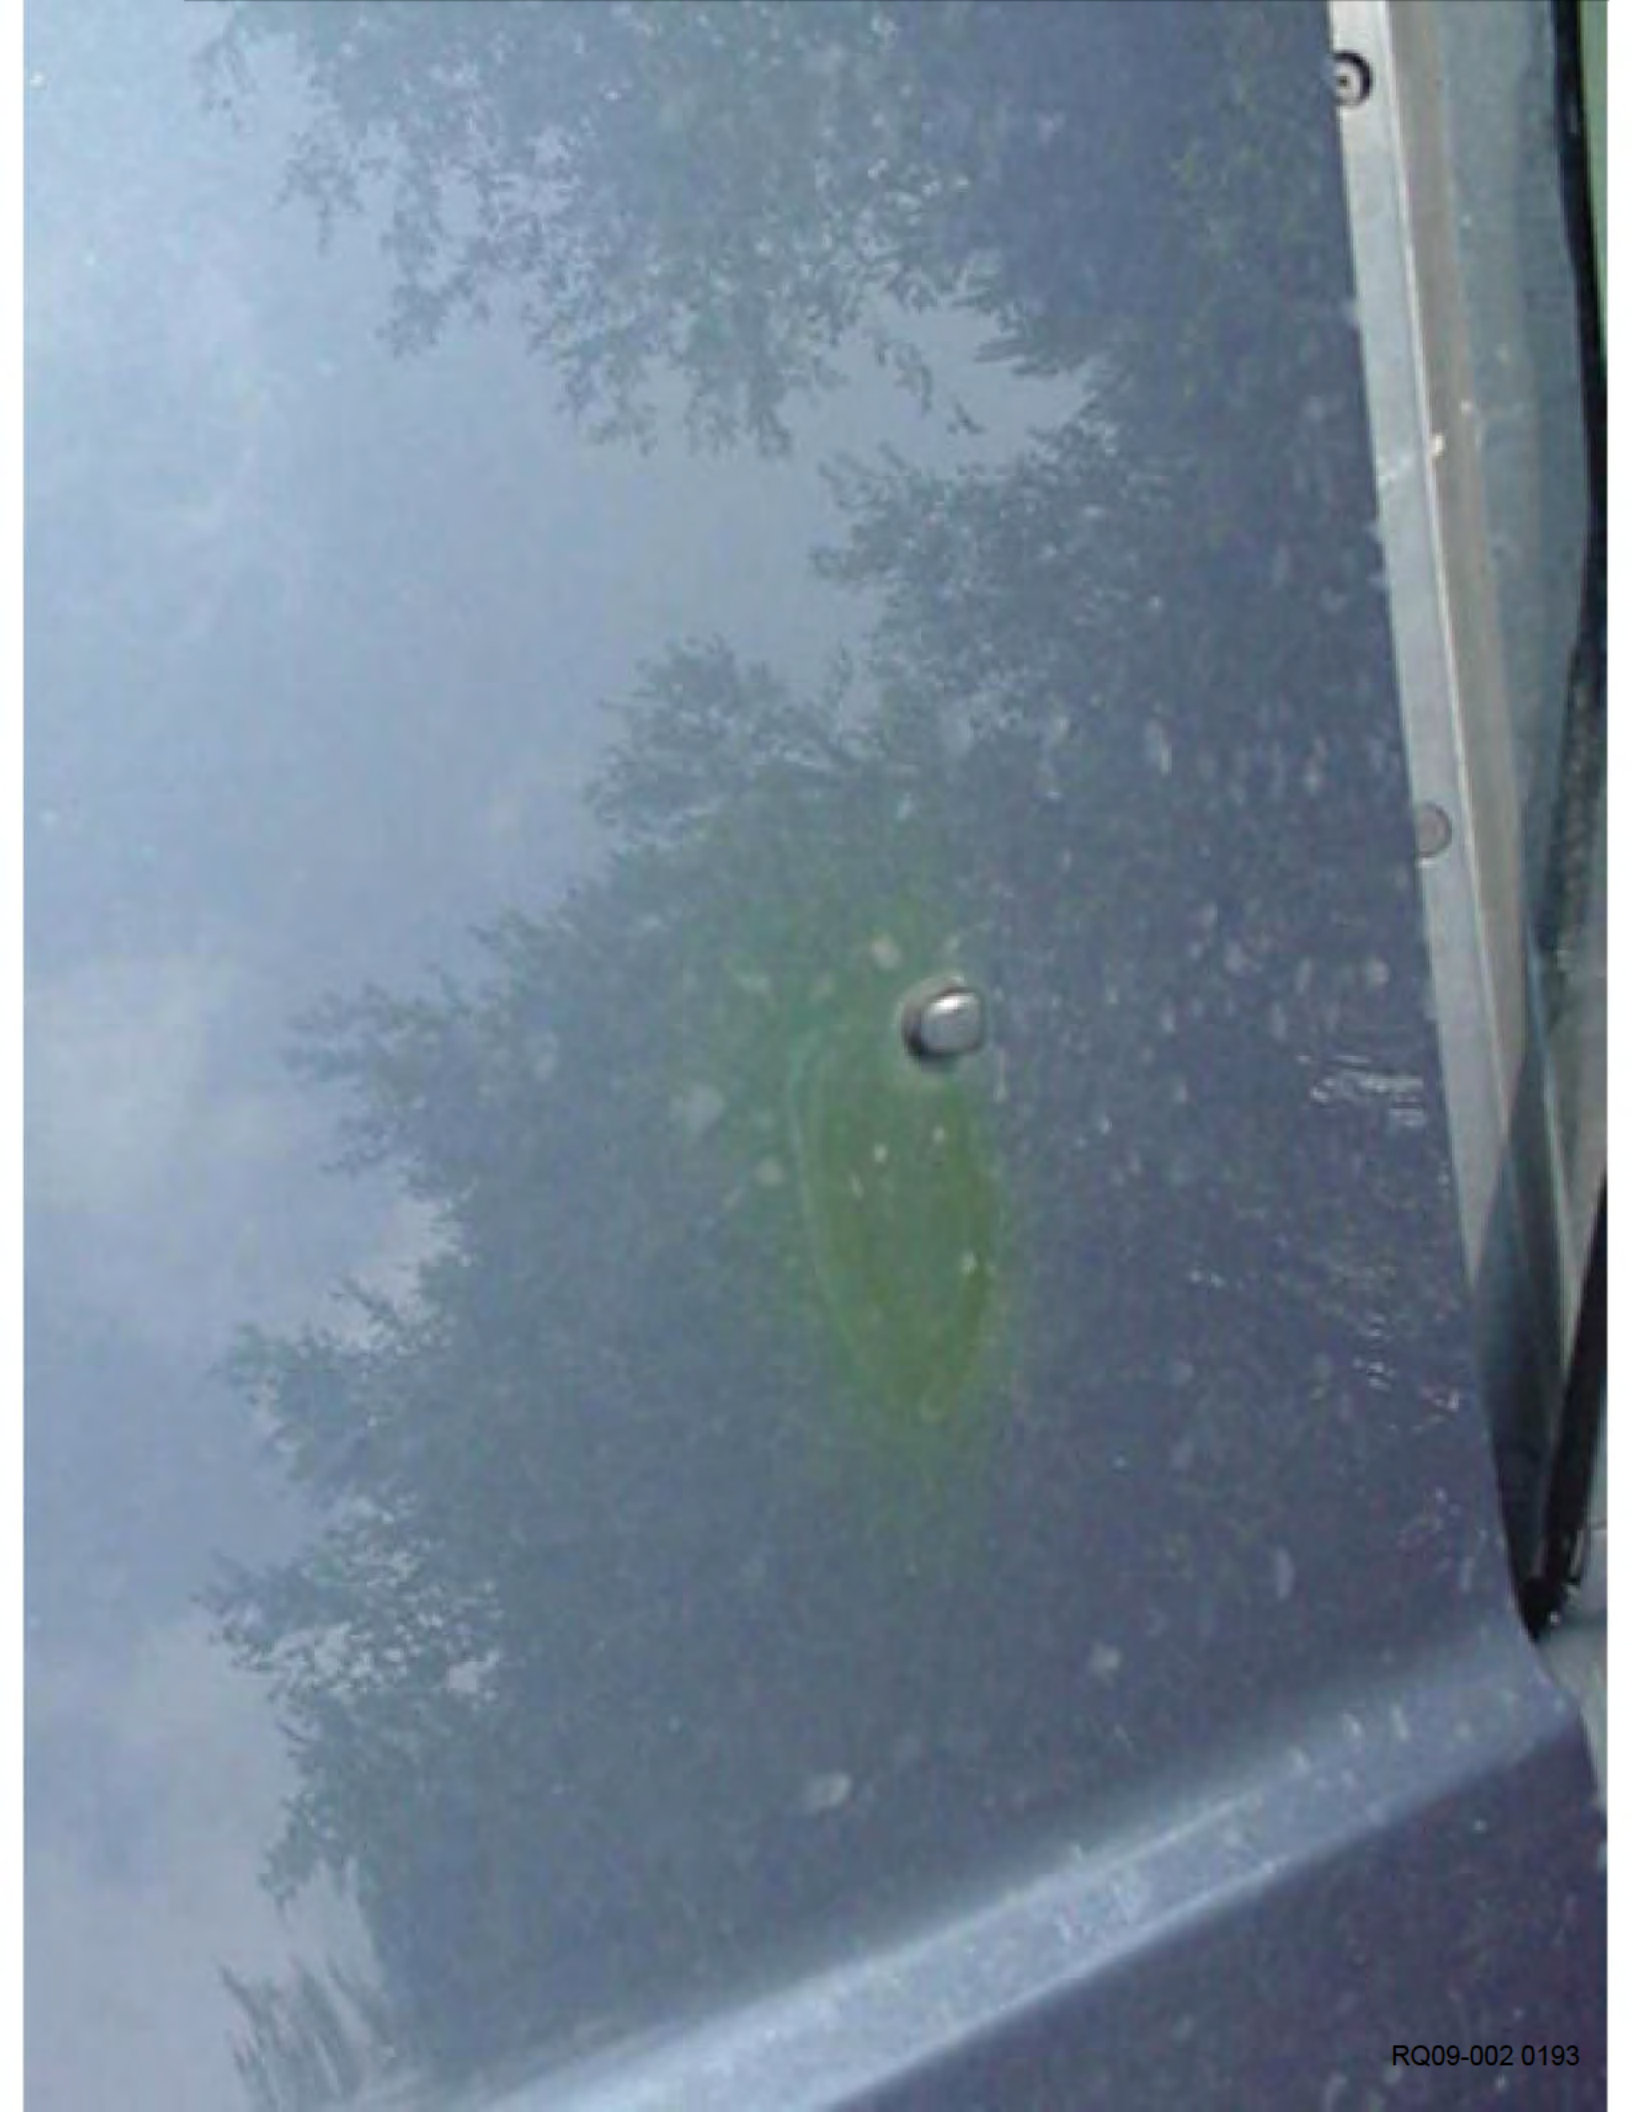
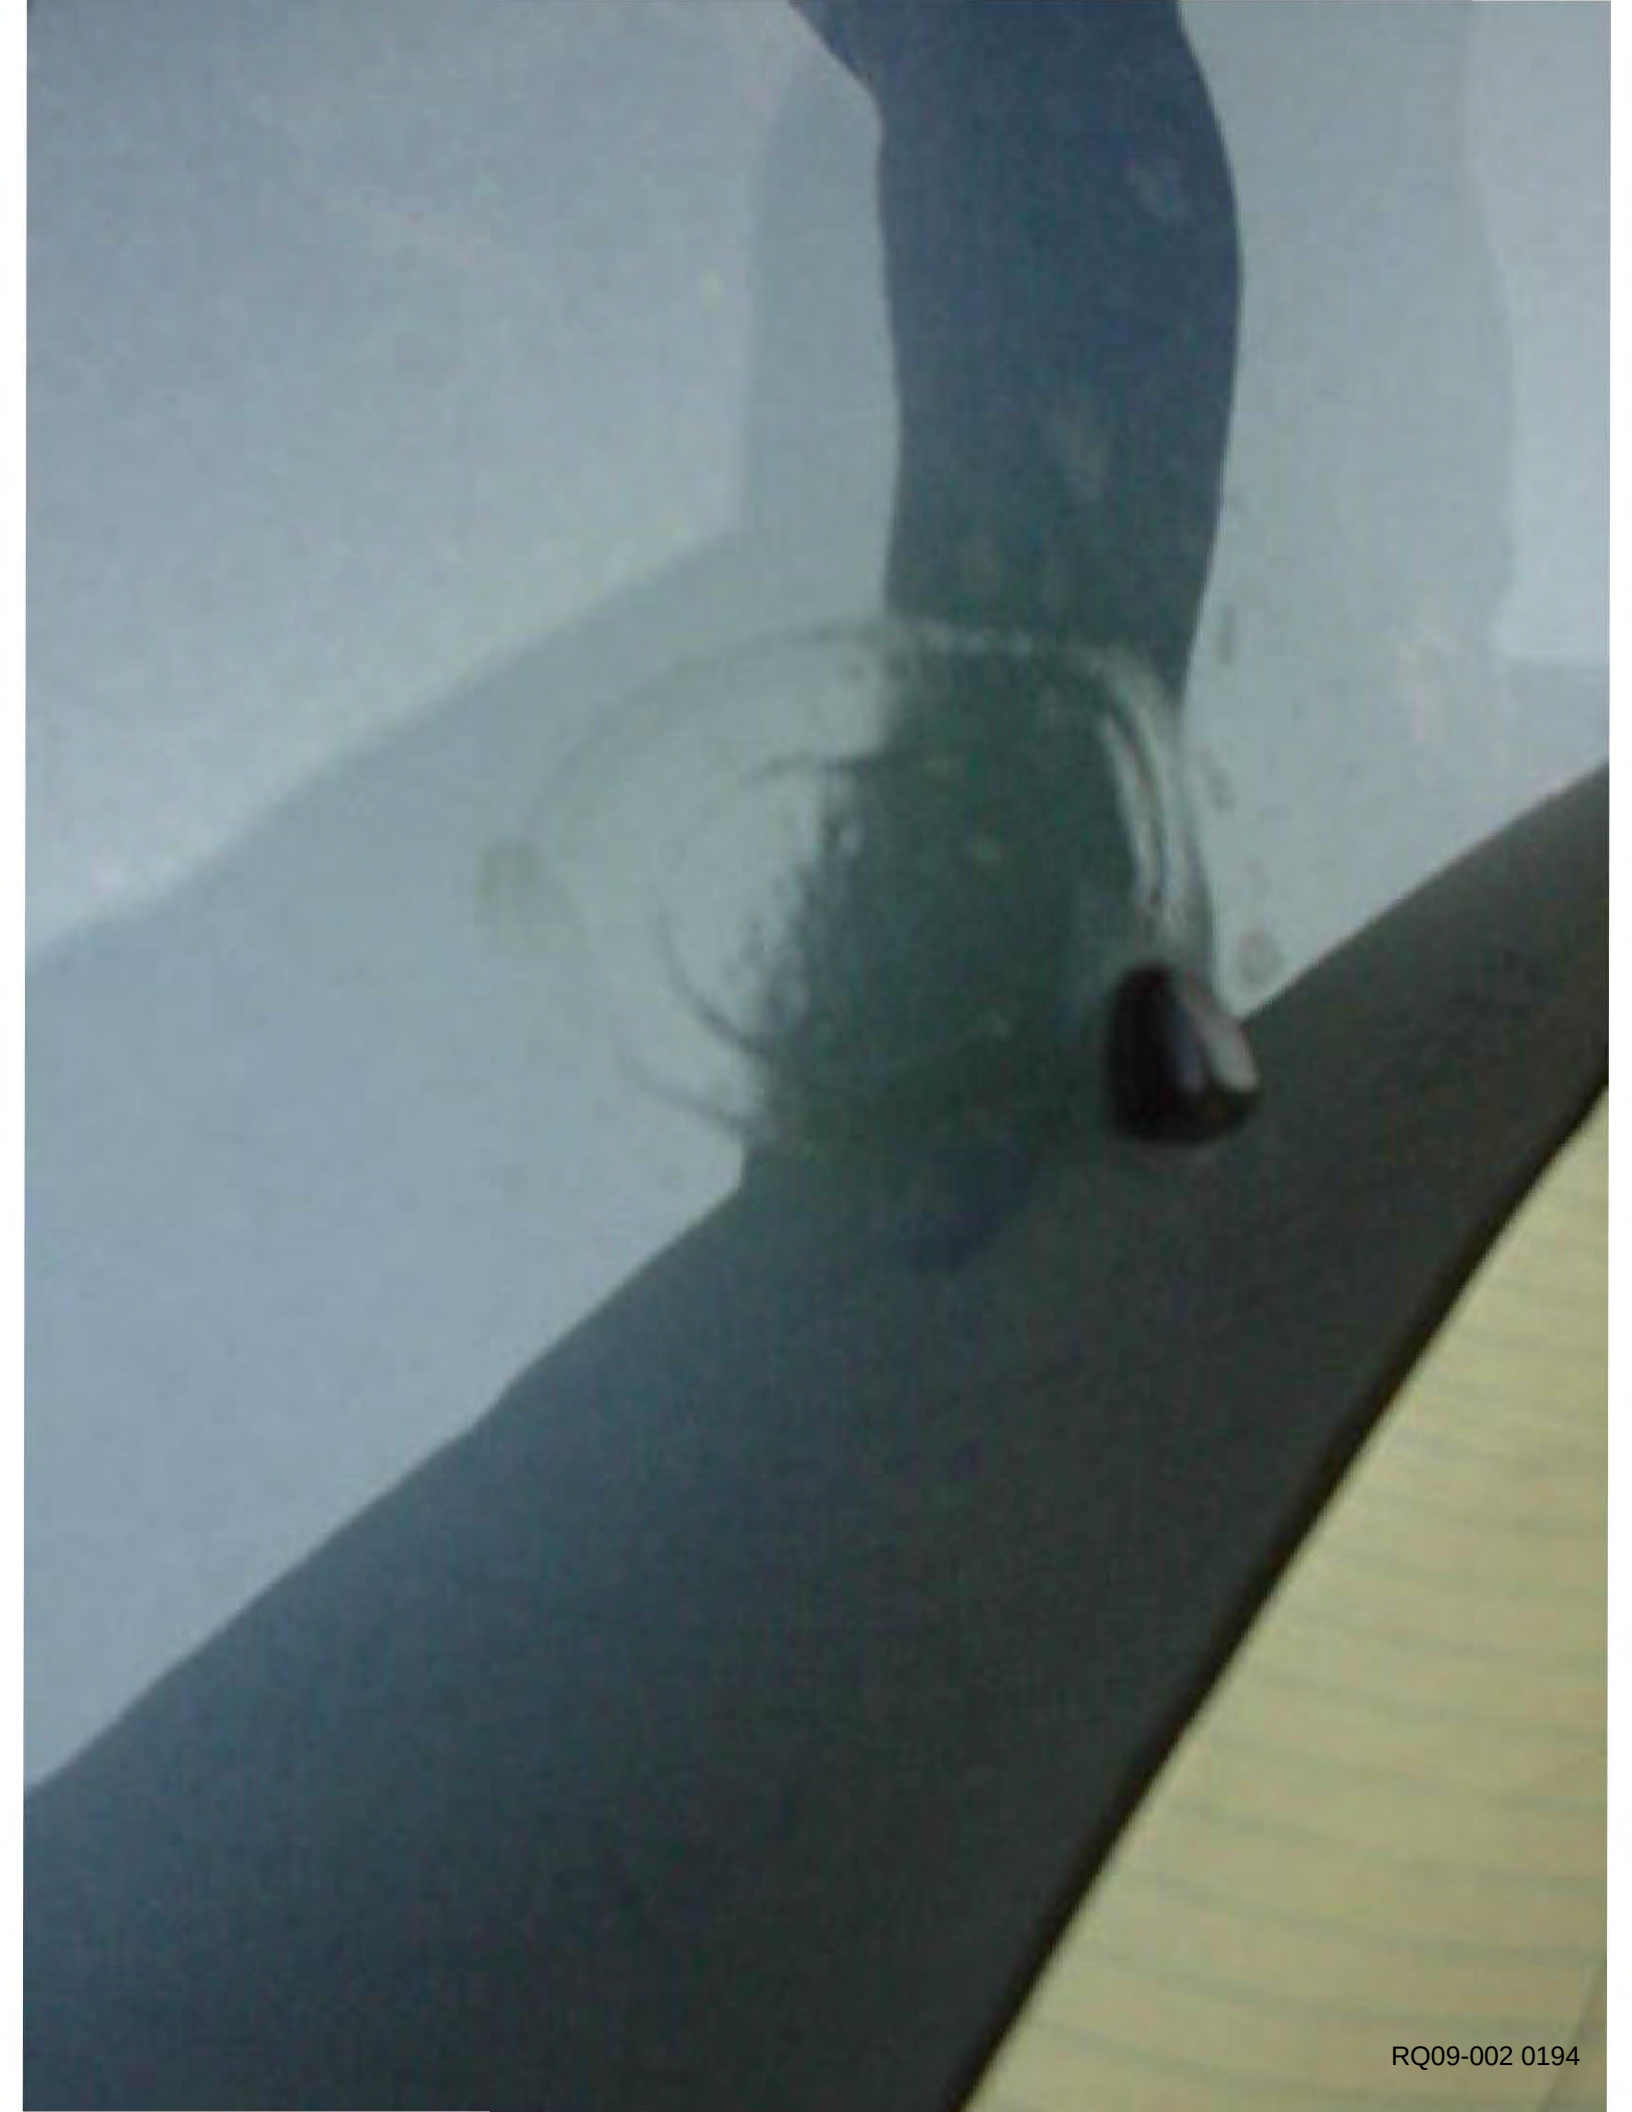
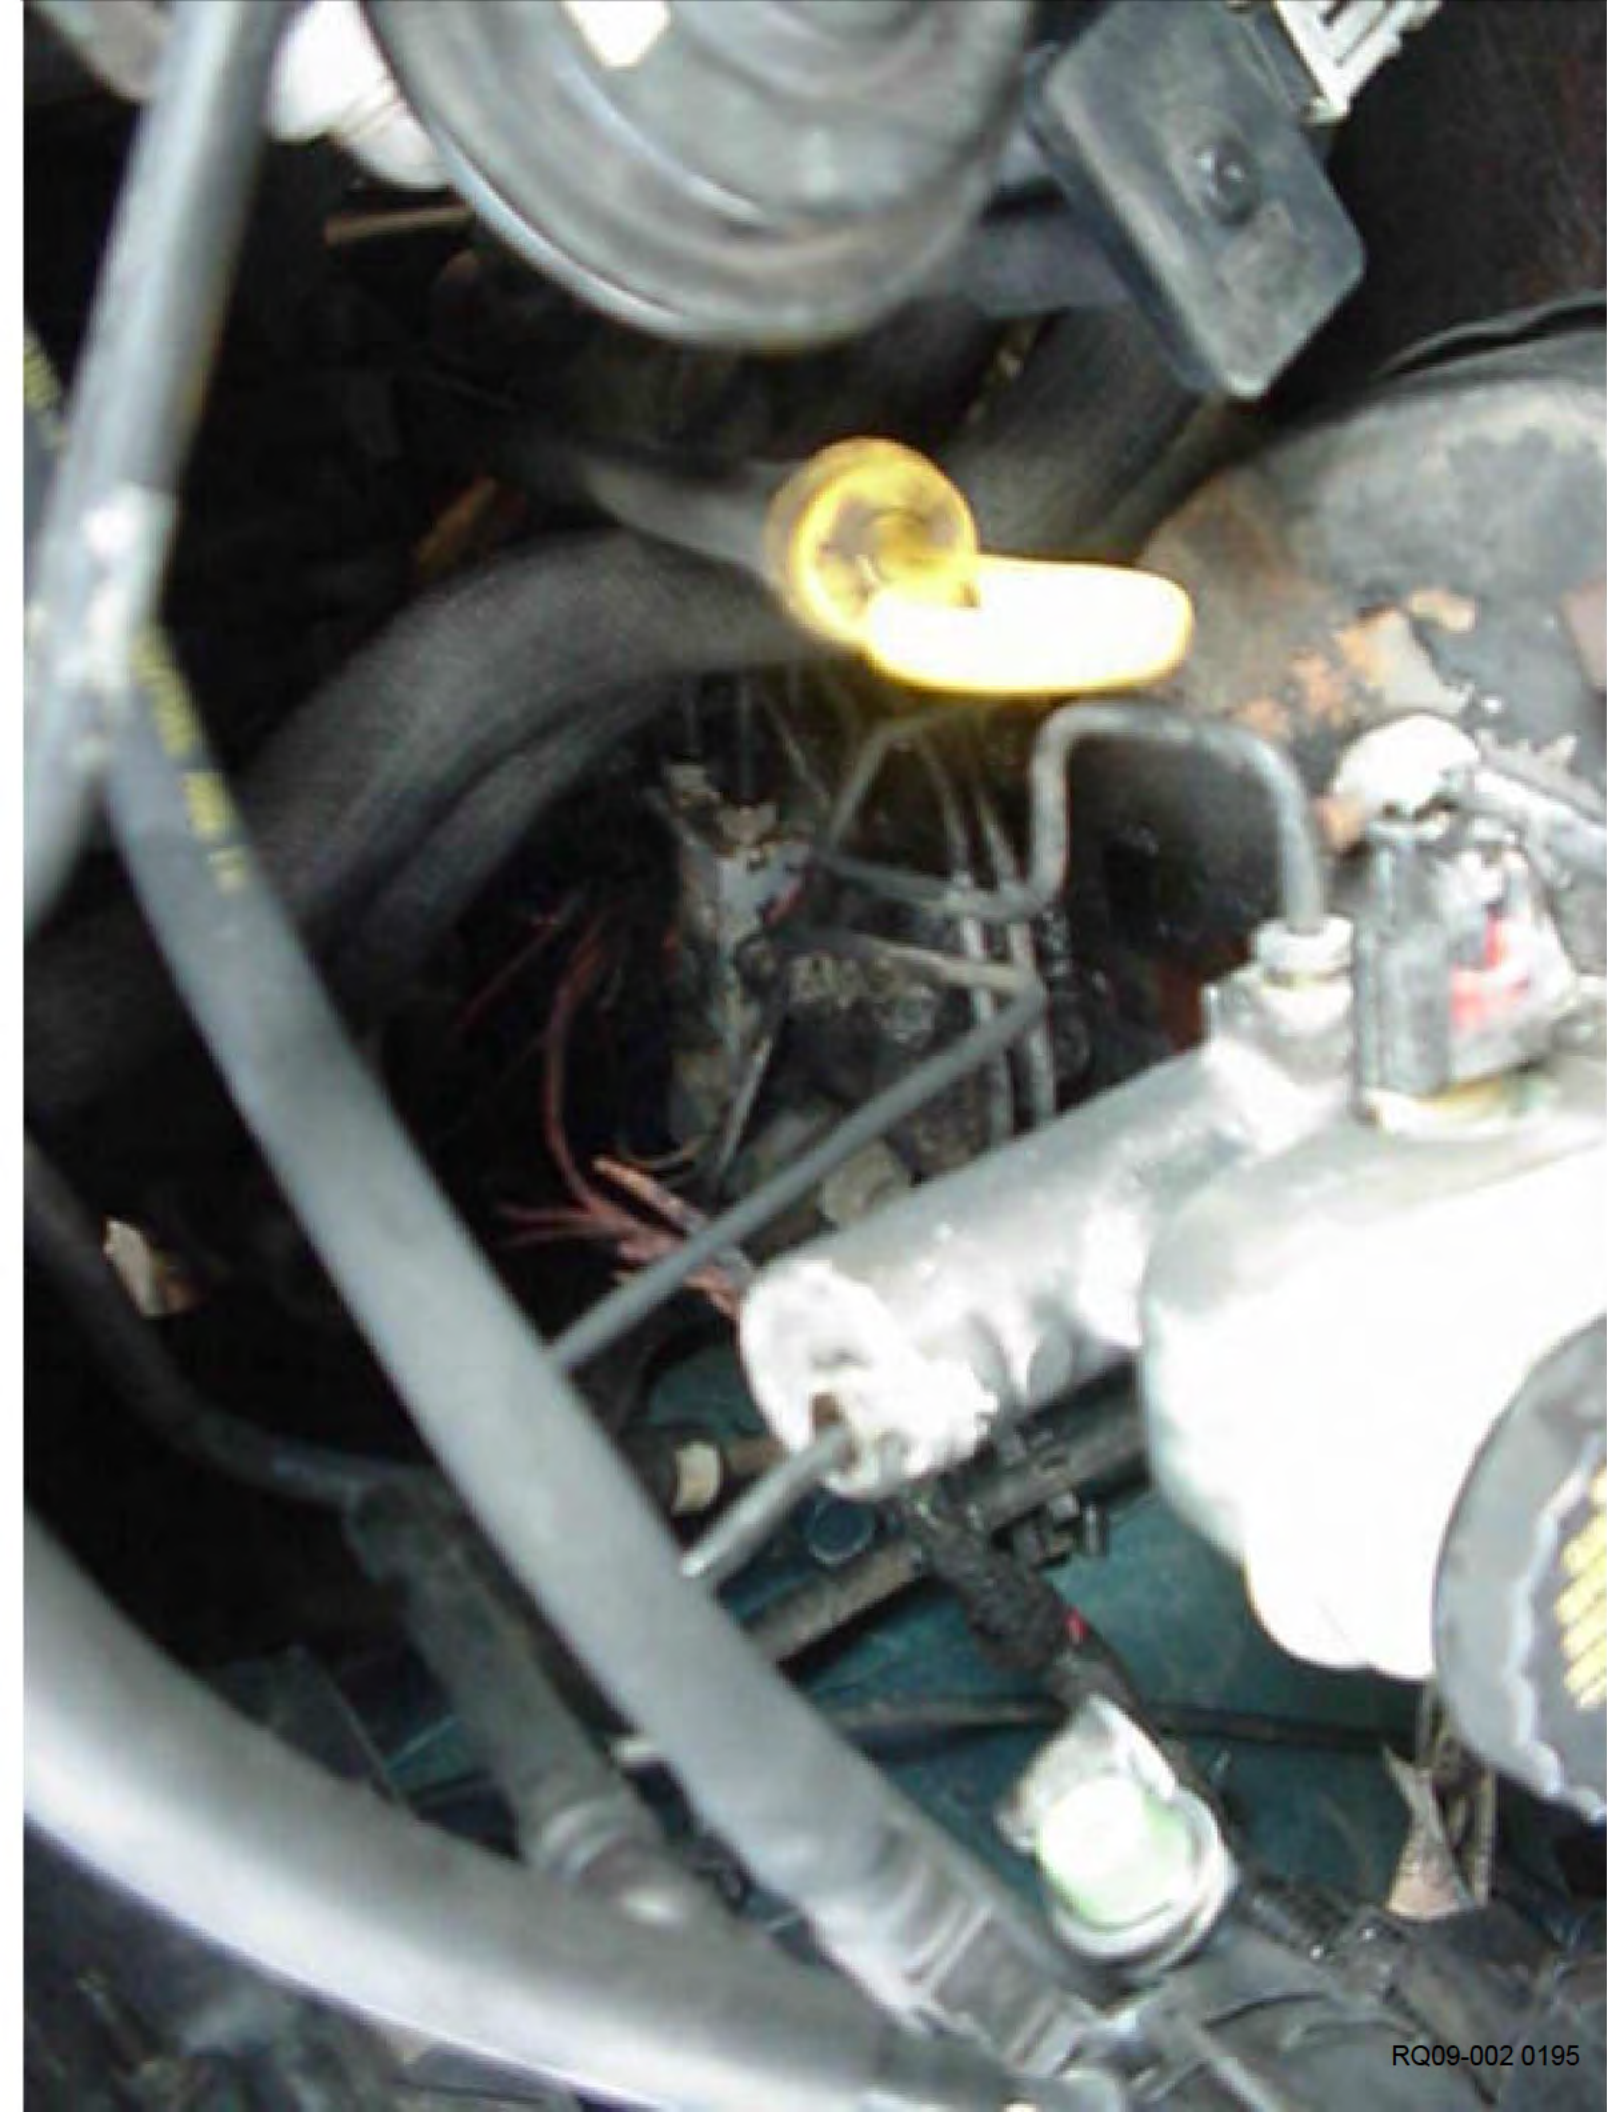
This vehicle had 07S51 performed on 5-2-07, using labor operation A, at the same dealer. Vehicle came back with damage allegedly resulting from 07S51. Please review pics and advise. Vehicle is at Clinton-Tecumseh Ford (MI). Please give me a call after you review pics.
