# Net Meeting Summary Sheet

**Issue:** ABS Module and/or harness damage after FSA 07S51

**Vehicle:** Escape

**Model Year(s):** 2001 and 2002

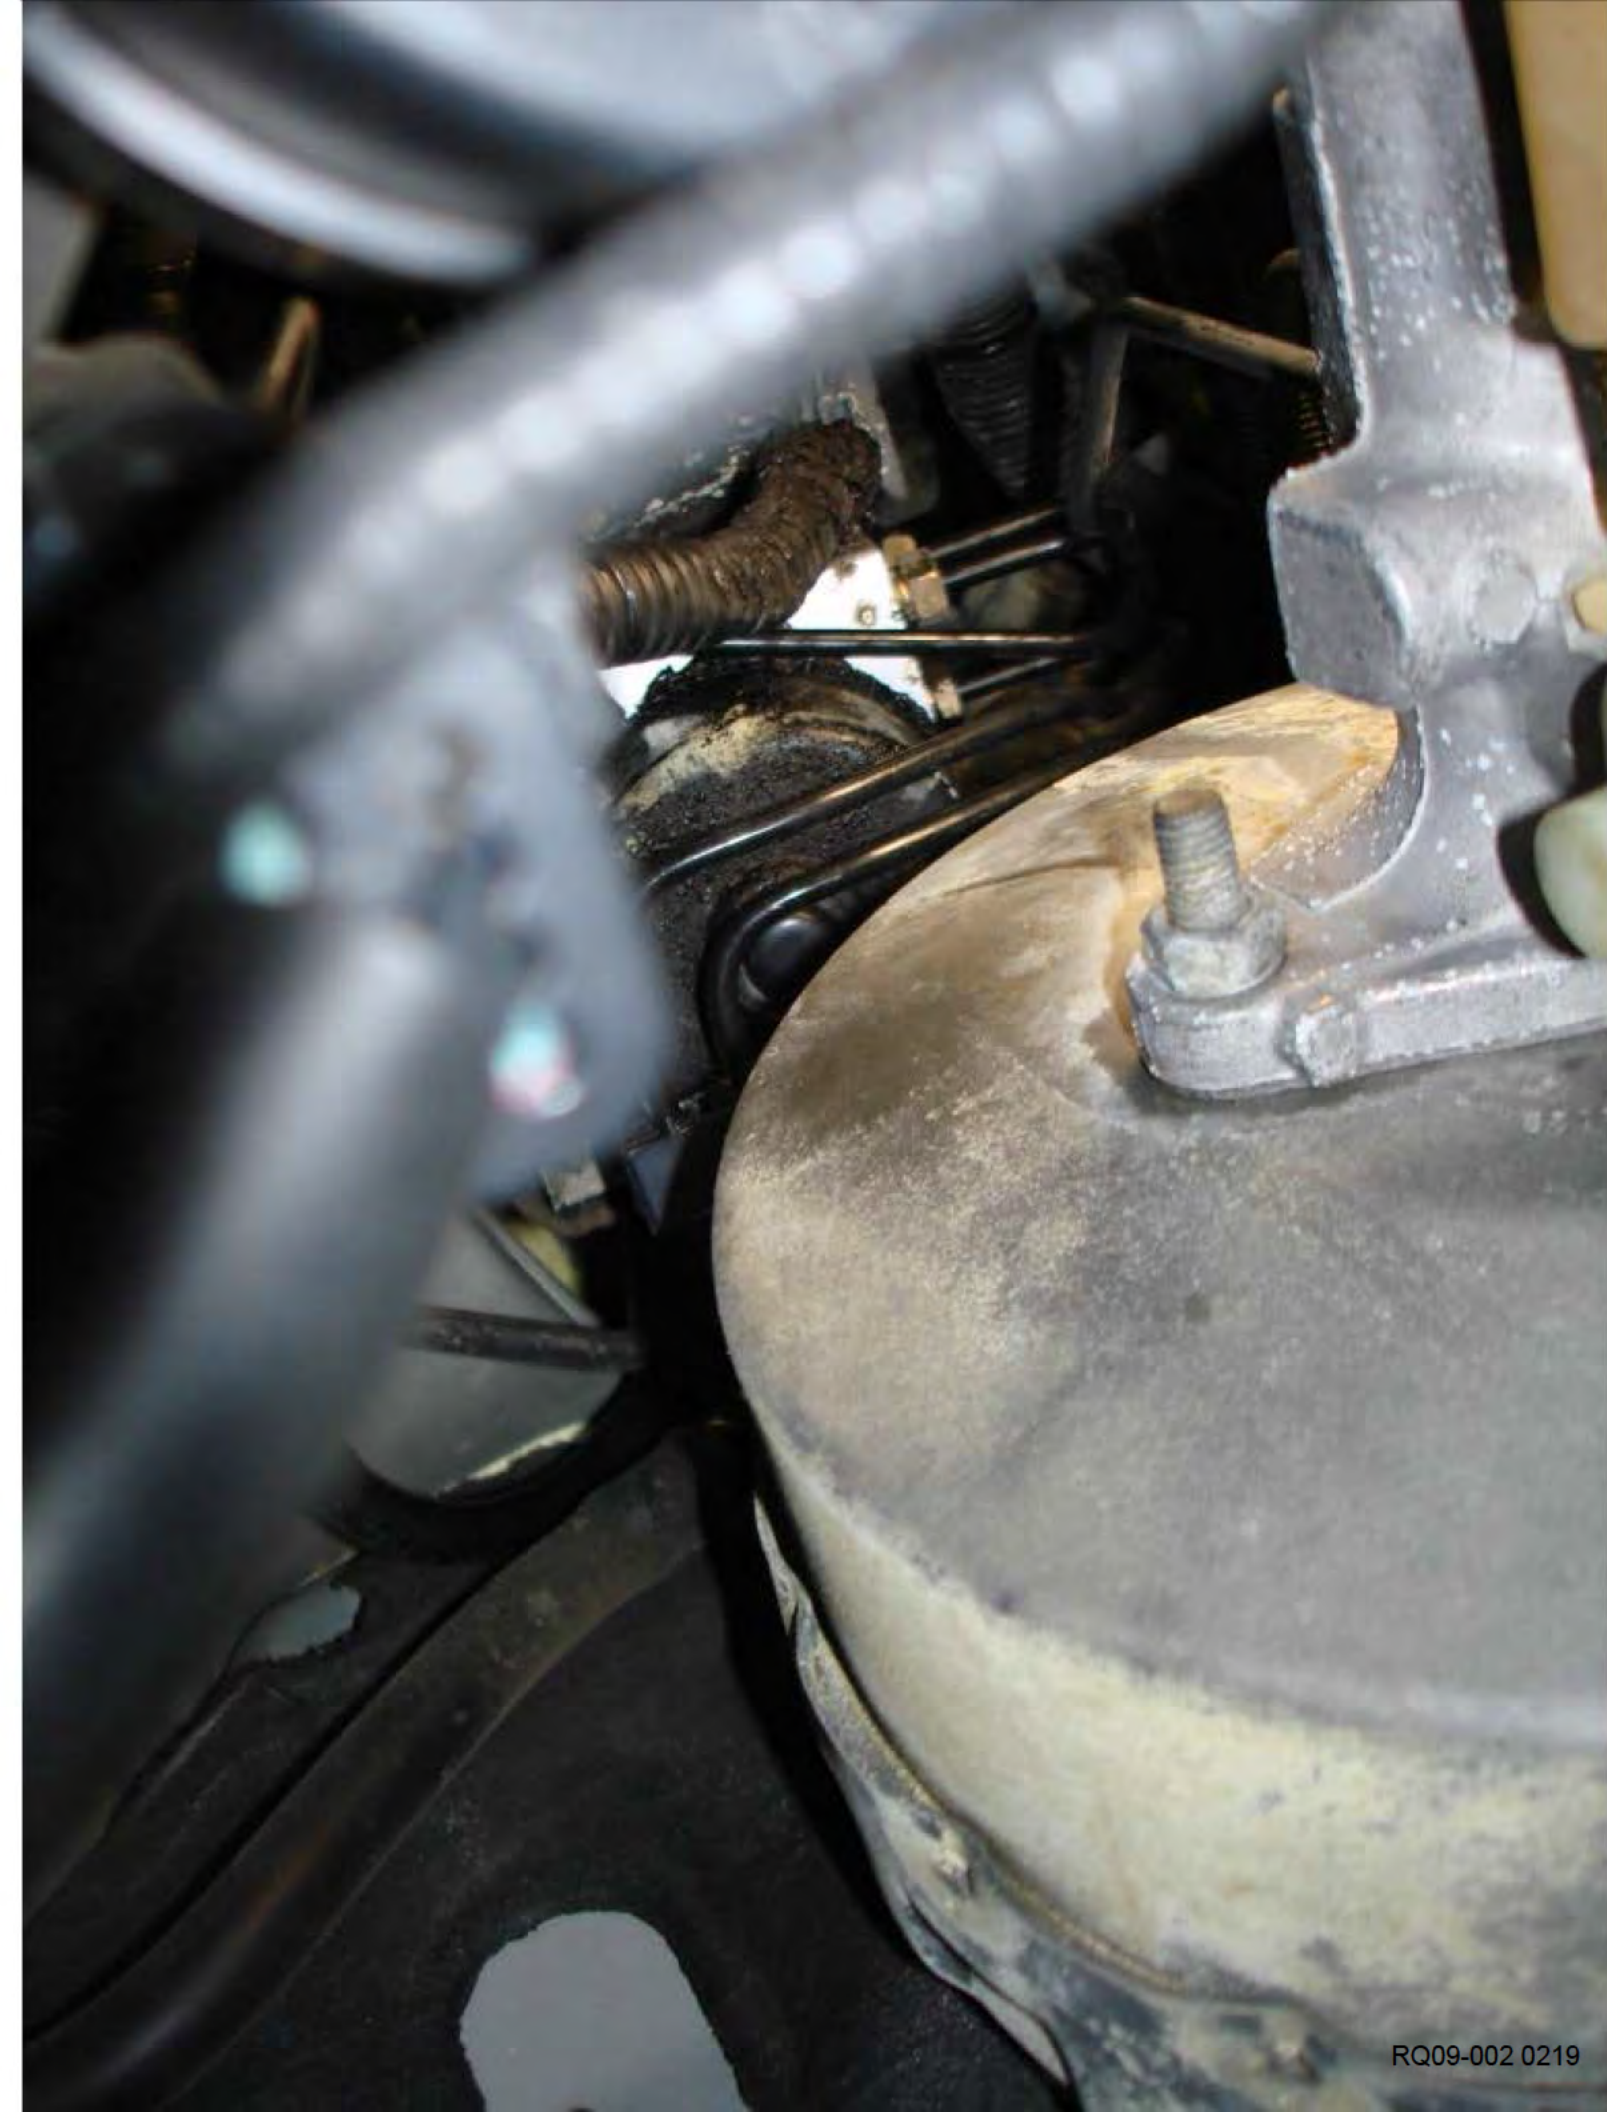
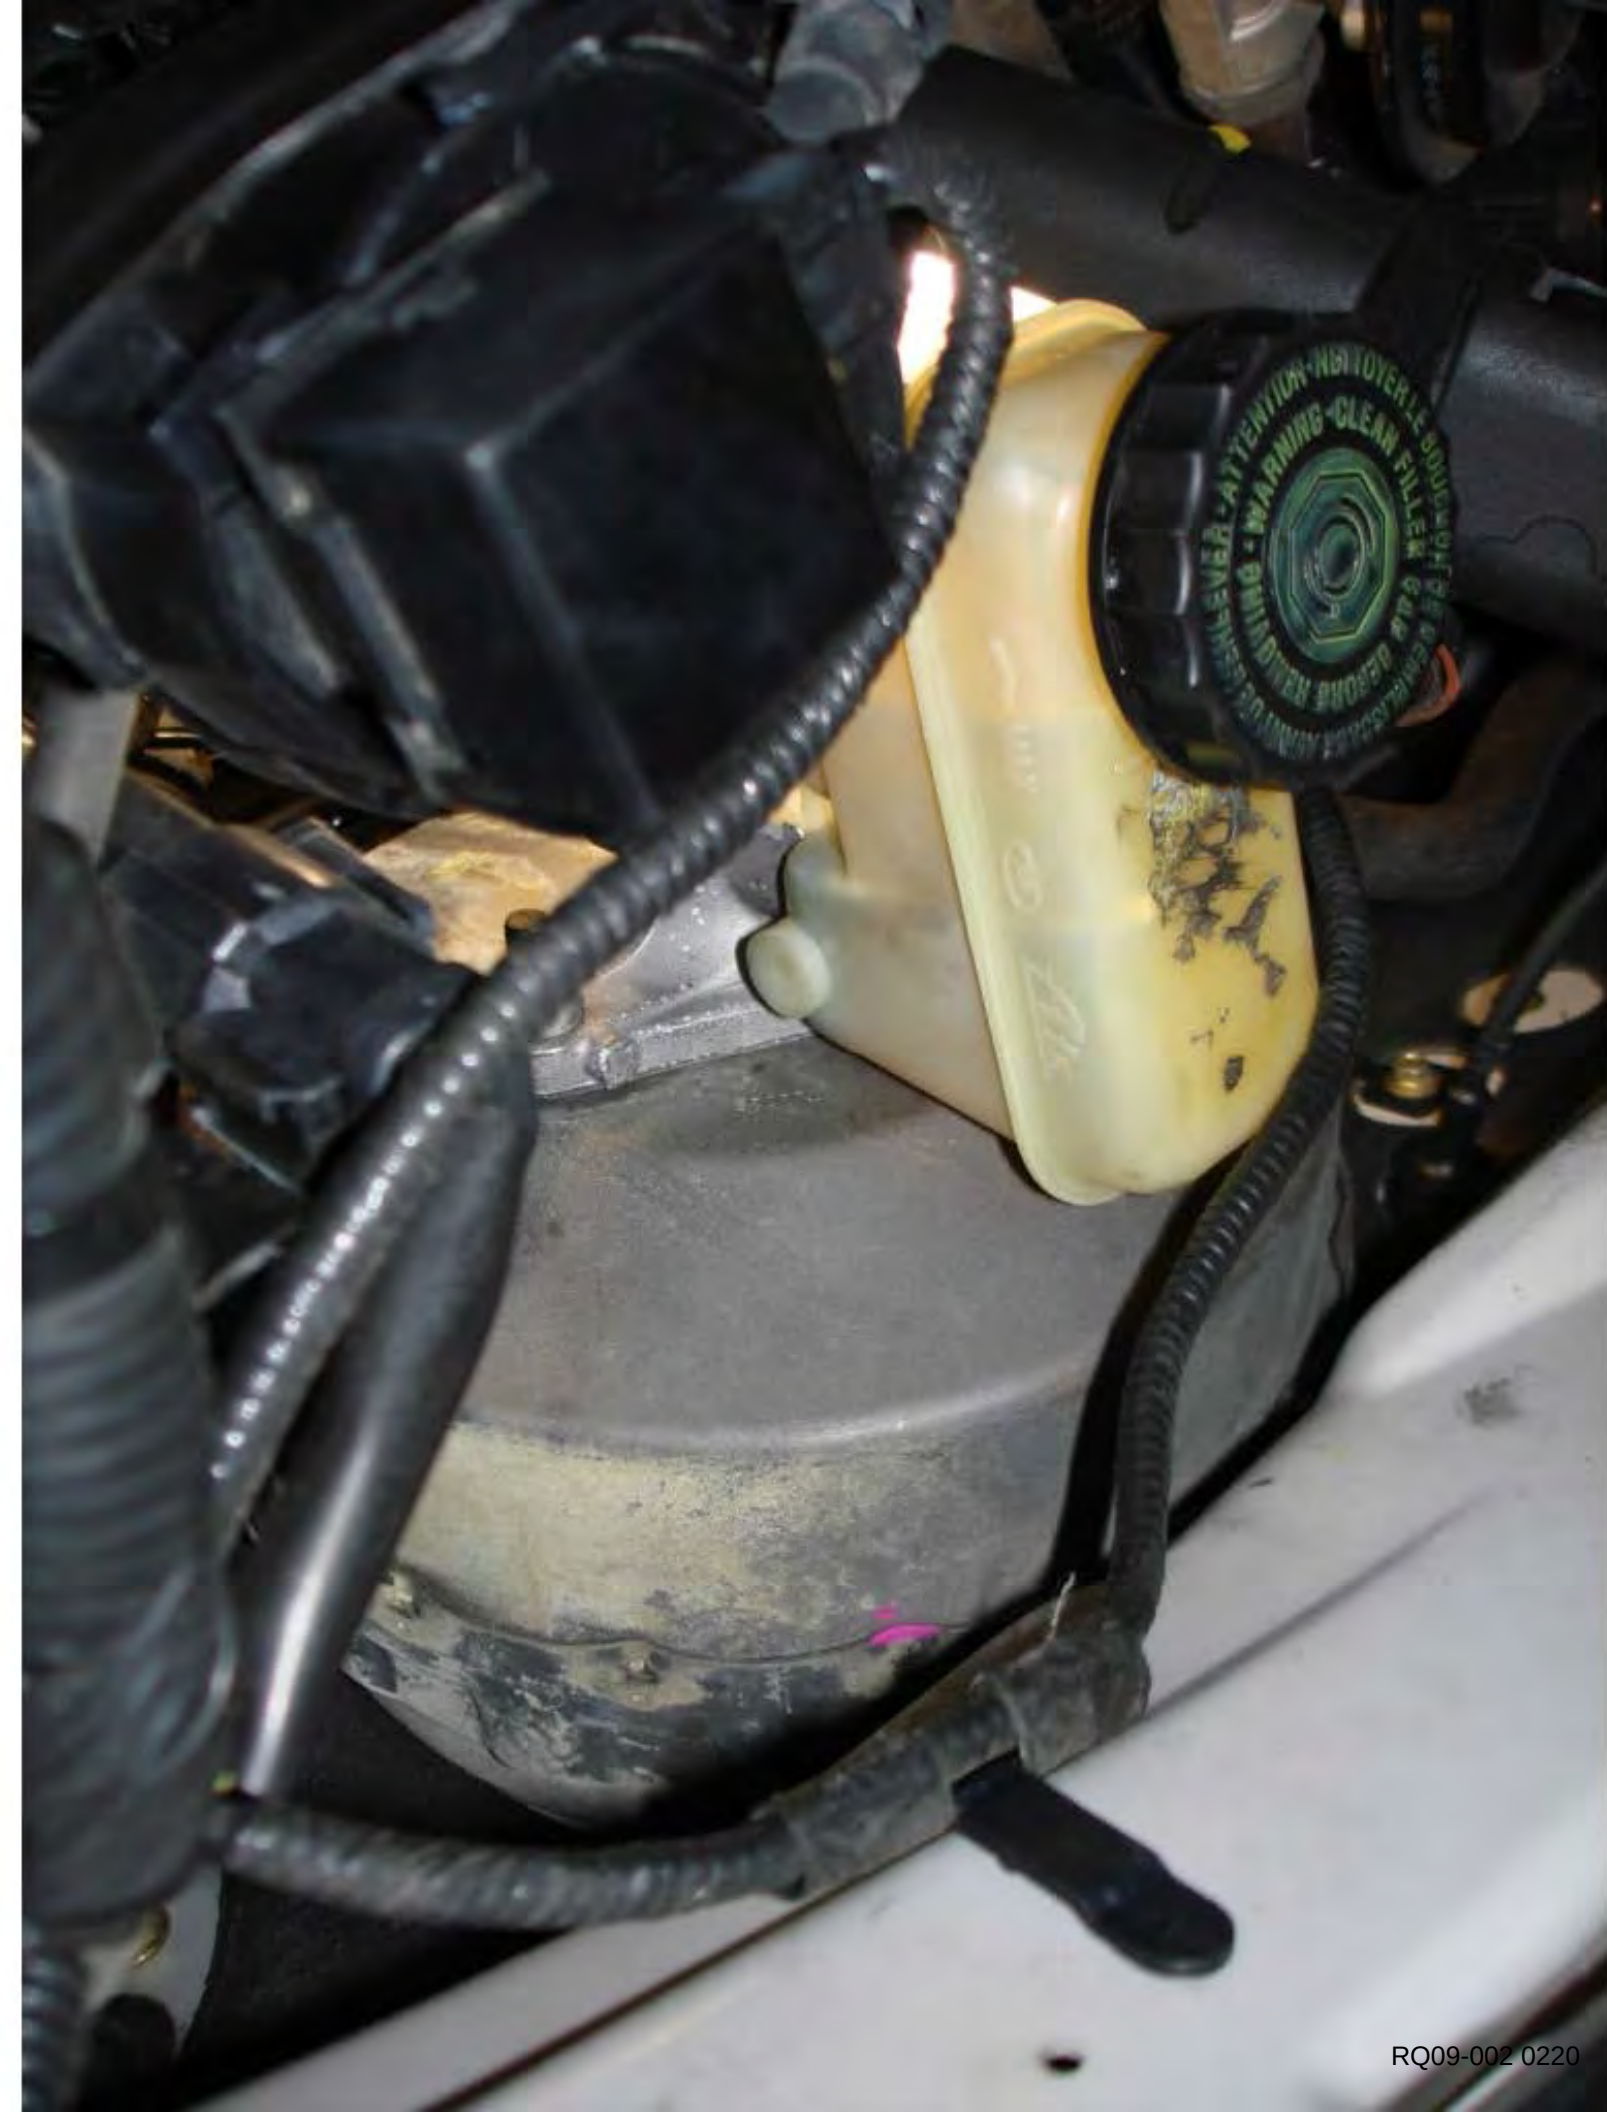
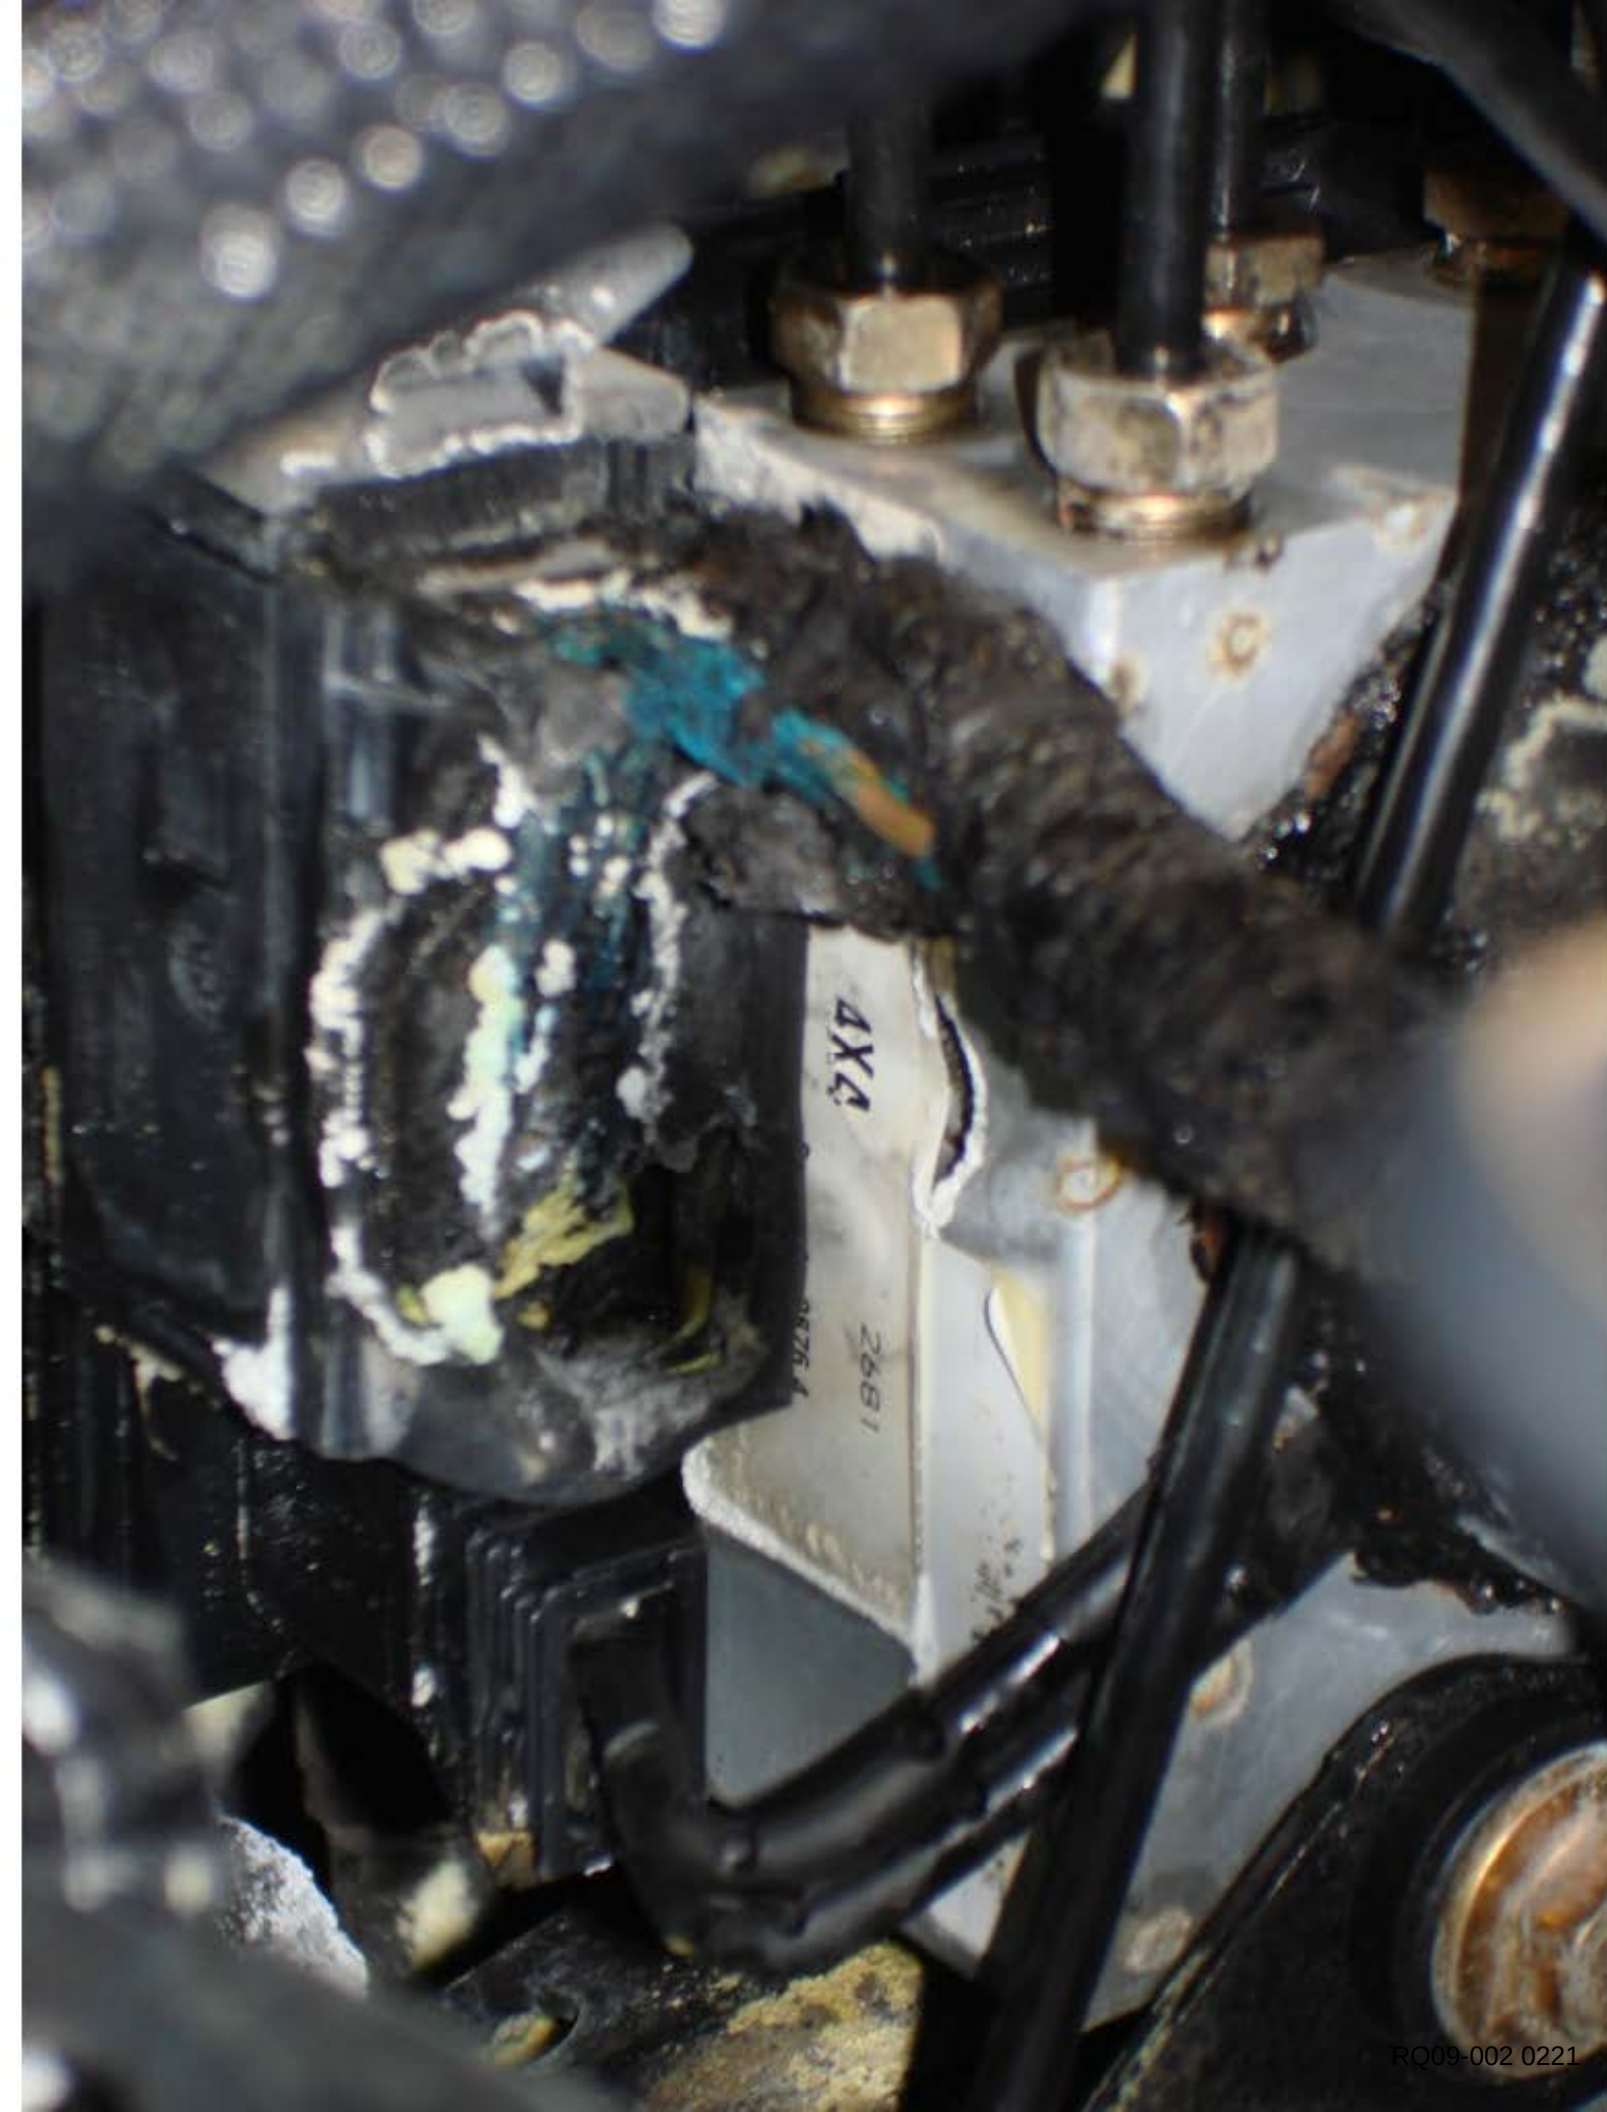
John and Deb, sorry for the delayed response, been tied up on another issue all day... I'm fine with the booster, but what I can see of the pump motor on the HCU has me concerned. Looks like the pump motor leads are damaged and the housing has thermal damage to the paint. I'd would ask that they evaluate the pump motor because the photos are hard to really tell what things look like sometimes. If they are ok with the motor than I'm fine with your suggestion. THANKS!

We don't see reason (heat damage at least) to justify booster or HCU replacement. Do you agree? Do you still want parts back? If so, we plan on approving the ECU and connector and having them sent back. Let us know if you need more..

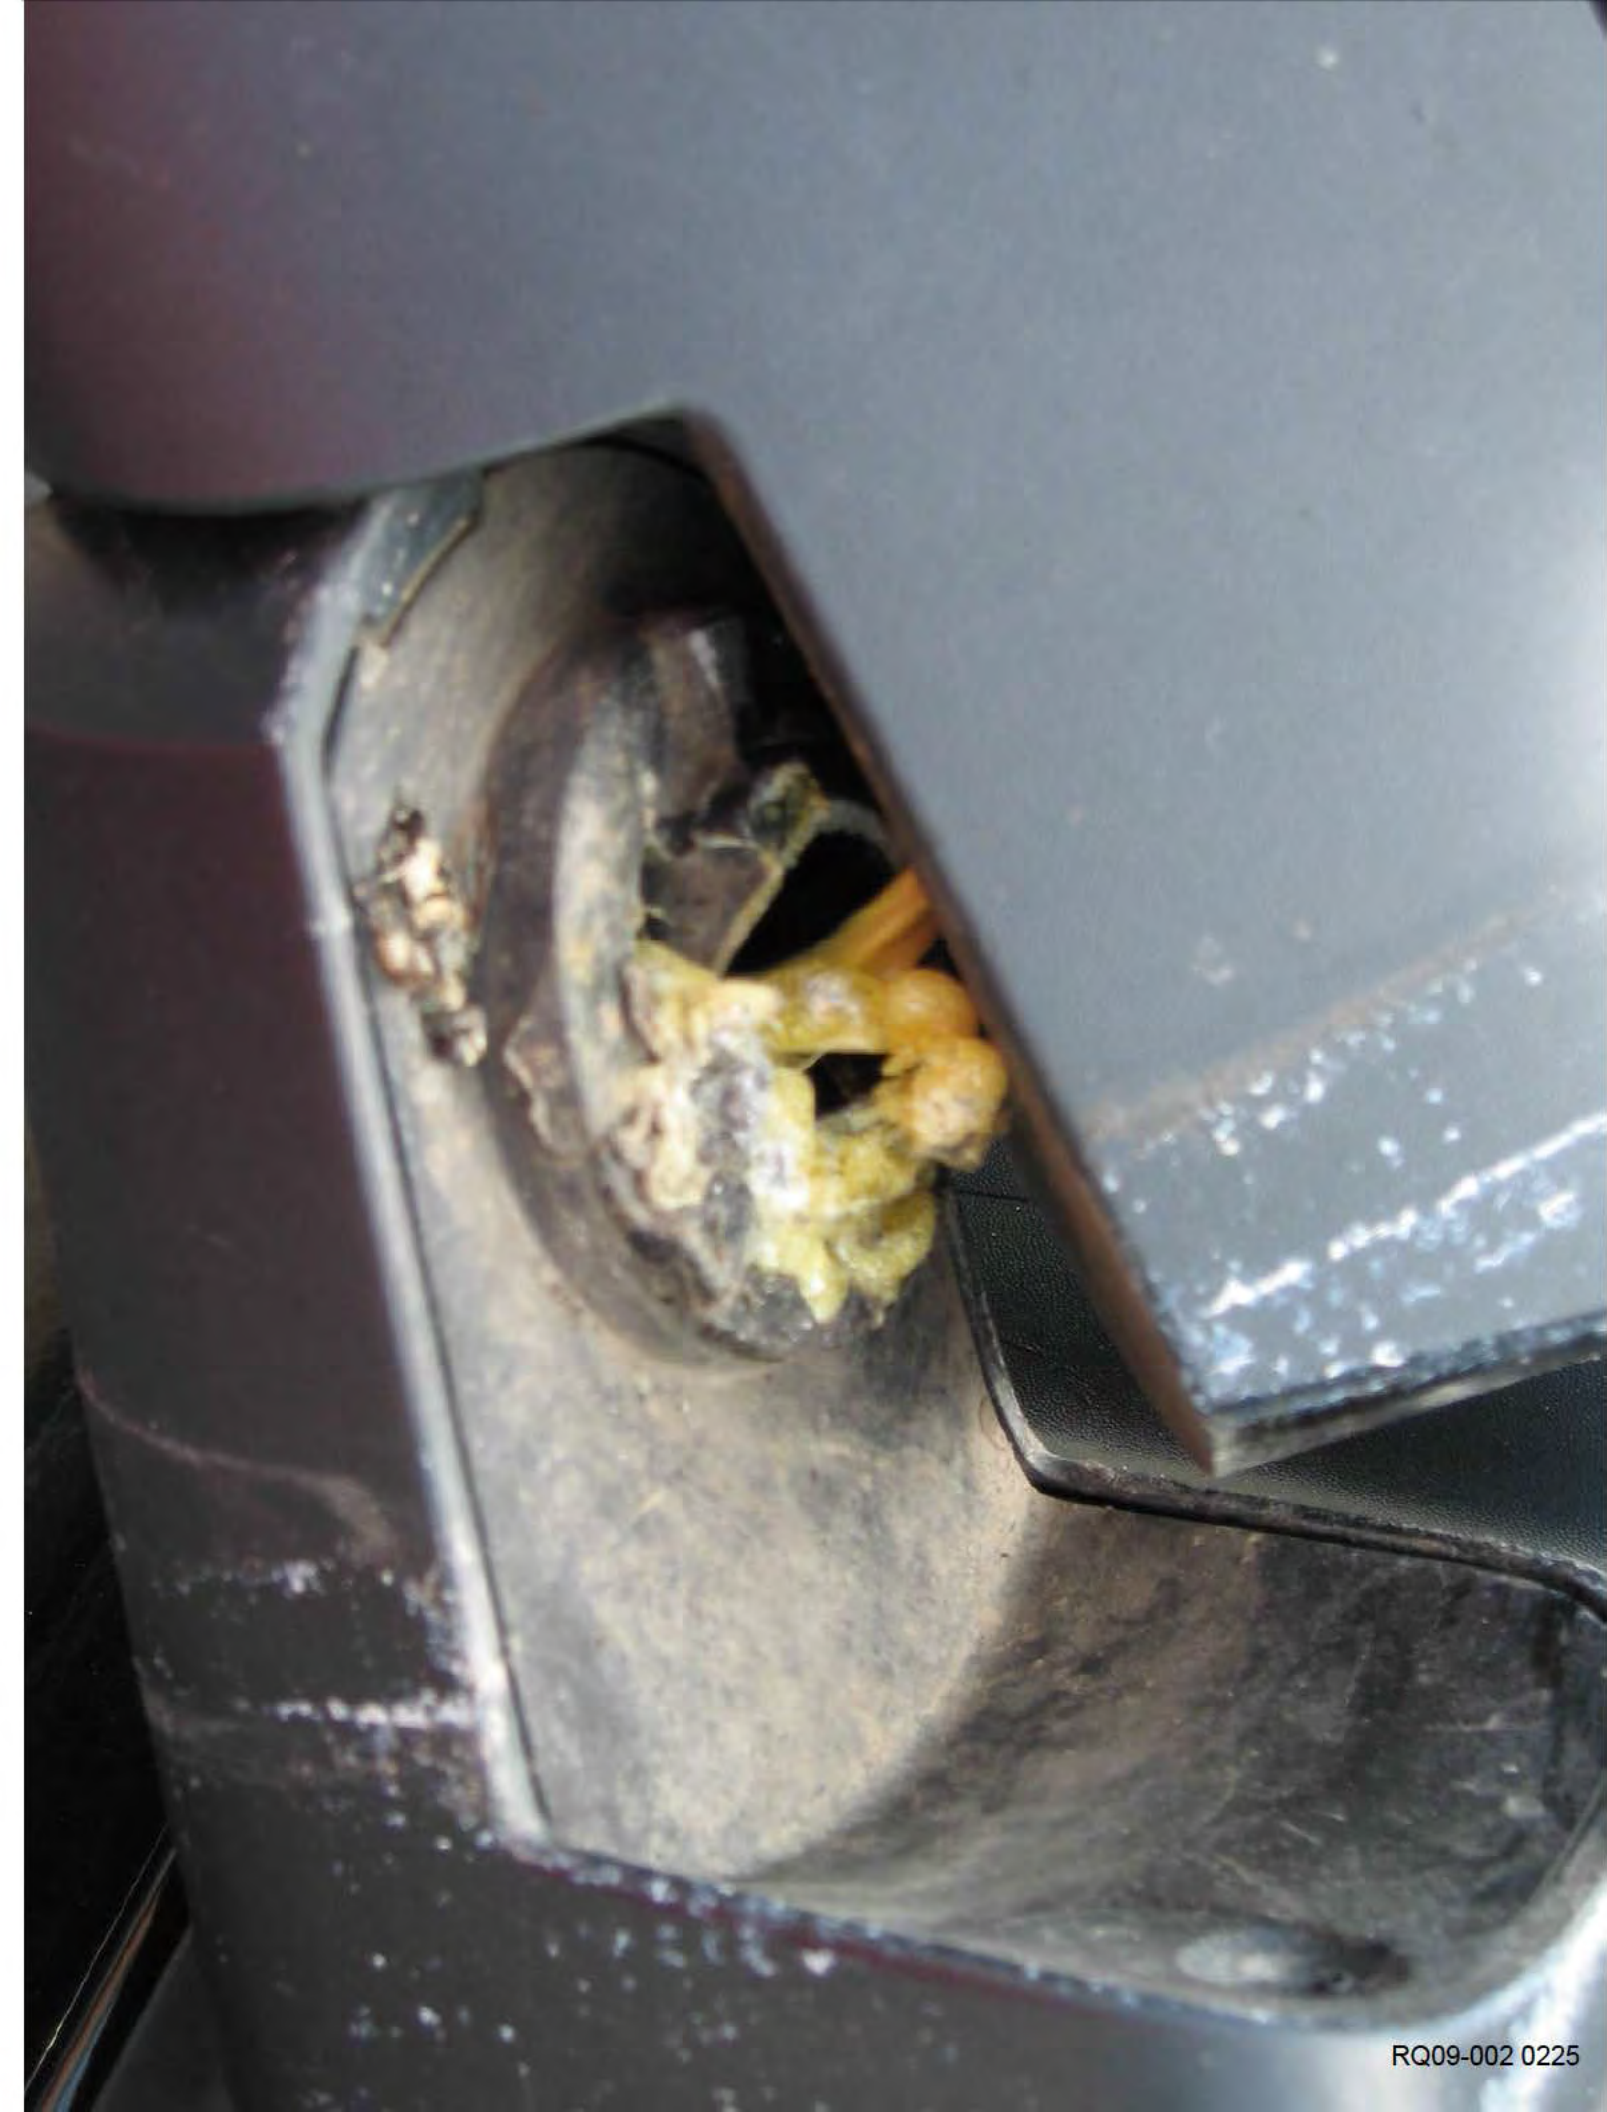
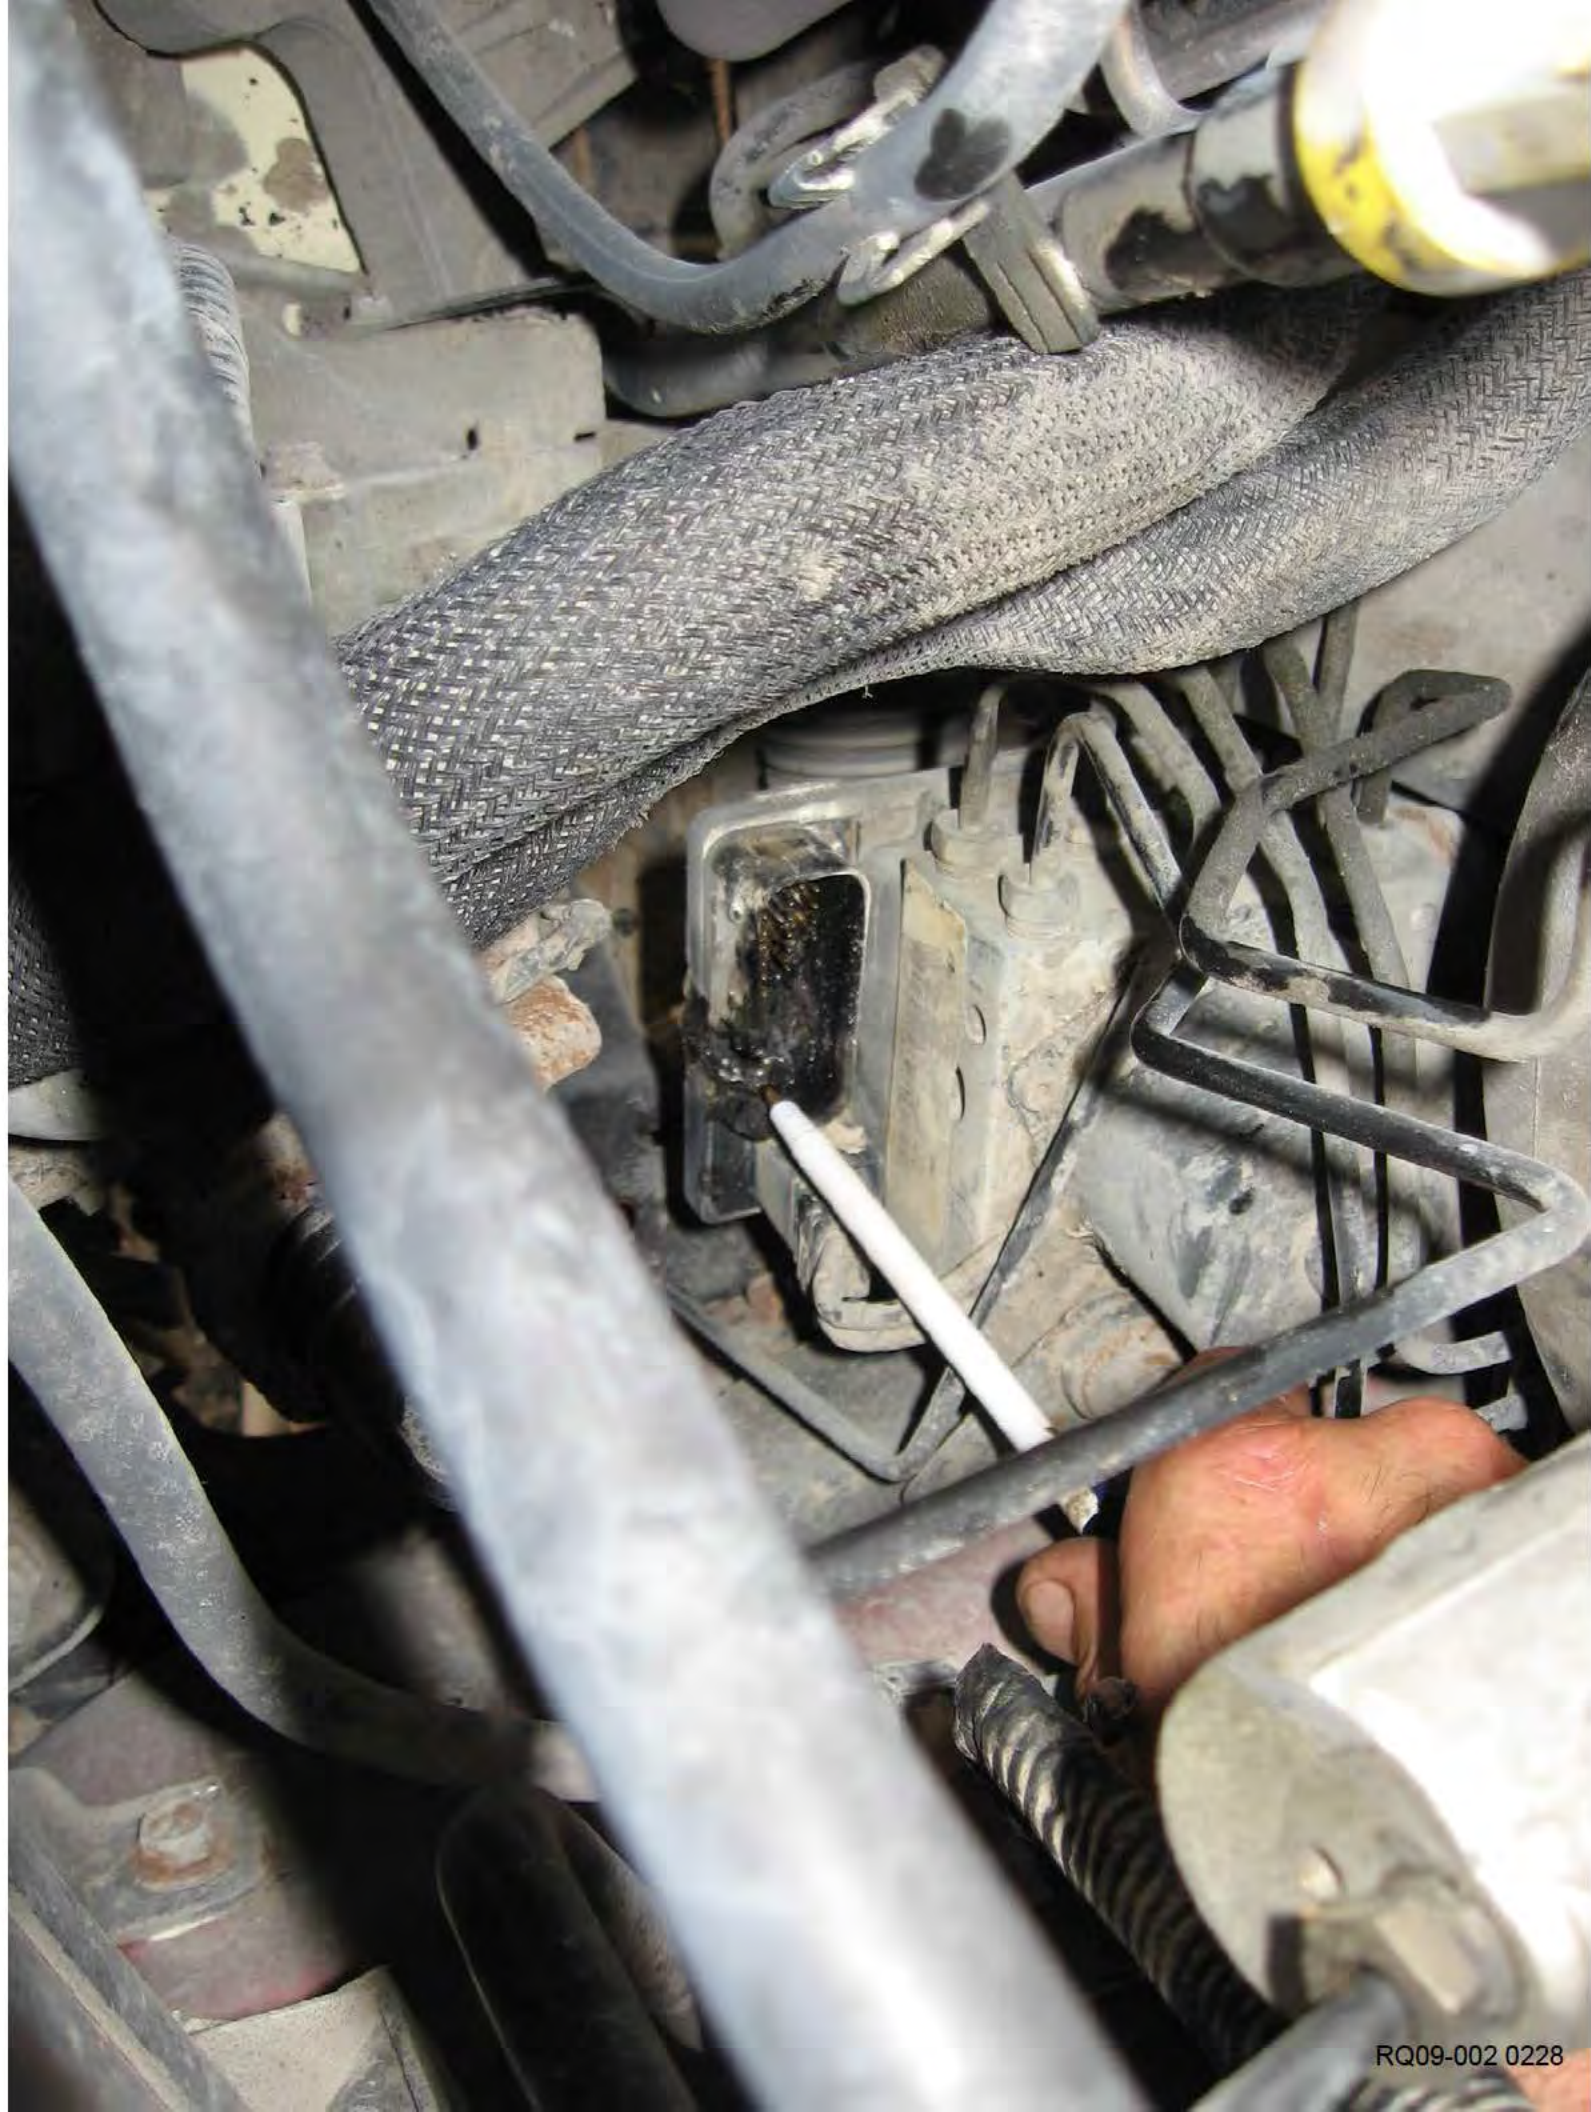
Please a reality check for me. Take a look at the HCU and see if you would warranty replacement?
