Action	Document	Start Date:	End Date:	Subject/Objective:	Responsible:	Summary:
Action 09-01	09-01_PQA2004470102.pdf	11/19/2004	11/19/2004	Failure analysis of overheated pencil coils	Sub-Supplier Fairchild (Pulse's supplier for IGBT)	IGBT overheated due to current related overstress
Action 09-02	09-02_MPV05-009.pdf (German Original) 09-02_MPV05-009_EN.pdf (English Translation)	9/1/2004	3/4/2005	Failure analysis of 8 failed pencil coils	Supplier Pulse	Coils were damaged by external influences; electrical overstress resulting from missing ground connection caused IGBT to overheat
Action 09-03	09-03_0001924068.pdf (German Original) 09-03_0001924068_EN.pdf (English Translation)	11/25/2004	3/23/2005	Component analysis of ignition coil	Audi AG	Exact analysis not possible because of damage degree
Action 09-04	09-04_11-Z-05-2207.pdf (German Original) 09-04_11-Z-05-2207_EN.pdf (English Translation)	4/14/2005	4/15/2005	Failure analysis of overheated pencil coils	Volkswagen Laboratory	IGBT latch-up, impaired capacitor soldering

Action 09-05	09-05_MPV05-018.pdf (German Original) 09-05_MPV05-018_EN.pdf (English Translation)	9/1/2004	4/25/2005	Failure analysis of overheated pencil coils	Supplier

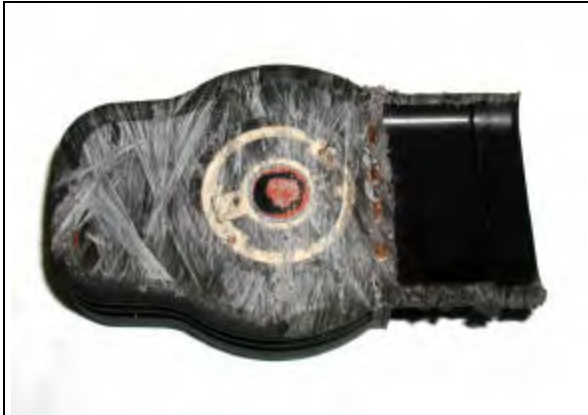
Ref Audi - # 21-2005-04-08-f-001
Portion of module as received.

Ref# VW 26-2005-04-12-p-001
 Analysis of this device revealed signs of electrical and over heating damage primarily in the ring structure of the device. The nature of this damage is indicative of an overvoltage event, possibly an arcing across the ring structure. Once the initial damage occurred, current was allowed to flow and resulted in the overheating damage noted.

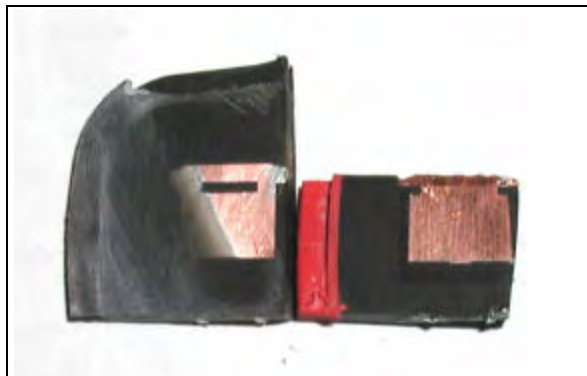
Ref VW - # 26-2005-04-12-p-001
Portion of module as received.

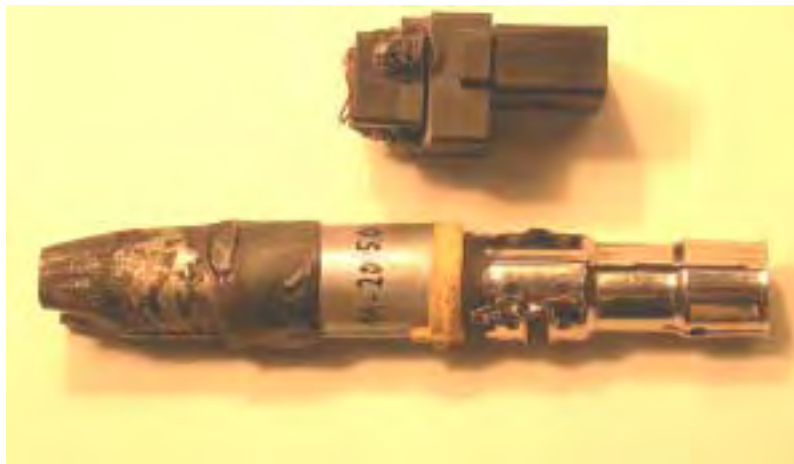
- Teile-Nummer: 022 905 100A L2 B1F5 6 11/04 Fa. Bremi
- FZG-Nr.: WVGBC77L44D071365
- das Material vom Primärspulenkörper wurde durch Temperatureinwirkung plastisch verformt (Abbildung 1).
- der IGBT ist beschädigt. Nach dem Austrennen wurde festgestellt, dass der IGBT-Körper sehr stark angeschmort ist (Abbildung 5).

Abbildung 1: Spulen Ansicht

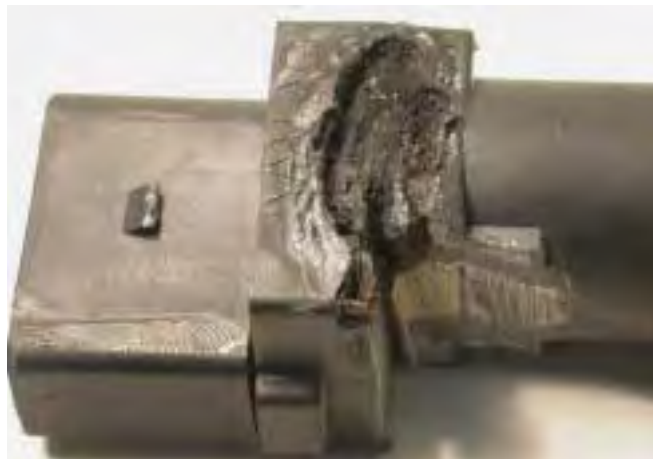
- Teile-Nummer: 022 905 100A L2 5397 4 15/04 Fa. Bremi
- FZG-Nr: WVGZG77L25D020581
- das Material vom Spulenkörper wurde im Bereich der Platine durch Temperatureinwirkung plastisch verformt und ist verschmort (Abbildung 6).
- Nach dem Austrennen und Vermessen wurde festgestellt, dass der IGBT durchlegiert ist.

Abbildung 6: Spulen Ansicht

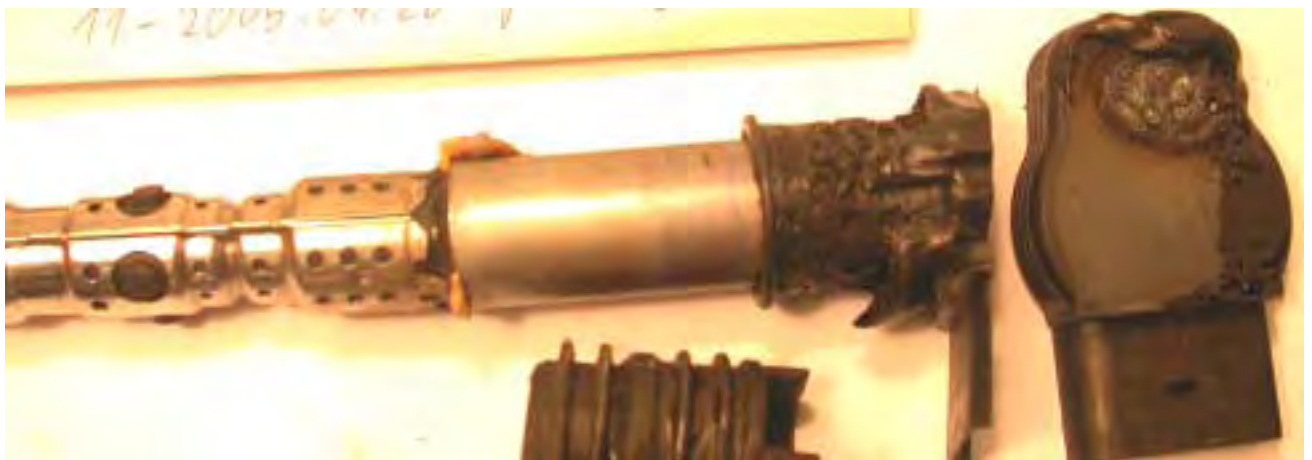
- Teile-Nummer 06B 905 115L L1 0A8F 4 01/04 Fa. Bremi
- FZG-Nr: VWVPD63B24E239903
- das Material vom Primärspulenkörper wurde durch Temperatureinwirkung plastisch verformt , die Vergussmasse über dem IGBT ist stark verschmort (Abbildung 9).

Abbildung 9: Spulen Ansicht

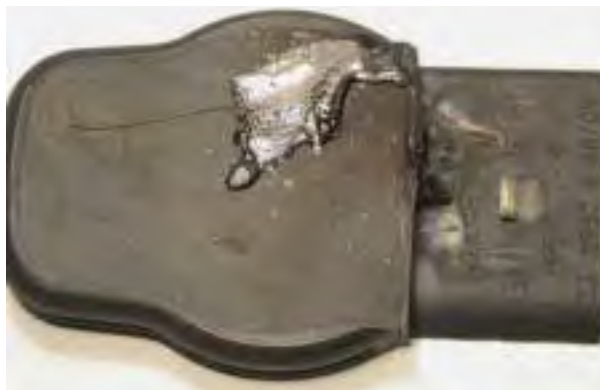
- Teile-Nummer: 06B 905 115 L L1 N93C 6 48/03 Fa. Bremi
- FZG-Nr: WWWPD63B24E239903
- Die Vergussmasse über der Ansteuerplatine hat einen Riss und ist im Bereich des Steckers Pin 1 stark verschmort (Abbildung 11).
- Der IGBT ist defekt.

Abbildung 12: Spulenansteuerung Ansicht

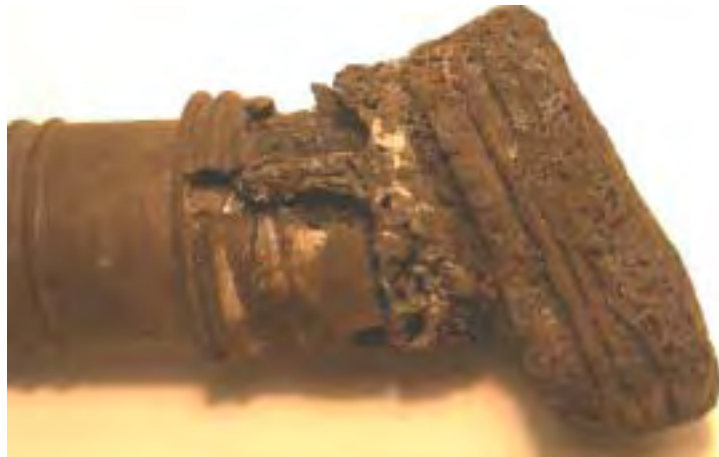
- das Material vom Primärspulenkörper und der Ansterelektronik wurde durch Temperatureinwirkung plastisch verformt und ist stark verschmort (Abbildung 14).

Abbildung 15: Spulenansicht

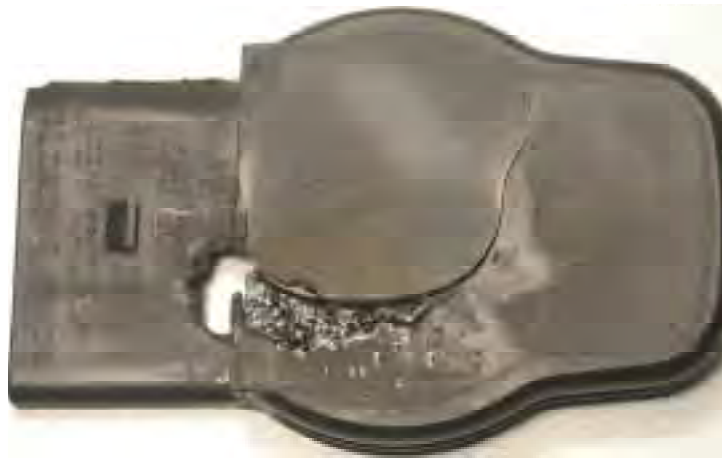
- Teile-Nummer: 06B 905 115N L1 DADB 5 32/04 Fa. Bremi
- FZG-Nr: WVVAD63B75E056942
- Die Vergussmasse über der Ansteuerplatine hat einen Riss und ist im Bereich des Steckers Pin 1 stark verschmort (Abbildung 17).

Abbildung 18: Ansteuerelektronik Ansicht

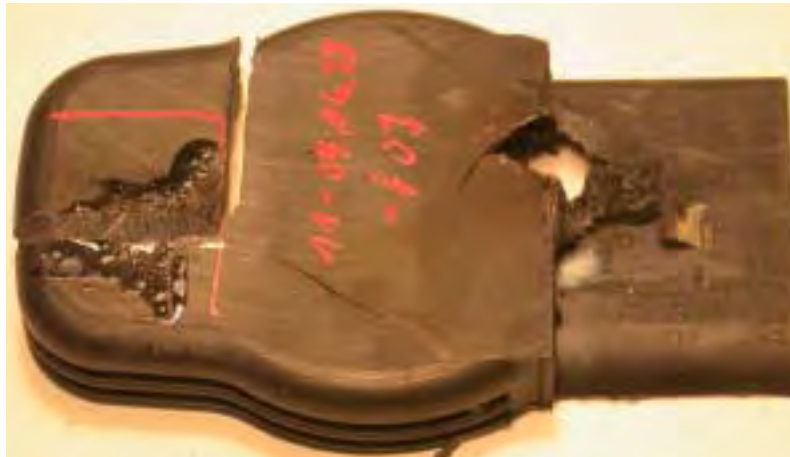
- Teile-Nummer 06B 905 115L L1 N45B 5 49/03 Fa. Bremi
- FZG-Nr: VWVPD63B94P199954
- Die Vergussmasse über der Ansteuerplatine hat einen Riss und ist im Bereich des Pin 1 stark verschmort.
- nach dem Austrennen und Vermessen wurde festgestellt, dass der IGBT ist i.O. ist.

Abbildung 21: Ansteuerelektronik Ansicht

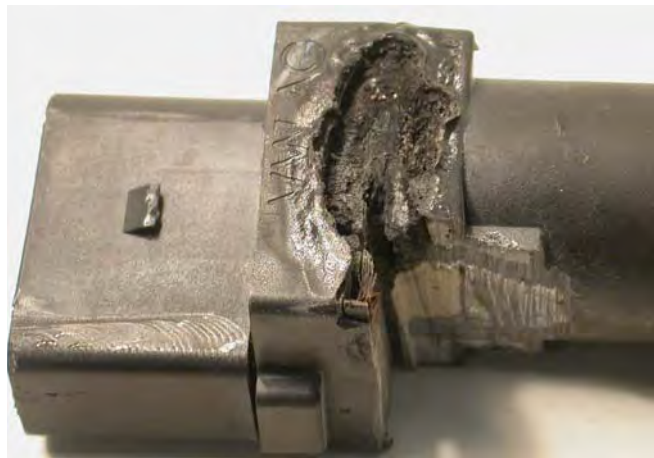
- Part number: 022 905 100A L2 5397 4 15/04 Brems
- Vehicle no.: WVGZG77L25D020581
- the coil body material was plastically deformed in the area of the printed circuit by temperature adjustment and is charred (image 6).
- After it was ripped out and aligned it was established that the IGBT had failed.

Image 6: coil view

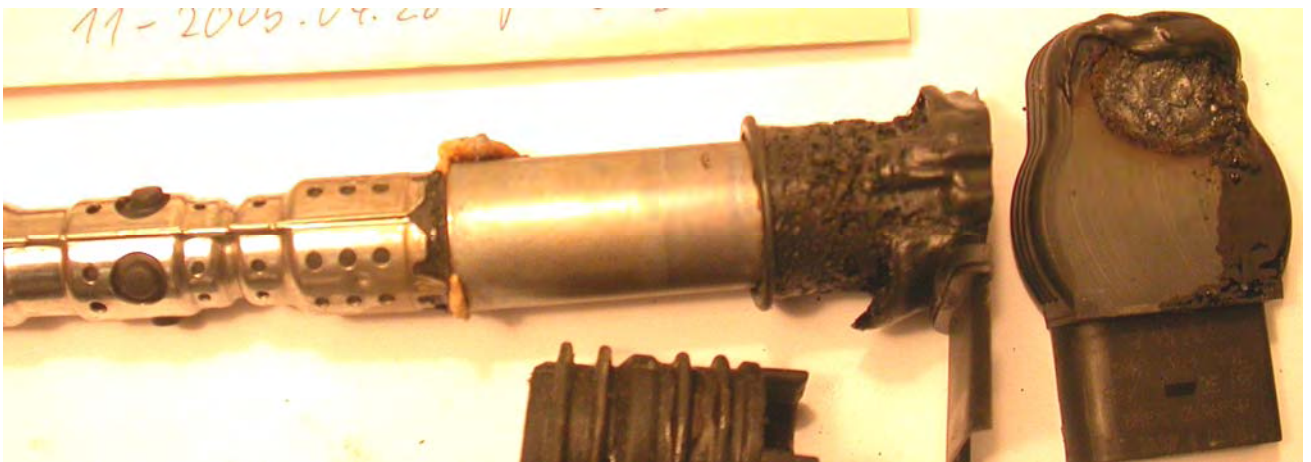
- Part number 06B 905 115L L1 0A8F 4 01/04 Bremi
- Vehicle no.: WVWPD63B24E239903
- the material of the primary coil body was plastically deformed by a temperature adjustment, the sealing compound over the IGBT is very dirty (image 9).

Image 9: coil view

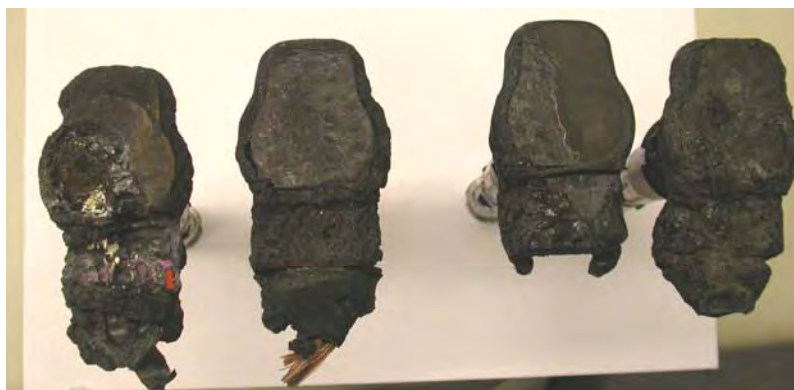
Image 1: Overview of SZS 11-2005.07.19-f-001-004

All SZS are very plastically deformed because of strong thermal effects, particularly the 11-2005.07.19-f-001 coil (image 1, first part on left).

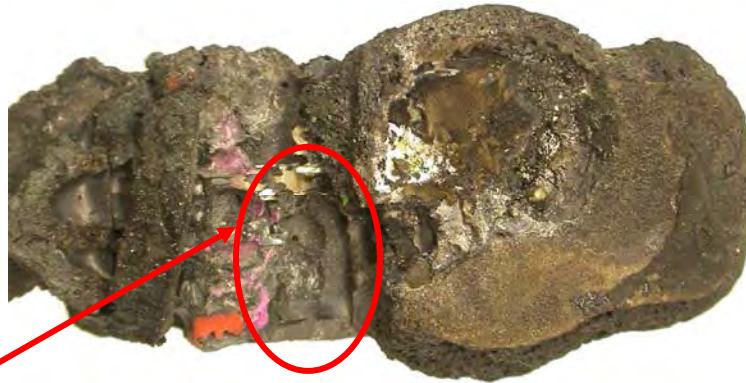
Image 2: part 11-2005.07.19-f-001 plan view

Pin 3 and 4 are not longer available in the investigated part.

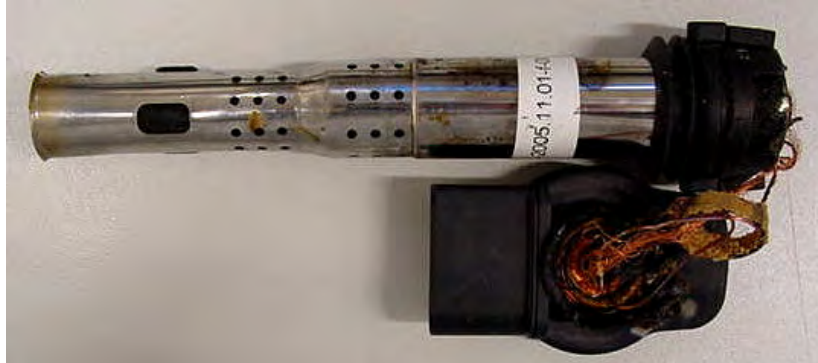
Photo 1

The coil received is damaged, photo 1.

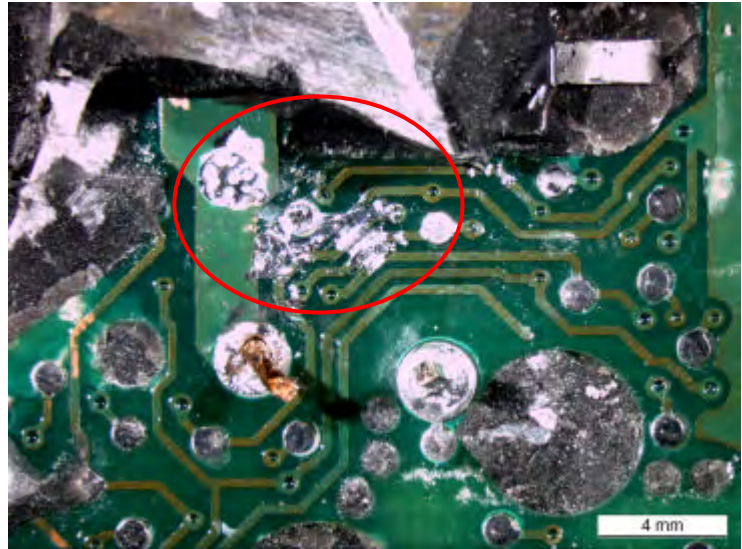
Photo 5

Photo 5, show the area with soldering material coming from the IGBT or wire soldering points .

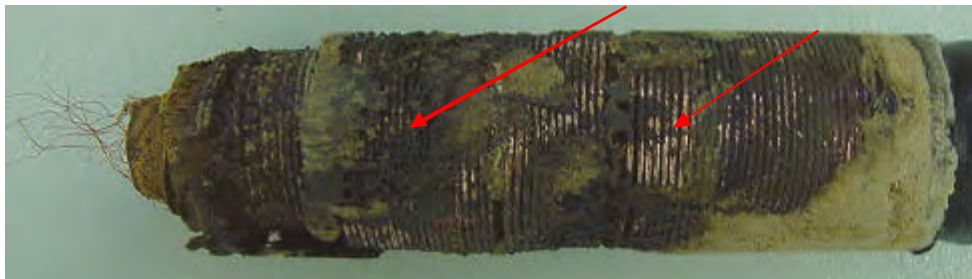
Photo 6

The windings appear very burned, photo 6.

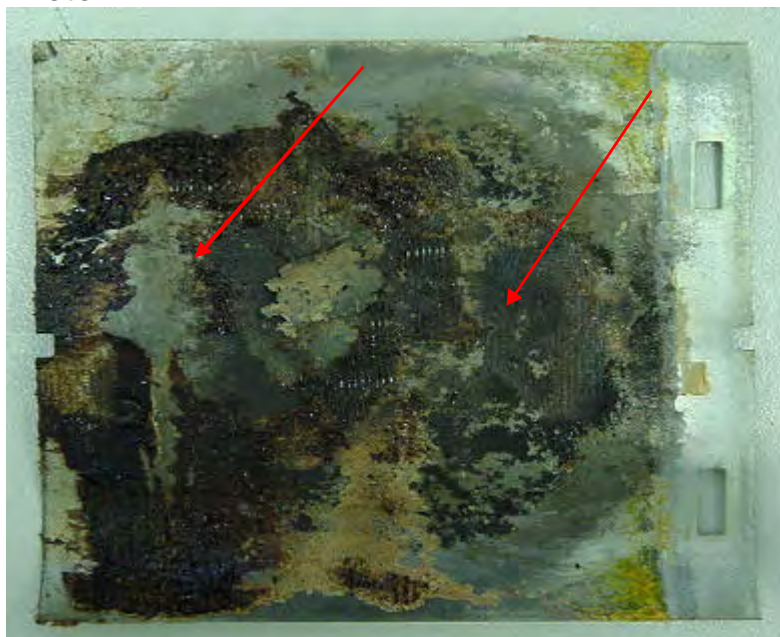
Photo 7

Photo 7, show the inside of the shield with plastic melted.

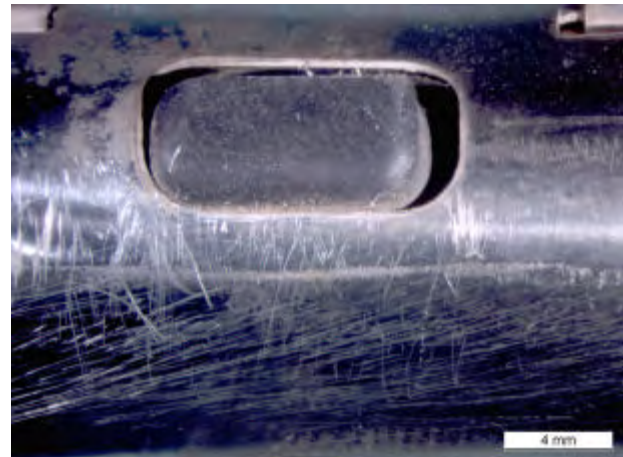
Photo 3

Follow, the material has been scratched from the surface of the long shield, photo 3.

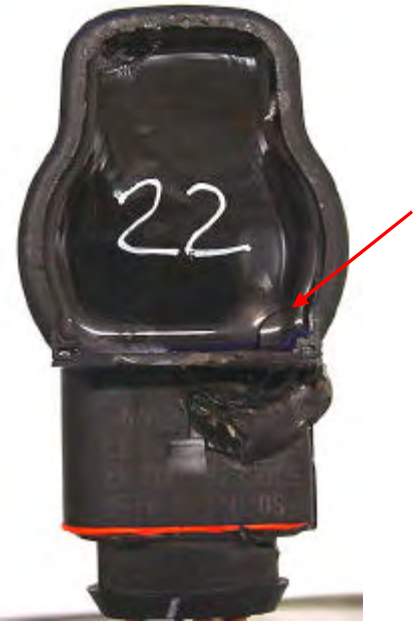
Photo 4

Photo 4, show head of the coil very damaged.

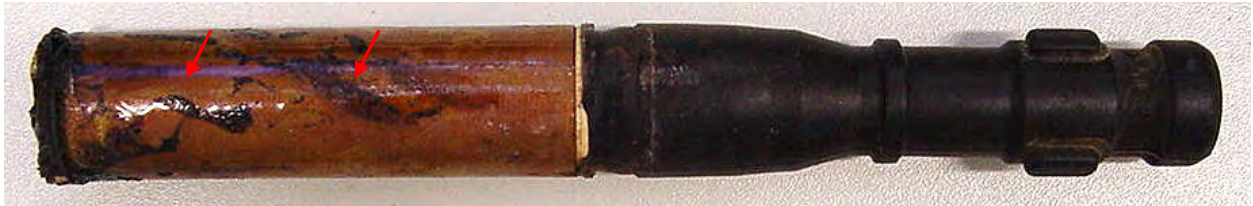
Photo 9

Not discharge point are observed, photo 9.
In LV area is visible the primary coil former burned. The primary winding is not damaged.

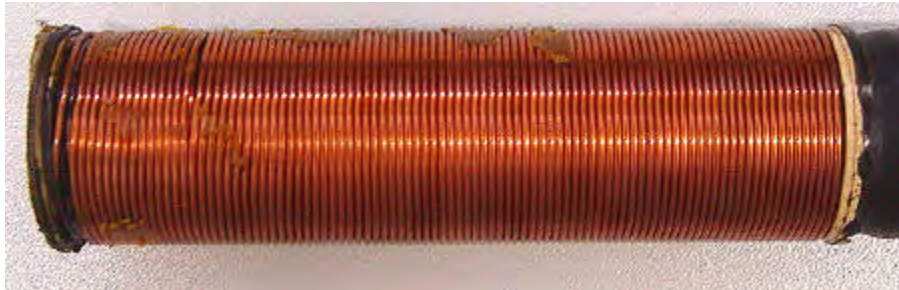
Photo 10

In the coil was removed the plastic tape for to check the integrity of the primary windings, photo 10. The windings appear in good condition.

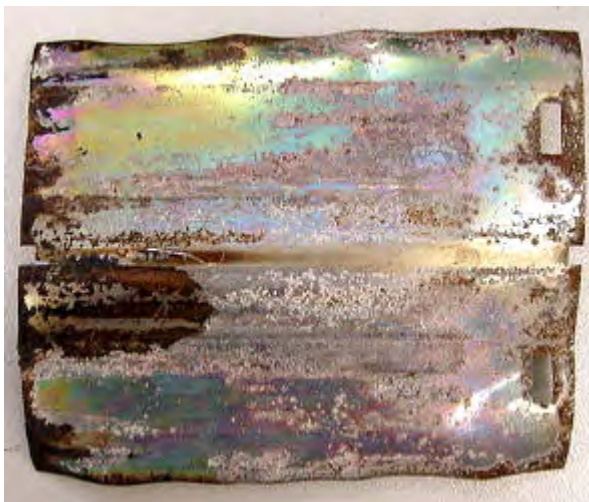
Photo 11

No contact point were observed in the external (photo 11) and internal (photo 12) surface of the shield. On the surface of the shield it was observed the oxidation.

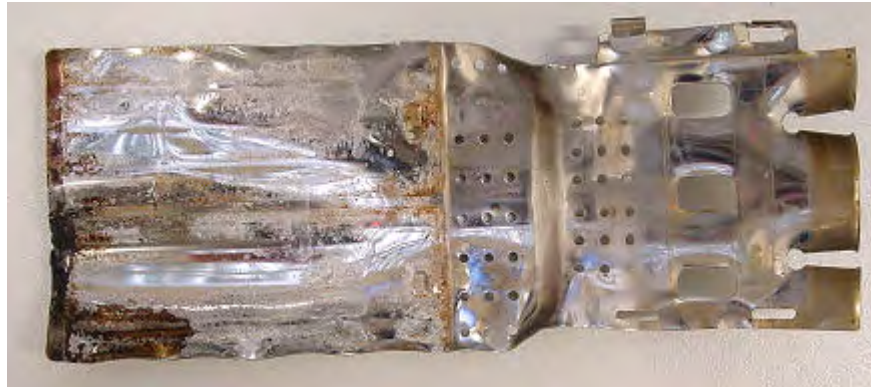
Photo 13

No discharge point were observed in the surface of the long shield, photo 13.
There is the oxidation residual coming from the internal shield.

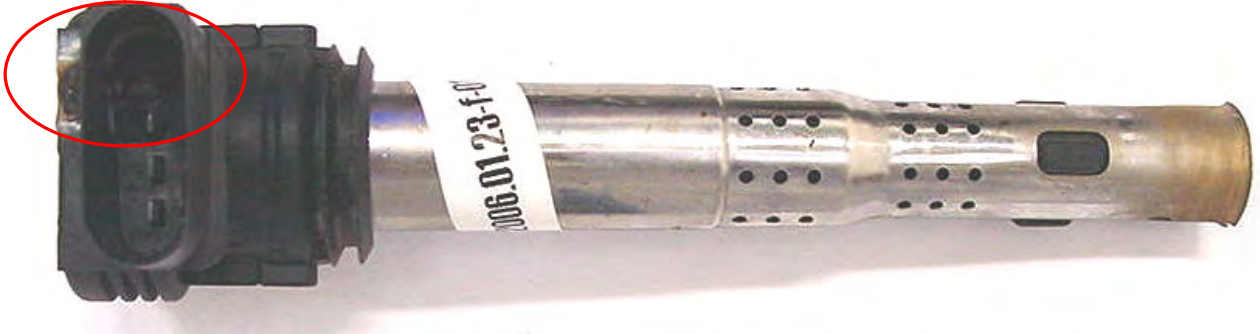
Photo 1

In the surface of the long shield there is a unknown material, we suppose that this material coming from the motor plug well.

Is our opinion that the unknown material was coming from the engine.

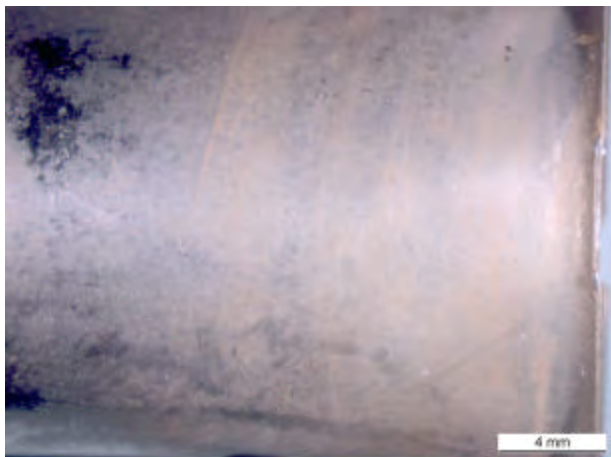
Photo 3

Photo 3, show the zoom of the unknown material present on the long shield.

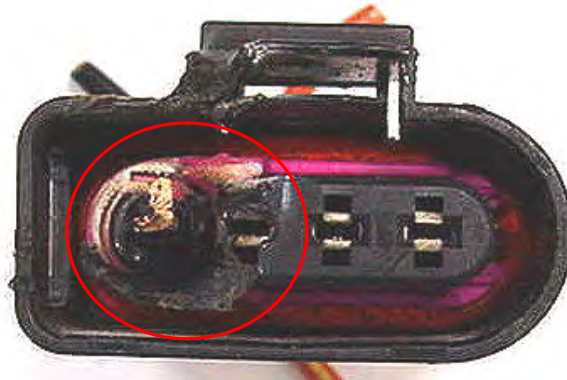
Photo 5

Photo 5, show the connector LV with the pin 1 of the head connector.

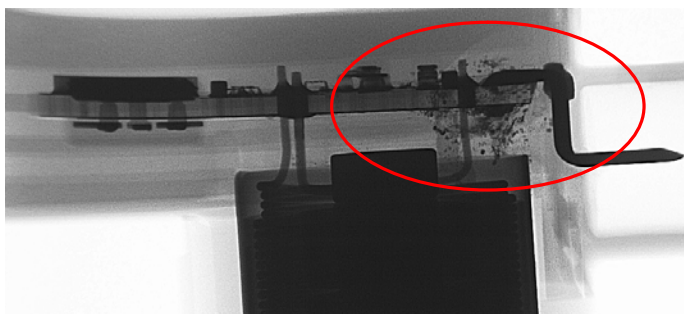
Photo 6

The X-ray, show the electronic very damaged, photo 6.

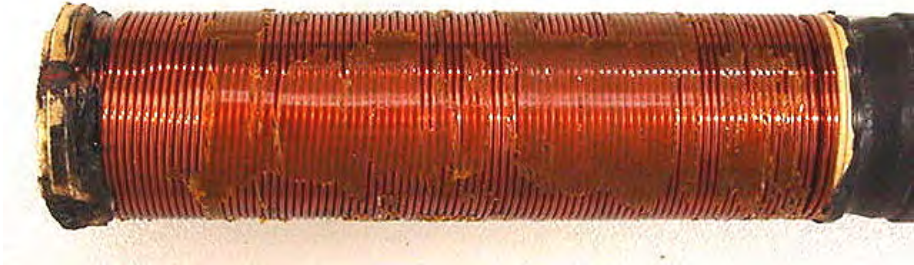
Photo 11

In the coil was removed the plastic tape for to check the integrity of the primary windings, photo 11. The windings appear in good condition.

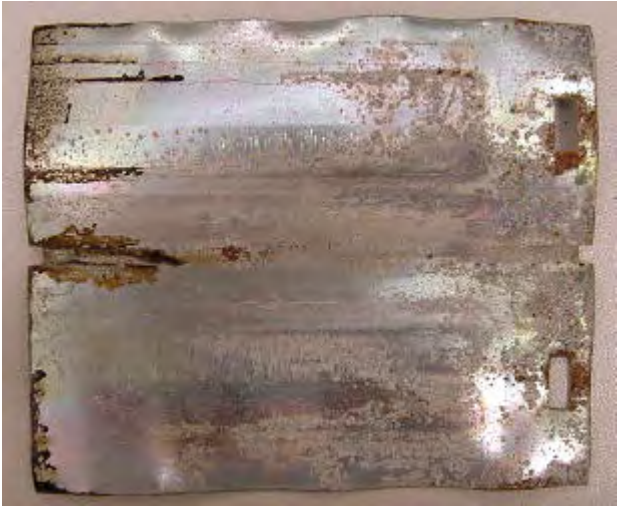
Photo 12

No contact point were observed in the external (photo 12) and internal (photo 13) surface of the shield. On the surface of the shield it was observed the oxidation.

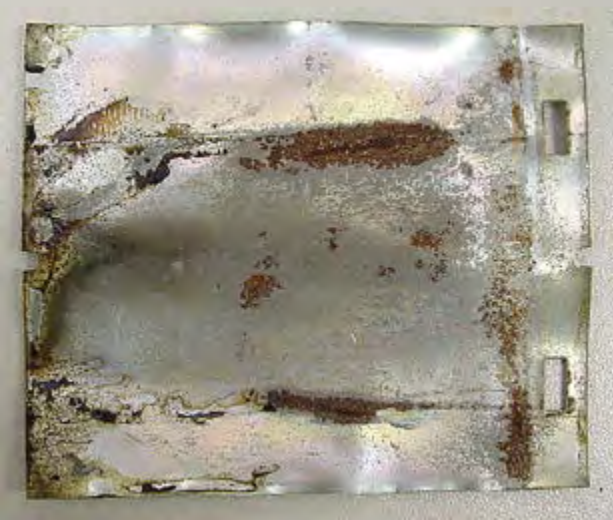
Photo 13

Therefore, in our opinion there was probably humidity penetration on the shield that has determined the oxidation of the internal metal shield.

Change of the head rubber in order to guarantee a better sealing between the plug well and the ambient area in all tolerances condition -> in wk 04/06.

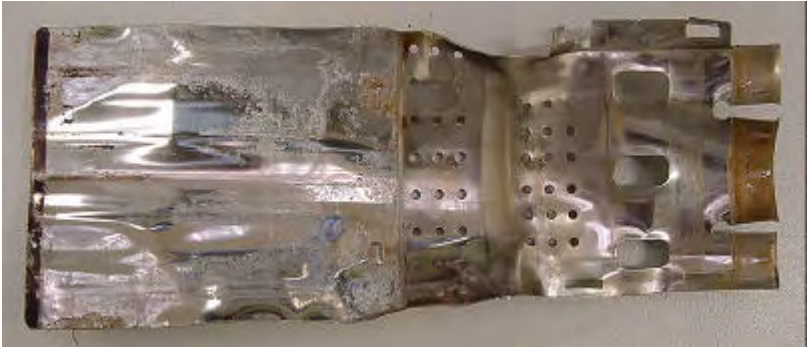
Photo 13

No discharge point were observed in the surface of the long shield, photo 13. There is the oxidation residual coming from the internal shield.

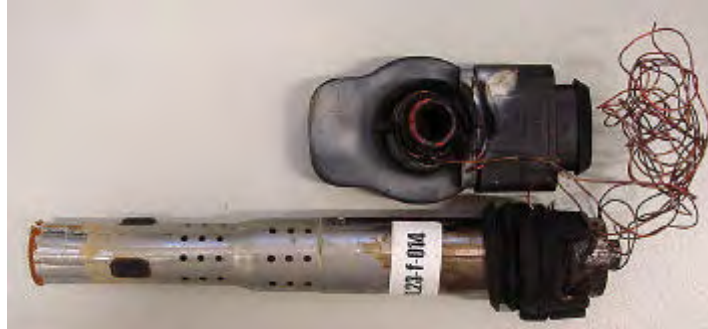
Photo 1

The coil was received in Eldor in this condition, photo 1.
The head is detached from the windings.

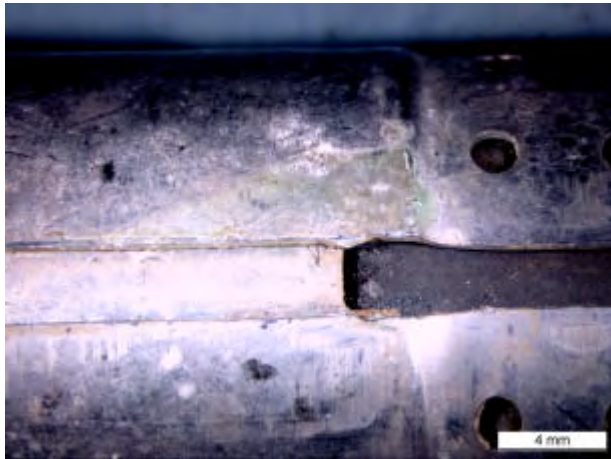
Photo 2

Photo 2, show the zoom of the unknown material present on the long shield.
Follow, the material has been scratched from the surface of the long shield, photo 3. Not residual remaining on the surface. So no oxidation observed.

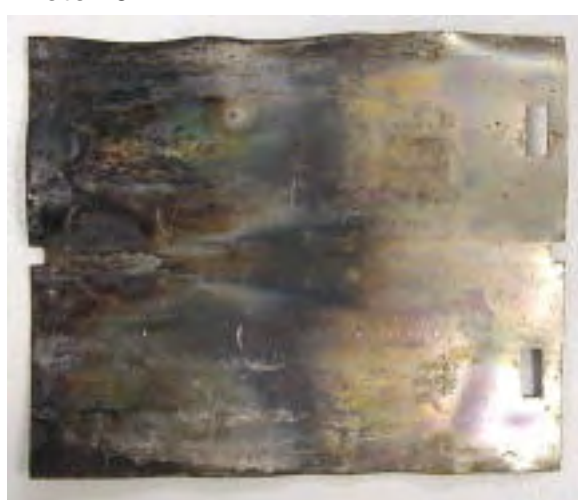
Photo 13

Photo 13, show the external of the shield that it appear very overheat.

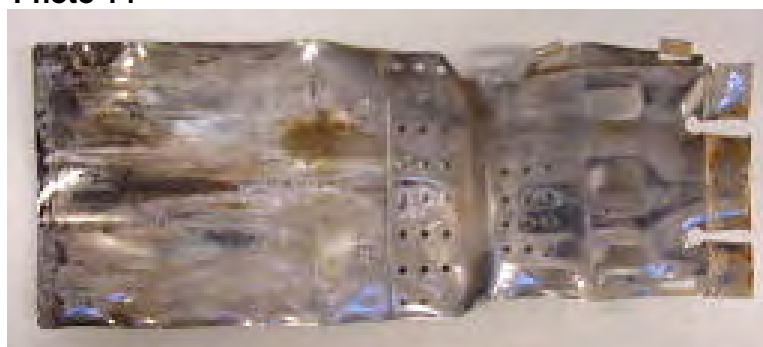
Photo 14

The long shield appear overheat for the excessive heating due to the high temperature reached by the coil, photo 14.

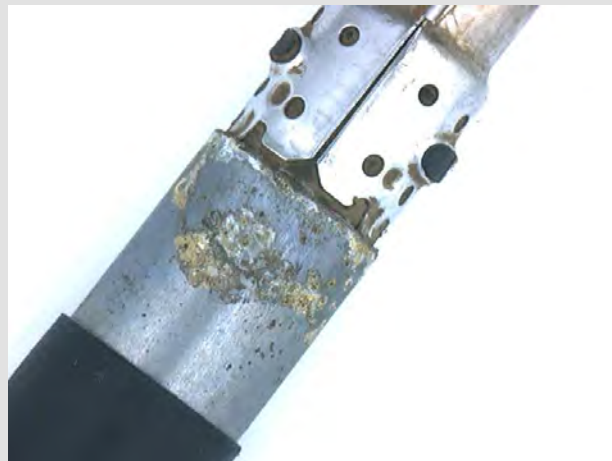
Korrodierte Stabzündspule im 3.6l-VR6-FSI Passat nach 850 mls LL

Bei den Korrosionsprodukten handelt es sich im wesentlichen um oxidische Zinkverbindungen mit Spuren von Cl und K. Tensidische Elemente (P, Na), die auf Reinigungsmittel hinweisen, wurden nicht gefunden.

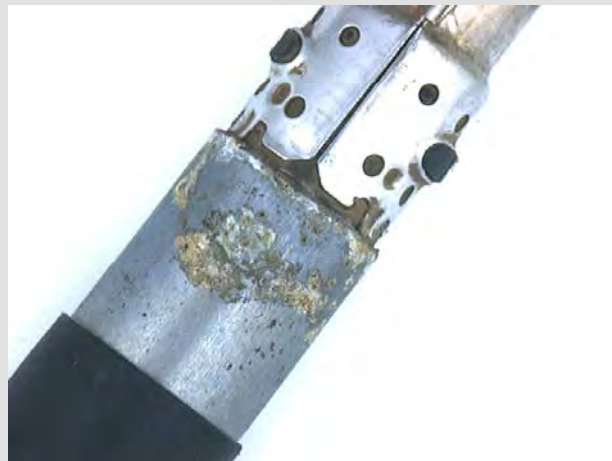
Corroded ignition coil in the 3.6l VR6 FSI Passat after 850 mls LL

The corrosion material is essentially oxidic zinc compounds with traces of Cl and K. Tensidic elements (P, Na) that would suggest a cleaner were not found.

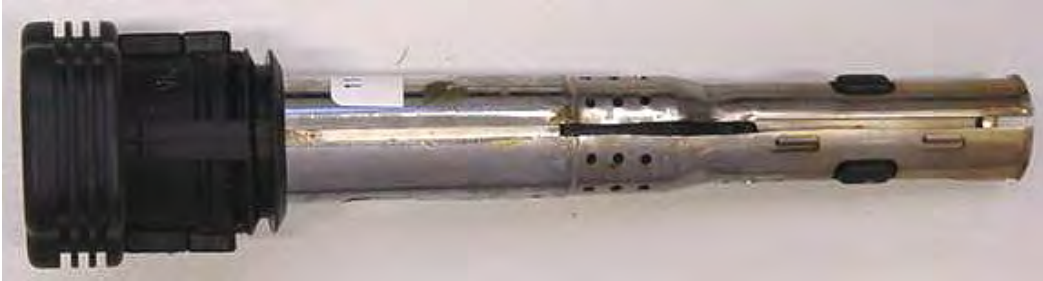
Photo 1

Not damaged are present on the external surface of the coil, photo 1.

In the surface of the long shield there is a unknown material, we suppose that this material coming from the motor plug well.

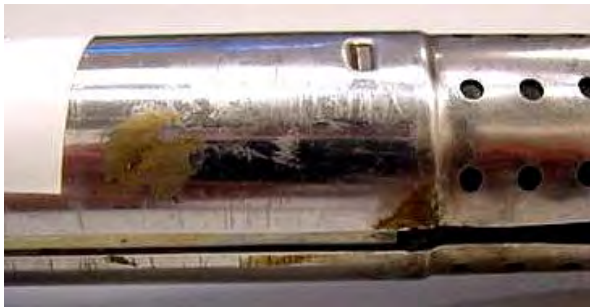
Photo 2

Photo 2, show the zoom of the unknown material on the surface of the long shield.

Follow, the material has been scratched of the surface from long shield. Not residual remaining of the material in the surface. The residual was not coming from the external surface of the coil.

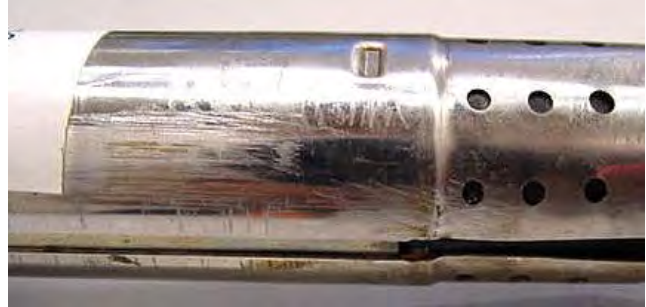
Photo 3

Photo 3, show the long shield clean, after the removing of the unknown material.

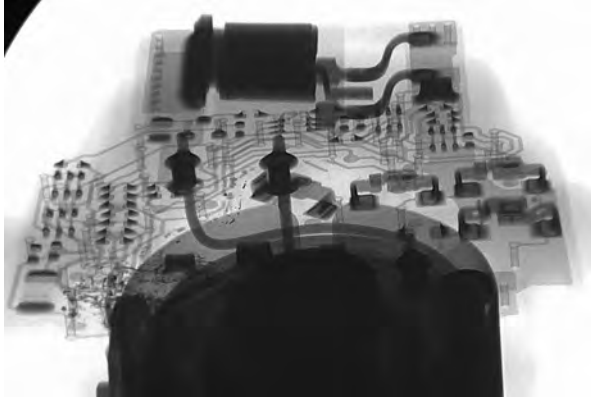
Photo 4

The X-ray, show the pencil very damaged, photo 4.

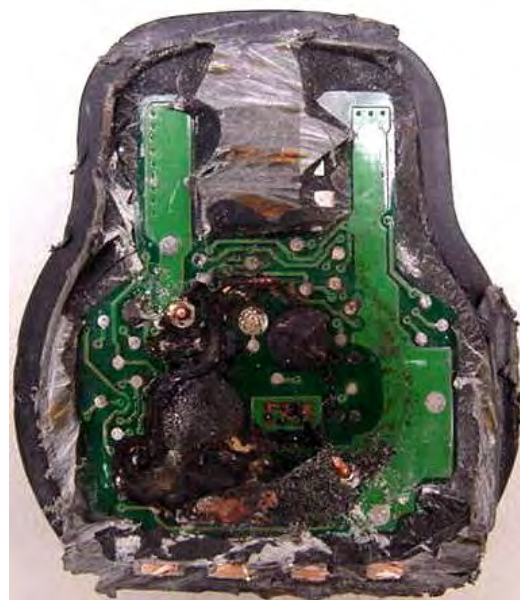
Photo 7

Photo 7, show the burn area on the bottom side of the pcb.

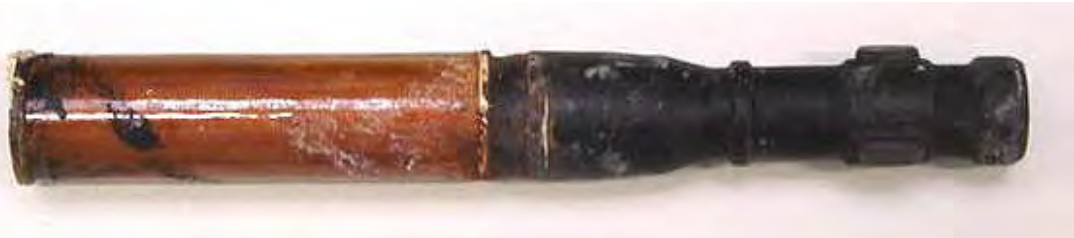
Photo 8

The long shield was extract from the pencil for to check the primary windings : the plastic tape results damaged, but not contact point are observed between the primary wire and the shield, photo 8.

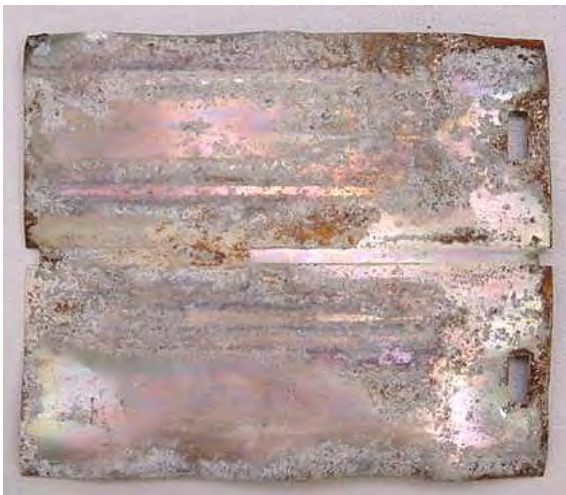
Photo 9

On the external surface of the shield it was observed the oxidation, see photo 9.
On the internal surface of the shield it was observed the oxidation, photo 10.
No contact point were observed in the surface of the shield.

Probably humidity penetration on the PCB that has determined the burning of the electronic.

Change of the head rubber in order to guarantee a better sealing between the plug well and the ambient area in all tolerances condition -> in wk 04/06.

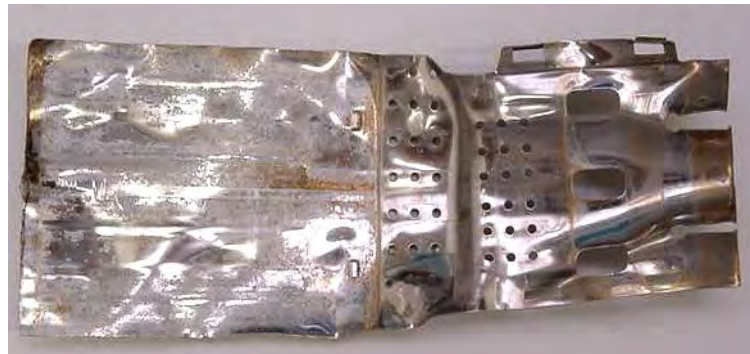
Photo 11

On the internal long shield there is the oxidation residual coming from the internal shield, see photo 11.

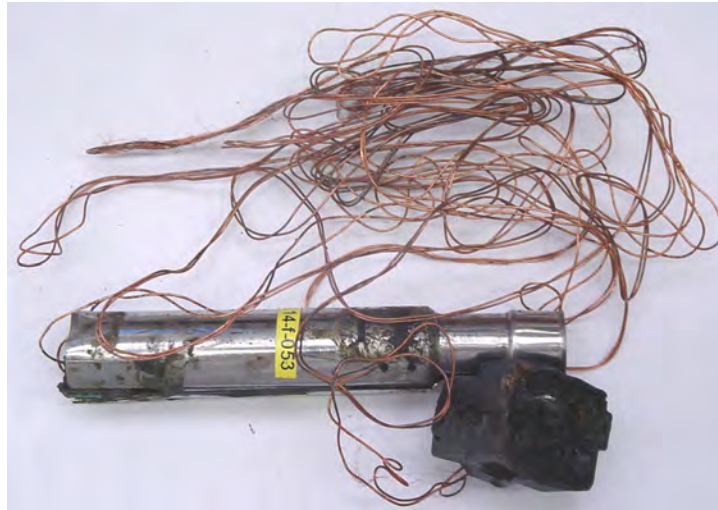
Photo 1

The coil received is very burnt, photo 1.

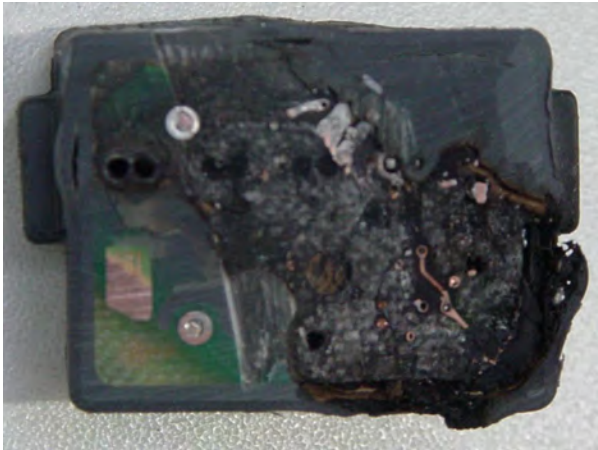
Photo 3

Electronic very burnt, photo 3, 4.

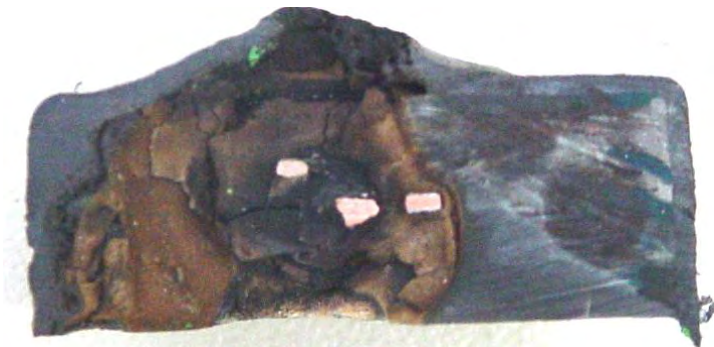
Photo 5

The IGBT is very carbonized, photo 5, 6.

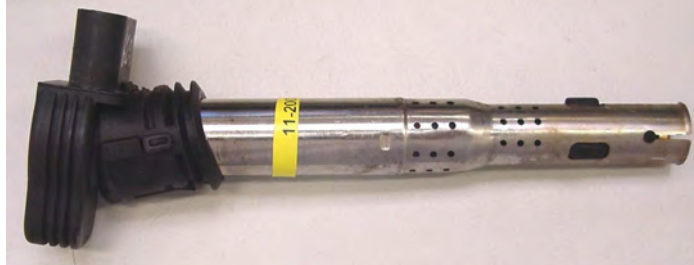
Photo 1

The coil is very melted in the head area, photo 1.

- Probably humidity penetration on the pcb that has permitted the driving the IGBT in continuous mode determining the melting of the primary and secondary coil former.

Starting in wk 02/07 new FSI pencil coil Gen II with primary potted, that don't permit the humidity penetration.

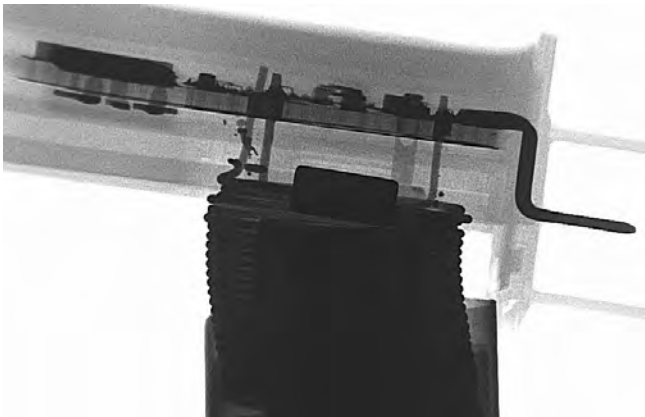
Photo 2

The X-ray show the pencil coil very melted, photo 2, 3.

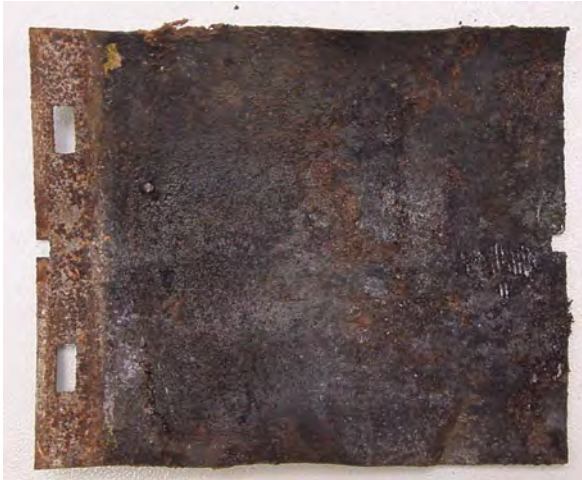
Photo 6

The surface internal and the external of the shield are carbonized, photo 6, 7.

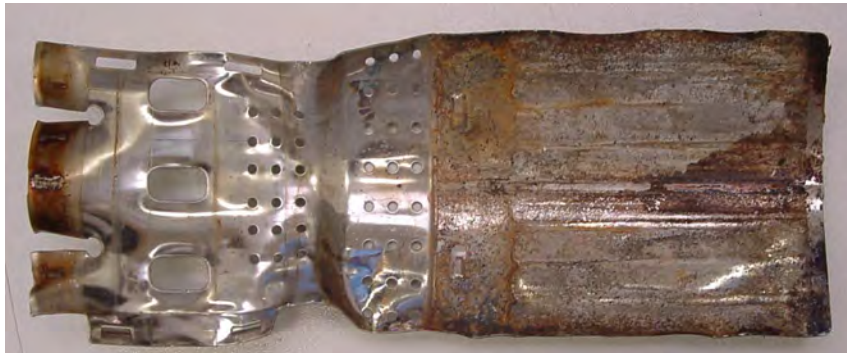
Photo 8

On the surface of the long shield there is some residual of the carbonized coming from the internal shield, photo 8.

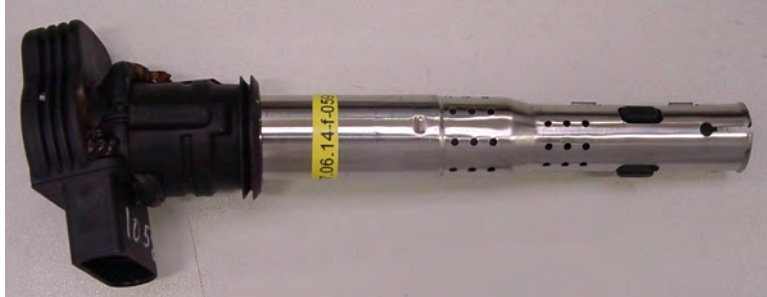
Photo 1

The coil is very melted, photo 1.

A possible root causes is due to a bad electrical behaviour of the IGBT, that has put in driving continuous the coil causing the melting of the windings.

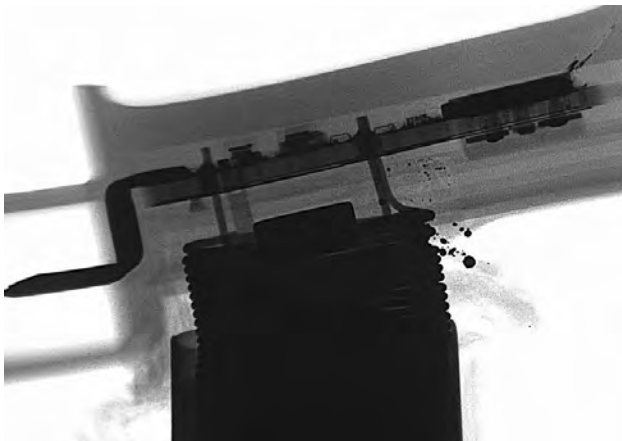
Photo 2

The X-ray, show the windings melted (photo 2) and the pcb that in the lgbt area appear damaged(photo 3).

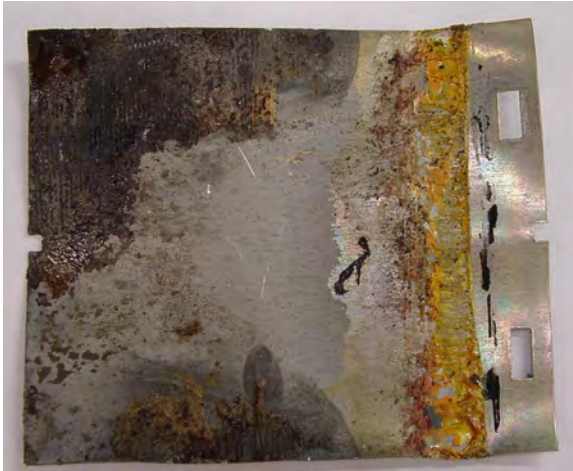
Photo 6

On the internal surface of the shield there are residual of the protection tape melted , photo 6.
The external surface of the shield appear overheated, photo 7.

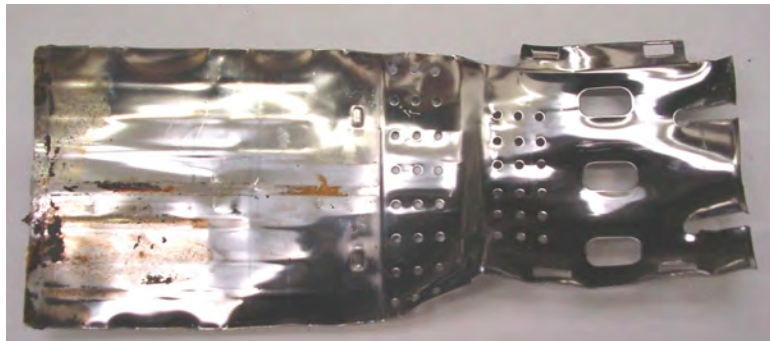
Photo 8

On the internal surface of the long shield there are some residual of the plastic tape melted coming from the internal shield, photo 8.

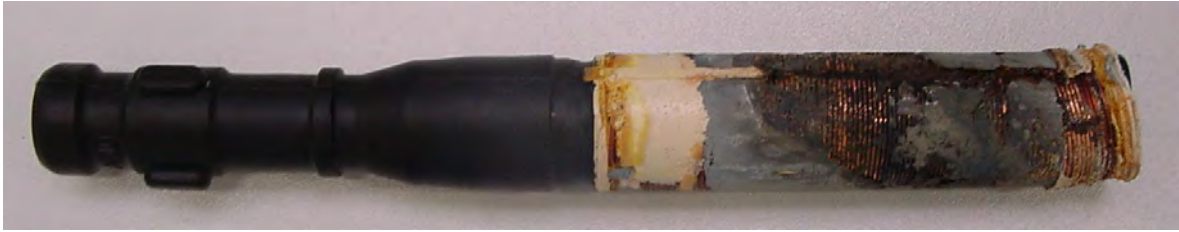
Photo 5

The windings are very melted, photo 5.

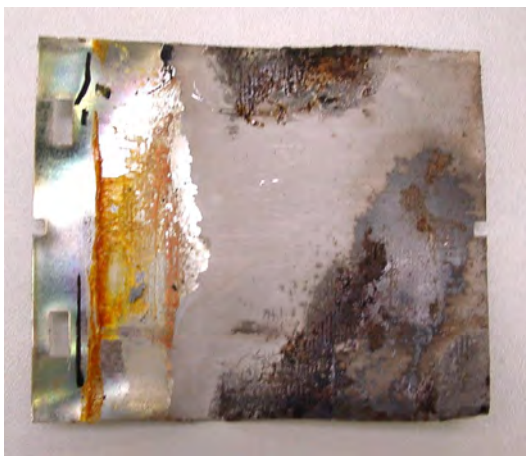
Photo 6

On the internal surface of the shield there are residual of the protection tape melted, and some oxidation sign, photo 6.

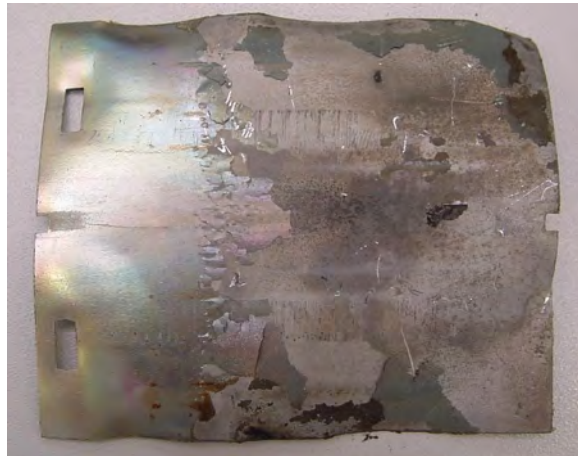
Photo 7

On the external surface of the shield there is some oxidation sign, photo 7.

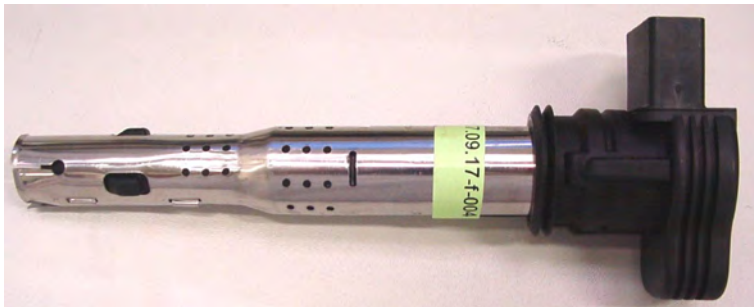
Photo 1

No damaged are present on the external surface of the coil (photo 1), but on the head resin has been observed a crack on IGBT area, photo 2.

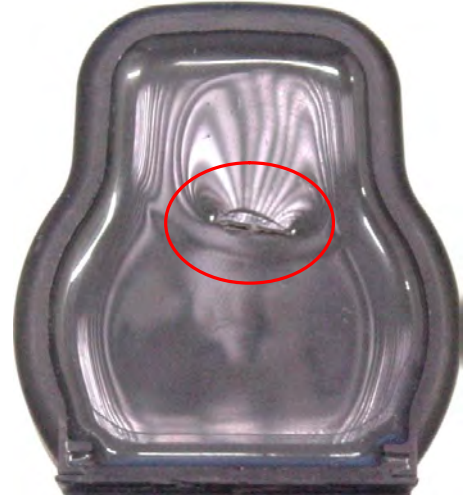
Photo 2

Crack in the head resin on IGBT area.

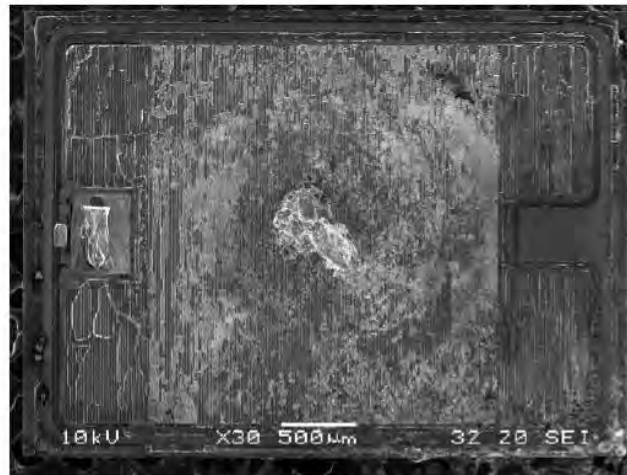
“The module with encapsulated IGBT device exhibited signs of thermal damage. Radiographic analysis confirmed possible damage inside the module. Curve tracer testing performed by PAL On Semiconductor indicated resistive shorts on all leads. The module was immersed in concentrated sulfuric acid in an attempt to chemically etch away the mold compound. The damage observed after chemical decapsulation is typical of massive EOS and resulting in a thermal damage. It was concluded that the most likely scenario of events was that the IGBT device was initially electrically overstressed by a high emitter current surge.”

Figure 6: SEM overview of the massive electrical/thermal damage on the die & wires.

2) Eldor asked to ON the possibility to double or apply more SSD pulse during the “final test” in order to check the device in more severe condition and screen out possible weakness parts.

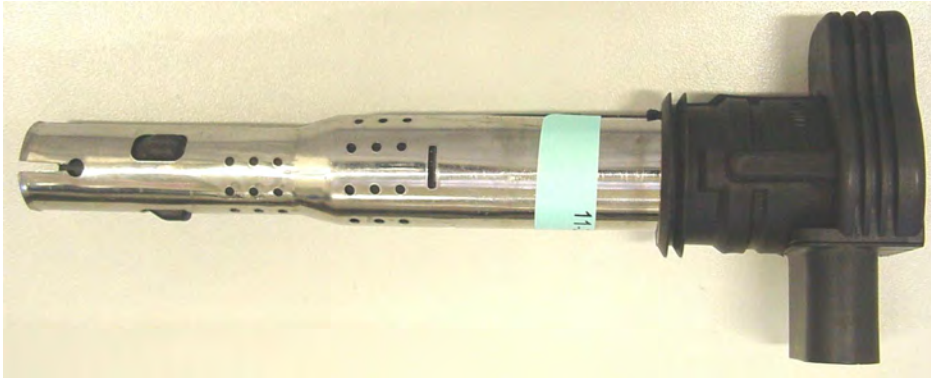
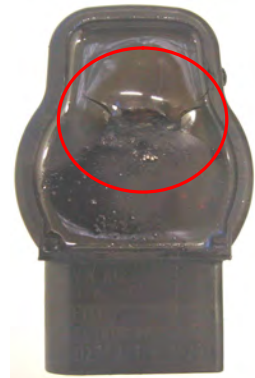
The coil appears very damaged on the head, photo 1. 2.

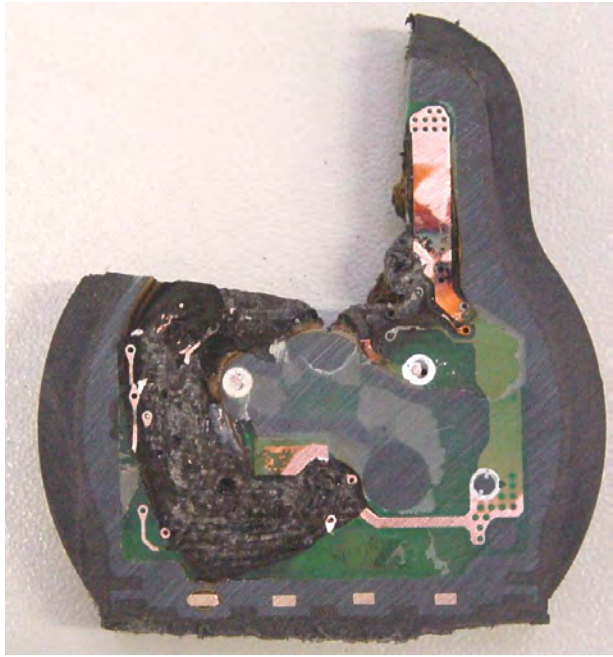
Photo 6

Photo 6, show the burnt area on the bottom side of the electronic.

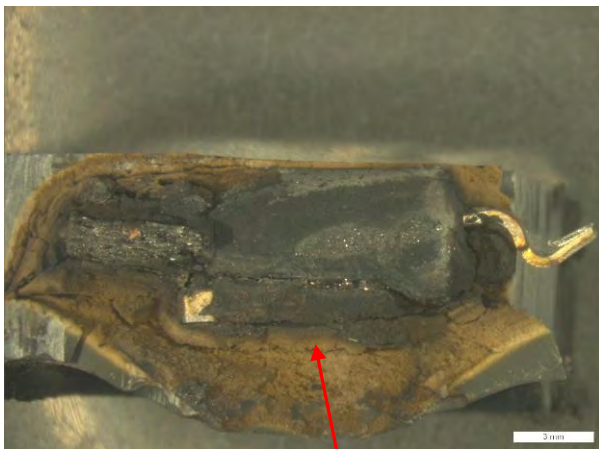
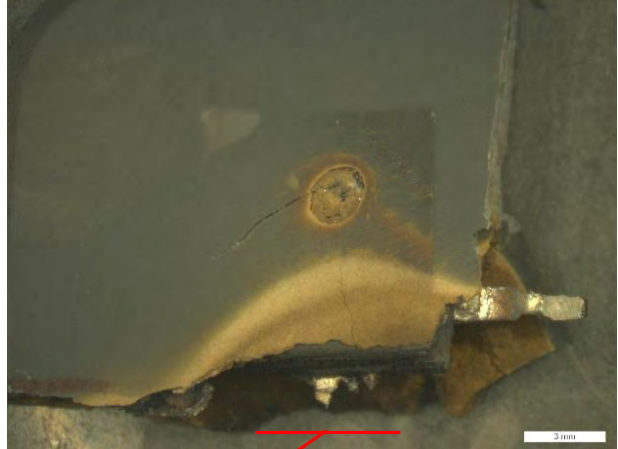
Photo 7, 8, show the condition of the IGBT extracted from the pcb.

- IGBT carbonised;
- Windings melted;
- Electronic burnt;
