Action	Document	Start Date:	End Date:	Subject/Objective:	Responsible:	Summary:
Action 09-01	09-01_PQA2004470102.pdf	11/19/2004	11/19/2004	Failure analysis of overheated pencil coils	Sub-Supplier Fairchild (Pulse's supplier for IGBT)	IGBT overheated due to current related overstress
Action 09-02	09-02_MPV05-009.pdf (German Original) 09-02_MPV05-009_EN.pdf (English Translation)	9/1/2004	3/4/2005	Failure analysis of 8 failed pencil coils	Supplier Pulse	Coils were damaged by external influences; electrical overstress resulting from missing ground connection caused IGBT to overheat
Action 09-03	09-03_0001924068.pdf (German Original) 09-03_0001924068_EN.pdf (English Translation)	11/25/2004	3/23/2005	Component analysis of ignition coil	Audi AG	Exact analysis not possible because of damage degree
Action 09-04	09-04_11-Z-05-2207.pdf (German Original) 09-04_11-Z-05-2207_EN.pdf (English Translation)	4/14/2005	4/15/2005	Failure analysis of overheated pencil coils	Volkswagen Laboratory	IGBT latch-up, impaired capacitor soldering

Action 09-05	09-05_MPV05-018.pdf (German Original) 09-05_MPV05-018_EN.pdf (English Translation)	9/1/2004	4/25/2005	Failure analysis of overheated pencil coils	Supplier

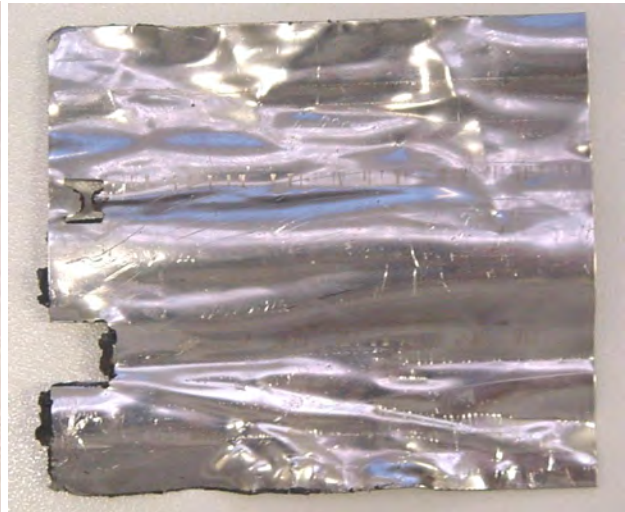
Photo 11

On the external surface of the shield are not observed damaged or anomalies, photo 11.

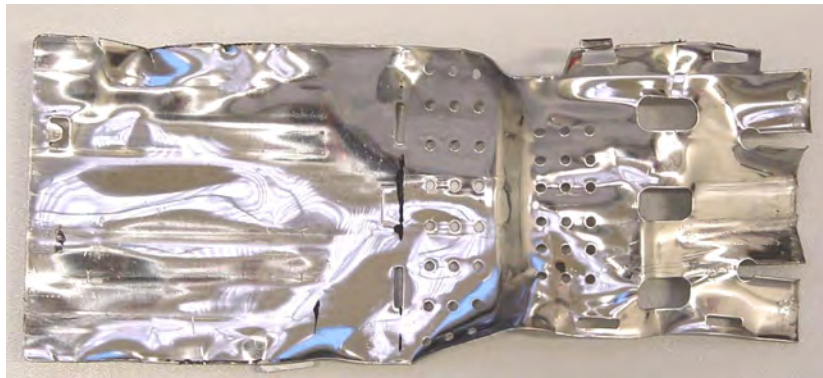
Photo 12

On the internal surface of the shield are not observed damaged or anomalies, photo 12.

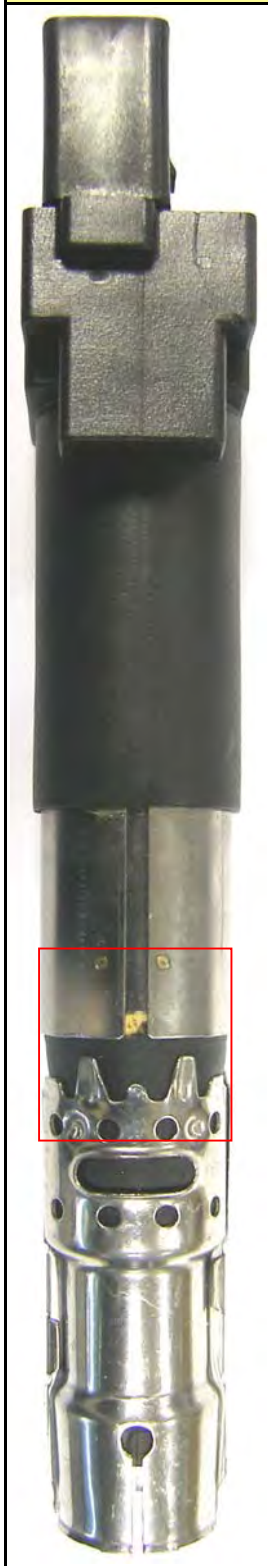
Stabspule komplett

- schon im Anlieferungszustand ist eine Längung der Stabspule im Bereich der Schirmbleche und eine Überhitzung des HS-Rüssels erkennbar
- nach der Demontage der Schirmbleche und des HS-Schutzschlauches sieht man deutlich, dass der HS-Rüssel deformiert und im Bereich des HS-Anschlusses geschmolzen ist

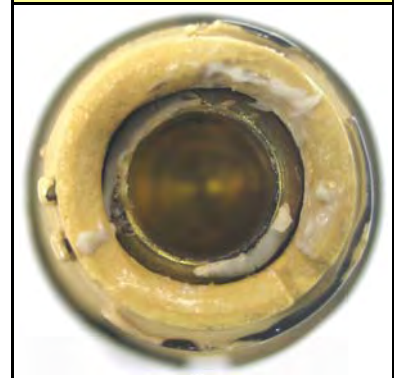
HS-Rüssel geschmolzen

The trunk of the primary ignition coil is penetrated. The cause could be an overheating (on engine side) which caused the melting of the trunk and the loss of insulation. This could have been started by a faulty or wrongly fitted spark plug, a spark-over between the coil and the SAE connection of the spark plug is also possible (see MPA07-047).

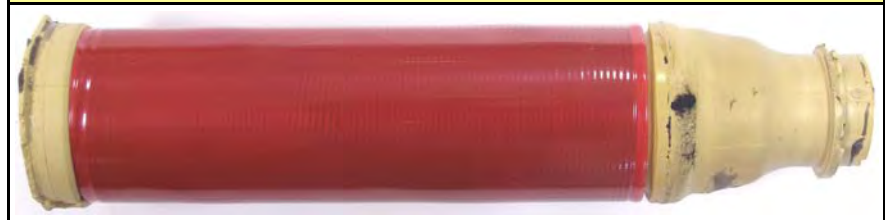
Spulensystem komplett - HS-Rüssel thermisch deformiert

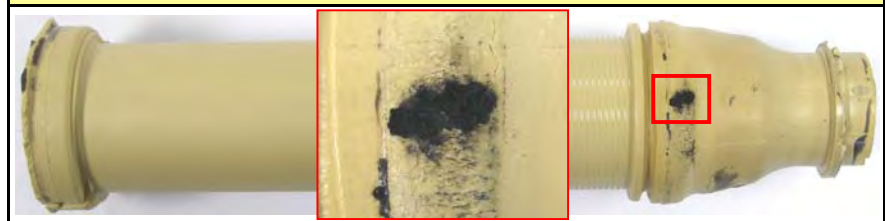
Primärspulenkörper - Durchschlag am aufgeschmolzenen HS-Rüssel

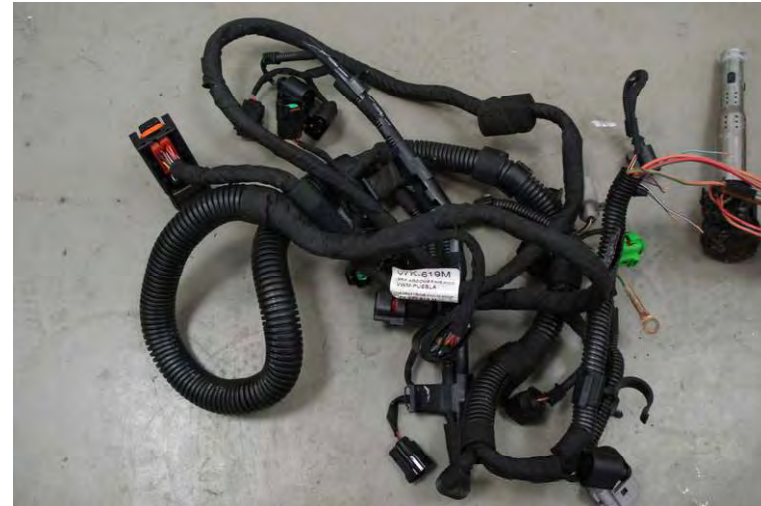
Engine pre-wiring from the vehicle.

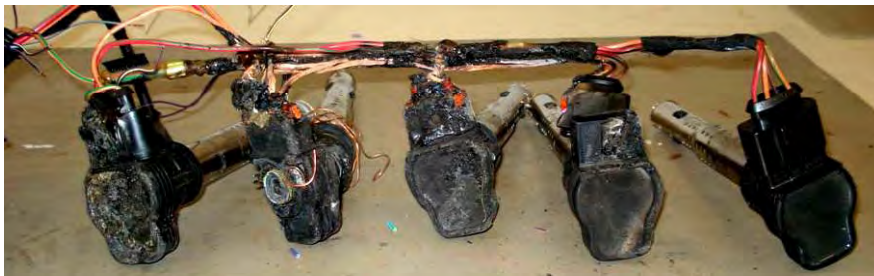
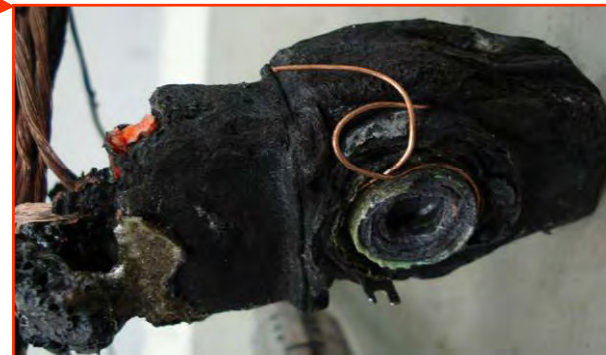
Engine pre-wiring resistance measurement, inspection

Resistance measurement between the control pin of the coils and the pins of the injection valves did not produce any noticeable resistance values ($R_{95-96} = \infty \Omega$).

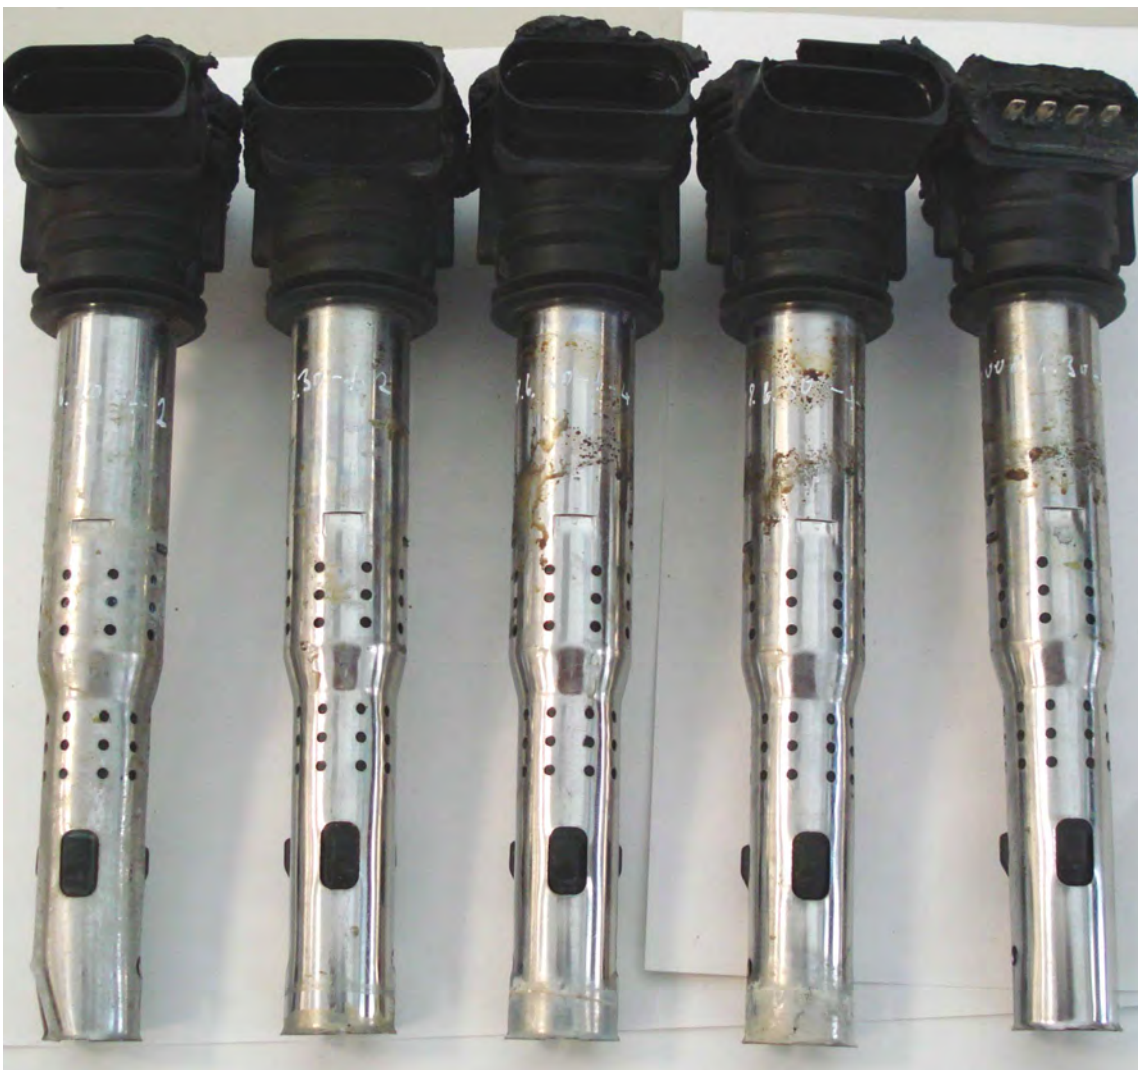
Abbildung 2: Spulen Übersicht

An allen Spulen befinden sich Feuchtigkeitsspuren im Bereich des Zündkerzen-Anschlusses. Die Spulenköpfe weisen eine thermische Verformung auf, wahrscheinlich aufgrund einer externen Wärmequelle.

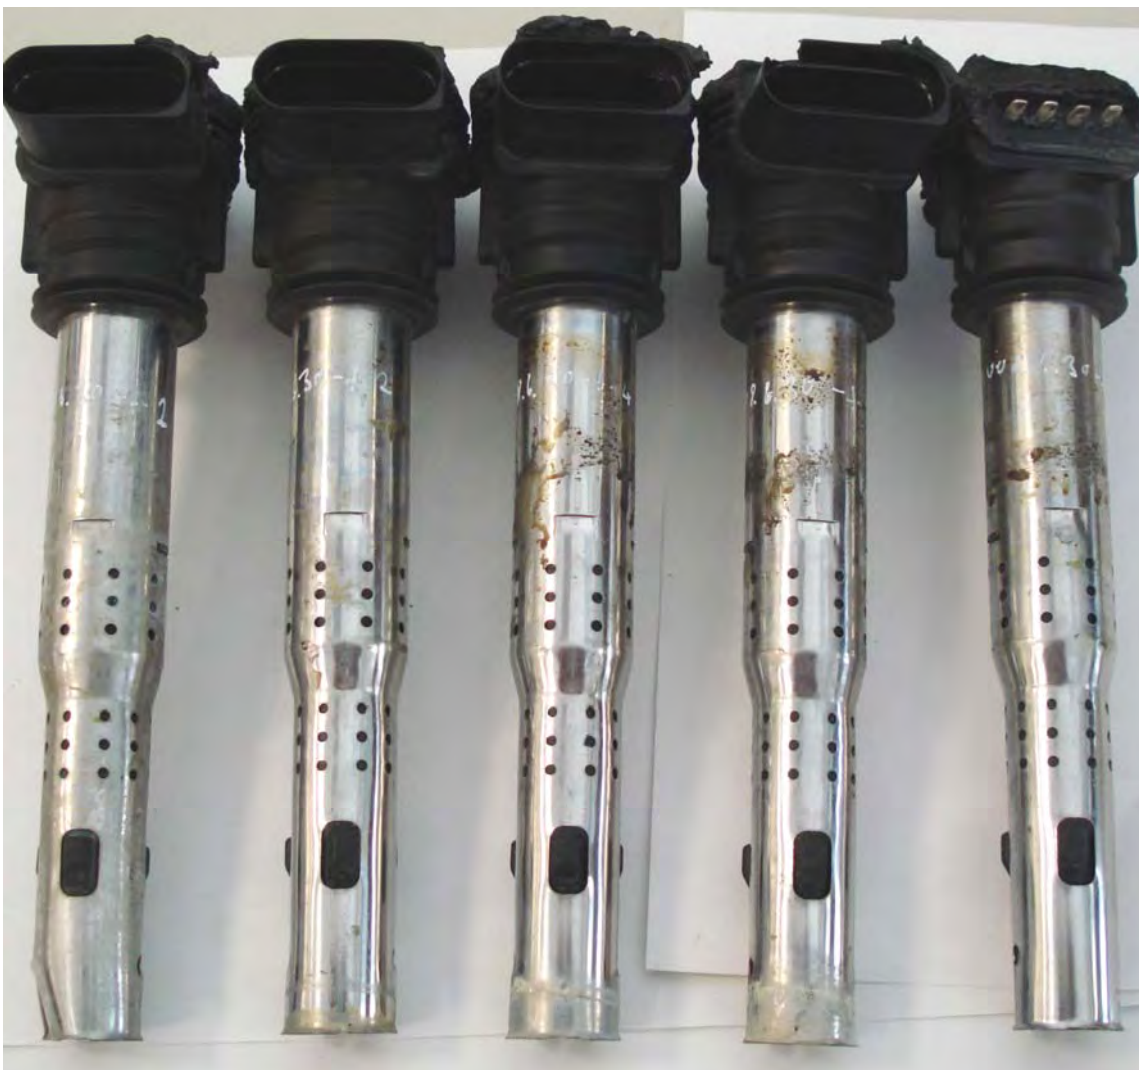
Image 2: coil overview

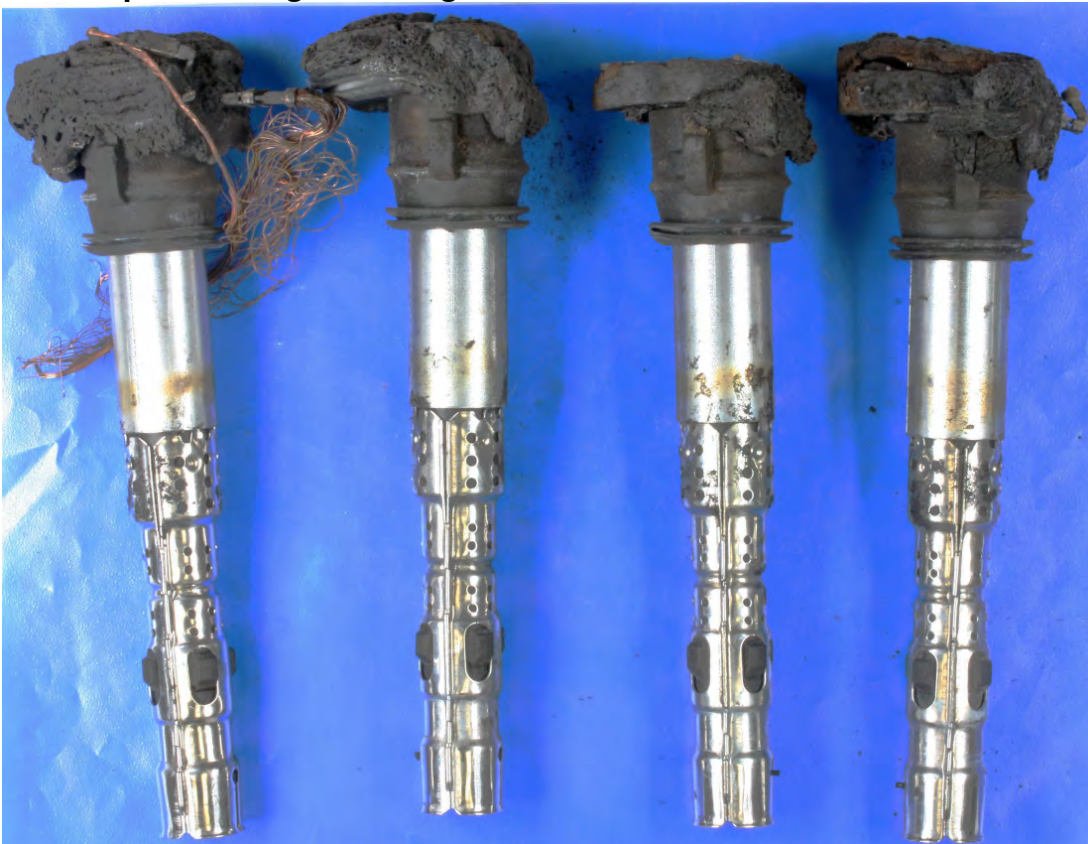
Alle vier Spulen weisen einen sehr hohen Schädigungsgrad auf, so dass eine gesicherte Aussage über den Schadensverlauf nicht mehr möglich ist.

Abbildung 1: Spulen Draufsicht

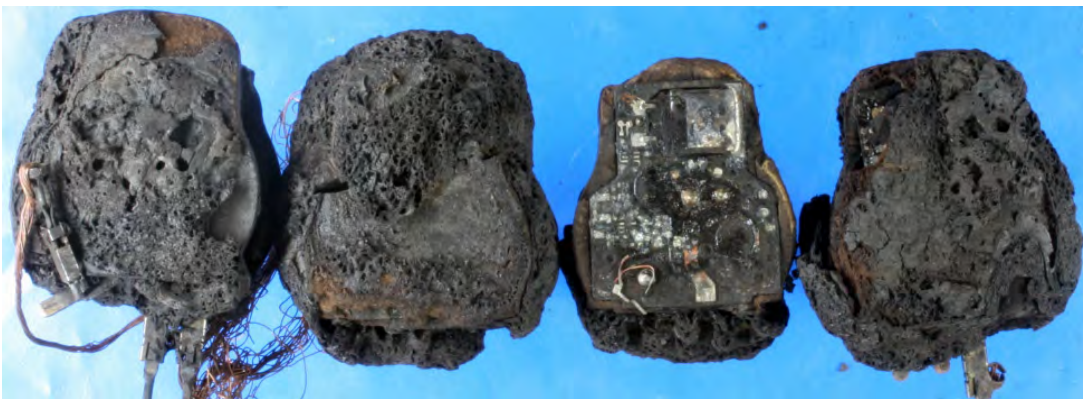
-1 -2 -3 -4
Abbildung 2: Spulenkopf Draufsicht

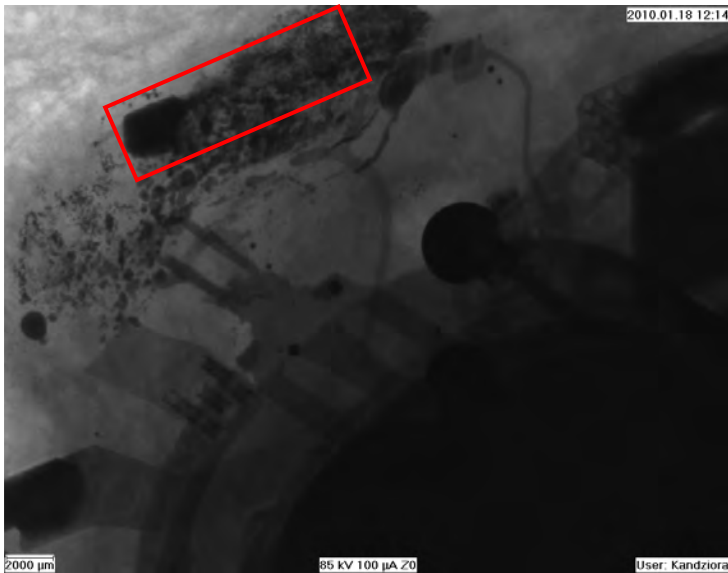
Abbildung 8: Platine-4, Bereich des RC -Gliedes

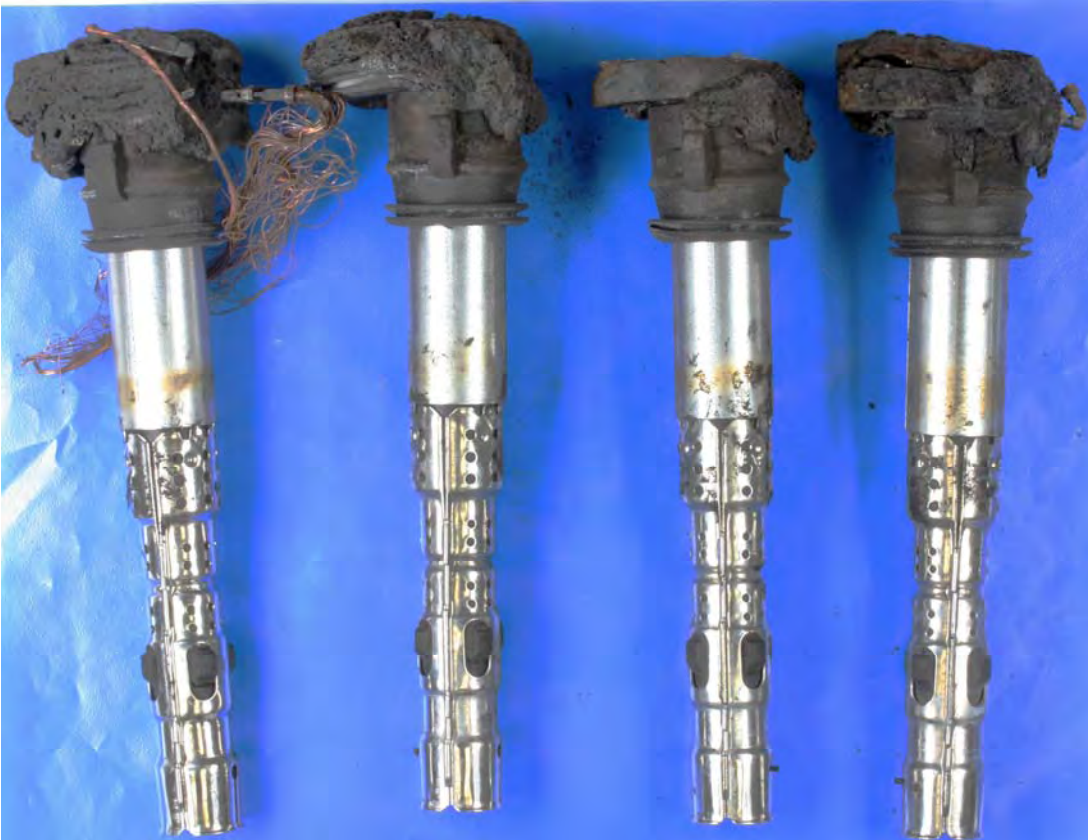
Image 1: coil top view

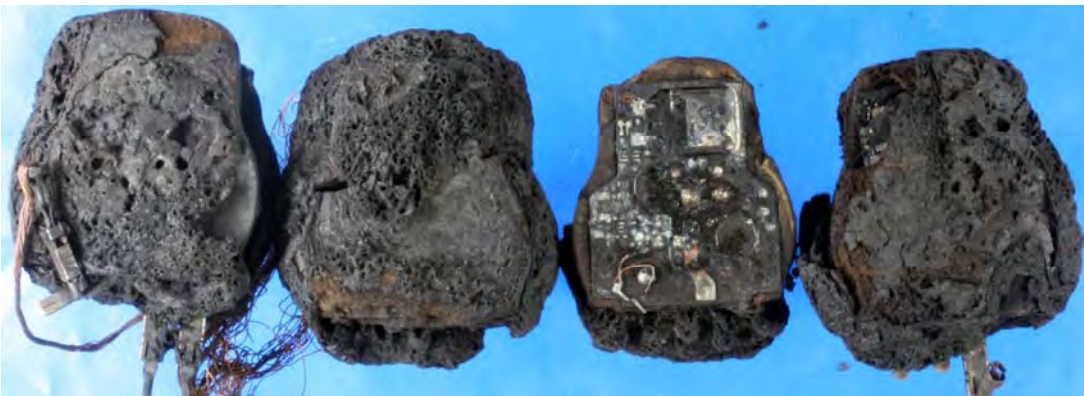
Image 2: coil head top view

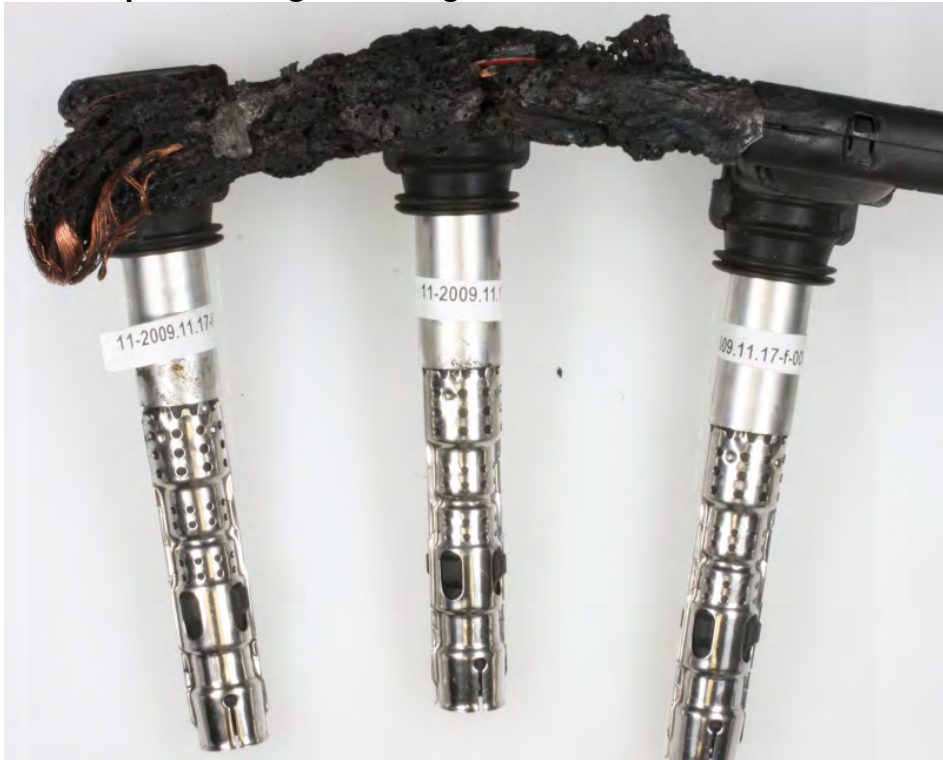
Schadensursächlich ist die Spule 11-2009.11.17-f-010. Ein Defekt am RC-Glied hat zur thermischen Überlastung der stromführenden Kontakte (Pin1) und in der Folge zur Schädigung des Spulenkopfes geführt.

Abbildung 1: Teile Übersicht

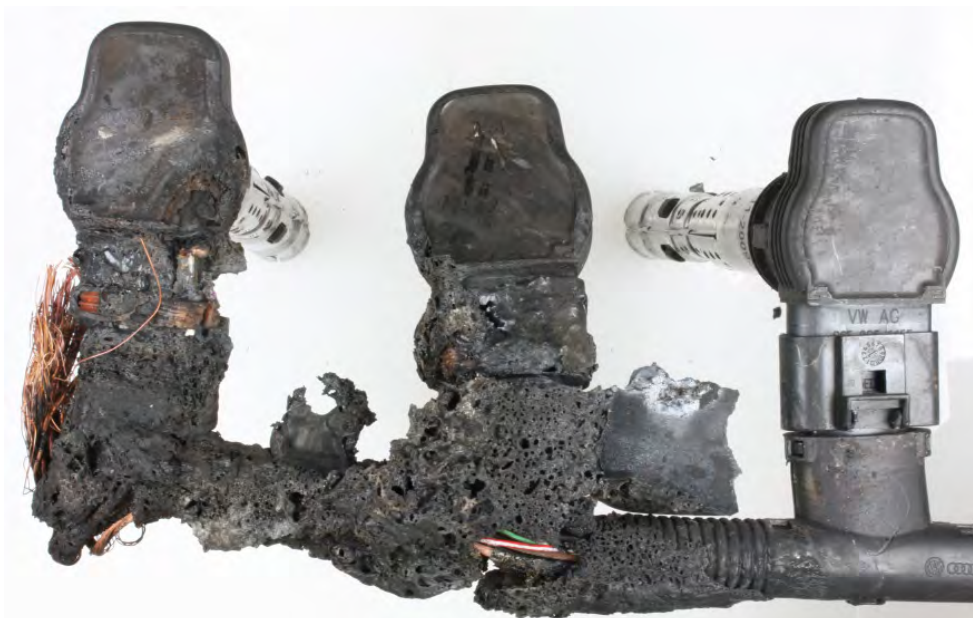
Abbildung 2: Teile Übersicht, Draufsicht

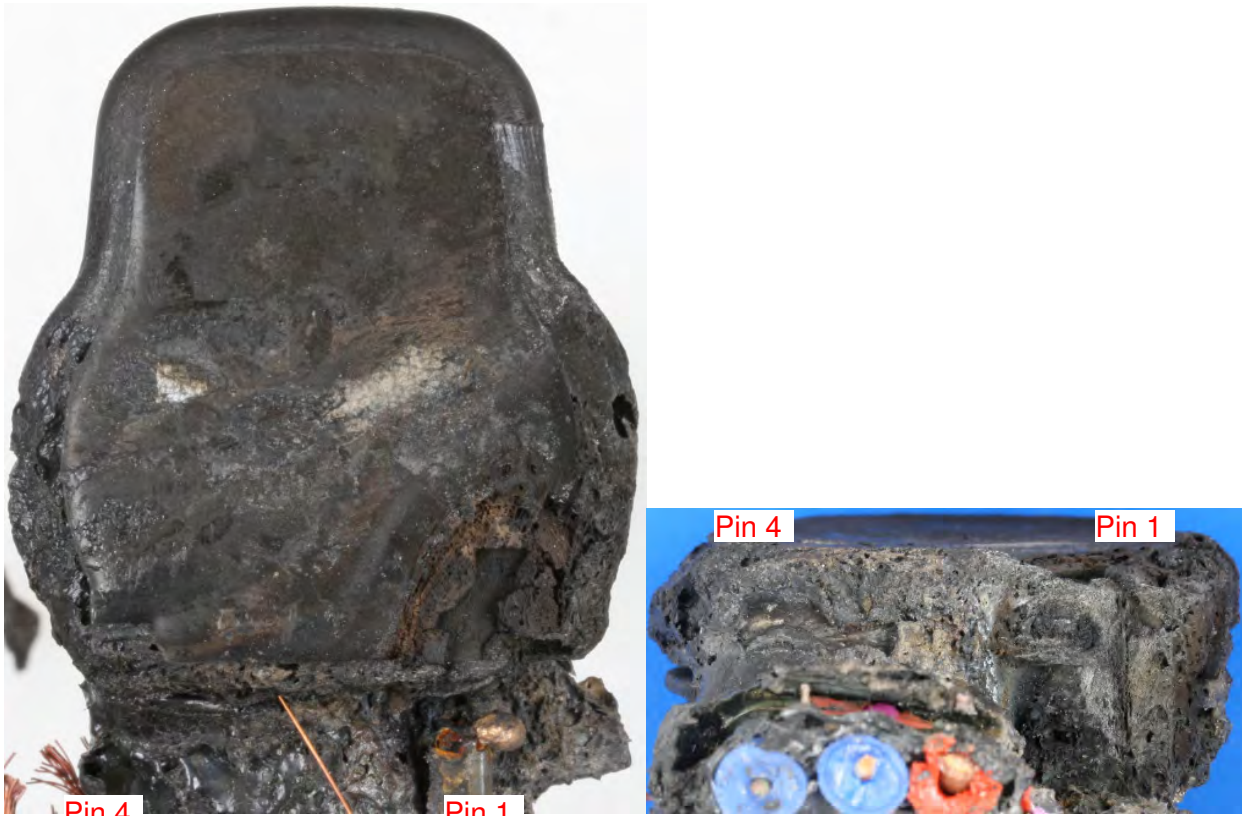
Spulenkopf Draufsicht
Abbildung 3: 11-2009.11.17-f-010

Coil 11-2009.11.17-f-010 was the cause. A fault on the RC link lead to the overheating of the conducting contacts (Pin1) and lead to the damage of the coil head.

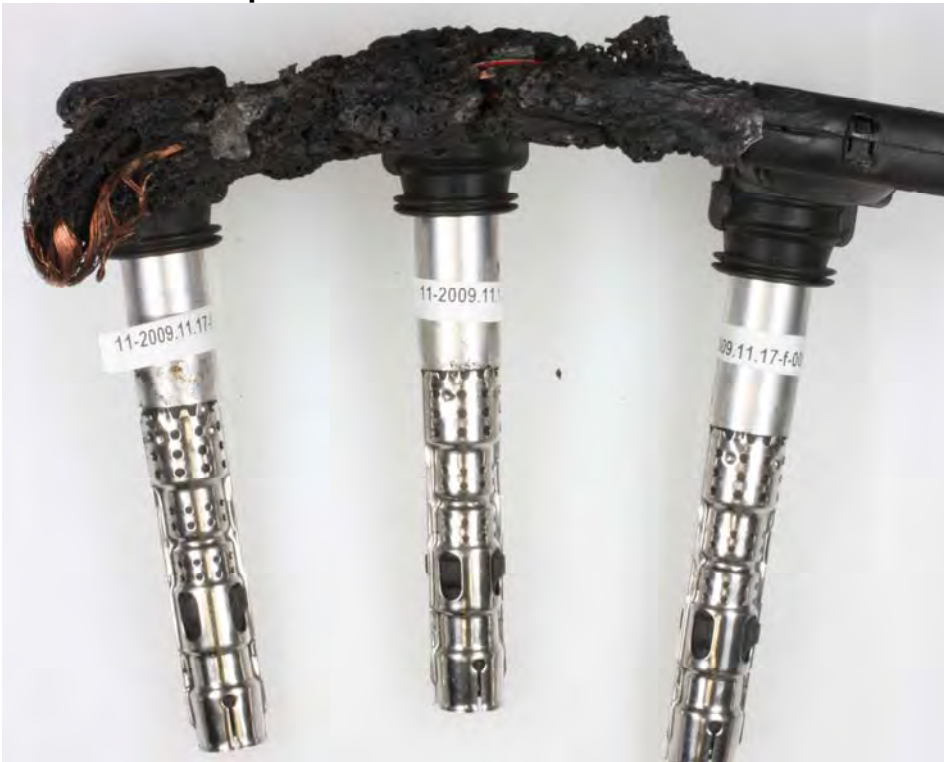
Both the other coils were damaged as well due to the heat created. All three coils are from version Pulse R2. The production date can only be read on coil 11-2009.11.17-f-008: CW47 / 2007

Image 1: parts overview

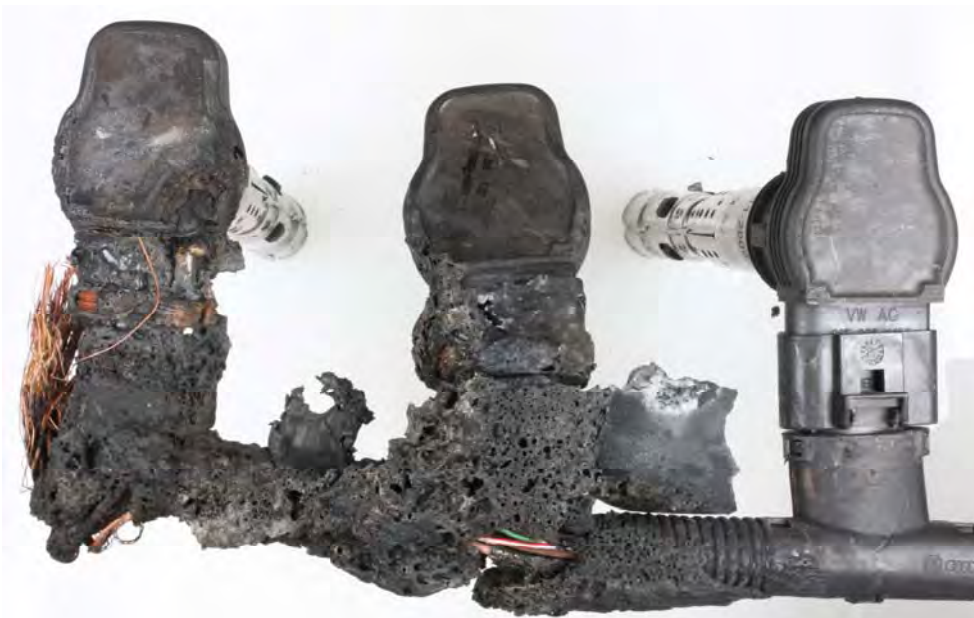
Image 2: parts overview, top view

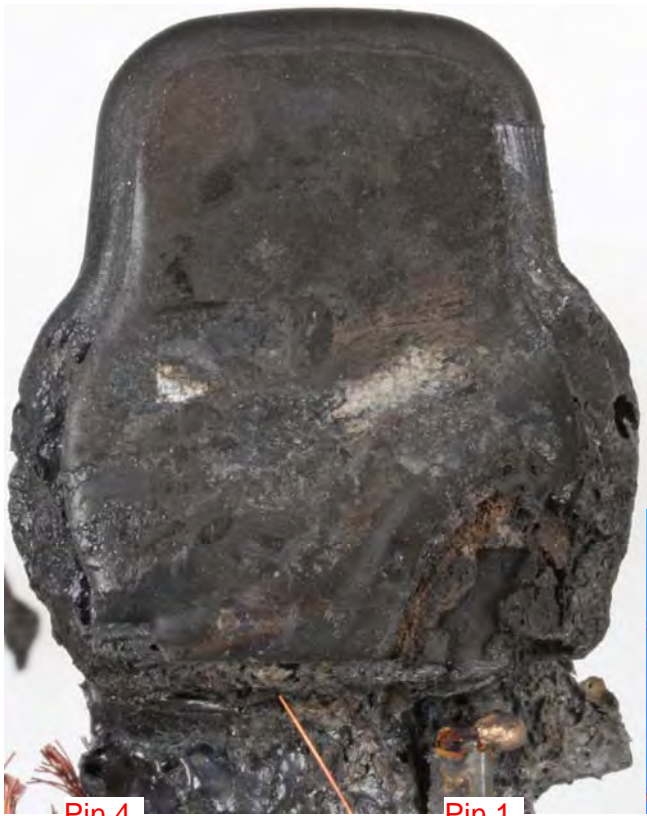
coil head top view
Image 3: 11-2009.11.17-f-010

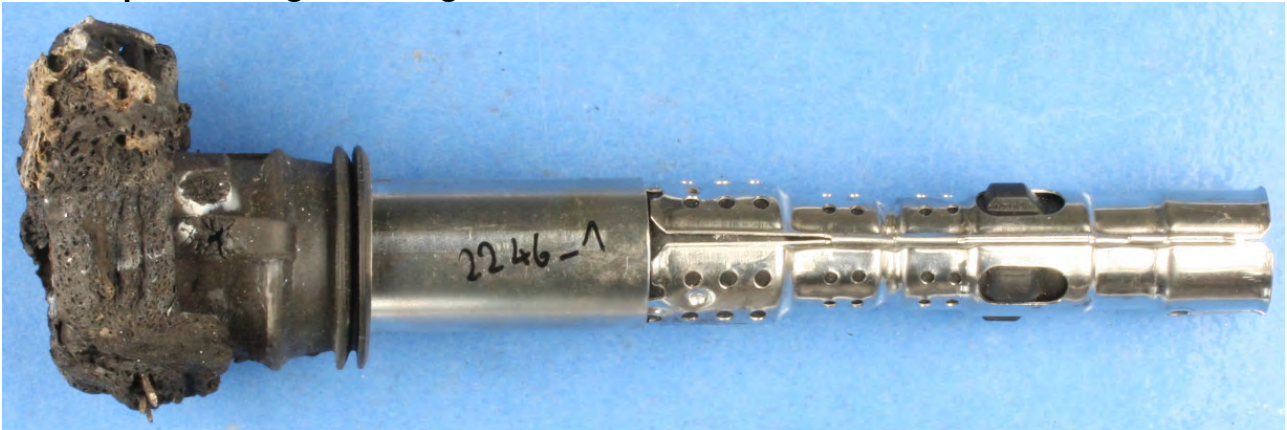
Abbildung 1: 11-z-10-02246_1

Schadensursächlich in dem FZG VIN_01221 war die Spule 11-Z-10-02246_1.

The coil 11-Z-10-02246_1 was the cause of the damage in the vehicle VIN_01221.

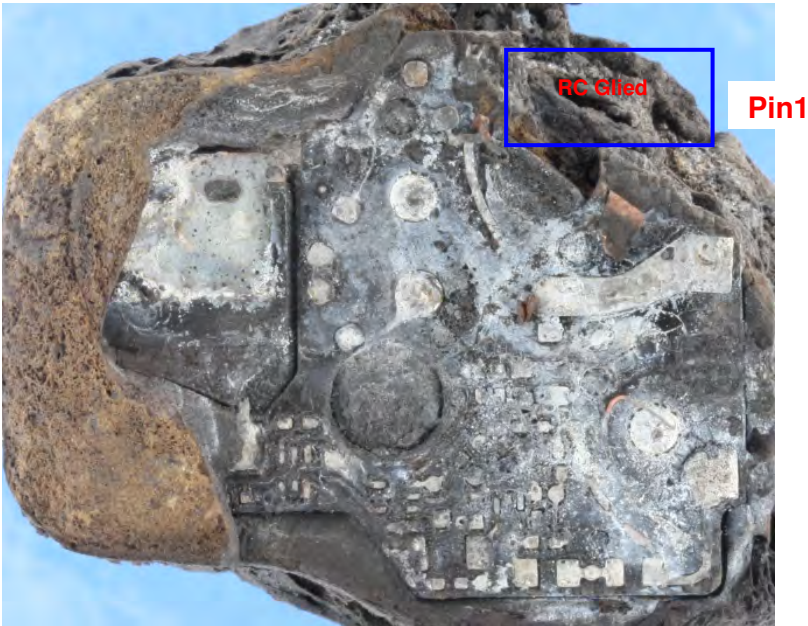
Schadensursächlich in dem FZG VIN_11725 war die Spule 11-Z-10-02246_10.

Abbildung 11: 11-z-10-02246_10, Schädigung des Spulenkopfes im Bereich des RC-Gliedes

The coil 11-Z-10-02246_10 was the cause of the damage in the vehicle VIN_11725.

The ceramic condenser could have been mechanically damaged in the production process, this damage then lead to a low resistance shunt circuit of the supply voltage due to a temperature change occurring during operation.

Image 11: 11-z-10-02246_10, damage to the coil head in the area of the RC link

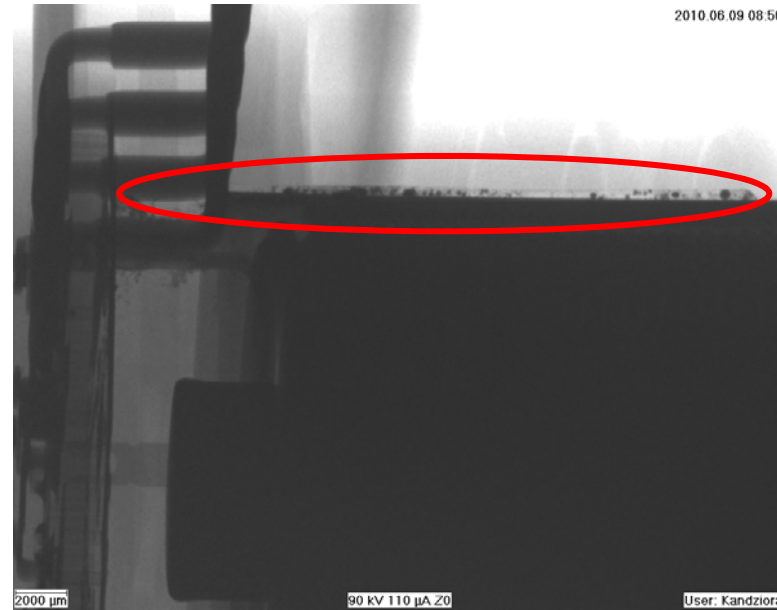
SAB 11-2010.04.15-019: short circuit 14V<-> earth

Solder from terminal 15 melted and leading connection to the return plate built up, the short circuit (14V and earth) occurred as a consequence of this

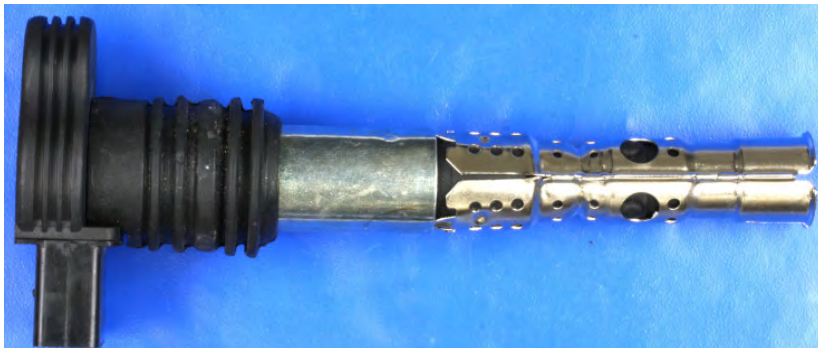
Keine Nest-
Kennzeichnung

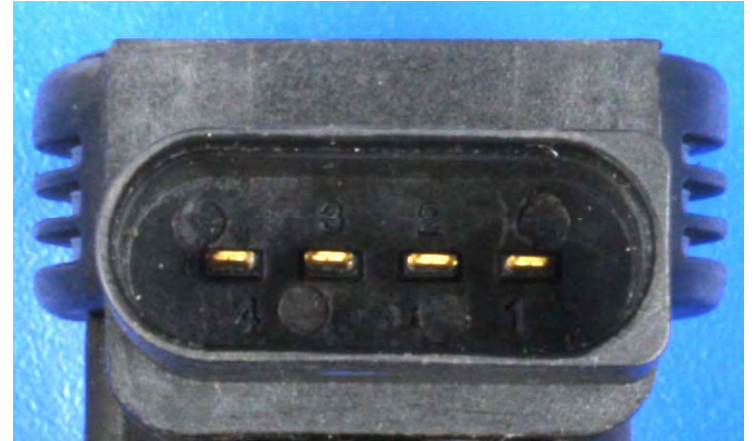
1014_1

No nest
identification

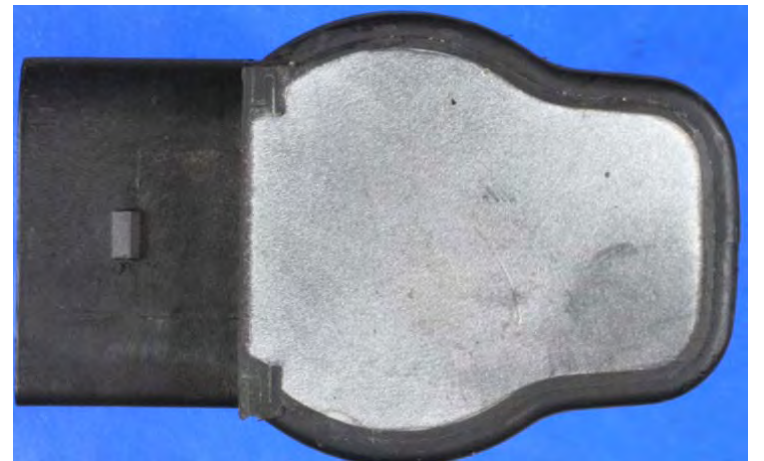
No label

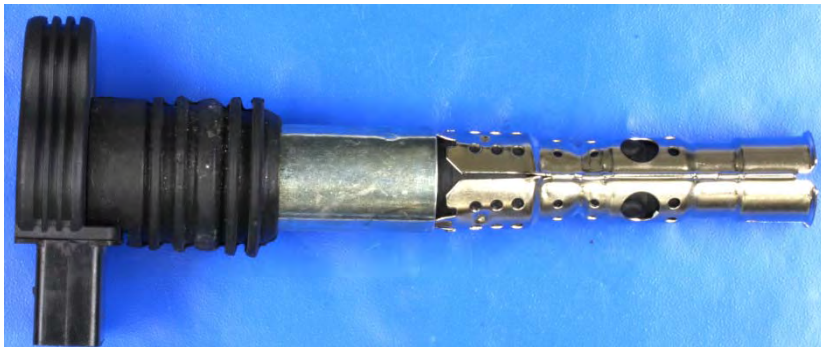
1014_2

No nest
identification

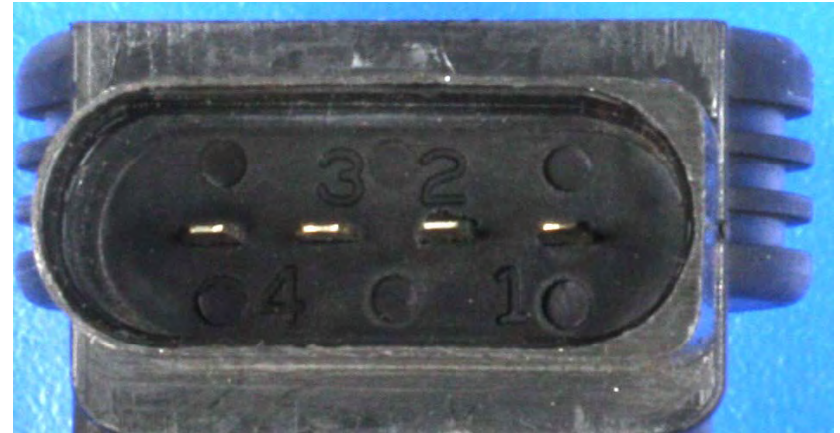
No label

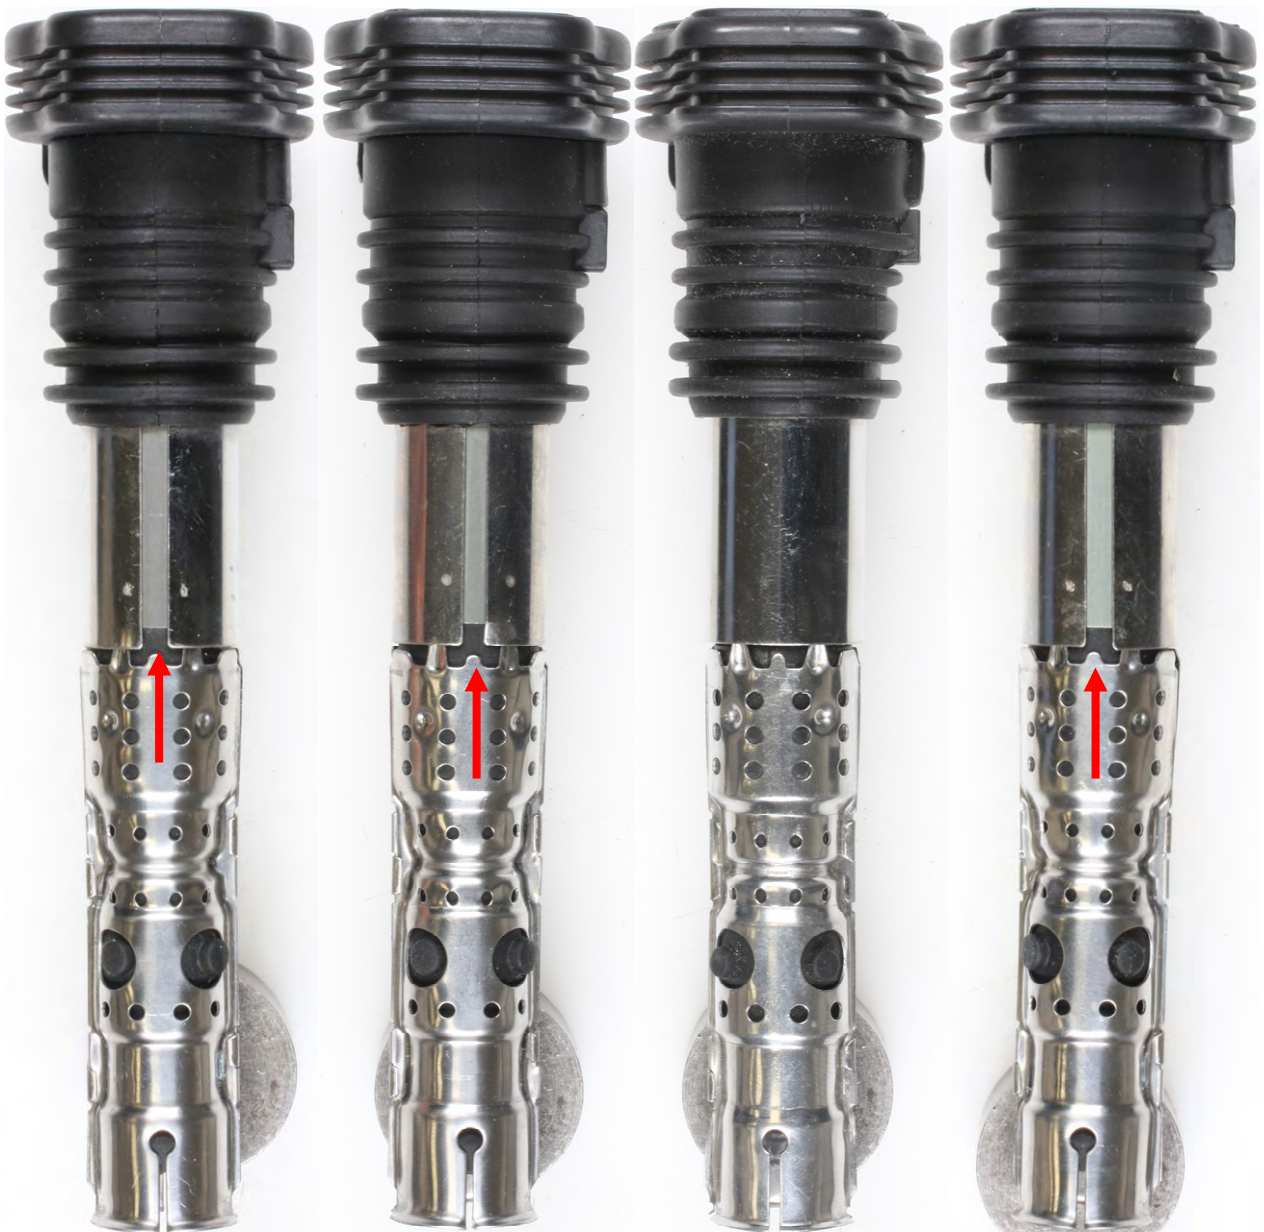
Abbildung 3: Spulenübersicht, Markierung: unterschiedliche Lage des Rückschlußblechs

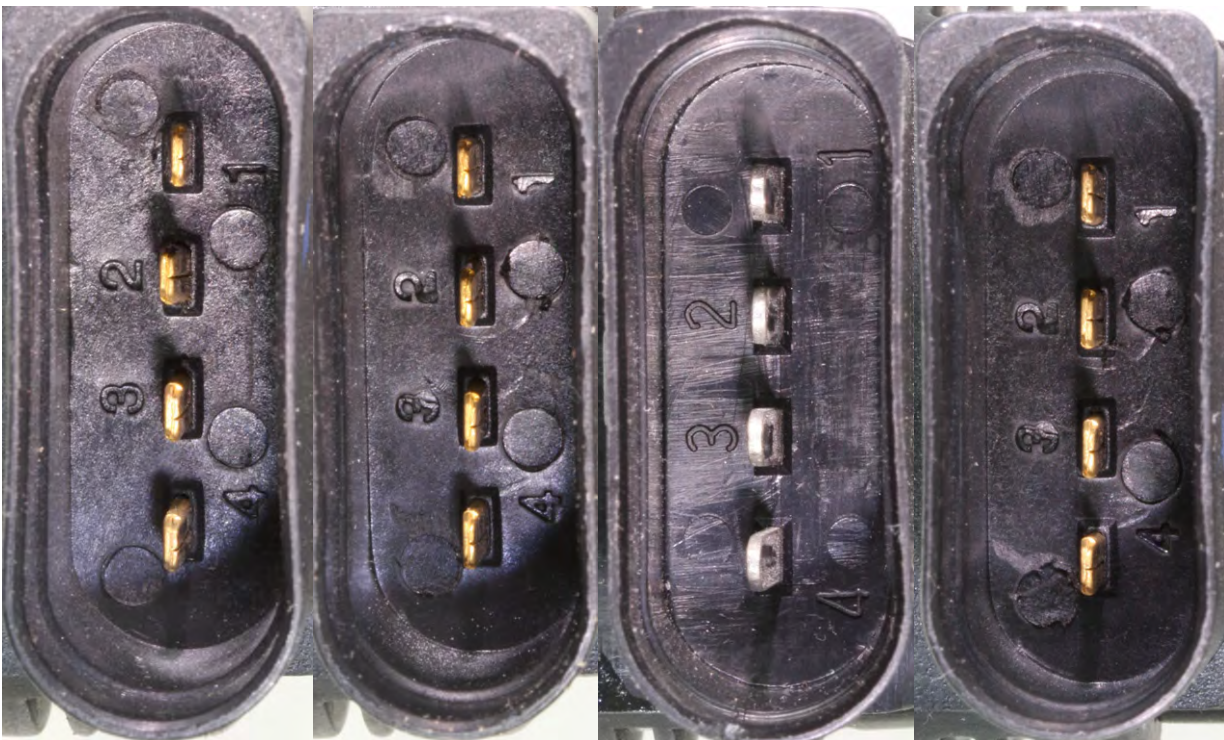
-1
Kontakte aus Messing
Abbildung 5: Stecker

-2
Messing

-3
Verzinkt

-4
Messing

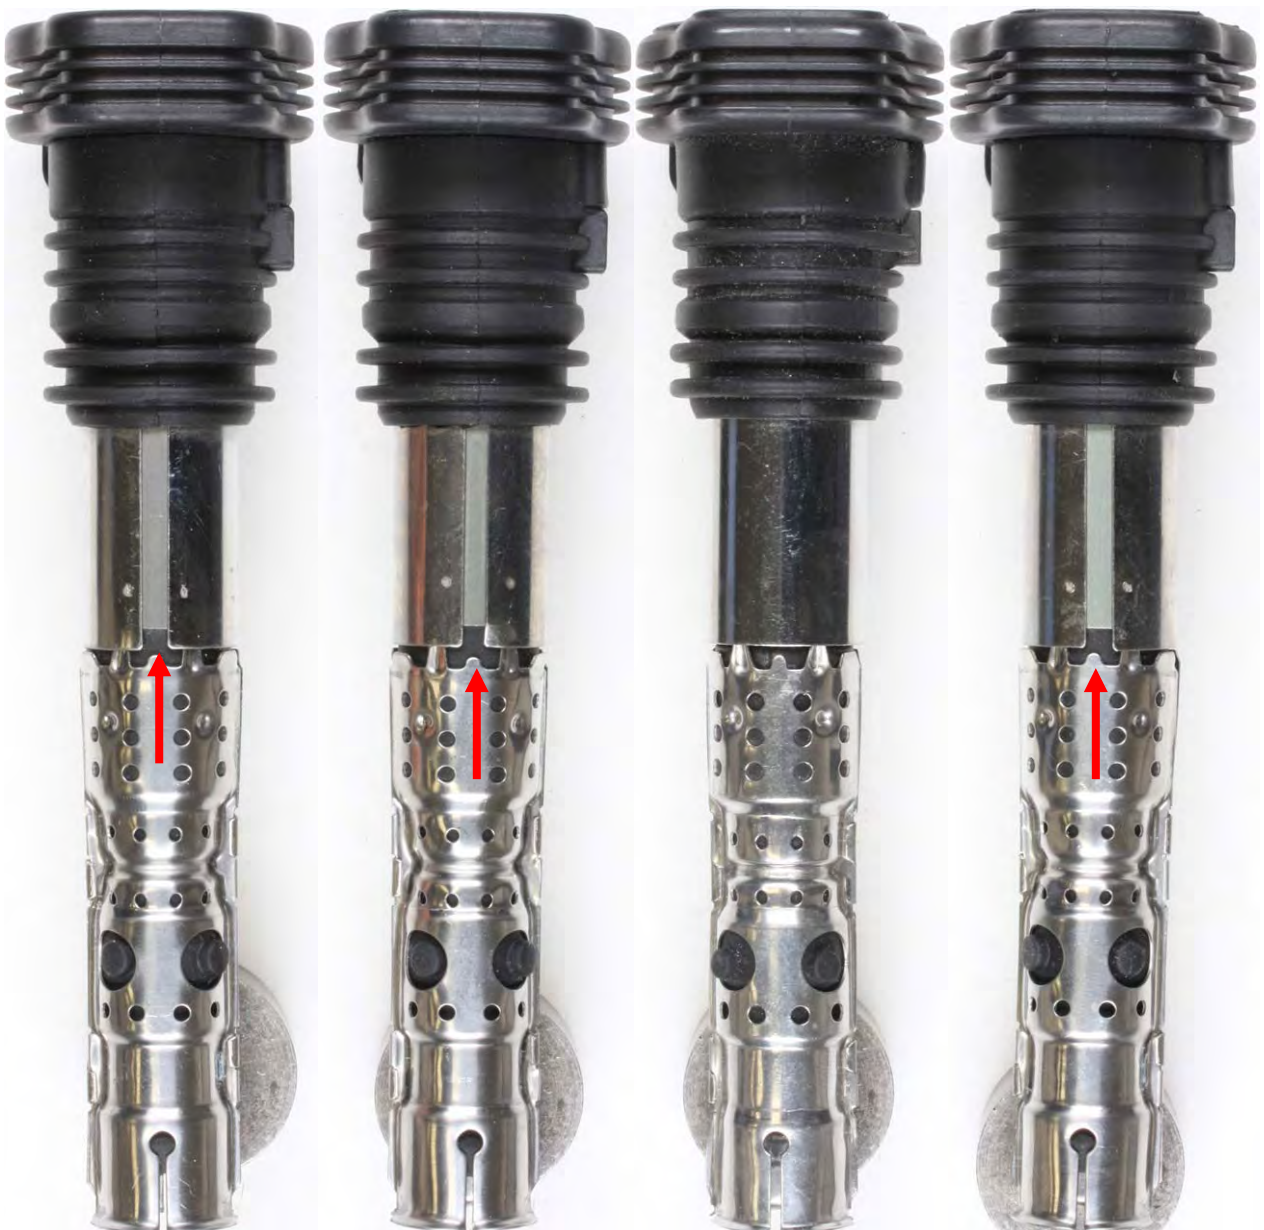
Image 3: coil overview, mark: varying position of the return plate
