CR pump CP4 - Findings report		Report no. 19427																																																															
				Date 11.01.2008																																																															
Department: Non-responsive content removed	Person responsible: Non-responsive content removed	Telephone: Non-responsive content removed	Use <table border="1" style="float: right;"> <tr> <td>internal</td> <td></td> </tr> <tr> <td>external</td> <td style="text-align: center;">x</td> </tr> </table>		internal		external	x																																																											
internal																																																																			
external	x																																																																		
To: Non-responsive content removed																																																																			
Attn. of: Non-responsive content removed

Pump type: CP4.1S_348_2x5.25_REC_3.3_1.95_MT4.2	Customer: VW	Project: R4 2,0 BIN5	Project/ design sample version C / C2

CP4 – Findings on VW R4 2.0 BIN5 / #686-0163

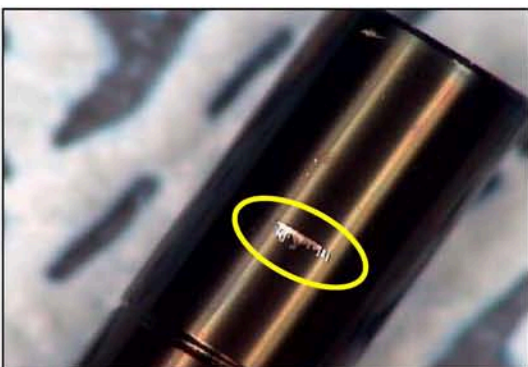
Spalling of C-coating on the case surface of the HP piston (see Fig. 5)

Fig. 5. HP piston, high pressure side

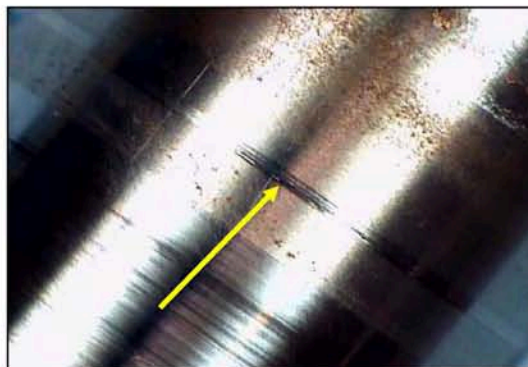
- Delivery rates after endurance test without significant quantity drift compared to new condition.
- Leakage at shaft seal at -25 °C in low-temperature leak test after endurance test, probably due to:
 - several wear marks on the camshaft
 - structured wear marks (steps, "criss-crossing")
 The various wear marks on the camshaft (see also the appendix) can be explained by the two following hypotheses:
 - dismantling and refitting of the flange (leak tightness cannot be guaranteed after refitting)
 - operation with different supply pressures and internal pressures or increased low-pressure pulsations (The operating conditions of this engine test are unknown.)

Fig. 6. Camshaft, running area of shaft seal

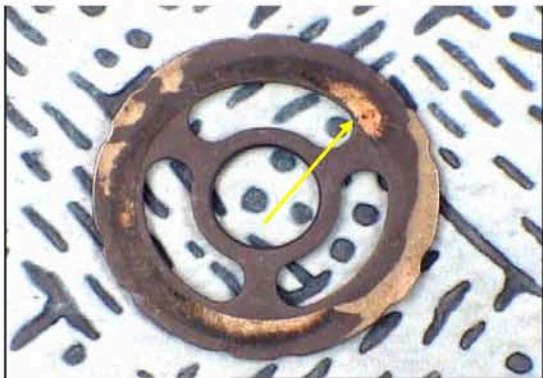
Oxidation marks in the wear region of the spring cup (see Fig. 5) toward the tappet body (see Fig. 6) Oxidation marks in the wear region of the spring cup (see Fig. 7) toward the tappet spring (see Fig. 8) Oxidation marks in the wear region of the tappet spring (see Fig. 9) toward the cylinder head (see Fig. 10) Oxidation marks in the wear region of the intake valve (see Fig. 11) toward the sealing disk (see Fig. 12)

Fig. 7. Spring cup, spring side (oxides)

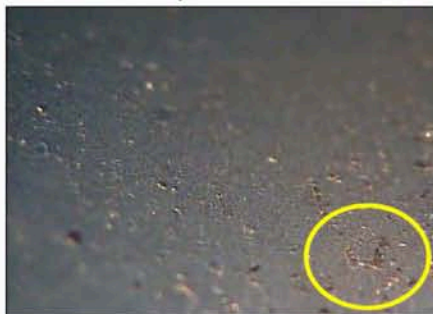
3.4 Bearing - Many wear particles pressed into in the radial bearing surface (Fig. 13) and oxidized (Fig. 14).			<table border="1"> <tr> <td><input type="checkbox"/></td> <td><input checked="" type="checkbox"/></td> <td><input type="checkbox"/></td> </tr> </table>		<input type="checkbox"/>	<input checked="" type="checkbox"/>	<input type="checkbox"/>									
<input type="checkbox"/>	<input checked="" type="checkbox"/>	<input type="checkbox"/>

Fig. 14. Detail from Fig. 9, oxidized particles on the surface

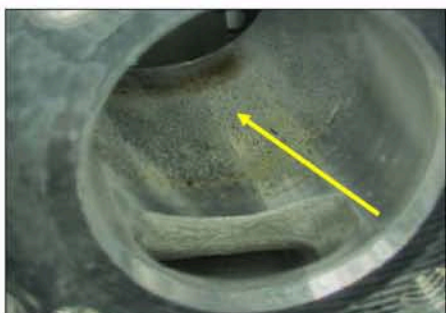
3.6 Boreholes - Tappet borehole with scoring by wear particles (Fig. 17) which are oxidized on the surface (Fig. 18). - Wear particles in the metering unit borehole (Fig. 19)			<table border="1"> <tr> <td><input type="checkbox"/></td> <td><input checked="" type="checkbox"/></td> <td><input type="checkbox"/></td> </tr> </table>		<input type="checkbox"/>	<input checked="" type="checkbox"/>	<input type="checkbox"/>									
<input type="checkbox"/>	<input checked="" type="checkbox"/>	<input type="checkbox"/>

Fig. 17. Tappet borehole

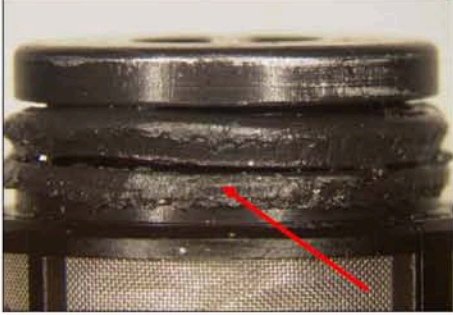
3.7 Built-on components (metering unit, overflow valve, counting point) Metering unit O-ring twisted and sheared off (Fig. 20).			<table border="1"> <tr> <td><input type="checkbox"/></td> <td><input type="checkbox"/></td> <td><input checked="" type="checkbox"/></td> </tr> </table>		<input type="checkbox"/>	<input type="checkbox"/>	<input checked="" type="checkbox"/>									
<input type="checkbox"/>	<input type="checkbox"/>	<input checked="" type="checkbox"/>

<p>Fig. 19. Housing, metering unit borehole</p>			<p>Fig. 20. Metering unit, O-ring toward cylinder head</p>		
<p>5. Parts distribution</p> <p>The pump will be stored at RB until 06/2008 and then scrapped.</p>					
<p>6. Appendix</p> <p>None</p>					
<p>Non-responsive content removed</p>

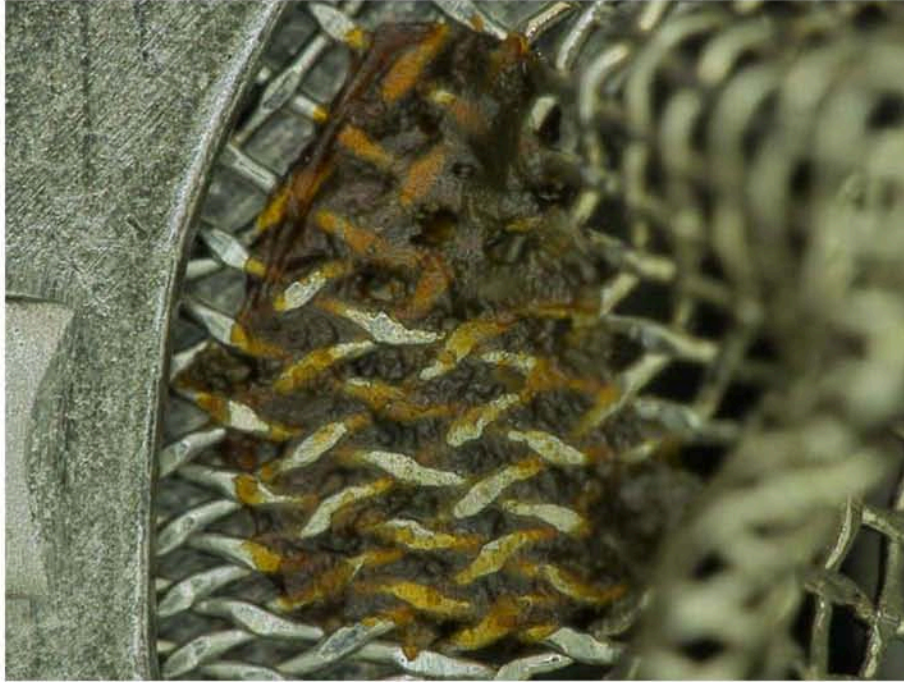
Fig. 5

Covering at the edge (100-fold magnification)

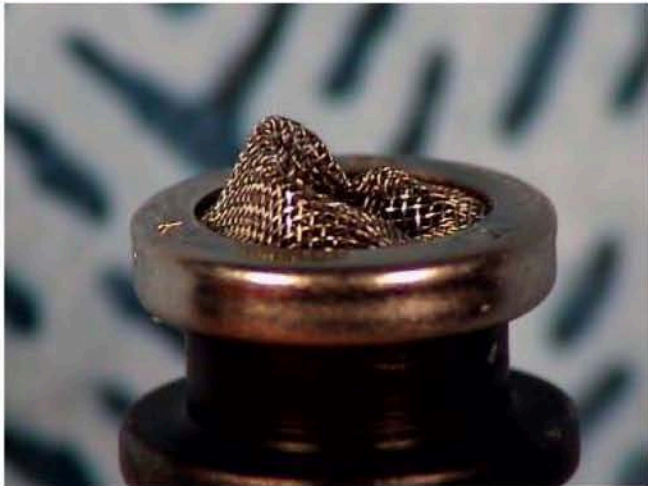
- Part 30 – Loading over the complete area:
Beginning of deformation: $p_1=11.5 \text{ bar_rel}$ (at 9.5 bar_rel still OK)

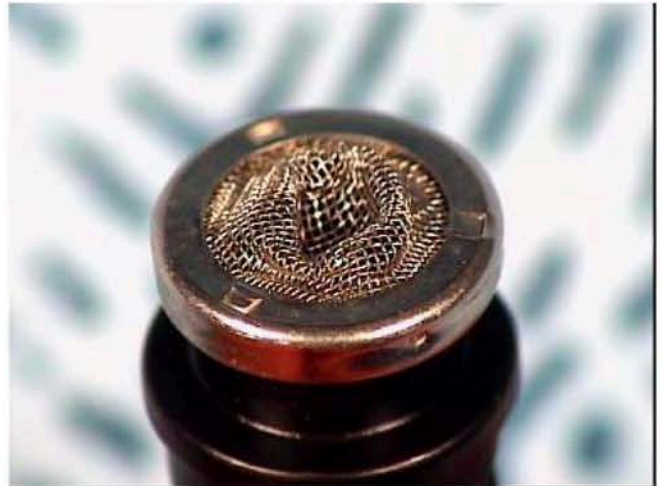
- Part 31 – Loading over the complete area:
Beginning of deformation: $p_1=11.5 \text{ bar_rel}$ (at 10.5 bar_rel still OK)

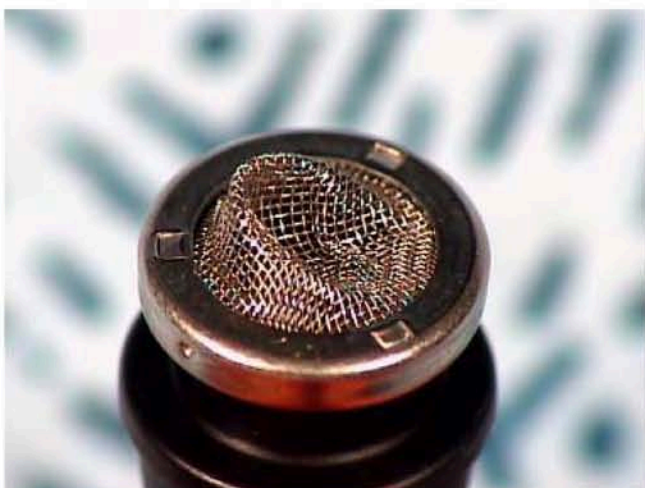
- Part 34 – Loading over the complete area:
Beginning of deformation: $p_1=10.5 \text{ bar_rel}$ (at 7.5 bar_rel still OK)
