Rattling pump – 03L 130 755 – 2.0l 4V longitudinal CR TDI

Subject: Regarding brand acceptance run: Breakdowns Q verification run 2.0l TDI BIN5 in Audi A3 - AU 353 08050

CP4 Diesel high-pressure fuel pump in CR injection systems from 1800 bar (EU5)

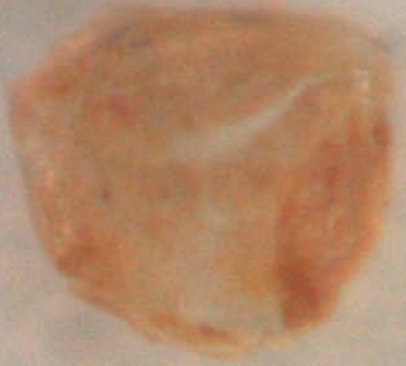
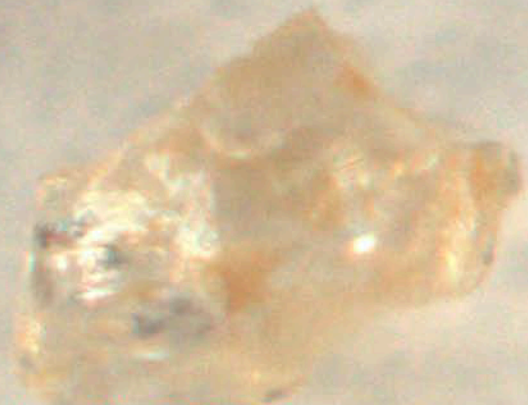
Particles from the intake valve seat

Length: 270.15 μ m

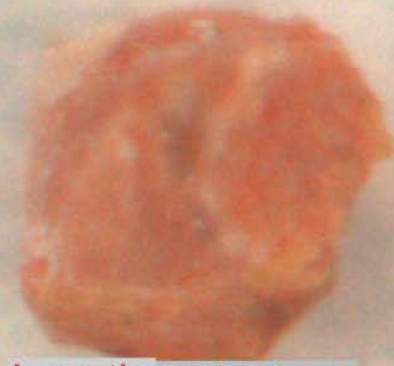
Length: 200.98 μ m

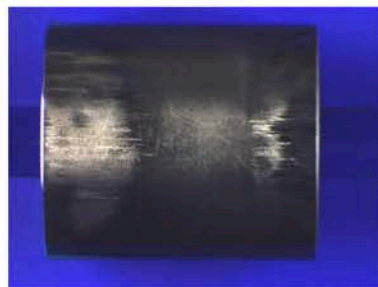
_0579 (150 h)

Considerable aluminum oxide build-up (black) as an indication of high temperatures
