<b>CR pump CP4 - Diagnosis report</b>		Report no.	[REDACTED]										
				Date	12/3/2007										
Department:	Person responsible:	Telephone:	Use	internal											
Non-responsive content removed				external	x										
To:	Non-responsive content removed														
For information:	[REDACTED]														
<b>Pump type:</b> CP4.1S_348_2x5,25_REC_3,3_1,95_MT4,2		<b>Customer:</b> VW	<b>Project:</b> R4 2.0 BIN5	<b>Project / design pattern type</b> C / C2											
<b>Part number (TTNo.):</b> 0445B21060_10		<b>Date of manufacture:</b> 690	<b>Serial number:</b> 4422	<b>Manufacturing plant - line</b> 011M FeP(Feuerbach plant) – M -											
<b>SAP-No.:</b> DS – 154947		<b>Samos no.:</b> 568938	<b>Customer order no.:</b>	<b>Engine/Vehicle number</b> 03LD/17486											
<b>Customer part number</b>		<b>Endurance run type [customer]:</b> Engine trial	<b>Endurance run conditions:</b> Oil dilution + LP full load	<b>DSBFD no.:</b> 18589

<b>Mileage</b> 995 h		<b>Parts receipt at dept. DS-PC/EDI:</b> 12/03/2007	<b>Process no.</b> 2007-CP4 / 0043	<b>Confidentiality note</b> Confidential											
<b>1 Subject</b> CP4 customer return Oil dilution program + LP full load															
<b

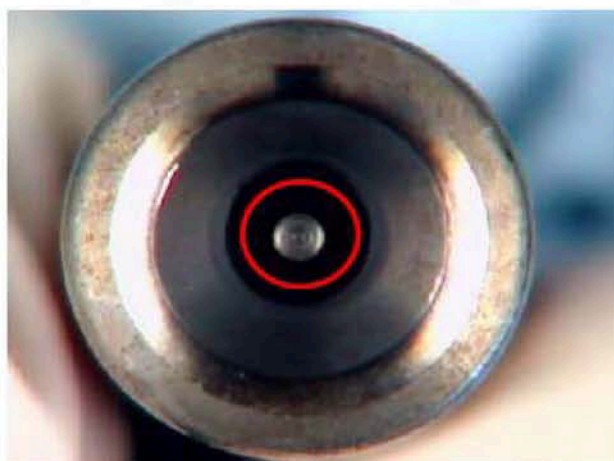
Fig. 1: roller crest

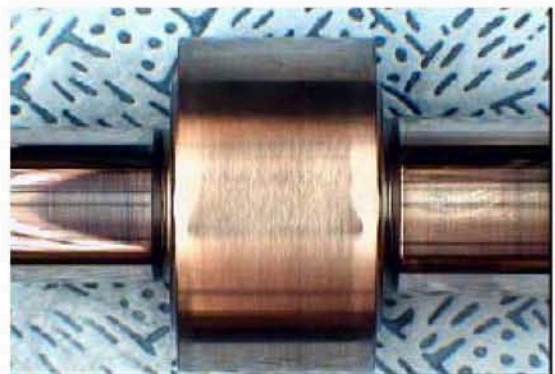
<b>Mileage</b> 100000 km / -miles	<b>Parts receipt at dept. DS-PC/EDI:</b> 11/13/2007	<b>Process no.</b> 2007-CP4_0115	<b>Confidentiality note</b> Confidential												
<b>1. Subject</b>															
CP4 customer returns without complaint Diagnosis after end of endurance run															
<b>2. Conclusion</b>															
No hydraulic modification. No critical wear detected.  The pump has <b>passed</b> the test.															
<b>3. Results of diagnosis (visual findings)</b>															
			Legend rating stages	OK uncritical Critical	<table border="1"> <tr><td>X</td><td></td><td></td></tr> <tr><td></td><td>X</td><td></td></tr> <tr><td></td><td></td><td>X</td></tr> </table>	X				X				X	
X															
	X														
		X													
<b>3.1 Drive</b> No striking feature					<table border="1"> <tr><td>X</td><td></td><td></td></tr> </table>	X									
X															
<b>3.2 Drivetrain</b> Only running marks visible (see roller Fig. 1 and camshaft Fig. 2)					<table border="1"> <tr><td>X</td><td></td><td></td></tr> </table>	X

Fig. 2: Camshaft

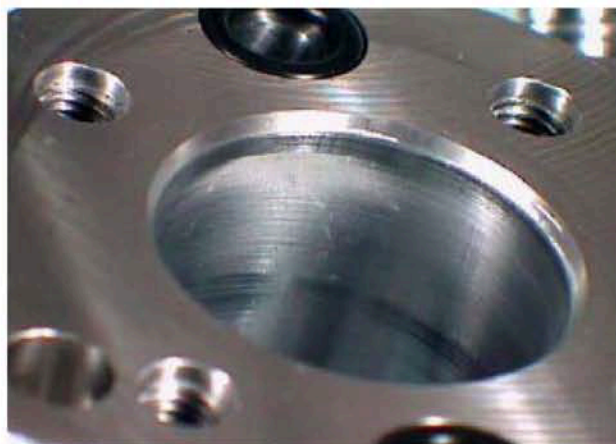
Fig. 3 Housing of tappet hole

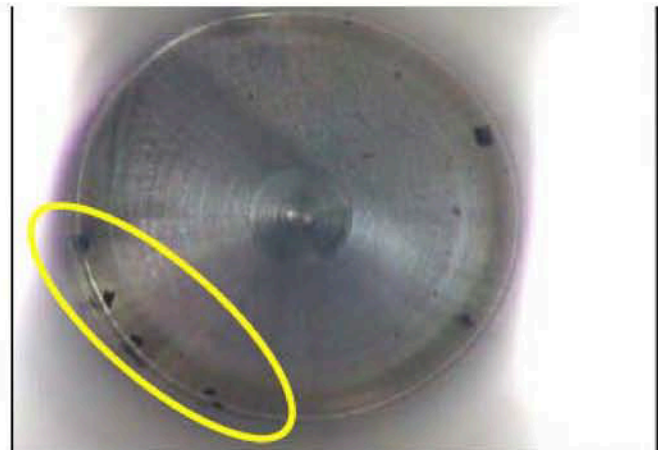
<b>CR pump CP4 - Diagnosis report</b>		Report no. <span style="background-color: black; color: black;">[REDACTED]</span>
				Date <b>2/28/2008</b>		
<b>Department:</b> Non-responsive content removed	<b>Person responsible:</b> Non-responsive content removed	<b>Telephone:</b> Non-responsive content removed		<b>Use</b> internal <input type="checkbox"/> external <input checked="" type="checkbox"/>		
<b>To:</b> Non-responsive content removed						
<b>For information:</b> Non-responsive content removed						
<b>3.4 Bearing</b> No striking feature				<input checked="" type="checkbox"/>		
<b>3.5 Shaft seal</b> Slight recession of the shaft seal into the camshaft				<input checked="" type="checkbox"/>		
<b>3.6 Holes</b> Cavitation erosion in the tappet hole outside the moving range of the tappet (see Fig. 6); foreign particles in the metering unit hole (see Fig. 7) and in the overflow valve hole (see Fig. 8)				<input checked="" type="checkbox"/>

Fig. 8 Housing, overflow valve

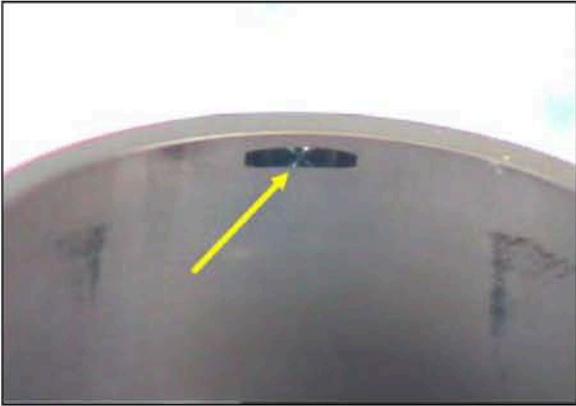
**Fig. 1** Tappet body inside, housing side

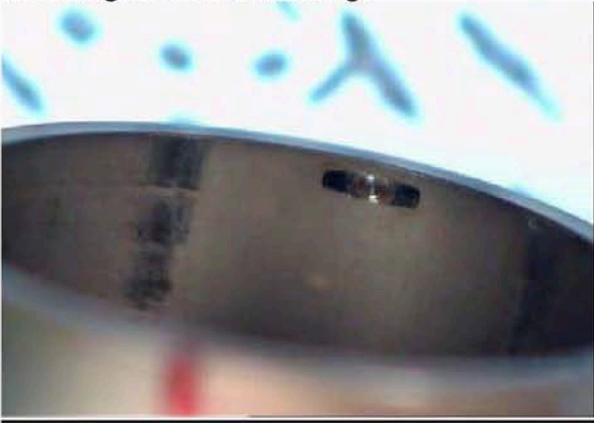
<b>Fig. 1 Tappet body inside, housing side</b>				<b>Fig. 2 Roller front surface, housing side</b>			
<b>4. Hydraulic function</b>							
	n[rpm]	p_rail [bar]	I_MU [A]	Delivery rate [l/h] of new part 12/7/2006	Delivery rate [l/h] after testing 12/20/2007	<input checked="" type="checkbox"/>	
Starting point	200	200	0.4	3.9	3.7	<input checked="" type="checkbox"/>

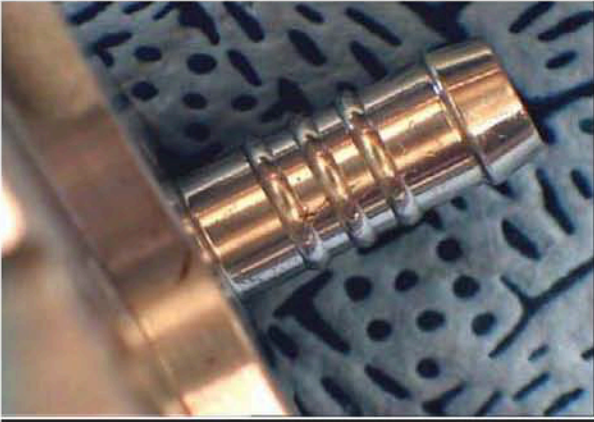
**Fig. 1 Feed connection**

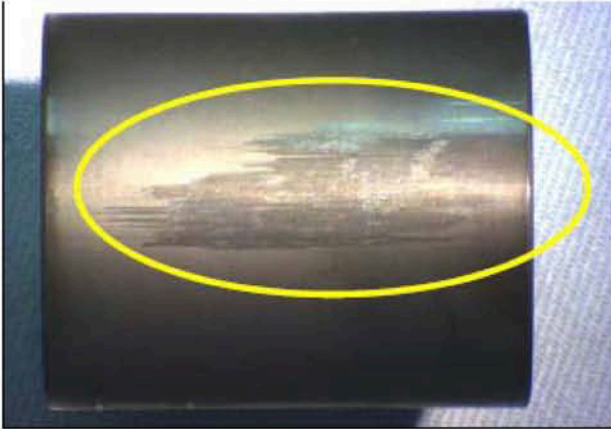
**Fig. 1 Tappet body, lateral surface**

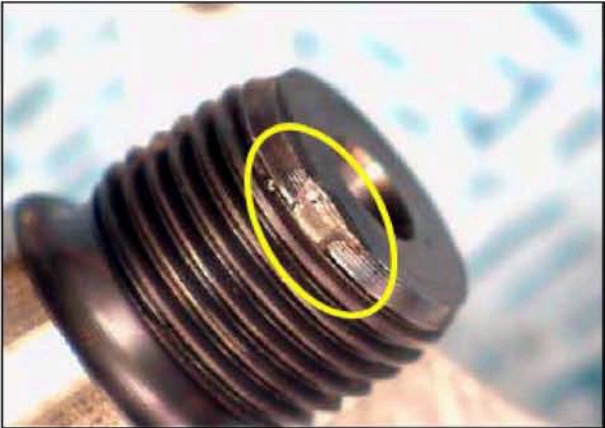
<b>3. Results of diagnosis (visual findings)</b>			Legend rating stages { <div>           OK            uncritical            Critical         </div>		<table border="1"> <tr><td>x</td><td></td><td></td></tr> <tr><td></td><td>x</td><td></td></tr> <tr><td></td><td></td><td>x</td></tr> </table>		x				x				x
x															
	x														
		x													
<b>3.1 Drive</b> Camshaft damaged on the first thread pitch (fault and breakage of the flank, see Figs. 1 and 2)					<table border="1"> <tr><td></td><td>x</td><td></td></tr> </table>			x							
	x														
<b>3.2 Drivetrain</b> No striking feature					<table border="1"> <tr><td>x</td><td></td><td></td></tr> </table>		x								
x

<b>Fig. 1 Camshaft, thread</b>			<b>Fig. 2 Camshaft, front surface</b>

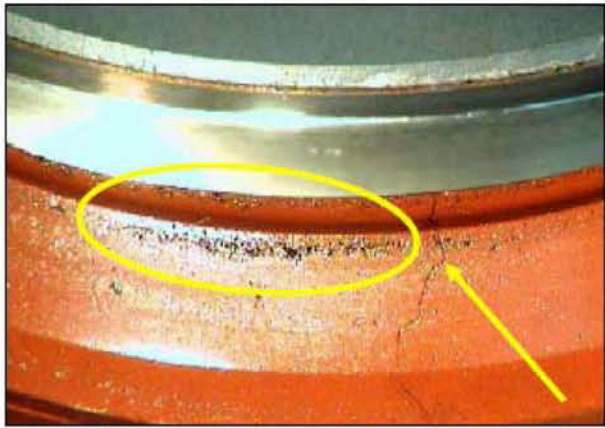
<b>Fig. 1 Flange, shaft seal sealing lip</b>			<b>Fig. 4: Camshaft, shaft seal running range</b>

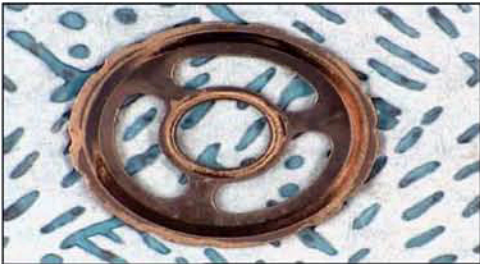
<b>3.3 High pressure</b>		fretting wear at the sealing surface of the intake valve / stationary seal ring (Fig. 2)

Fig. 1: Spring plate			Fig. 2: Intake valve

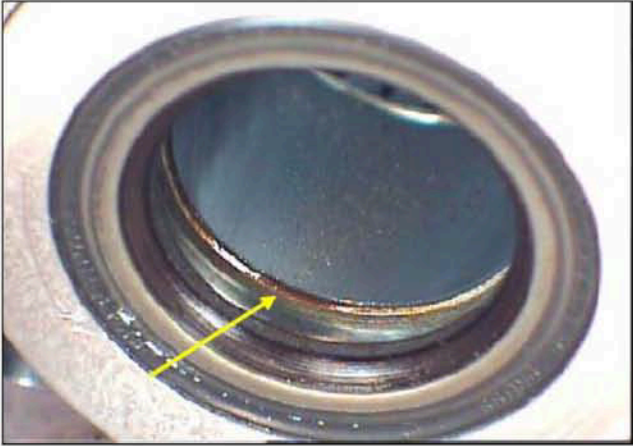
<b>Fig. 15 Flange, the edge of the bearing bush (deposits)</b>					
<b>4. Hydraulic function</b>					
				Delivery rate [l/h] of new part	Delivery rate [l/h] after testing
	n[rpm]	p_rail [bar]	I_MU [A]		
No functional testing due to the complaint.					
<b>5. Destiny of the parts</b>

The deposit is mainly composed of defined soaps and small amounts of carbonyl compounds (possibly fuel aging products). The observed metal particles were probably entrained by the damage process.

The tin particles found in the deposit may have originated from the detachment of the residue from the bushing (galvanization of the wide band).

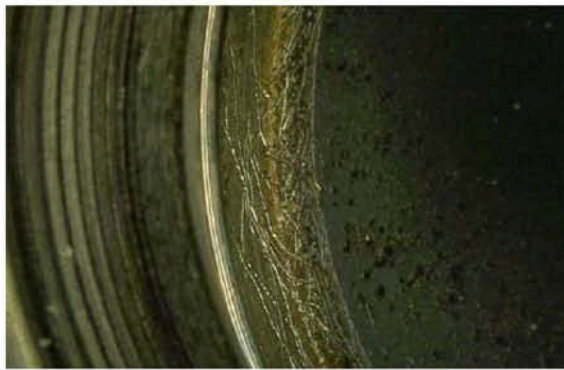
Besides containing various metal particles, the residue is an organic residue (fuel conversion?) with fine iron particles. These very fine iron particles which rapidly oxidize (rust) would be responsible for the (reddish-brown) color.

2.008-1206  
CR\_ARA\_M\_08\_1759  
Overview of flange bearing bushing with detached residues

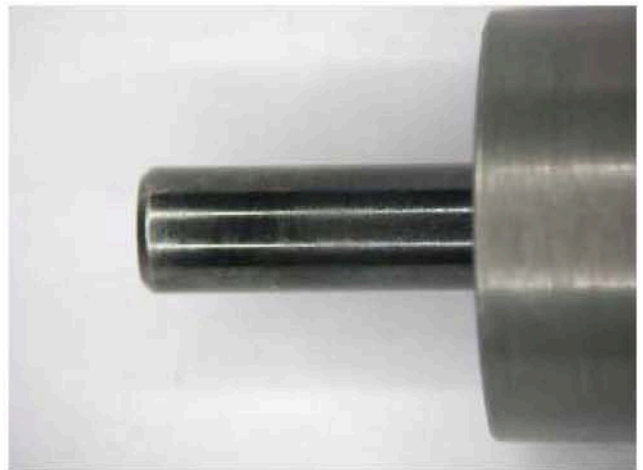
Tappet housing

- Wear of the components is low and without significant striking features.

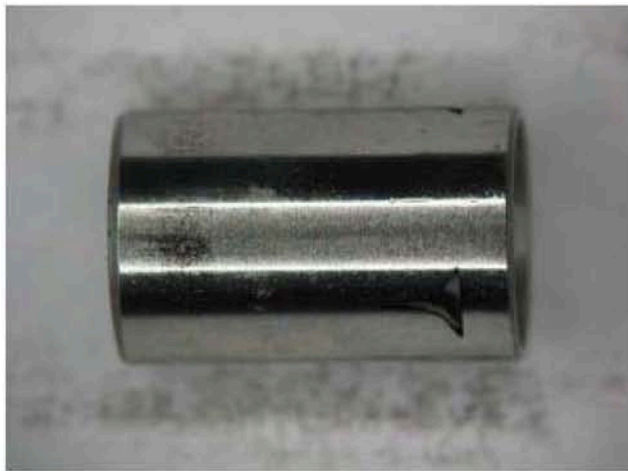
Piston

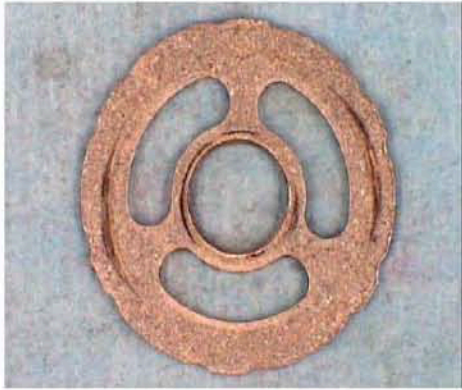
Fig. 1 Sprina plate, tappet side

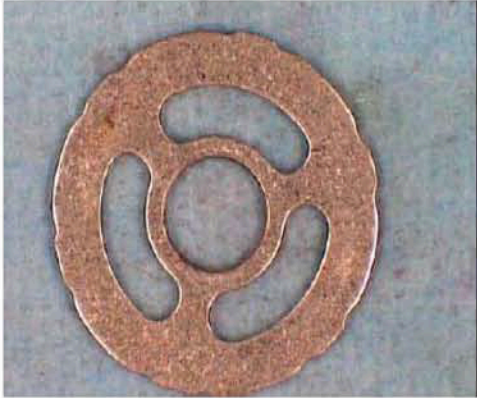
Fig. 1 Sprina plate, sprina side

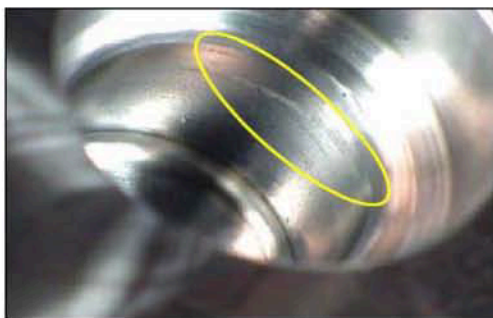
- At the metering unit and metering unit hole, marks of an oblique assembly can be recognized. The risk of O-ring damage is confirmed by complaints in the 0-km range and is being pursued using 8D.
- The cavitation erosion in the tappet hole outside the tappet guide is an indication of excessively low pump interior pressure.
- Wear of the remaining components is low and without significant striking features.

**Fig. 1 Housing, metering unit hole (scrape marks)**

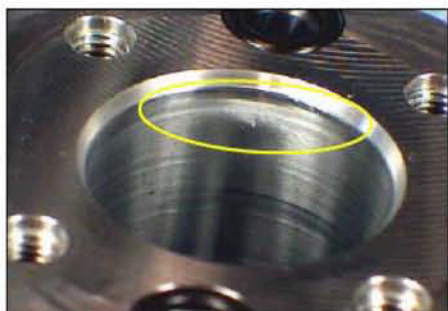
**Fig. 3 Housing, tappet hole (cavitation)****4. Hydraulic function**

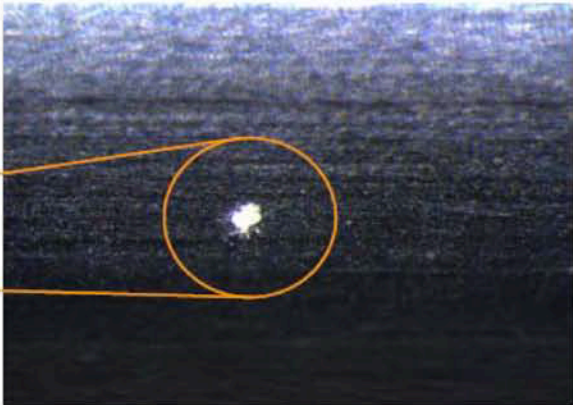
- Camshaft, cam track Abrasive wear in the center of the cam track along the entire circumference of the cam due to the turned tappet (see Appendix 1, Figure 11 to 14)
- Tappet assembly:
  - Roller support, running surface of the roller: C coating is locally entrained (see Appendix 1, Fig. 16)
  - Roller support, HP piston contact surface: Particle indentations (see Appendix 1, Fig. 15)
  - Tappet body / roller support: Tappet body has rotated relative to the roller support (see Appendix 1, Figures 19 and 20).

<p>Image 2: Roller support to the right C coating</p> </div> </div>

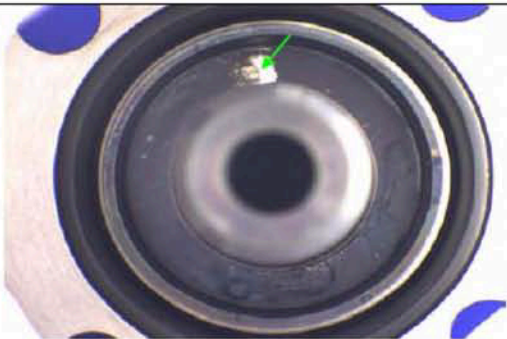
<p>Fig. 2: Cylinder head to the right, tappet spring suspension system</p>

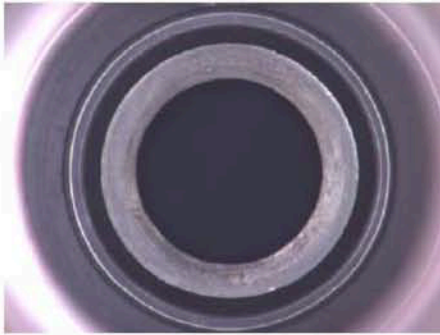
Figure 3 cylinder head to the right, SV system

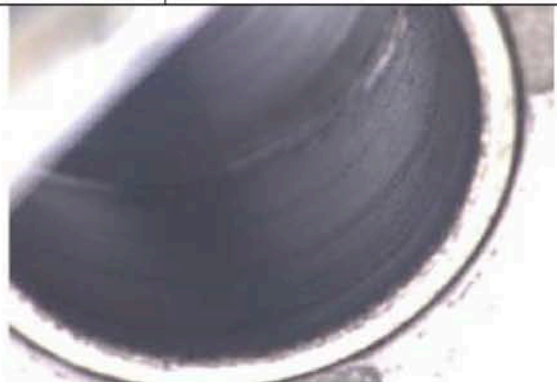
**Fig. 6: Housing mount bushing, radial**

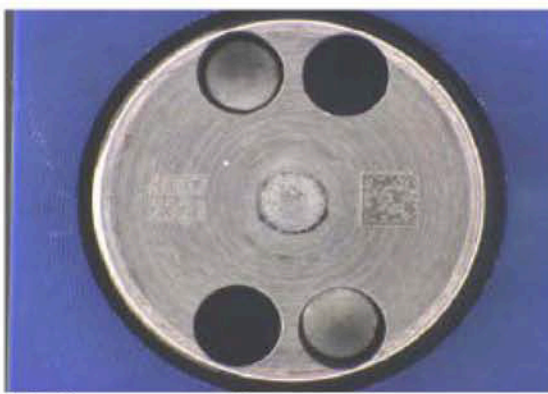
**Fig. 11: Roller support, piston system**

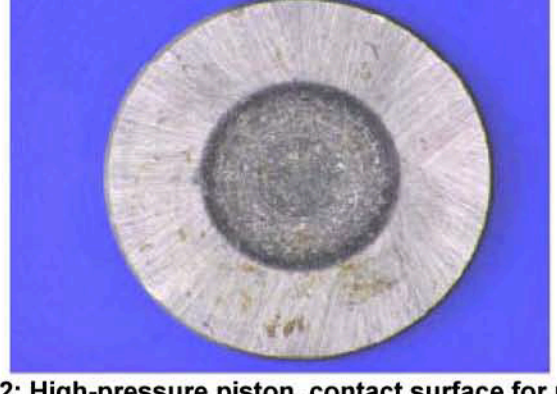
**Fig. 12: High-pressure piston, contact surface for roller support**

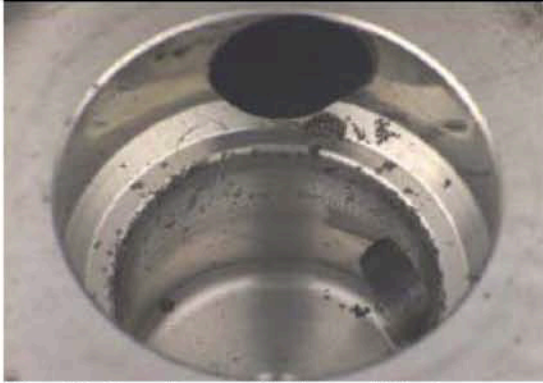
<b>3.6 Holes</b> As a result of drivetrain damage, particle marks and particles are in the metering hole.			<input type="checkbox"/> <input checked="" type="checkbox"/> <input type="checkbox"/>			
<b>3.7 Attached components (metering unit, overflow valve, counting point)</b> As a result of drivetrain damage, there are particles on the MU (metering unit).			<input checked="" type="checkbox"/> <input type="checkbox"/> <input type="checkbox"/>			
<b>3.8 O-rings</b> No striking feature			<input checked="" type="checkbox"/> <input type="checkbox"/> <input type="checkbox"/>			
<b>3.9 Other</b> No striking feature			<input checked="" type="checkbox"/> <input type="checkbox"/> <input type="checkbox"/>			
<b>3.10 Images</b>

<b>Fig. 13: Metering unit, screen</b>			<b>Fig. 14: Housing, metering unit hole</b>		
<b>4. Hydraulic function</b> The pumps were already opened by the customer. Therefore, hydraulic back measurement no longer possible.					
<b>5. Destiny of the parts</b> The pump parts remain with Robert Bosch GmbH at the request of the customer					
<b>6. Appendix</b> None					
Tested:	Non-responsive content removed	Telephone:	Non-responsive content removed	Date:	2/23/2011
Signature:	[REDACTED]	Signature:	[REDACTED]	Date:	2/23/2011
Department	[REDACTED]	Telephone:	[REDACTED]	Date:	3/2/2011

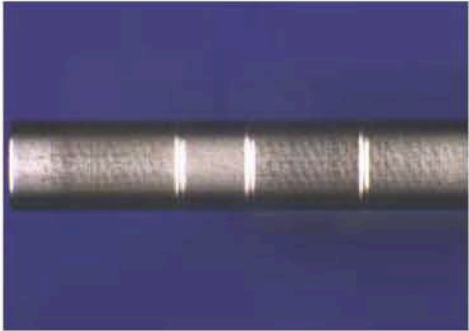
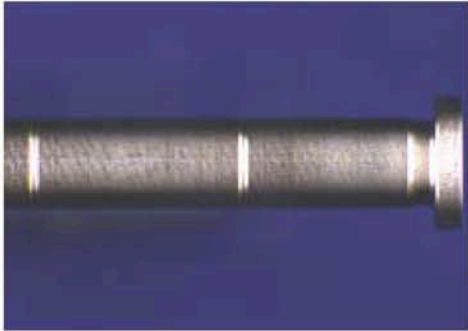
<b>CR pump CP4 - Diagnosis report</b>		Report no. <span style="background-color: black; color: black;">[REDACTED]</span>				
				Date 2/23/2011				
Department: Non-responsive content removed	Person responsible: Non-responsive content removed	Telephone: Non-responsive content removed	Use	<table border="1"> <tr> <td>internal</td> <td></td> </tr> <tr> <td>external</td> <td>x</td> </tr> </table>	internal		external	x
internal								
external	x							
			<b>Confidentiality note</b> Confidential					
<b>3.3 High pressure</b> The high-pressure piston shows waviness and discoloration that can occur during grinding under certain circumstances. (Rating 4), see Figures 1 and 2				<table border="1"> <tr> <td></td> <td>x</td> <td></td> </tr> </table>		x		
	x							
<b>3.4 Bearing</b> No striking feature				<table border="1"> <tr> <td>x</td> <td></td> <td></td> </tr> </table>	x			
x

<b>Fig. 1: High-pressure piston, high-pressure side (rating 4)</b>		<b>Fig. 2: High-pressure piston, low-pressure side (rating 4)</b>						
<b>Fig. 3: Roller support, running surface (rating 5)</b>		<b>Fig. 4: Roller, running surface (rating 5)</b>
