CR pump CP4 - Diagnosis report		Report no.	19420
				Date	12/4/2007
Department:	Person responsible:	Telephone:	Use	internal	
Non-responsive content removed			external		x
Pump type:	Customer:	Project:	Project/ design sample version		
CP4.1XX_298_2x5,25_REC_3,3_1,95_MT4,2	VW	R4 2.0 EU5	D / C2		
Item number (Part no.) :	Date of manufacture:	Serial number:	Plant - line		
0445B21058	010207	0045	0110 FeP - 1		
SAP-No.:	Samos no.:	Customer order no.:	Engine/Vehicle number		
DS-164763	578256		AU 481-8-8008		
Customer part number	ER type [customer]:	Endurance run conditions:	DSBFD no.:		
	Q endurance run		19420		
Mileage:	Received by DS-PC/EDI on:	Process no.	Confidentiality note		
80000 km	10/22/2007	2007 - CP4 / 0006	Confidential		
Complaint:	None. Endurance run end.

CP4 customer return
Q-ER; CAG 0000 067; AU 481-8-8008

Subject: Teleconference 9/18/2008, Production measures to reduce drivetrain damage

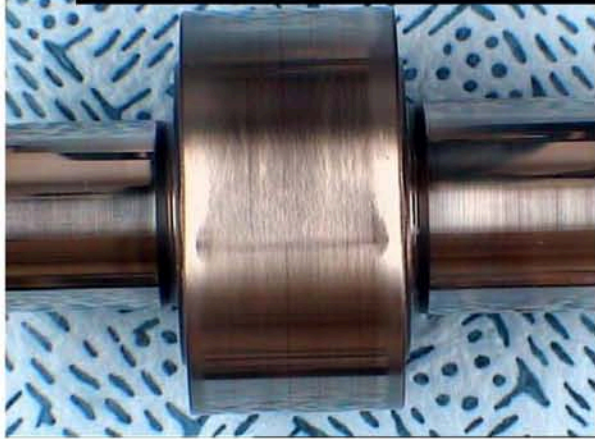
Only very slight wear visible (Fig. 1 and 2)

Fig. 1 010207-0045_cam track_running surface

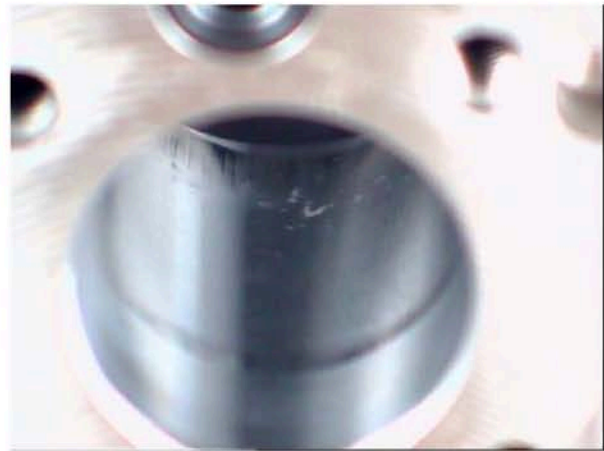
Only very minor cavitation erosion in the tappet bore (Fig. 4)

Fig. 4 010207-0045_housing tappet bore

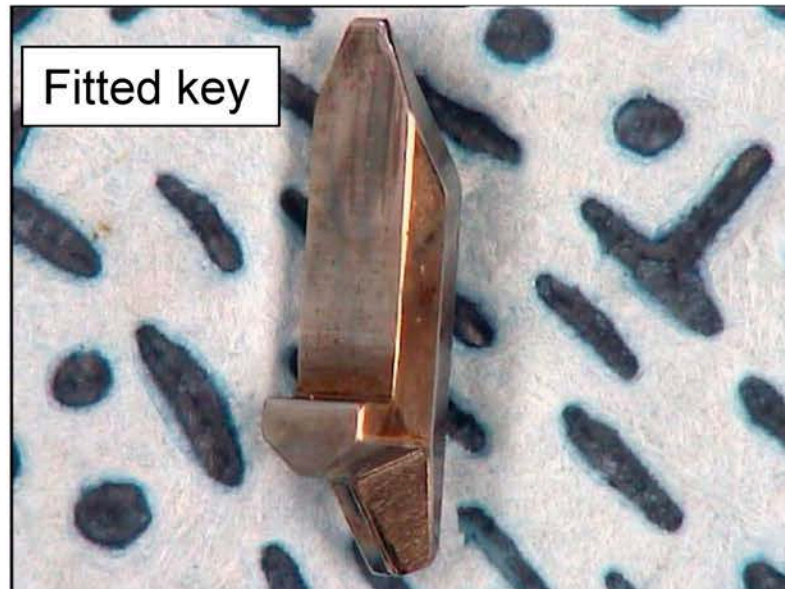
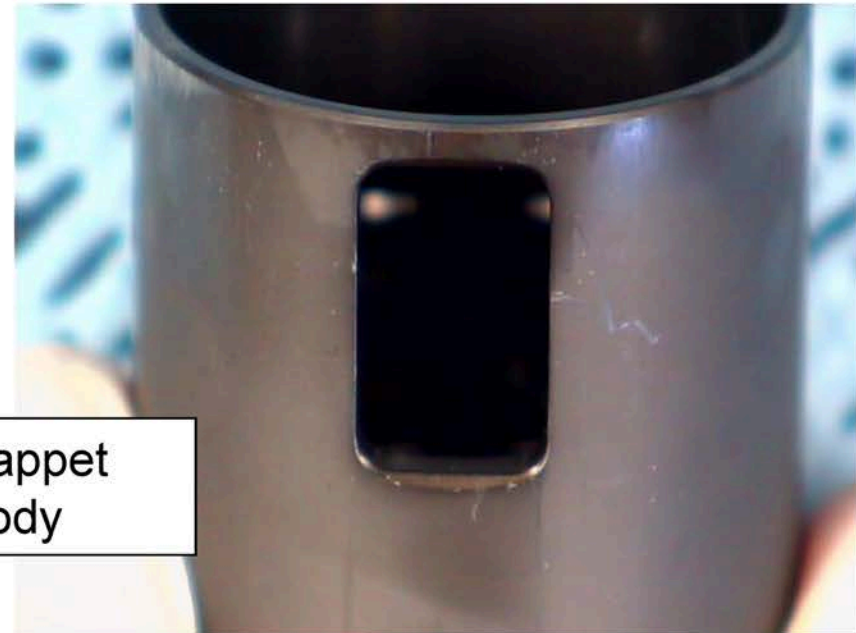
CP4, Tappet anti-turning lock, Status 3/2008

- First 2 pumps after approx. 500h ER indicate a good result.
- Parts from near-series production process show tappet breakages (deformation, internal stresses in tappet body)

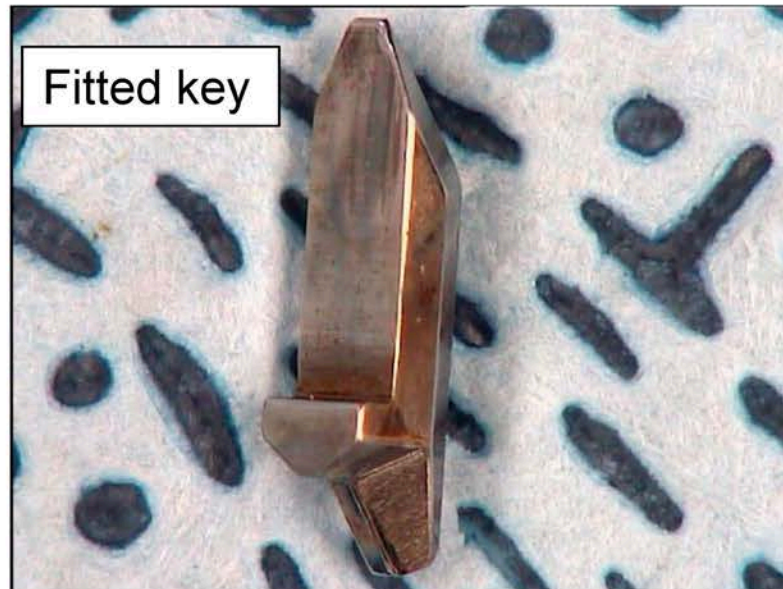
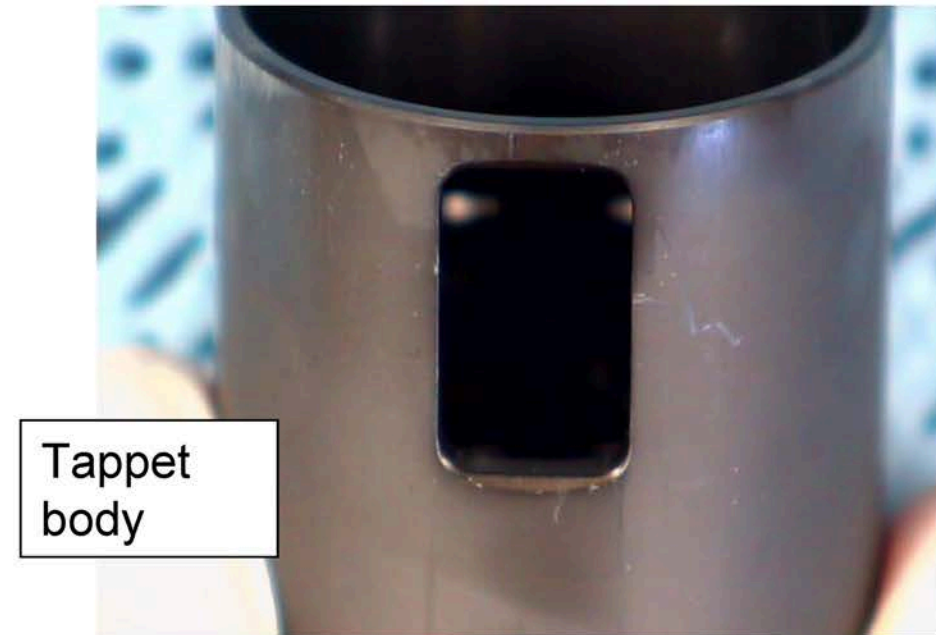
CP4, Tappet anti-turning lock, Status 3/2008

- First 2 pumps after approx. 500h ER indicate a good result.
- Parts from near-series production process show tappet break-ages (deformation, internal stresses in tappet body)

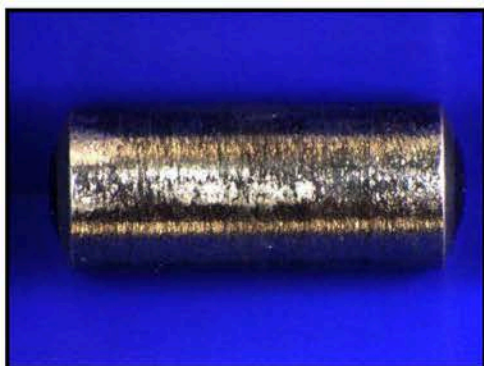
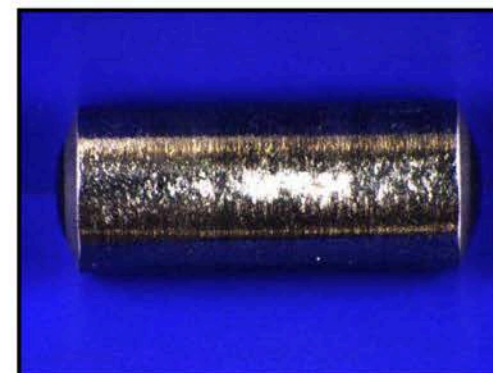
Field failed pump **W26** (bench 1) from Non-responsive content removed 2010-CP4_0013 (QMM 4A236)

->Drivetrain damage

- Complete camshaft, roller, RS wear
- no final 90° turn
- Corrosion on intake valve plate left

Complete abrasive wear

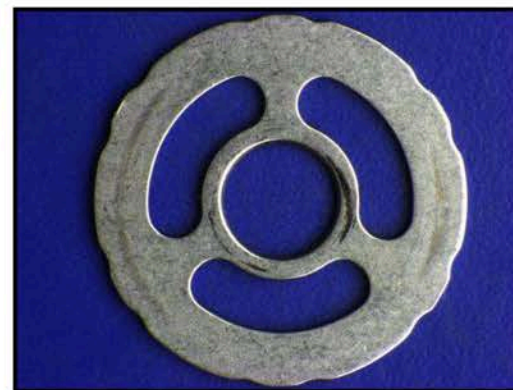
Brownish fuel deposits

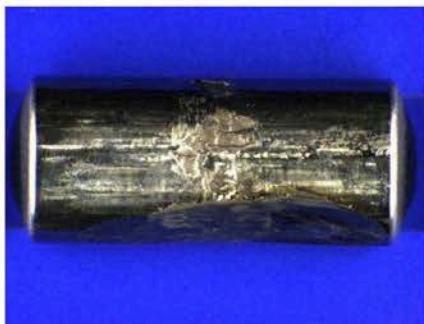
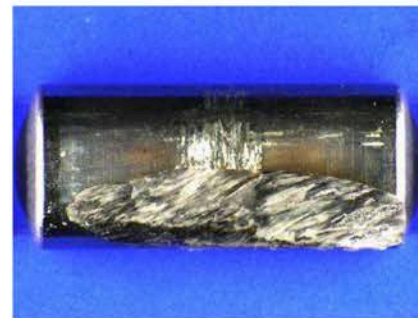
2010-CP4_0051 field failed pump **W26** Non-responsive content removed 22,270 km (vehicle) 0445 010 619; DM: 10/13/2008

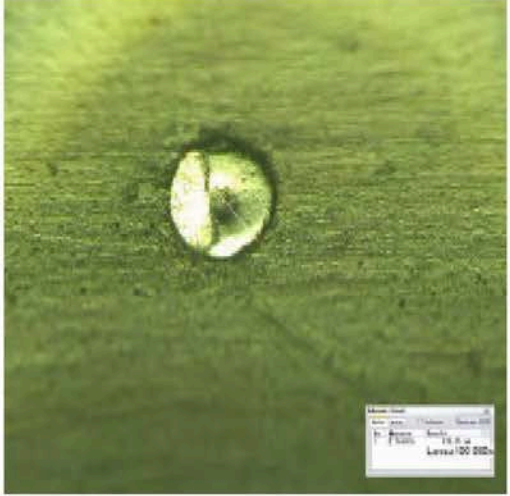
Explanation of terms: "Metal splashes"

<p>A microscopic image showing a circular metal splash on a green surface. The splash is roughly spherical with some internal structure visible. A small white label is present in the bottom right corner of the image.</p>	<p>Affected component: Roller support</p> <p>Remark: Metal splashes are frequently rough-finished and then become visible. Depending on the size and height, a visible shadow is also created by the finishing process</p>
	<p>Cause: During the C3 coating process of the RS, ambient material is entrained and deposits on the component. There are different shapes, sizes and degrees of metal splashes. Depending on the time of occurrence, the metal splashes are finally coated with C3</p>

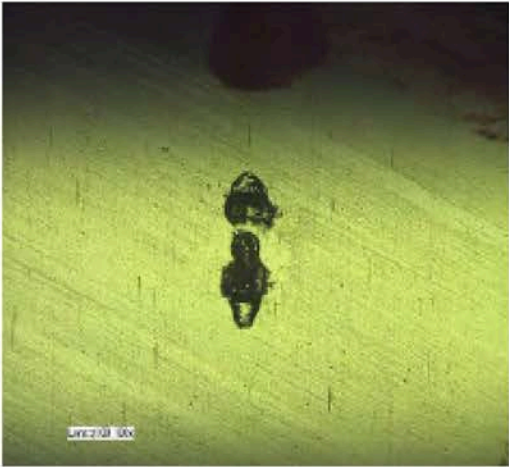
Explanation of terms: "Fusing"

<p>Affected component: Roller</p>

<p>Suspected cause: Fusing occur during the C3 coating process of the roller end due to insufficient contacting between the rollers in the holder. Partly excessive current flows and leads to material melts of the roller having depressions and elevations. Occurrence is strongly scattered</p>
