TF: Audi overload tests

CP4 diagnosis: VW R4 2.0i EU5 - first findings

CP4 - Drive Train Failures - Analysis

Cause-effect relationship CP4 drivetrain damage

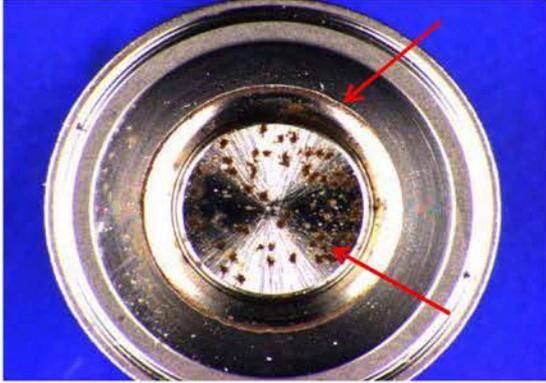
Intake valves: Deposits and corrosion products (see 3.10, Figures 4 and 5)

Fig. 5: Intake valve - right

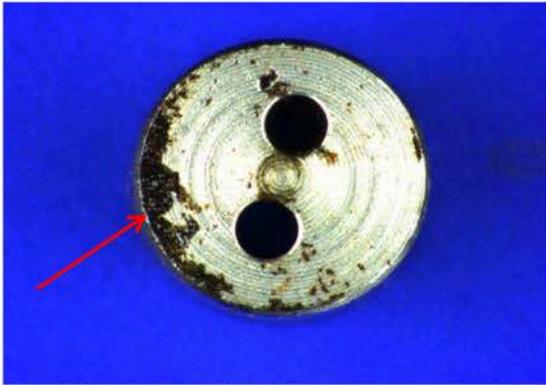
- Metering unit: Function not OK; control pistons caked on due to corrosion (see 3.10, Figures 6 to 8 and report in the appendix)

Fig. 7: MU pistons - housing side

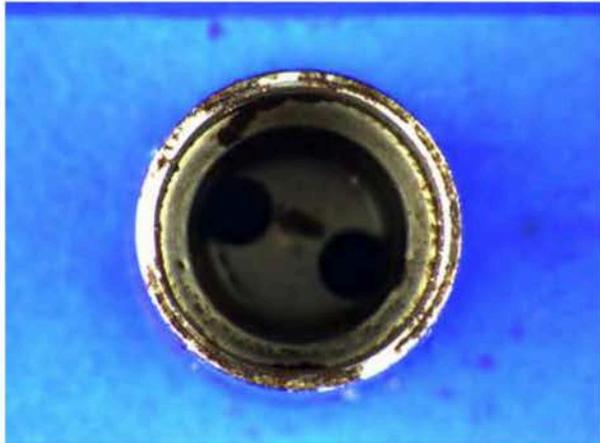
Fig. 9 Pistons - pump-side

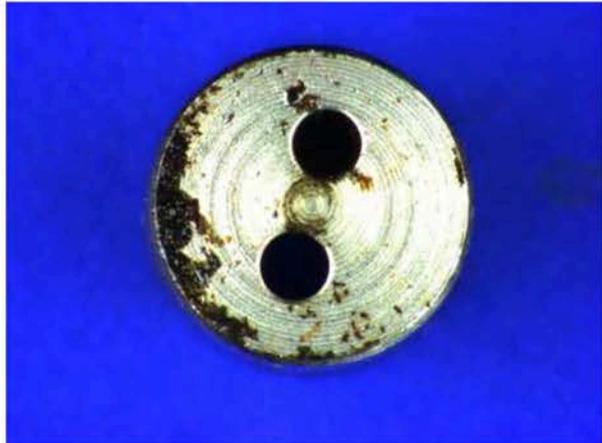
Fig. 10 Pistons - housing-side

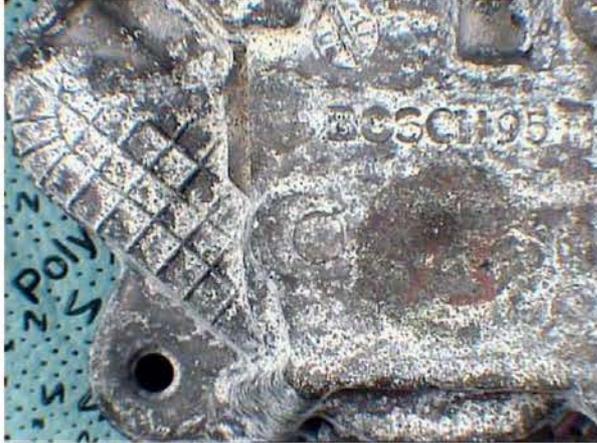
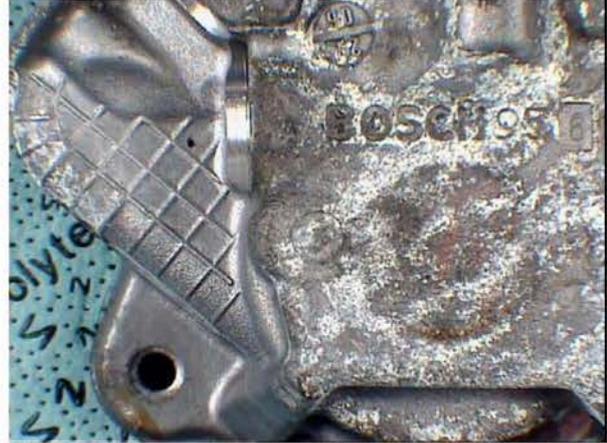
Visual findings: The differences in the degrees of corrosion could be due to the respective relative position of the pumps in the test chamber (see Fig. 1 to 4).

Fig. 1 001-Housing

Fig. 2 002-Housing

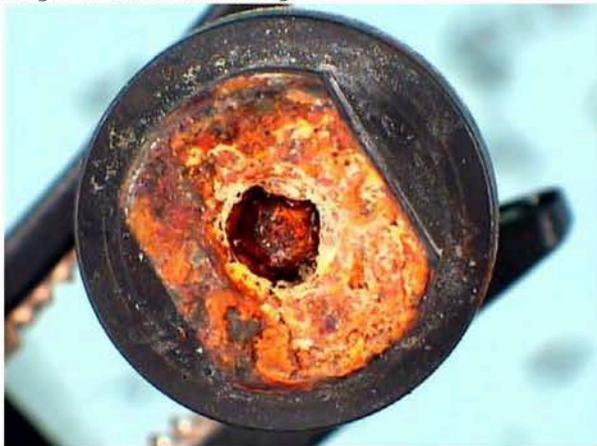
By contrast with 002, the OV of the pump 001 showed considerable corrosion, both on the surface as well as on the supporting surface. The corrosion on the surface would have been promoted by the laser labeling which is only found on sample pumps. The corrosion on the supporting surface for the housing could lead back to an evidently too low tightening torque (break-loose torque = 5Nm). The tightening torque (in production 25 Nm) is not defined for dummy pumps. They are tightened manually and can therefore move quite a lot (Fig. 5 and 6).

Fig. 3 001-OV

Fig. 4 002-OV

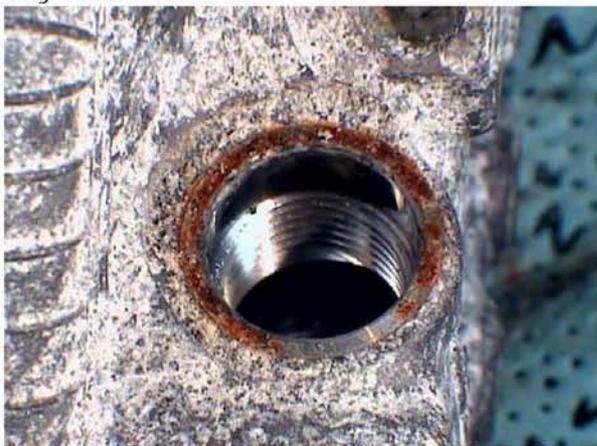
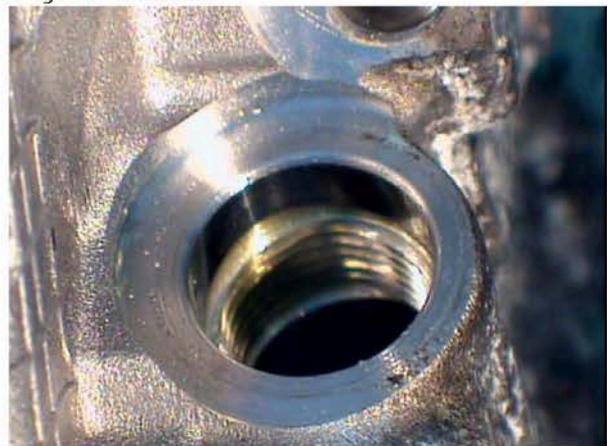
Fig. 5 001 OV sealing area

Fig. 6 002 OV sealing area

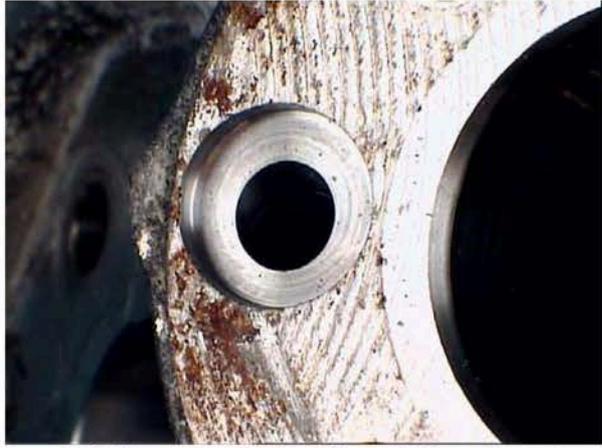
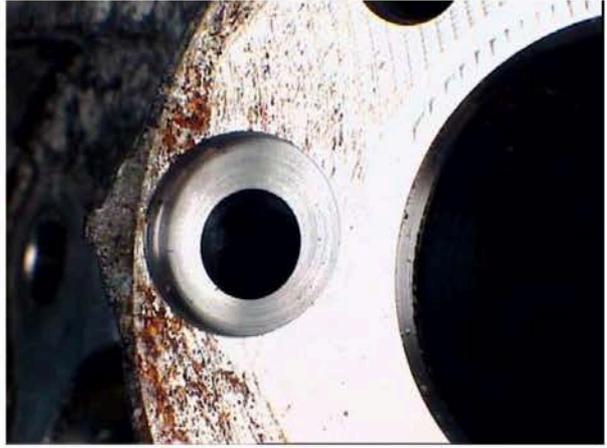
The sealing area of the housing/cylinder head is not critical: no rust under the sealing area (Fig. 7 and 8).

Fig. 7 001 Housing/cylinder head O-ring Fig. 8 002 Housing/cylinder head O-ring

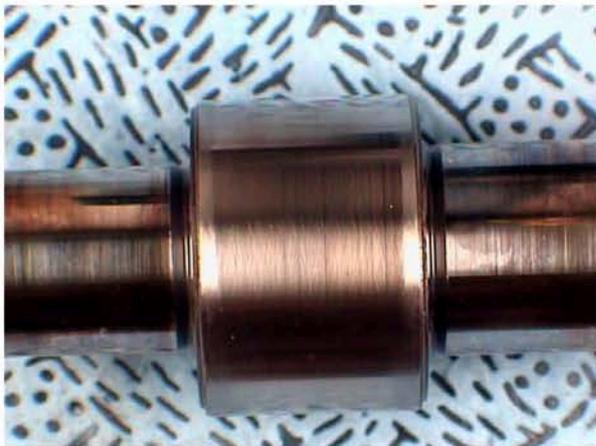
The drivetrain parts (camshaft, roller, roller support, LP pistons, bearings) show no significant signs of wear (Fig. 1 to 3). Copper particles were found pressed into the flange bearing (Fig. 4). The slight scoring marks on the running surface of the contact bearing of the camshaft can be explained by particle contamination (Fig. 5). The tappet bore shows initial stages of cavitation erosion (Fig. 6).

Fig. 1 Camshaft running surface

Fig. 2 Roller

Fig. 3 Roller support

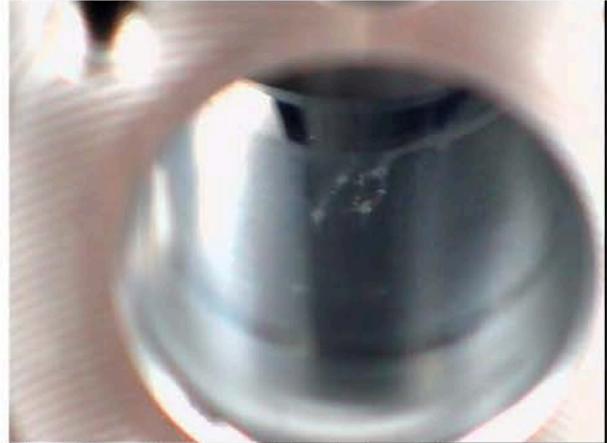
Fig. 6 Housing tappet body bore

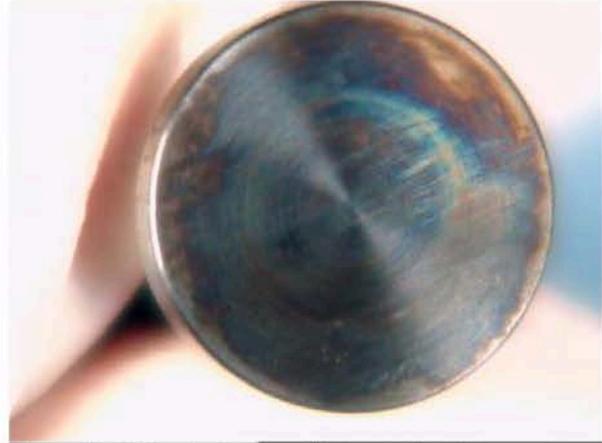
The drivetrain parts (camshaft, roller, roller support, bearings) show no significant signs of wear (Fig. 1 to 4). The C layer on the high-pressure pistons and piston foot show no signs of wear (Fig. 5 and 6). No striking feature present.

Fig. 6 HP pistons piston foot

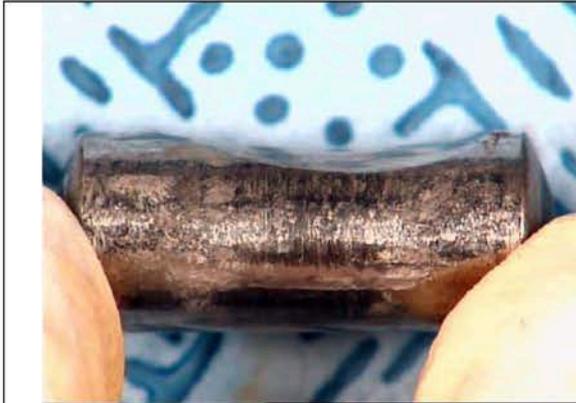
Fig. 1 Roller tappet

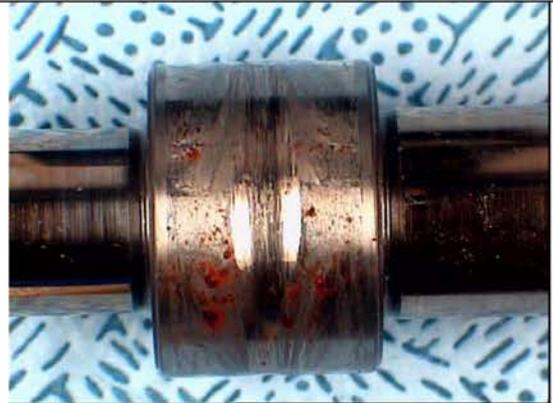
Fig. 2 Cam track roller TDC

Roller support, intake valve and gasket also show signs of rust (Fig. 5 to 7). Steel and rust particles have pressed into the bearings and have caused scratches on the tappet body casing and in the tappet bore (Fig. 8 and 9).

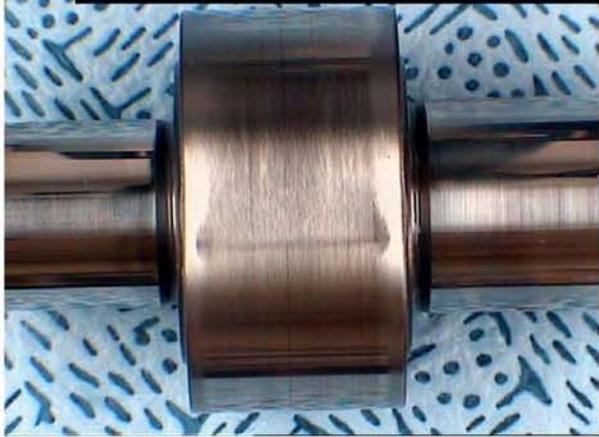
Fig. 1 010207-0045_cam track_running surface

Only very slight wear visible (Fig. 1 and 2)

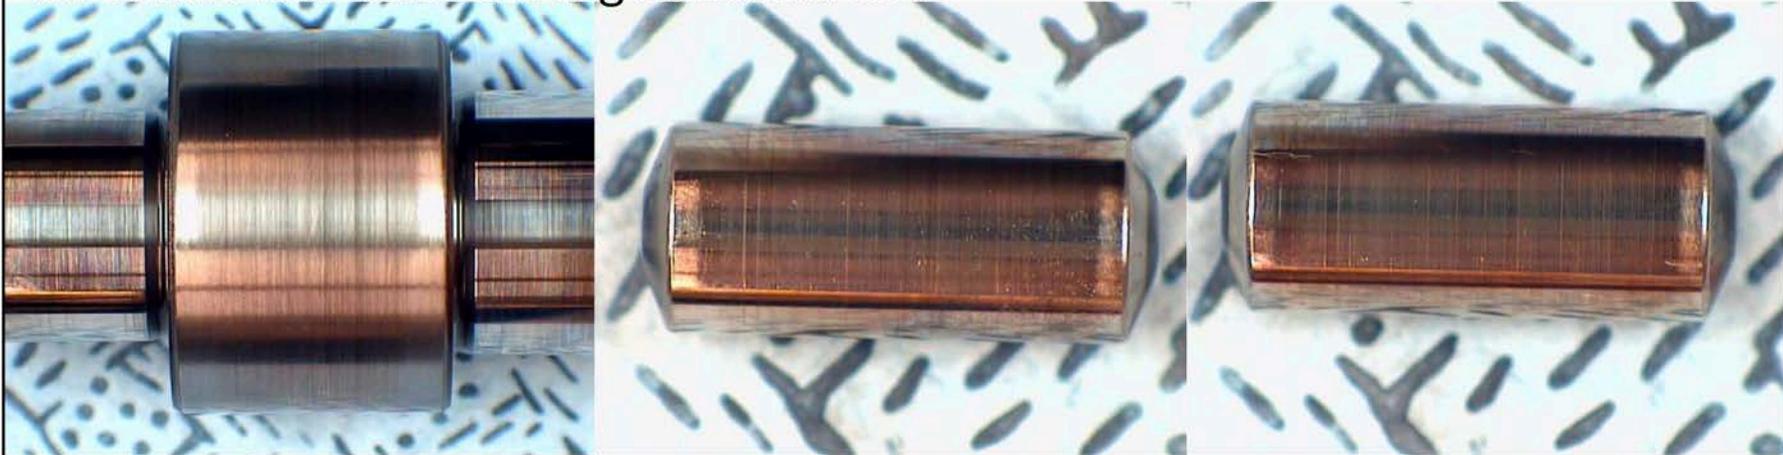
Cam track and roller running surfaces: OK.

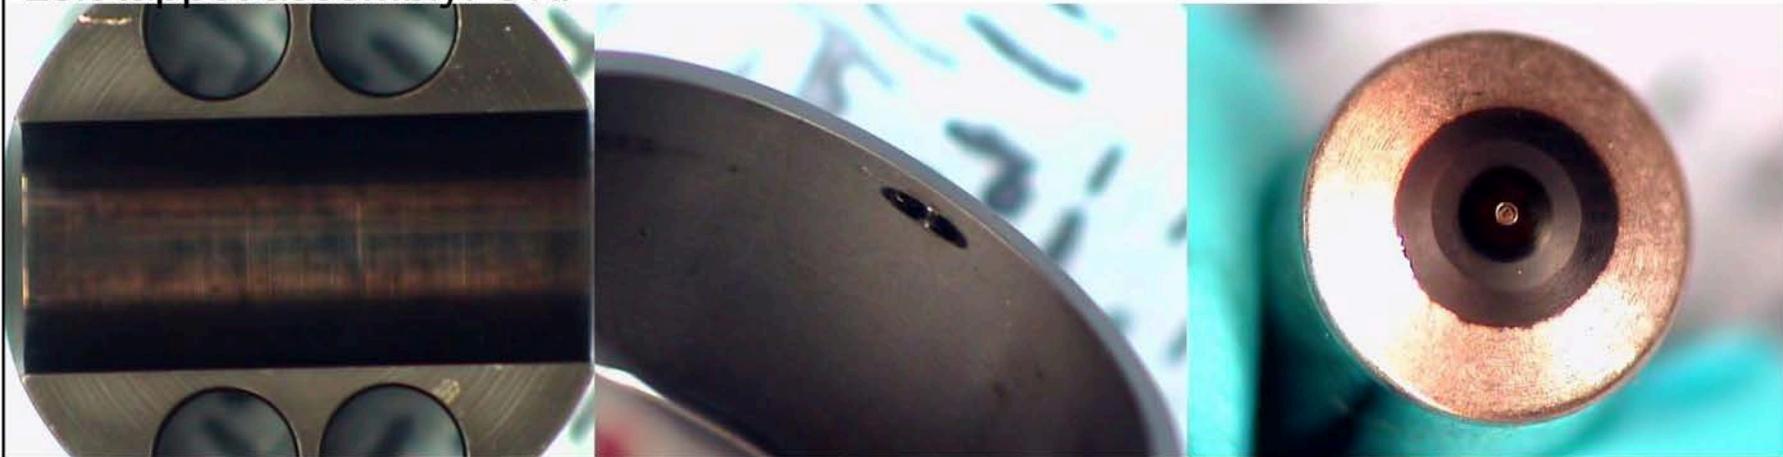
Left tappet assembly: OK.

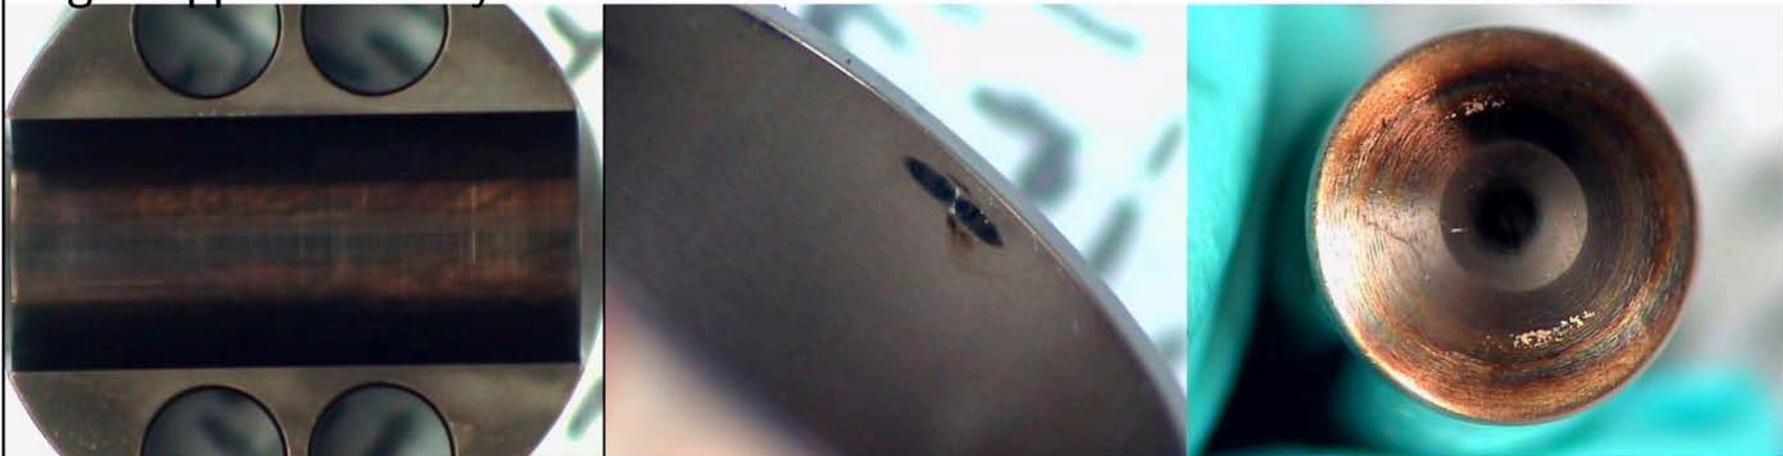
Right tappet assembly: OK.

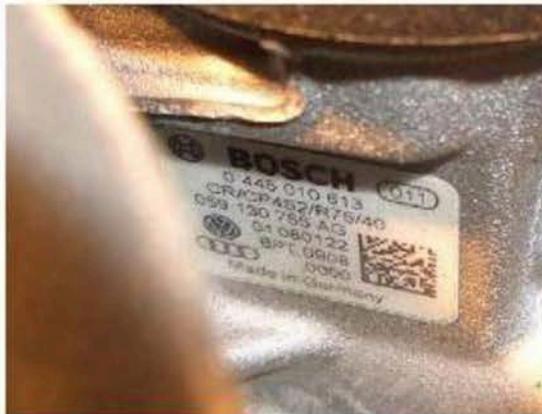
7L69D024, 24.853 km, 10.10.2008

Yes, it is typical drivetrain damage.

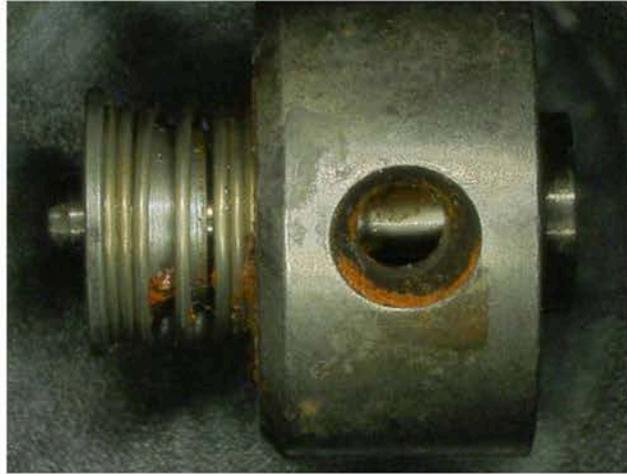
Fig. 1
CR_ARA_M_09_0001
CP4.2 HS DNA2826
left intake valve -
overview 1

Order:
CP4.2HS customer returns from Audi
with unusual deposit on intake valve

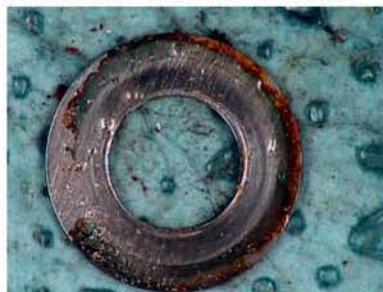
Intake valve disk

Brownish deposits (corrosion?)

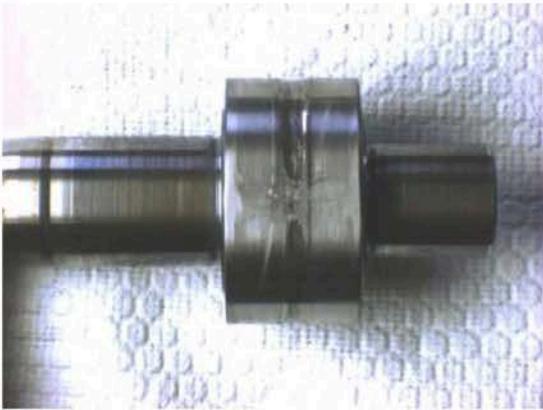
Camshaft

- Drivetrain damage Considerable wear in the center of the cam track through perpendicular roller as a result of sluggish roller, respective deep wear track on the roller. Wear in the middle of the running surface on the roller support.
There are numerous chips on the MU strainer, OV strainer, in the CH intake valve compartment, in the OV and MU bores and in the bearings and on the shaft seal.
- MU fastening screw missing upon delivery -> probably dismantled by the customer

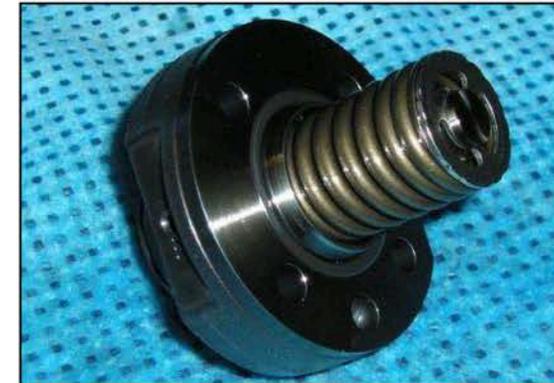
Fig. 2: Cylinder head with seized pump piston

They were due to external cylindrical grinding of the pump pistons in the form of roundness defects

Nom.: $0.7 \mu\text{m}$ Actual-failure parts to $3.38 \mu\text{m}$

- 5/7/2009 100% gauge insertion check
- 05/14/09: refined 100% gauge insertion check
- Analysis of grinding process is running

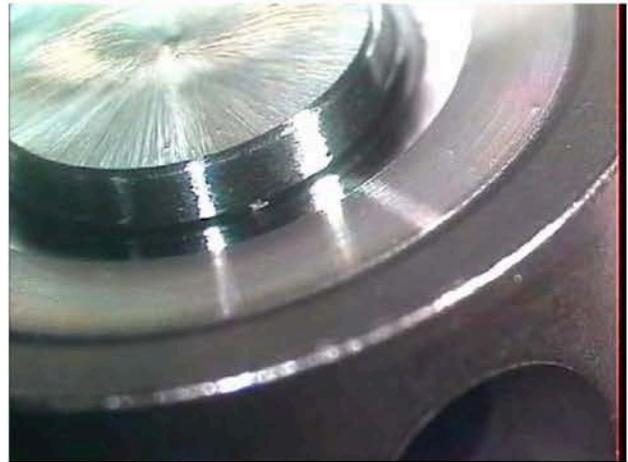
- 0km: 5 x pumps 0445010507/ 03L130755
- Field: 1 x pump 0445010507/ 03L130755
- DM
 - 11/8/2007
 - 9/28/2007
 - 10/31/2007
 - 11/8/2007
 - 09/17/2007 **Field**
 - 10/31/2007

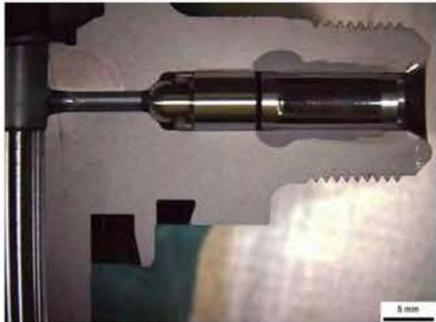
Cylinder head CP4 – breakdown Field complaint

Pump type: 0445010611/ 059 130 755
 AB Failure date: 1/17/2008
 DM - pump 9/29/2007
 Cons. no.: 01-0141
 Mileage: 1,771 km
 Vehicle: Q7 3L V6 TDI CR
 Failure: Breakdown - field complaint
