EA11-004

HONDA

4/27/2012

DRIVERS MASTER SWITCH BURNED UP AND DOOR
HARNESS WAS MELTED

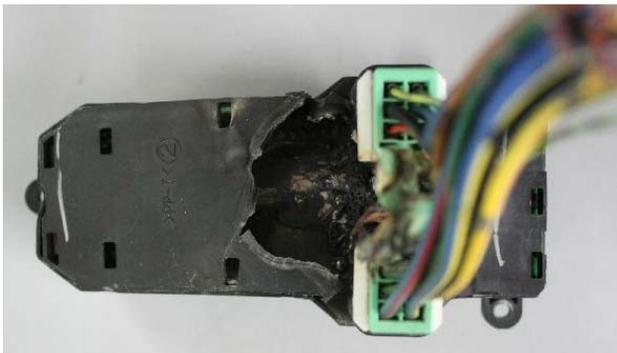
Full view of PCB (Component side)

Discoloration and attachment of white abnormal substances are confirmed on the outer circumstances and the case rib.

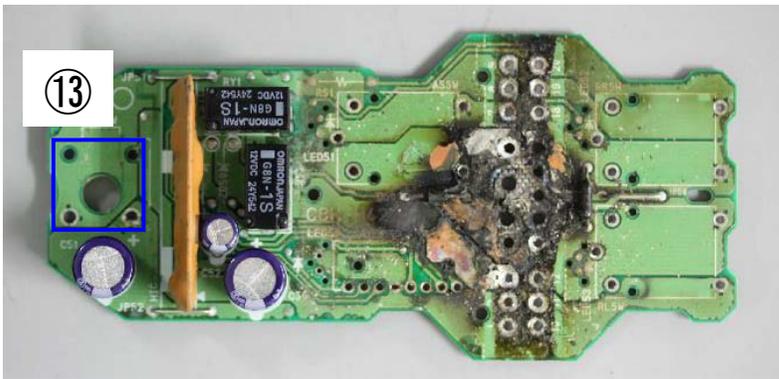
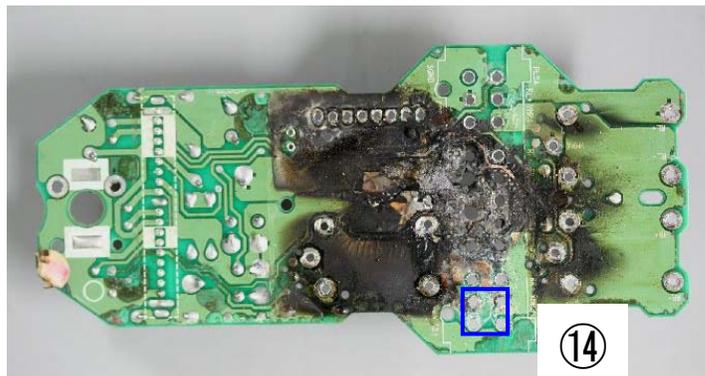
Existence of sugar in attached substances

- Sucrose and Glucose were confirmed on the surface of the PCB under connectors

Measuring Area	⑬	⑭
Existence of Suger	No	Yes (Sucrose and Glucose)

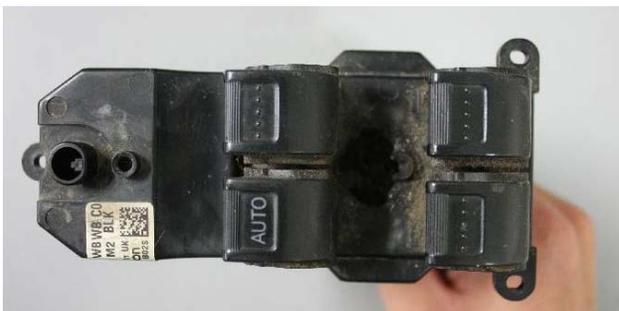
PWS全景_01

多量の塵埃が付着

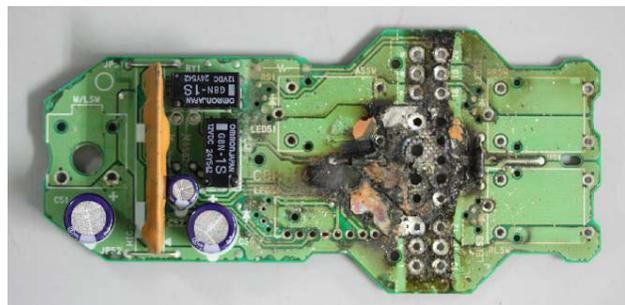
基板全景(部品面)

基板の外周、及びケースリブ上に変色、白色異物の付着が認められる。

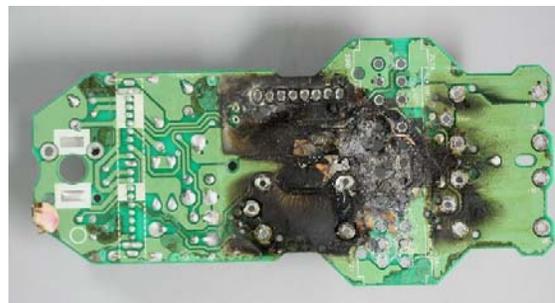
基板全景(はんだ面)

基板の外周、及びカバーリブ上に変色や白色異物の付着が認められる。

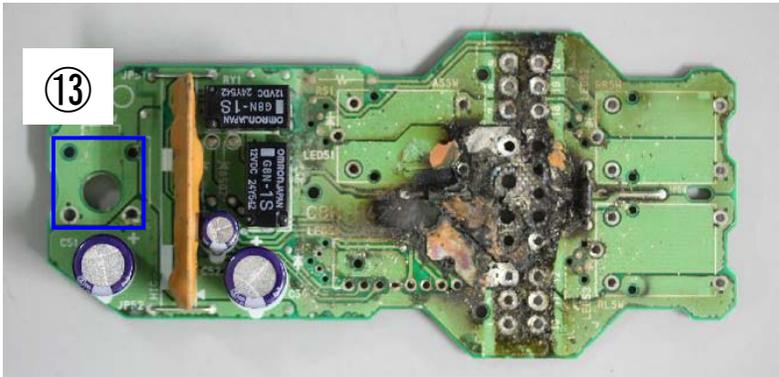
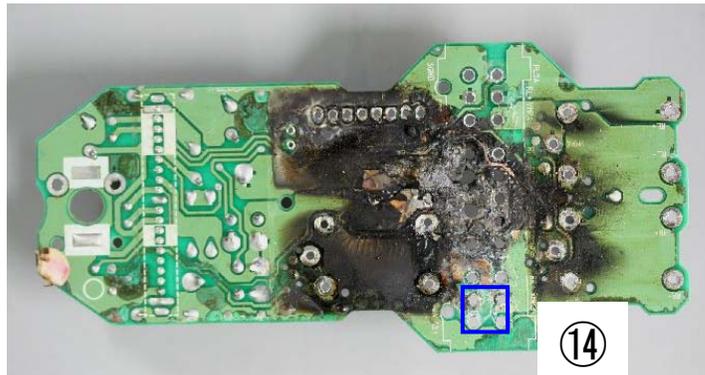
・コネクタ下部の基板表面よりブドウ糖及びシヨ糖が検出された。

測定箇所	⑬	⑭
糖の有無	無	有(ブドウ糖、シヨ糖)

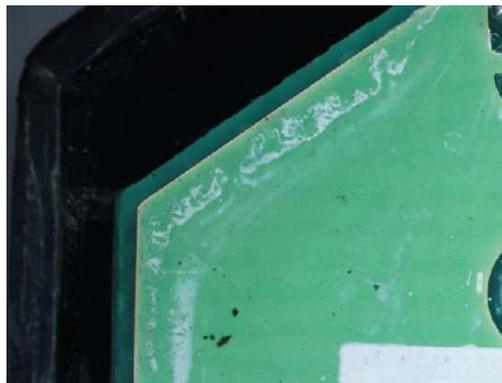
Area A

Detected element:
C,O,Na,Al,Si,S,C
l,Sn

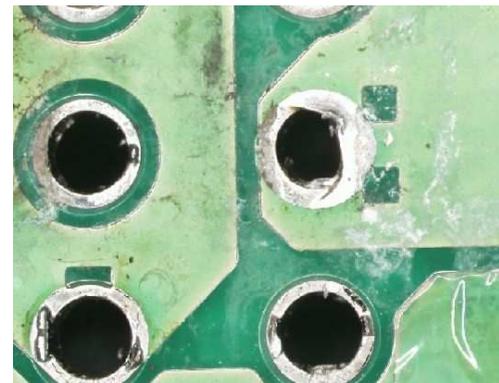
Area B

Detected element:
C,O,Pb,Sn

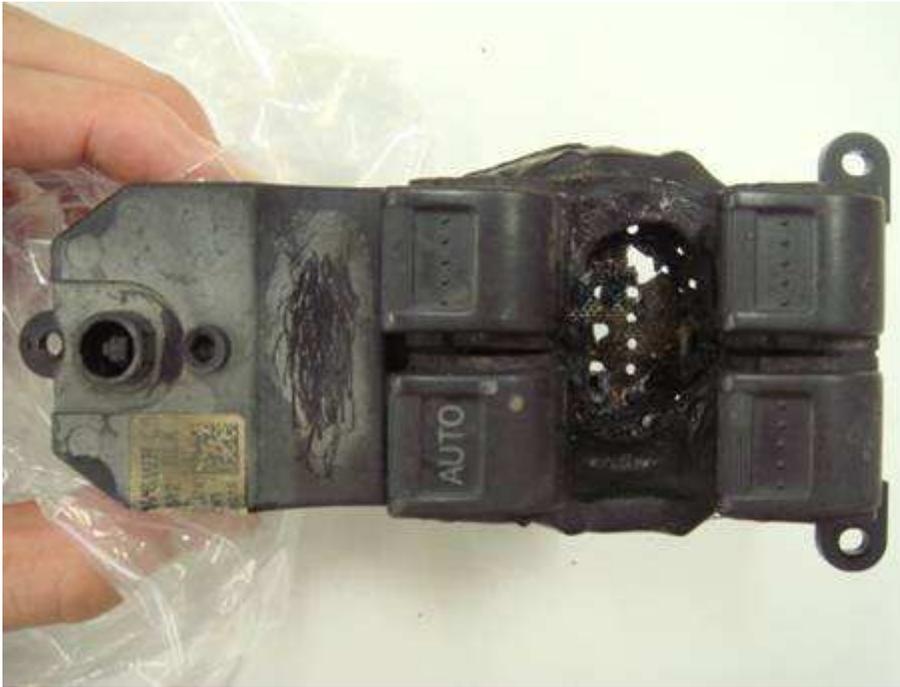
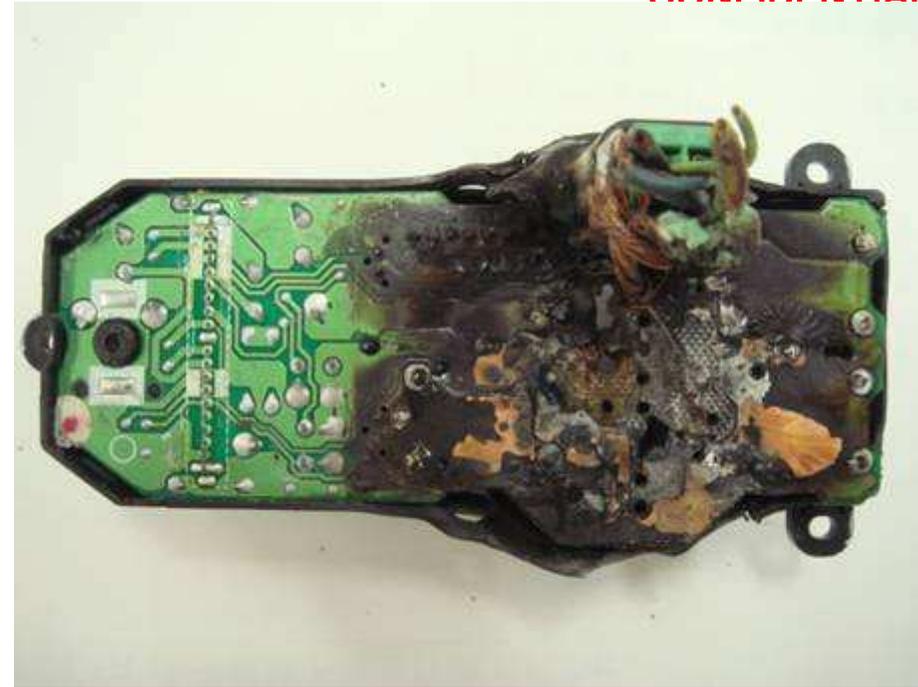
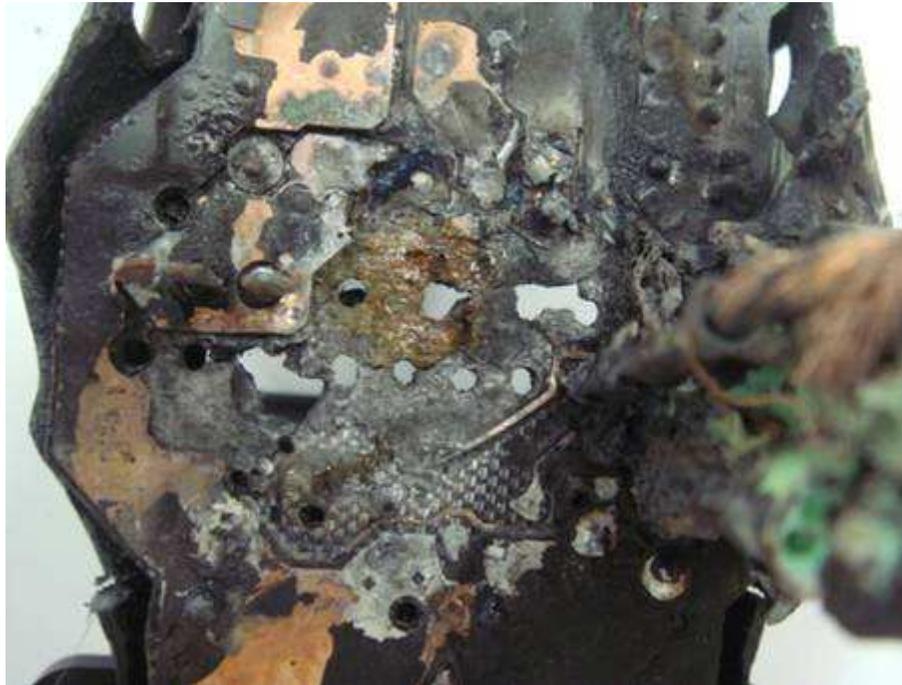
Honda control No. : 8
Part No. : 35750-S9A-C04
VIN : SHSRD78826U [REDACTED]
Vehicle production date : 2006.6.21
Registration date : 2006.7.24
Occurrence date : 2010.2.24
Mileage : 48932mile

OC designated type : C8H-H42-BO2S
LOT : 0766E1
OC designated control No. : AQU-100525-009

PCB AW Category: H42	
Component side	
Soldering side

C, O, Na, Al, Si, Cl, Pb, and Sn are detected as a result of EDX analysis of the attachment.

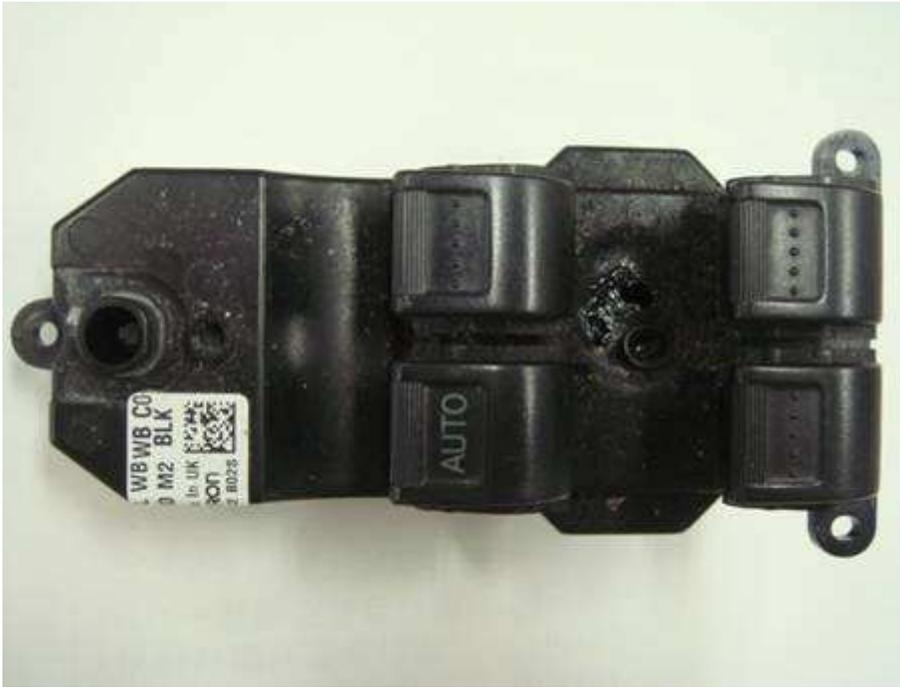
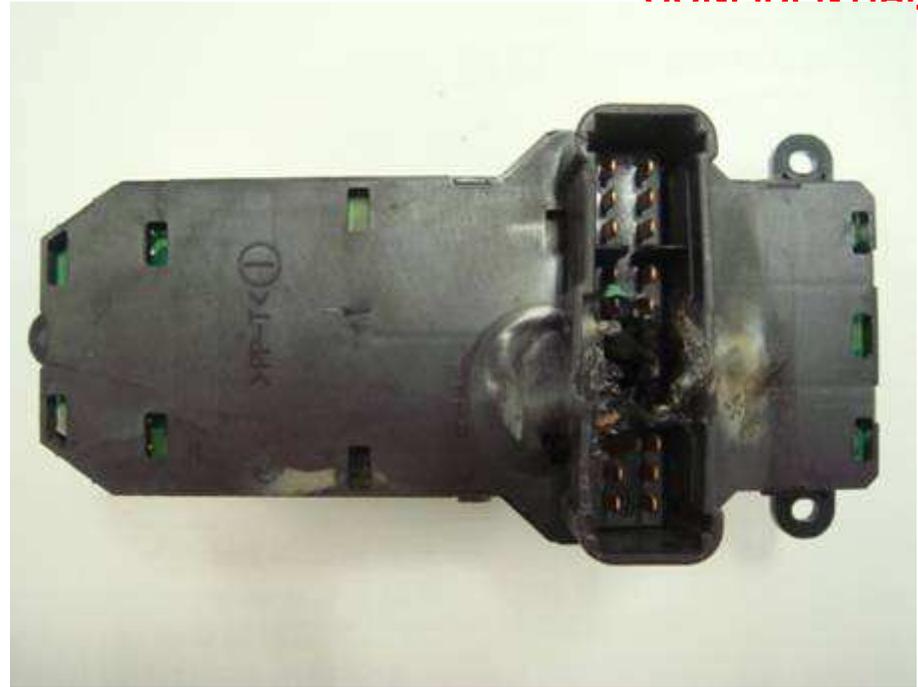
Honda control No. : 9
Part No. : 35750-S9A-C04
VIN : SHSRD78916U [REDACTED]
Vehicle production date : 2006.4.6
Registration date : 2006.5.30
Occurrence date : 2010.3.10
Mileage : 48969mile

OC designated type : C8H-H42-BO2S
LOT : 0936E1
OC designated control No. : AQU-100525-010

C, O, Al, Si, Cl, Cu, Pb, and Sn are detected as a result of EDX analysis of the attachment.

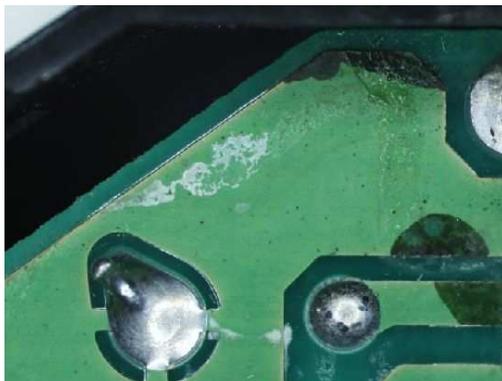
Area A

Detected element:
C,O,Al,Si,Cl,Sn

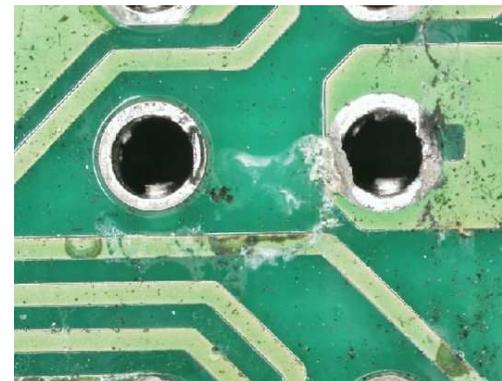
Area B

Detected element:
C,O,Cu,Si,Pb,Cl,Sn

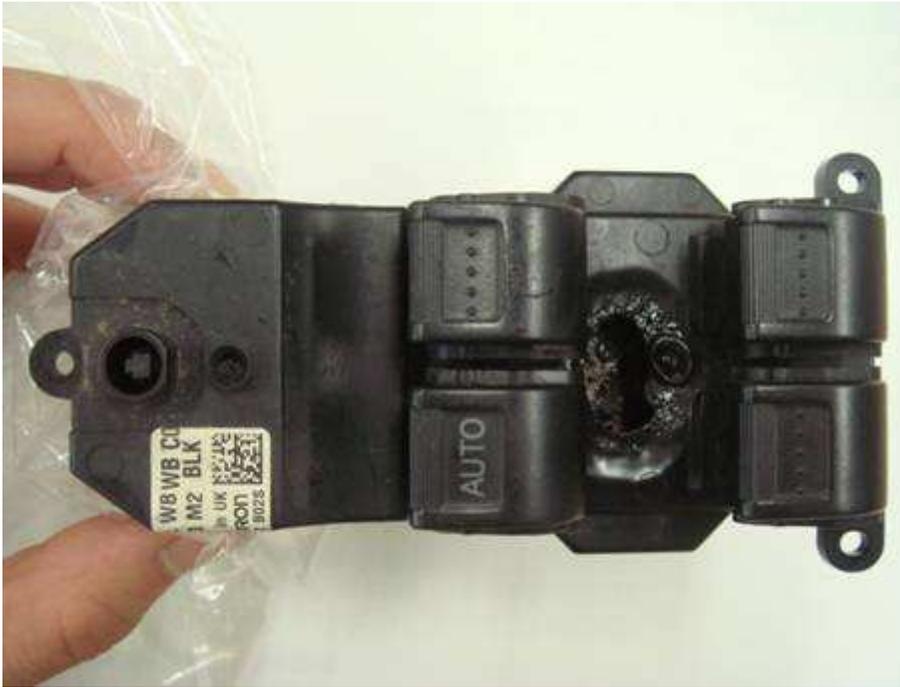
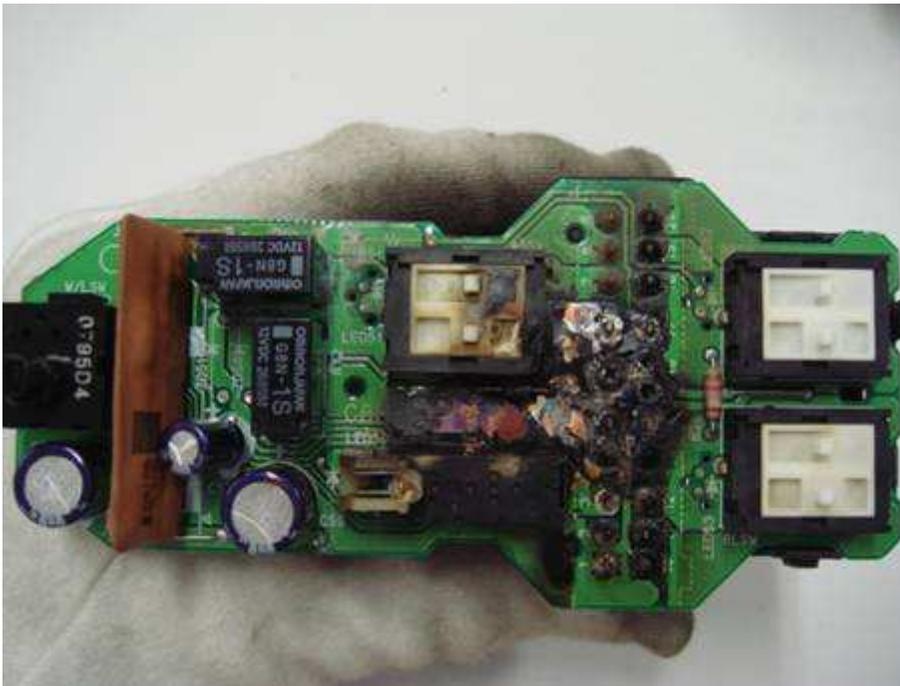
車両製造日 : 2005.12.22
登録日 : 2006.2.25
発生日 : 2010.1.25
走行距離 : 66200mile

OC形式 : C8H-H42-BO2S
ロット : 07Z5E1
OC管理No : AQU-100525-008

基板AW分類:H42
部品面	
はんだ面

付着物のEDX分析結果、C,O,Na,Al,Si,S,Cl,Pb,Snが検出されました。

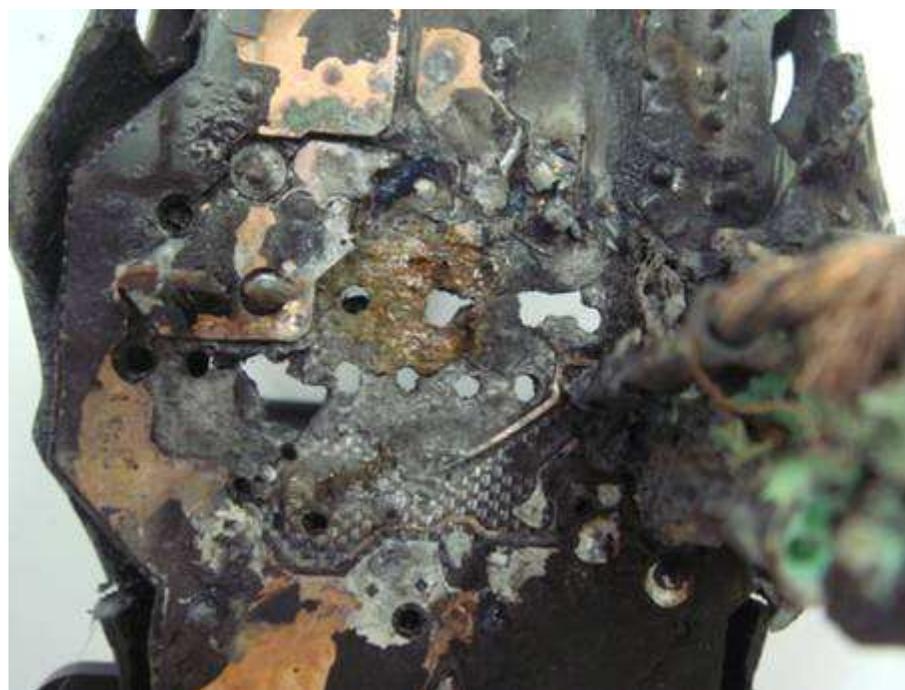
基板AW分類:H42	
部品面	
はんだ面

付着物のEDX分析結果、C,O,Na,Al,Si,Cl,Cu,Pb,Snが検出されました。

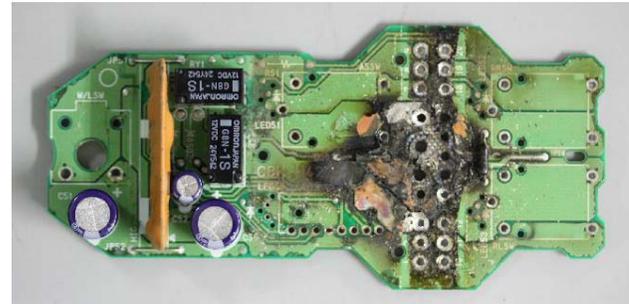
Full view of PCB (Component side)

Discoloration and attachment of white abnormal substances are confirmed on the outer circumstances and the case rib.

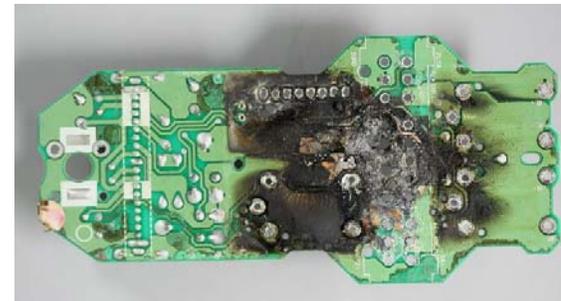
Full view of PCB (Soldering side)

Discoloration and attachment of white abnormal substances are confirmed on the outer circumstances and the case rib.

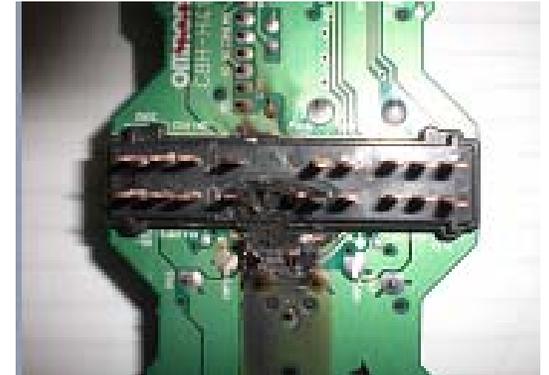
VMP1 端子を中心に溶損
(VMP1 端子は通電中に脱落)

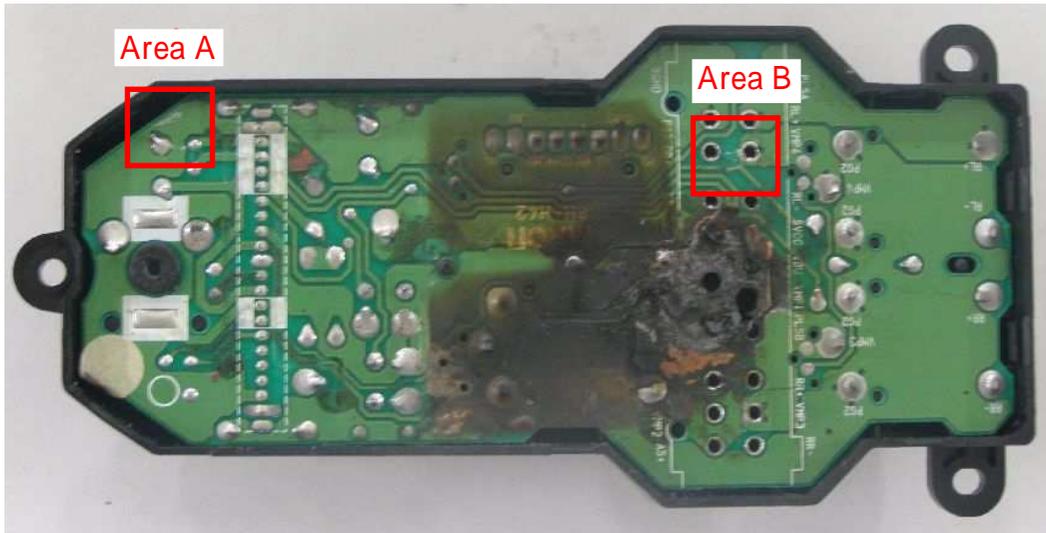
Full view of PCB (Soldering side)

C, O, Al, Si, Cl, Cu, Pb, and Sn are detected as a result of EDX analysis of the attachment.
