PE11-017

HONDA

ATTACHMENT Q2

Summary Description

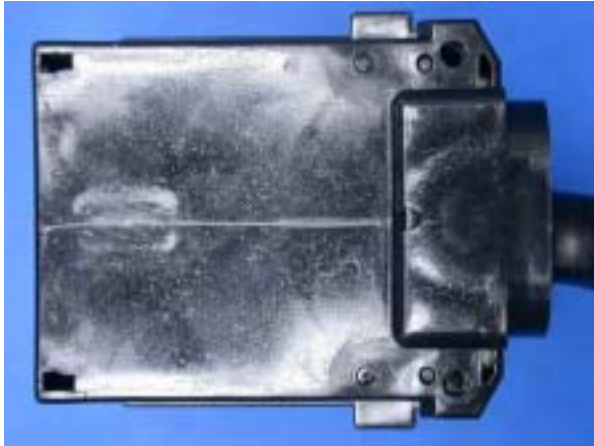
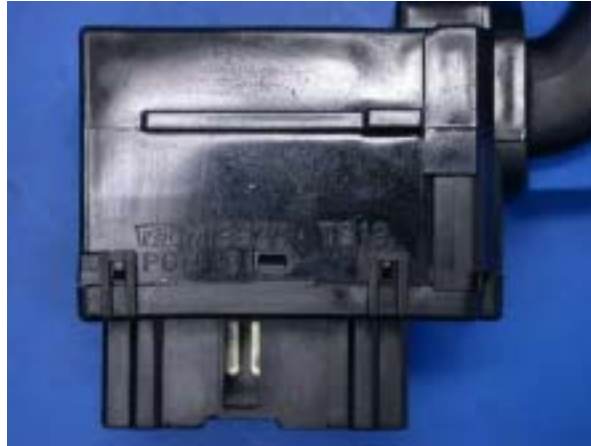
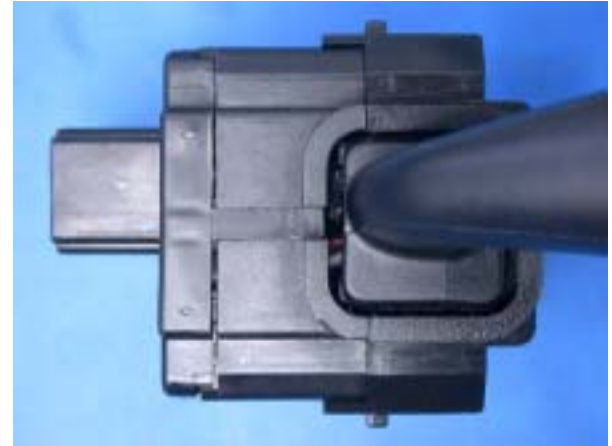
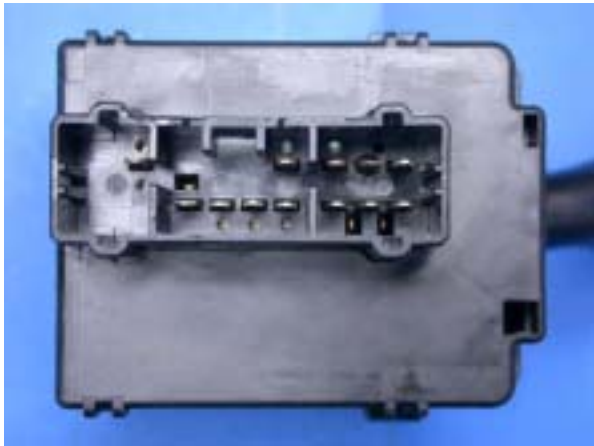
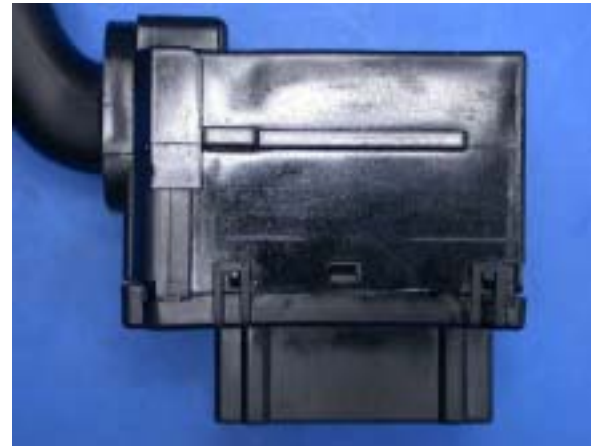
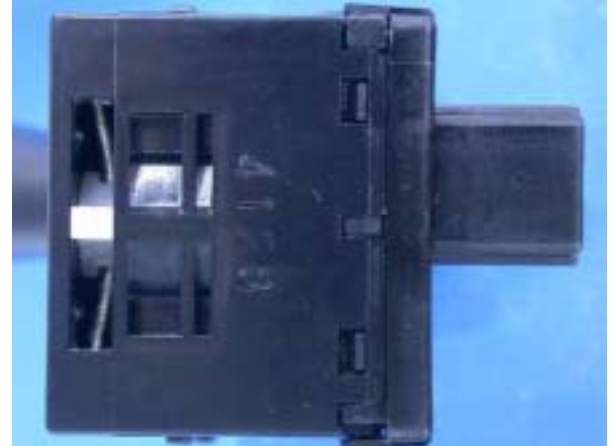
## 1-1). 外観確認

外観に傷・打痕等なく、特に異常は見られない。

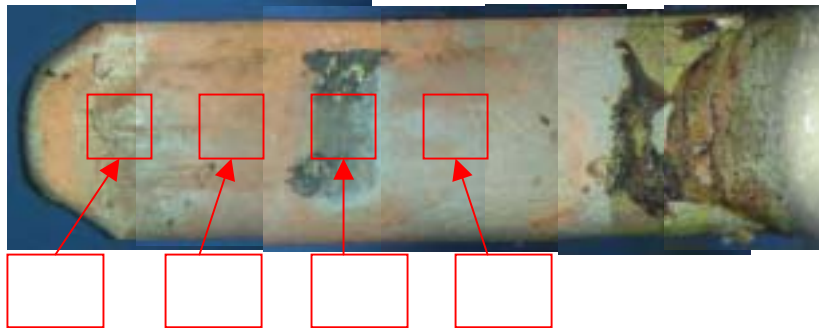
不具合品Lo端子	180	12	2.9M	200
不具合品Hi端子	0.01	0.01	0.01	0.01
量産品	0.01	0.01	0.01	0.01

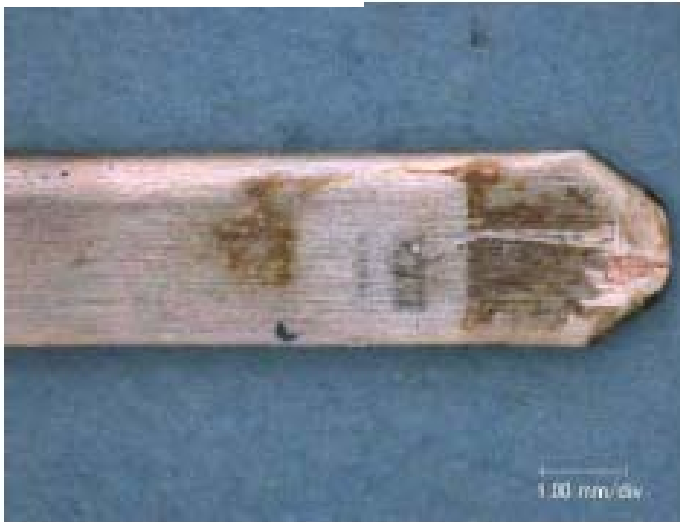
- ② Terminal A : Terminal end is slightly discolored to brown. By element analysis, mainly Ag and slight C, O, Cu, S were detected, (since Ag was detected from normal part, we suspect it is plating), slight S, which is a corrosive element, was detected.

Photo. 6 Terminal A tab end actual state

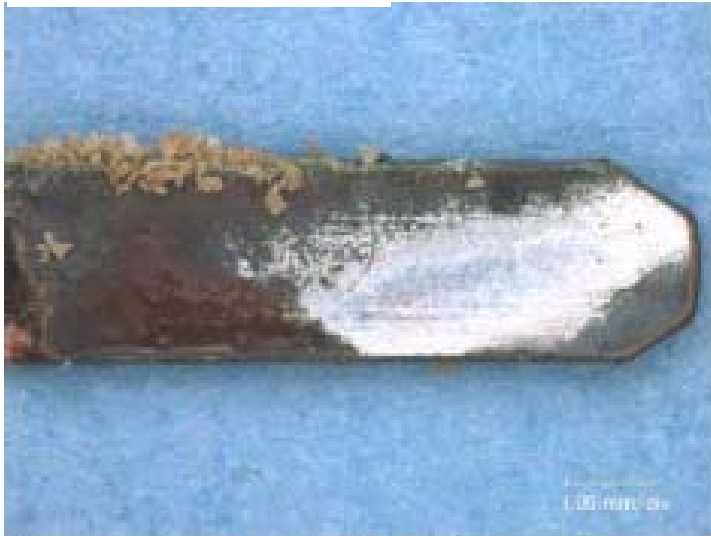
- ③ Terminal B : Terminal end and root discolored to brown and white substance adhered to the root.  
Brown adhered substance: Mainly Sn, and C, O, Br, Cl with slight Si, Cu. White adhered substance : Mainly C, and slight O, Cu, Br, Si, Cl, Sn detected. (Sn detected from normal part, so suspected as plating). Also, slight Cl, which is a corrosive element, was detected.  
By element analysis, mainly Ag and slight C, O, Cu, S were detected.

Photo. 11 Terminal B tab end actual state

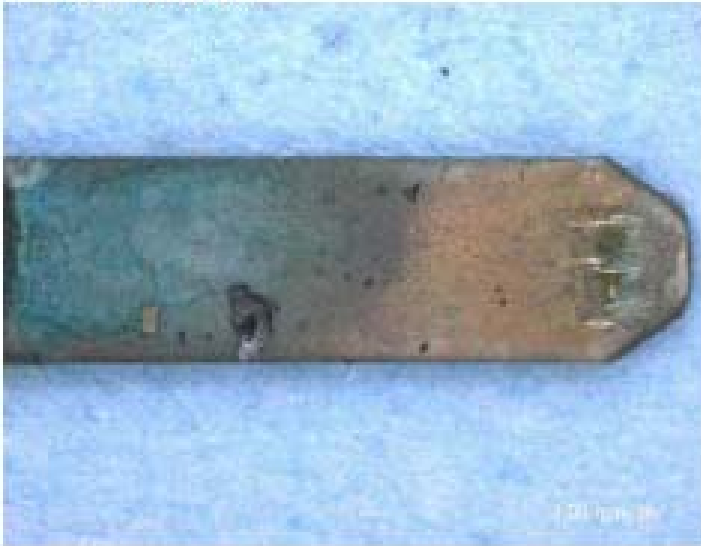
- ④ Terminal C : Root of terminal discolored to blue. Mainly C and slight O, Cu, Br, Cl detected. Since the color is different from that of connector (black, gray), we suspect there is a possibility that an organic substance other than connector adhered. Also, slight Cl, which is a corrosive element, was detected.

**Photo. 17** Terminal C tab end actual state

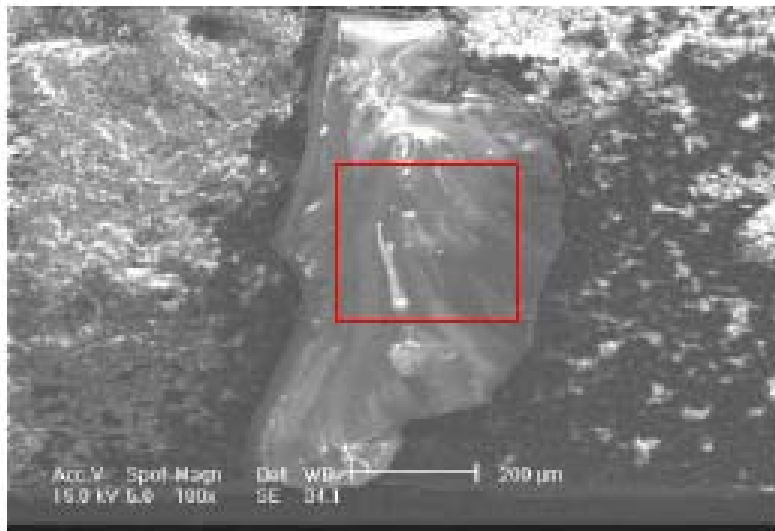
Photo. 21 Framed area of black adhesive in the previous page enlarged

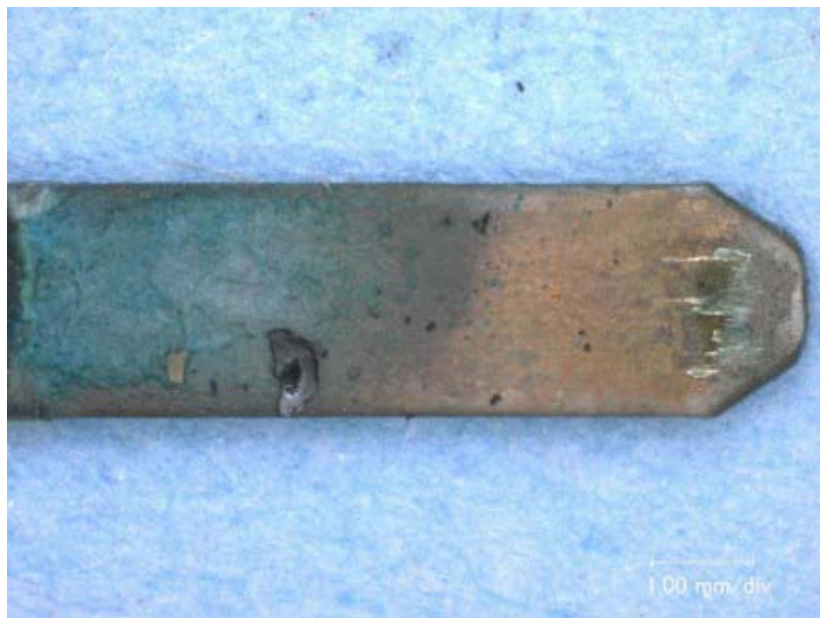
Photo. 17 端子C 舌片側 実体

**端子C:** 端子根元が青色に変色している。Cをメインに微量のO, Cu, Br, Clを検出。コネクタ色(黒、灰)とは異なる為、コネクタ以外の有機物が付着している可能性があるかと判断する。又、腐食性元素のClを微量検出した。

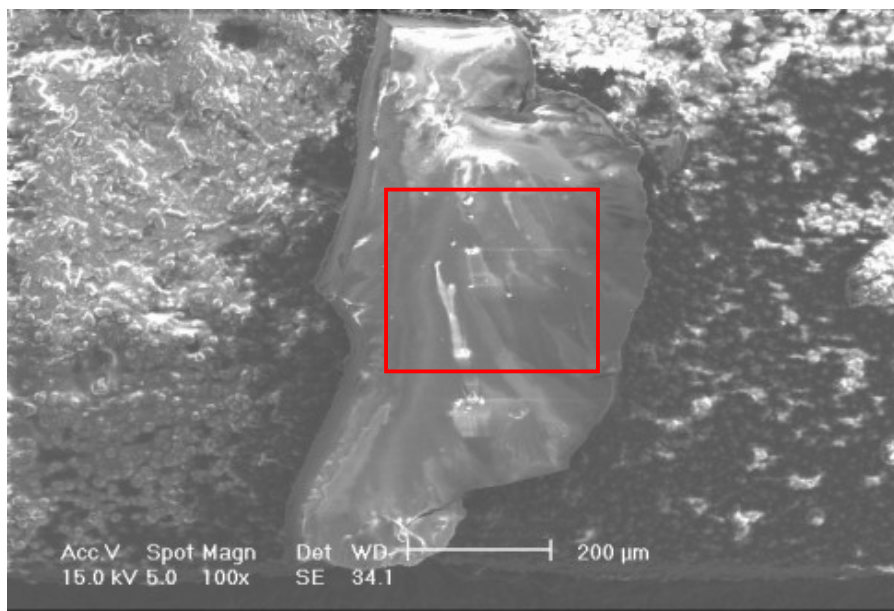
Photo. 21 前ページ黒色付着物 枠内拡大

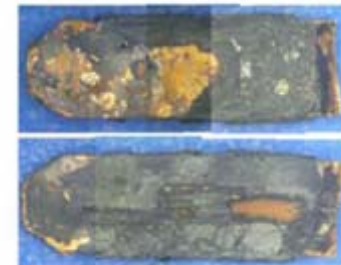
### 溶損端子

市場不具合品と同じ顔つき

- ◆接触圧、量産管理値内では異常が認められない。
- ◆接触圧1.5Nまで落とし、酸化を促進させるモードを加速要因として入れると、実車振動相当で事象再現した。
- ◆GND端子のみ接圧NG品を組み込み評価したが、若干の電圧降下が確認出来たのみで、溶損には至らなかった。(通常の倍のサイクル数実施)
- ◆メッキ材質を入れ替えたサンプルで評価したが、AgメッキのLo端子で溶損が再現。

⇒Lo端子にのみ発生する事象であるということが明確になった。
