PRODUCT ALLEGATION RESOLUTION
PRELIMINARY INSPECTION
FIRE

Customer's Name: [REDACTED] Inspection Date: **10/25/2007**
 Vehicle Brand: Chevrolet Model: 2006 TrailBlazer
 File # 71-566155666 VIN: 1GNET16S166 [REDACTED]

Inspected By: Walter Danes / EAA

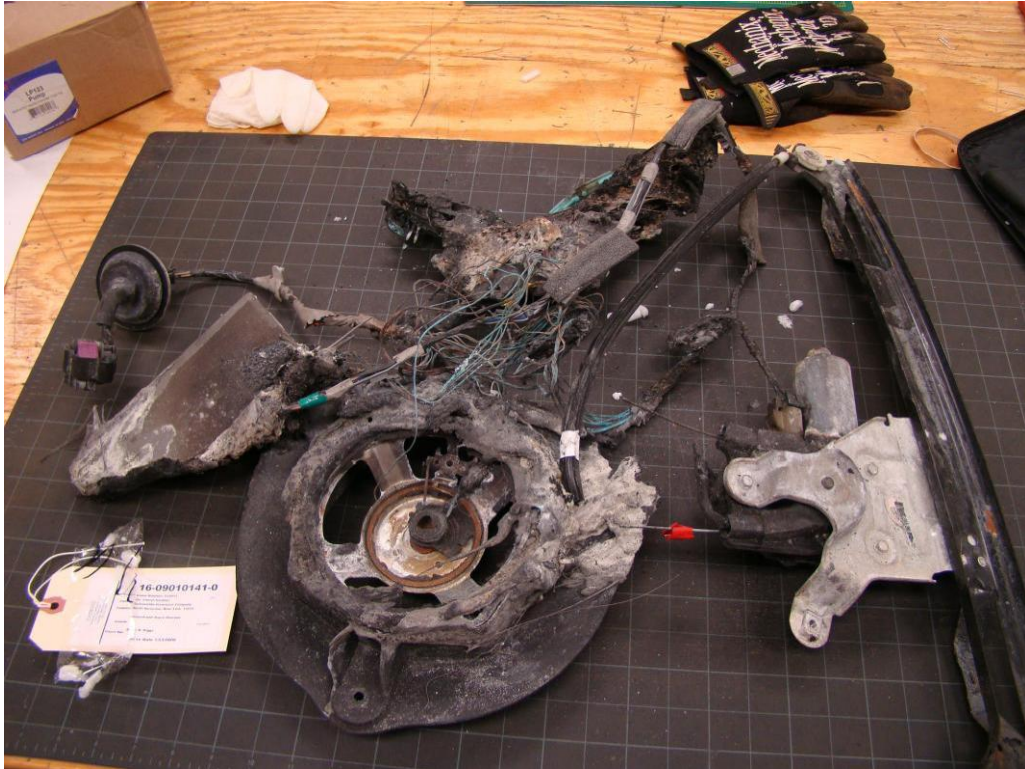
Photograph 1 The internal electrical door components.
