PE12-007

MCI

Response 10

# FULL VEHICLE TESTING AND TAG AXLE STEERING ANALYSIS

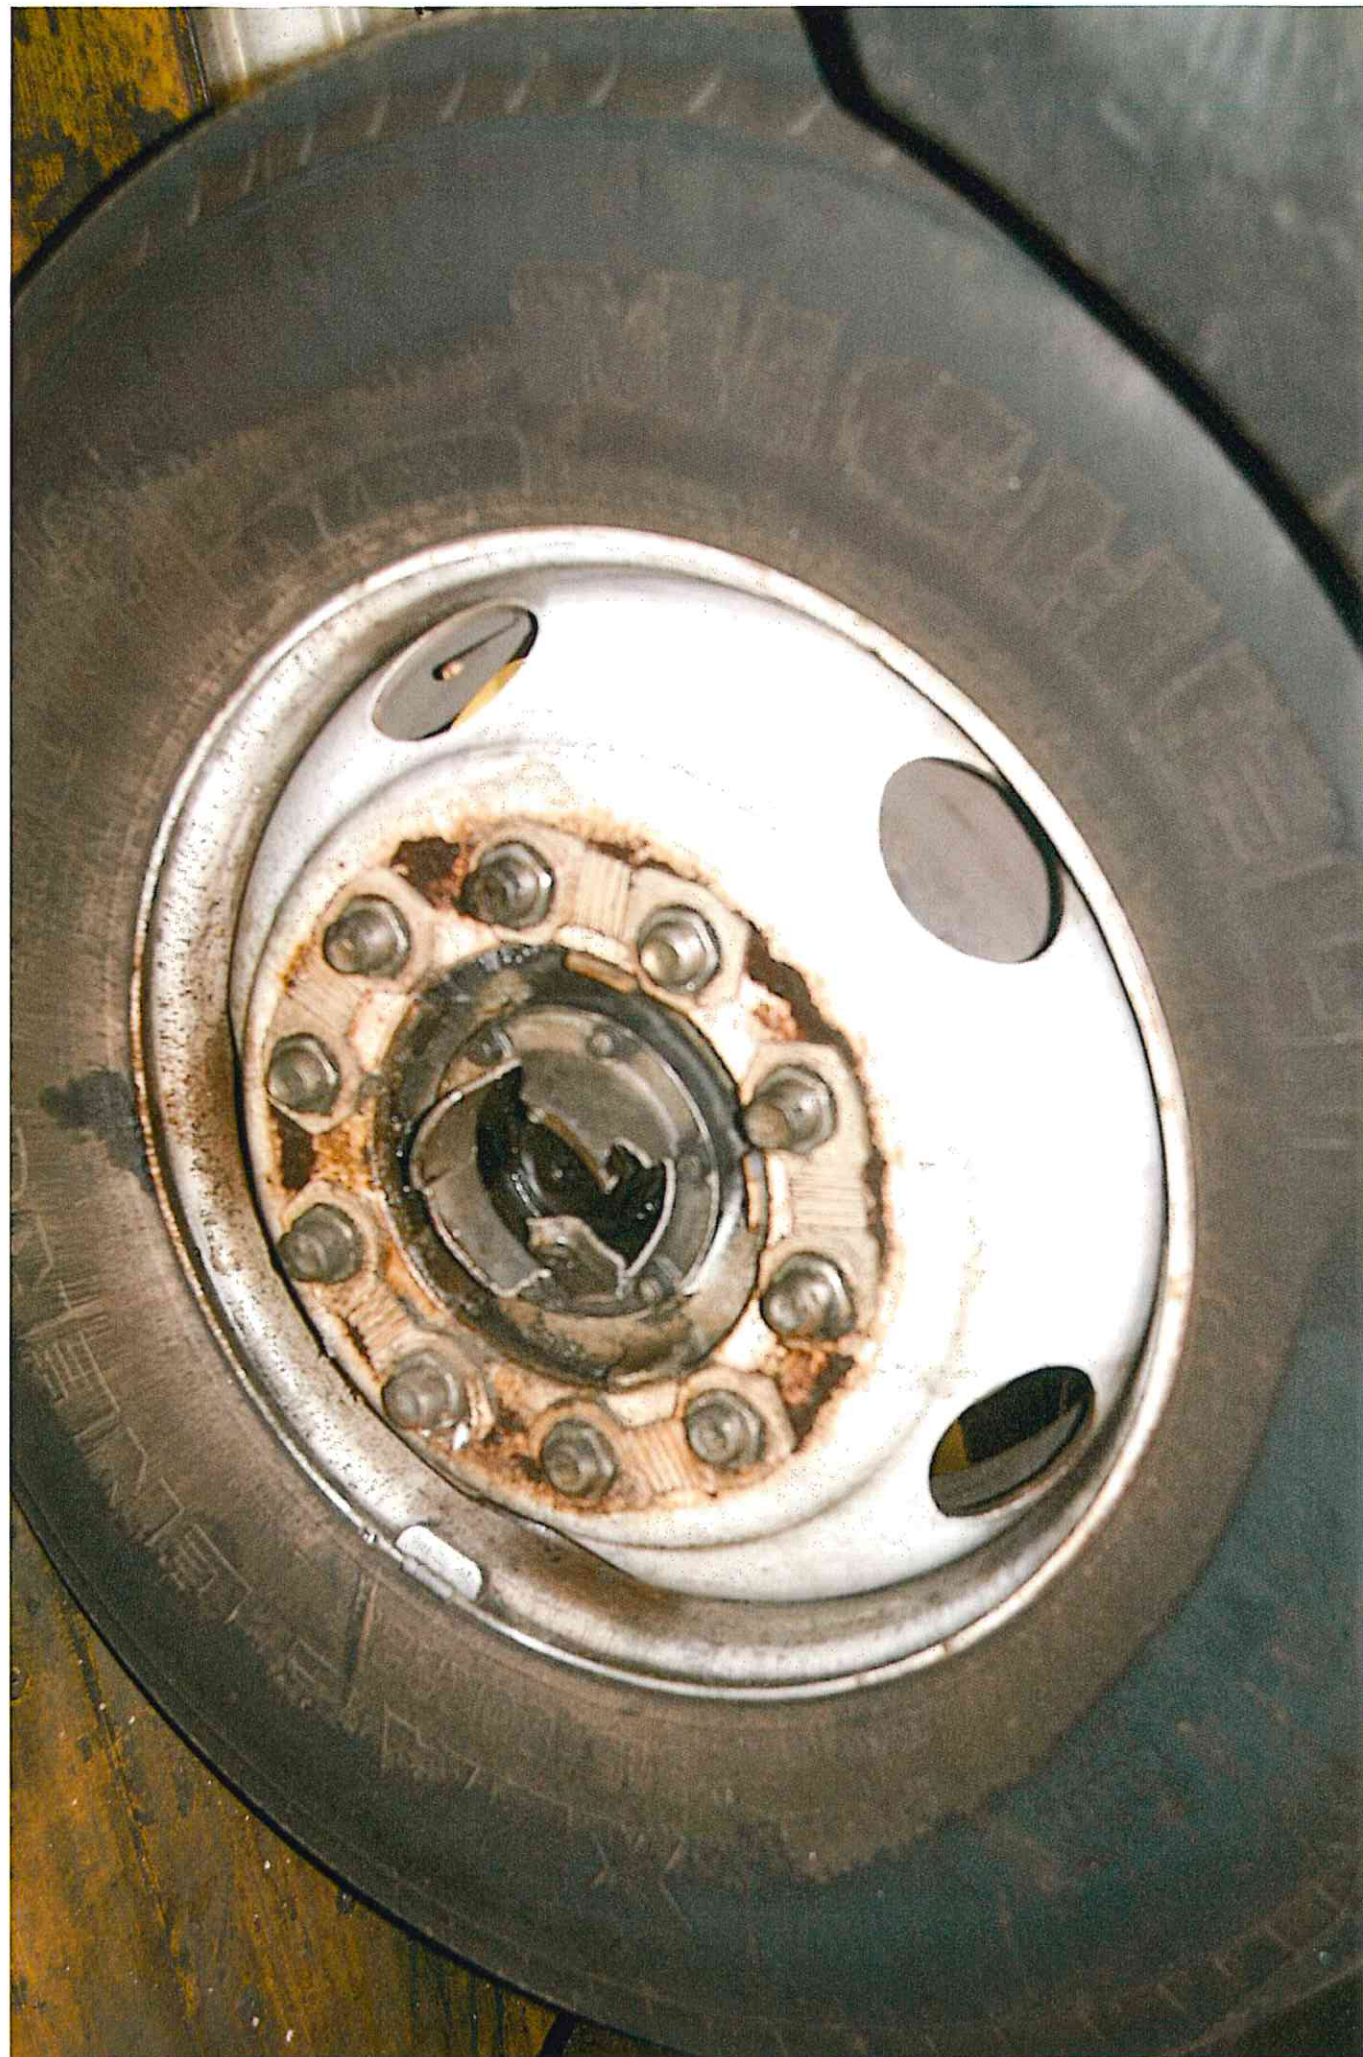
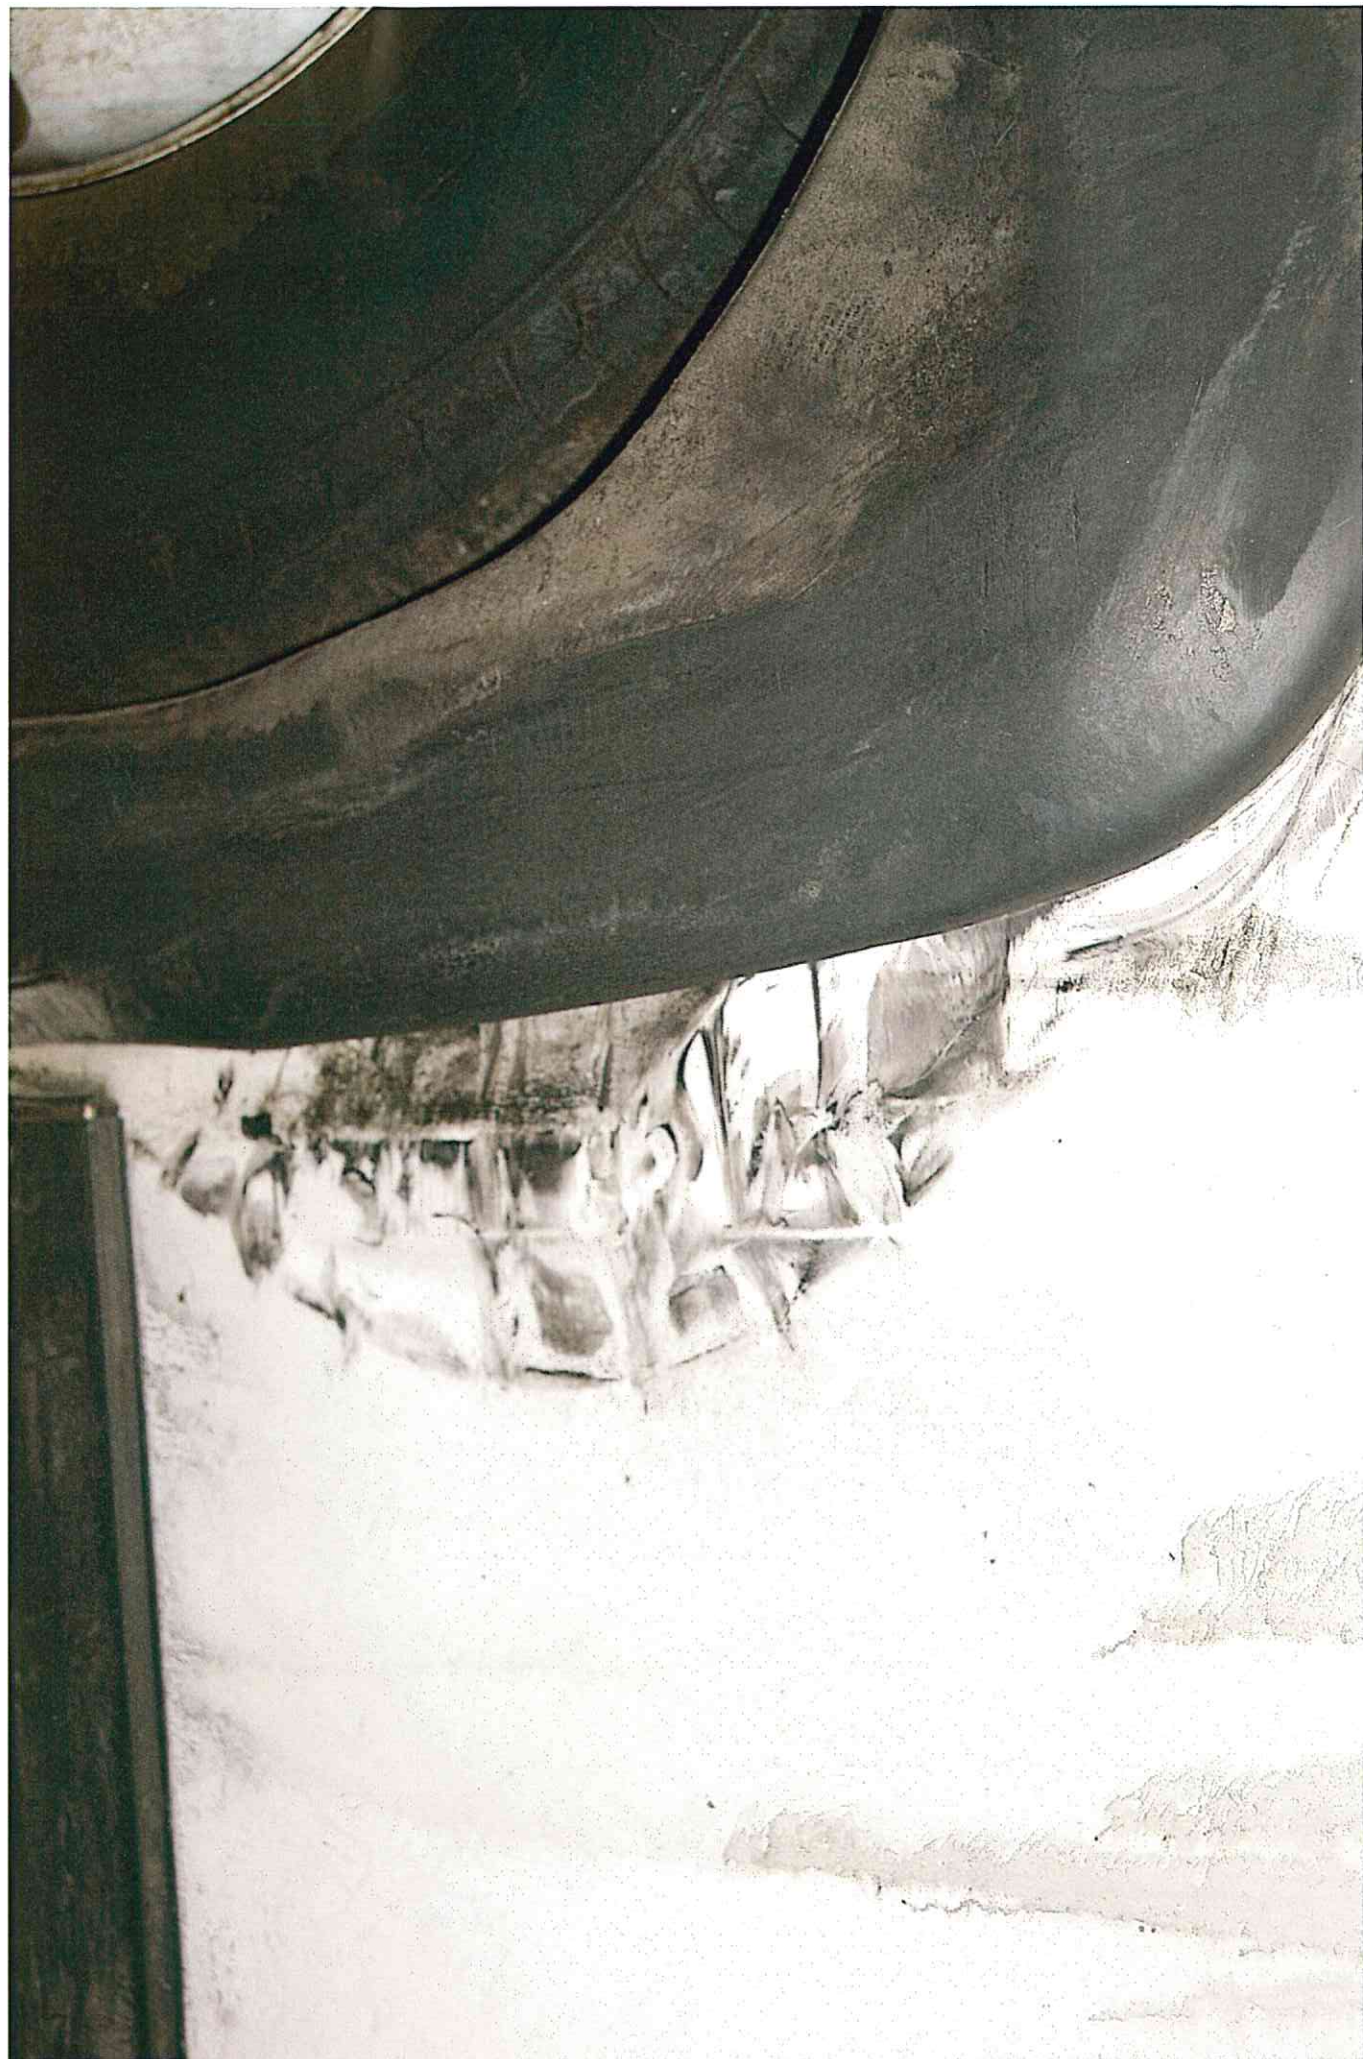
Photos - Damage Rear Drivers  
Side

**PHOTOS OF  
DAMAGE TO  
REAR  
DRIVER'S  
SIDE**

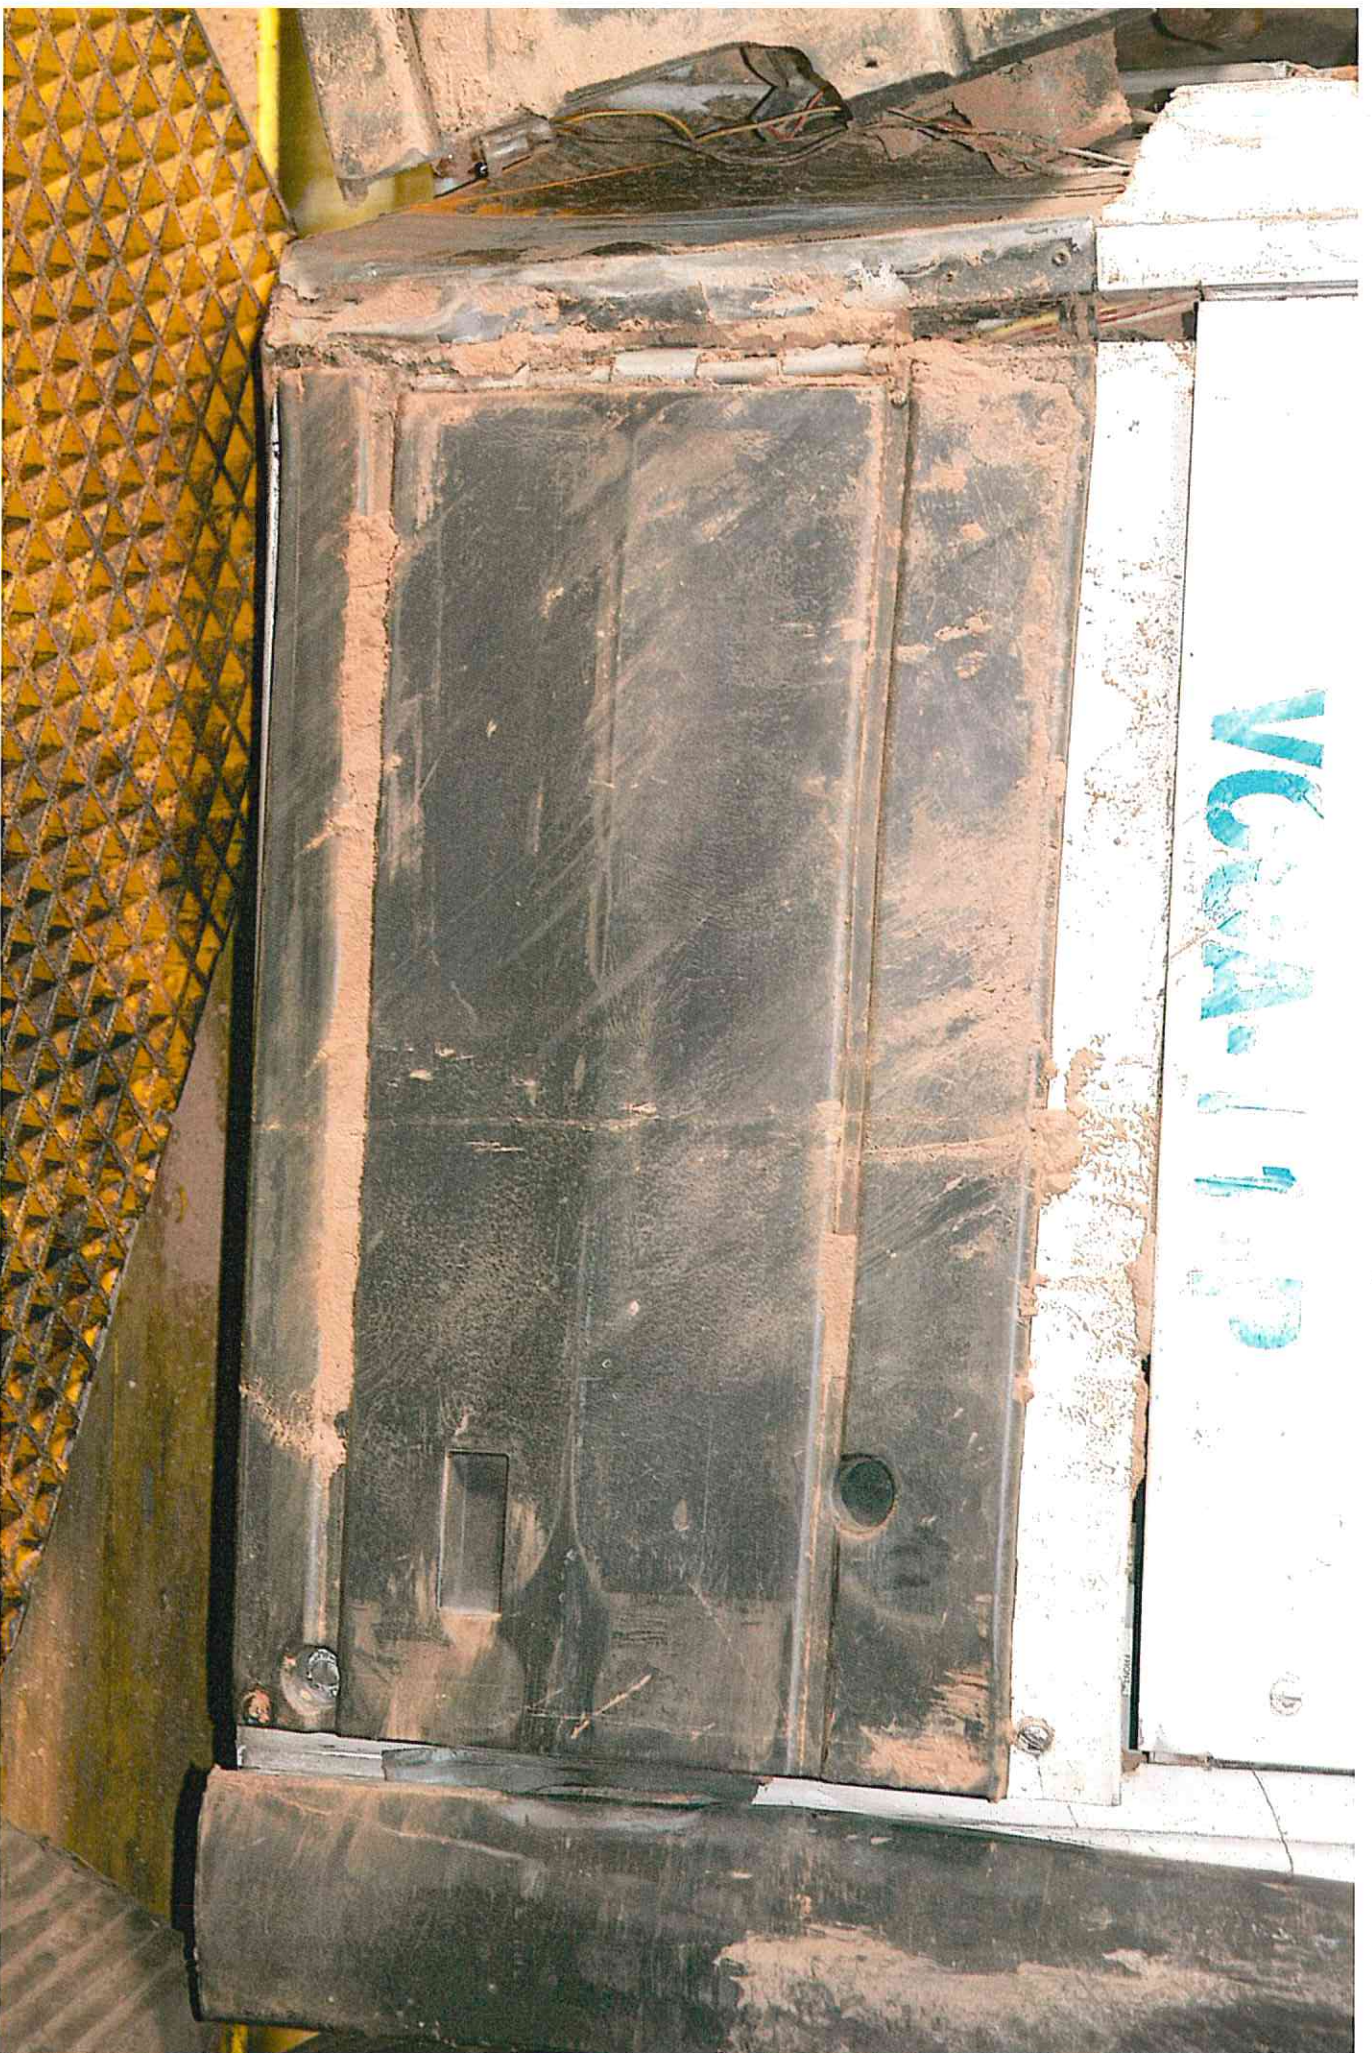
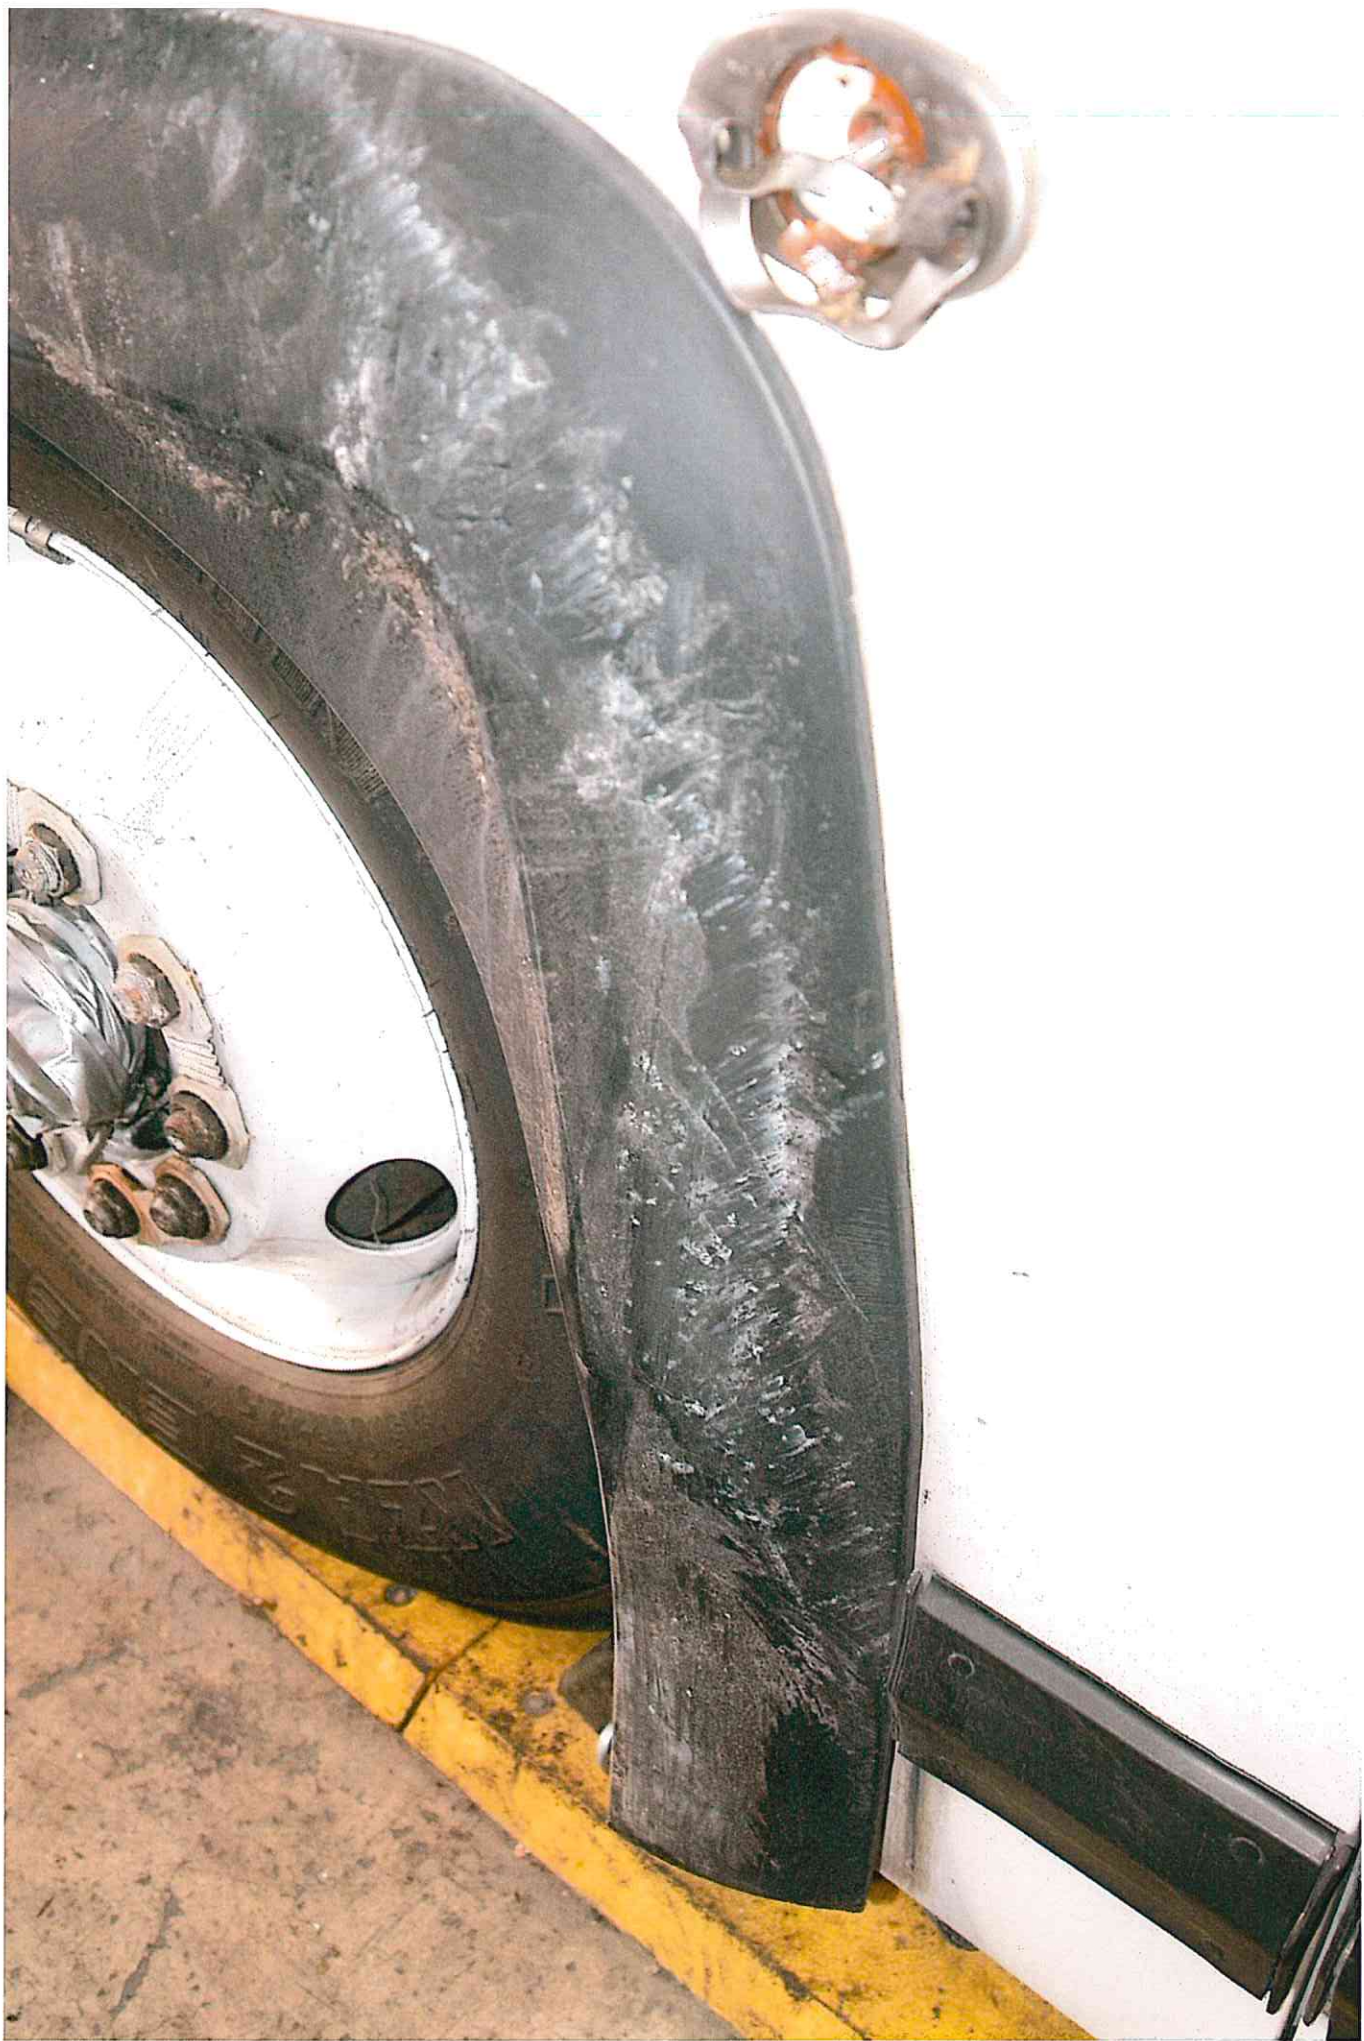
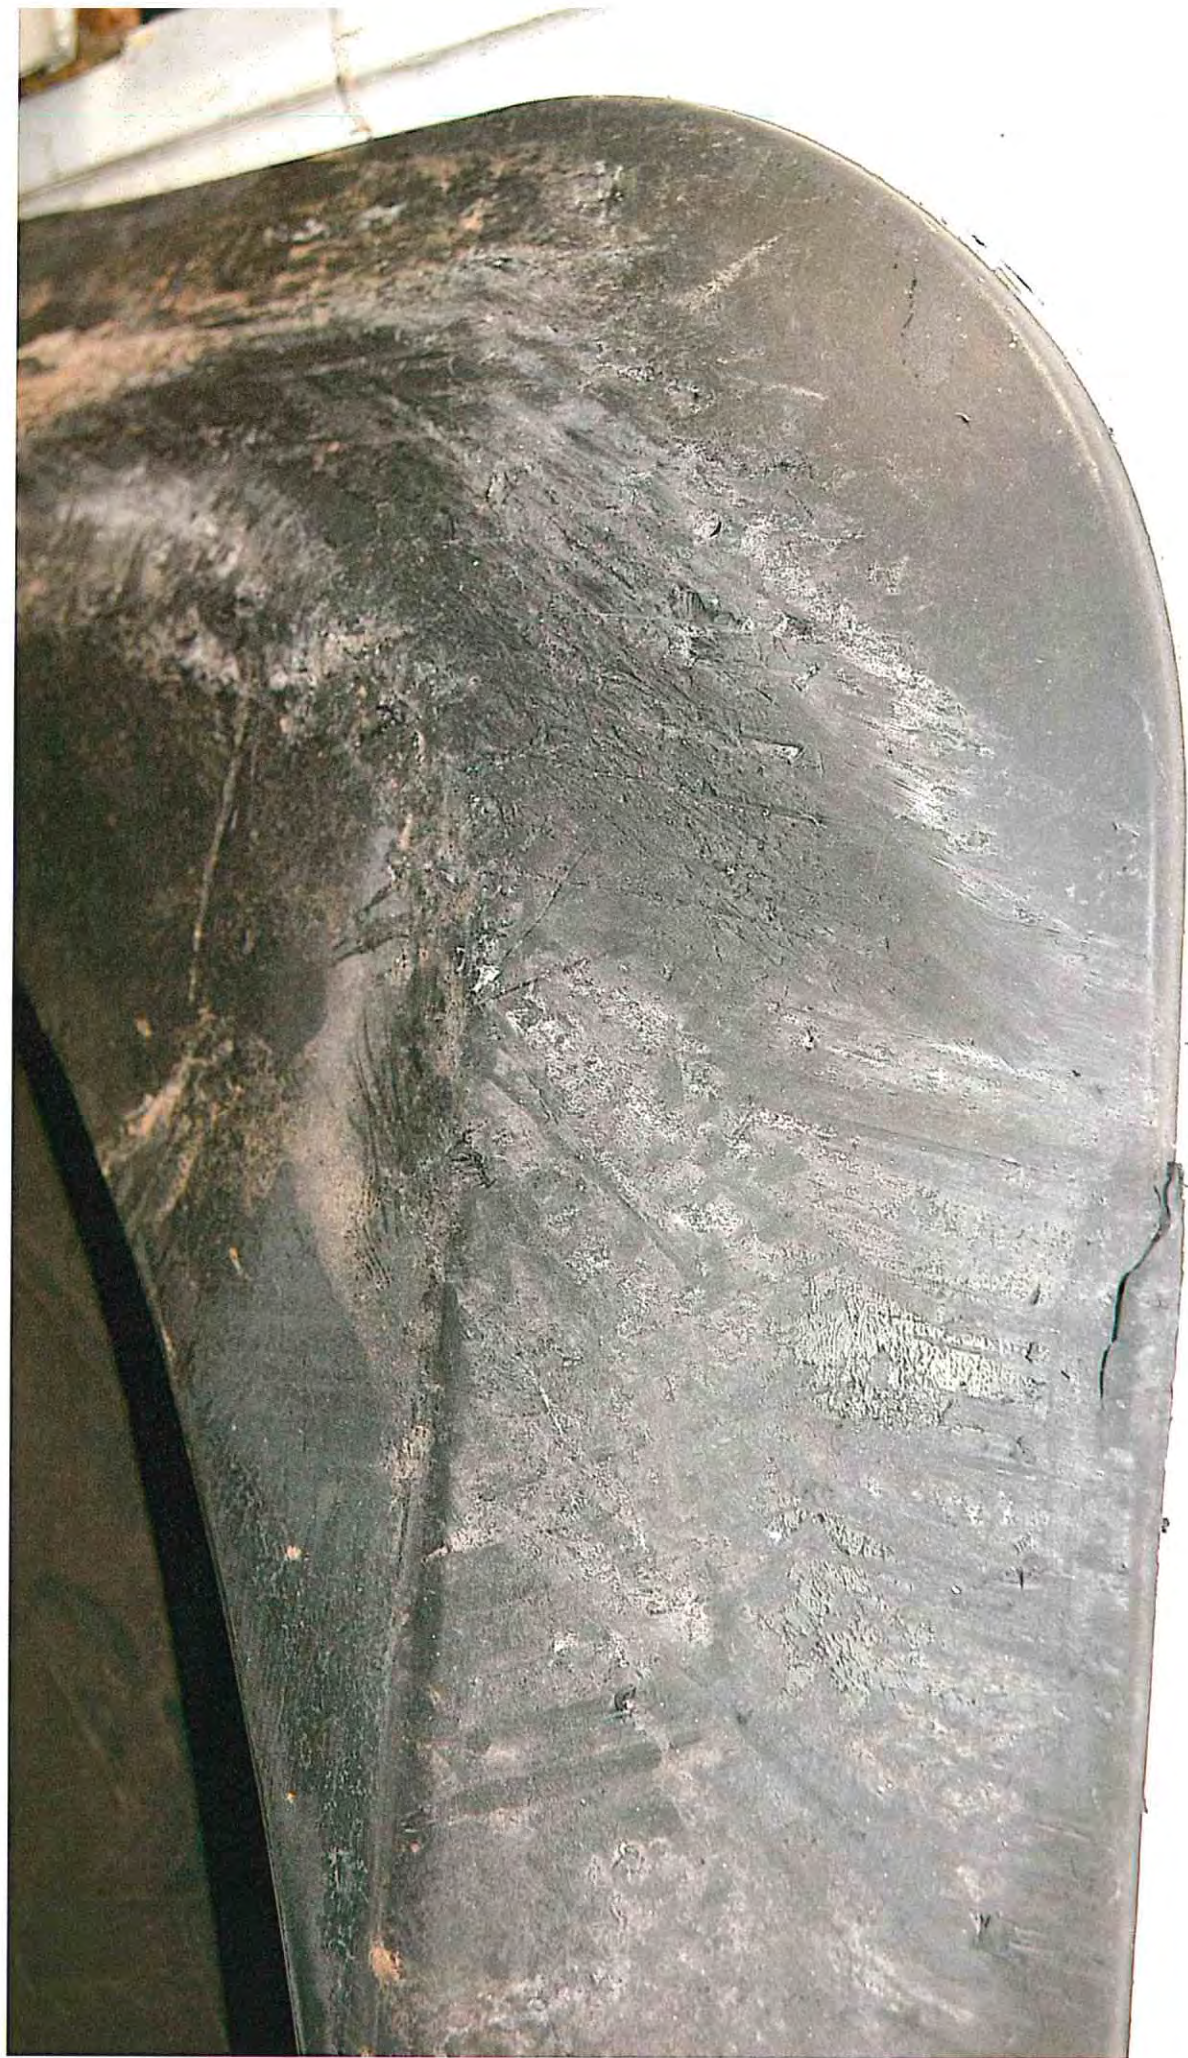
Photos - Damage to Front Left

**PHOTOS OF  
DAMAGE TO  
FRONT LEFT**

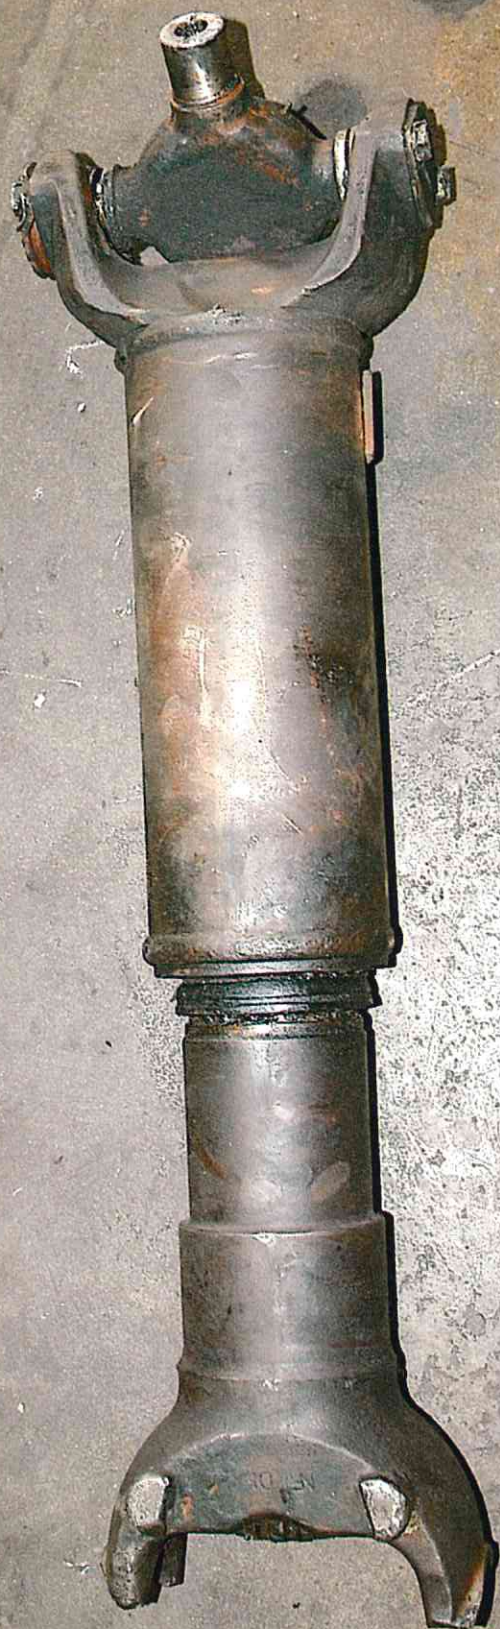
Photos of Driveshaft

# **PHOTOS OF DRIVESHAFT**
