| FTIR No : PR200702B00001 [Automobile] | | Report Date 2007 / 02 / 03 | |
| Subject | RW420 with Code B1312 High Resisance on Pass Sensor | | |
| VIN | JS2YA415X75 | Model Name | RW420 |

| Possible causal Part No. | 85101-80JS0-CNH | Possible causal Part Name | R.H. Front Seat Cushion |

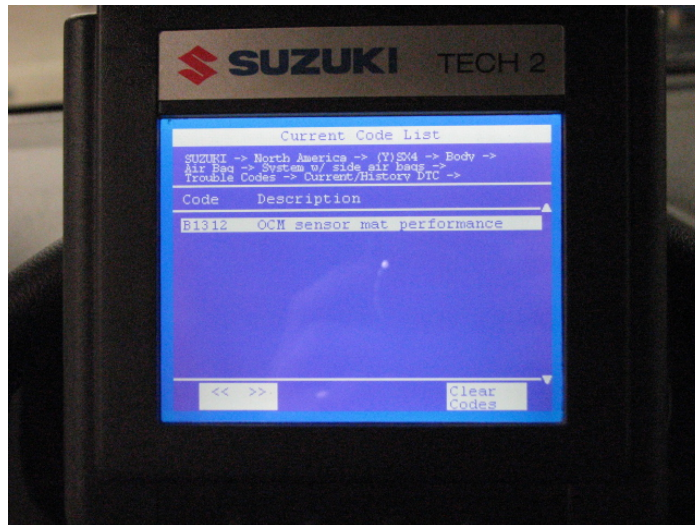
SX4 Airbag light comes on. DTC B1312

Additional data from TECH-II as shown below.

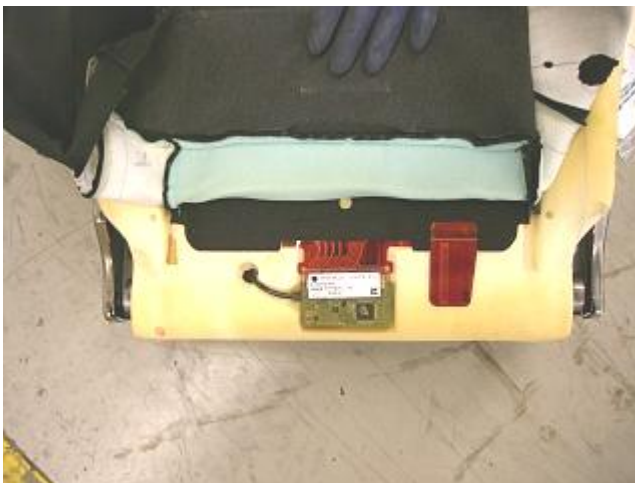
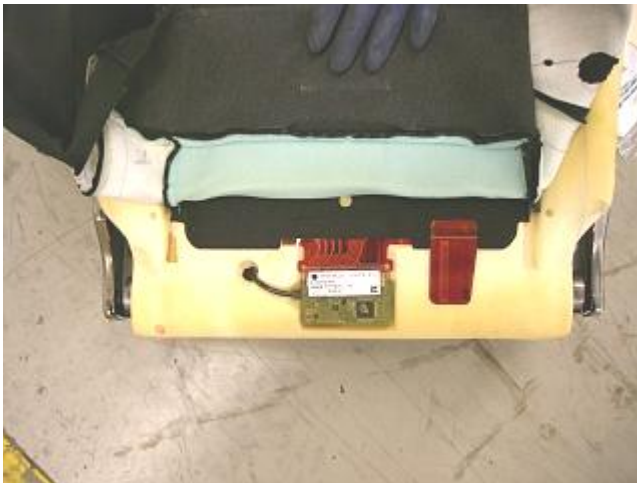
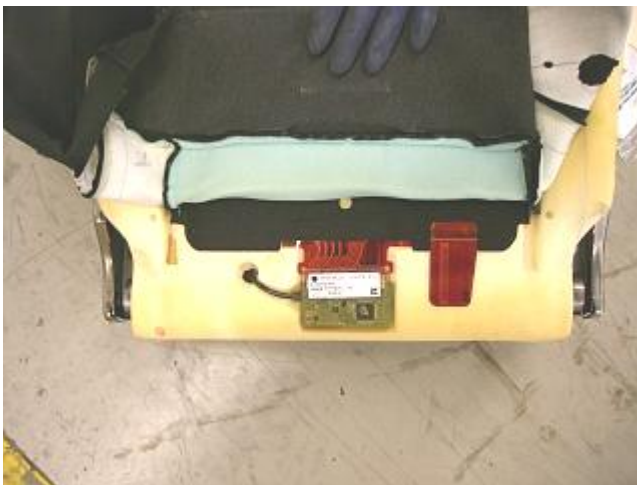
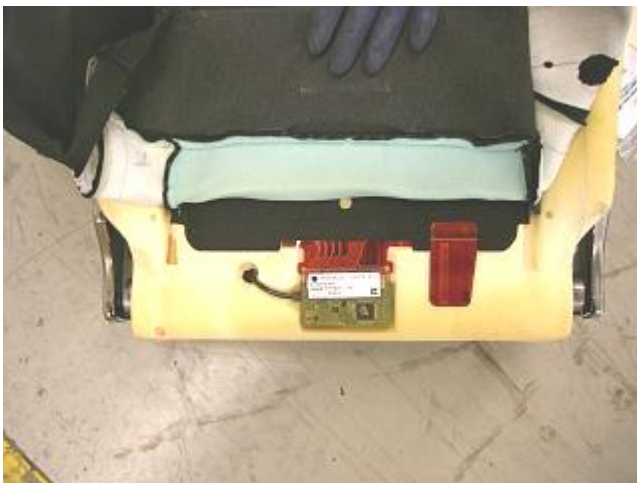
The seat cushion was installed on a known good vehicle and confirmed that the air bag light came on immediately and B1312 code stored. The DTC can not be cleared with Tech-II

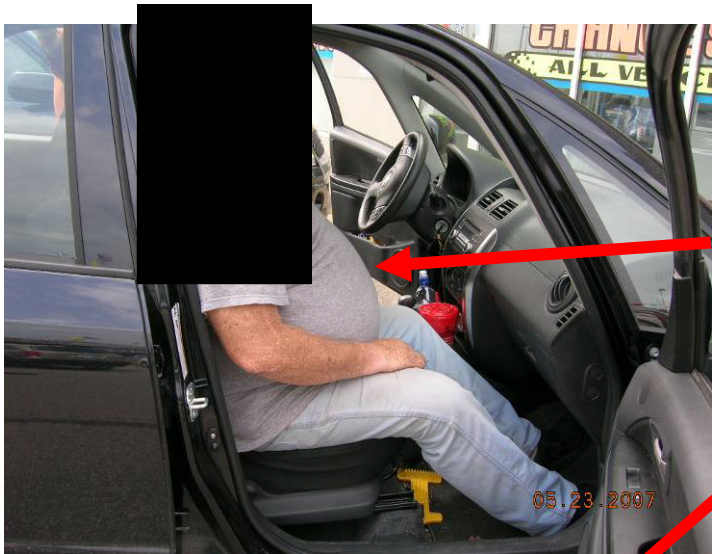
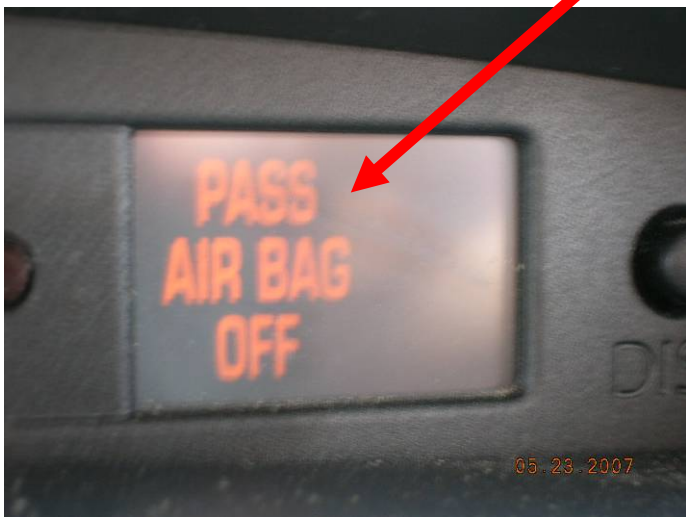
Customer in pass seat with Passenger Airbag Off indicator illuminated.

Tech2 data list shows OCM Status as: CHILD when customer is in passenger seat.

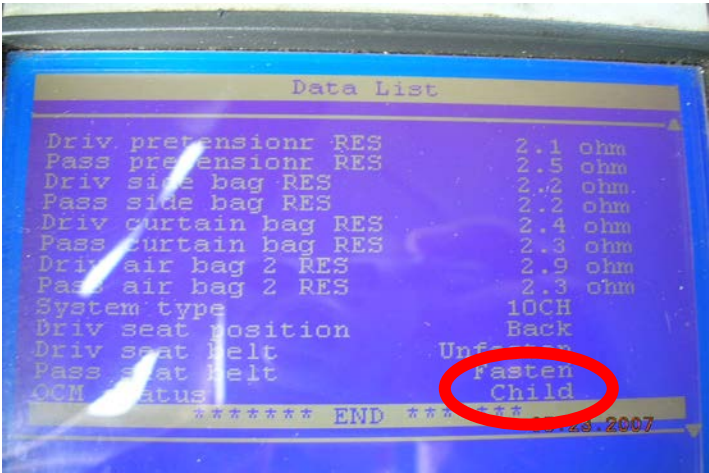
Tech2 data list shows OCM Status as: CHILD when customer is in passenger seat.

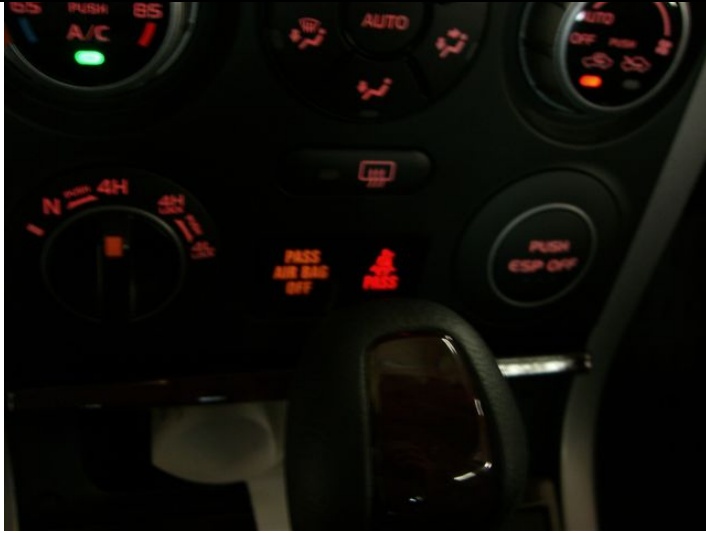
Customer complaint: Passenger "air bar off" light is on when the seat is empty.

At ASMC the incident seat was installed in a vehicle and driven for aprox. 300 miles. We were able to duplicate the issue when the seat was empty and when a laptop computer was placed in the seat. The laptop and case weigh 12 lbs.

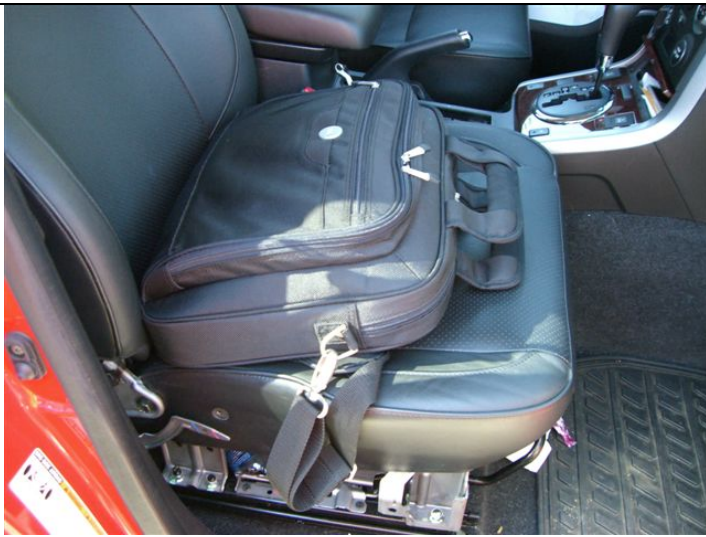
Seat with computer case. Weight is 12 lbs.

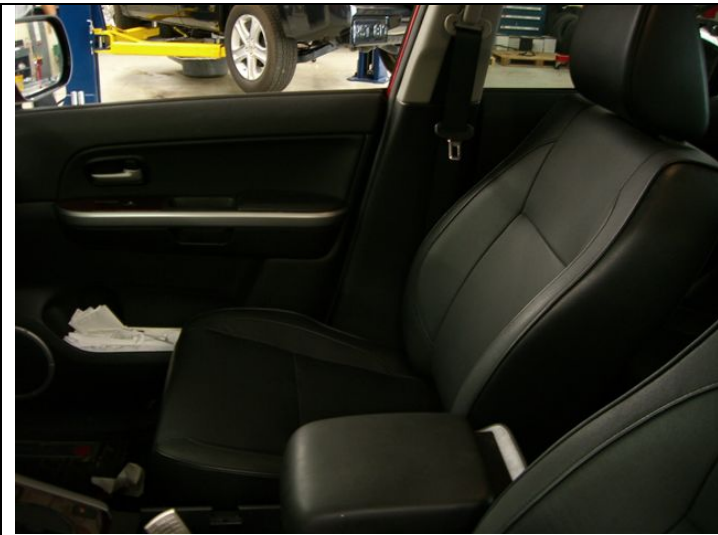
Empty seat.

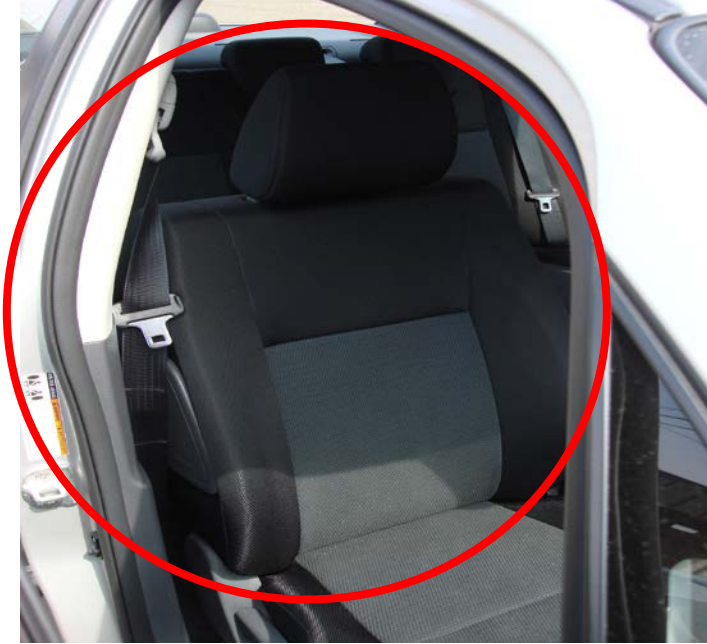
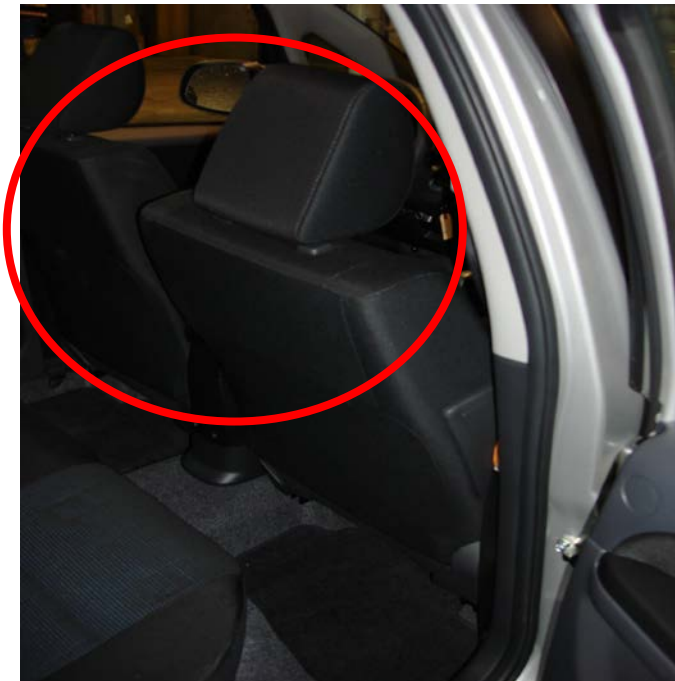
SEAT BACK ON PASS SIDE SEAT AS
COMPARED TO DRIVERS FRONT SEAT BACK.

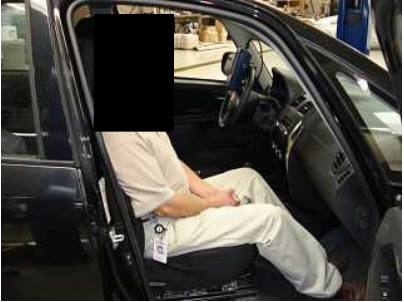
| 3 | <p>DSC02728.JPG (154kB)</p> | <p>Passenger seat position during testing.</p> | |

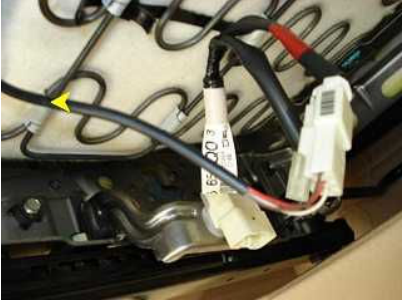
| 4 | <p>DSC02735.JPG (40kB)</p> | <p>The yellow arrow shows the mat harness where the two pinched marks are.</p> | |

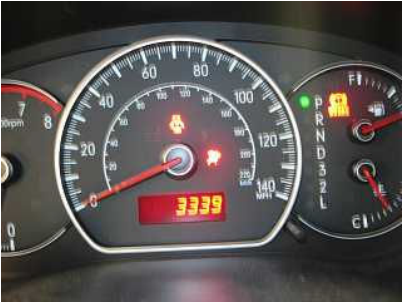
| What? | OCM mat sensor failure. | | |

| No. | File Name | File Description | |
|---|---|---|--|
| 1 | DSC02745.JPG (152kB) | Air bag light came on when nobody is sitting in the passenger seat. | |

| Feedback | <p><Root Cause> Partially strong force was added on OCS(Occupant Classification System) and as the result, crack was arisen on printed wiring in OCS(Occupant Classification System) .</p> <p><Countermeasure> Graphite for reinforcement on printed wiring have been removed and flexibility of printed wiring have been improved.</p> <p><Effective Vehicle and Date> Vehicle Name Date Grand Vitara and SX4 2008.06.02</p> |

| Course of action | Replaced seat cushion assembly. | | |

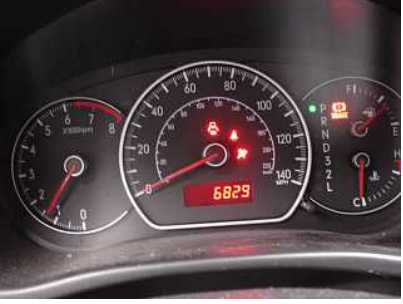
| Possible cause of Incident | Possibly the OCM sensor failed. | | |

| No. | File Name | File Description |
|---|---|--|
| 1 | DSC03173.JPG (151kB) | The air bag warning light is on when the engine running. |

| Course of action | Replaced seat cushion assembly. | | |

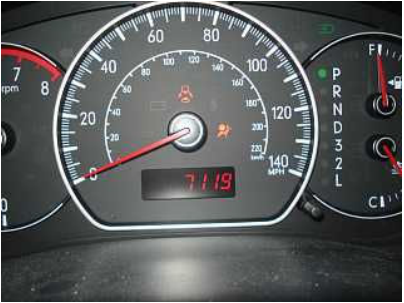
| Checked result | <p>After installation of the incident seat cushion the airbag light came on right away and found DTC B1312. Cleared code.</p> <p>After clearing the code the vehicle was driven for two days and the airbag and the passenger seat belt warning light came at the same time when nobody was sitting in the passenger seat and the seat belt was unbuckled at the passenger side.</p> <p>The passenger seat belt warning light went out after the engine shot off and restarted but the airbag light stayed on.</p> | | |

| No. | File Name | File Description | |
|---|---|---|--|
| 1 | DSC03190.JPG (145kB) | Airbag light is on. | |

| Course of action | Replaced seat cushion assembly. | | |
