Subject: 71-1035097733 PAR Case Sent to ESIS - No Action Required

A product allegation claim has been made in your region. The customer is alleging airbag nondeployment, wheels locked up and Onstar inoperative in a collision . This case is being escalated to ESIS because insurance involvement.

██████████
2012 Chevrolet Sonic
1G1JC5SHXC4██████████
CENTURY III CHEVROLET, WEST MIFFLIN PA (BAC) 113496
Kevin Codd, Body Shop Manager

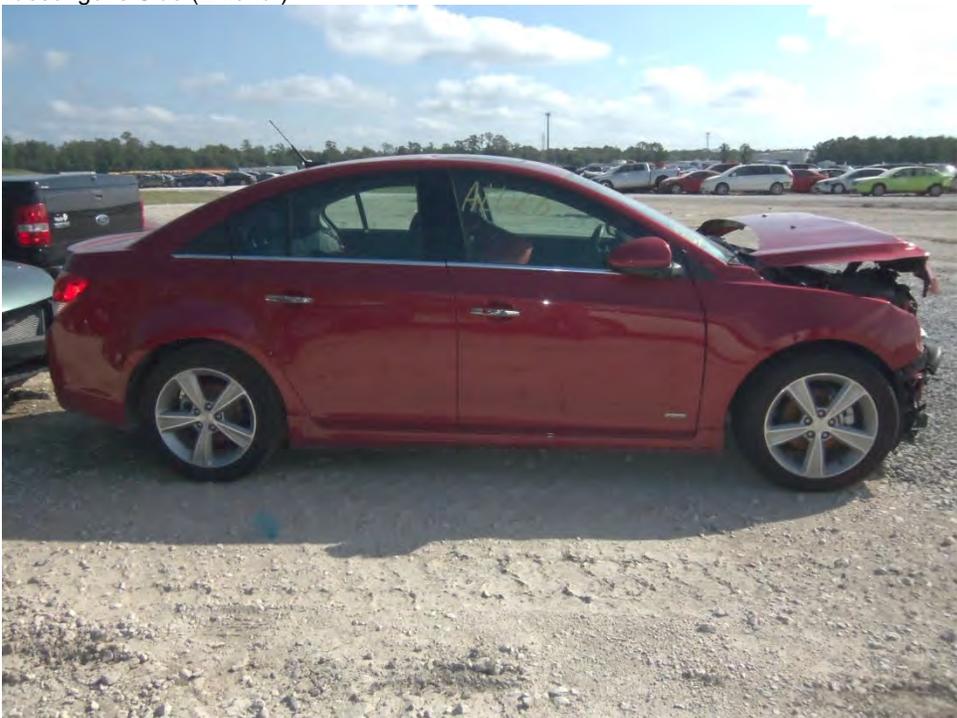
<p>Yes, Right front fender crushed.</p>

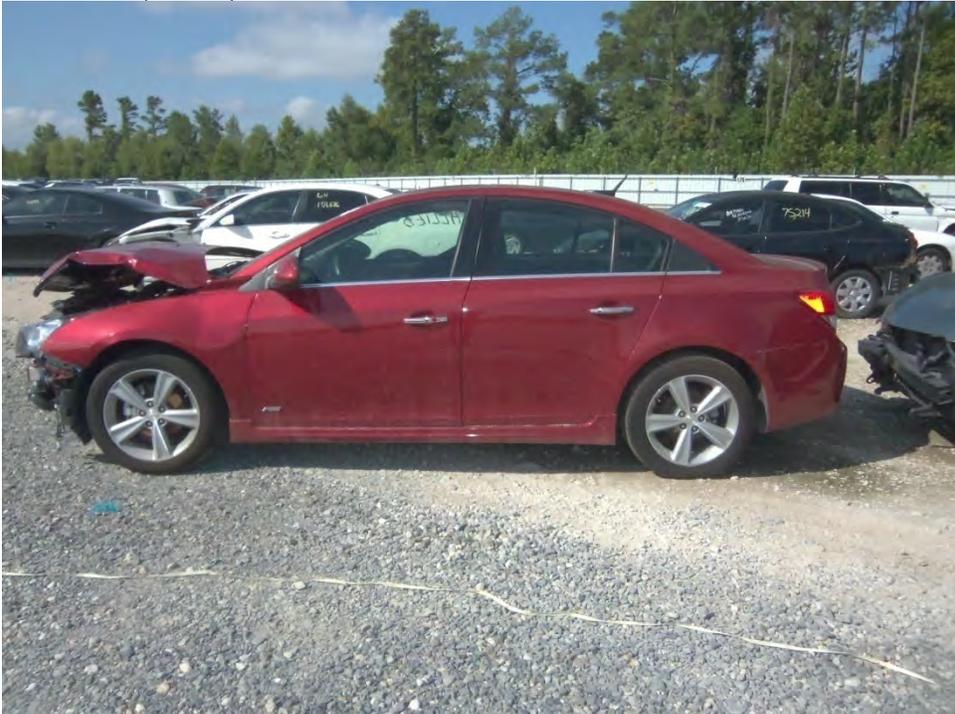
Yes, Entire front clip crushed towards the left front right front impact. Fender contacted left front door.

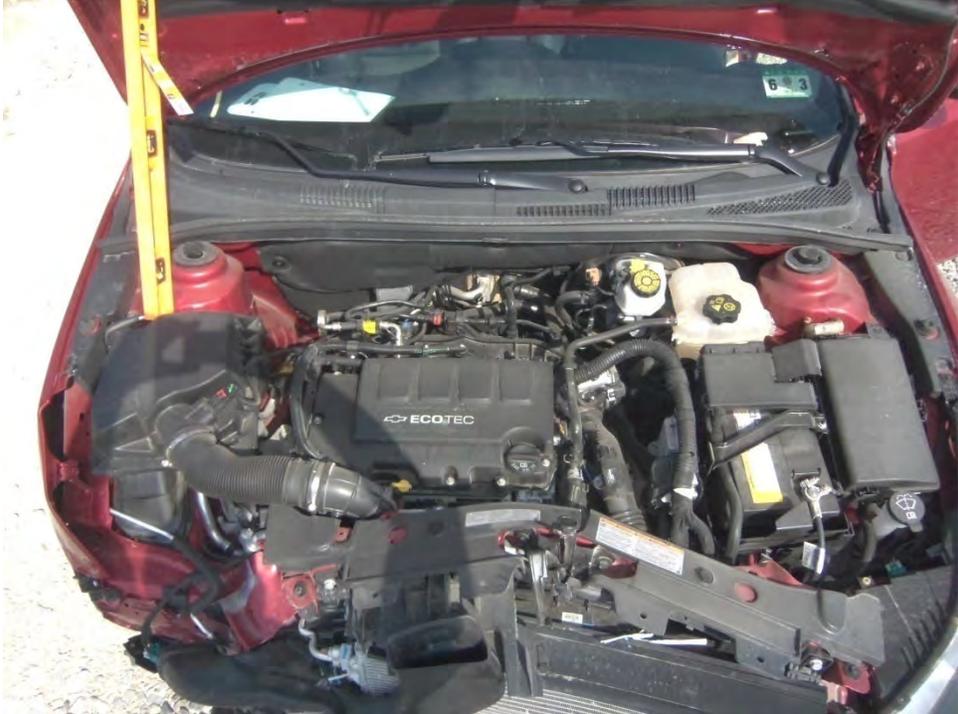
<p>Yes, Frontal angular impact of approximately 4-6' of crush from right to left, 35-40 degrees.</p>
10	<p>Driver's Side (Interior)</p>

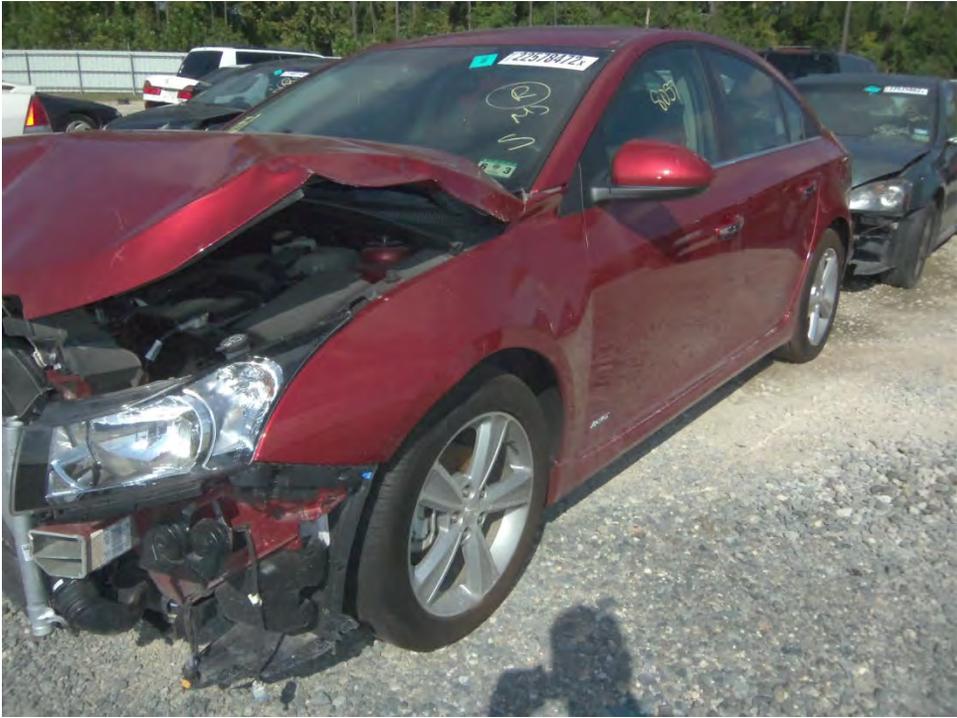
<p>Yes, Entire front clip crushed towards the left front right front impact. Fender contacted left front door.</p>
16	<p>Right Front Quarter View.</p>

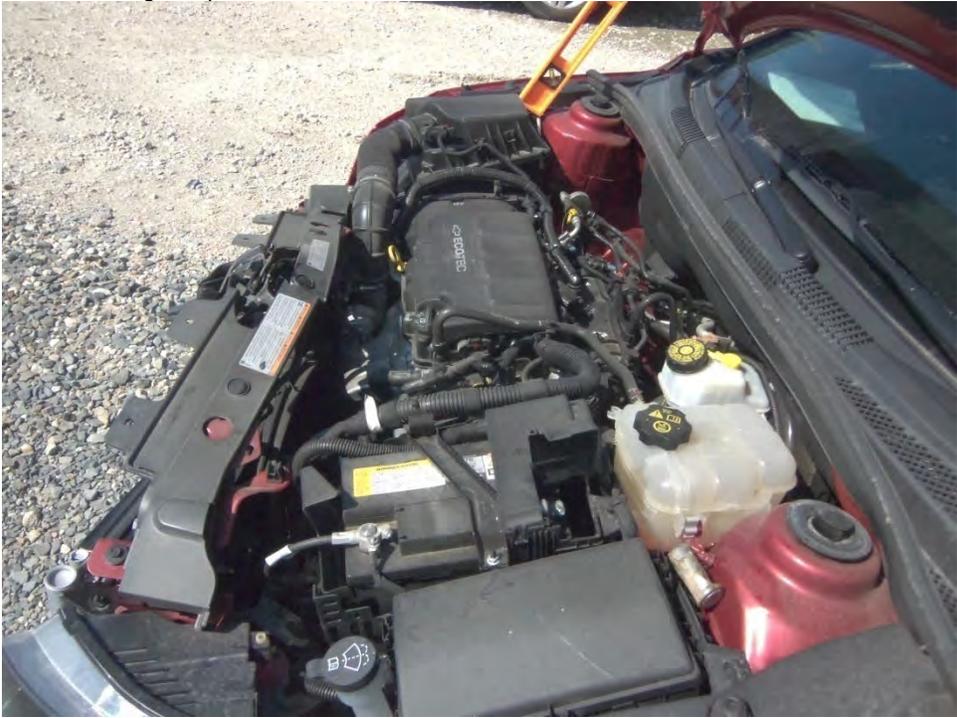
Yes, Frontal angular impact of approximately 4-6' of crush from right to left, 35-40 degrees.
20	Under Hood Impact Damage Inspection.

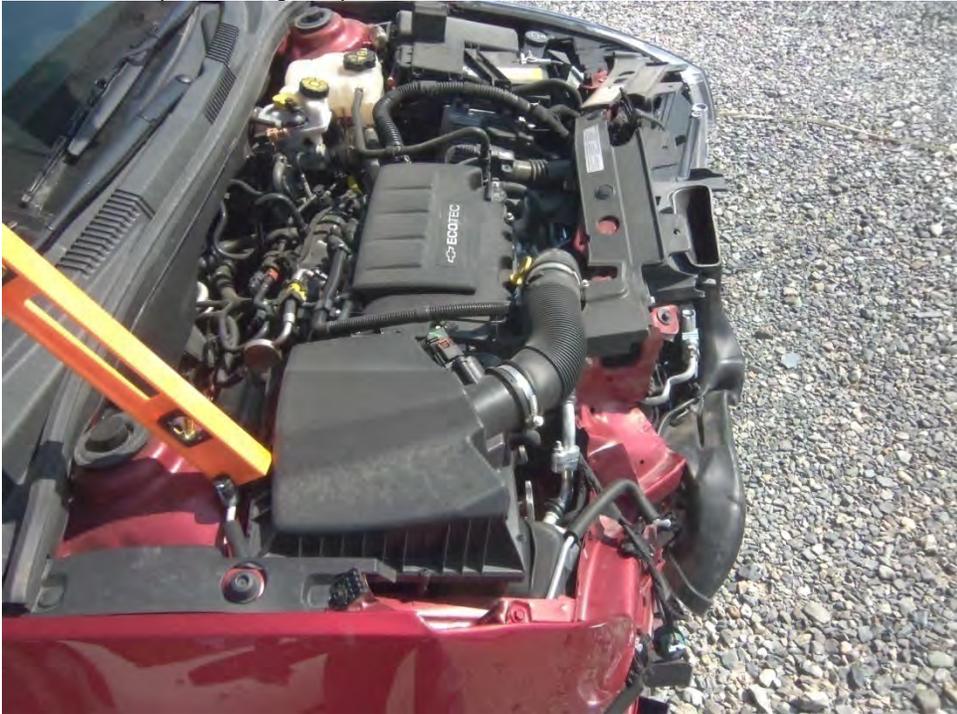
Yes, Frontal angular impact of approximately 4-6' of crush from right to left, 35-40 degrees.

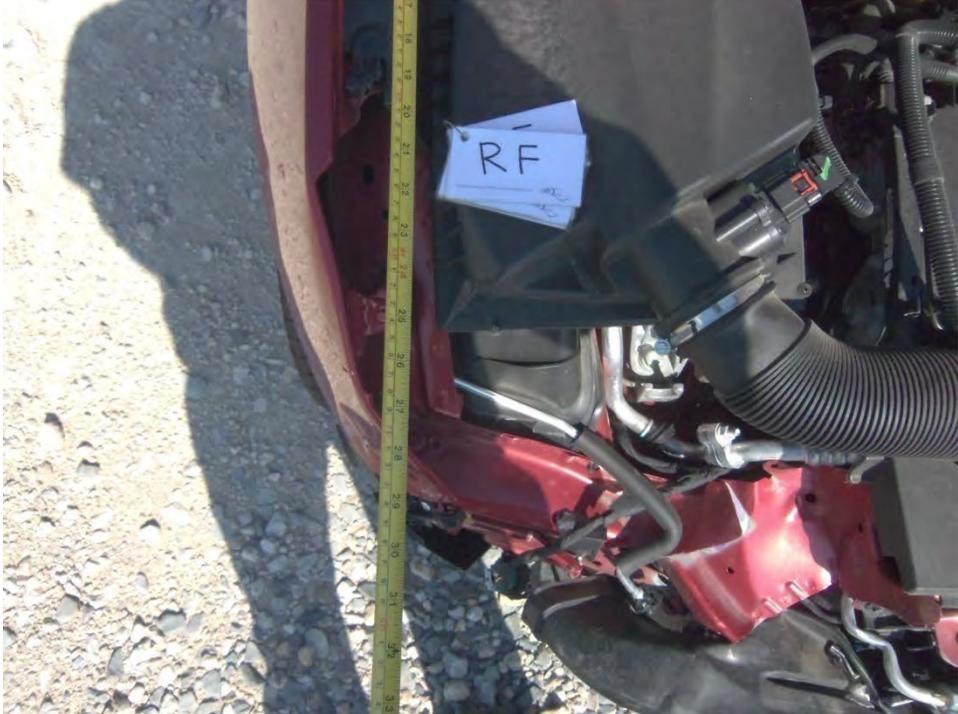
<p>Yes, Right front fender impact crush of 4-6".</p>
22	<p>Under Hood Damage, Right Side.</p>

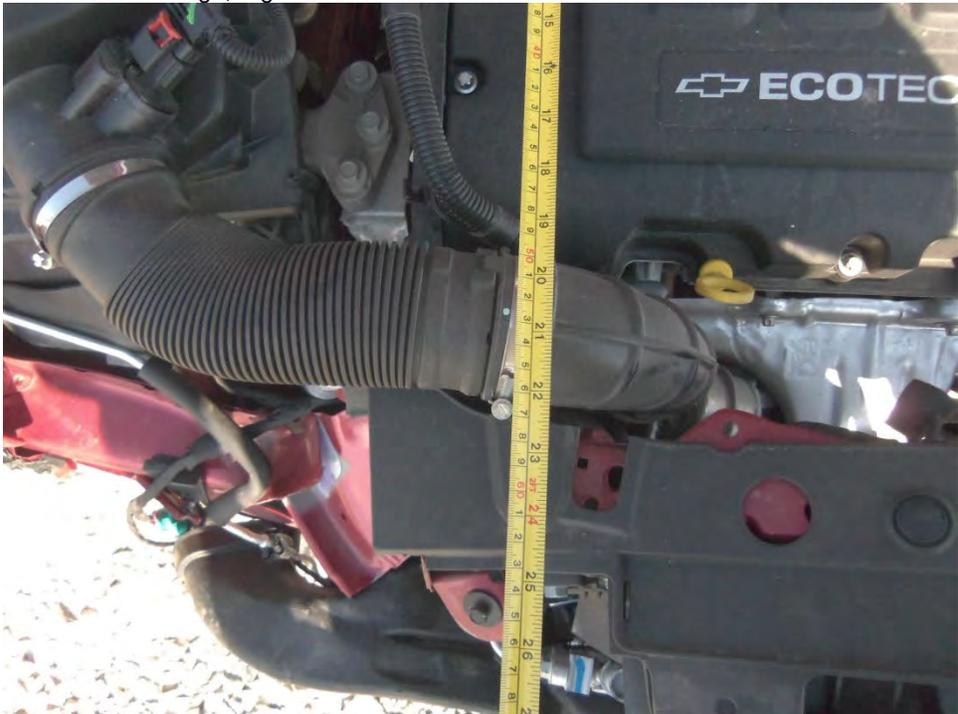
<p>Yes, Right front upper core support crushed inward 3-4".</p>

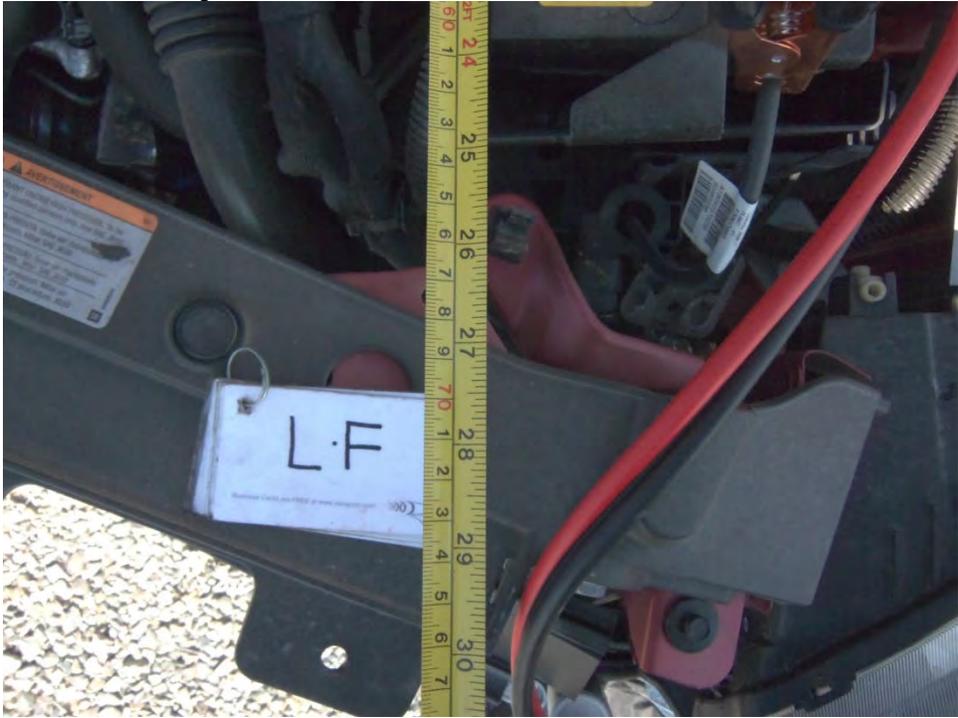
<p>A photograph showing the left side of the engine compartment. A yellow measuring tape is held vertically against a black plastic component. A white tag with 'L.F.' is attached to the component. The tape shows a measurement of approximately 1.5 inches.</p>	<p>Yes, Crushed inward 1-2".</p>
24	<p>Under Hood Damage, Left Front Fender.</p>

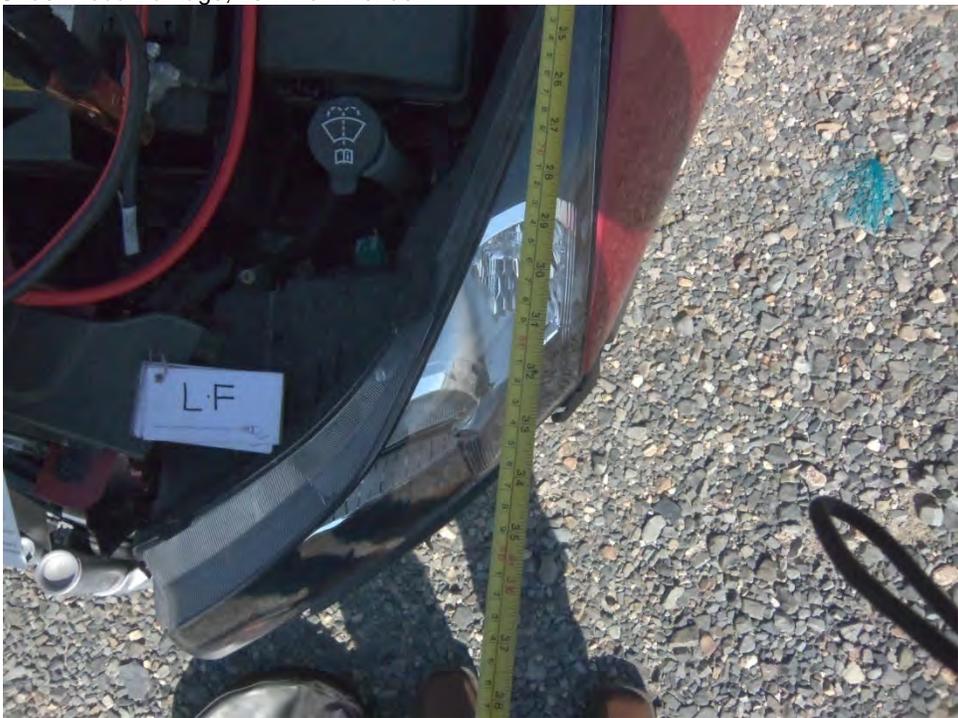
<p>A photograph showing the left front fender area under the hood. A yellow measuring tape is held vertically against the fender. A white tag with 'L.F.' is attached to the fender. The tape shows a measurement of approximately 1.5 inches.</p>	<p>Yes, Missing front bumper fascia.</p>

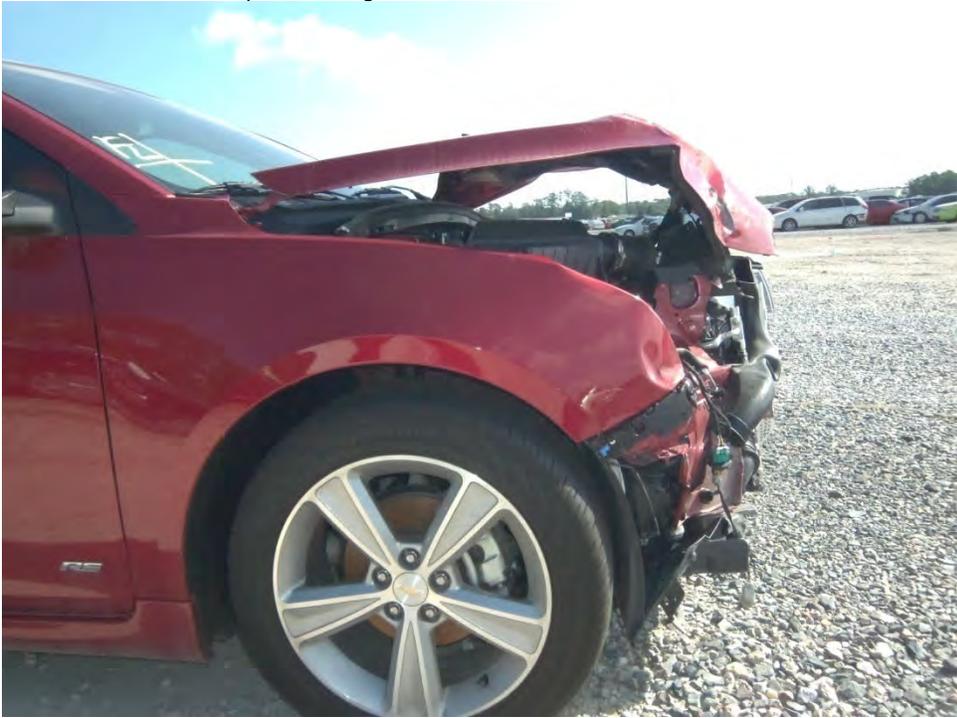
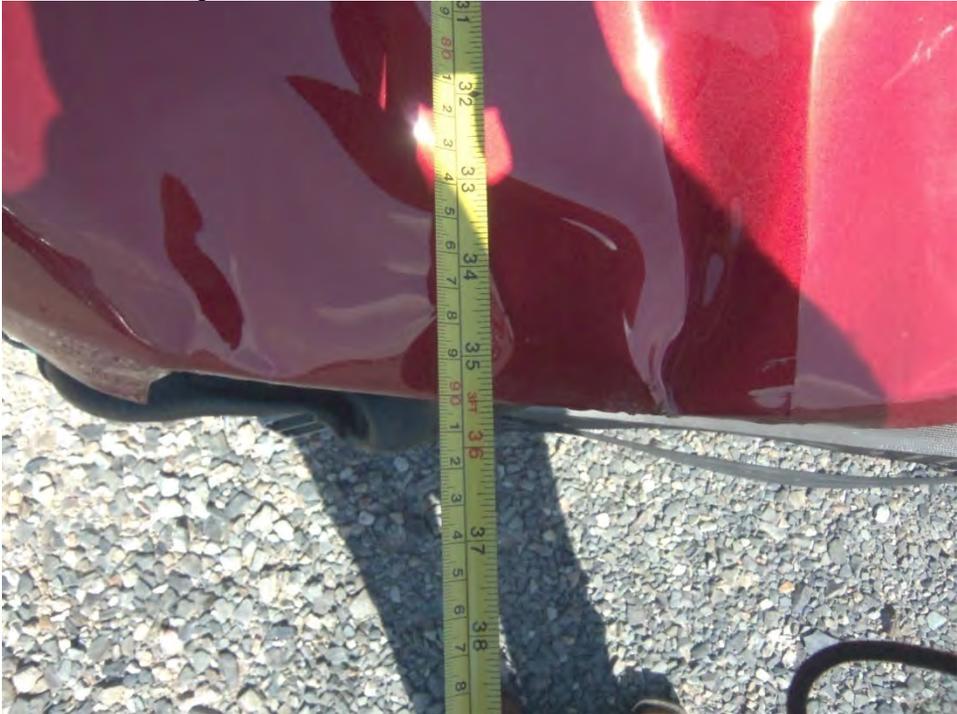
Yes, Hood crushed 6-8".

- The hood impact damage is located at the front leading edge with impact crush damage of approximately 6-8", however, the hood did not contact the windshield (see photos #25 & 26).

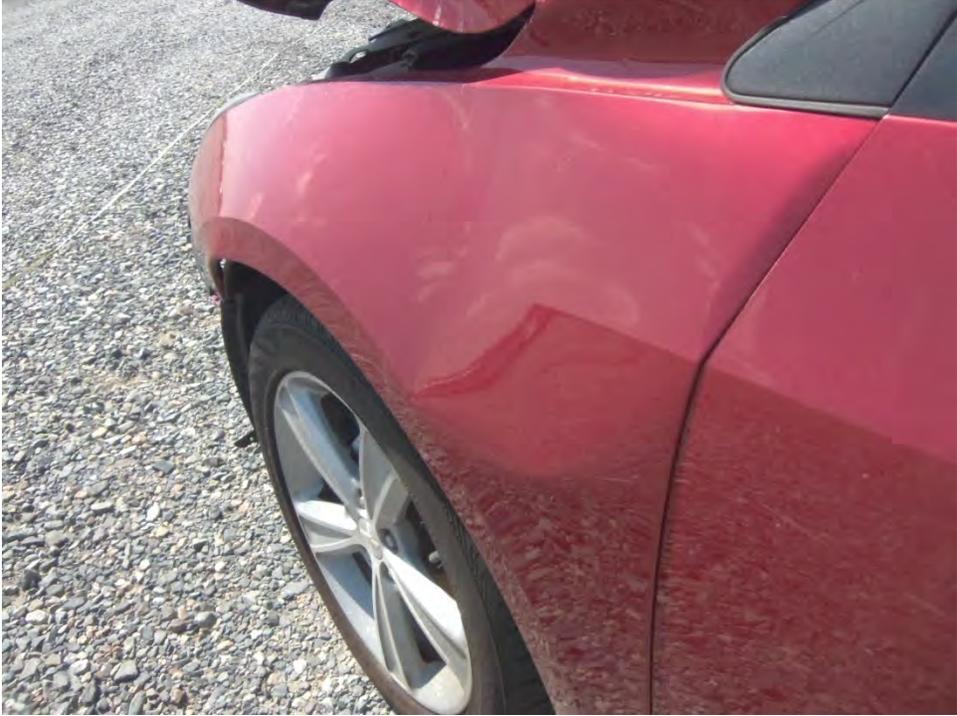
<p>Yes, Entire front clip crushed towards the left front right front impact. Fender contacted left front door.</p>
28	<p>Frontal Angular Impact at Approximately 35-40 degrees From the Right Front Area</p>

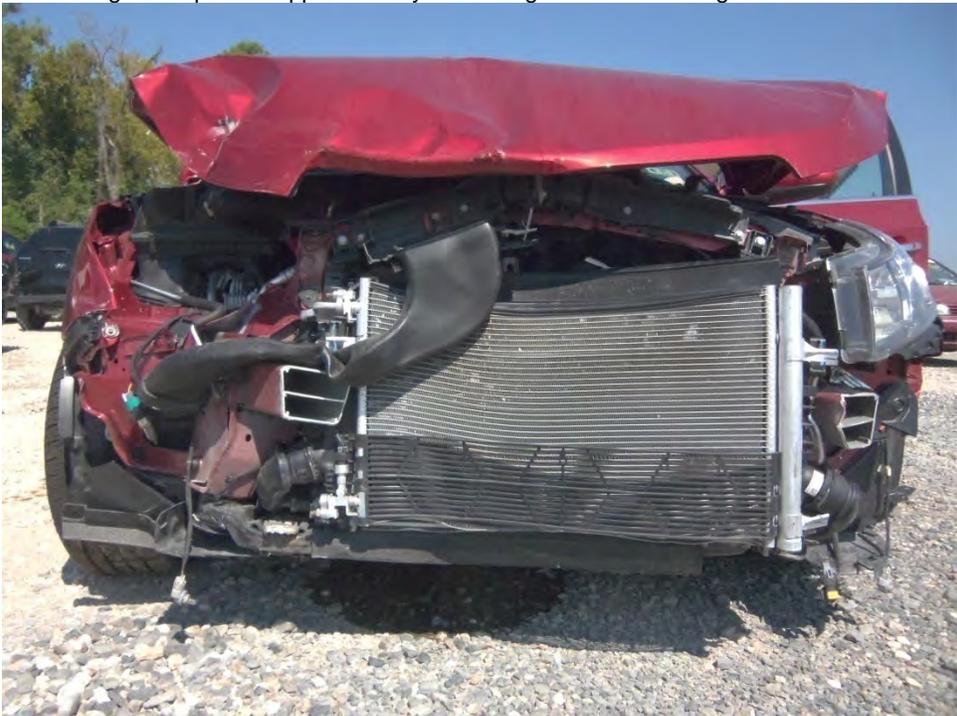
<p>Yes, Frontal angular impact of approximately 4-6' of crush from right to left, 35-40 degrees.</p>

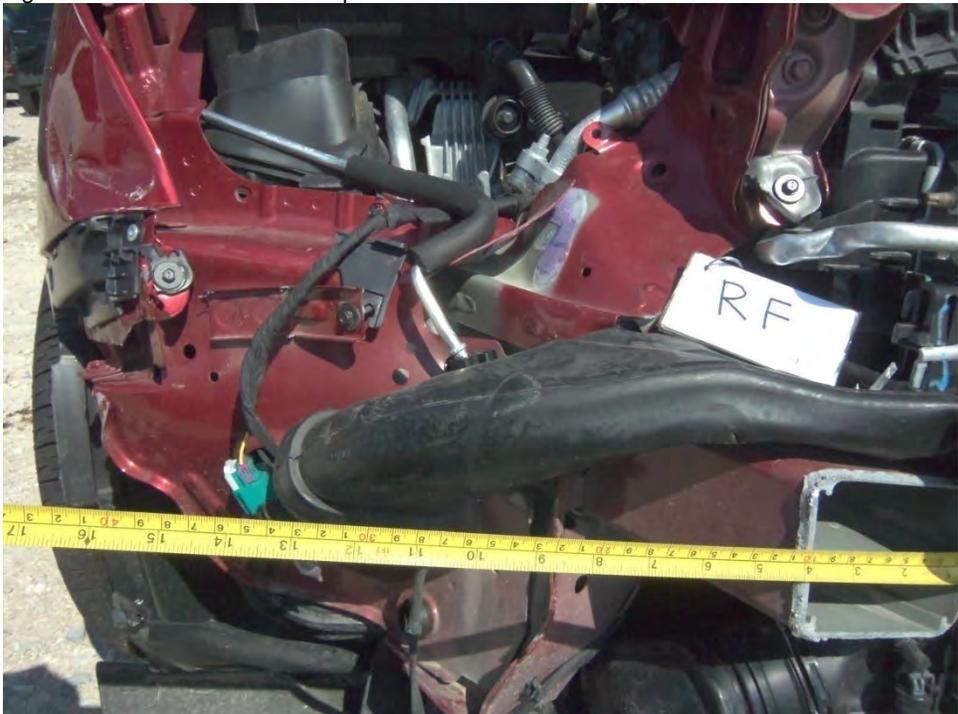
<p>Yes, Right front frame horn/final bent towards left 4-6".</p>
30	<p>Left Front Suspension</p>

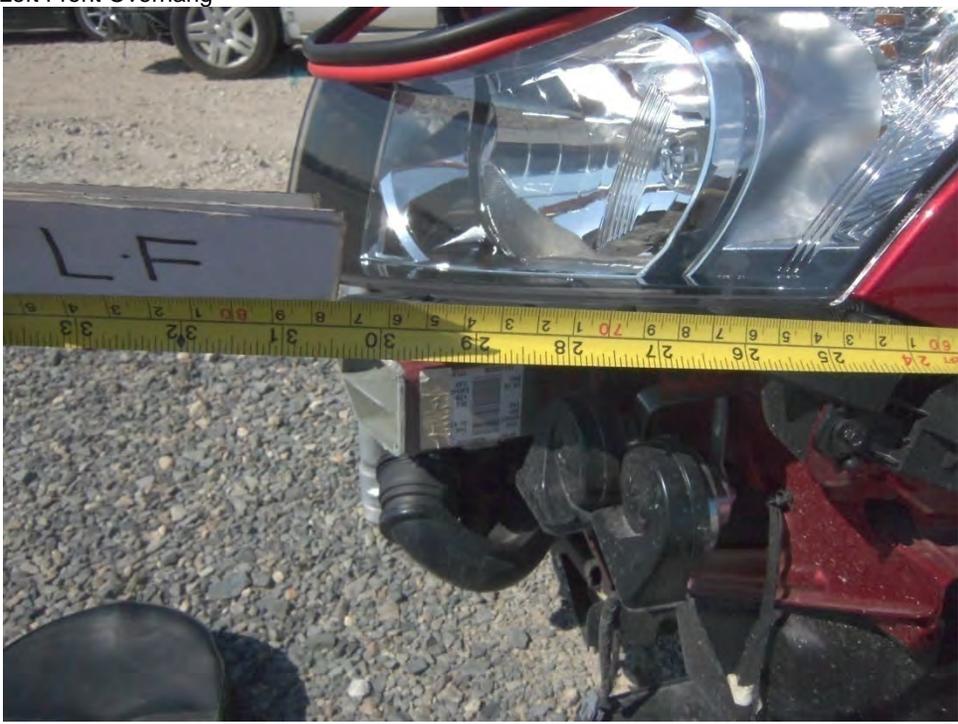
Yes, Missing front fascia.

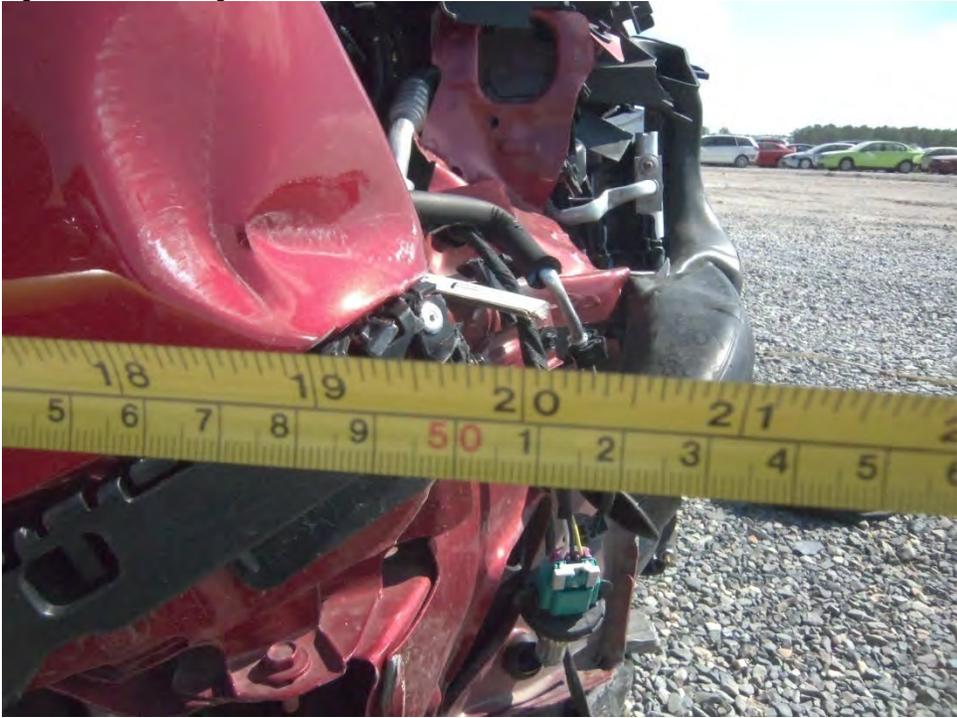
Photo #	Description / Photo	Damage (Yes/No)
37	<p>Right Front Overhang</p>

<p>Yes, 5-6" of impact crush to right front fender, headlamp missing.</p>
38	<p>Left Rear Overhang</p>

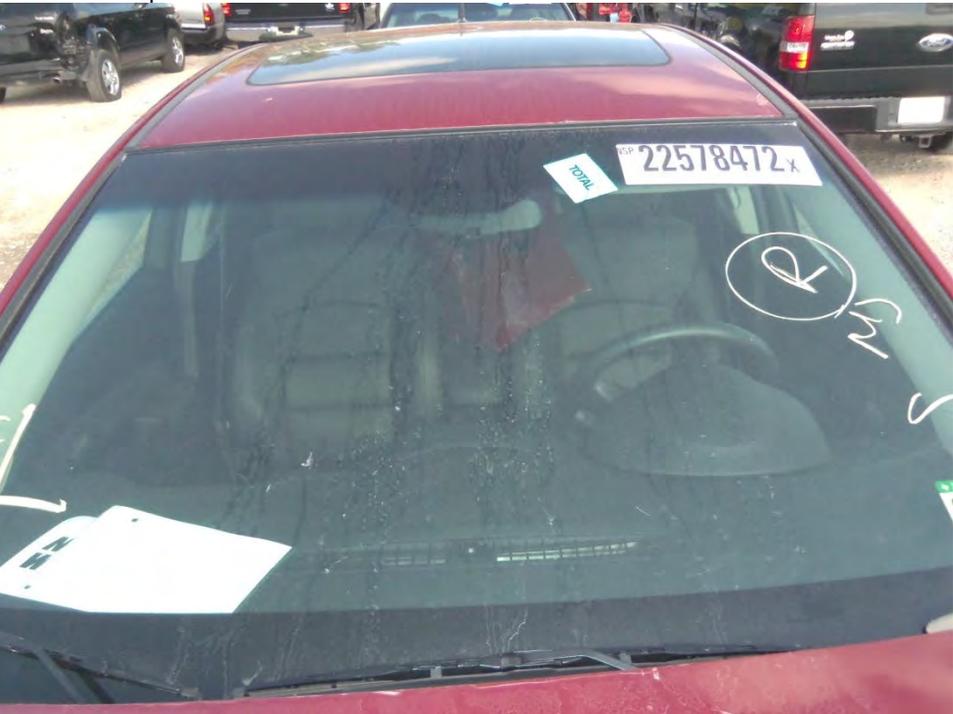
No
40	Windshield Inspection.

Note all window conditions: Undamaged; see photos # 40, and 52 - 55.

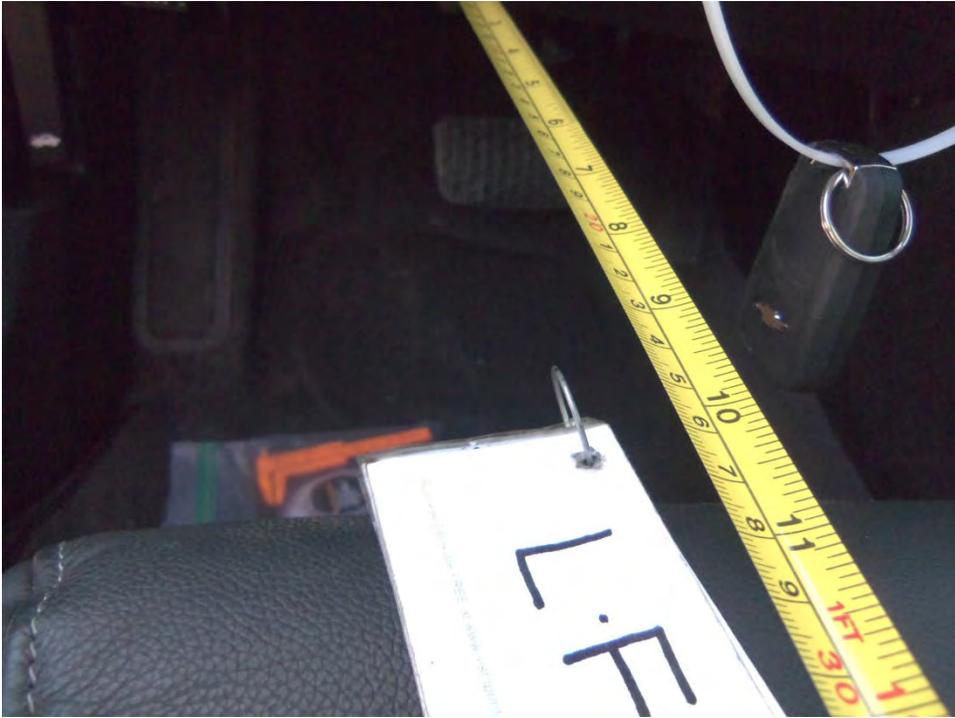
Photo #	Description / Photo	Damage (Yes/No)
43	<p>Driver's Seat Position.</p>

<p>No, Positioned approximately 10" back from knee bolster.</p>
44	<p>Driver's Seat Back Position.</p>

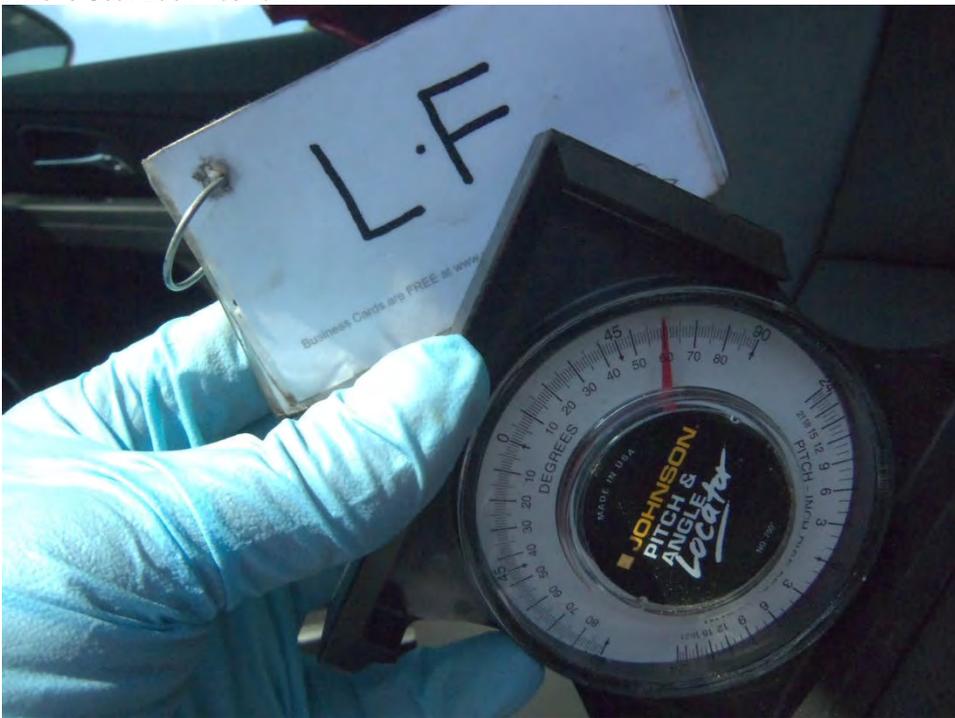
<p>No, Reclined back approximately 65 degrees.</p>

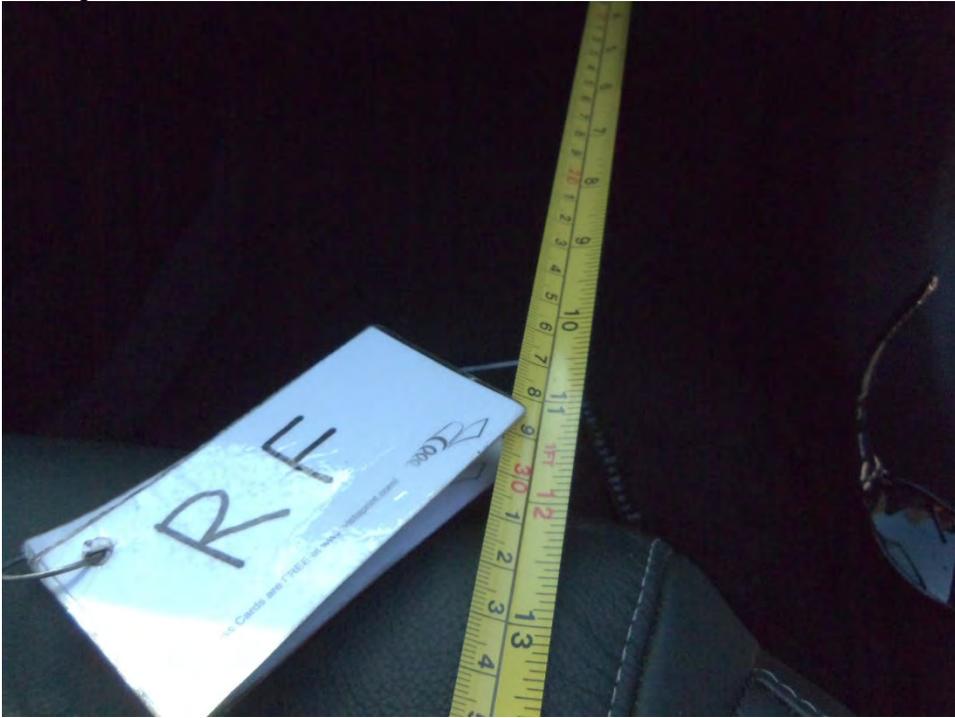
Photo #	Description / Photo	Damage (Yes/No)
45	Passenger, RF Seat Position.

No, Positioned approximately 12" back from knee bolster.
46	Passenger, RF Seat Back Position.

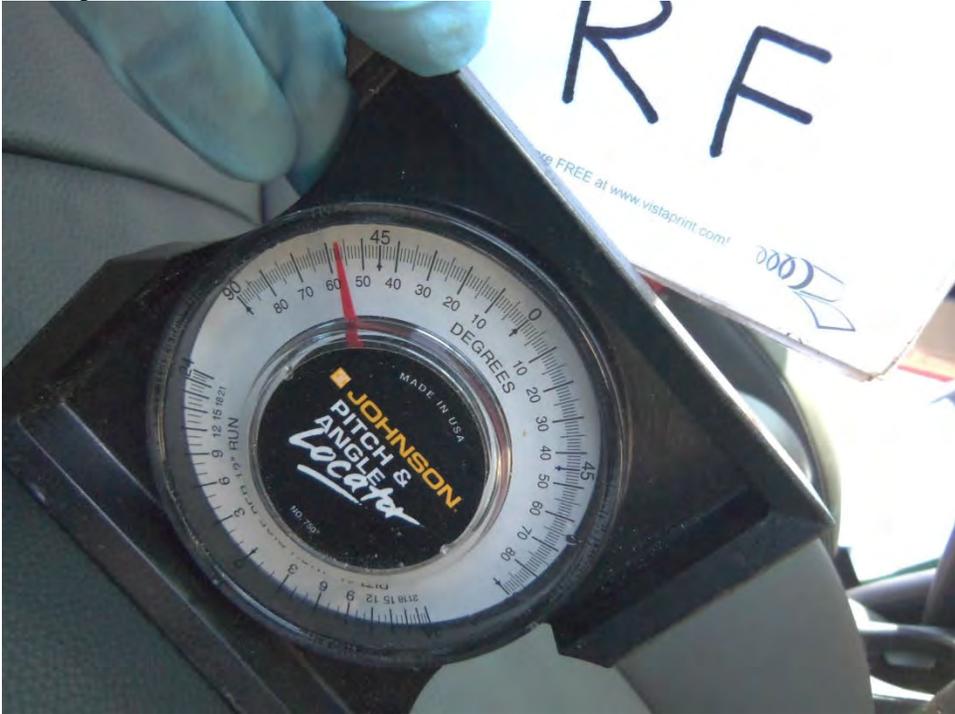
No, Reclined back approximately 58 degrees.

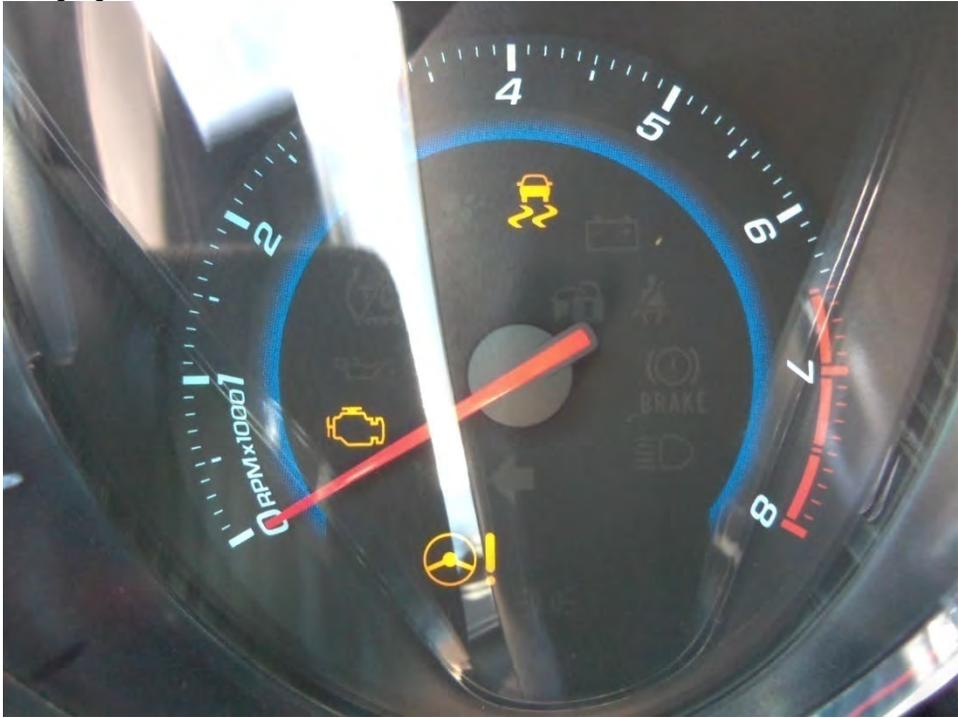
Photo #	Description / Photo	Damage (Yes/No)
47	Airbag Light Function Test.

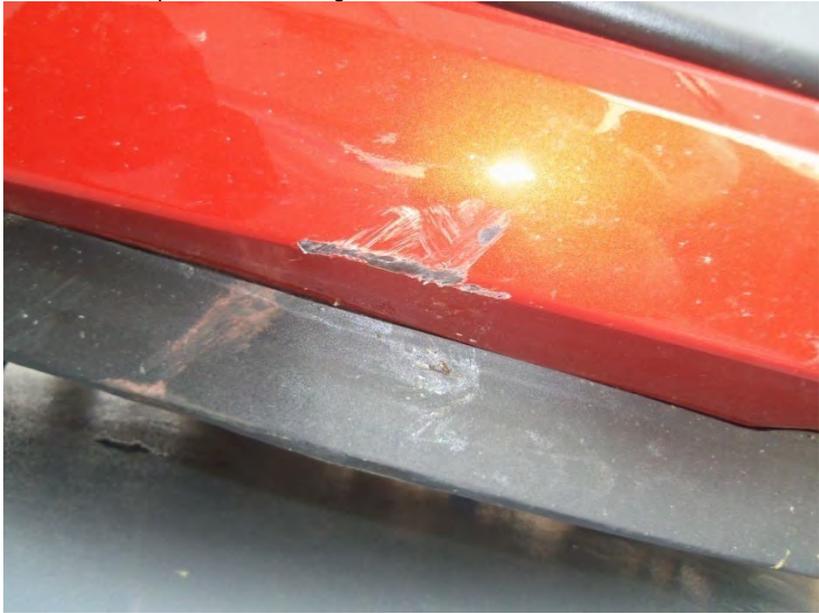
No
71-1100667354-18	Left Front Bumper Cover Damage

Left and right sides of front bumper cover damaged. (Photos 71-1100667354-18 and 71-1100667354-19)

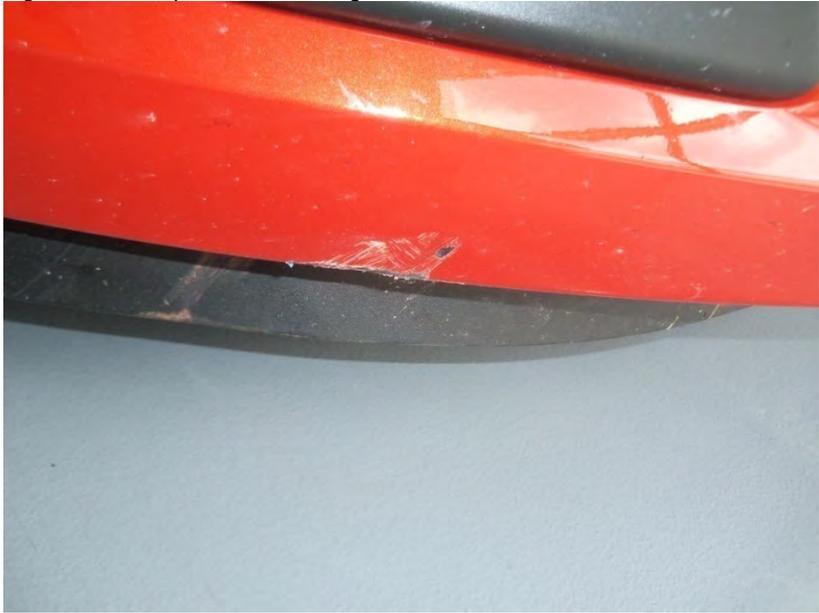
Photo #	Description / Photo	Damage (Yes/No)
71-1100667354-19	Right Front Bumper Cover Damage

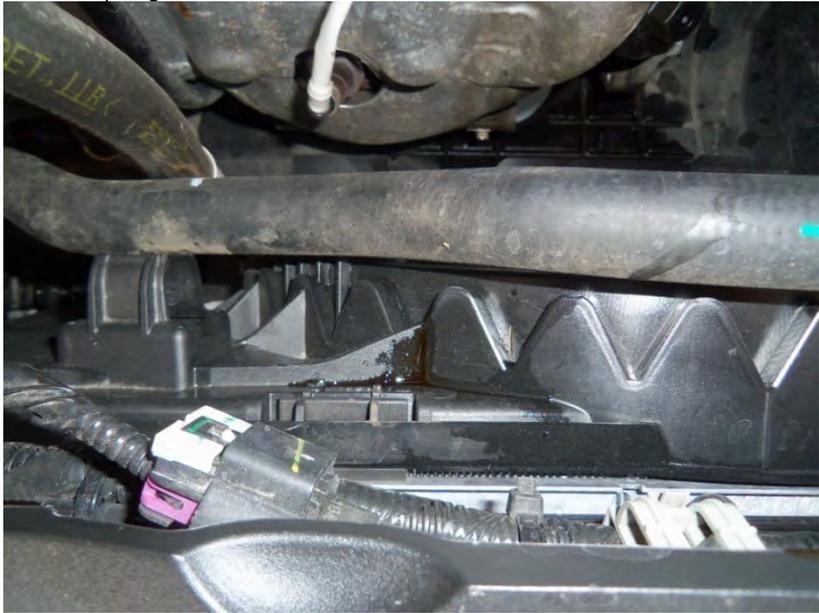
Yes
71-1100667354-20	Coolant Spillage on Fan Shroud

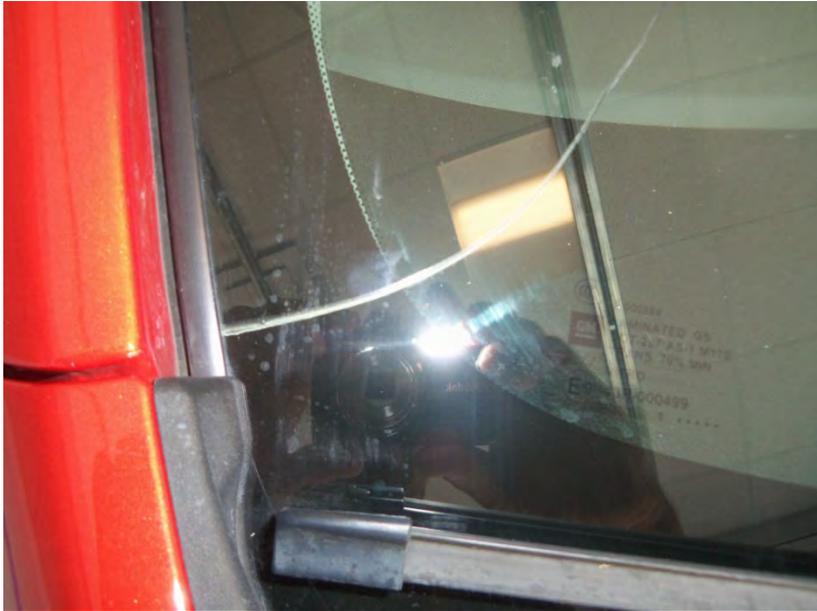
<u>Photo #</u>	<u>Description / Photo</u>	<u>Damage (Yes/No)</u>
71-1100667354-21	Cracked Windshield

- Collision damage had been repaired prior to inspection.
- Pretensioners were not deployed and SIR was not replaced per Woods Collision.
- Left and right sides of front bumper cover damaged. (Photos 71-1100667354-18 and 71-1100667354-19)
- Strong smell of engine coolant was evident at front of vehicle with spillage on front exhaust pipe (Photo 71-1100667354-14) and radiator fan shroud. (Photo 71-1100667354-20)
- Crack in right side of windshield. (Photo 71-1100667354-21)

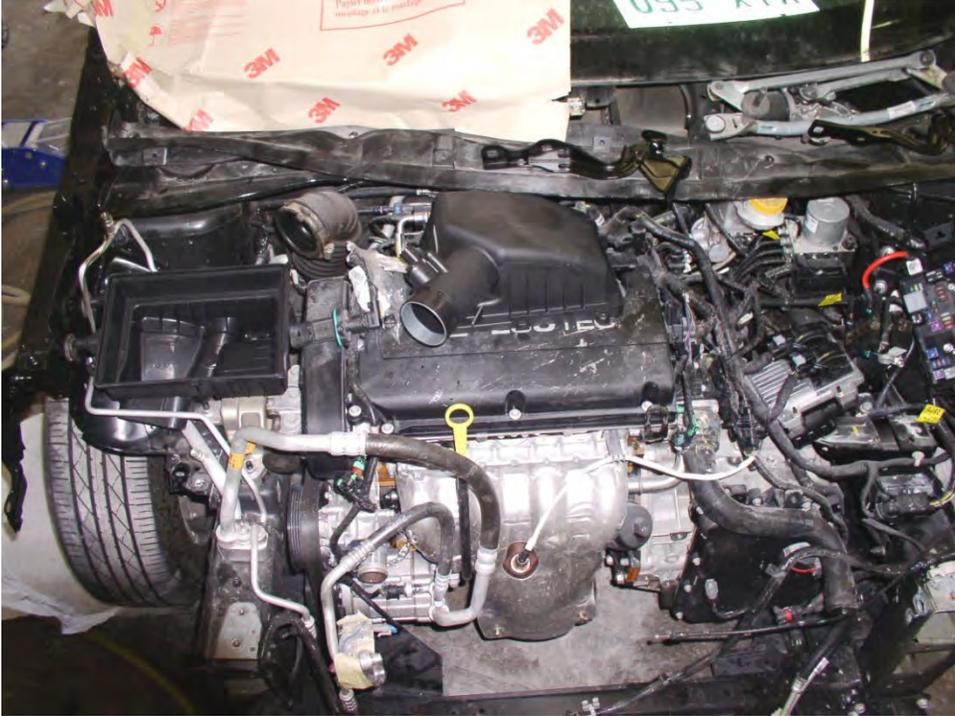
10	Under Hood

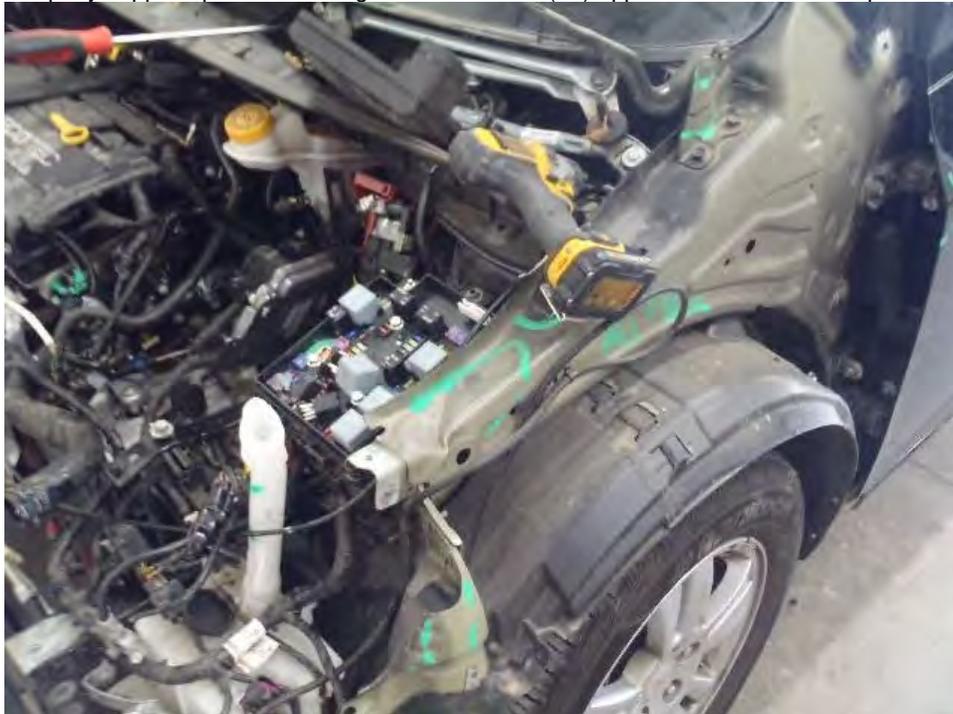
18 Insurance company supplied photo of damage to the left front (LF) upper frame rail before repair

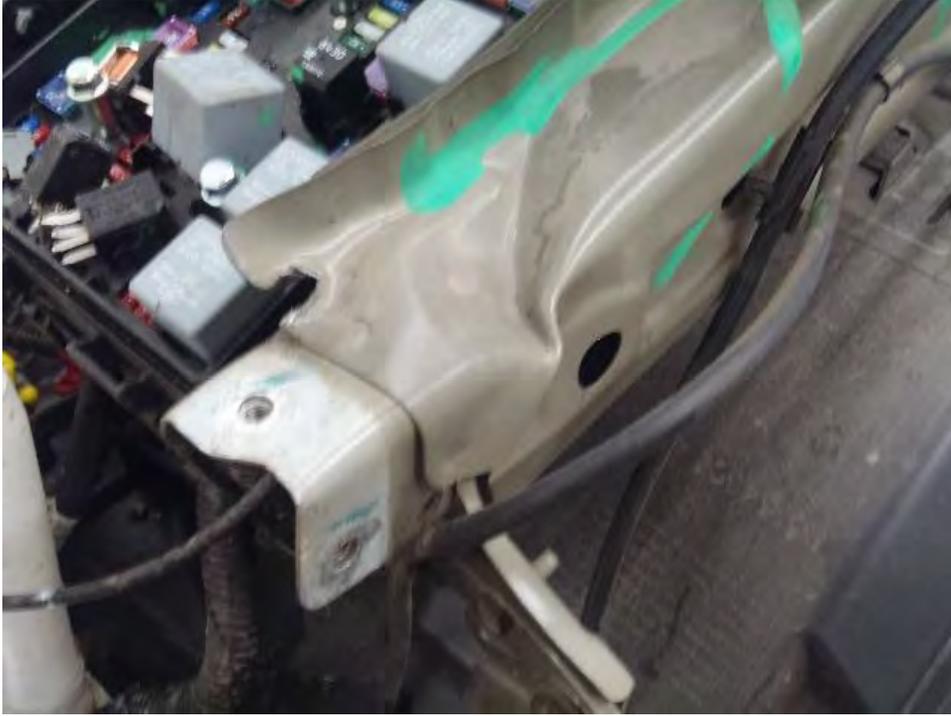
19 Close-up of buckle in LF upper frame rail (1)

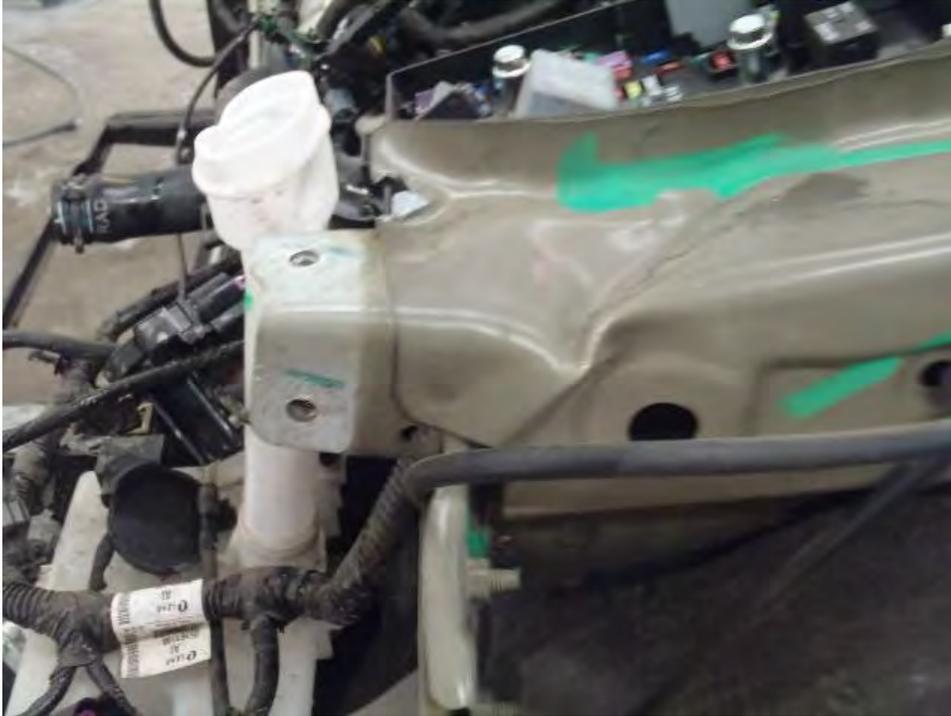
20 Close-up of buckle in LF upper frame rail (2)

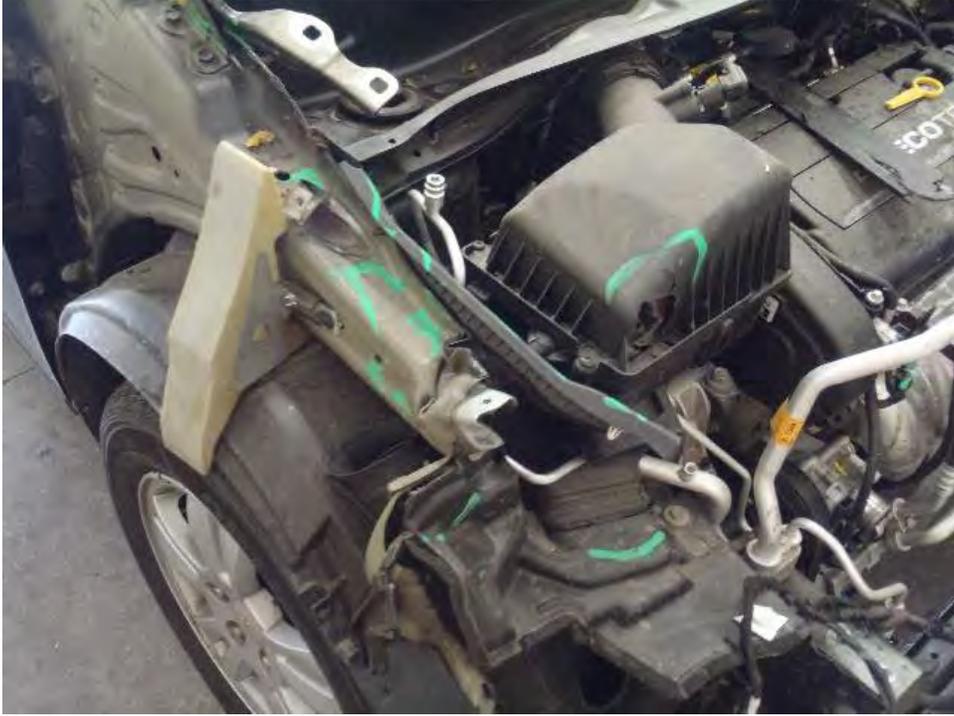
21 Insurance company supplied photo of damage to right front (RF) upper frame rail before repair

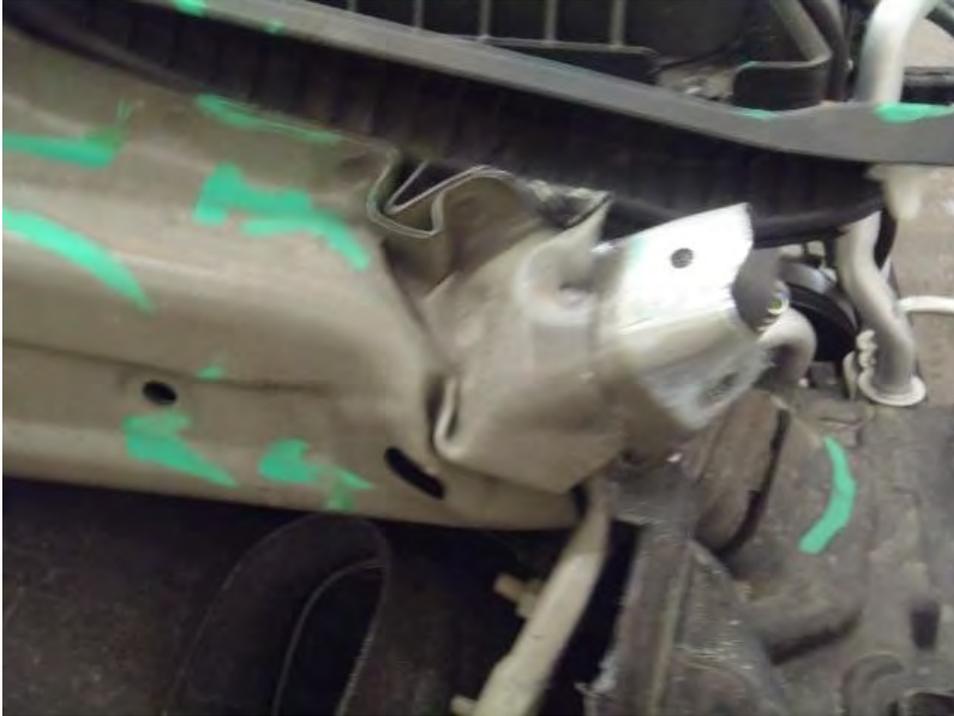
22 Close-up of buckle in RF frame rail
