Subject: 71-1035097733 PAR Case Sent to ESIS - No Action Required

A product allegation claim has been made in your region. The customer is alleging airbag nondeployment, wheels locked up and Onstar inoperative in a collision . This case is being escalated to ESIS because insurance involvement.

██████████
2012 Chevrolet Sonic
1G1JC5SHXC4██████████
CENTURY III CHEVROLET, WEST MIFFLIN PA (BAC) 113496
Kevin Codd, Body Shop Manager

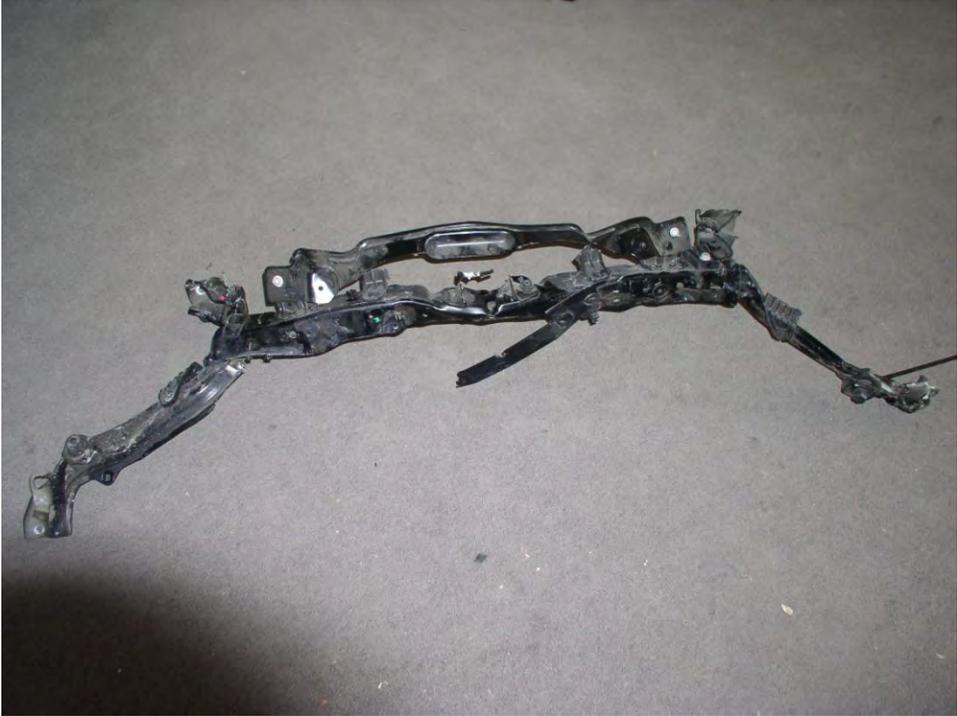
Y
24	Upper radiator support damage (2)

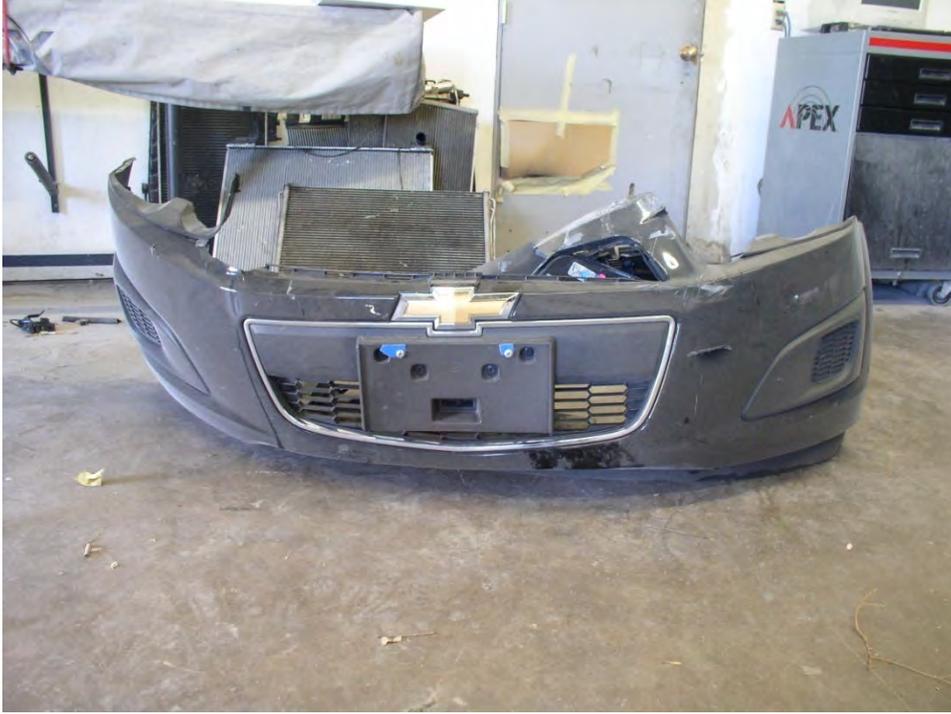
27 Front bumper cover showing impact zone above emblem (note no damage below the level of the emblem)

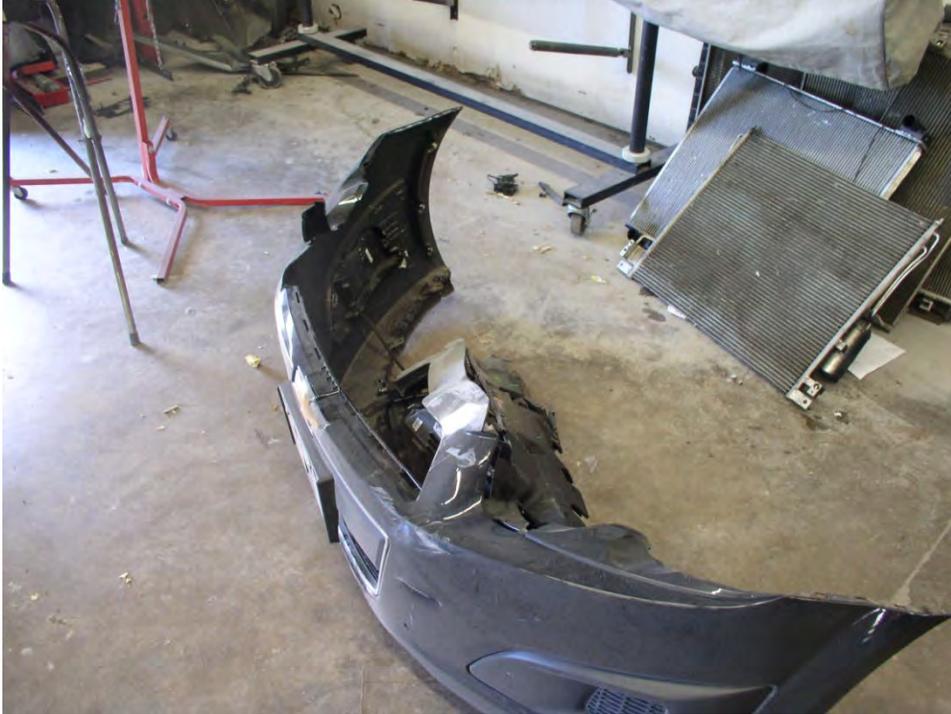
28 Front bumper cover showing impact zone above emblem (2)

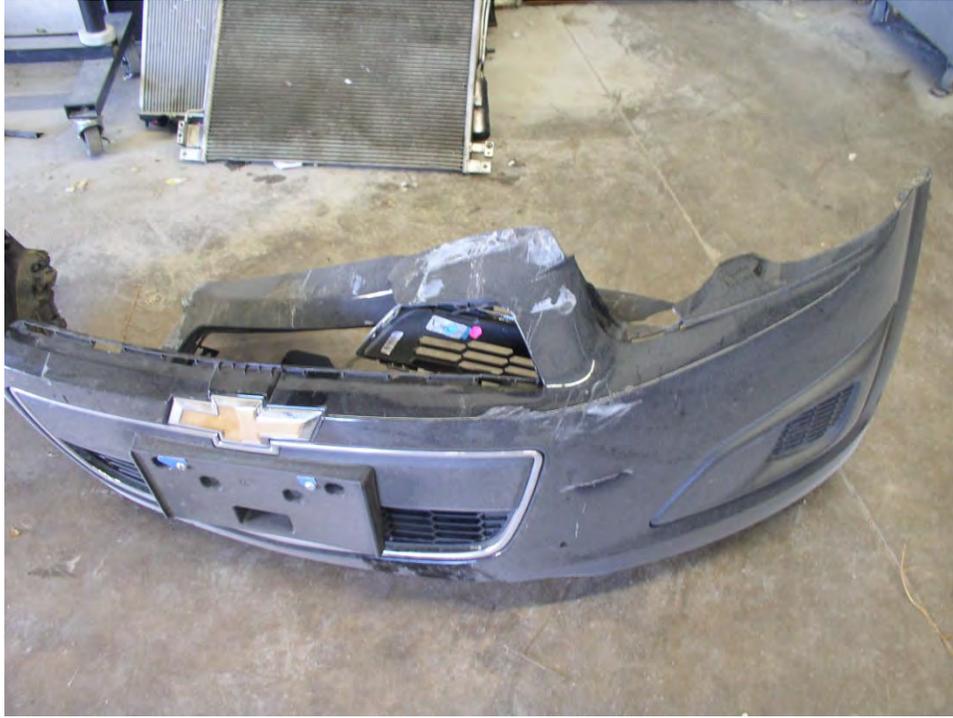
29 Front bumper cover showing impact zone above emblem (3)

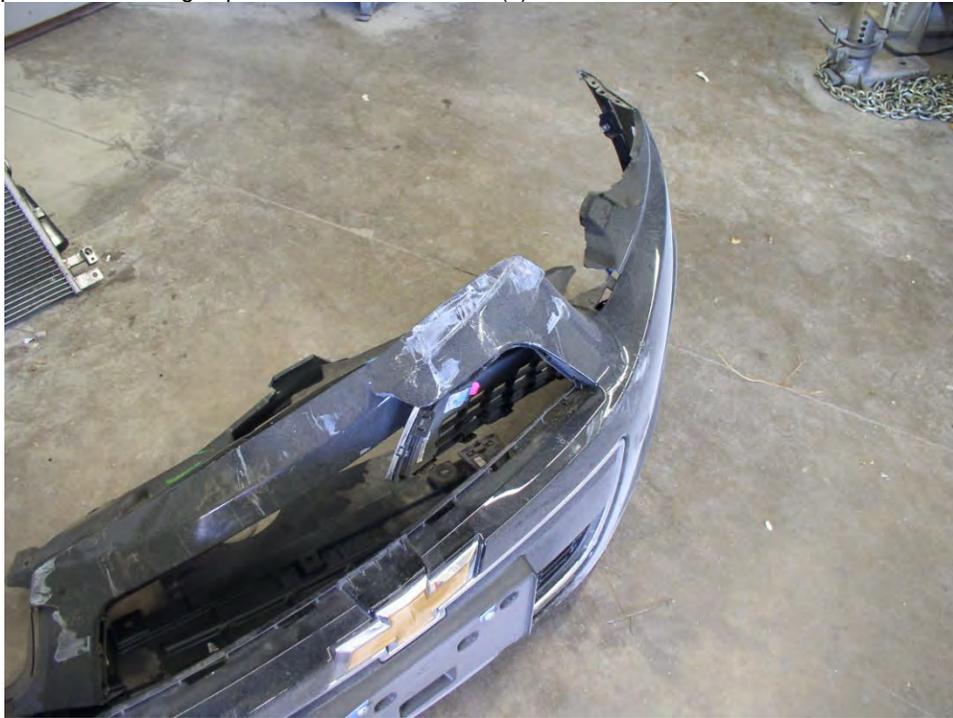
30 Front bumper cover showing impact zone above emblem (4)

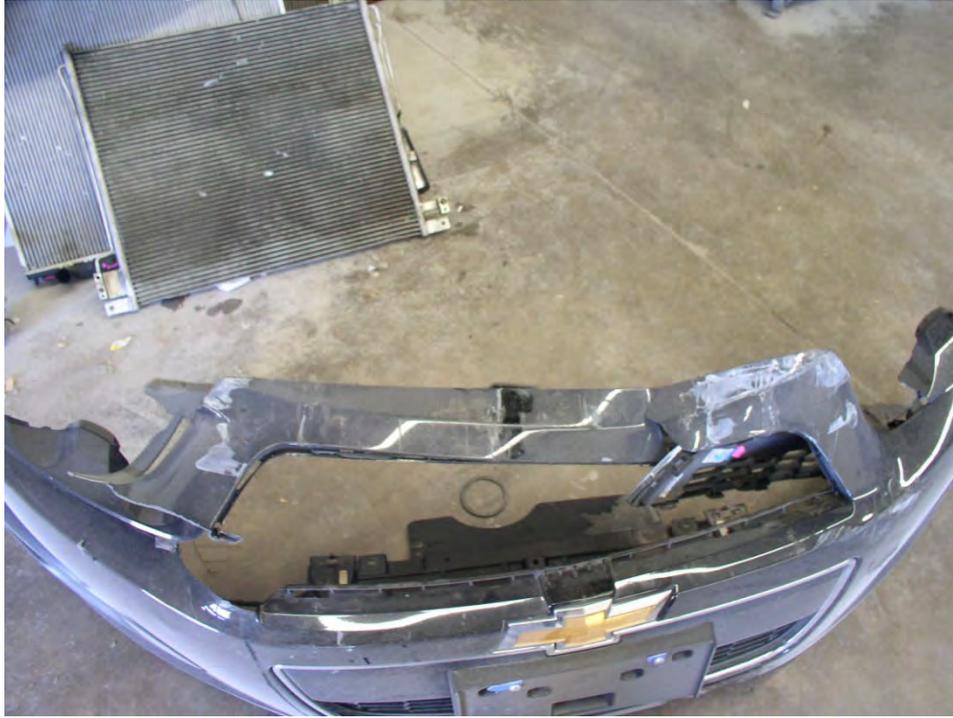
31 Front bumper cover showing impact zone above emblem (5)

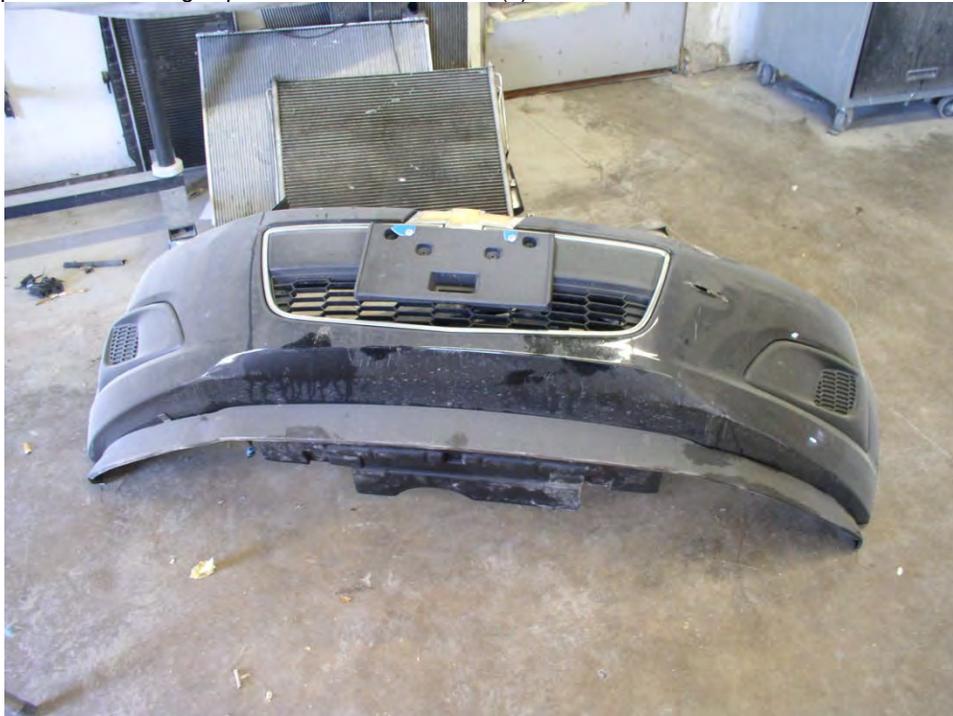
32 Front bumper cover showing impact zone above emblem (6)

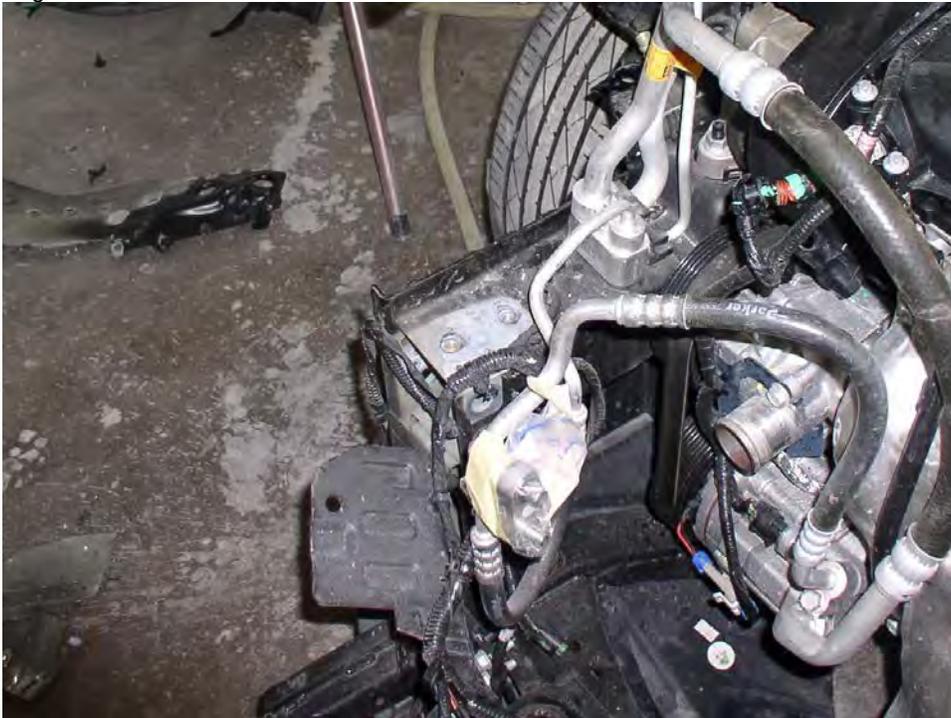
36 Close-up of right frame rail

- The point of impact was above the frame rails as evidenced by inspecting the front bumper and cover (photos 25-32).
- There is no damage to either the main frame rails or the bumper re-enforcement (photos 25, 26, and 33-36).

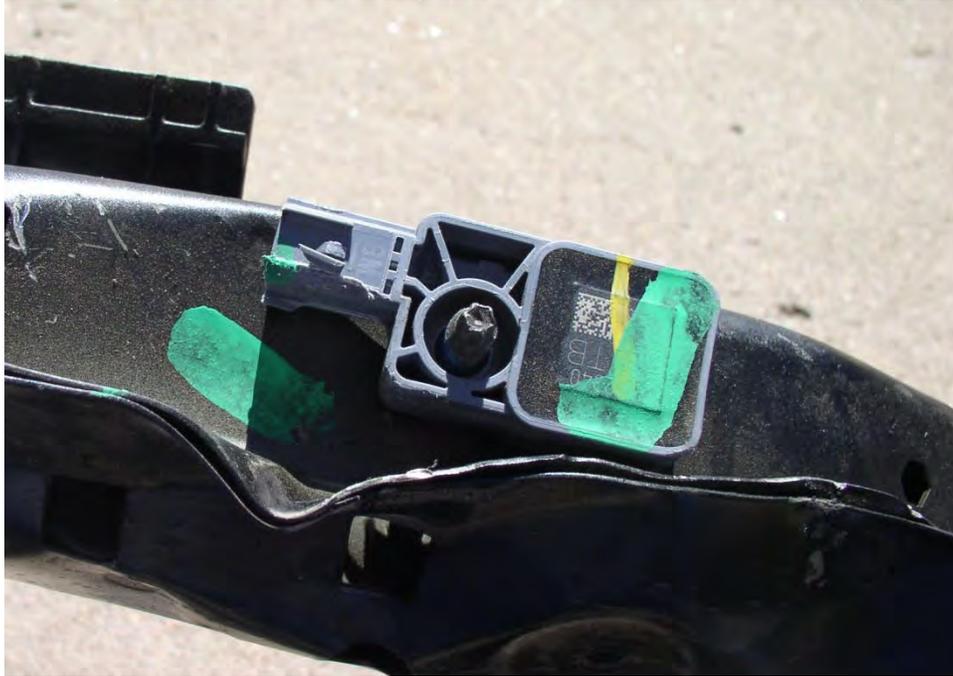
37 Right impact sensor (Connector is broken from impact and connector became disconnected)

- There is damage visible to the RF impact sensor "male" connector caused by the "female" connector being forcefully pulled off (photo 37). There is no visible damage to the "female" connector and the lock tab is in the "lock" position (photos 38 - 39).

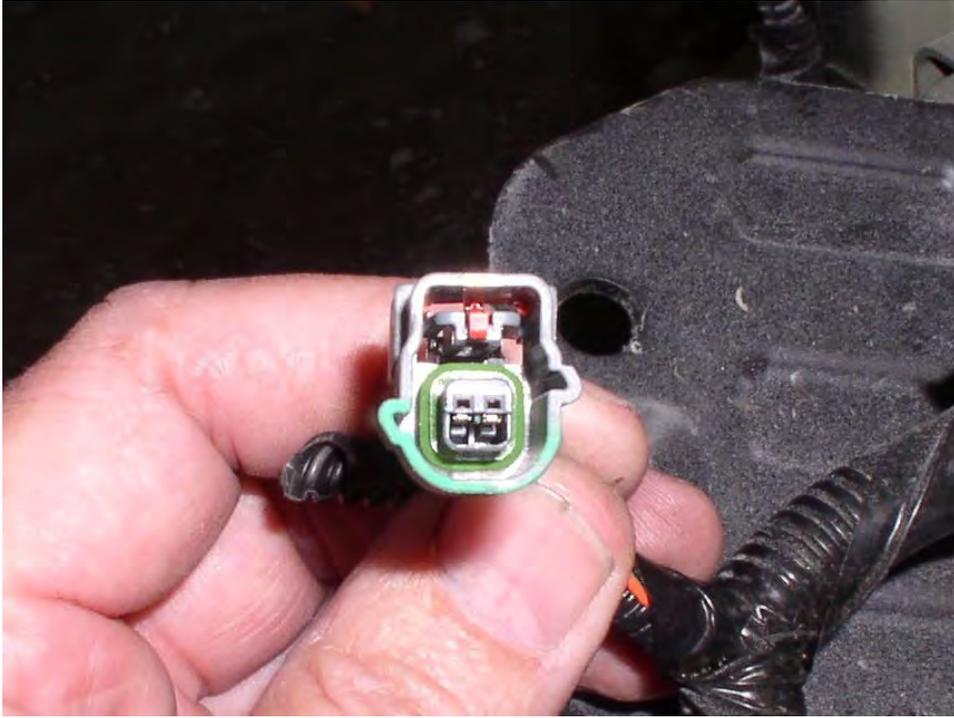
39 Right impact sensor end view

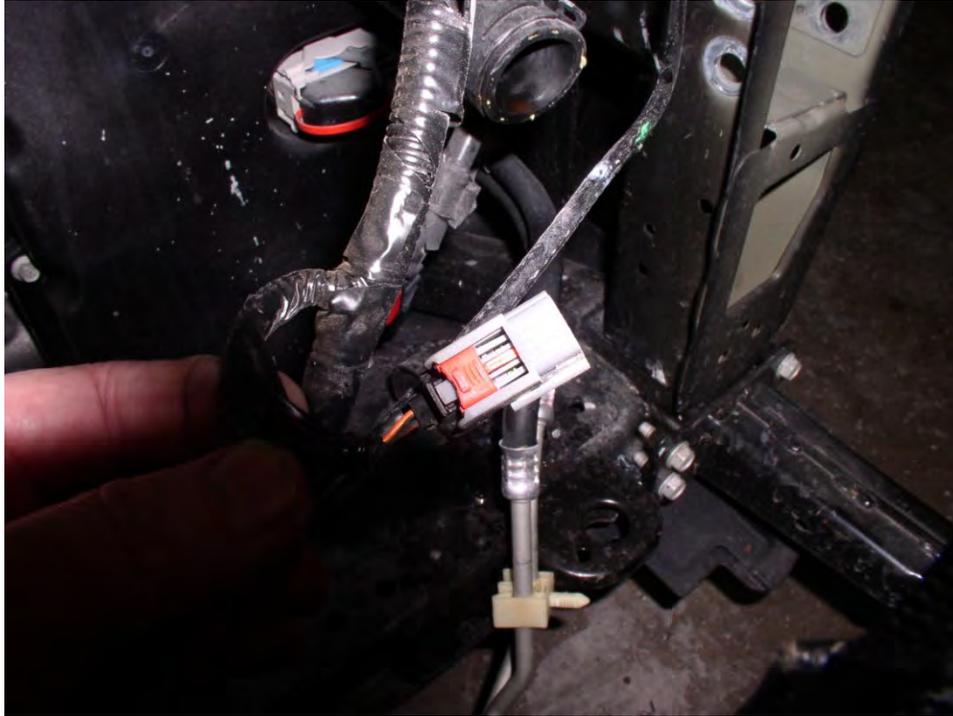
41 Left impact sensor connector intact and un-damaged

- There is no damage to the LF impact sensor and the connector was properly connected when the body shop and insurance personnel inspected the vehicle (photos 40 - 41).

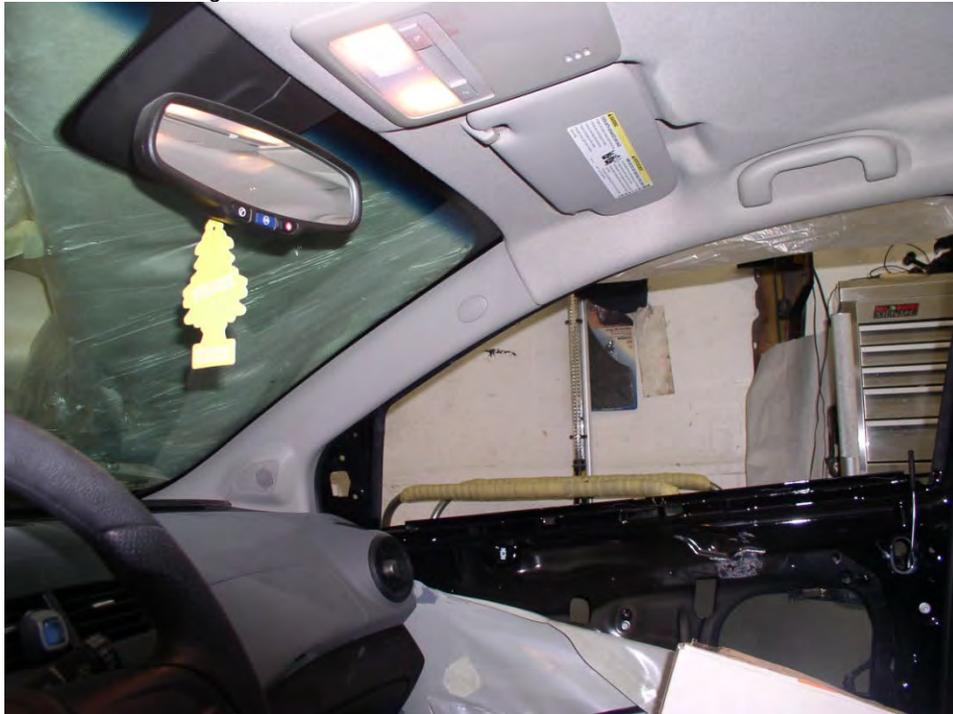
42 Passenger side roof rail air bag intact

- All of the airbags are in a non-deployed state and are intact, as are the seatbelt pretensioners (photos 42-50).
- There is no visible damage to the brake pedal (photo 51).

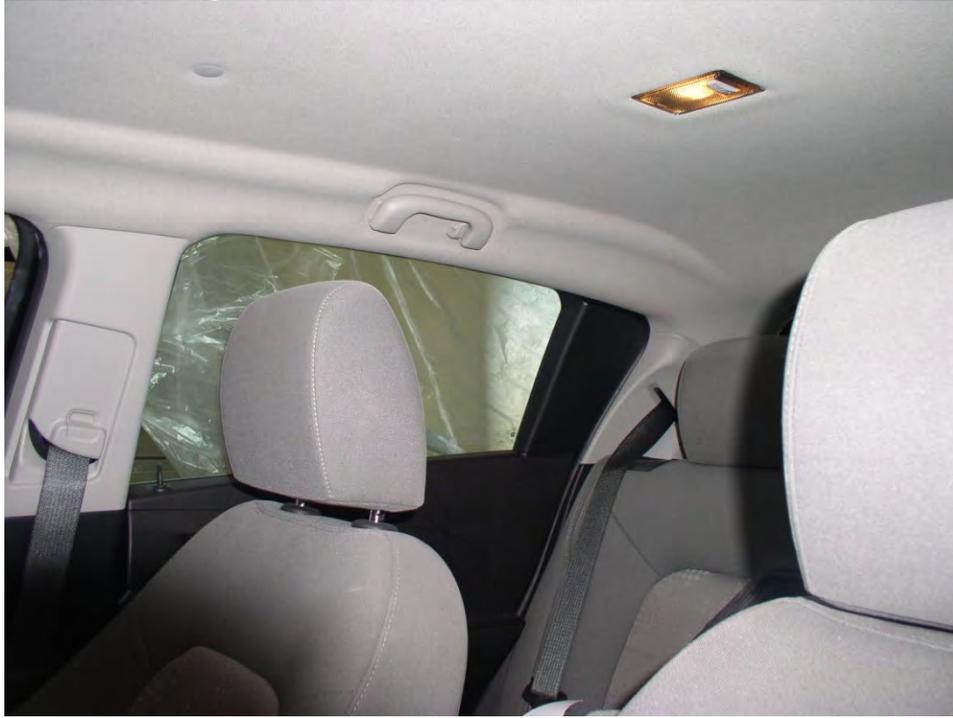
43 Passenger side roof rail air bag intact

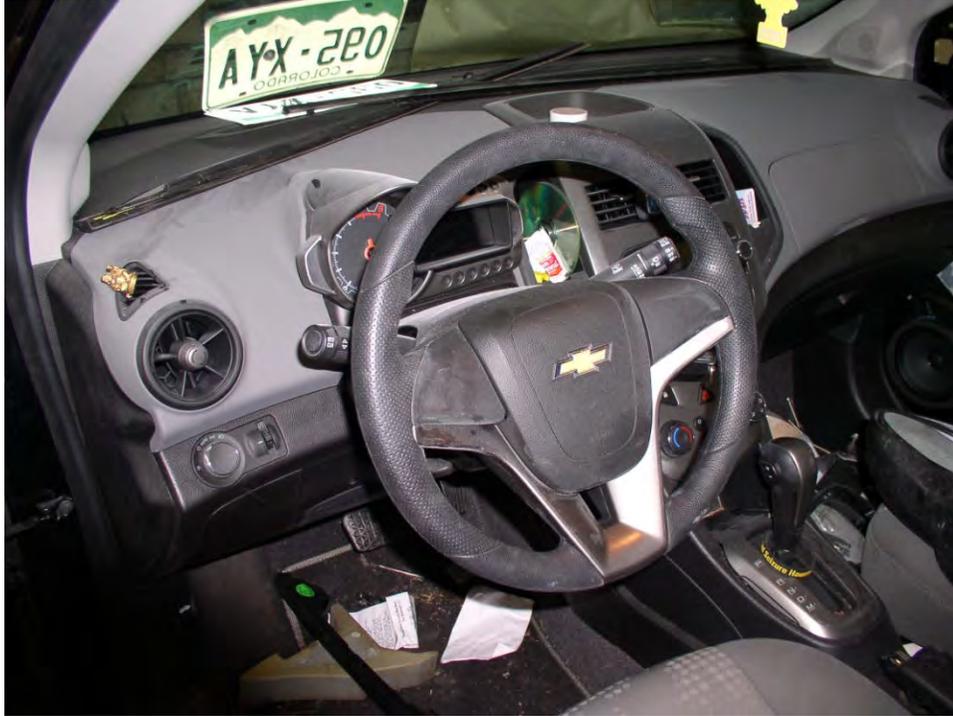
44 Driver's frontal airbag intact

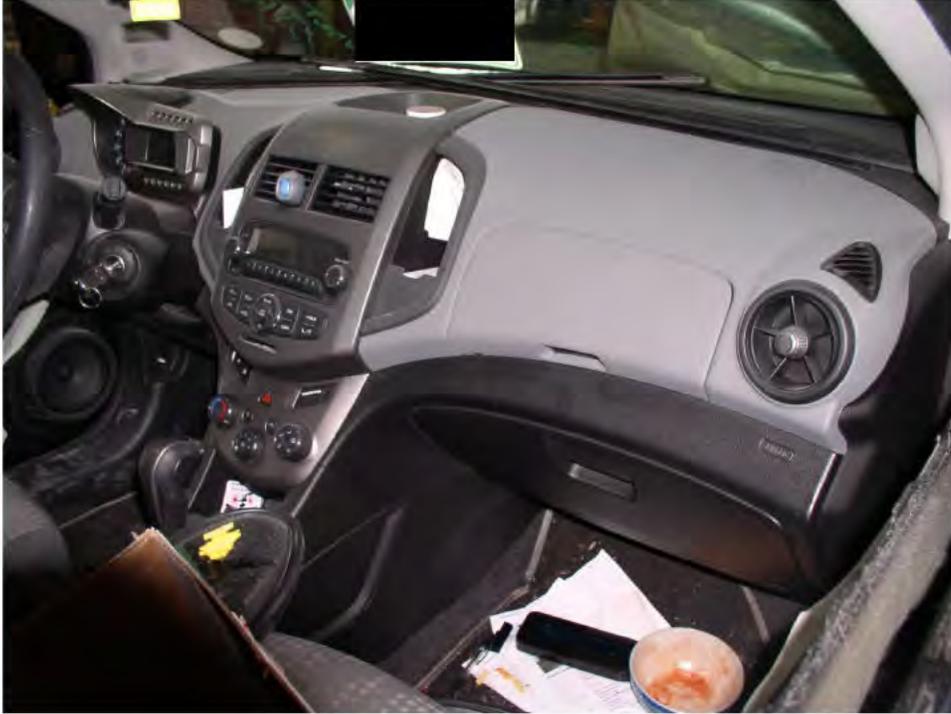
45 Passenger frontal airbag intact

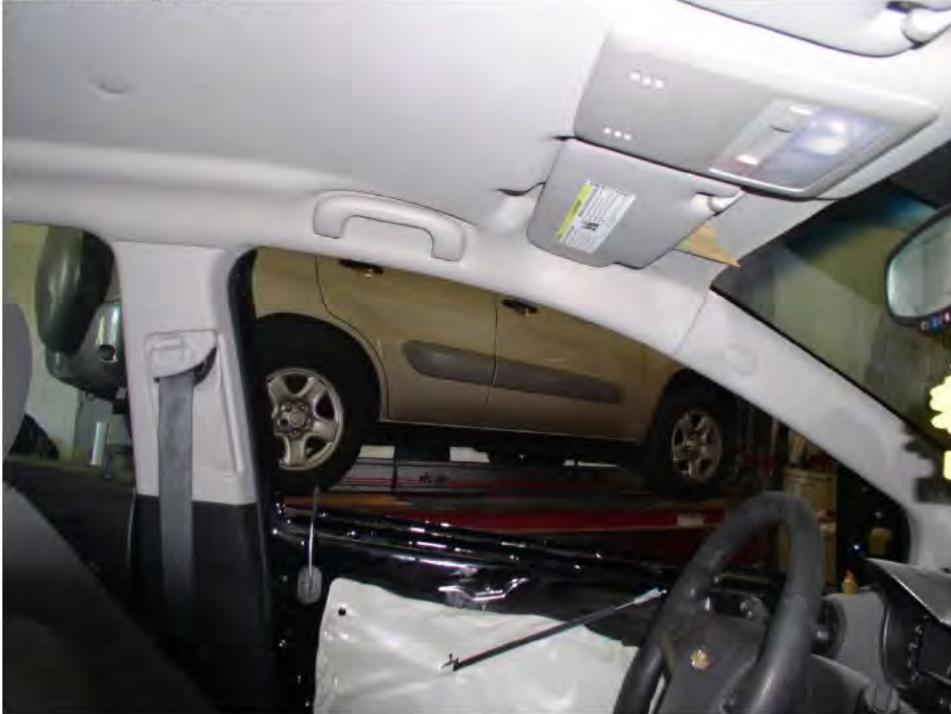
46 Driver side roof rail airbag intact

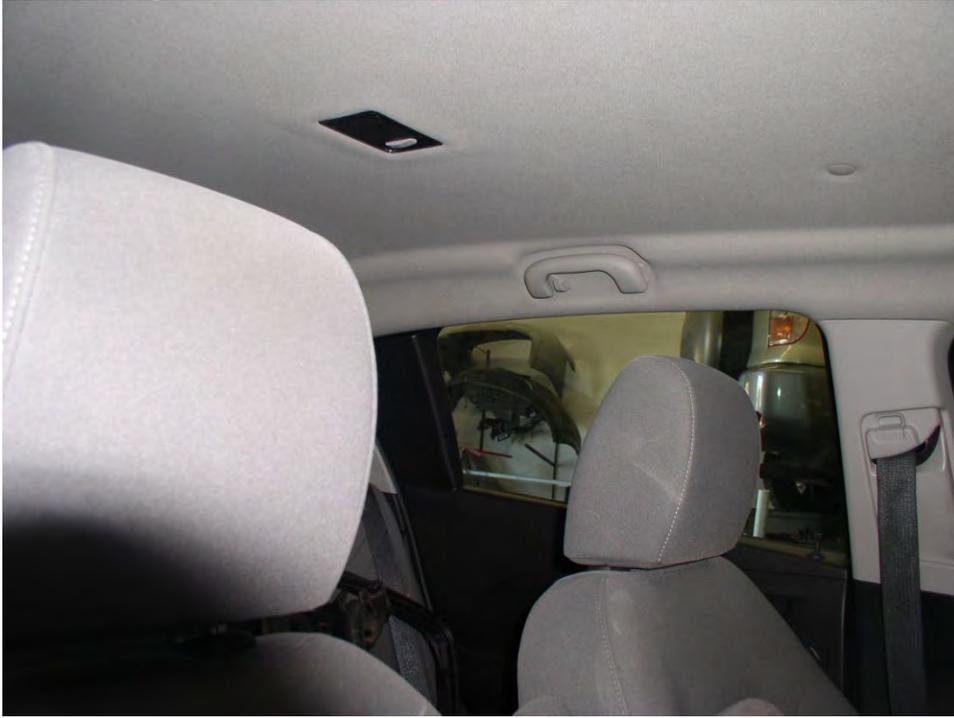
47 Driver side roof rail airbag intact

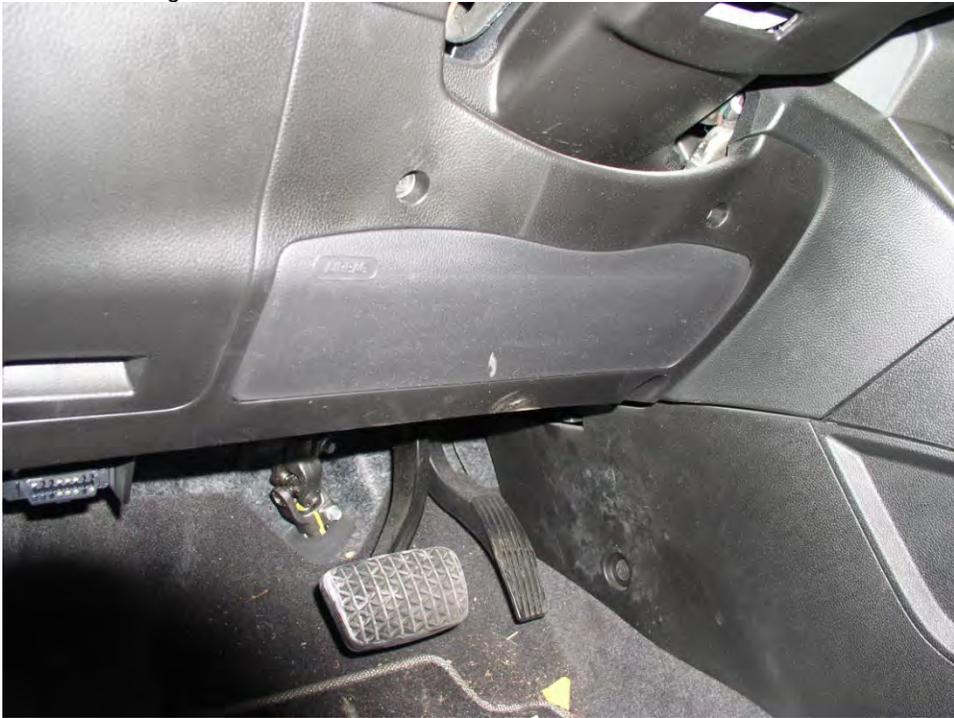
48 Driver's knee bolster airbag intact

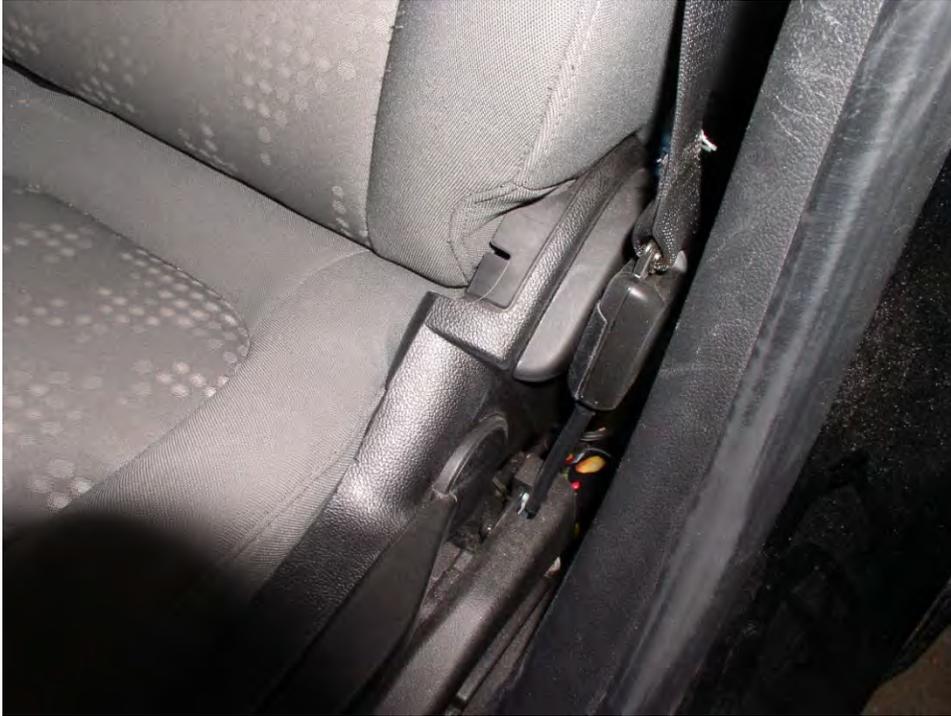
49 Driver's seatbelt pretensioner not deployed

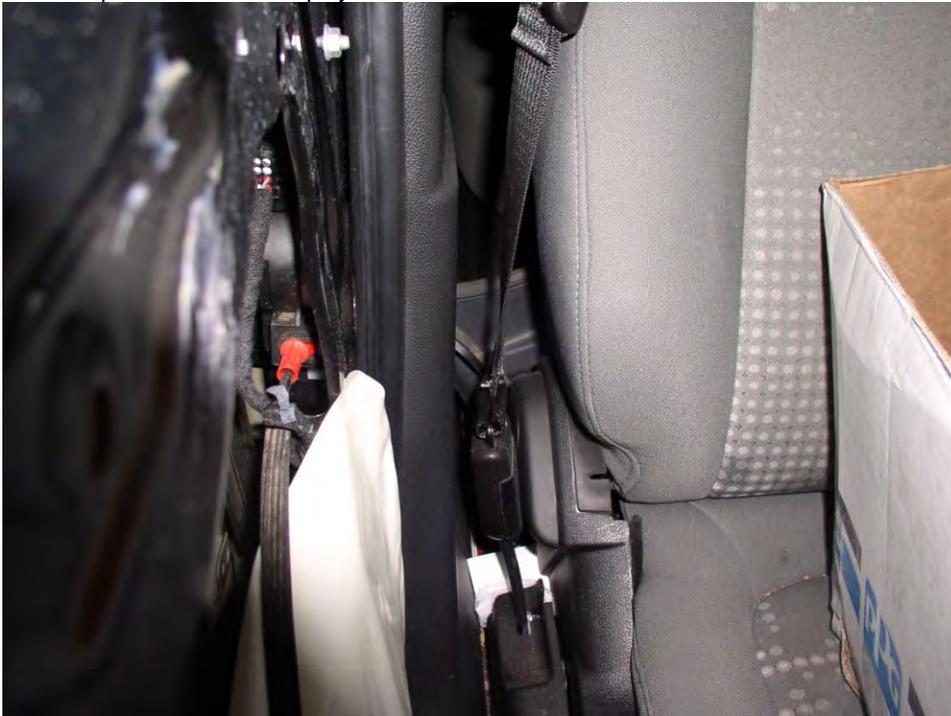
50 Passenger seatbelt pretensioner not deployed

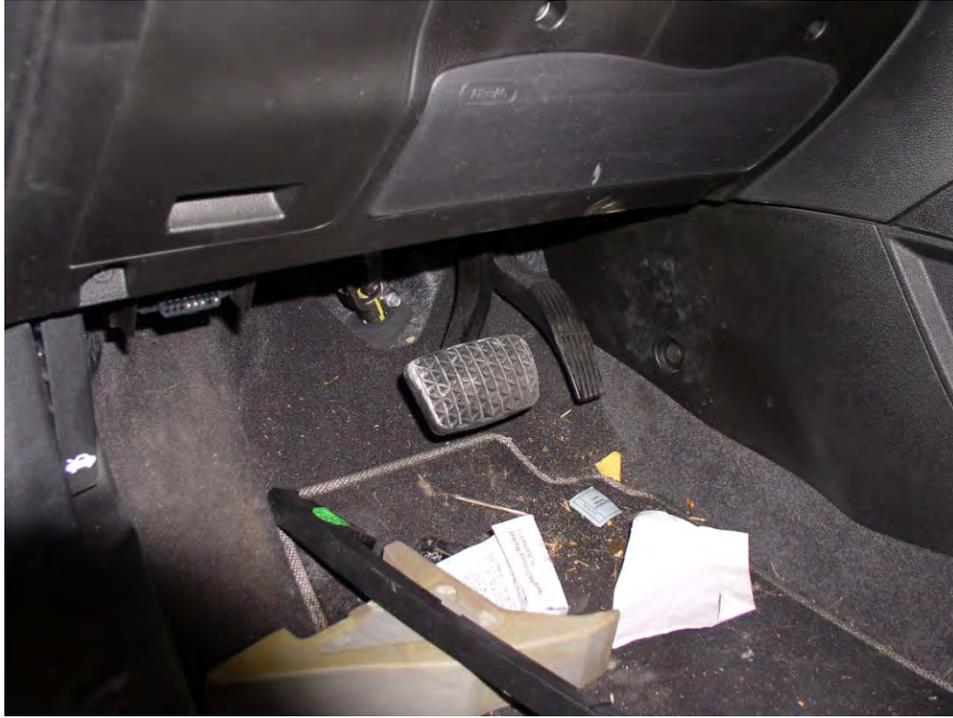
51 Pedals not deformed

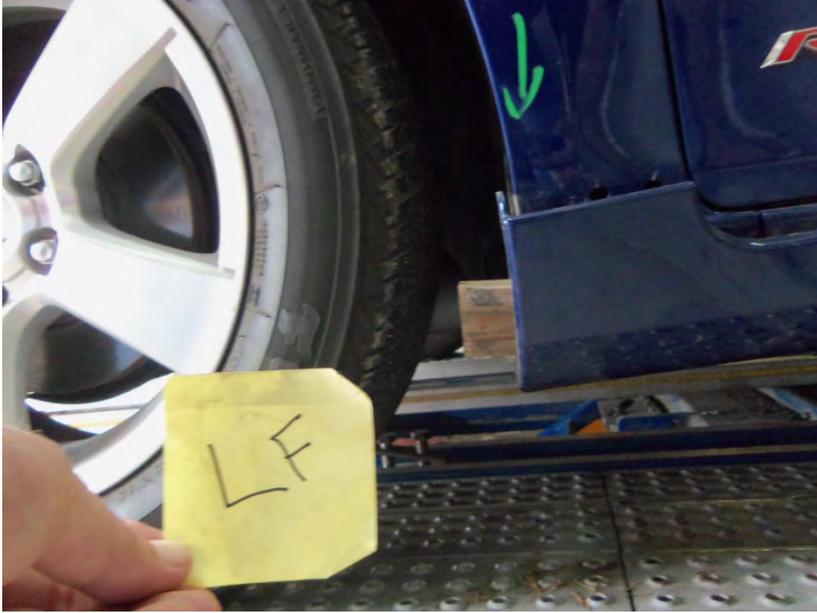
Photo #	Description / Photo	Damage (Yes/No)
71-1131644033-11	Damage to left front rocker panel

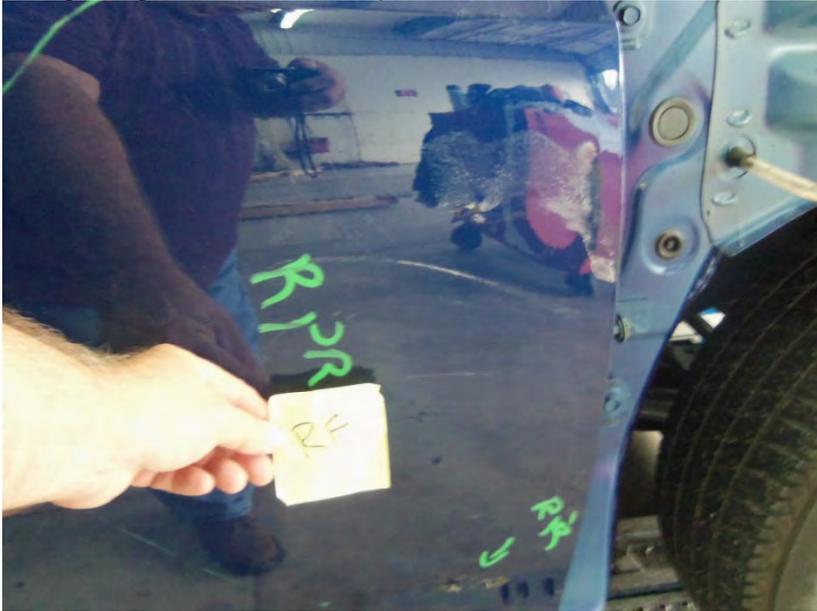
Yes
71-1131644033-12	Damage to right front door skin compressed and dented

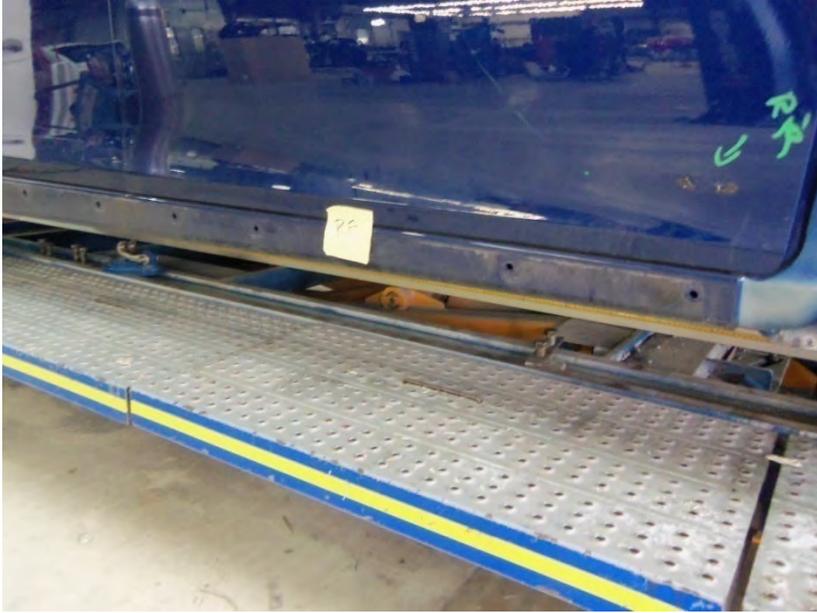
Photo #	Description / Photo	Damage (Yes/No)
71-1131644033-13	Right front rocker panel missing

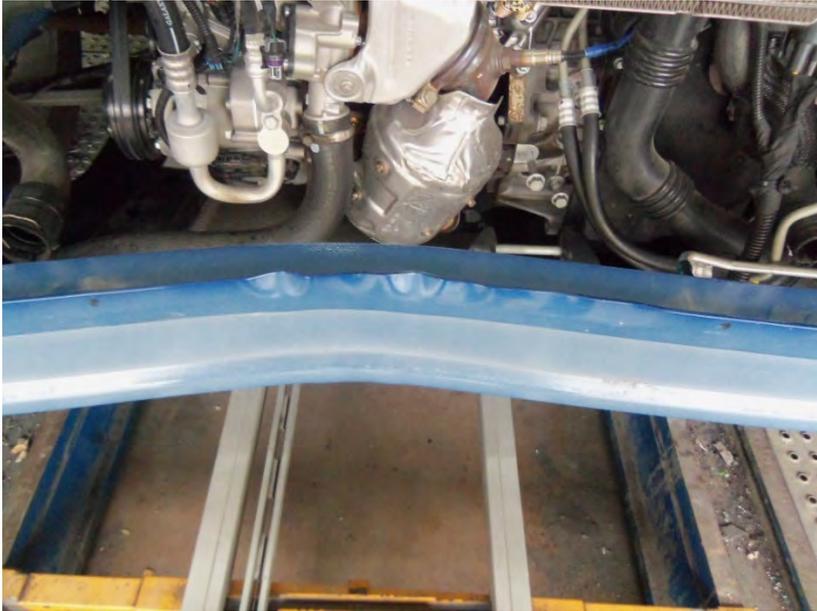
Yes
71-1131644033-14	Front bumper dented from impact

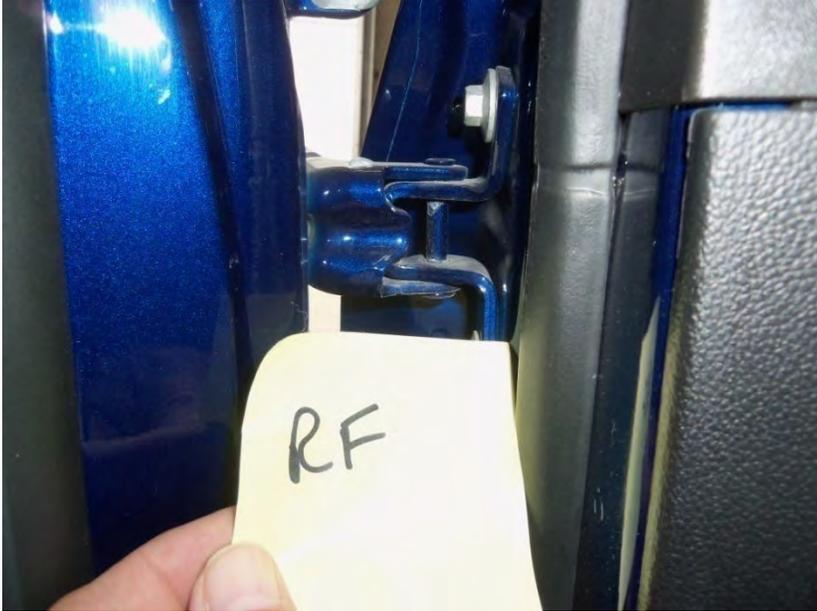
Photo #	Description / Photo	Damage (Yes/No)
71-1131644033-21	Right front upper door hinge

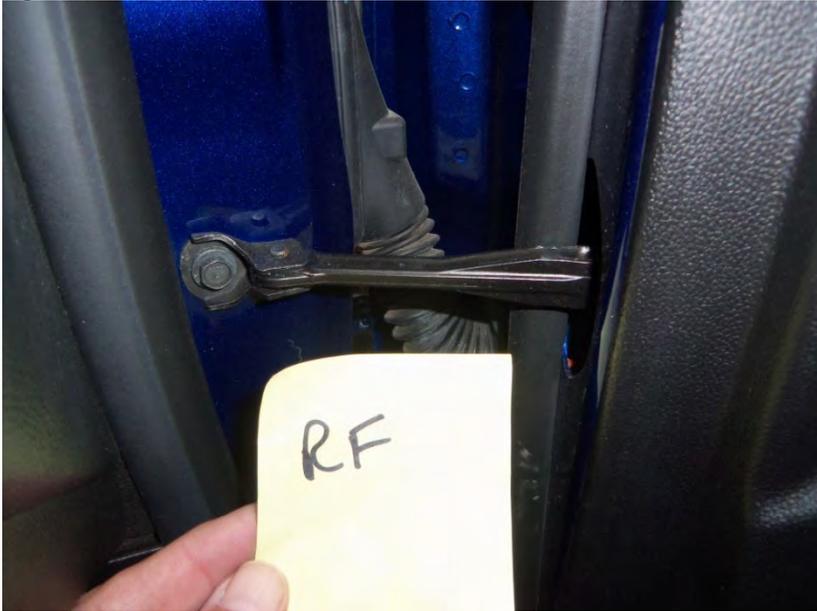
No
71-1131644033-22	Right front door stop

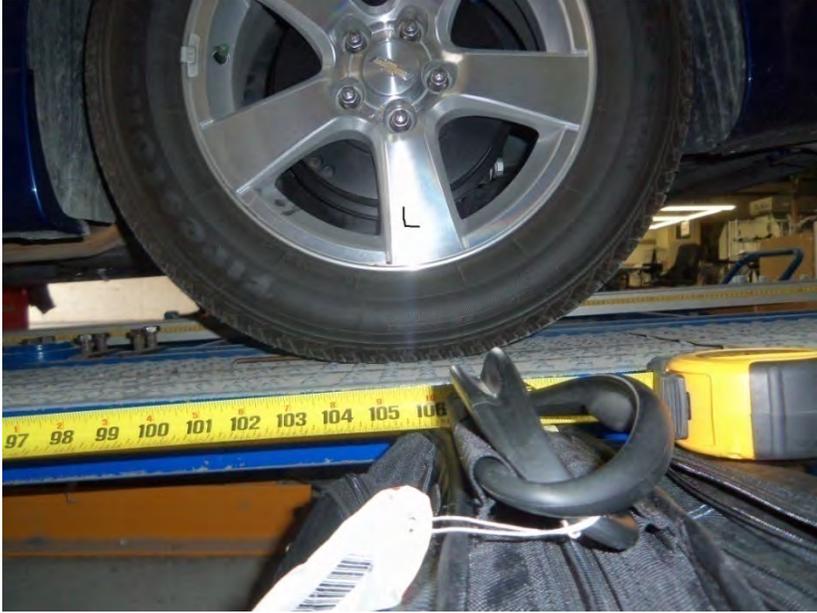
Photo #	Description / Photo	Damage (Yes/No)
71-1131644033-25	Driver side wheelbase 106 inches

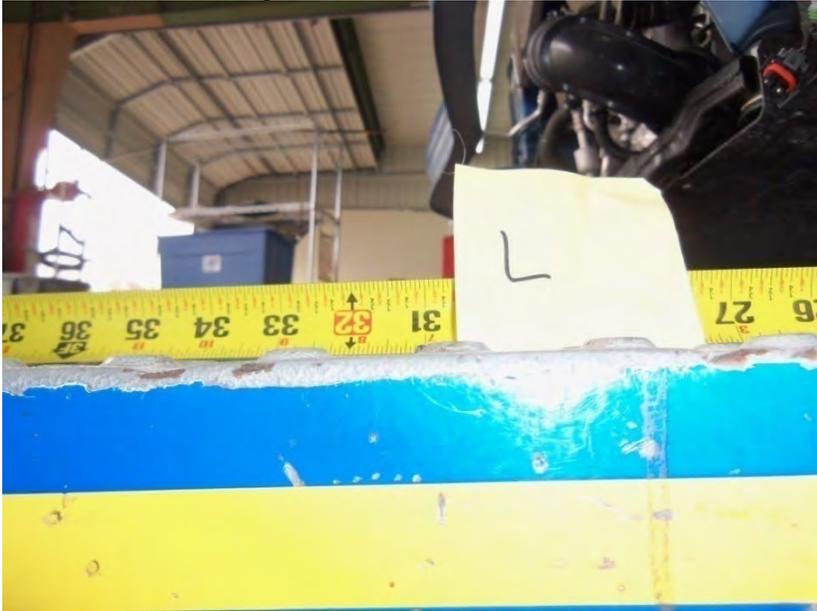
No
71-1131644033-26	Driver side front overhang 31 inches

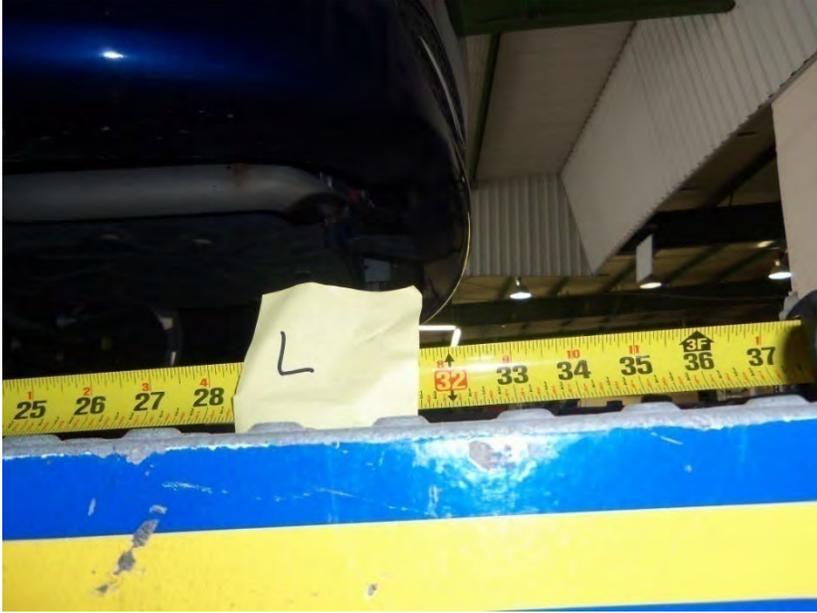
Photo #	Description / Photo	Damage (Yes/No)
71-1131644033-27	Driver side rear overhang 32 inches

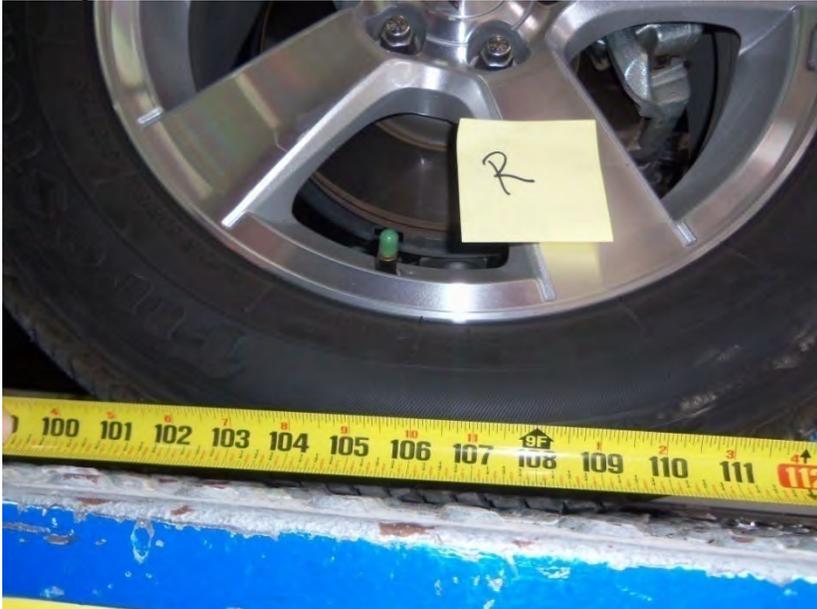
No
71-1131644033-28	Passenger side wheelbase 106 inches

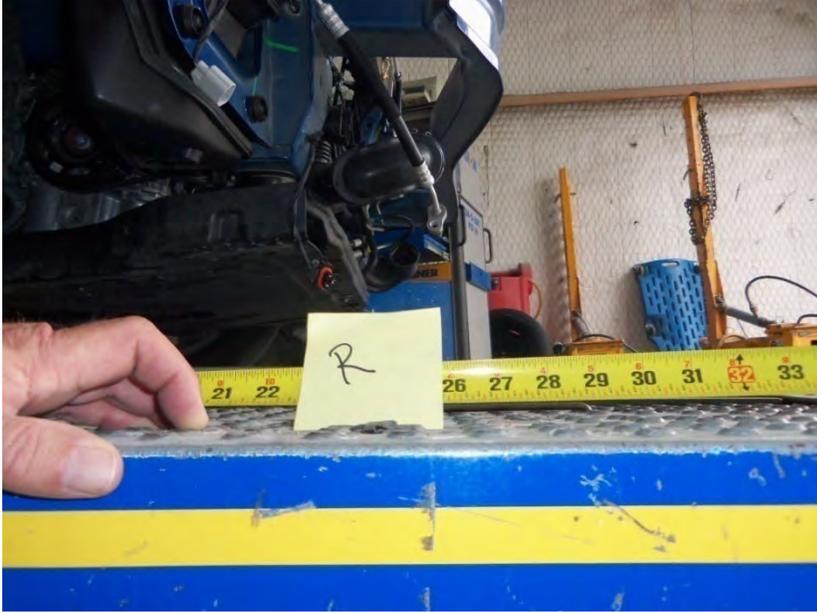
Photo #	Description / Photo	Damage (Yes/No)
71-1131644033-29	Passenger side front overhang 26 inches

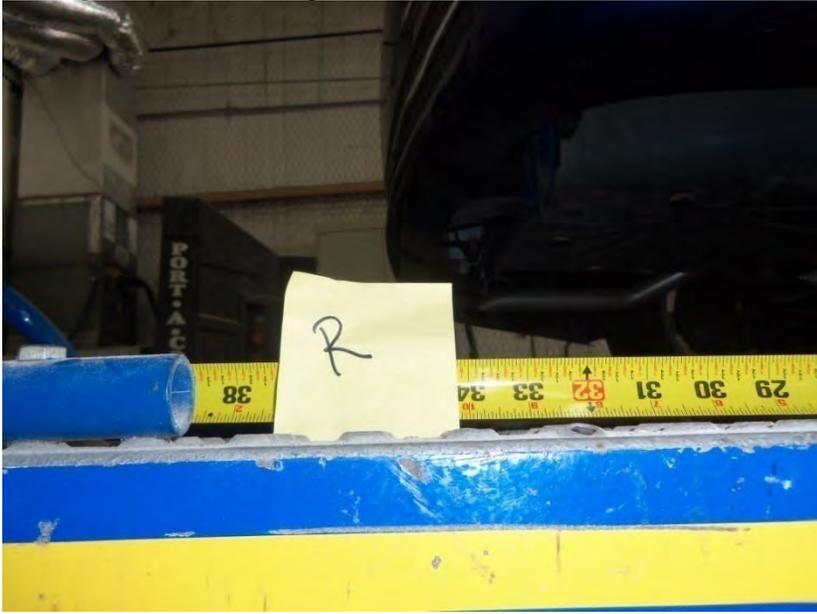
No
71-1131644033-30	Passenger side rear overhang 34 inches

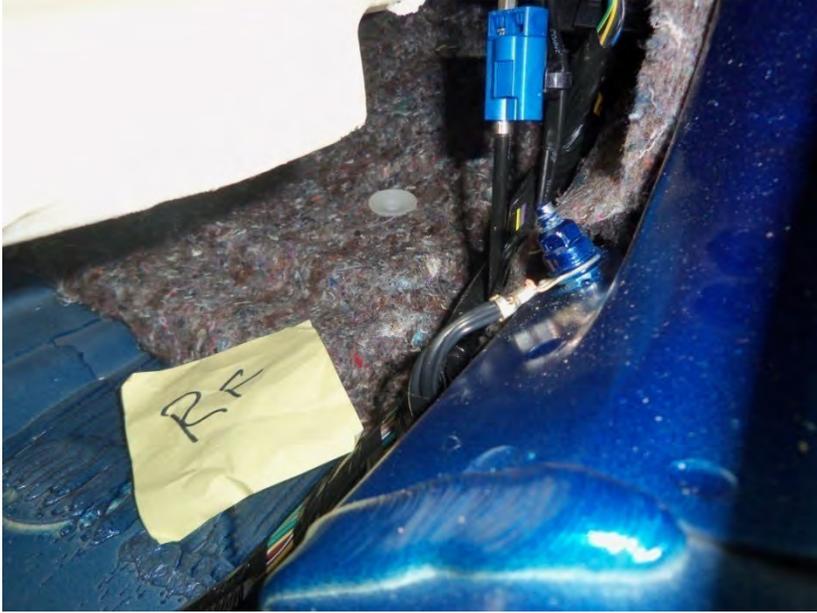
Photo #	Description / Photo	Damage (Yes/No)
71-1131644033-33	Right front carpet pulled back showing no water intrusion

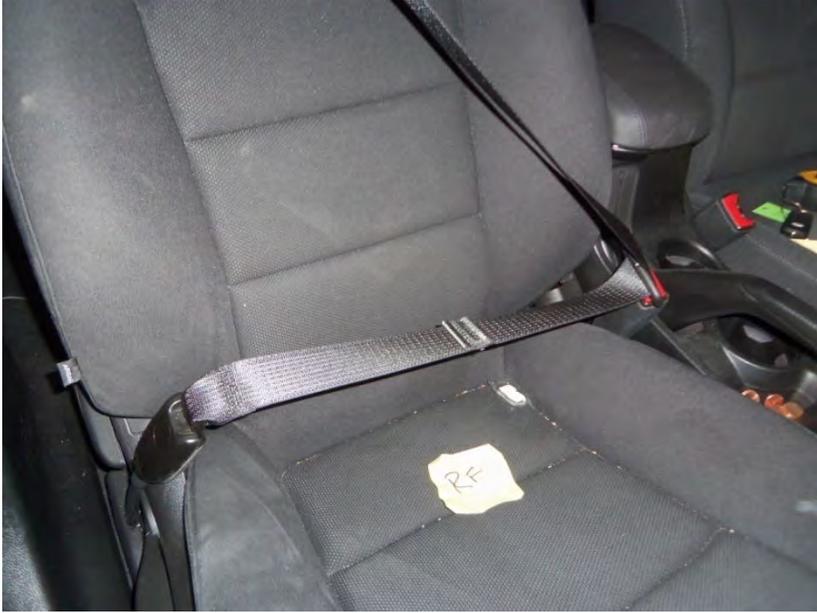
Photo #	Description / Photo	Damage (Yes/No)
71-1131644033-35	Right front seat belt buckled and fully retracted

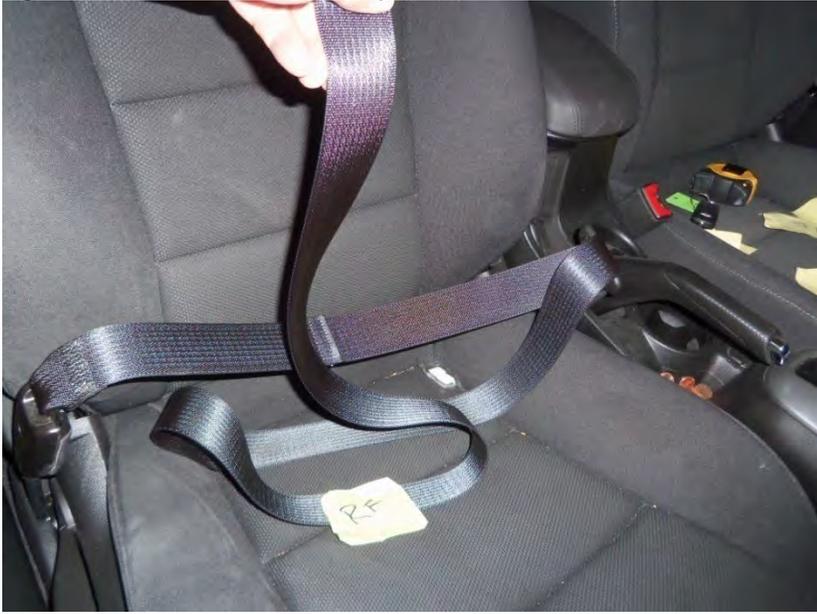
A photograph of the right front passenger seat in a vehicle. The seat is upholstered in dark grey fabric. A black seat belt is buckled and fully retracted, lying flat across the seat. A small yellow sticky note with the handwritten letters 'RF' is placed on the seat cushion. The center console and part of the driver's seat are visible in the background.	No
71-1131644033-36	Right front seat belt buckled and fully extended
