Subject: 71-1035097733 PAR Case Sent to ESIS - No Action Required

A product allegation claim has been made in your region. The customer is alleging airbag nondeployment, wheels locked up and Onstar inoperative in a collision . This case is being escalated to ESIS because insurance involvement.

██████████
2012 Chevrolet Sonic
1G1JC5SHXC4██████████
CENTURY III CHEVROLET, WEST MIFFLIN PA (BAC) 113496
Kevin Codd, Body Shop Manager

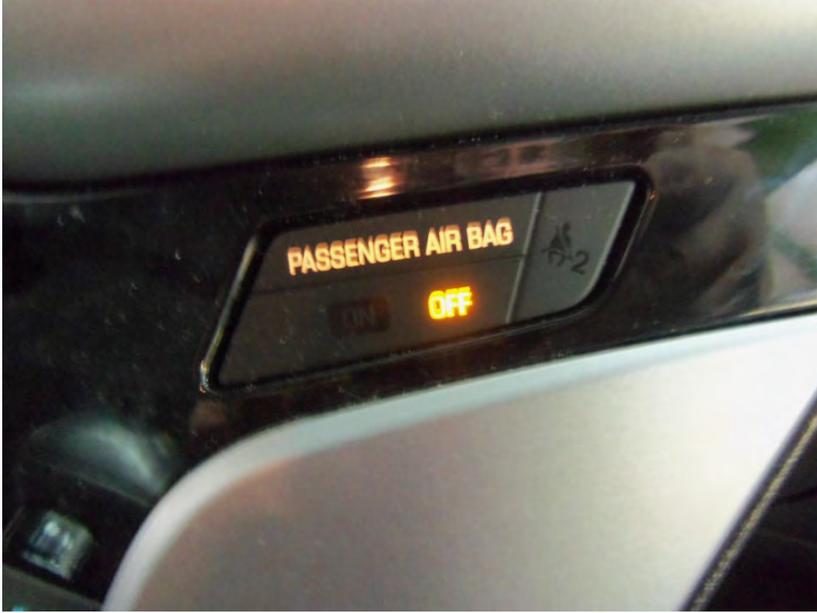
Photo #	Description / Photo	Damage (Yes/No)
71-1131644033-41	Passenger presence showing off with no passenger seated

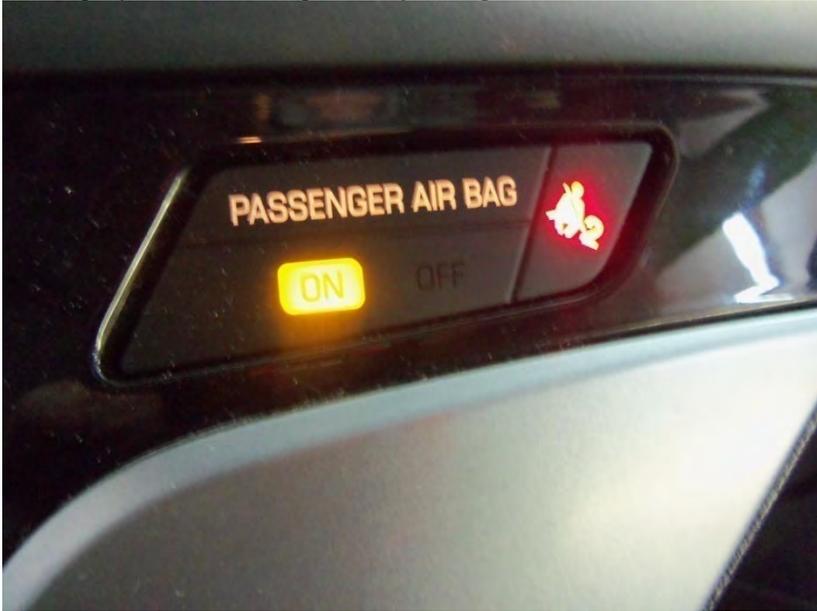
No
71-1131644033-42	Passenger presence showing on with passenger seated and seat belt unbuckled

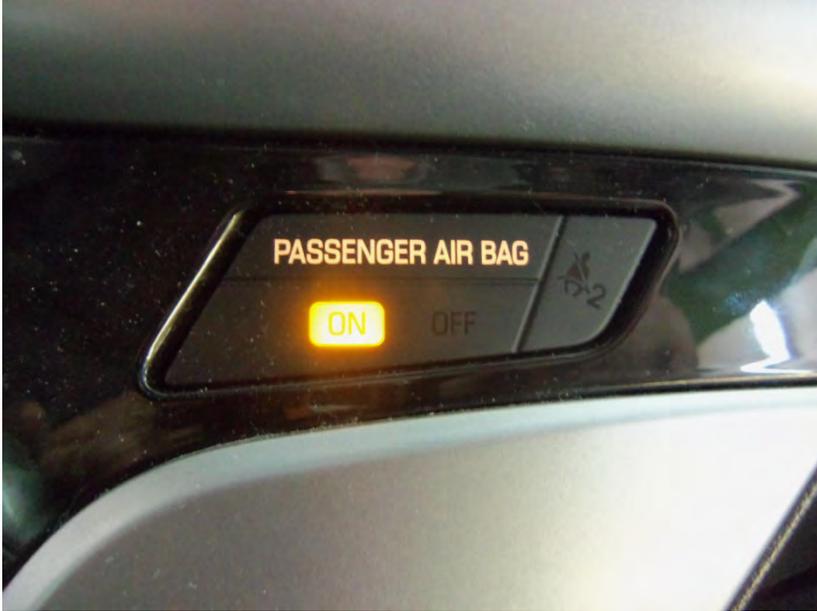
Photo #	Description / Photo	Damage (Yes/No)
71-1131644033-43	Passenger presence showing on;/ seatbelt light off with passenger seated and seat belt buckled

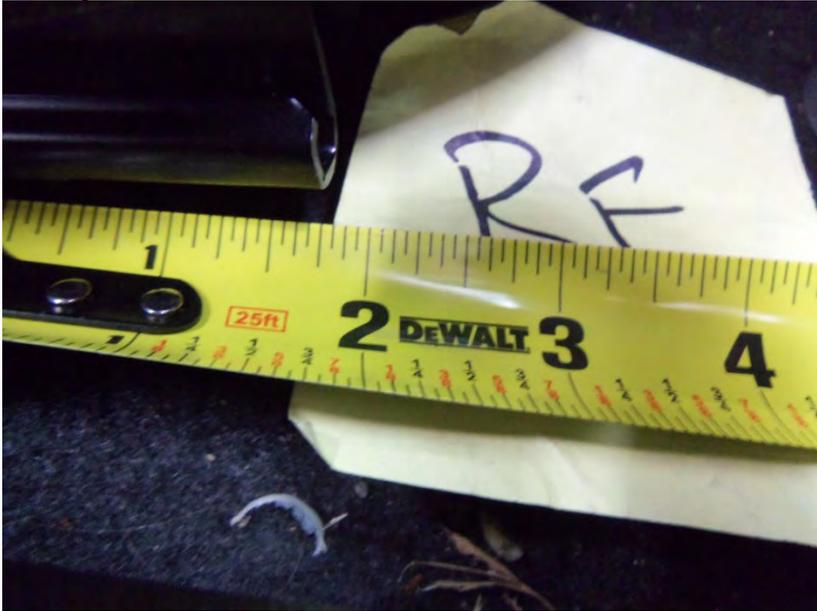
No
71-1131644033-44	Passenger seat measurement 13/4 inches back of seat track

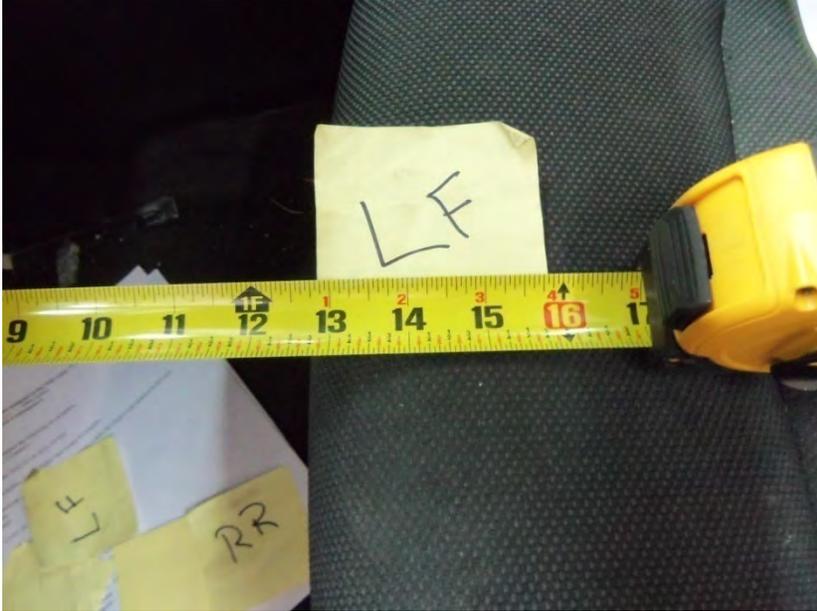
Photo #	Description / Photo	Damage (Yes/No)
71-1131644033-45	<p>Driver seat position 12 3/4 inches from instrument panel</p>

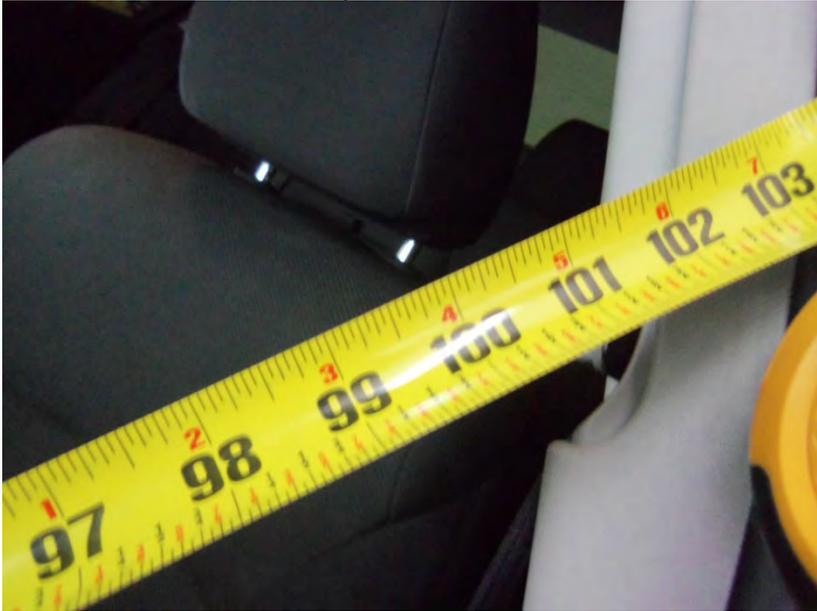
No
71-1131644033-46	<p>Driver front seat belt harness fully extended measurement 101 inches</p>

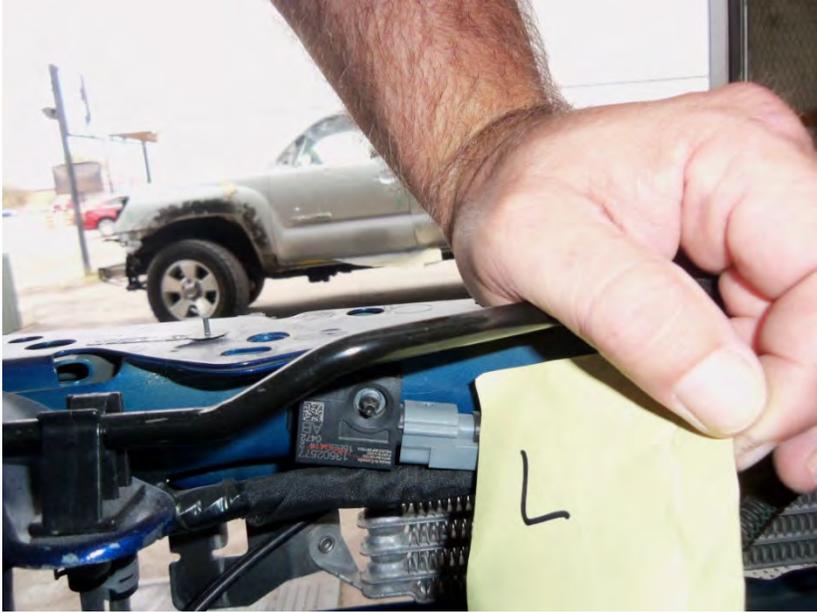
Photo #	Description / Photo	Damage (Yes/No)
71-1131644033-51	Left front air bag sensor

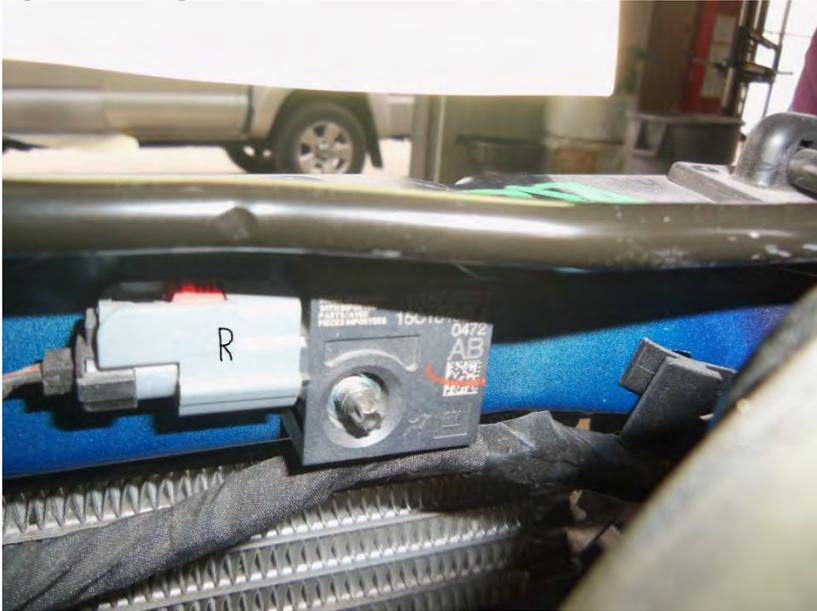
No
71-1131644033-52	Right front air bag sensor

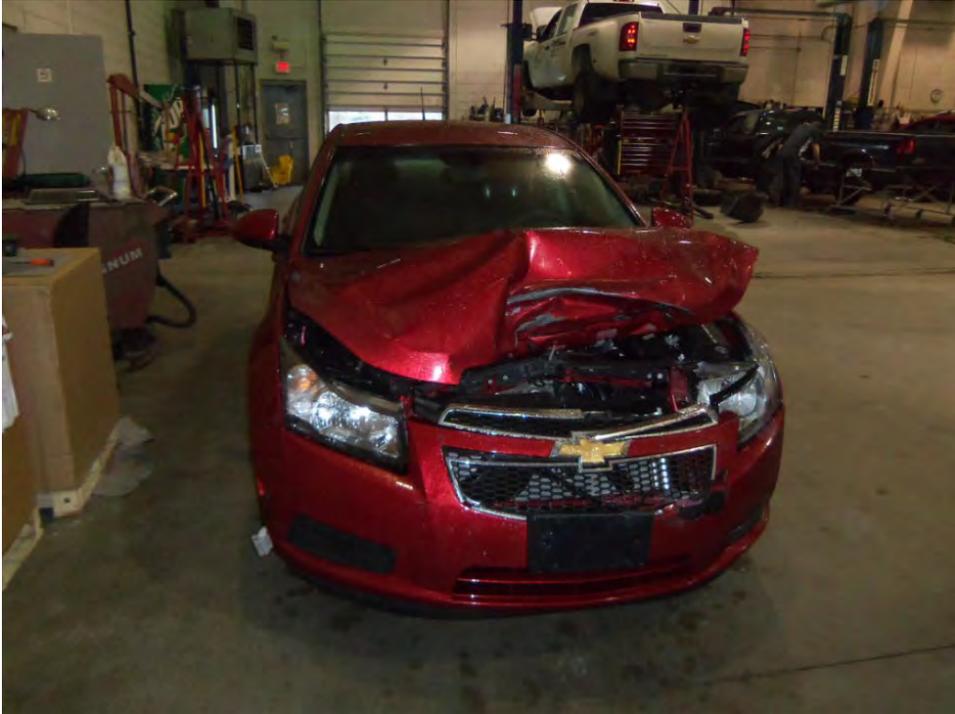
No
6	Front (Exterior)

Yes

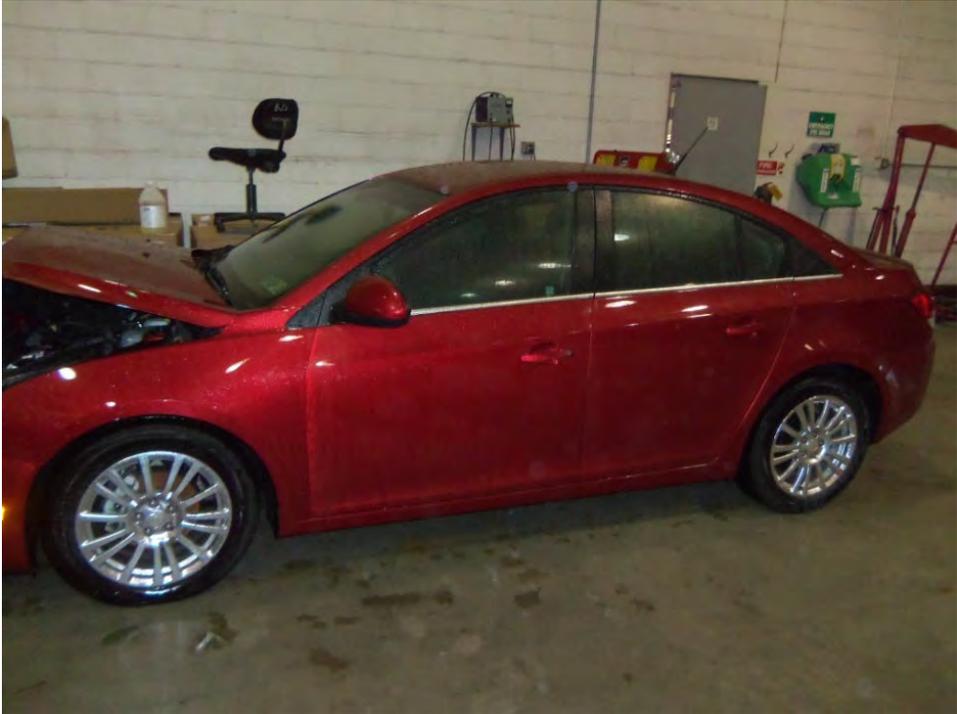
Photo #	Description / Photo	Damage (Yes/No)
9	Driver's Side (Exterior)

Yes
10	Under Hood

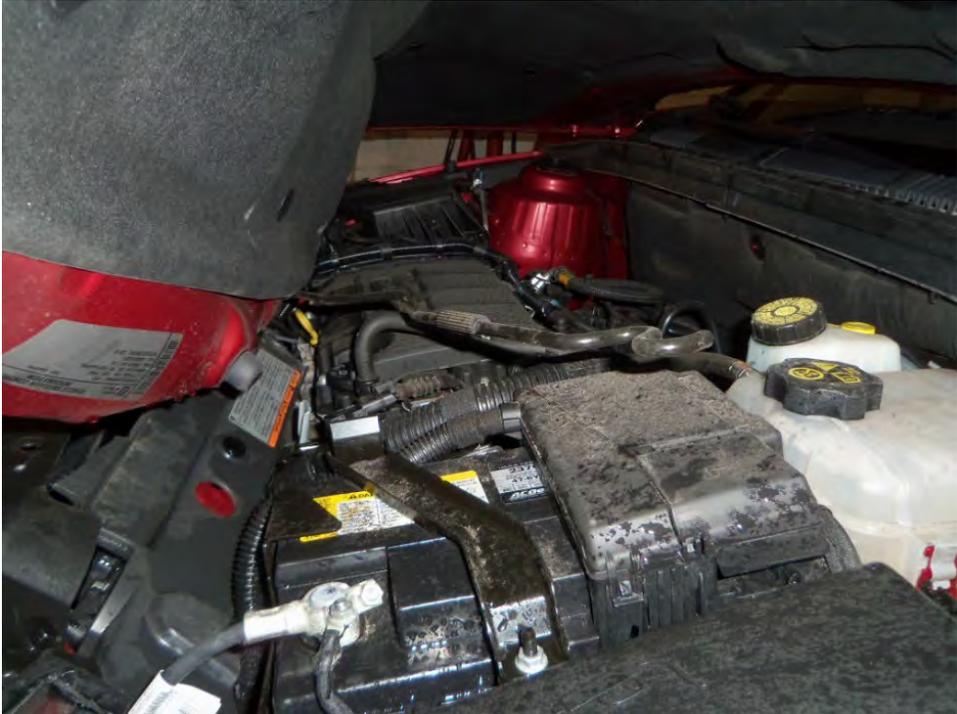
Yes

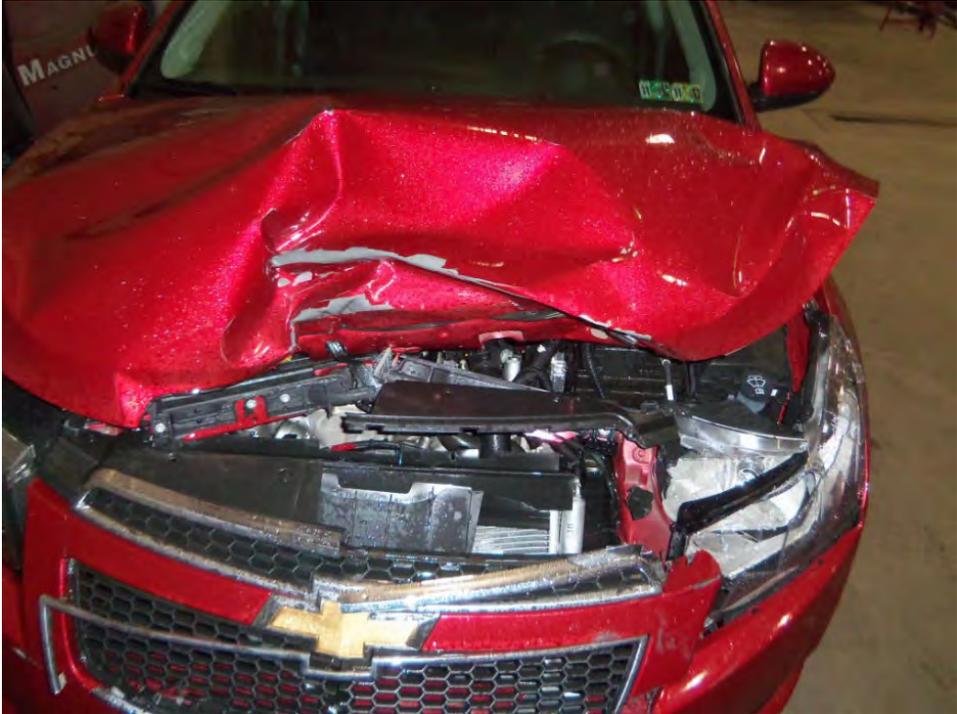
<u>Photo #</u>	<u>Description / Photo</u>	<u>Damage (Yes/No)</u>
23	Point of Impact

Yes
24	Point of Impact Measurement to Upper Radiator Support

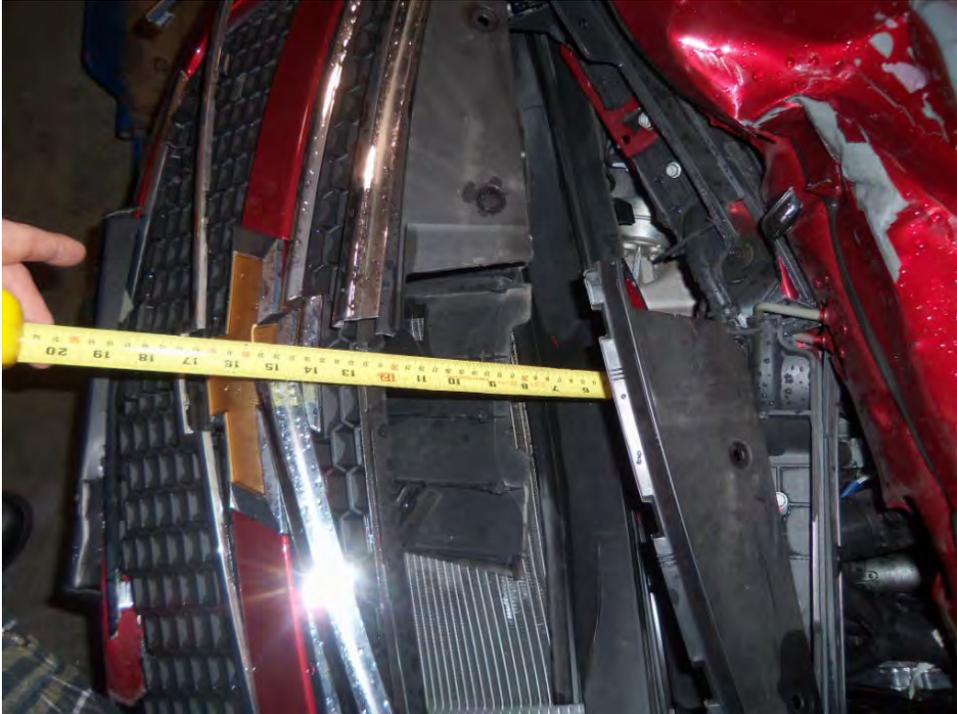
Yes

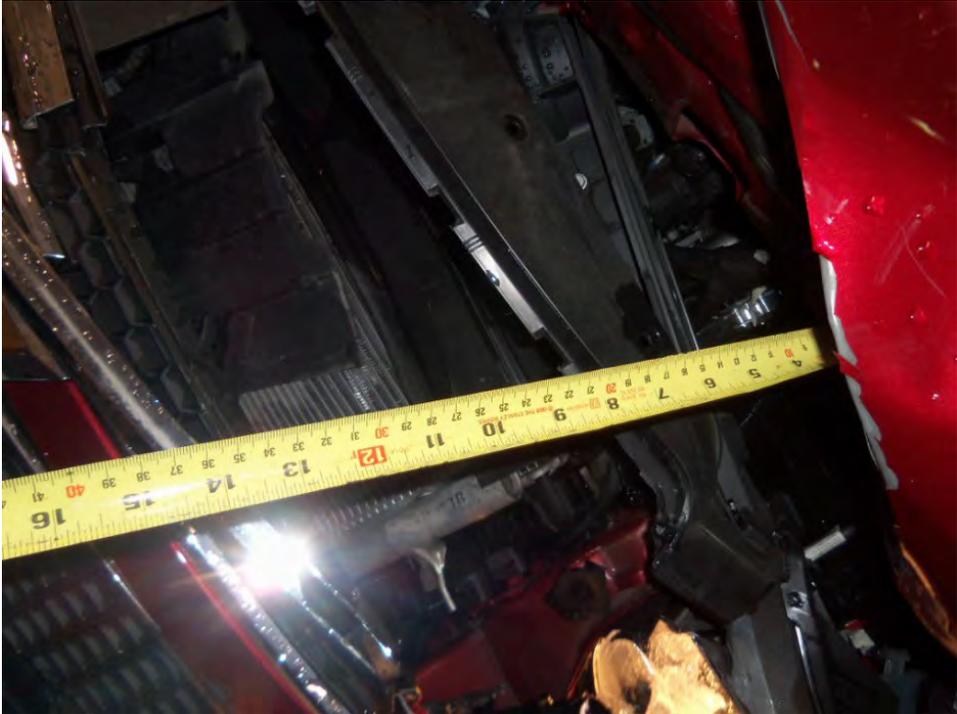
Photo #	Description / Photo	Damage (Yes/No)
25	Point of Impact To Hood Location

Yes
26	Driver's Hood Hinge

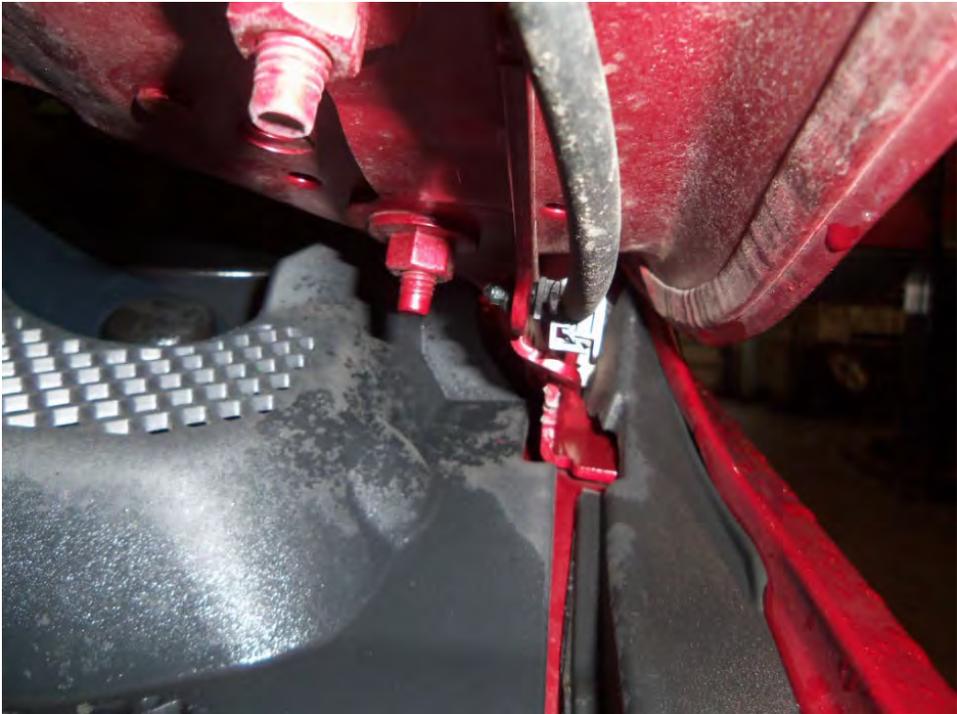
Yes

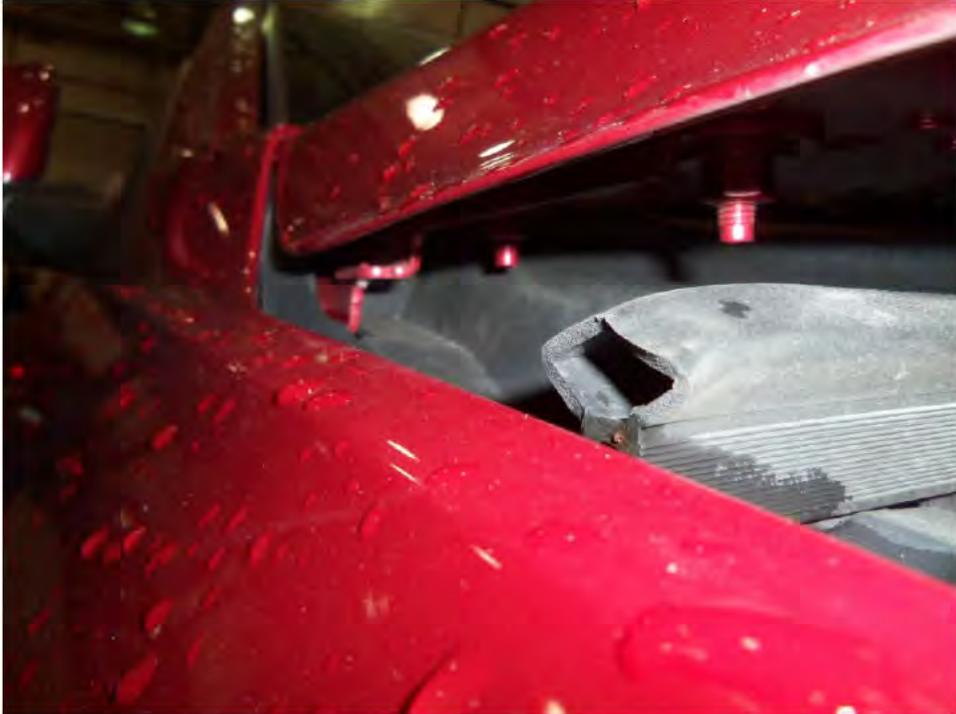
<u>Photo #</u>	<u>Description / Photo</u>	<u>Damage (Yes/No)</u>
27	Passenger Hood Hinge

Yes
28	Overlap of Driver's Fender to Hood

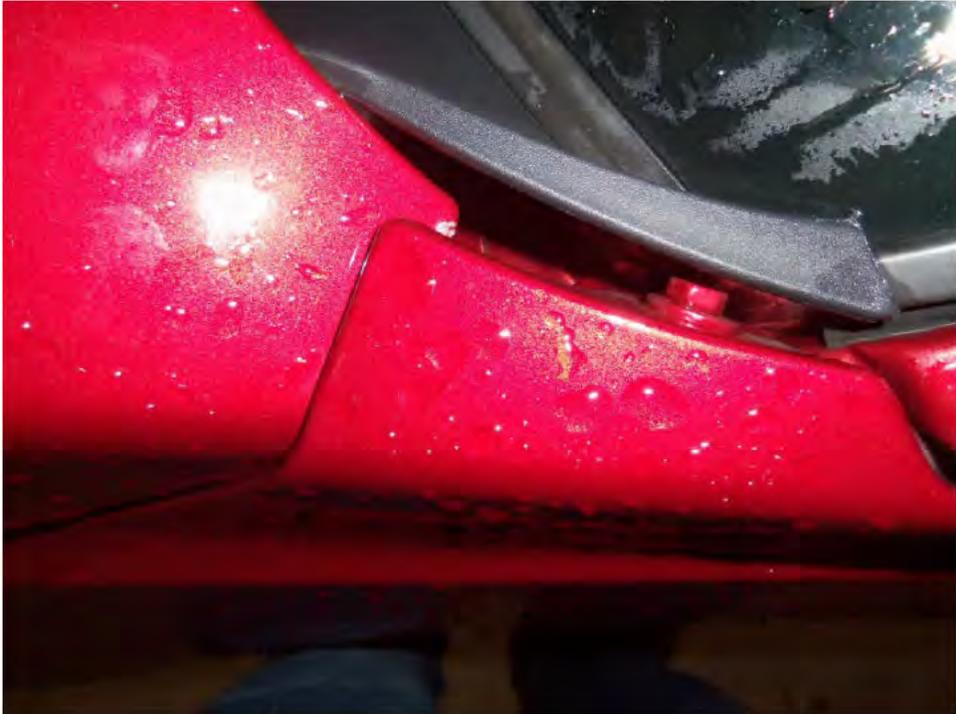
Yes

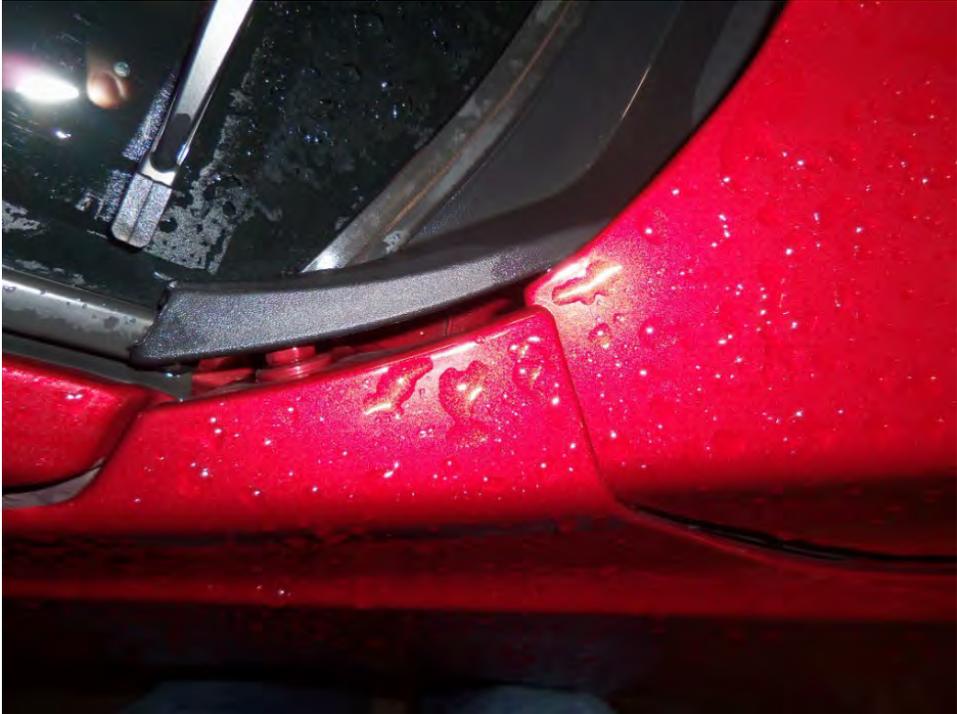
Photo #	Description / Photo	Damage (Yes/No)
29	Overlap of Passenger Fender to Hood

Yes
30	Damage to Hood

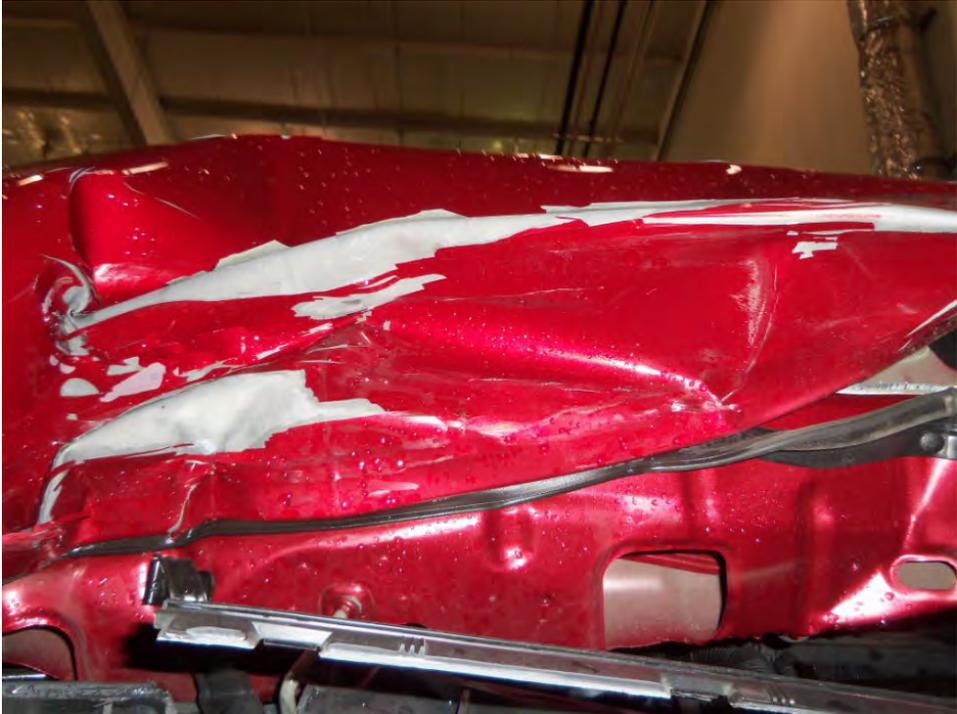
Yes

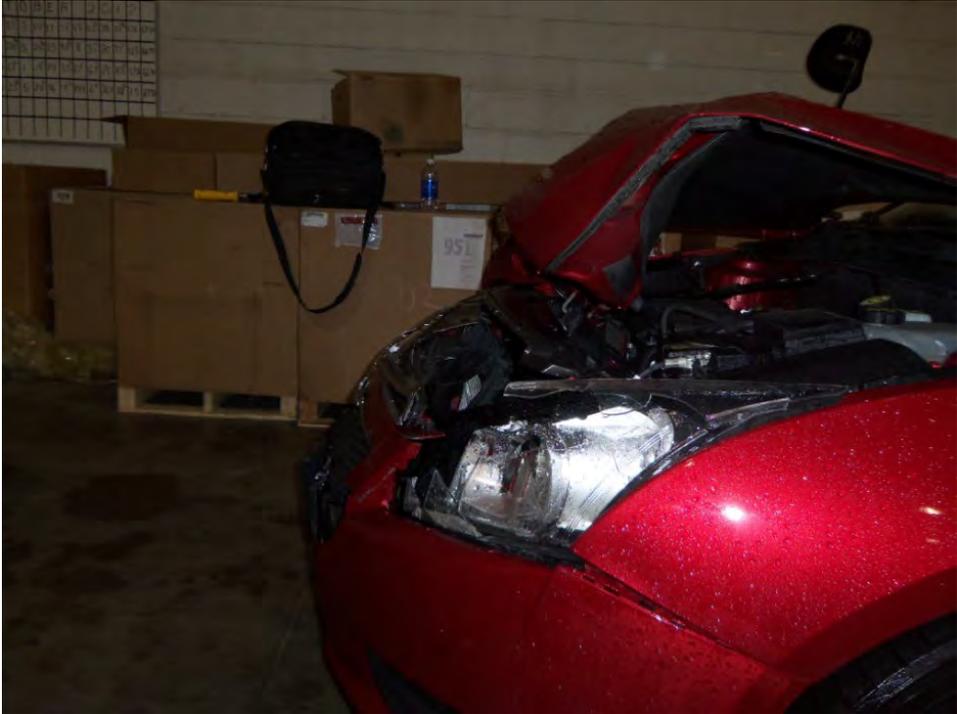
Photo #	Description / Photo	Damage (Yes/No)
31	Damage to Hood and Front Bumper

Yes
32	Damage to Hood and Driver's Headlamp

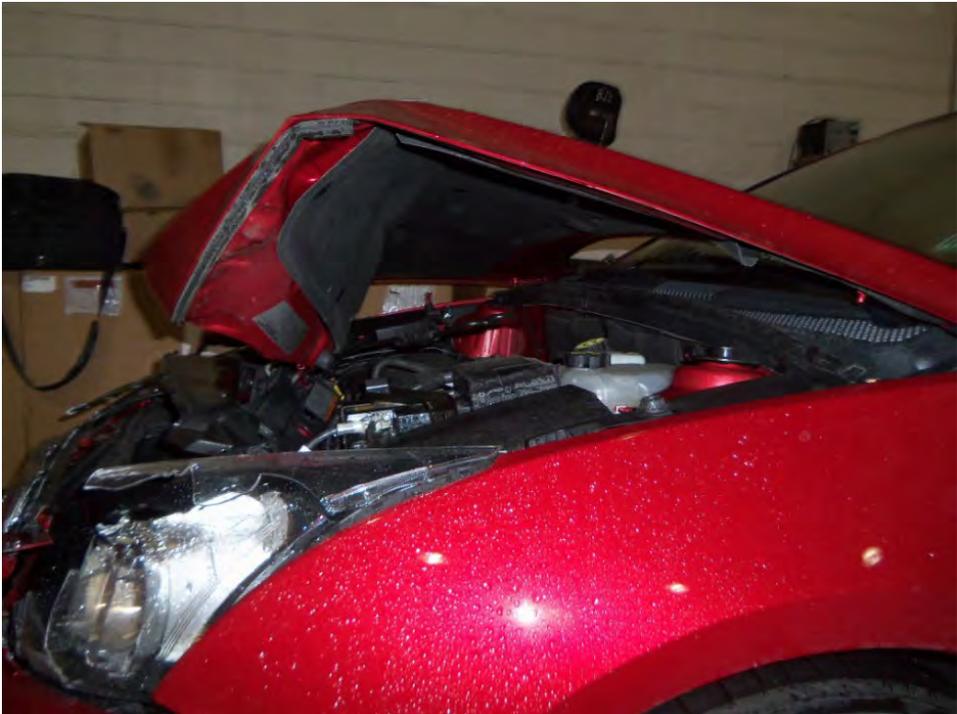
Yes

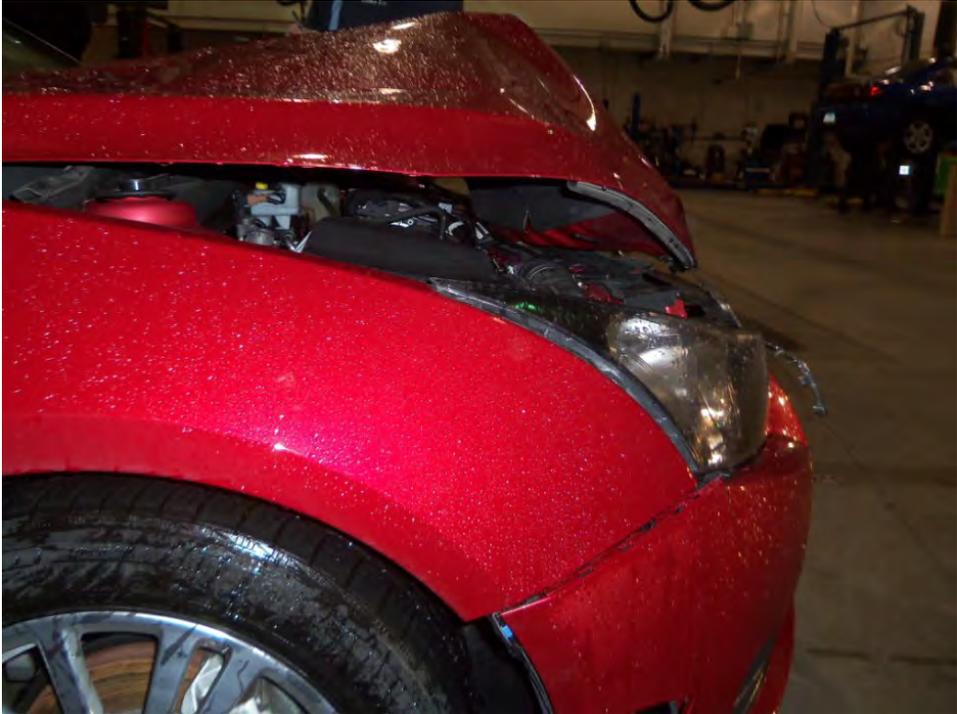
Photo #	Description / Photo	Damage (Yes/No)
33	<p>Gap from Passenger Side of Hood</p>

Yes
34	<p>Damage to Grille Driver's Side</p>

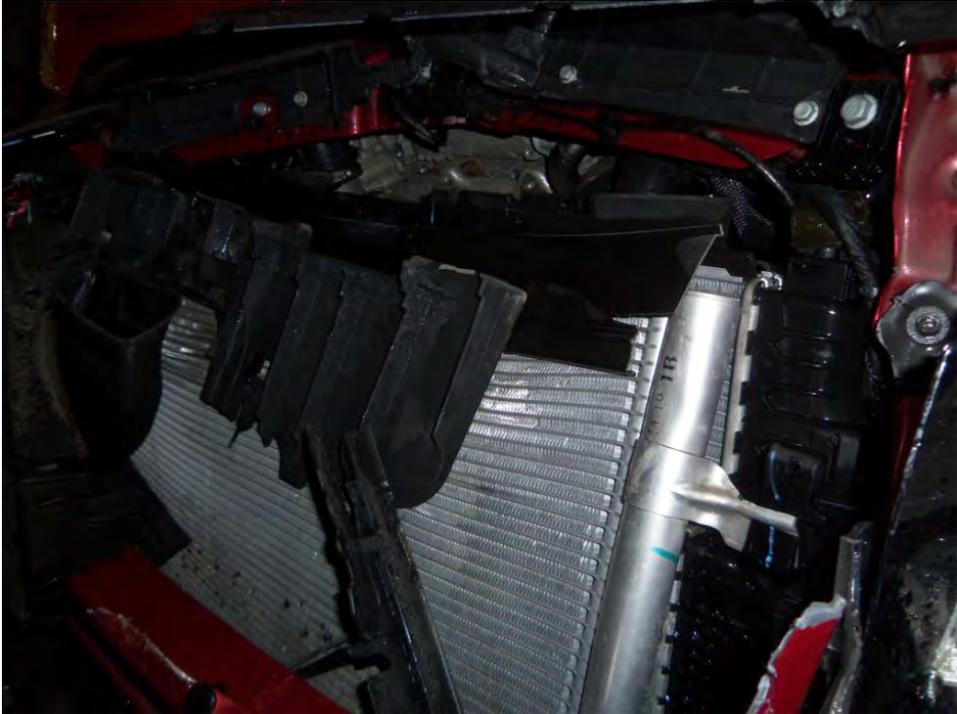
<u>Photo #</u>	<u>Description / Photo</u>	<u>Damage (Yes/No)</u>
35	Damage to A/C Condenser

Yes
36	Piece Missing from Front Bumper Reinforcement

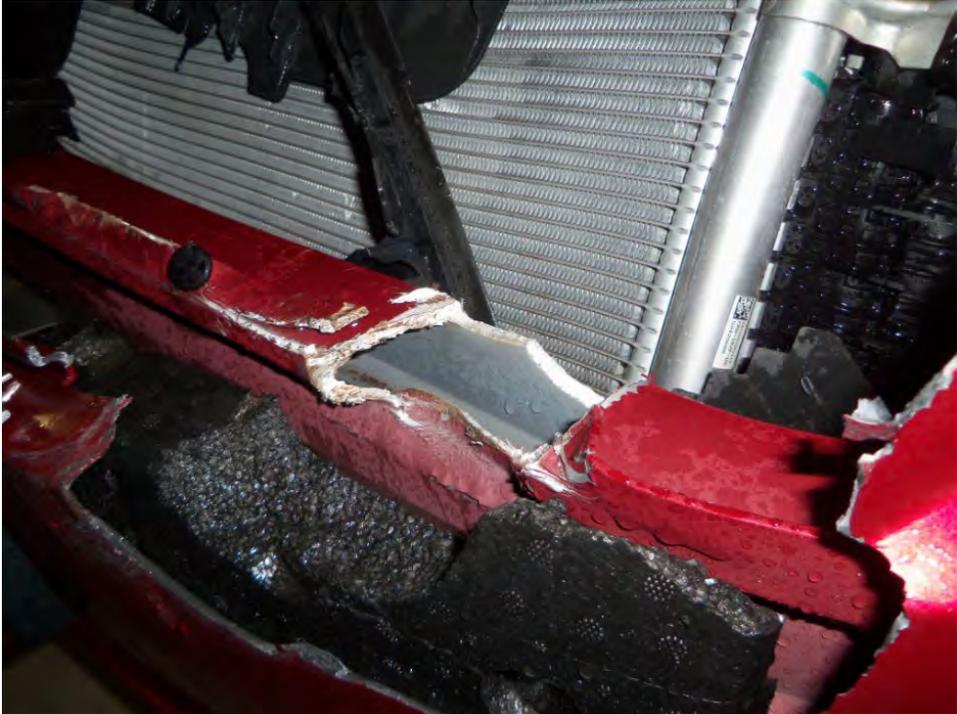
Yes

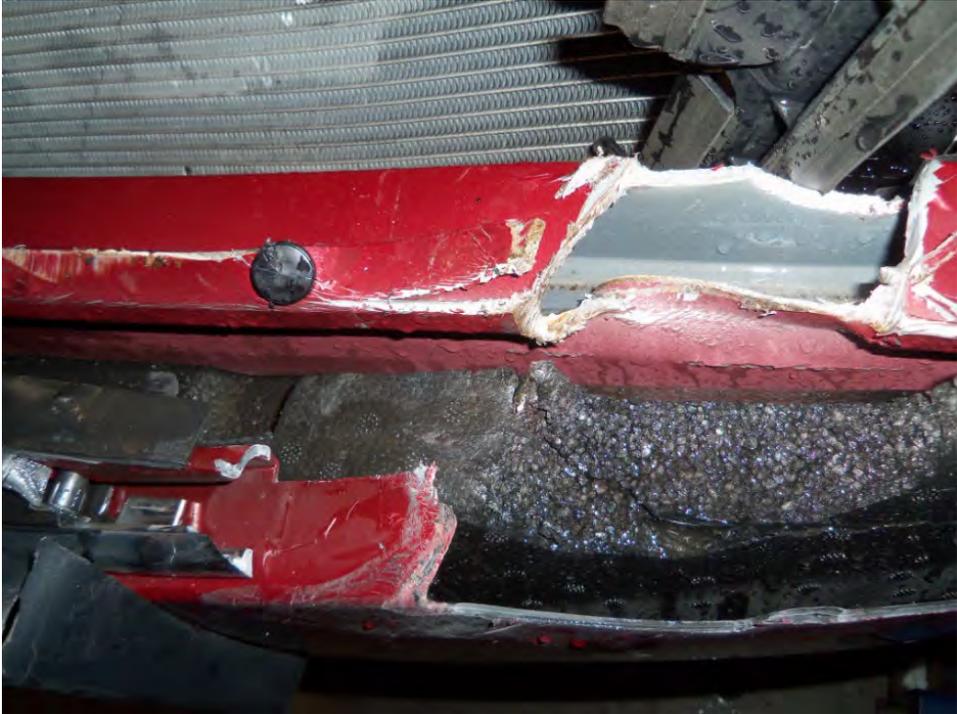
Photo #	Description / Photo	Damage (Yes/No)
37	<p>Piece Missing from Front Bumper Reinforcement</p>

Yes
38	<p>Front Bumper Reinforcement</p>

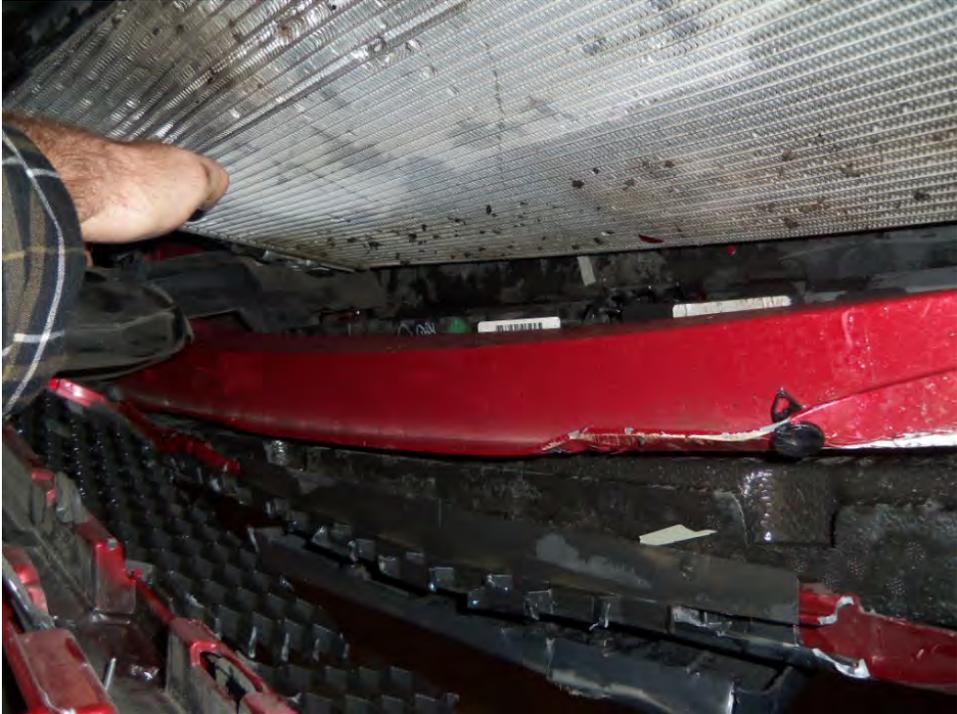
Yes

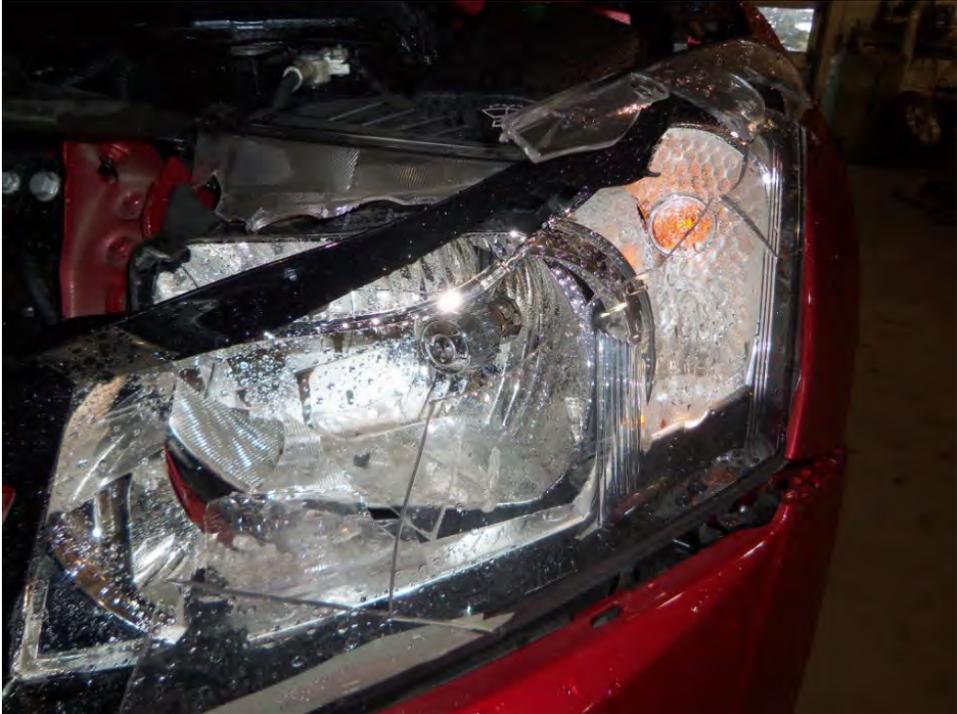
Photo #	Description / Photo	Damage (Yes/No)
39	Damage to Driver's Front Headlamp

Yes
40	Front Bumper Cover Alignment to Passenger Fender

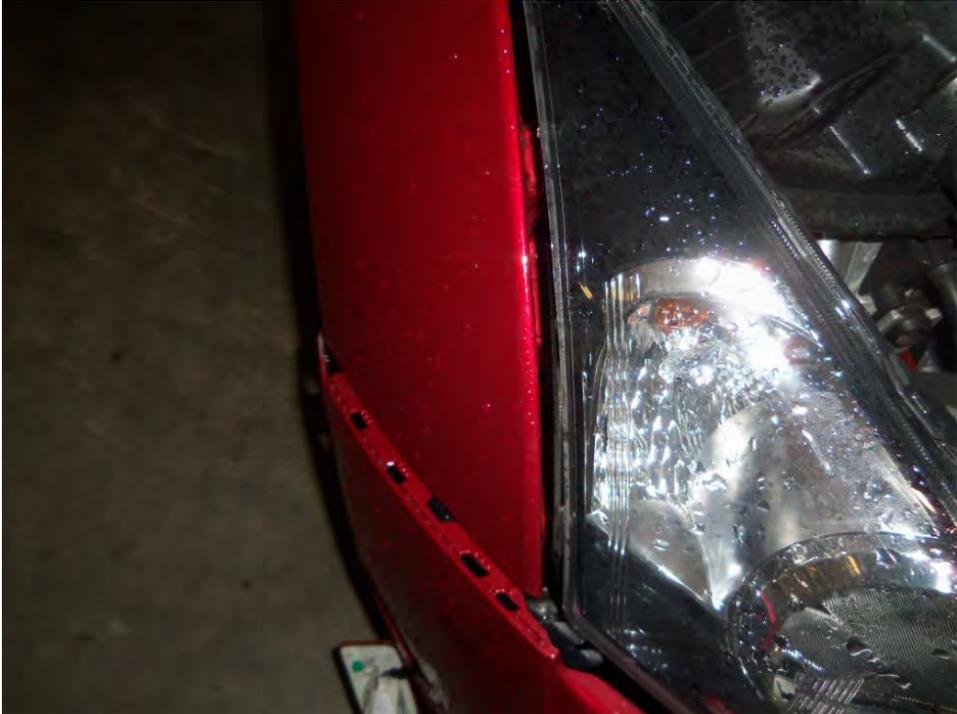
Yes

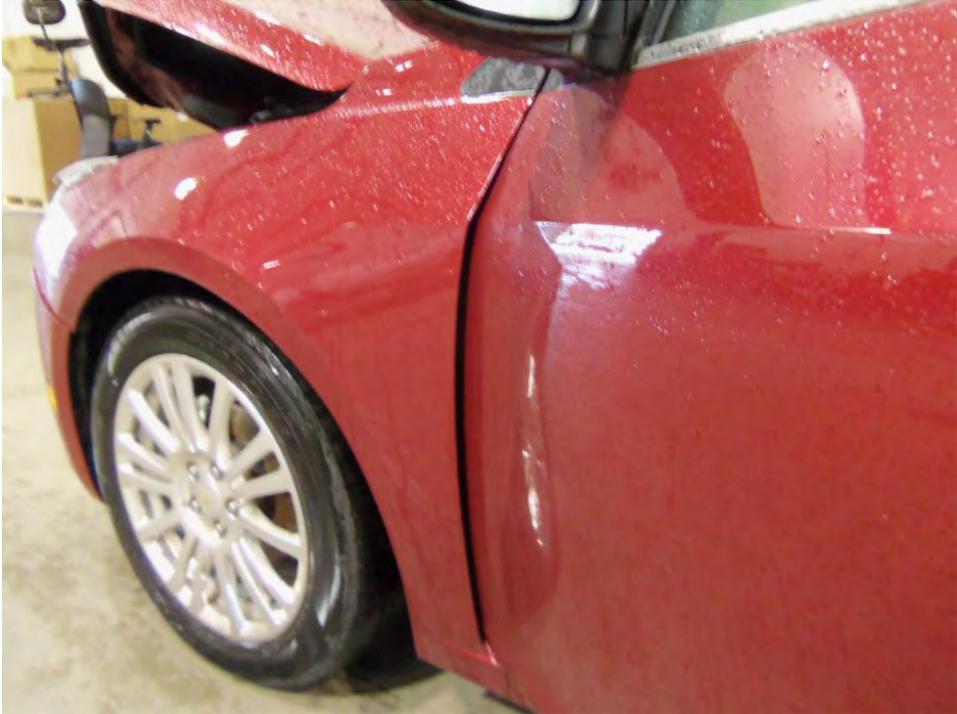
<u>Photo #</u>	<u>Description / Photo</u>	<u>Damage (Yes/No)</u>
41	Driver's Fender Rubbing on Front Door

Yes
42	Scrapes on Front Bumper on Passenger Side

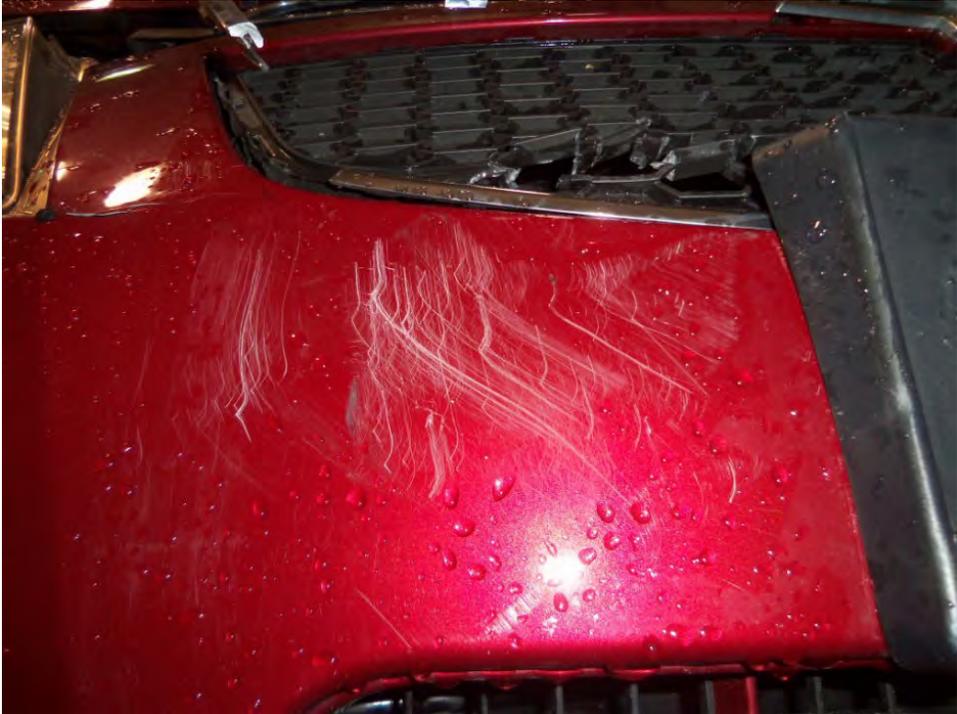
Yes

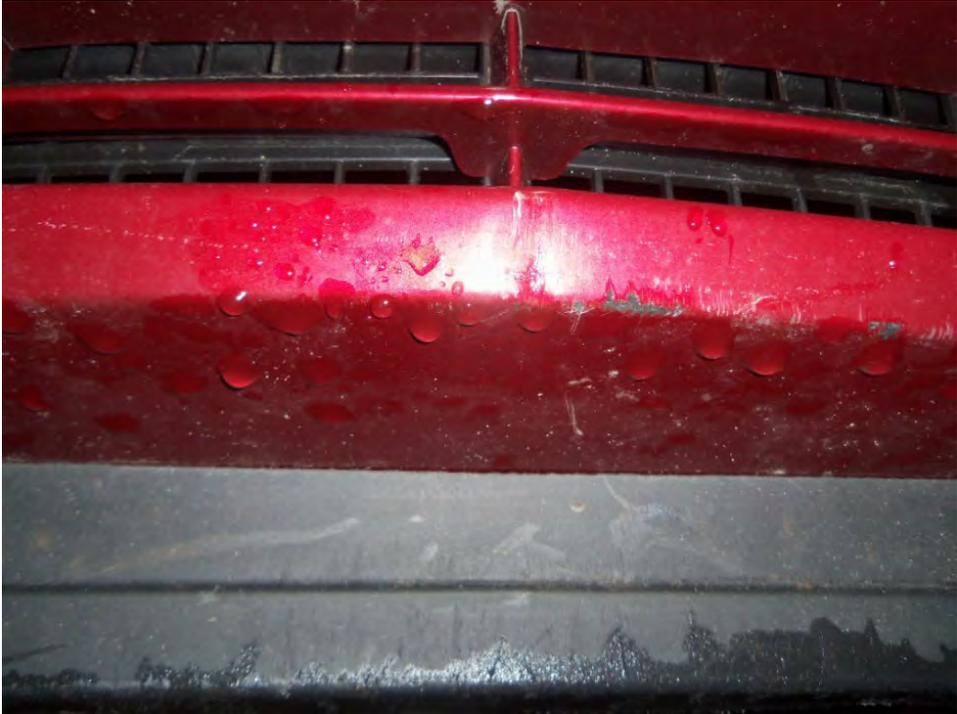
Photo #	Description / Photo	Damage (Yes/No)
43	<p>Scratched on Underside of Front Bumper</p>

Yes
44	<p>Driver's Wheel Base Measurement</p>

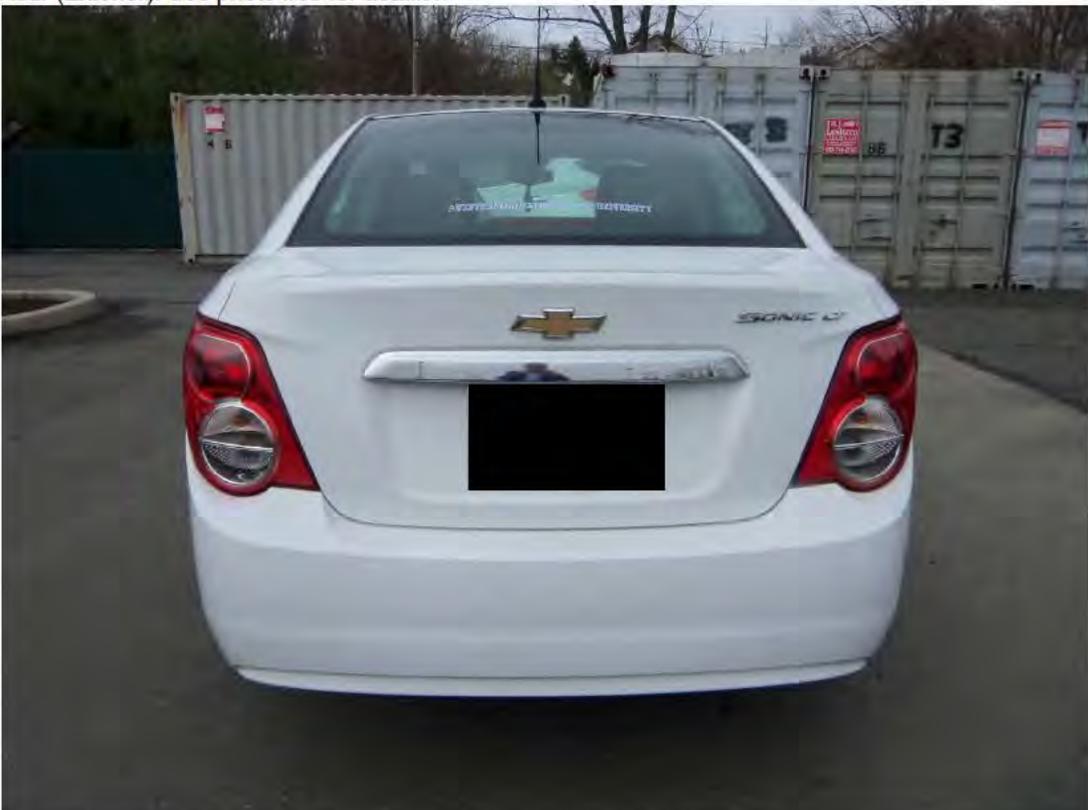
No
8	Rear (Exterior). See photo #30 for details.

Yes

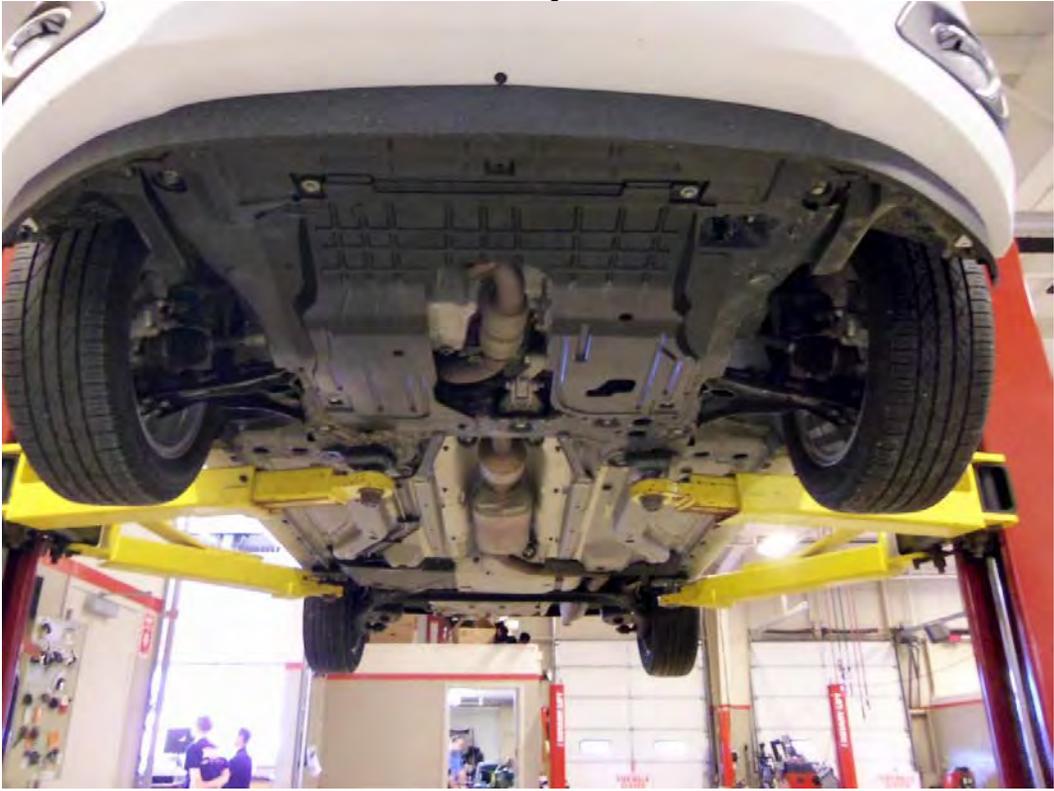
<u>Photo #</u>	<u>Description / Photo</u>	<u>Damage (Yes/No)</u>
25	Undercar Photo Taken From Front of vehicle Looking Rearward.

None present at time of inspection. See photos #25 – 28 for details.
 Note: Right front lower control arm was replaced after incident. See photo #29 of the photo log and attached repair records.
 Inspection revealed no other indications of any undercar damage.

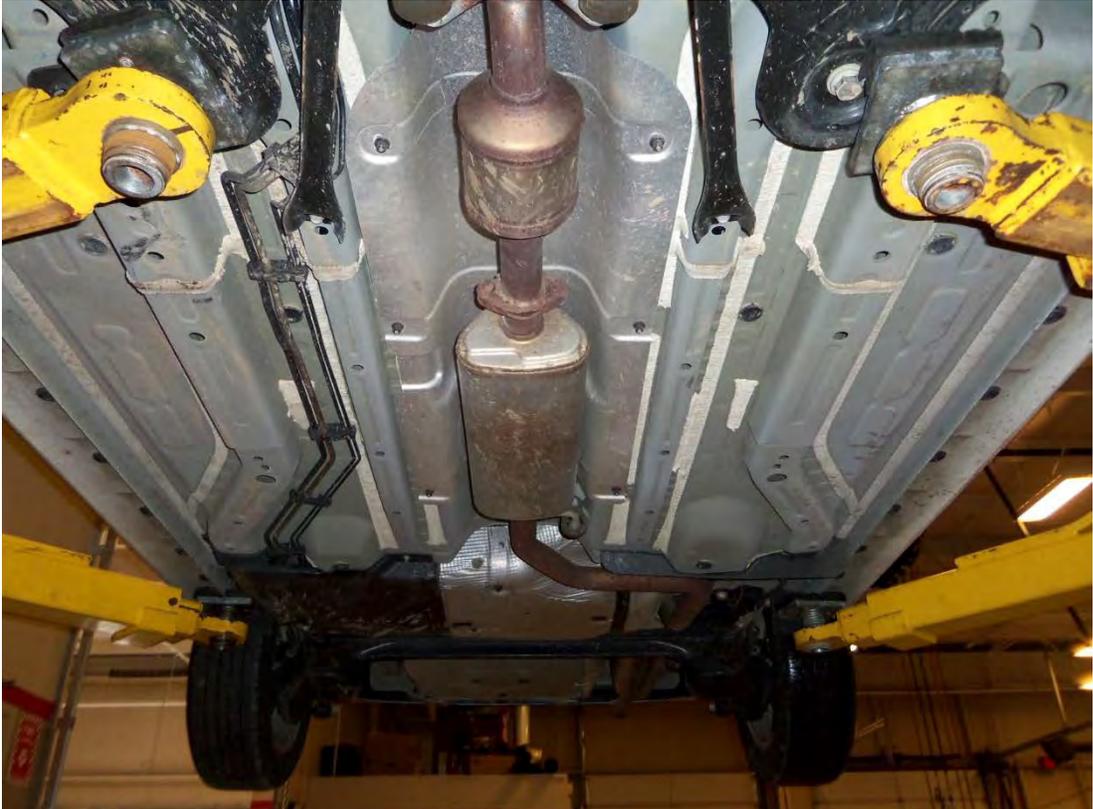
No
26	Undercar Photo Taken From Center of Vehicle Looking Rearward.
