Subject: 71-1035097733 PAR Case Sent to ESIS - No Action Required

A product allegation claim has been made in your region. The customer is alleging airbag nondeployment, wheels locked up and Onstar inoperative in a collision . This case is being escalated to ESIS because insurance involvement.

██████████
2012 Chevrolet Sonic
1G1JC5SHXC4██████████
CENTURY III CHEVROLET, WEST MIFFLIN PA (BAC) 113496
Kevin Codd, Body Shop Manager

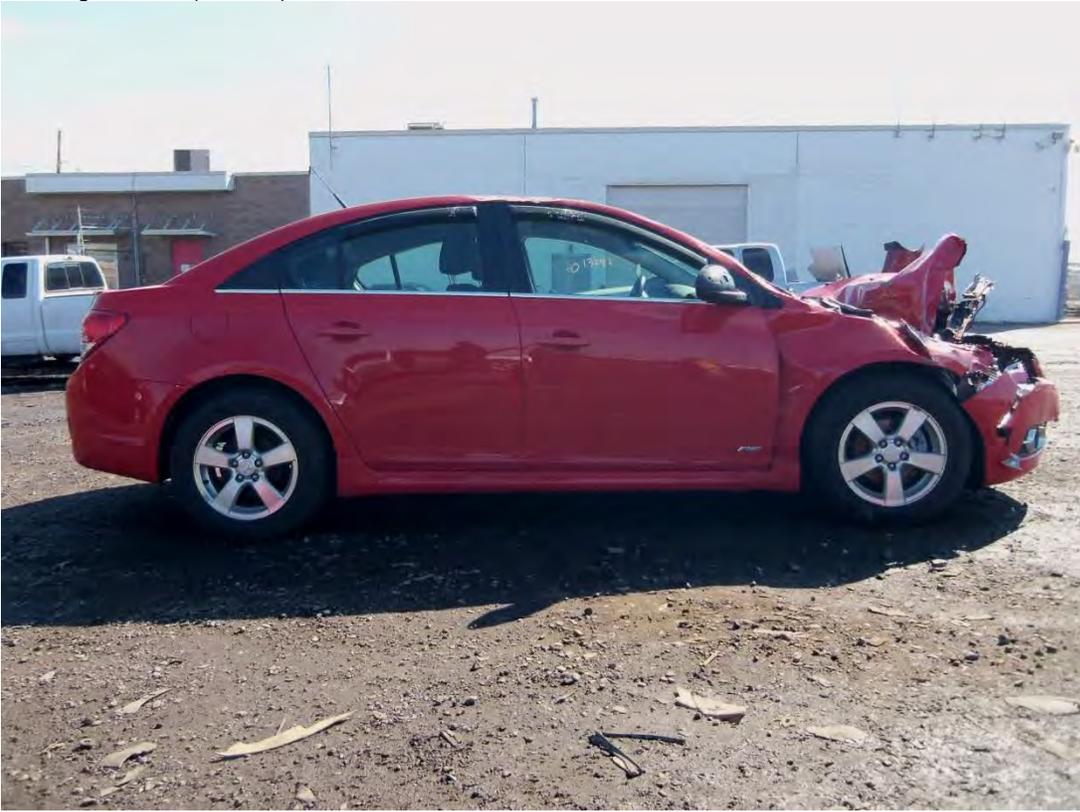
Photo #	Description / Photo	Damage (Yes/No)
7	<p>Passenger's Side (Exterior). Note Exterior Side Window Vent Shades.</p>

- Left Front Rocker Panel Trim Damage: See photo #18 of the photo log.
- Right Front Fender Damage: See photos #7 and 21 – 26 of the photo log.
- Right Front Rim Damage: See photo #16 of the photo log.

Right front fender: See photos #7, 21 – 26 of the photo log.
 Right front rim: See photo #16 of the photo log.
 Right side exterior "A" pillar: See photo #21 of the photo log.

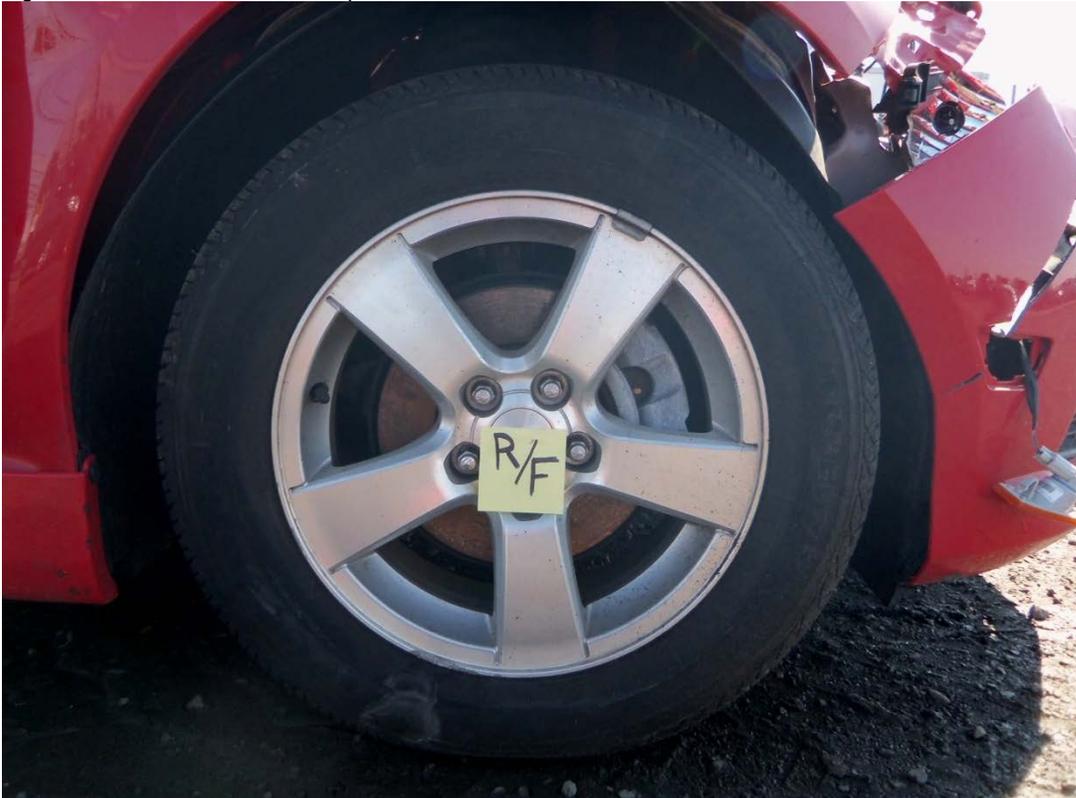
No
14	<p>Right Front Wheel and Tire. See photo #16 for details.</p>

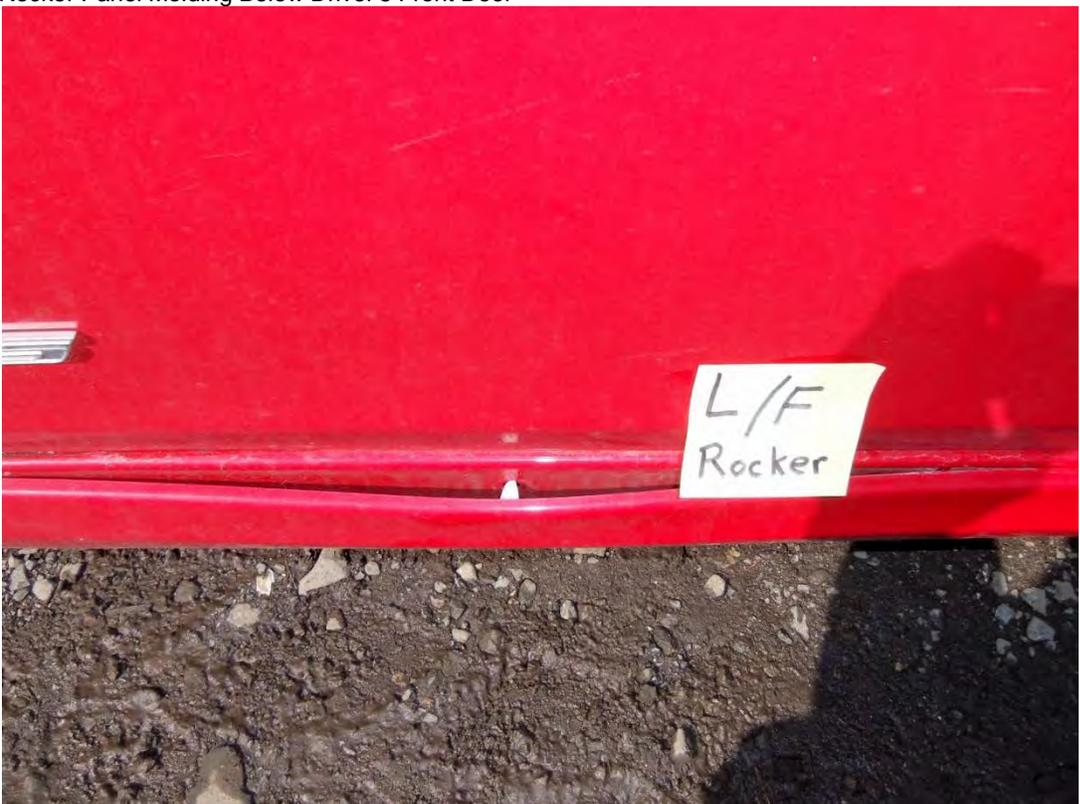
Yes
18	<p>Rocker Panel Molding Below Driver's Front Door</p>

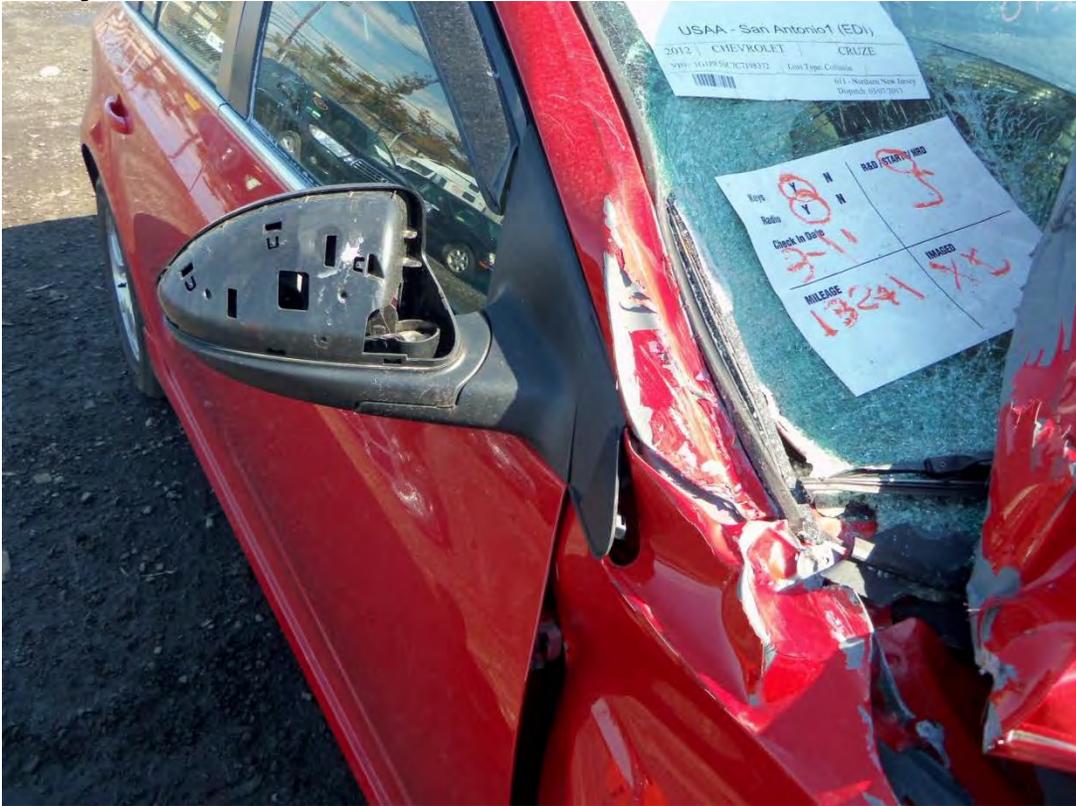
Photo #	Description / Photo	Damage (Yes/No)
21	Passenger Side Exterior "A" Pillar and Mirror

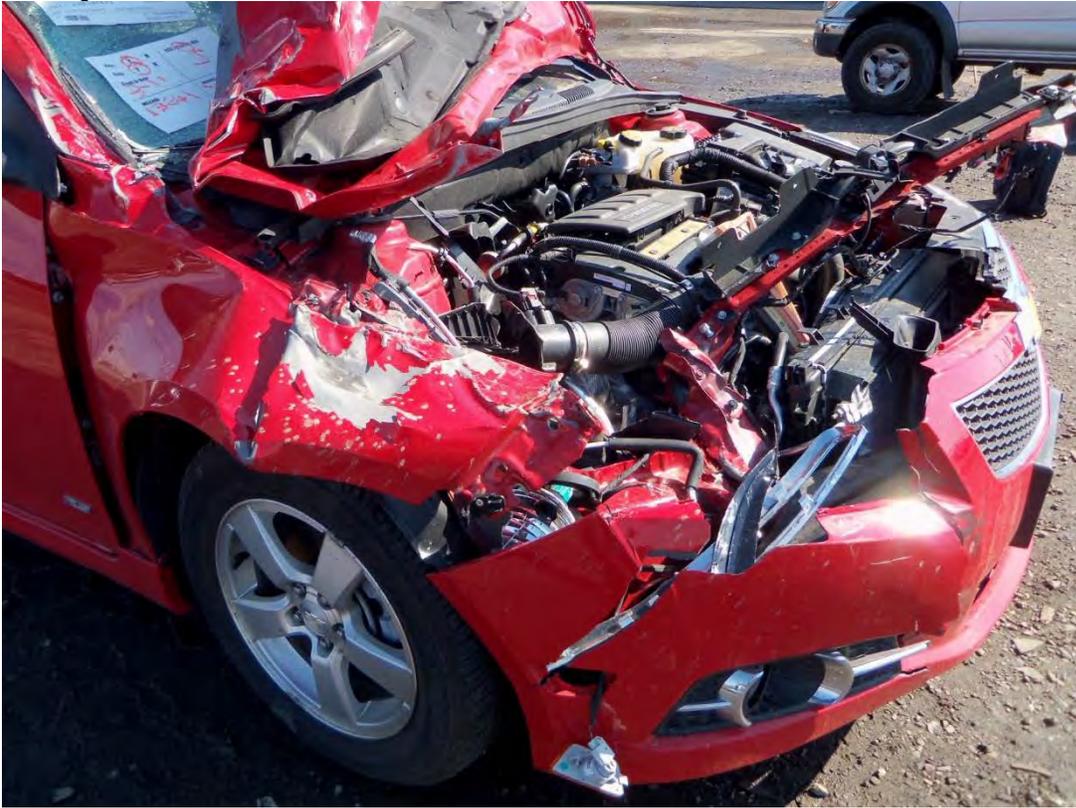
Photo #	Description / Photo	Damage (Yes/No)
23	<p>Passenger Side ¼ View of Front of Vehicle</p>

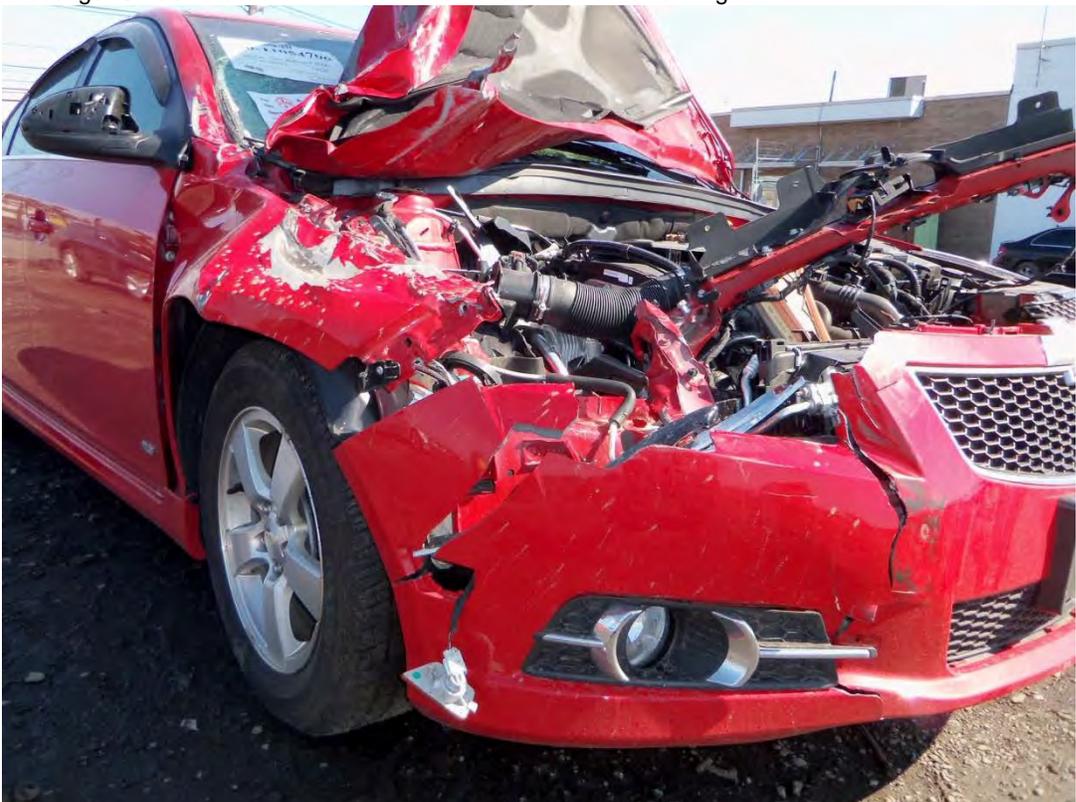
Yes
24	<p>Passenger Side ¼ View of Front of Vehicle Taken From a Lower Angle</p>

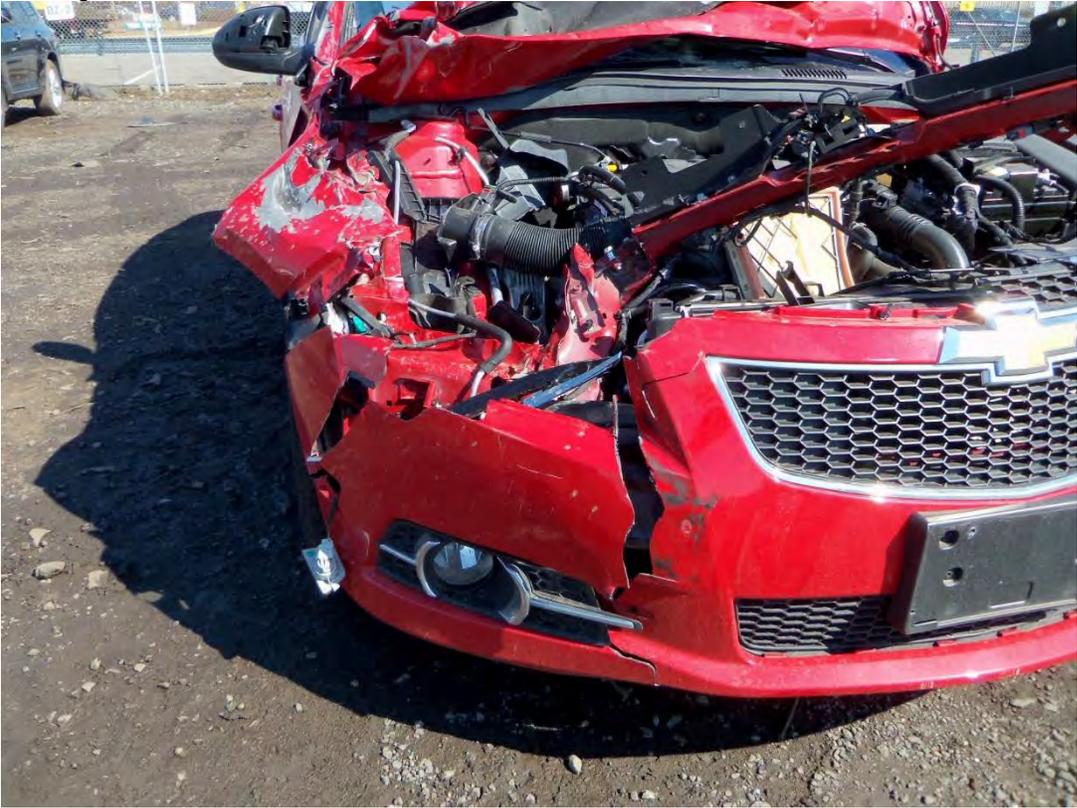
<u>Photo #</u>	<u>Description / Photo</u>	<u>Damage (Yes/No)</u>
25	Passenger's Side Front View

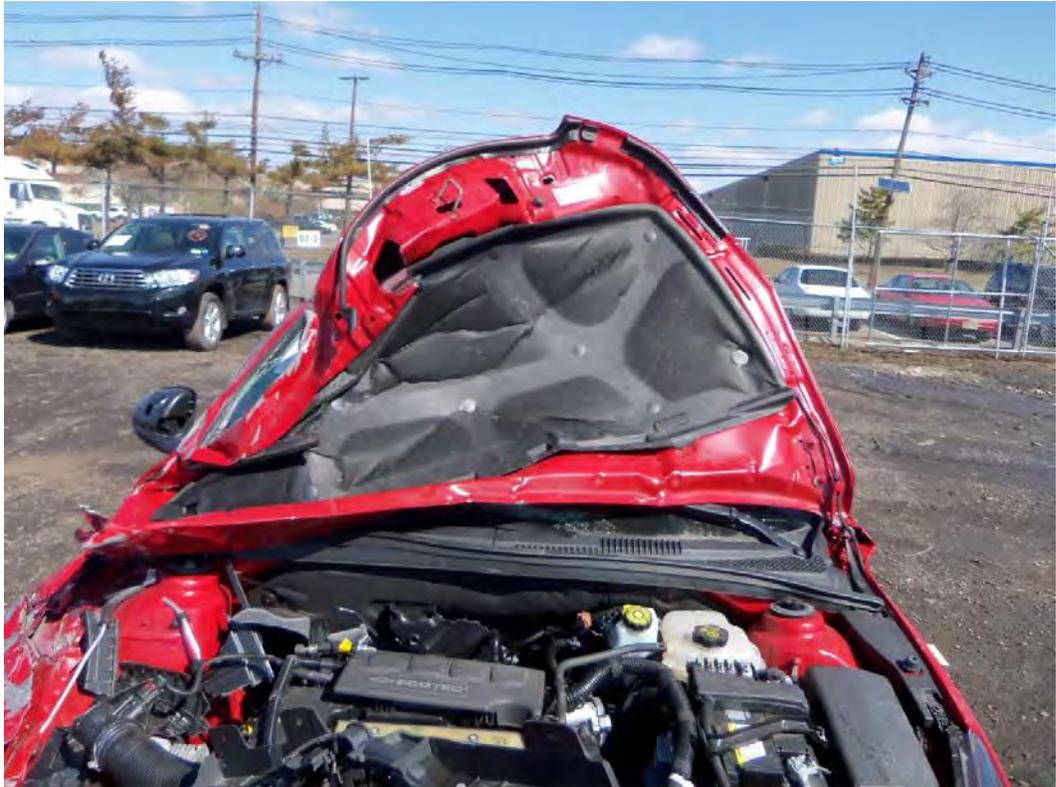
Photo #	Description / Photo	Damage (Yes/No)
27	<p data-bbox="217 317 428 338">Under Side of Hood</p>

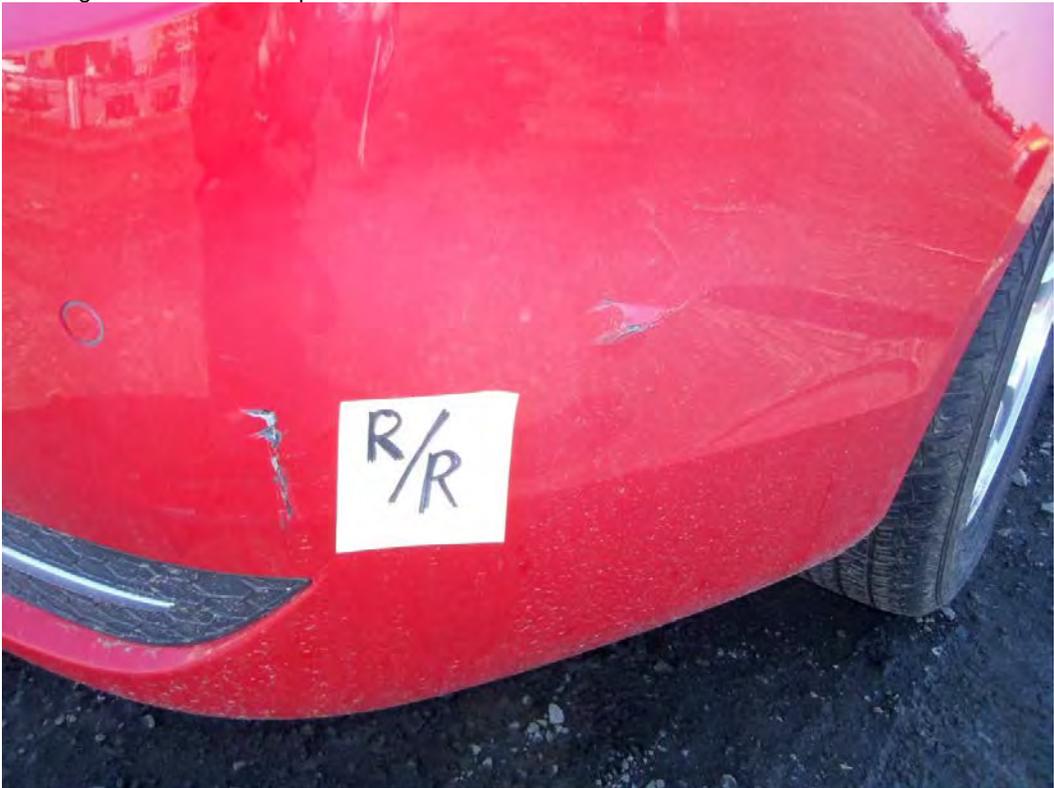
Yes
30	Passenger's Side Rear Bumper Fascia.

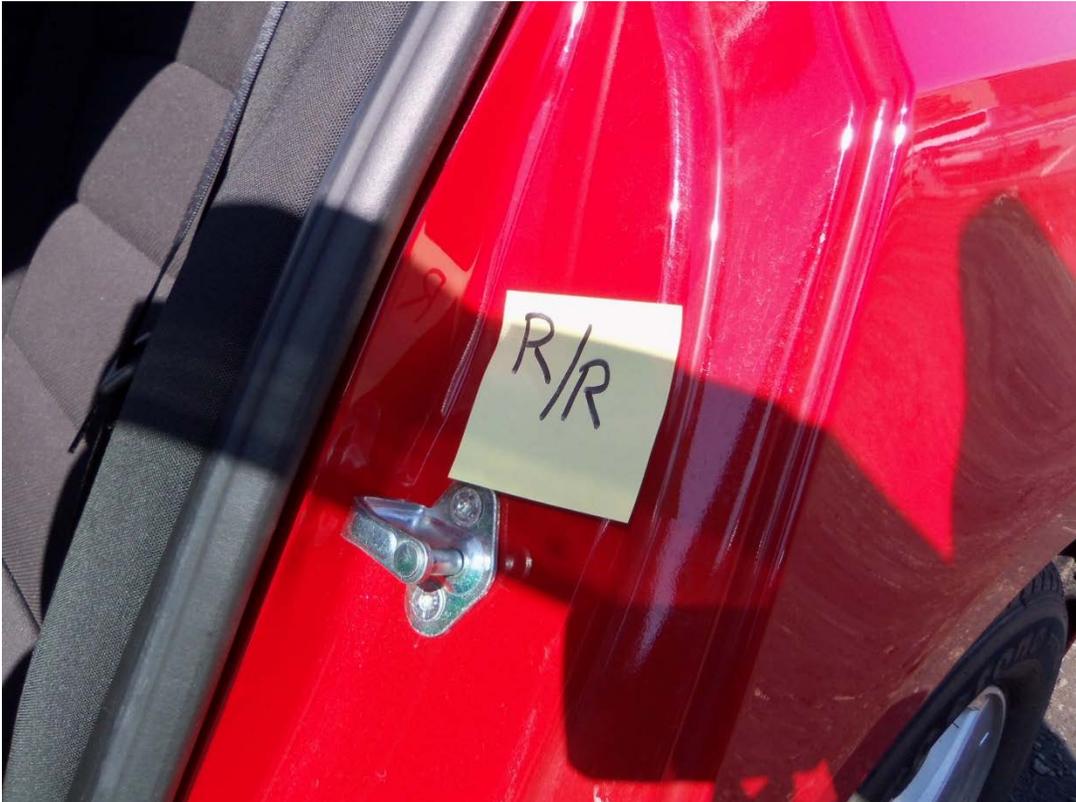
No
34	Driver's Side Rear Door Striker Post. NOTE: Photo is mis-labeled as right rear.

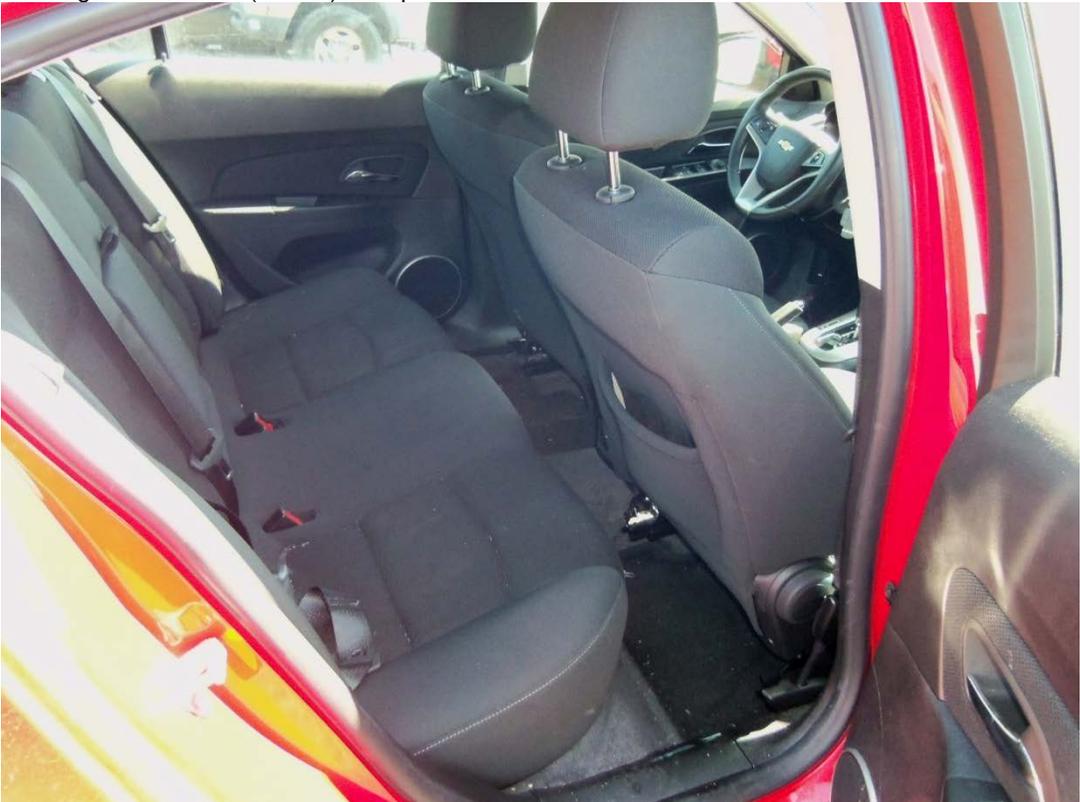
No
42	<p>Passenger's Side Rear (Interior). See photo #43 for details.</p>

Yes

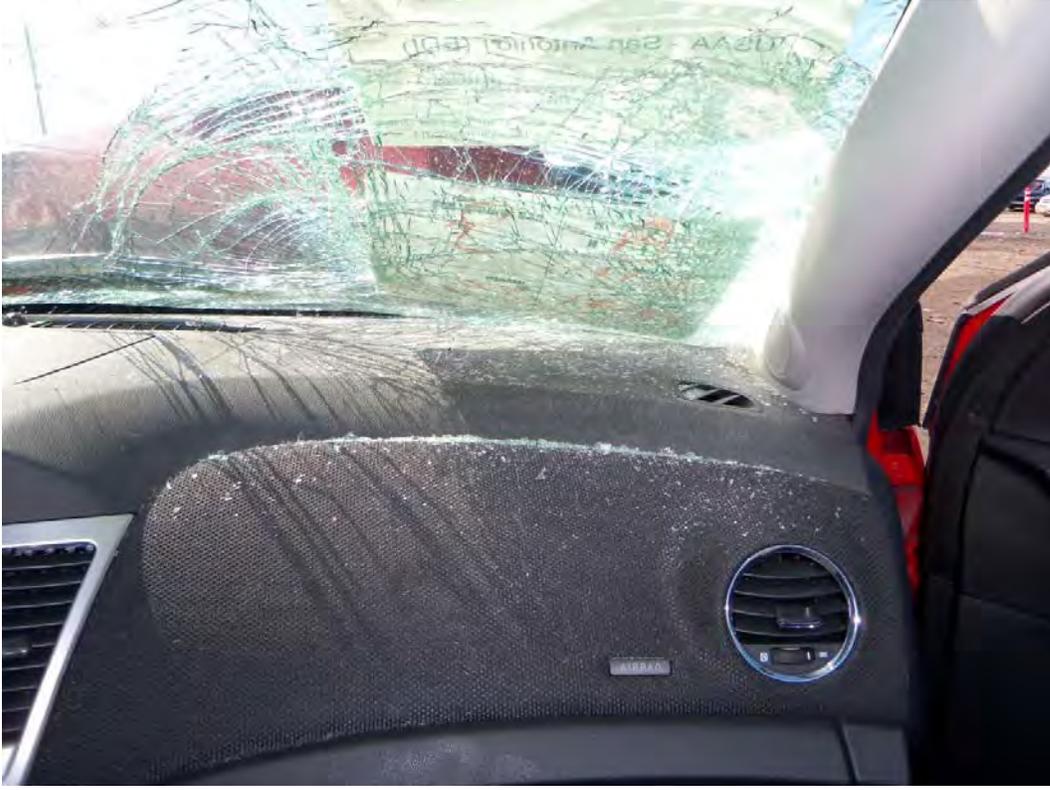
No
46	<p>Windshield Viewed From Inside on Passenger's Side. Note Glass Debris on IP.</p>

Yes

- Windshield Damage: See photo #10 of the photo log.
- Right Exterior "A" Pillar Damage: See photo #21 of the photo log.
- Upper Radiator Support Damage: See photo #11 of the photo log.

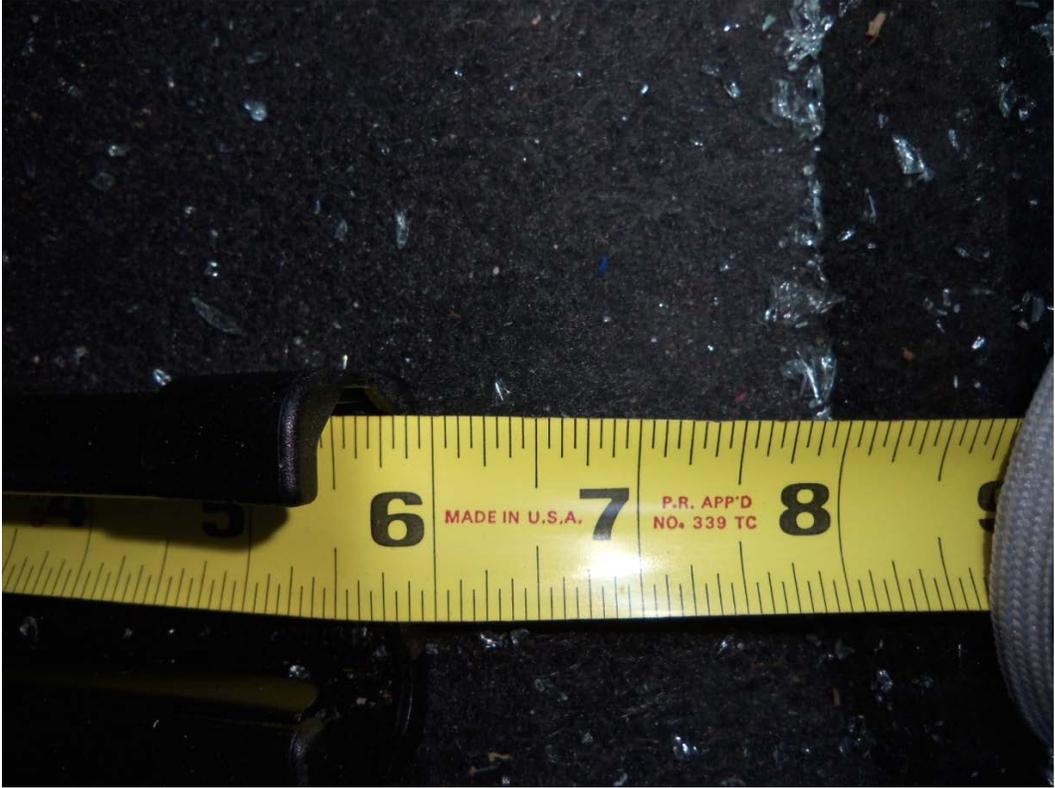
Photo #	Description / Photo	Damage (Yes/No)
47	<p>Passenger's Front Seat Track Measurement. Driver's side to I.P. Measurement Photo was Not Possible Due to no assistance available at salvage yard. See report for measurement of driver's seat to I.P.</p>

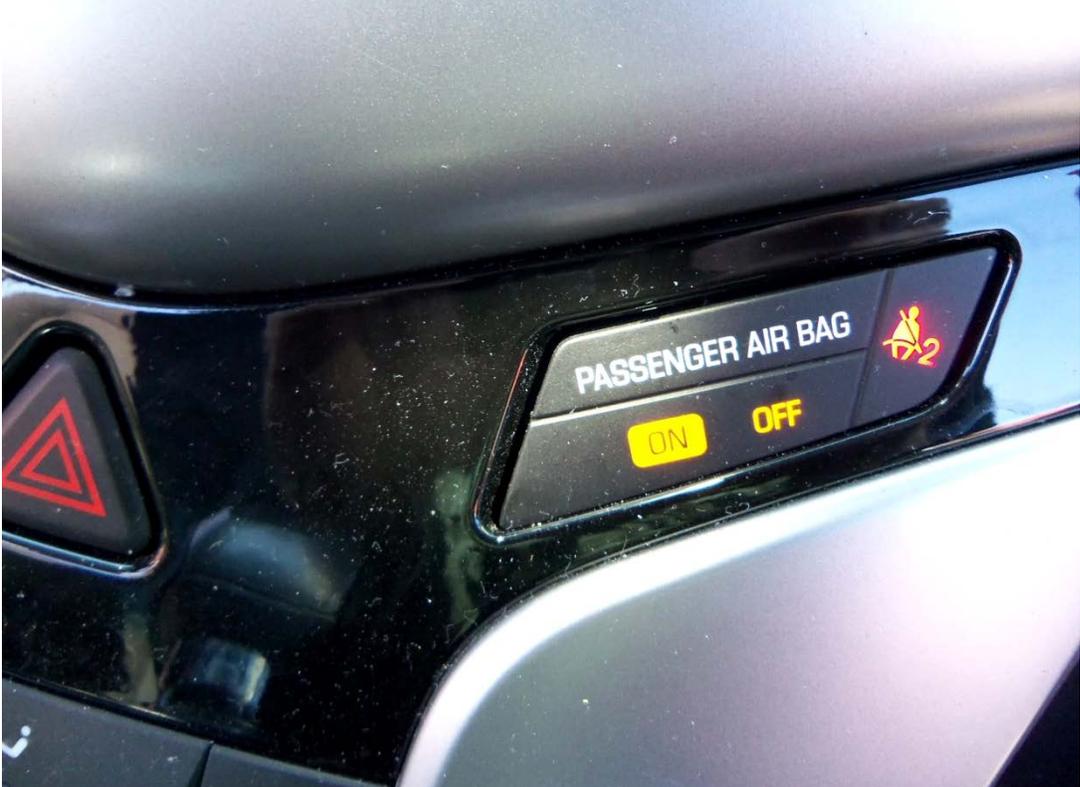
No
52	Passenger Airbag Status Lamp with Seat Unoccupied and Seat Belt Unlatched

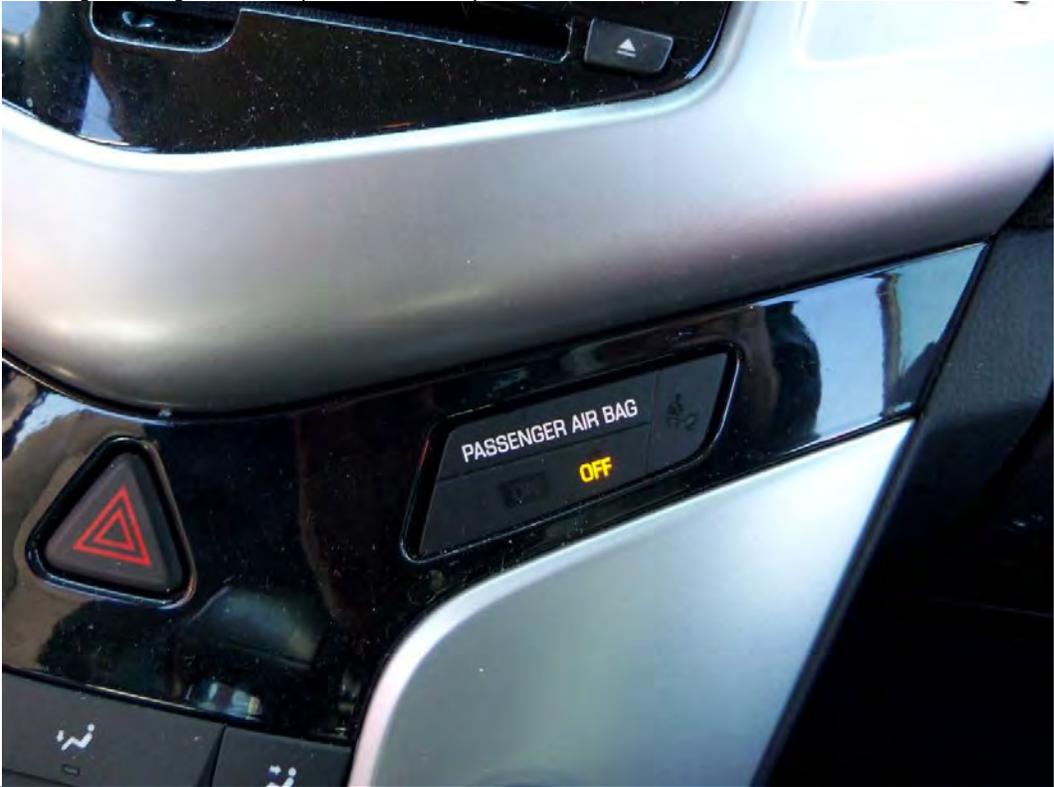
<u>Photo #</u>	<u>Description / Photo</u>	<u>Damage (Yes/No)</u>
53	Passenger airbag status lamp with seat occupied and seat belt latched

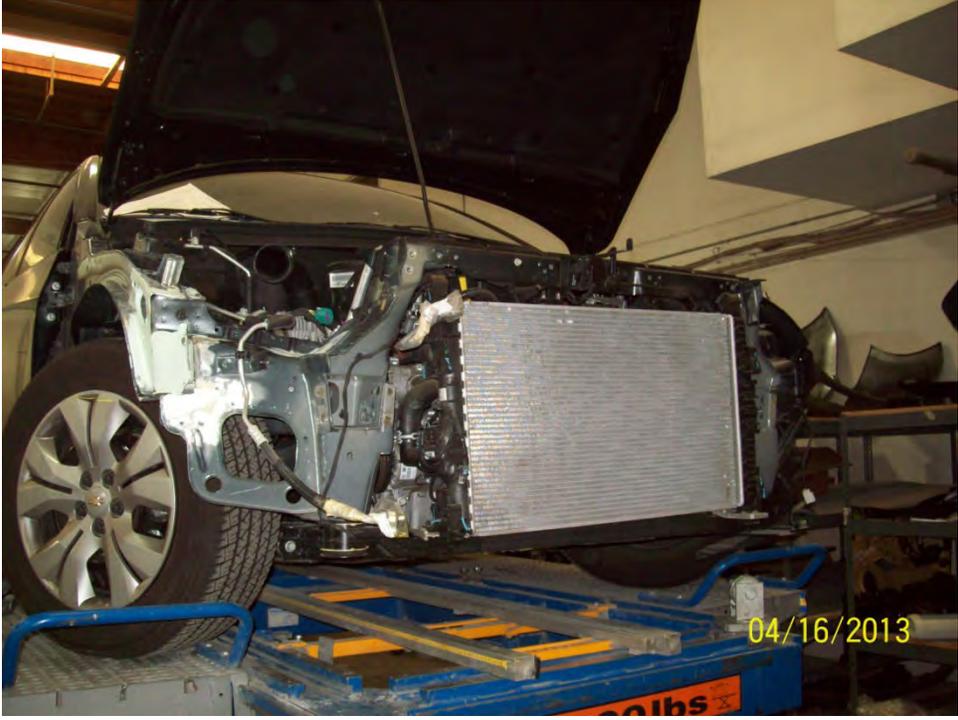
Photo #	Description / Photo	Damage (Yes/No)
7	<p>Front Exterior</p>

<p>04/16/2013</p>	Yes
8	<p>Front bumper support</p>

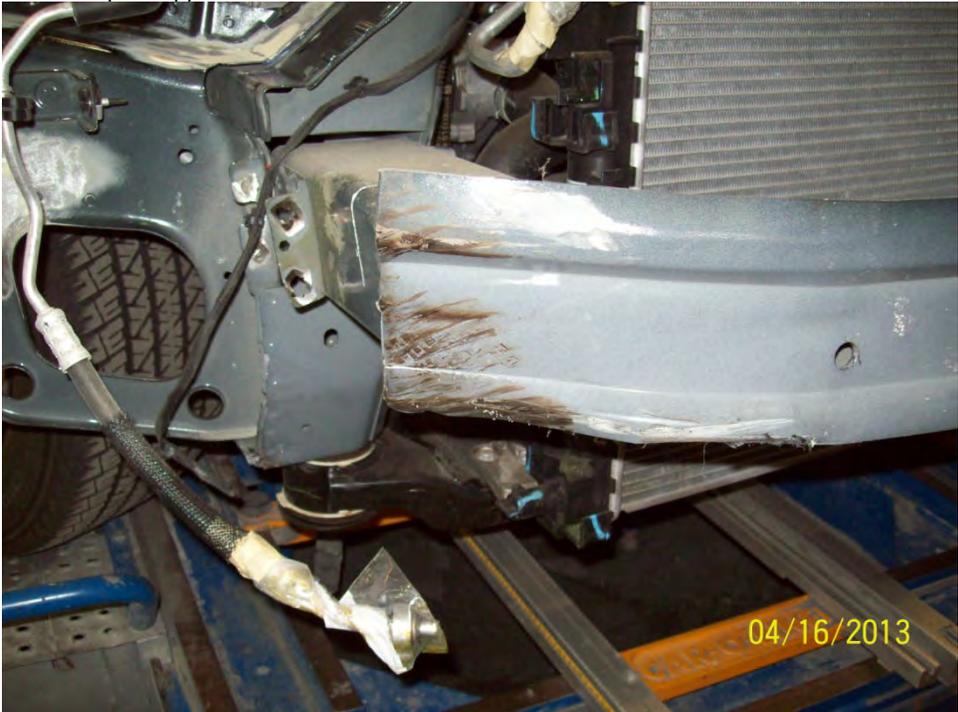
<p>04/16/2013</p>	Yes

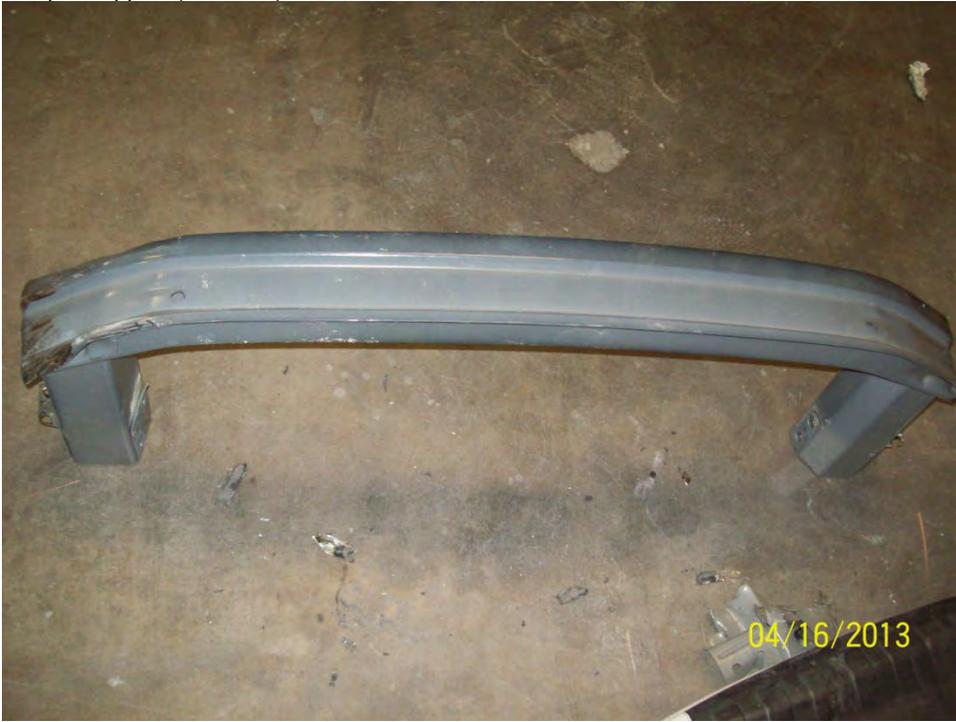
<u>Photo #</u>	<u>Description / Photo</u>	<u>Damage (Yes/No)</u>
9	Bumper support (removed)

Yes
10	Front passenger side

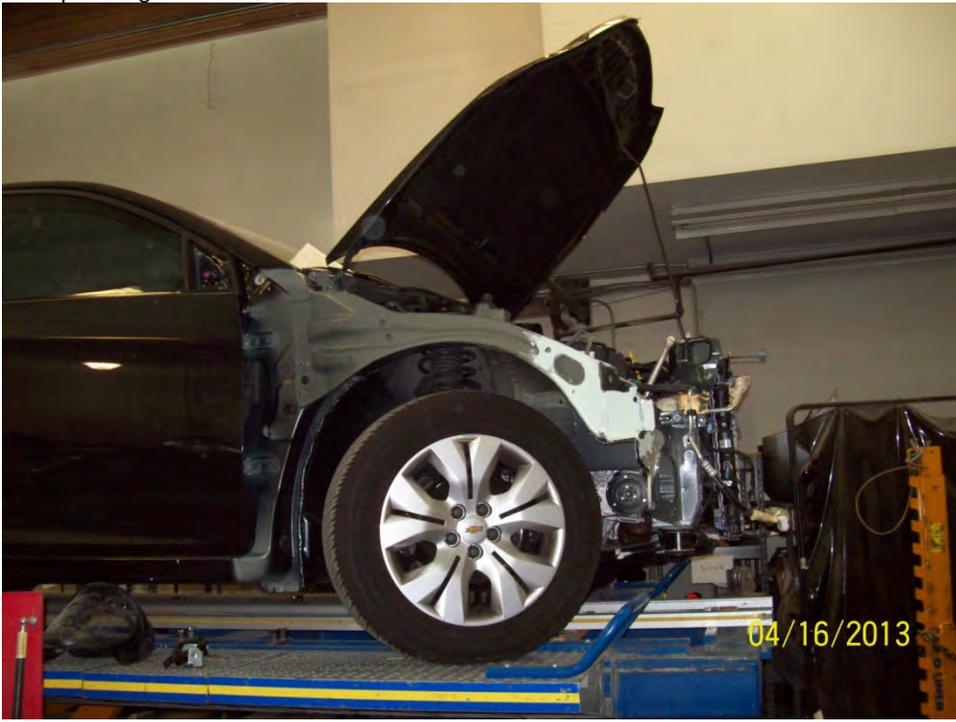
Yes

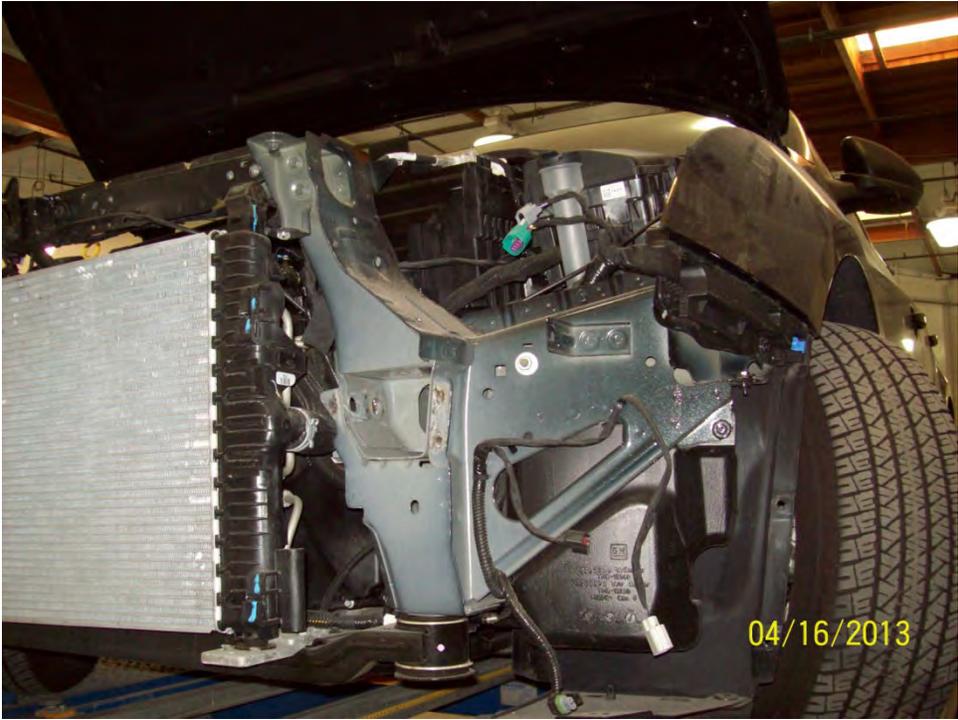
<u>Photo #</u>	<u>Description / Photo</u>	<u>Damage (Yes/No)</u>
11	<p>Front driver's side</p>

Yes
12	<p>Hood driver's side</p>

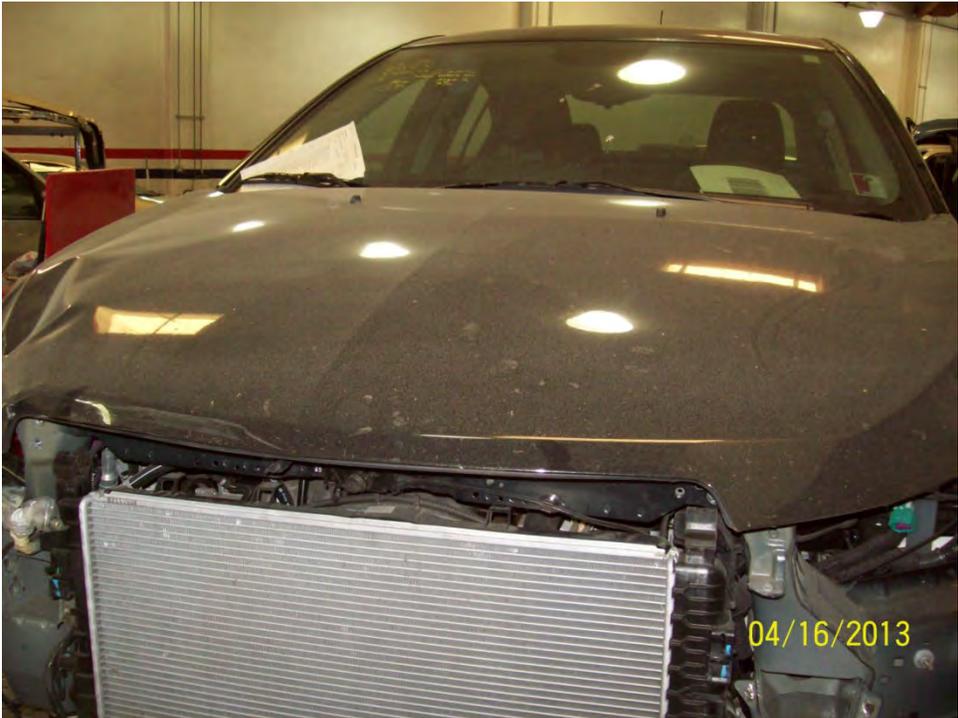
Yes

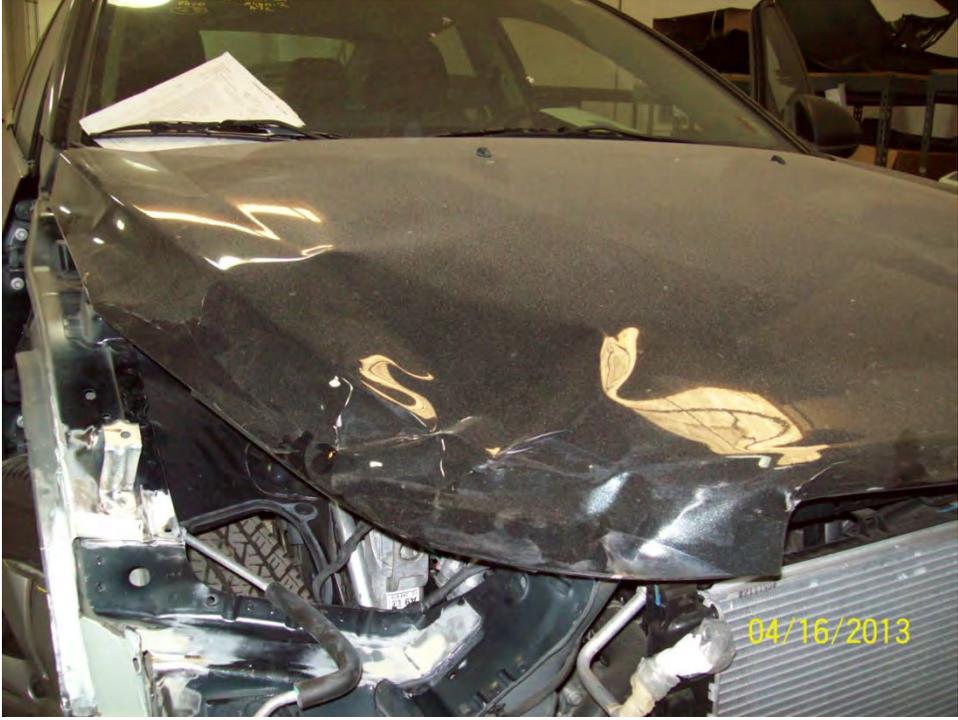
Photo #	Description / Photo	Damage (Yes/No)
13	<p>Hood passenger side</p>

Yes
14	<p>Passenger side exterior</p>

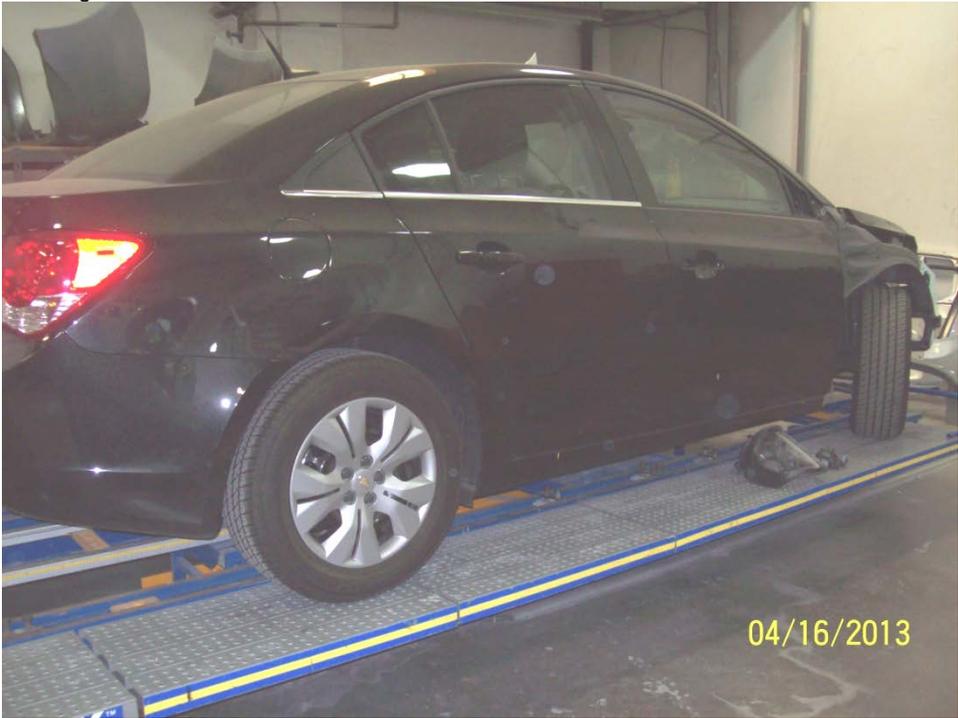
Yes

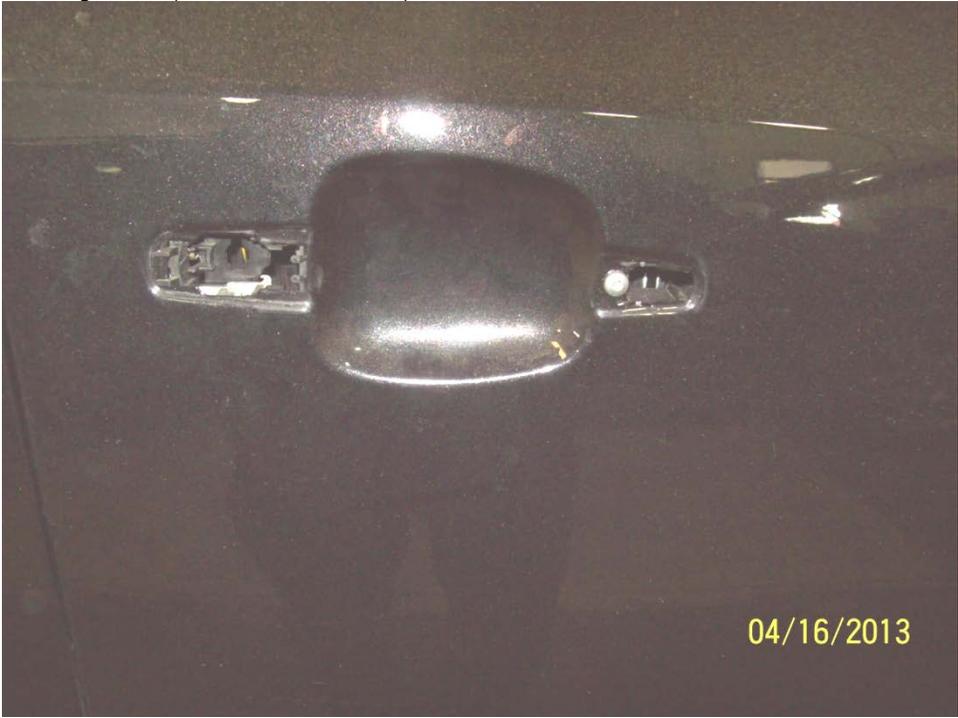
Photo #	Description / Photo	Damage (Yes/No)
15	Passenger side (door handle removed)

Yes
16	Passenger side (side view mirror removed)

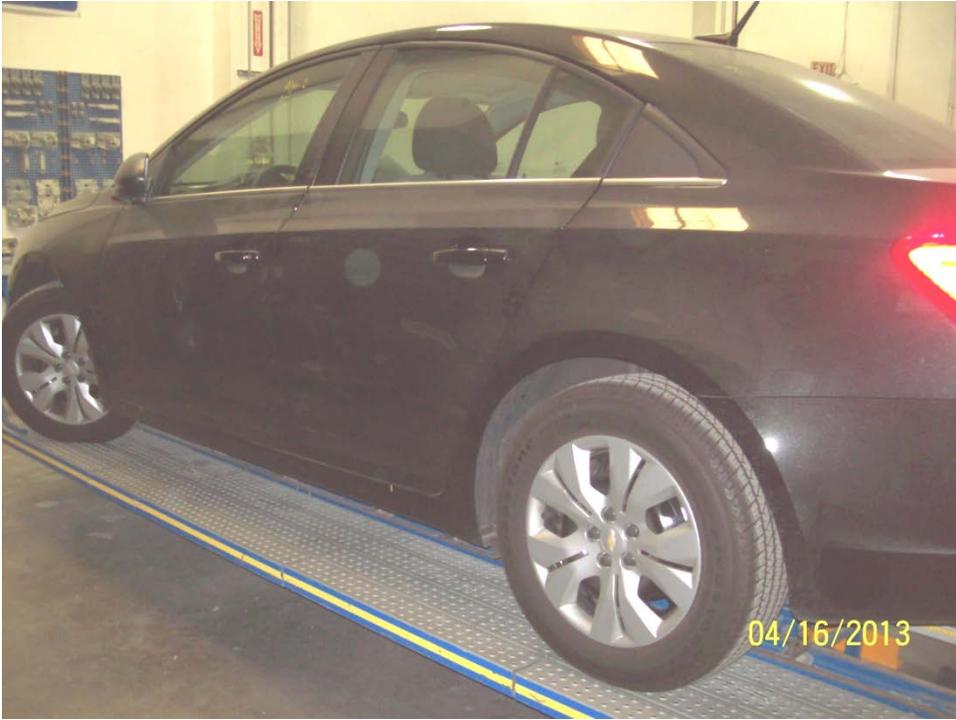
Photo #	Description / Photo	Damage (Yes/No)
19	Driver's side exterior

Yes
20	Driver's side interior

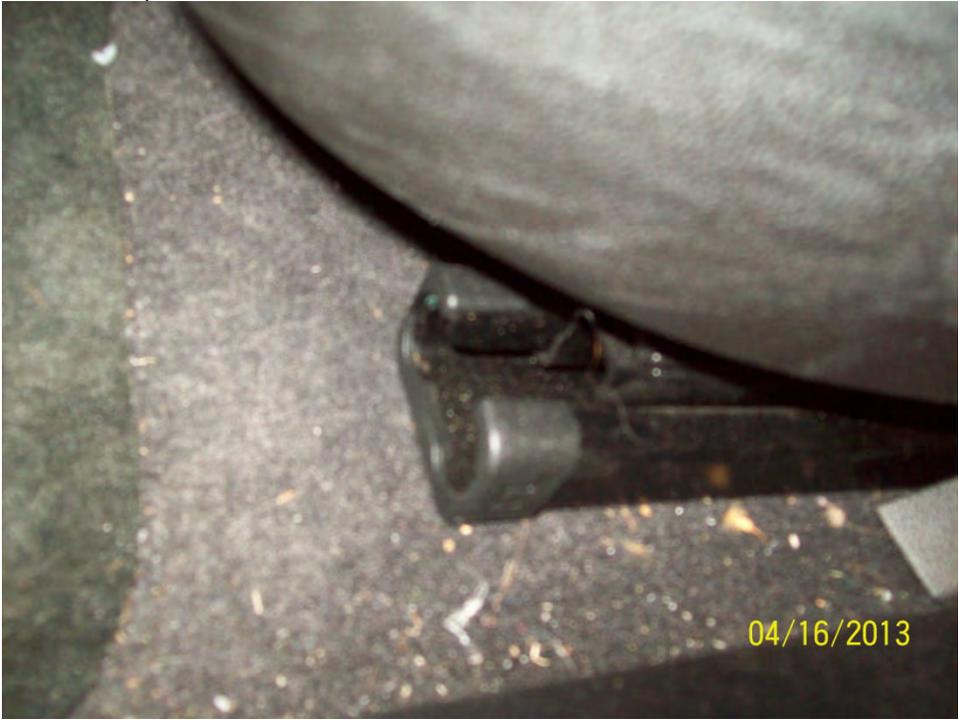
<u>Photo #</u>	<u>Description / Photo</u>	<u>Damage (Yes/No)</u>
21	Driver's seat position

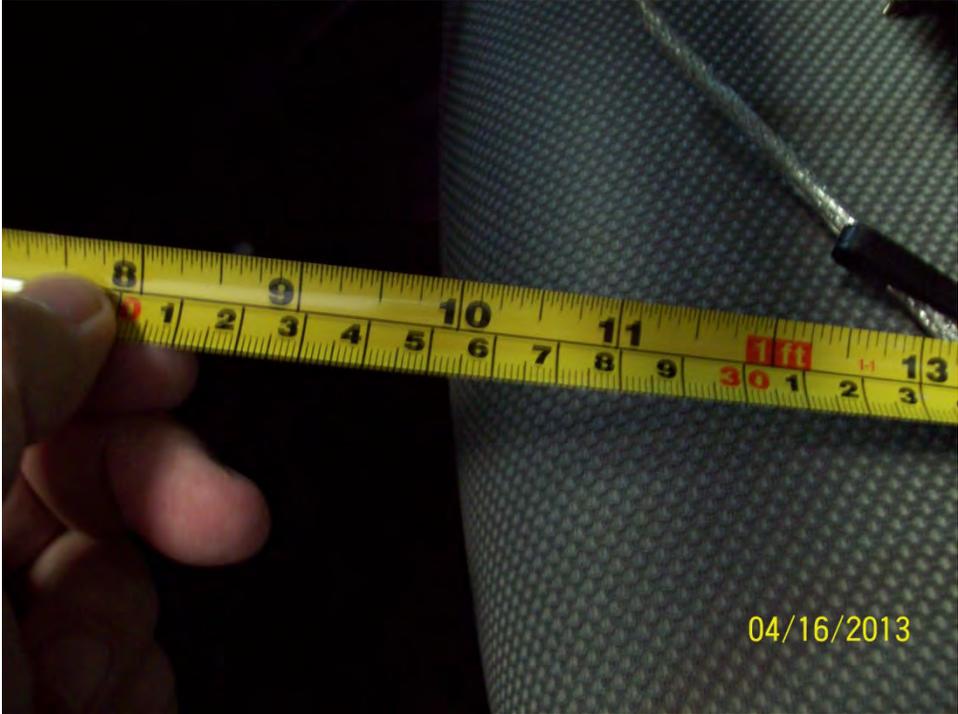
No
22	Driver 's seat distance to IP

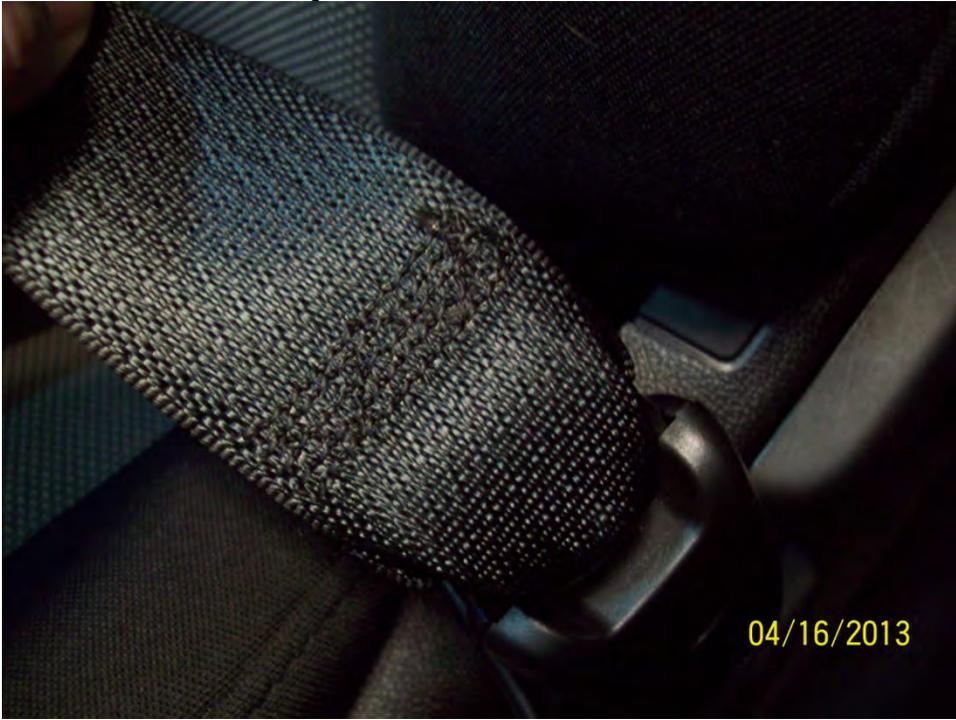
<u>Photo #</u>	<u>Description / Photo</u>	<u>Damage (Yes/No)</u>
23	Driver's side seat belt webbing
