Subject: 71-1035097733 PAR Case Sent to ESIS - No Action Required

A product allegation claim has been made in your region. The customer is alleging airbag nondeployment, wheels locked up and Onstar inoperative in a collision . This case is being escalated to ESIS because insurance involvement.

██████████
2012 Chevrolet Sonic
1G1JC5SHXC4██████████
CENTURY III CHEVROLET, WEST MIFFLIN PA (BAC) 113496
Kevin Codd, Body Shop Manager

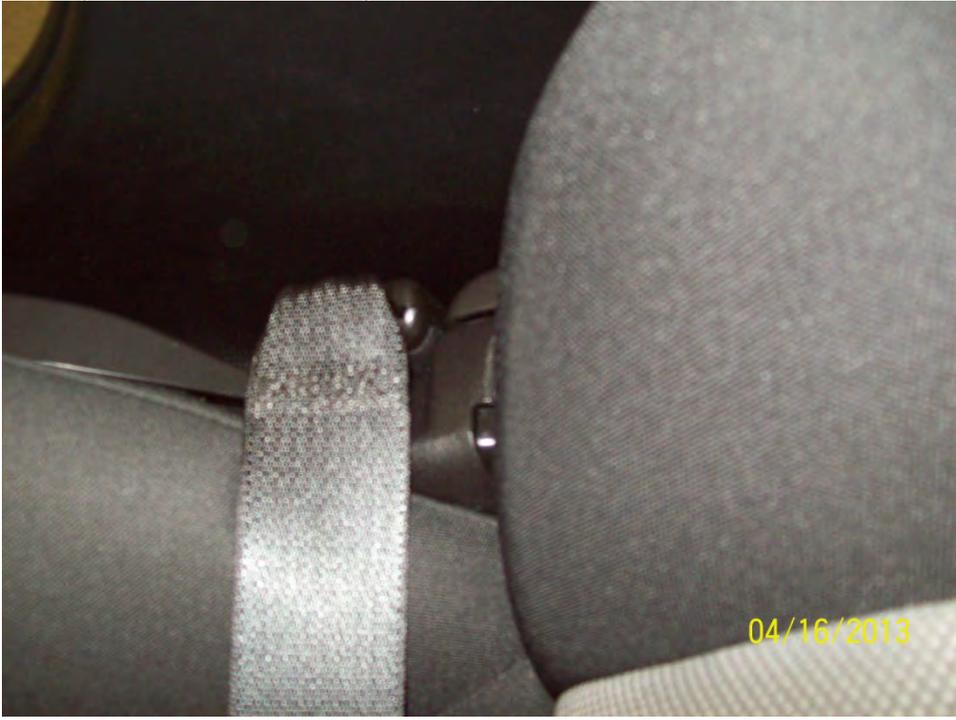
No
24	Passenger's side seat belt webbing

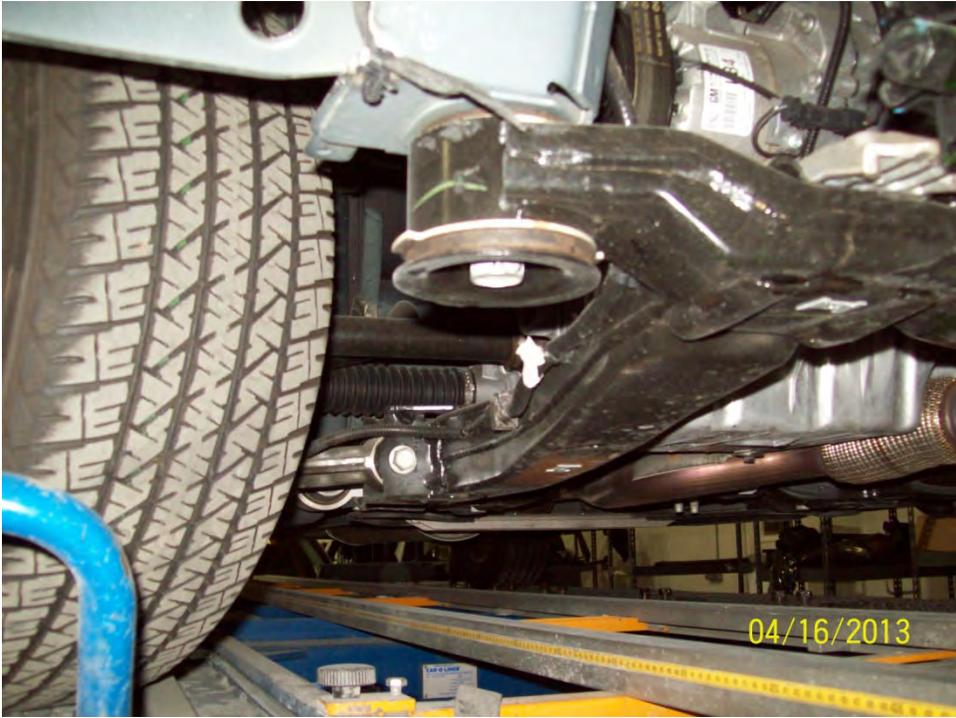
Photo #	Description / Photo	Damage (Yes/No)
25	<p>Undercar front</p>

Yes
26	<p>Undercar passenger front</p>

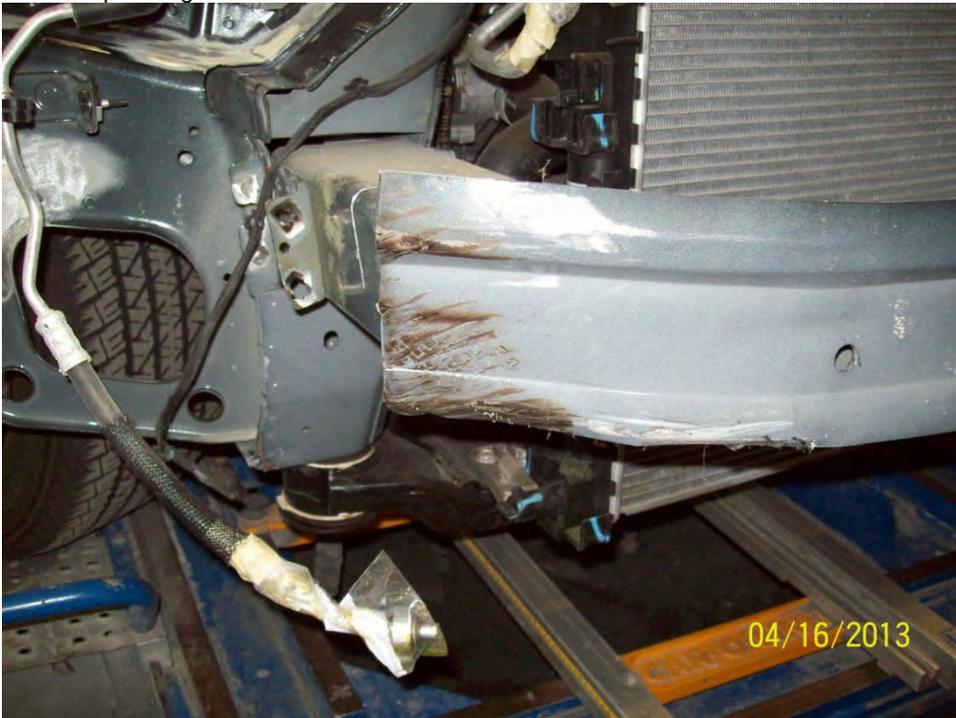
Yes

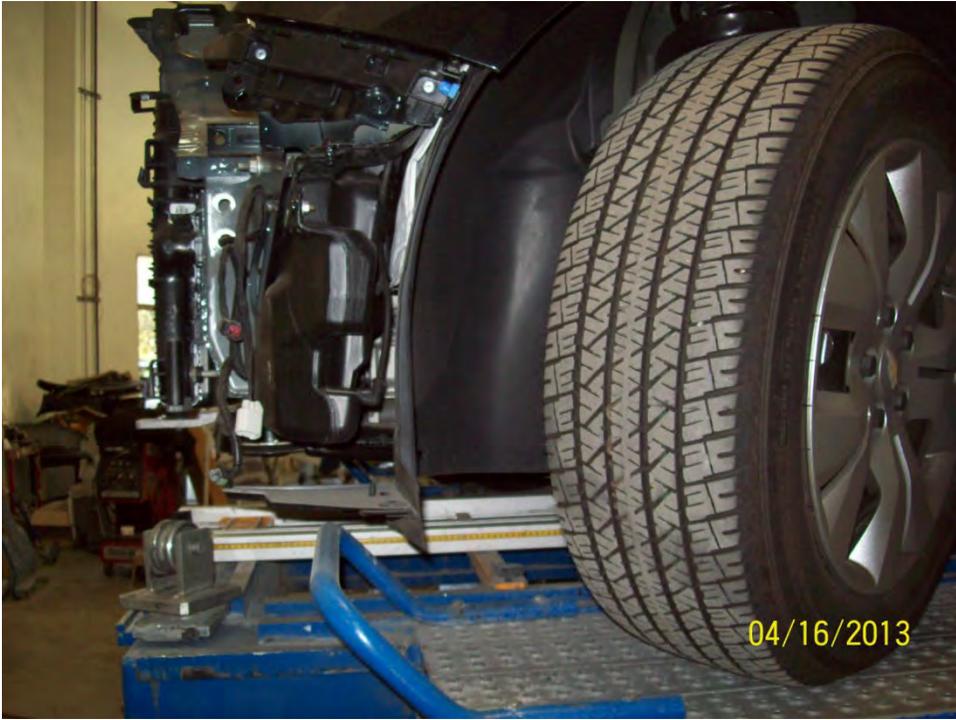
Photo #	Description / Photo	Damage (Yes/No)
27	<p>Undercar Driver front</p>

Yes
28	<p>Undercar rocker panel driver's side</p>

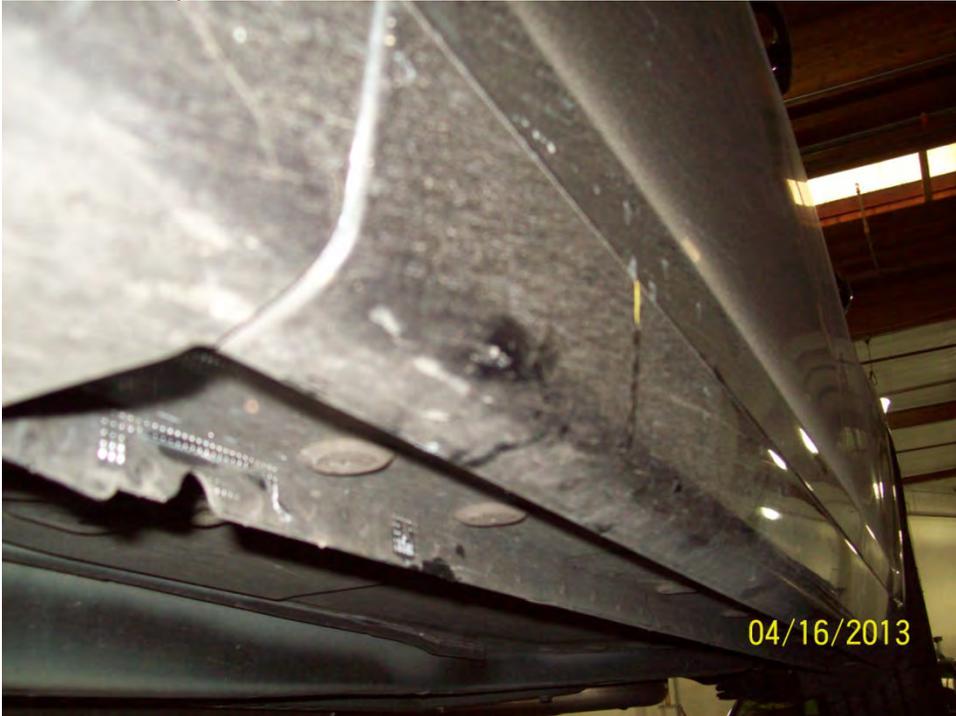
No

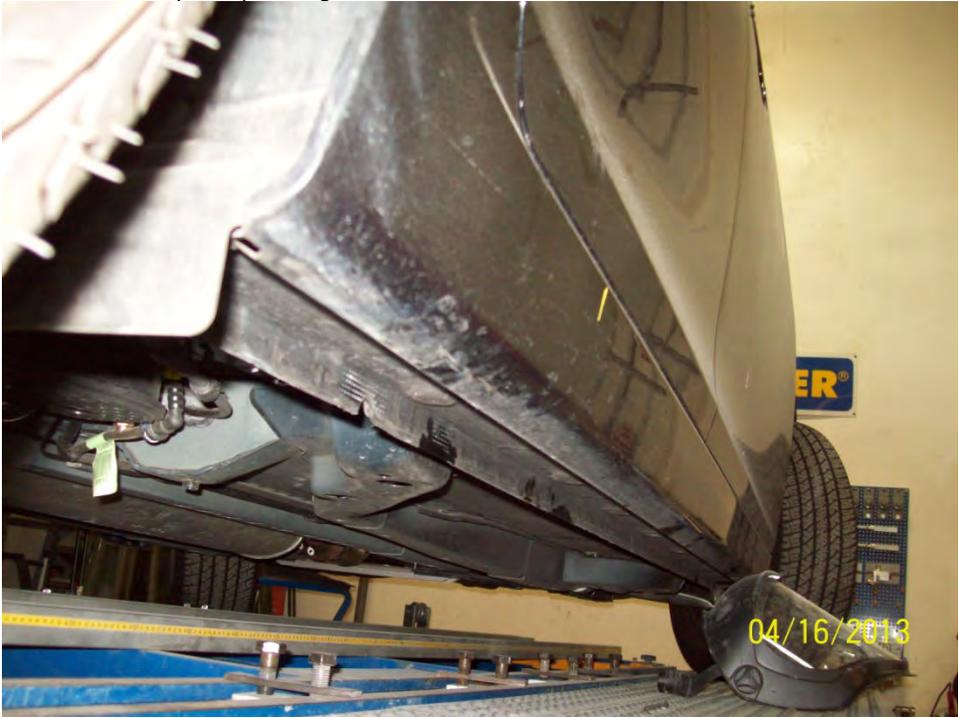
<u>Photo #</u>	<u>Description / Photo</u>	<u>Damage (Yes/No)</u>
29	Undercar rocker panel passenger side

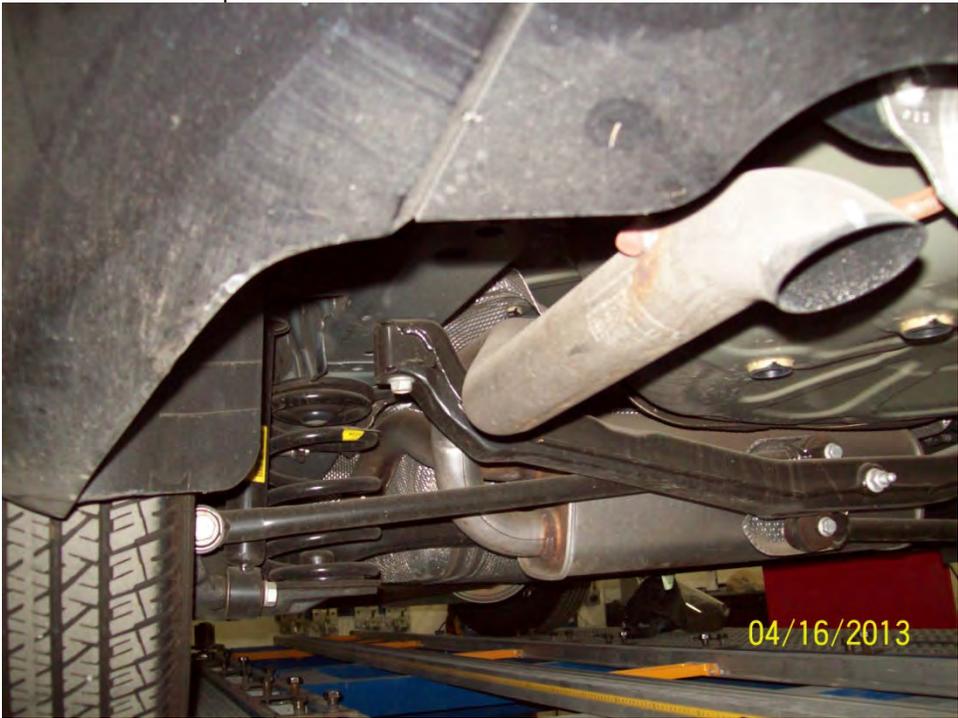
A photograph showing the driver's side rear suspension system. The image captures the rear axle, control arms, and a portion of the exhaust system. A yellow date stamp '04/16/2013' is visible in the bottom right corner of the photo.	No

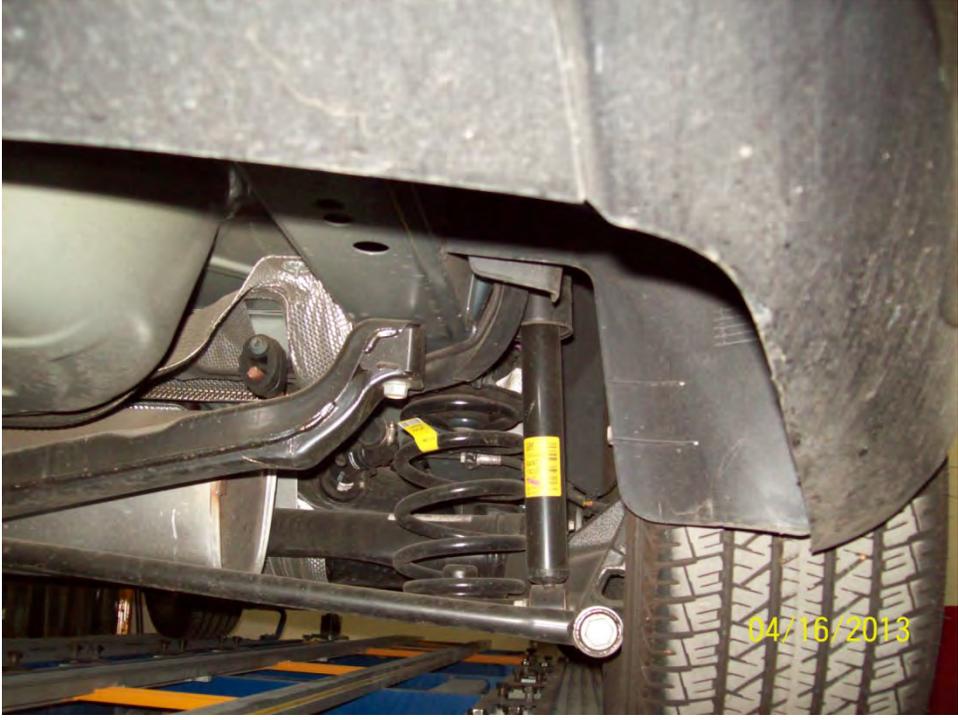
Photo #	Description / Photo	Damage (Yes/No)
31	Passenger's side rear suspension

No
32	Under car rear

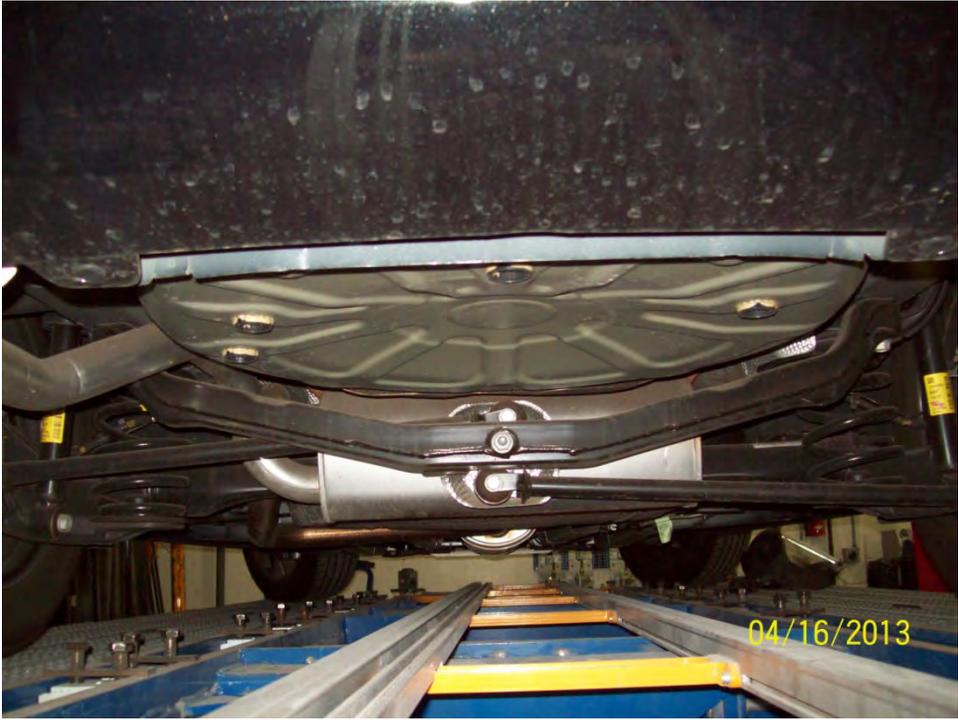
No

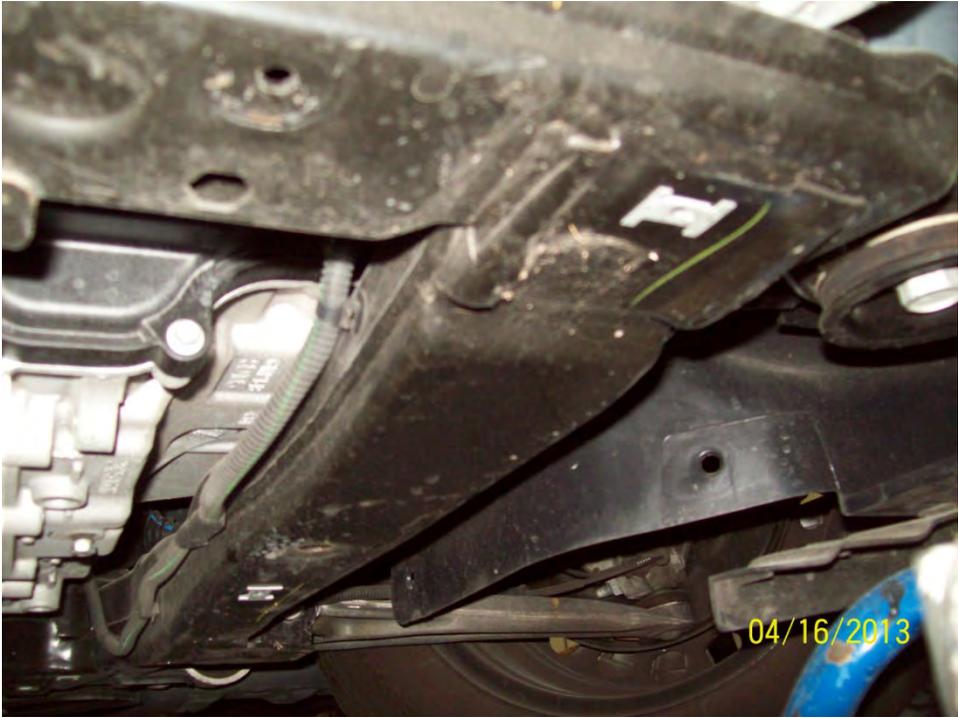
<u>Photo #</u>	<u>Description / Photo</u>	<u>Damage (Yes/No)</u>
33	Undercar front center

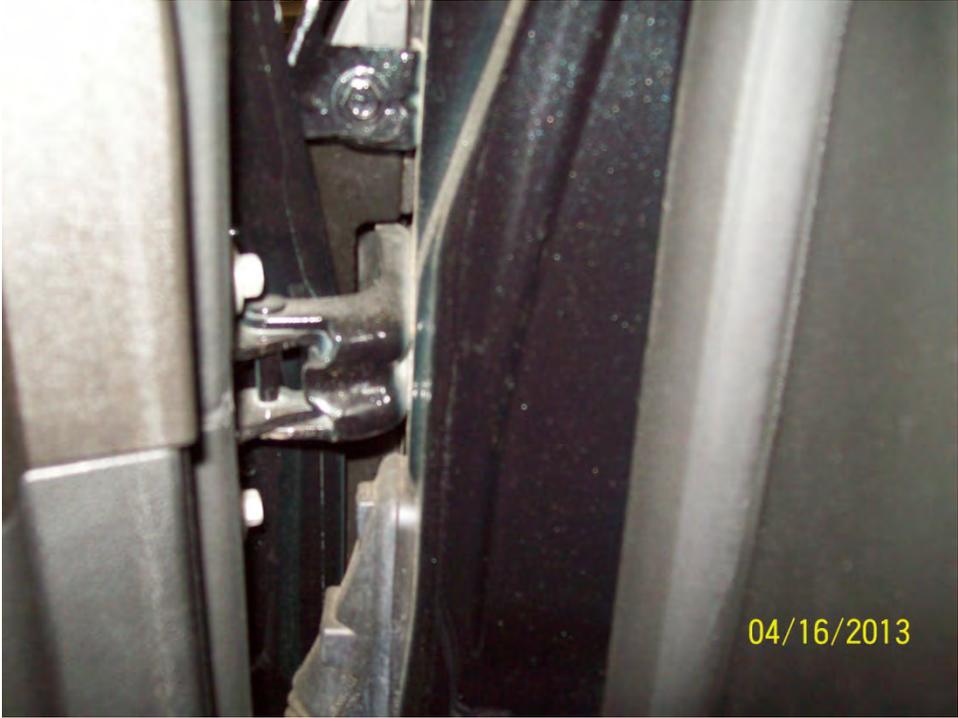
A close-up photograph of the upper door hinge mechanism on the driver's side of a vehicle. The image shows the metal hinge assembly and surrounding structural components. A yellow date stamp '04/16/2013' is visible in the bottom right corner of the photo.	No

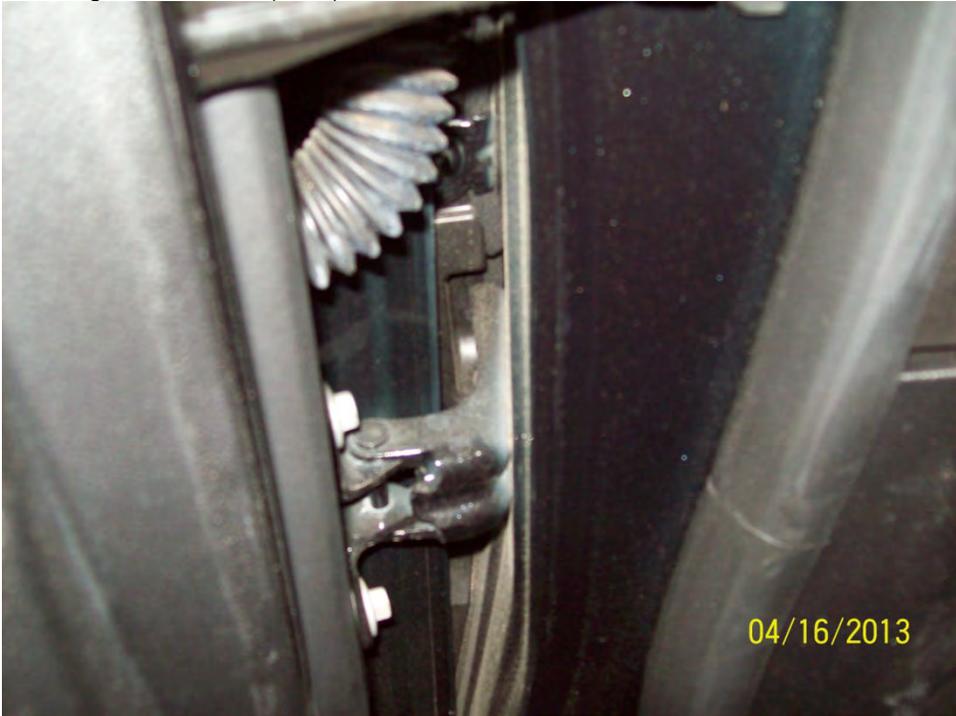
<u>Photo #</u>	<u>Description / Photo</u>	<u>Damage (Yes/No)</u>
35	Door hinges driver's side (lower)

No
36	Front overhang

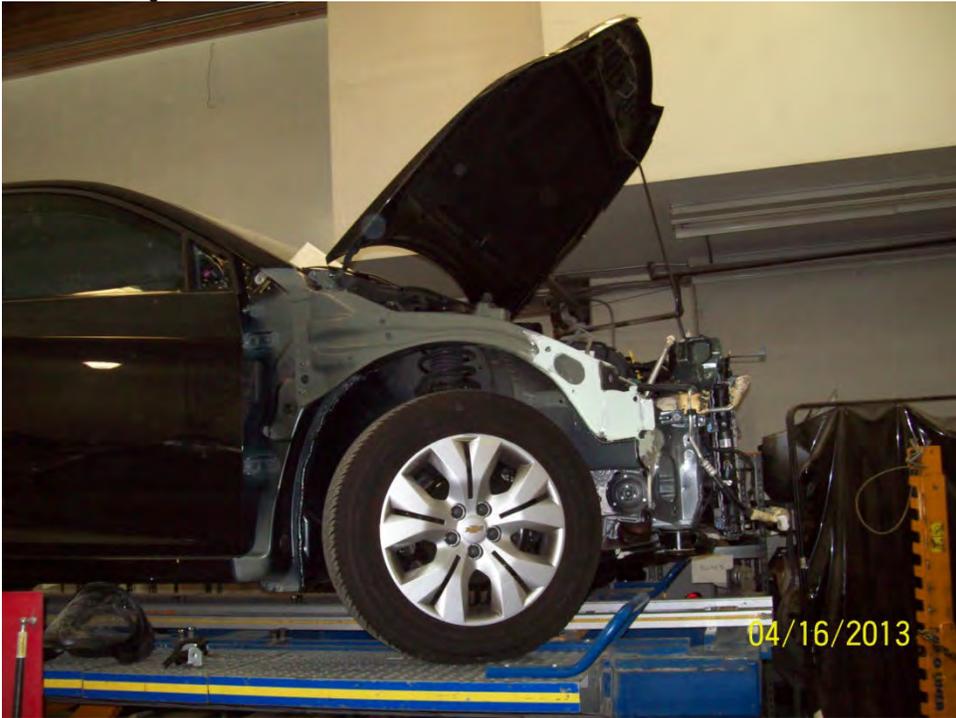
Yes

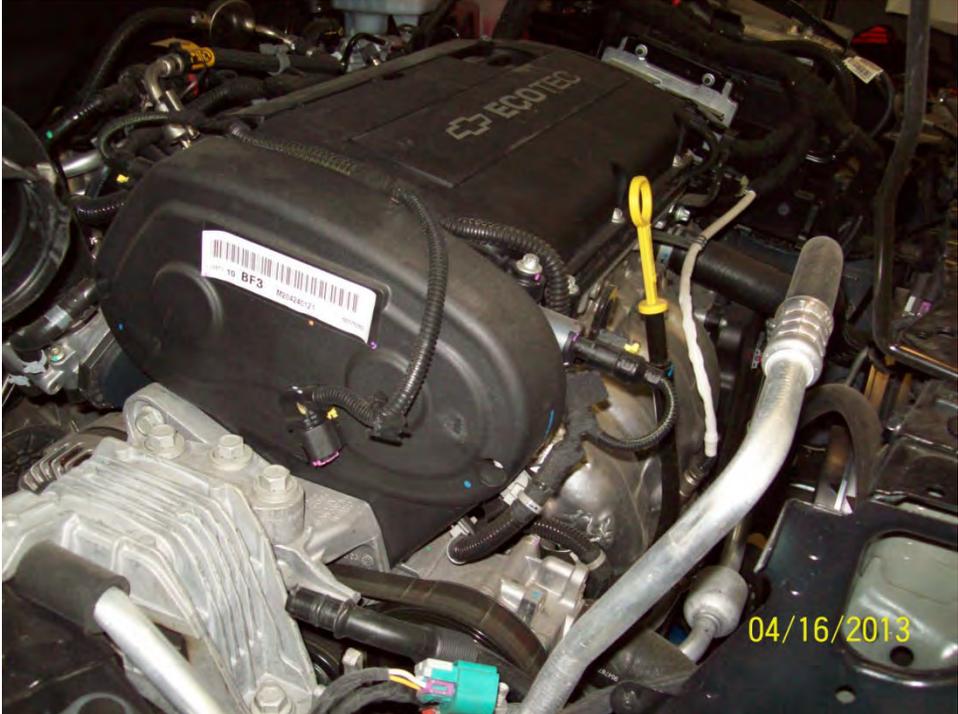
Photo #	Description / Photo	Damage (Yes/No)
37	Engine compartment

No
38	Engine compartment

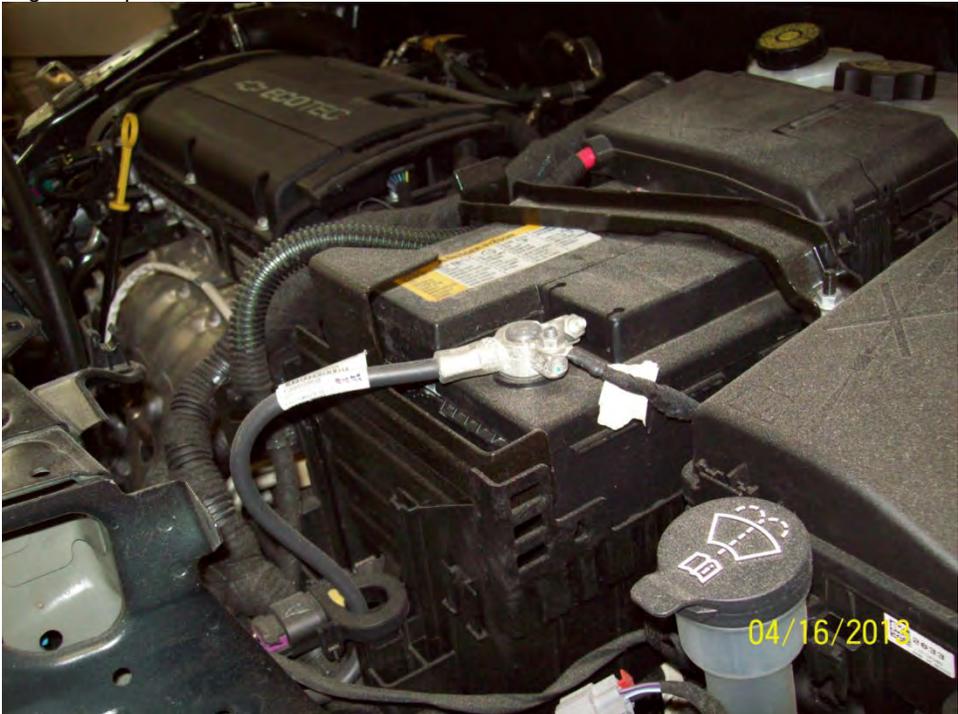
No

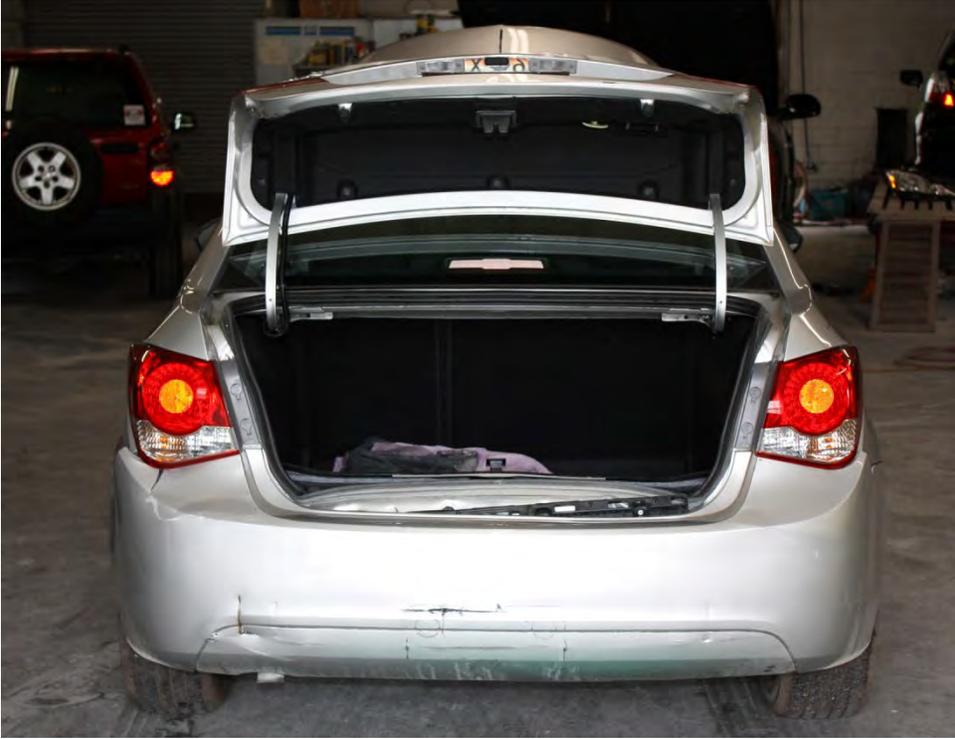
Photo #	Description / Photo	Damage (Yes/No)
7	Rear (Exterior)

Yes
8	Driver's Side (Exterior)

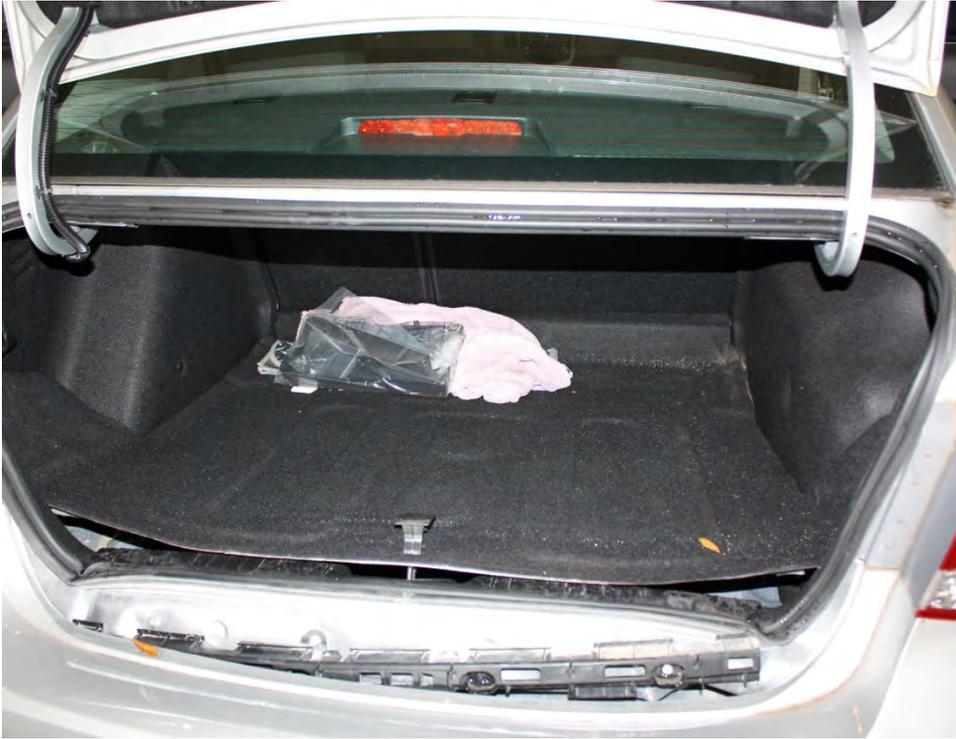
No
14	Trunk/Hatch/Cargo Area

Yes

-The left rear was damage from the impact (photo 14, 20)

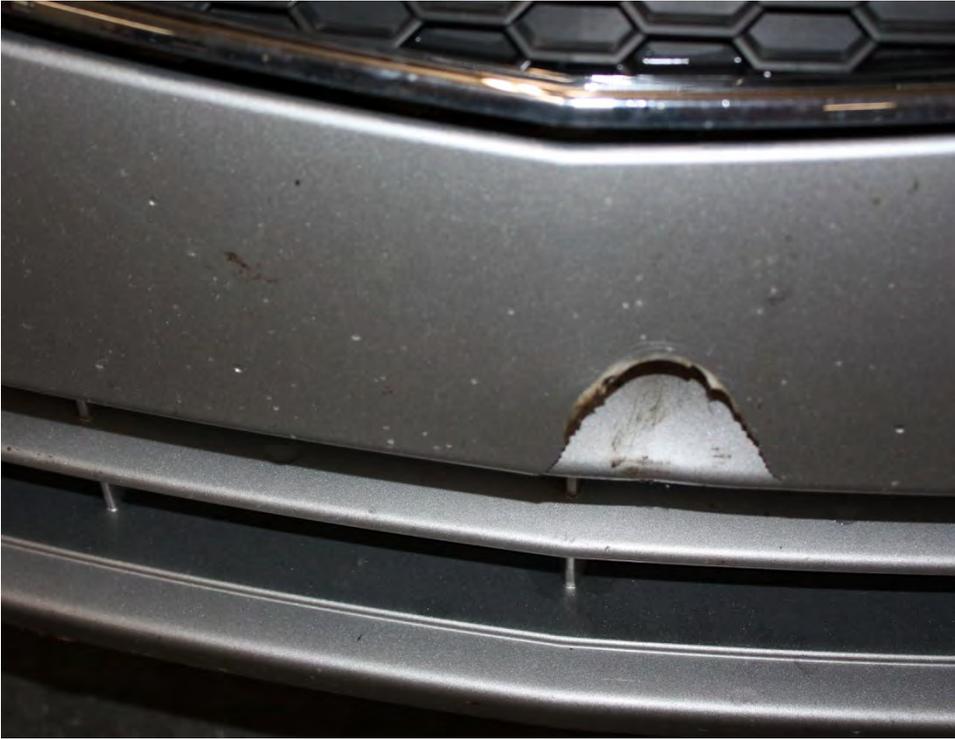
Yes
16	<p>Front Bumper Cover Damage</p>

Yes

There is minor damage to the front bumper cover in three spots. The center spot was actually cut (photos 15–17)

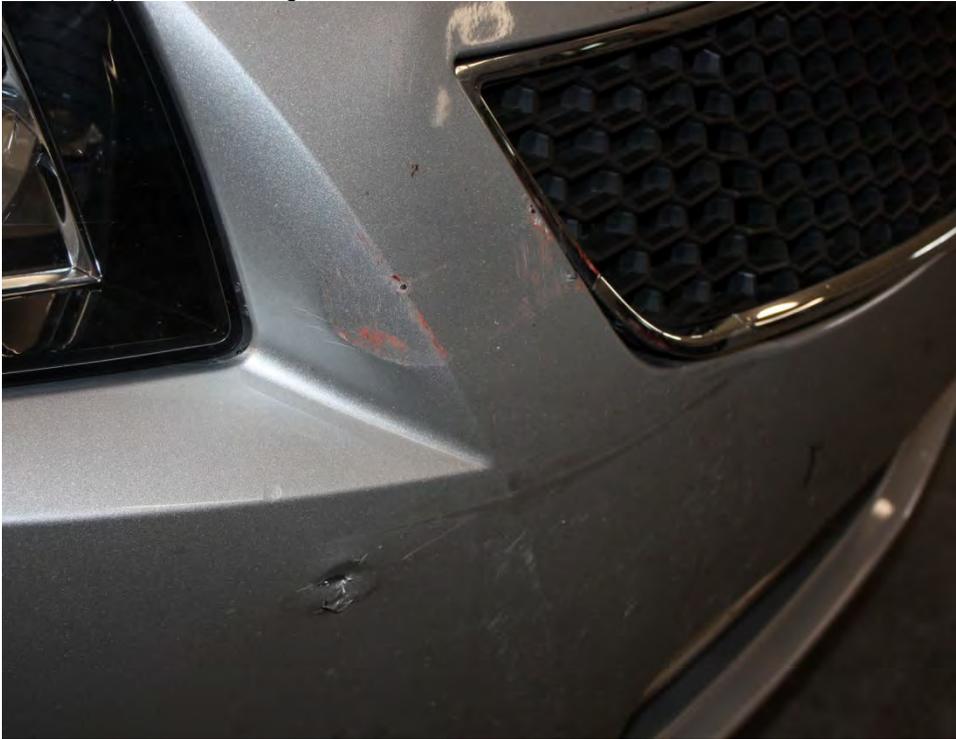
Photo #	Description / Photo	Damage (Yes/No)
17	<p>Front Bumper Cover Damage</p>

Yes
18	<p>Rear end Bumper Trunk Damage</p>

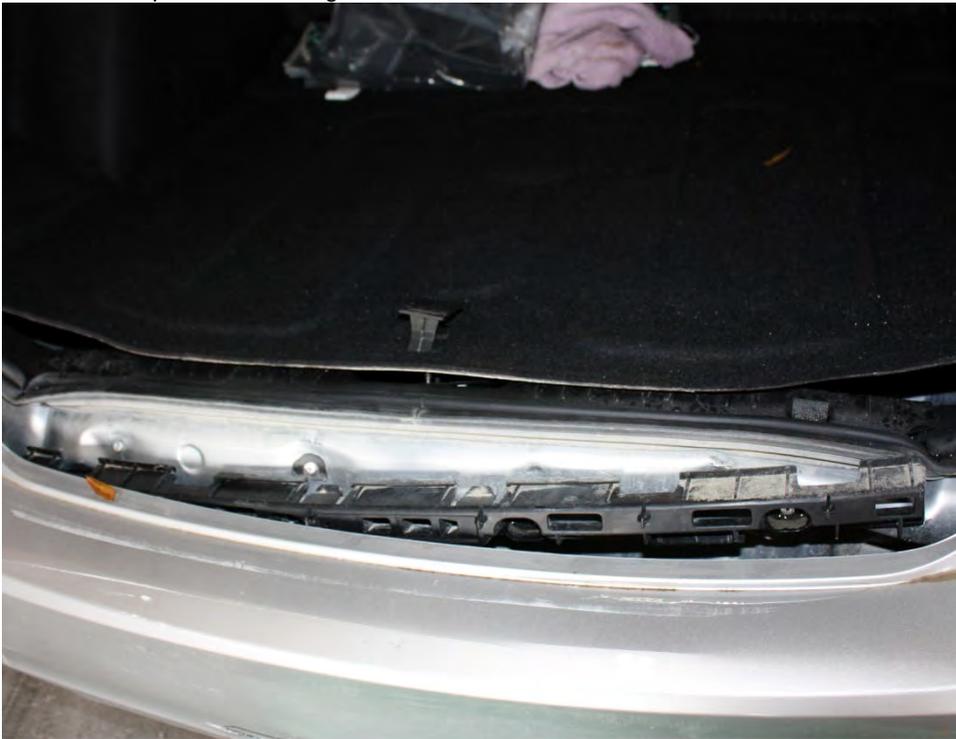
Yes

- There was damage to the rear of the vehicle. Photos 18-22.
- The front bumper cover was the only front end damage noted. Photos 15-17.
- The CDR recorded 2 non deployment events which resulted
- +- in the deployment of both front pretensioners. (Report attached).
- There was no rollover event recorded (report attached)

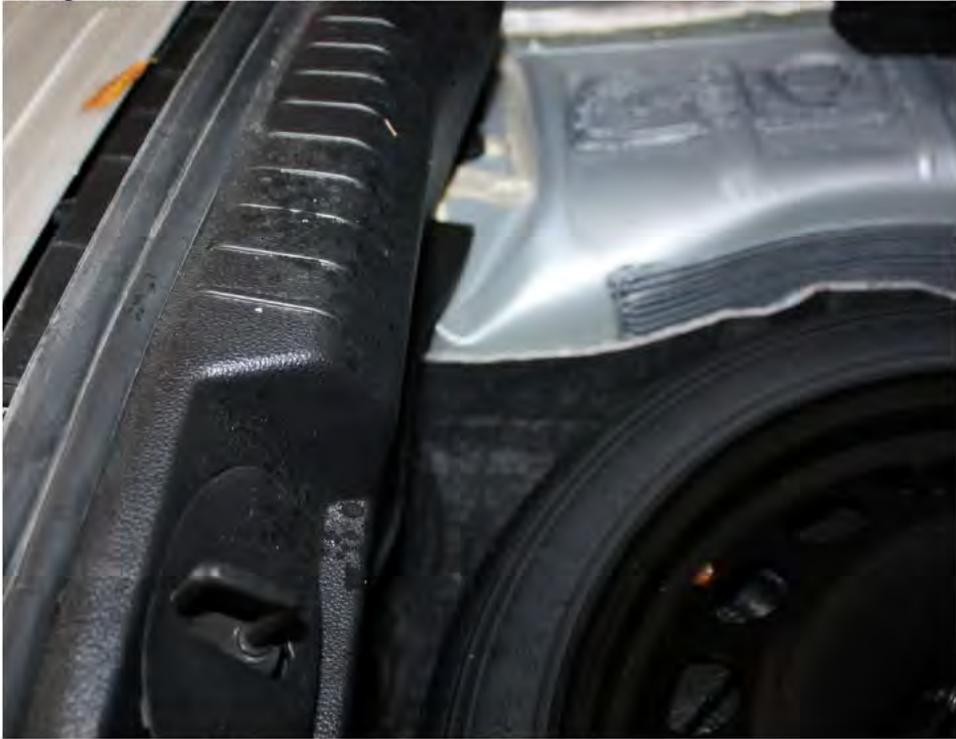
Yes
20	Damage Inner Left Trunk Frame Area

Yes

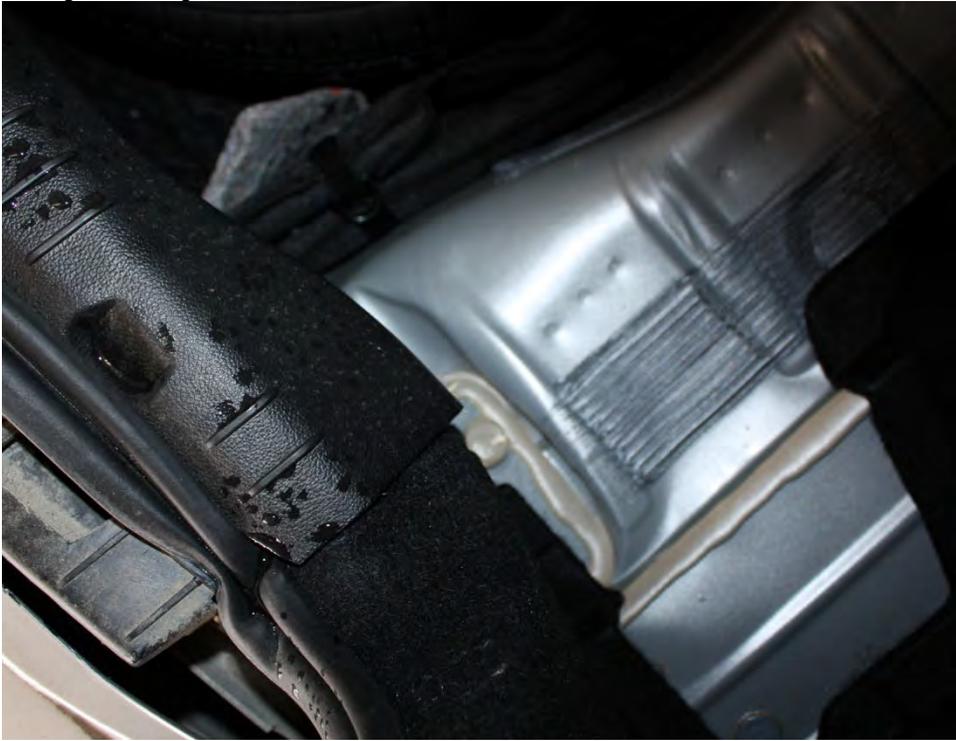
<u>Photo #</u>	<u>Description / Photo</u>	<u>Damage (Yes/No)</u>
21	Damage Inner Right Trunk Frame Area

Yes
22	Damage to Trunk Floor From Underneath

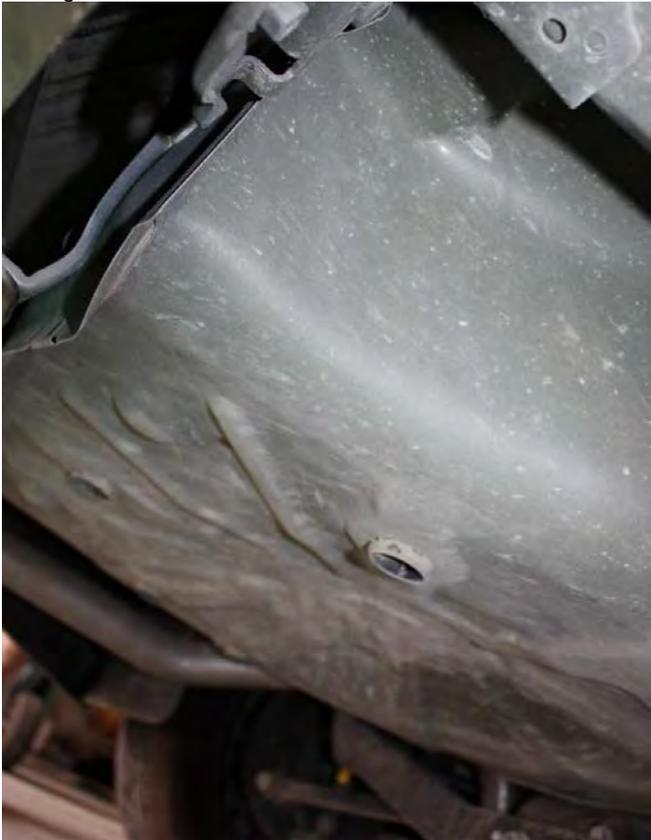
Yes

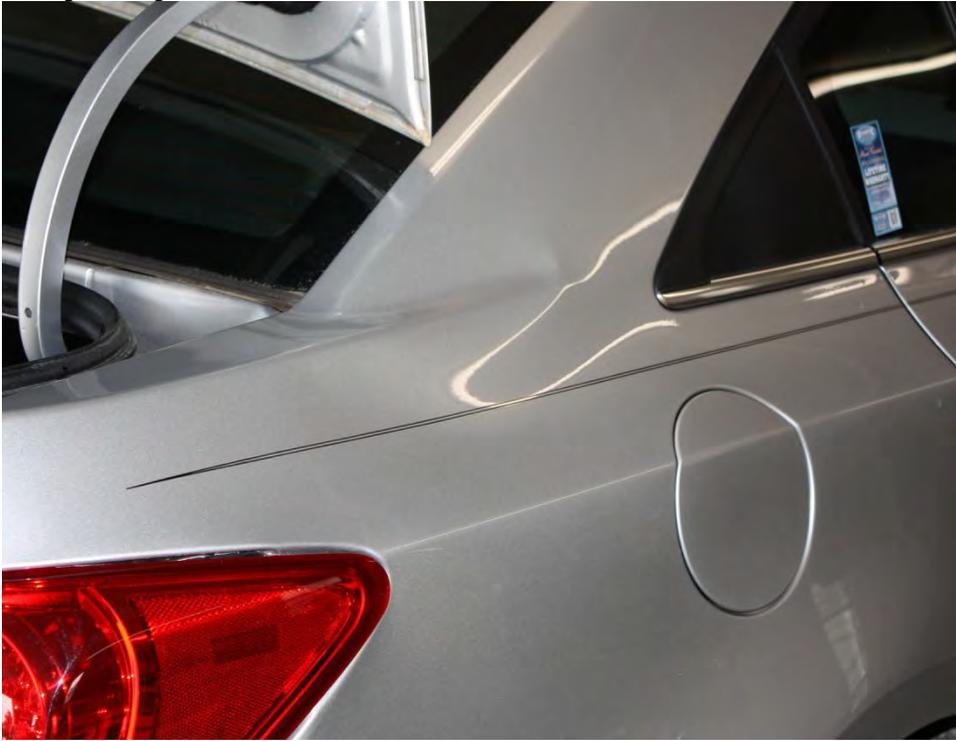
Photo #	Description / Photo	Damage (Yes/No)
23	Damage To Right C-Pillar Area

Yes
24	Damage To Left C-Pillar Area

The right rear damage is similar to the left side. It is bent just below the c pillar with the whole rear end bent inwardly (photo 23).

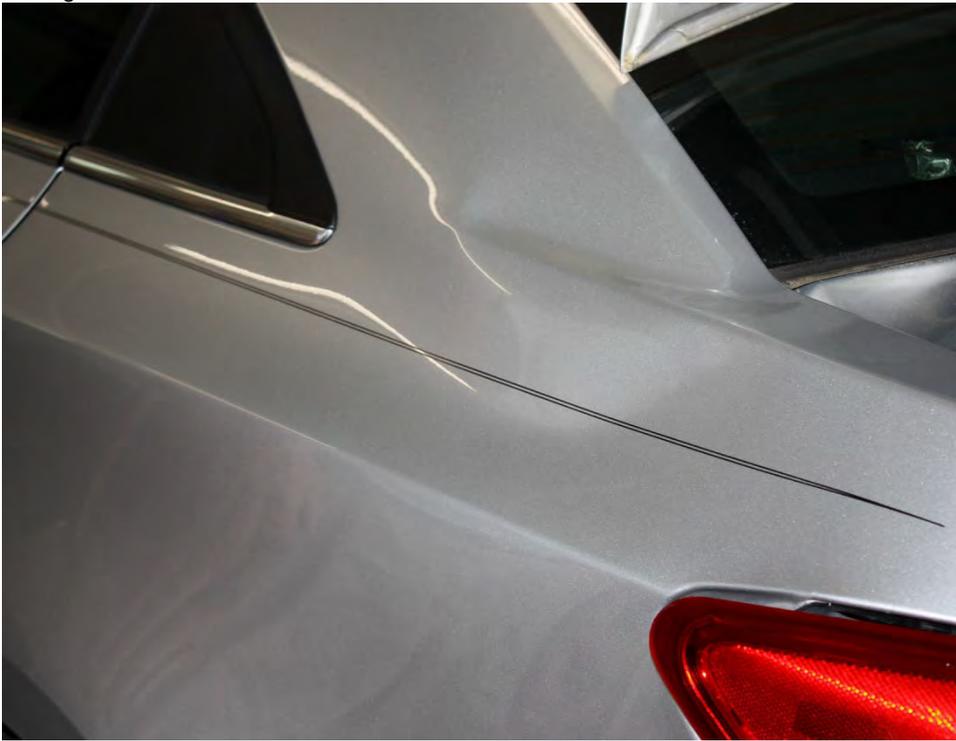
Yes

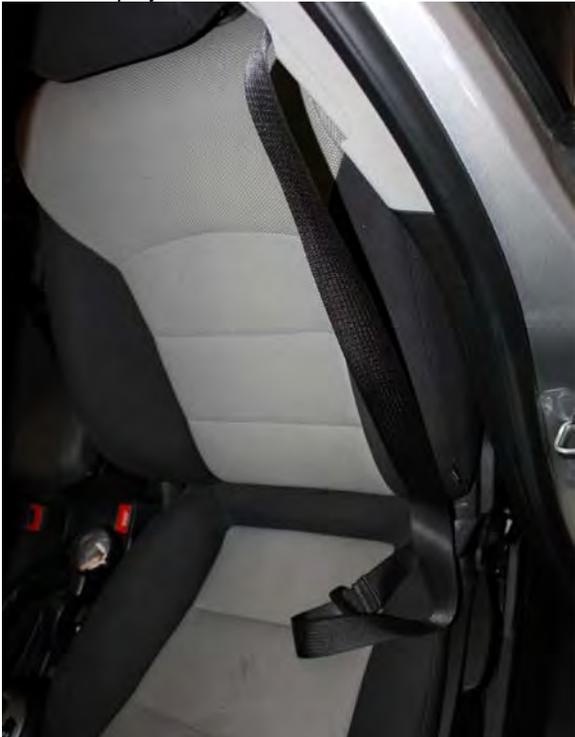
Yes
26	Driver's Deployed Pretensioner

Yes
