## RQ13-003 Request 9 Partial III Response

**Action 9-A:** Design, Development, and Validation Plan and Testing Specifications for the Generator Control Module (GCM) in the subject vehicles.

**Action 9-B:** Investigation and analysis of single vehicle BPIM/APM failure on Shanghai General Motors (SGM) vehicle.

**Action 9-C:** GM Investigation of BPIM (GCM) isolation related issues.

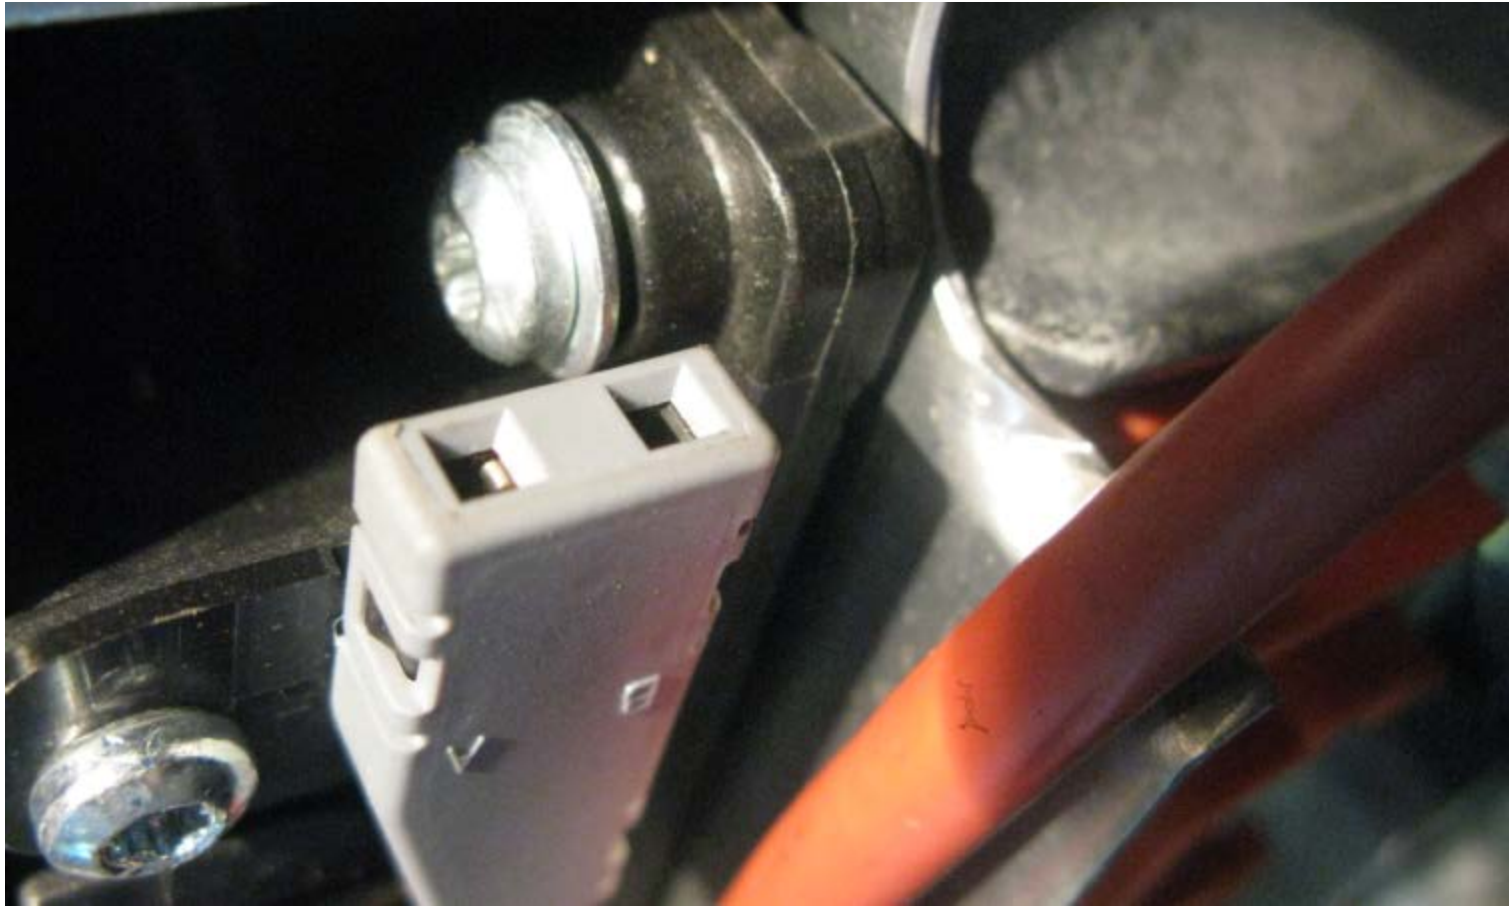
HVIL terminal (powerpack side)

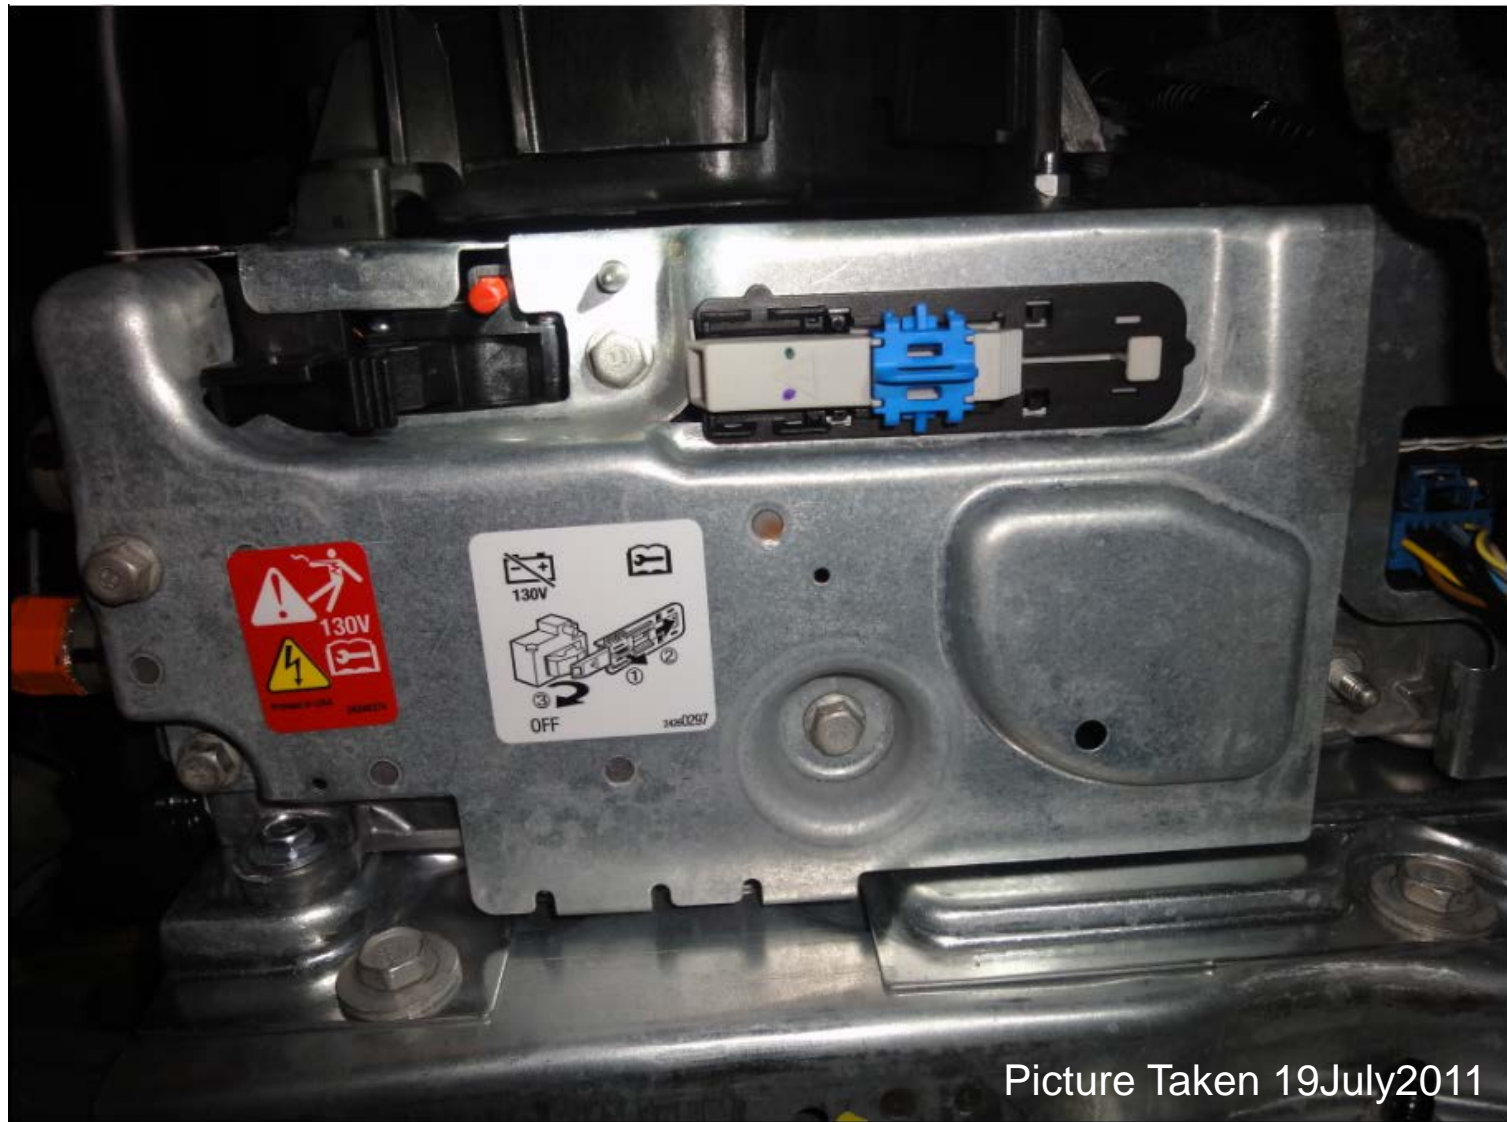
Picture Taken 19July2011

(fuse burned – fuse F23 and 175A)

Original HVIL Cover from reported failure: fuse burned – fuse F23 05July 2011

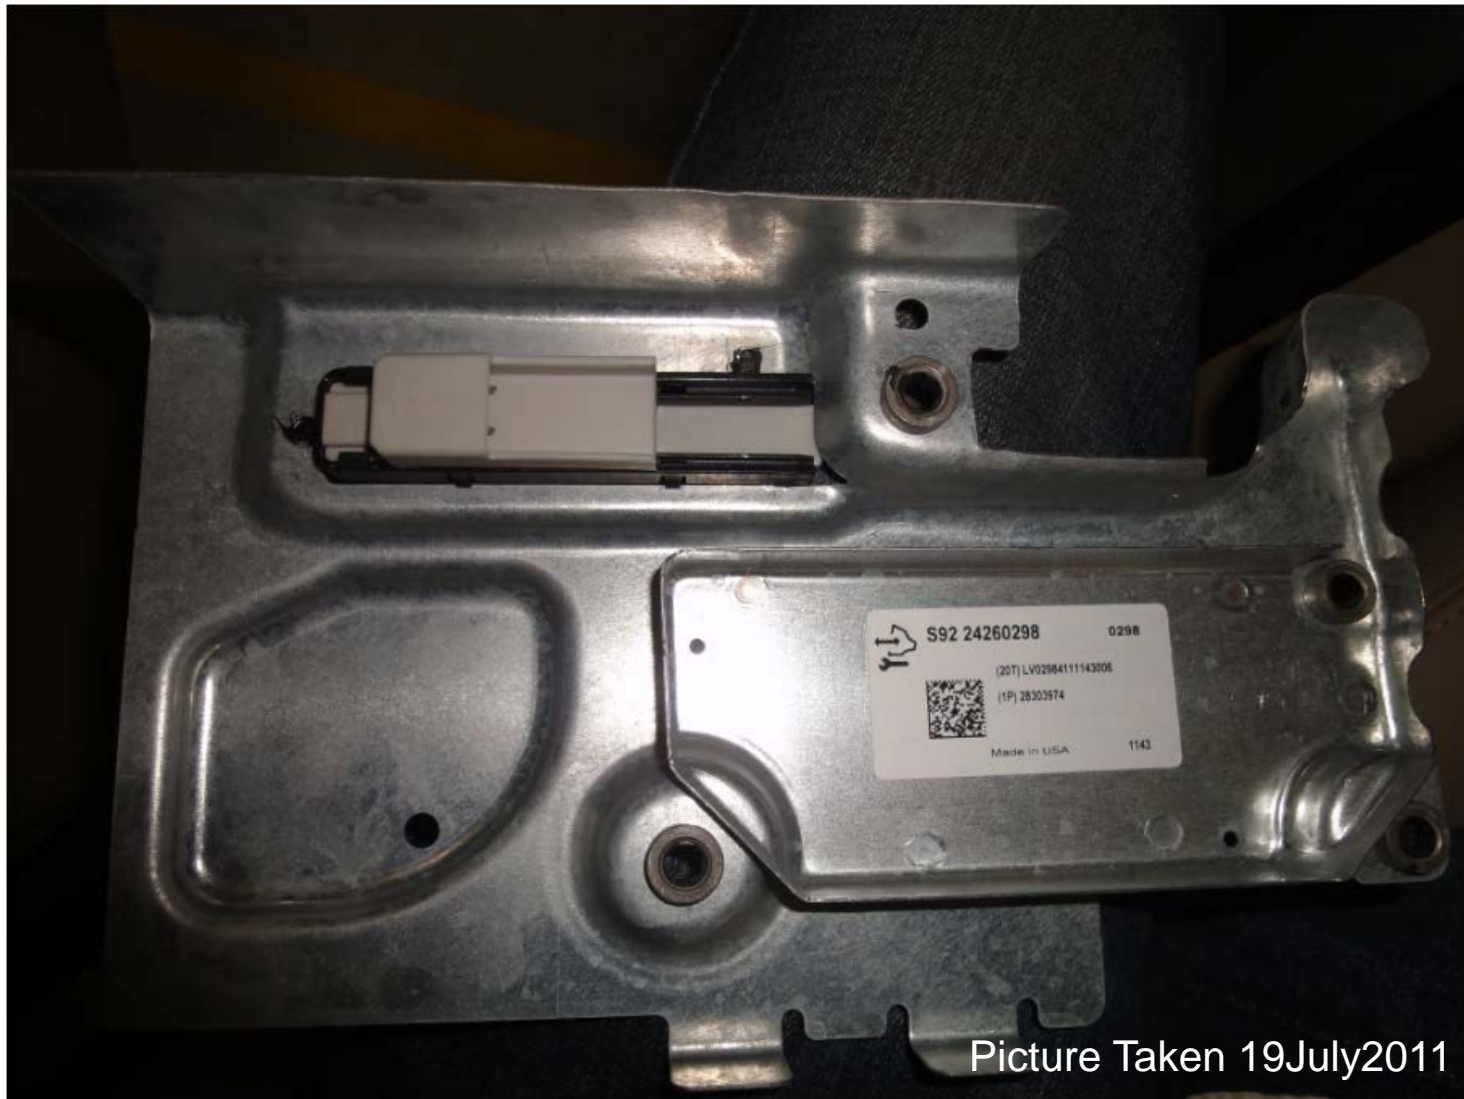
Picture Taken 19July2011

HVIL Cover (back)  
p/n S92 24260298  
(20T) LV02584111143?0  
(1P) 28303?74

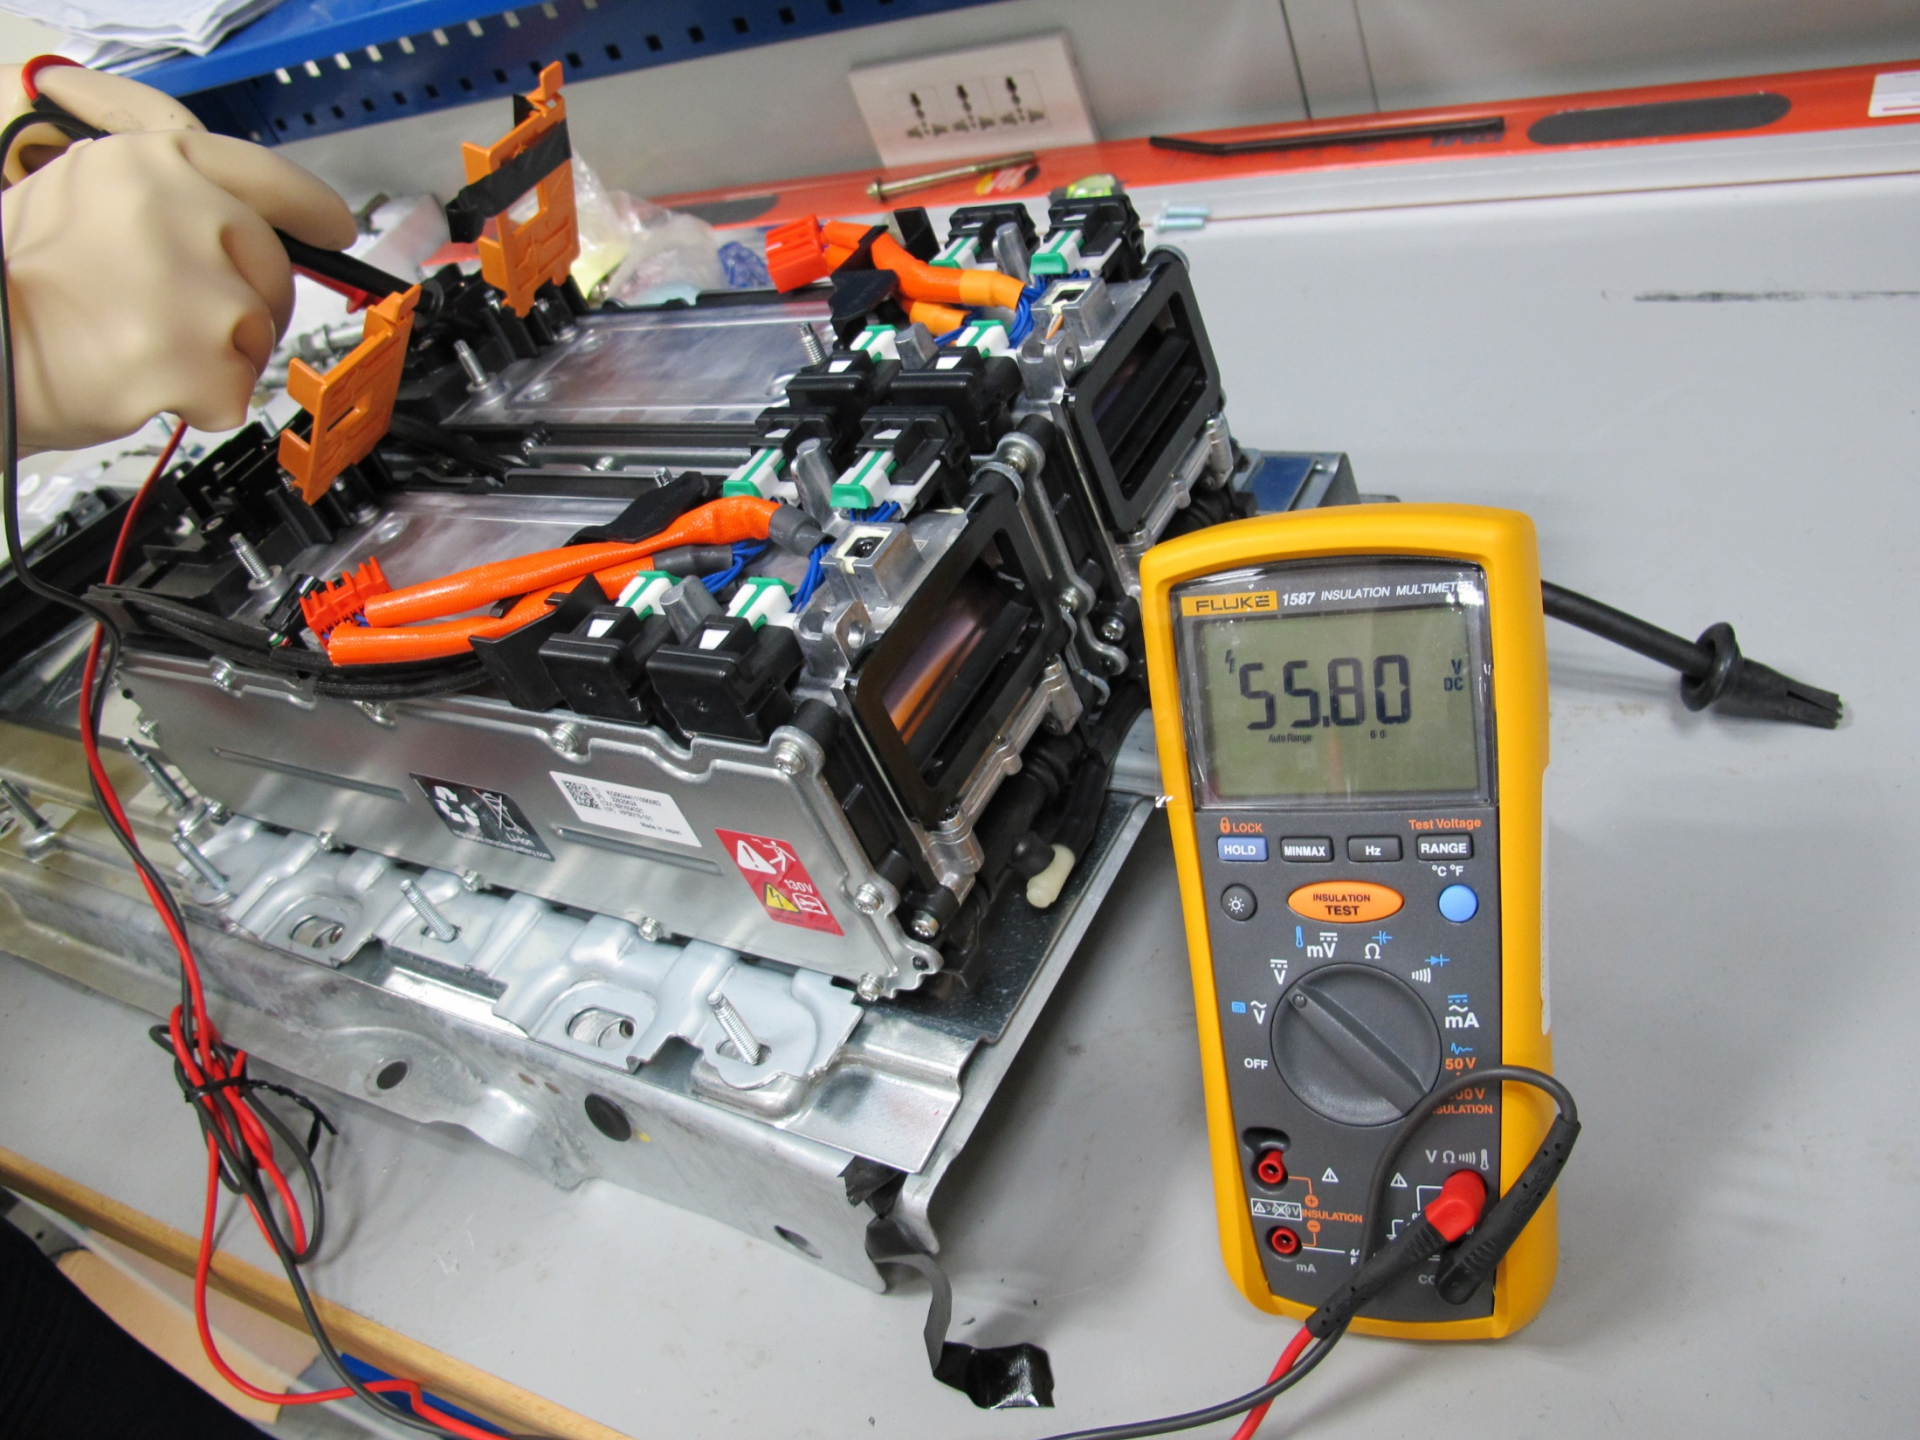
55.80 V DC

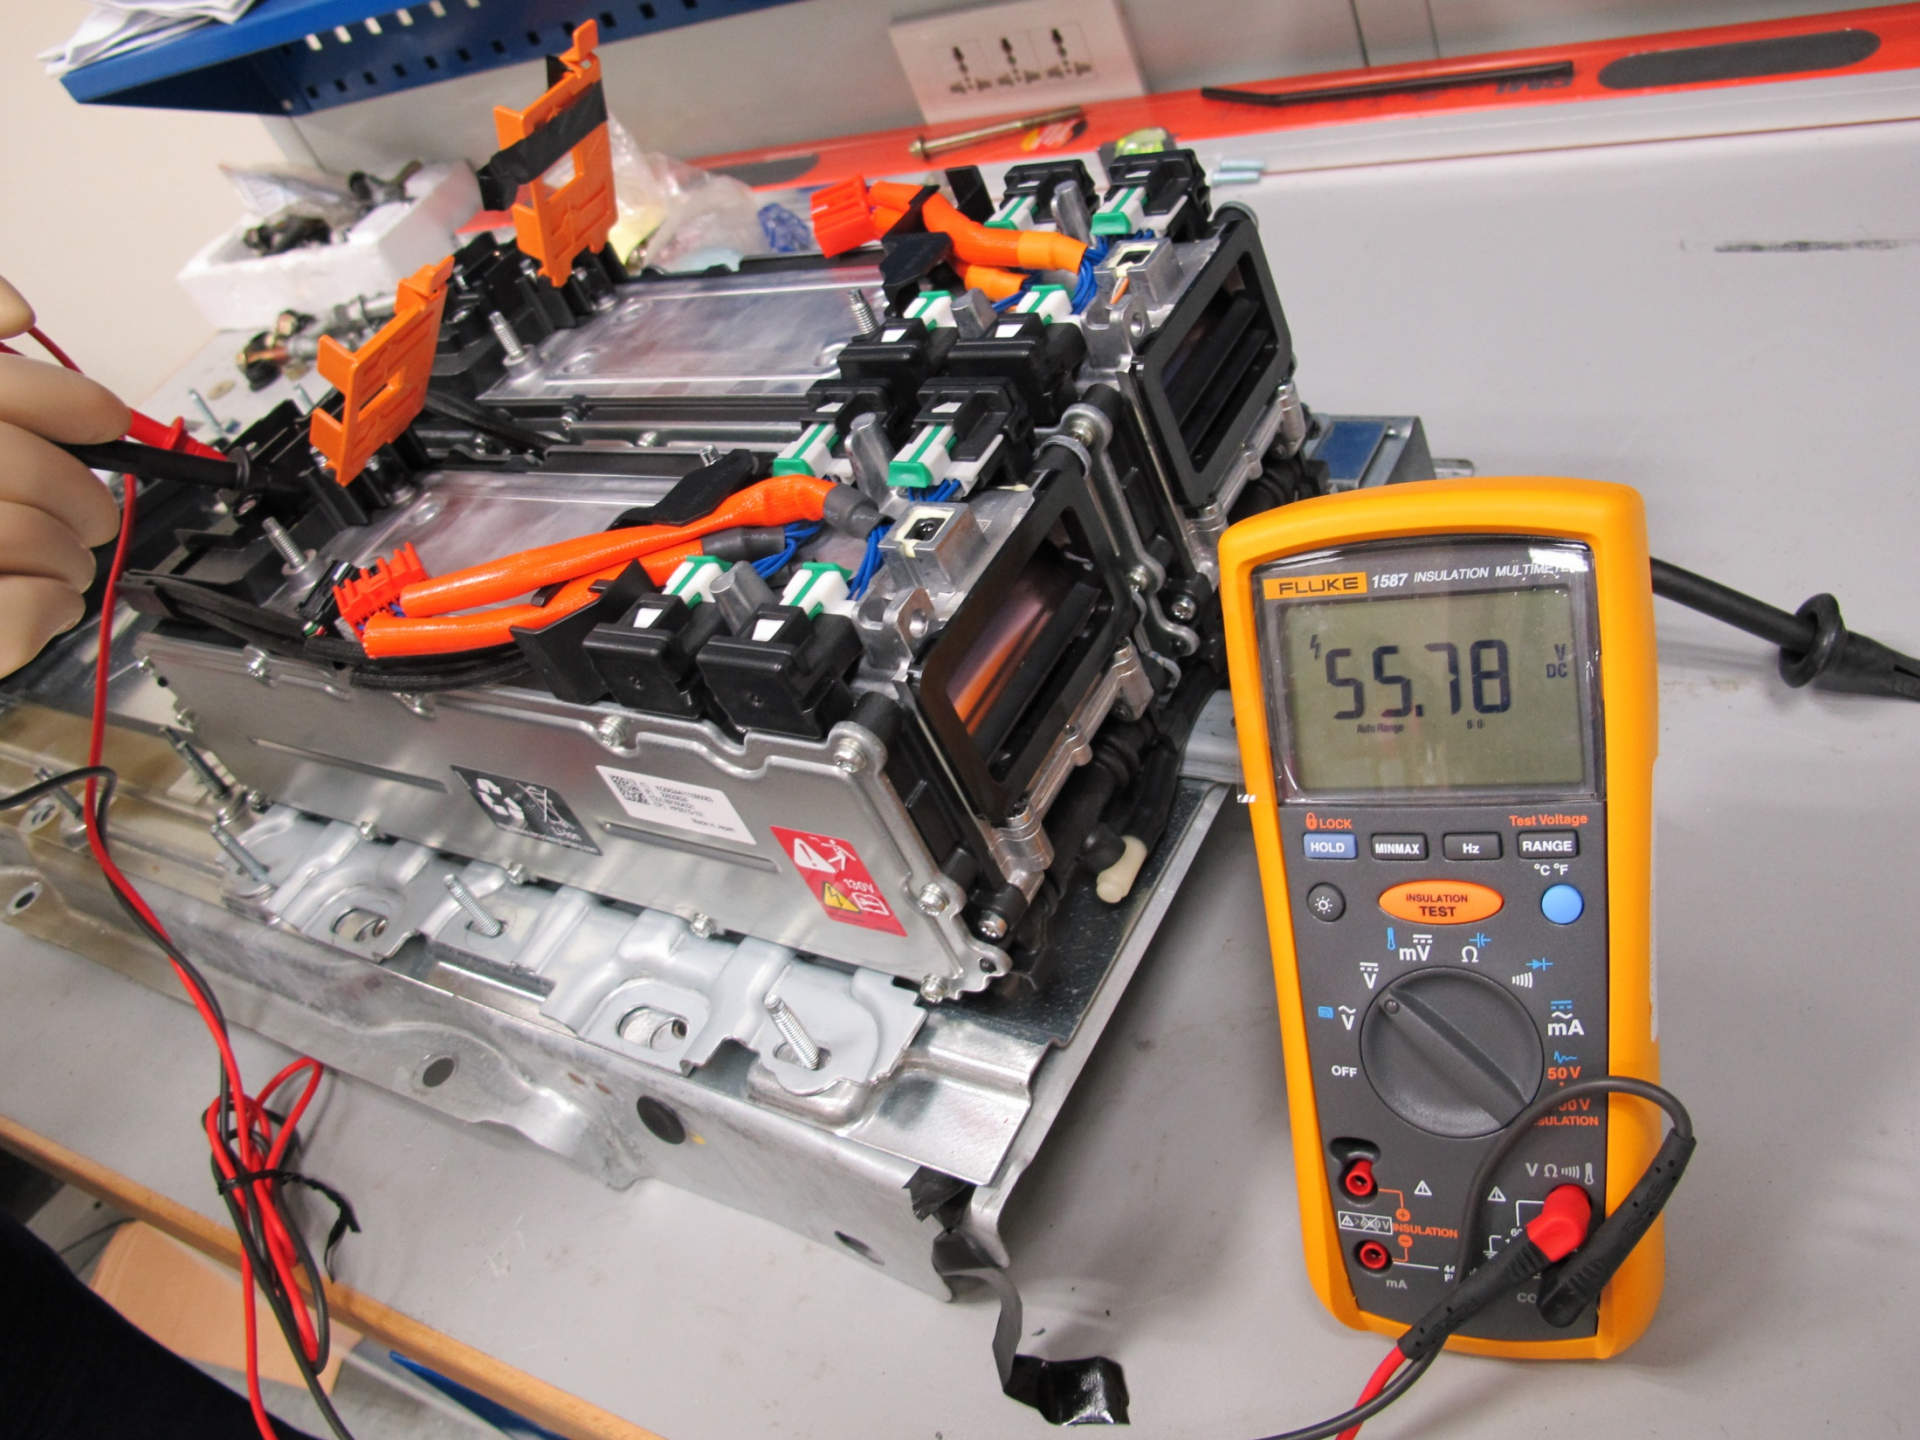
55.78 V DC  
Auto Range 60
