E-Assist Warranty Analysis

Date: October 25, 2012

2012 – 2013 Malibu, Regal, LaCrosse – eAssist – BPIM/APM Circuit Boards

eAssist: BPIM/APM Circuit Board Failures

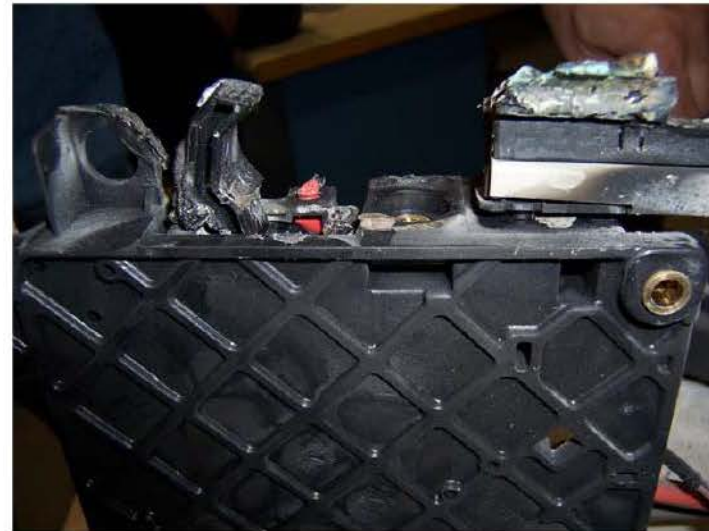
Control Board Only Collateral Damage / Sooted

Power Board Only Collateral Damage / Sooted

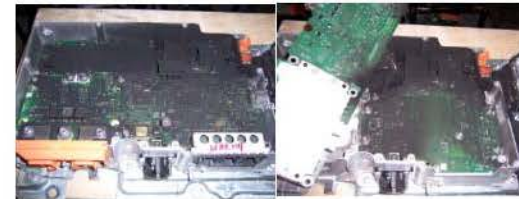
- ◆ Pack 370 - “White Marsh Type” Pwr PCB
- ◆ Pack 395 - Pwr PCB HV Isolation
- ◆ Pack 400 - Pwr PCB HV Isolation
- ◆ Pack 446 - Pwr PCB HV Isolation
- ◆ BPIM 556 - Pwr PCB HV Isolation
- ◆ Pack 632 - “White Marsh Type” Pwr PCB

“White Marsh Type”

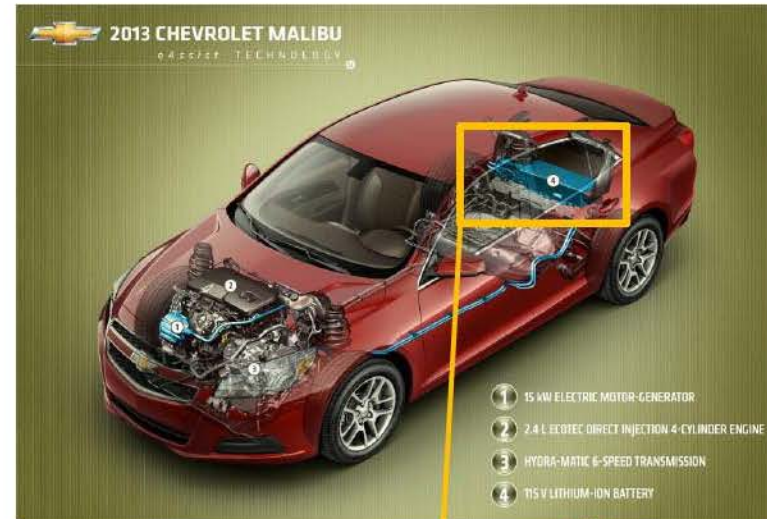
- All eAssist vehicles have a **Powerpack** which contains a **BAS Power Inverter Module (BPIM) / Accessory Power Module (APM)**, and a **115-V Lithium-Ion battery**
- The BPIM/APM contains three multi-layered **Printed Circuit Boards (PCBs)** comprised of conductive layers separated by isolating layers
- General practice is for two layers of isolation between conductive layers or one layer of adequate thickness.
- The three PCBs in the eAssist BPIM/APM have **at least one instance of conductive layers separate by only one isolating layer**
- This design showed **no issues during validation** but some isolation failures (short) began to occur in production
- The **failure rate increase dramatically coinciding with several board build lots in 2012**
- All boards built since January 2013 have dual isolation layers and the failure rate for isolation faults has been zero
