RQ13-004

HYUNDAI-KIA

RESPONSE TO REQUEST 8

# Elantra Touring CAB deployment verification test – (2/12/14)

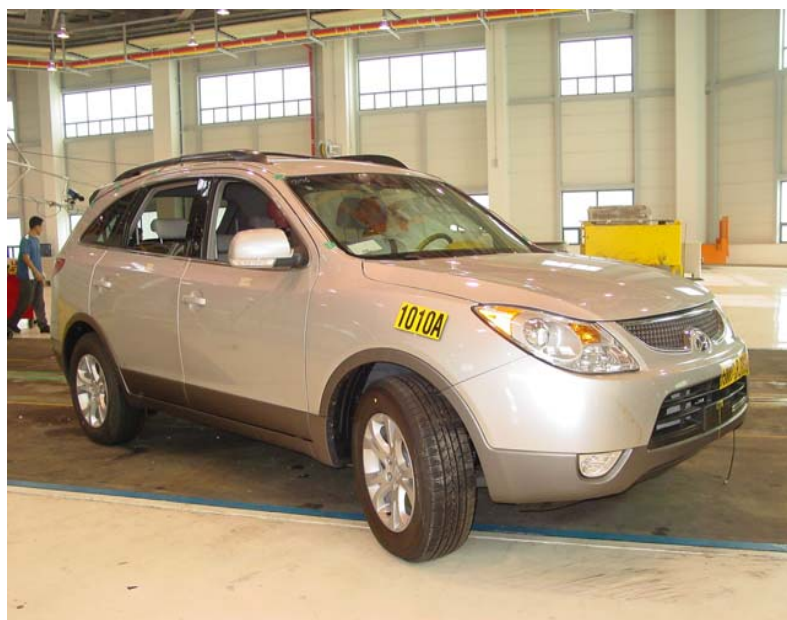
POST-TEST : FRONT QUARTER VIEW OF VEHICLE

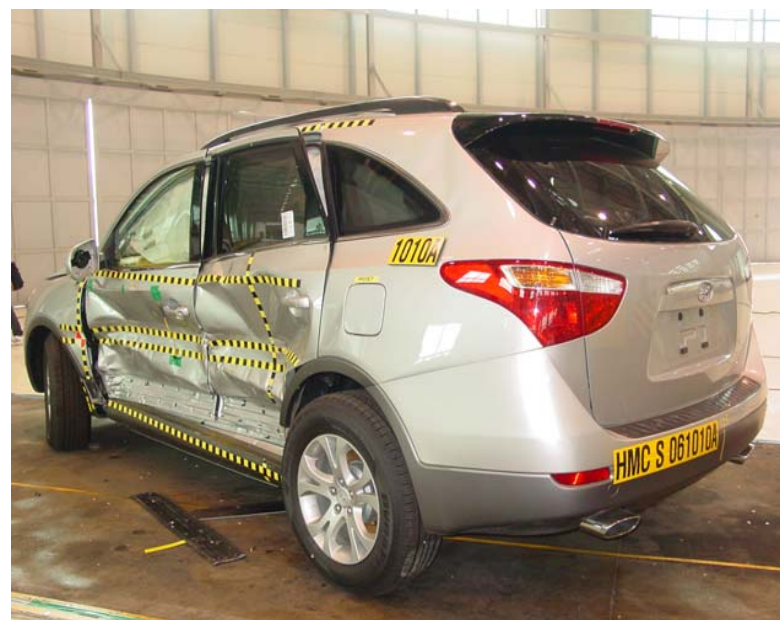
POST-TEST : REAR QUARTER VIEW OF VEHICLE

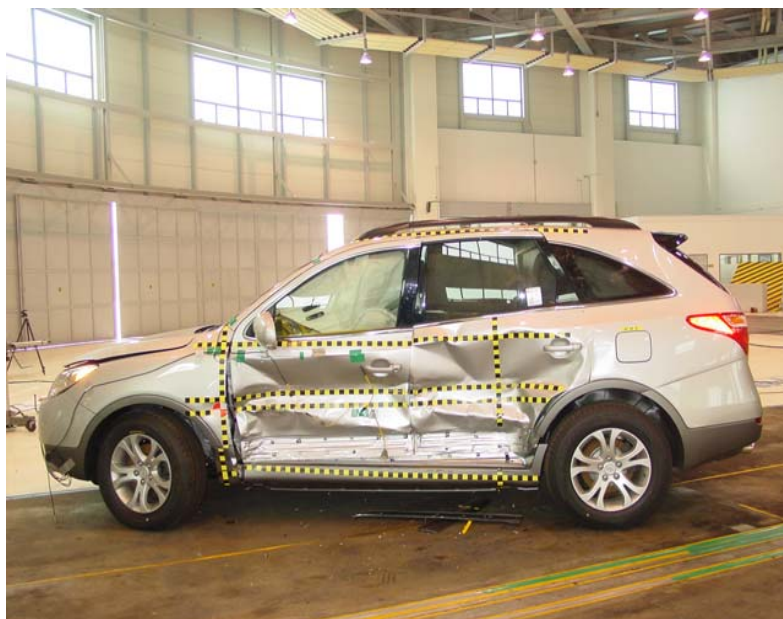
POST-TEST : LEFT SIDE VIEW OF VEHICLE

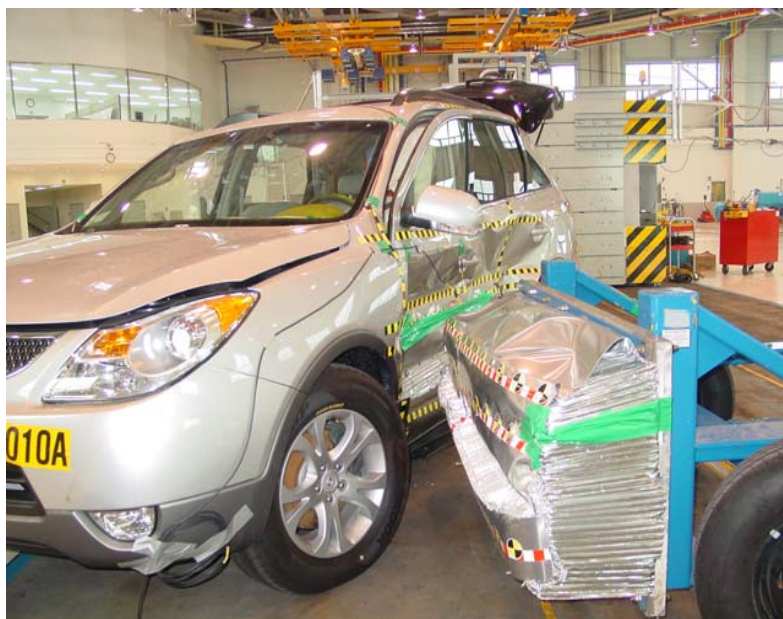
POST-TEST : FRONT VIEW OF IMPACTOR FACE

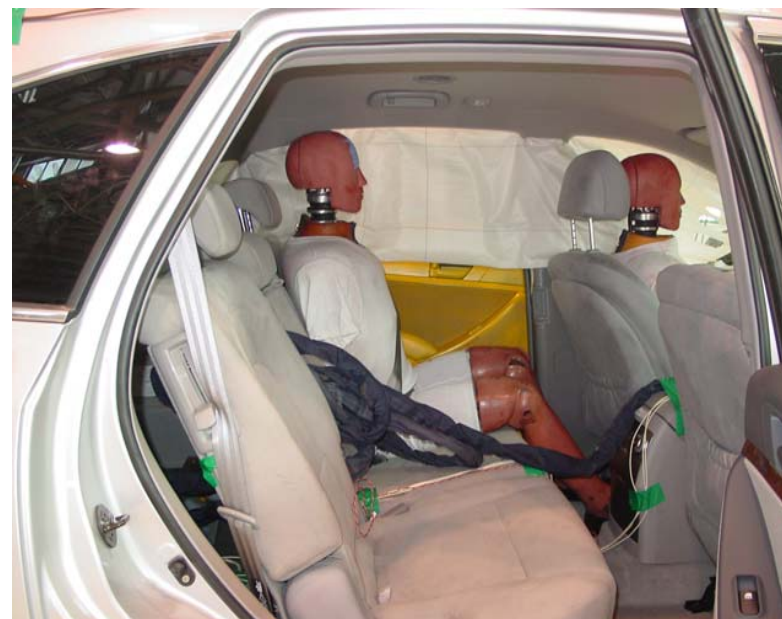
POST-TEST : OCCUPANT COMPARTMENT VIEW SHOWING FRONT  
SID

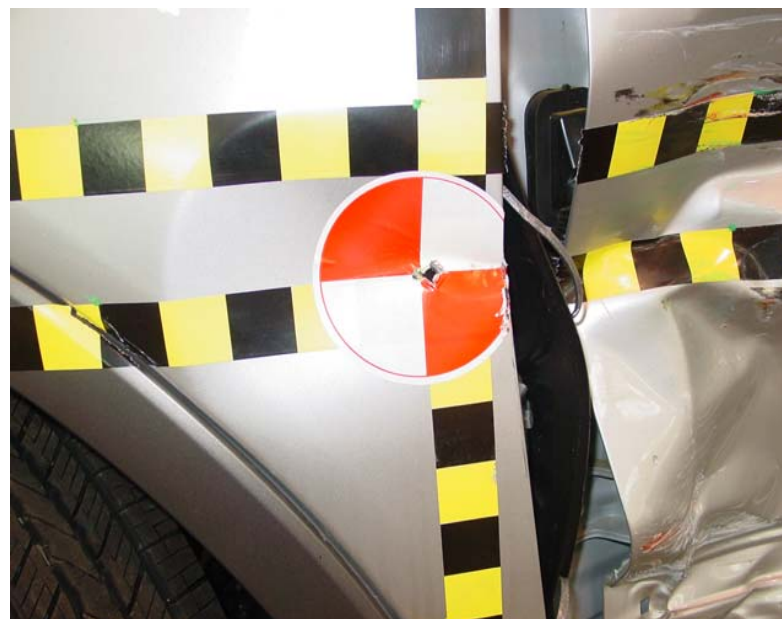
POST-TEST : OVERHEAD VIEW OF TEST VEHICLE AT IMPACT LOCATION

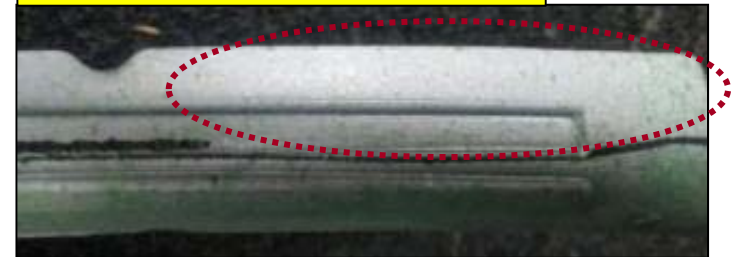
NG : Partial Insufficient spray
