Kia Motors America Field Product Quality Report

Subject/Title: Panoramic Sunroof Shattered

Model Desc: OPTIMA EX

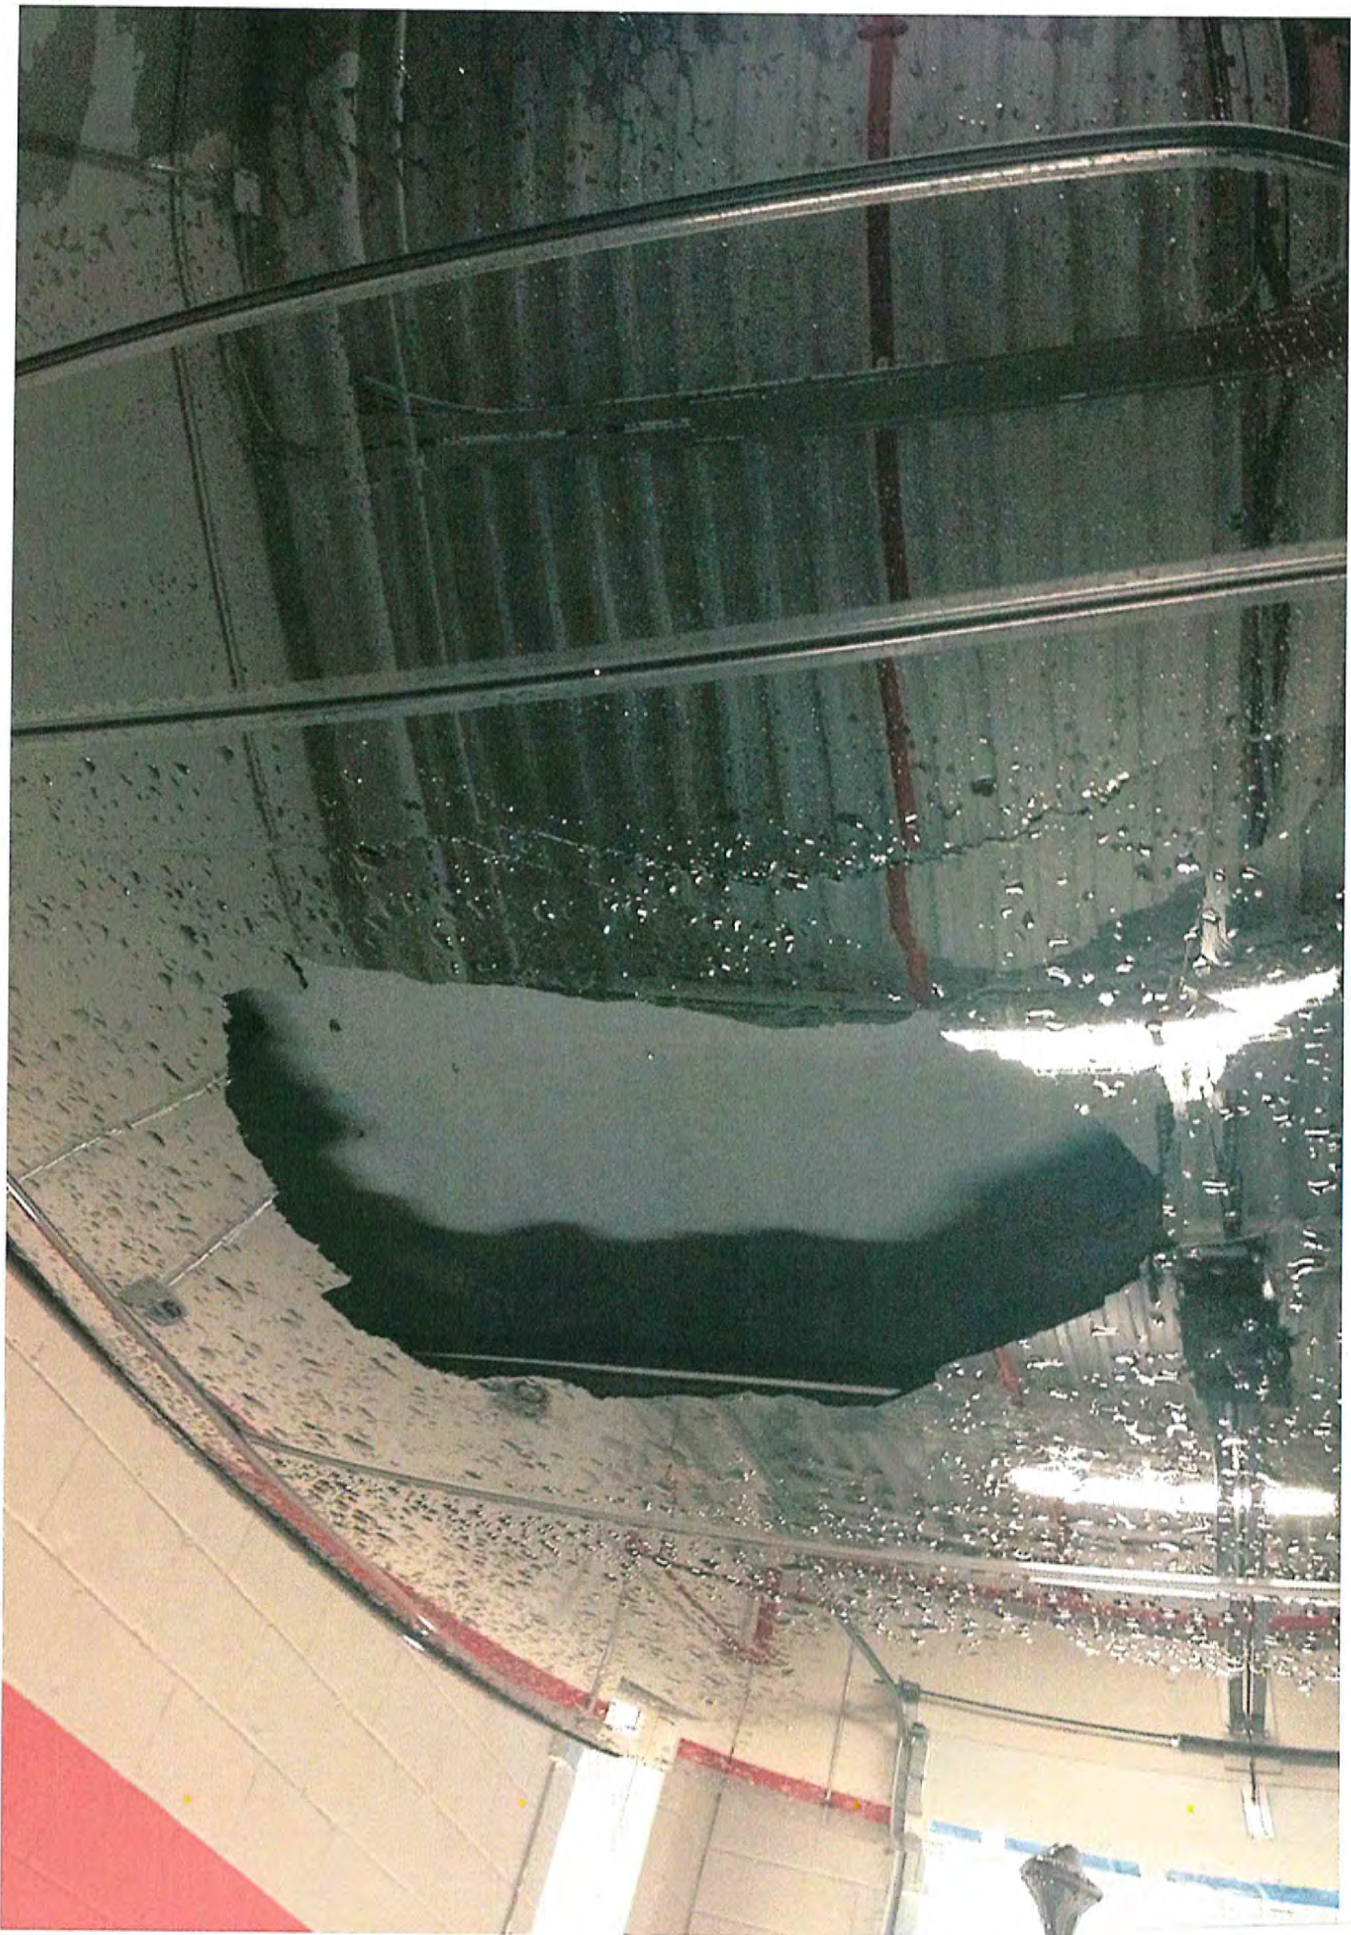
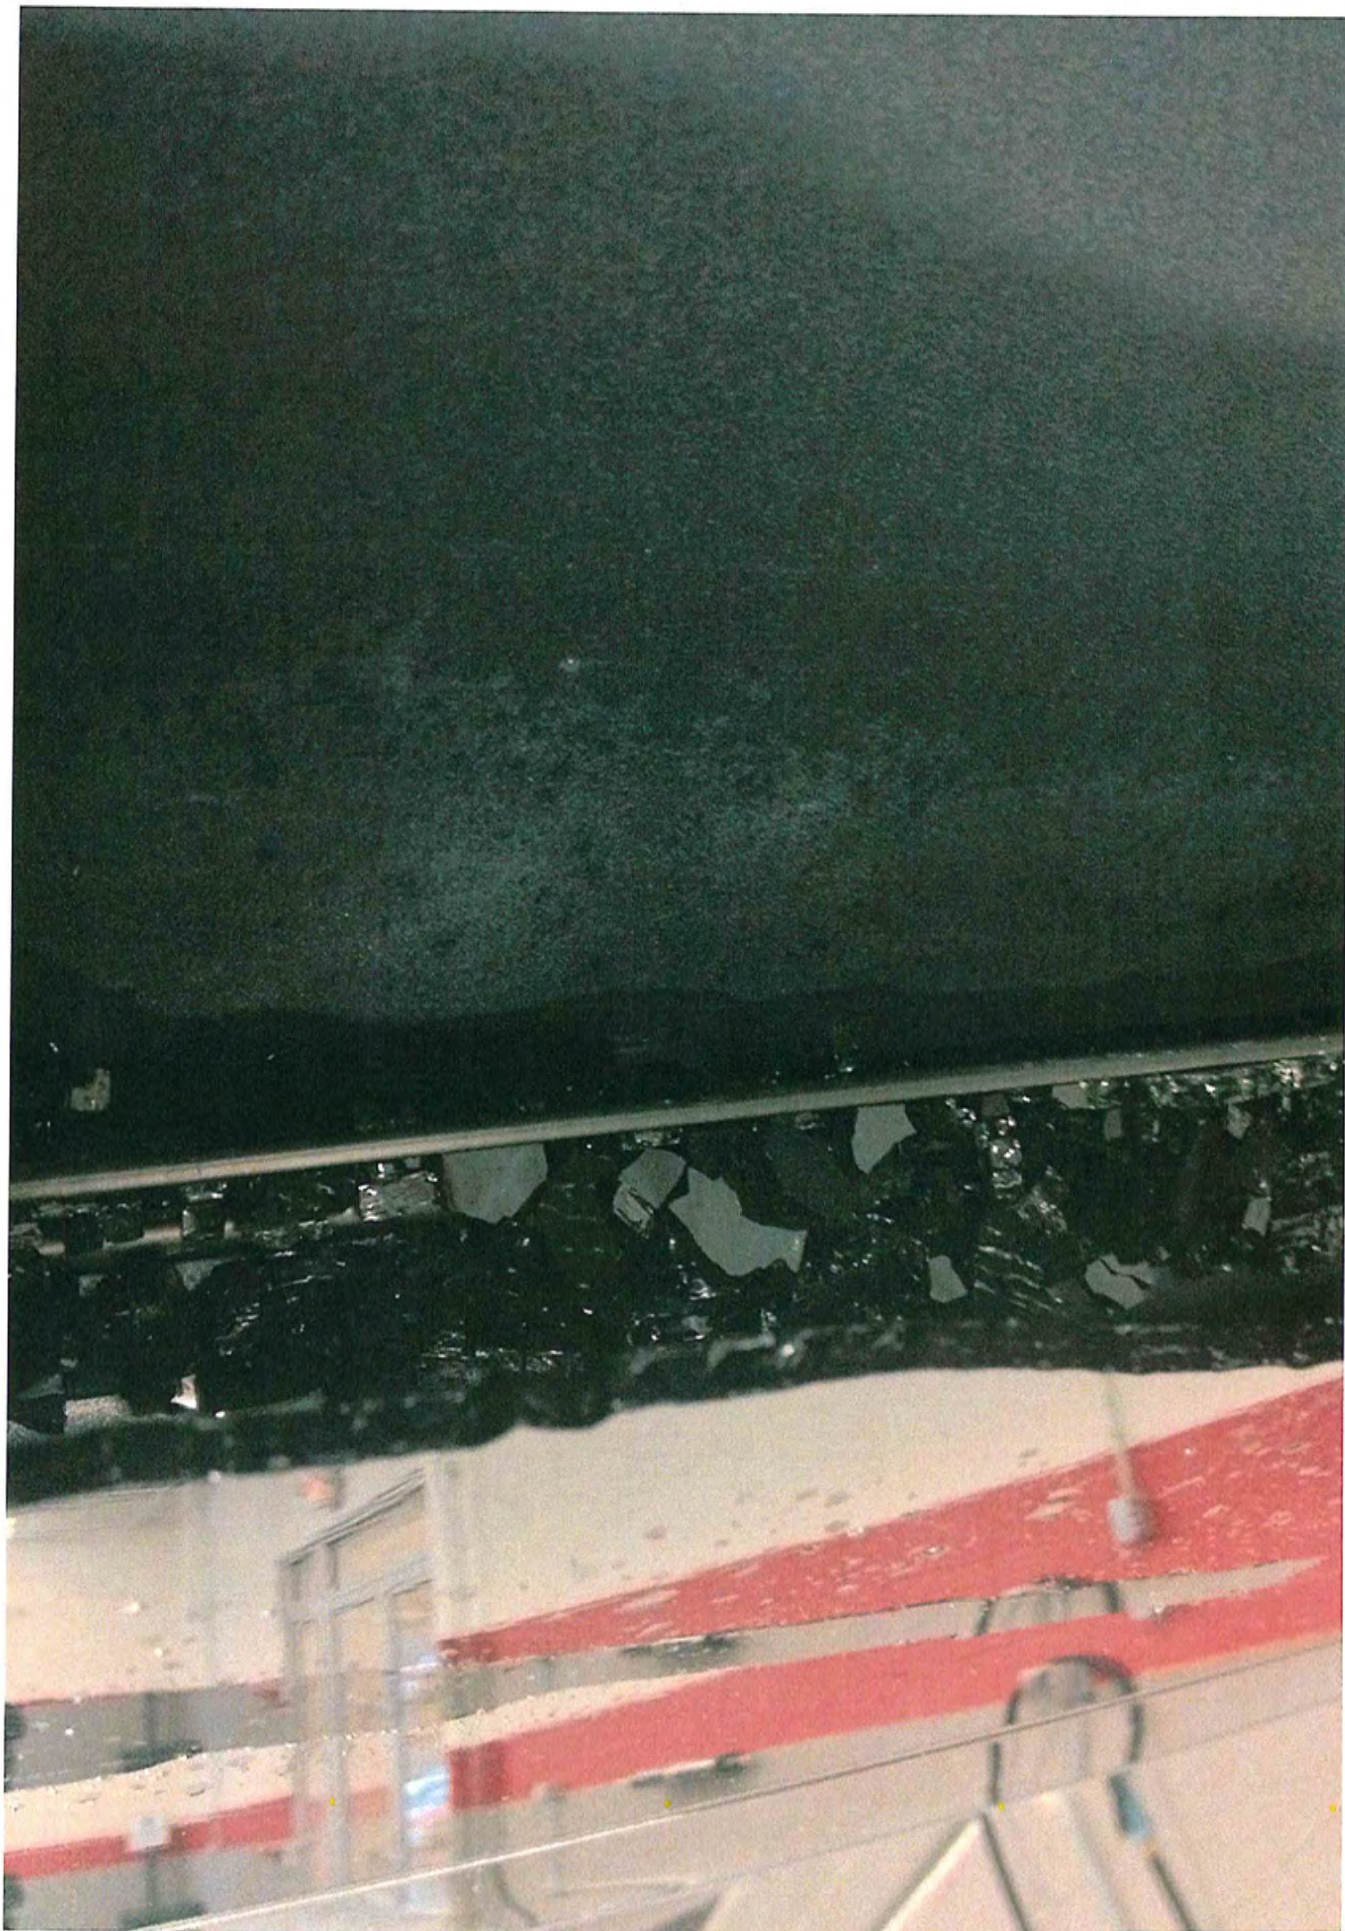
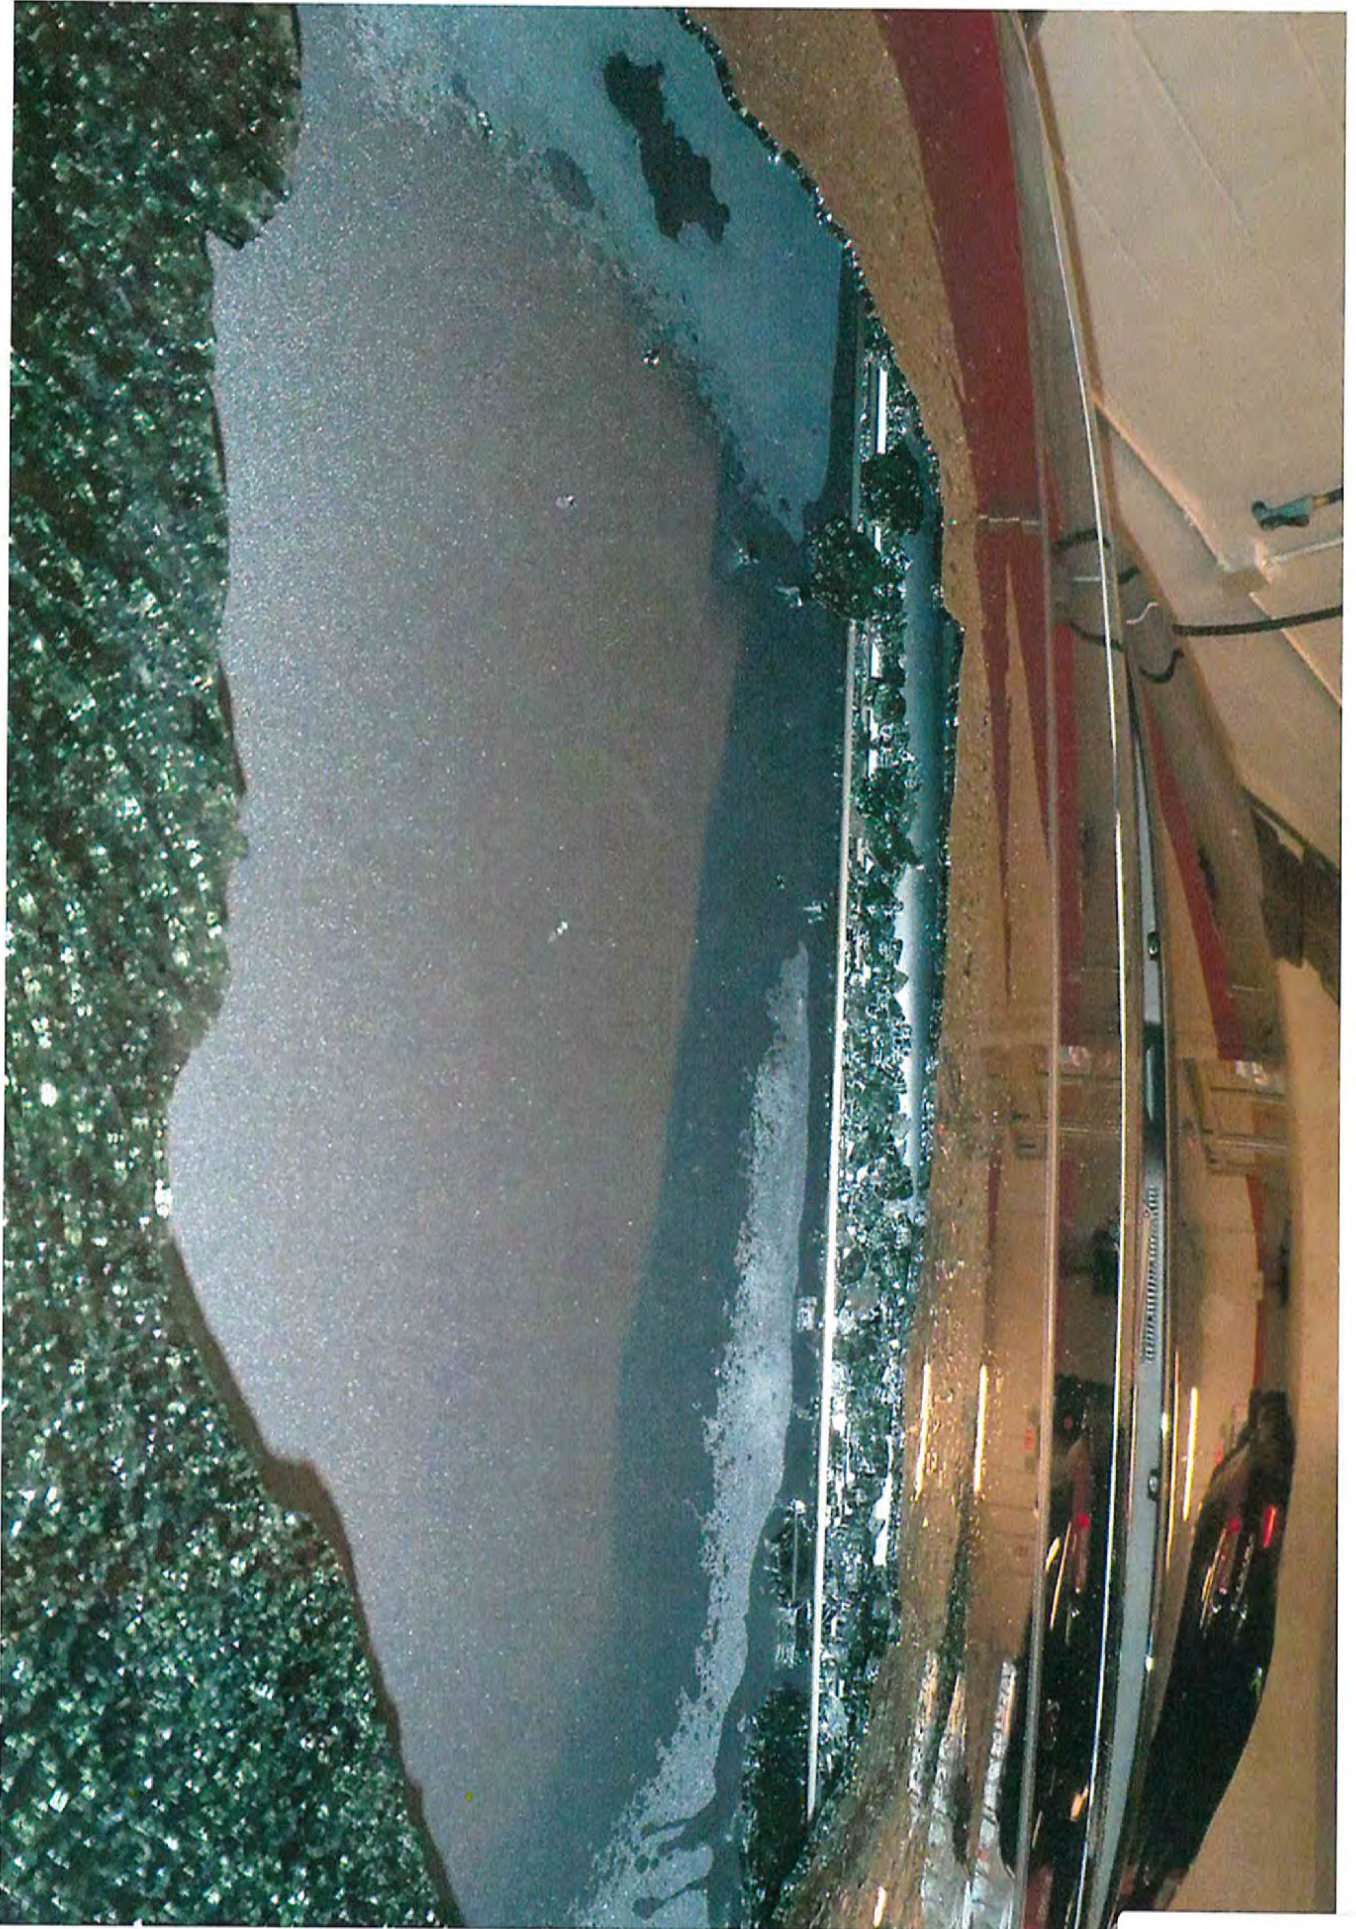
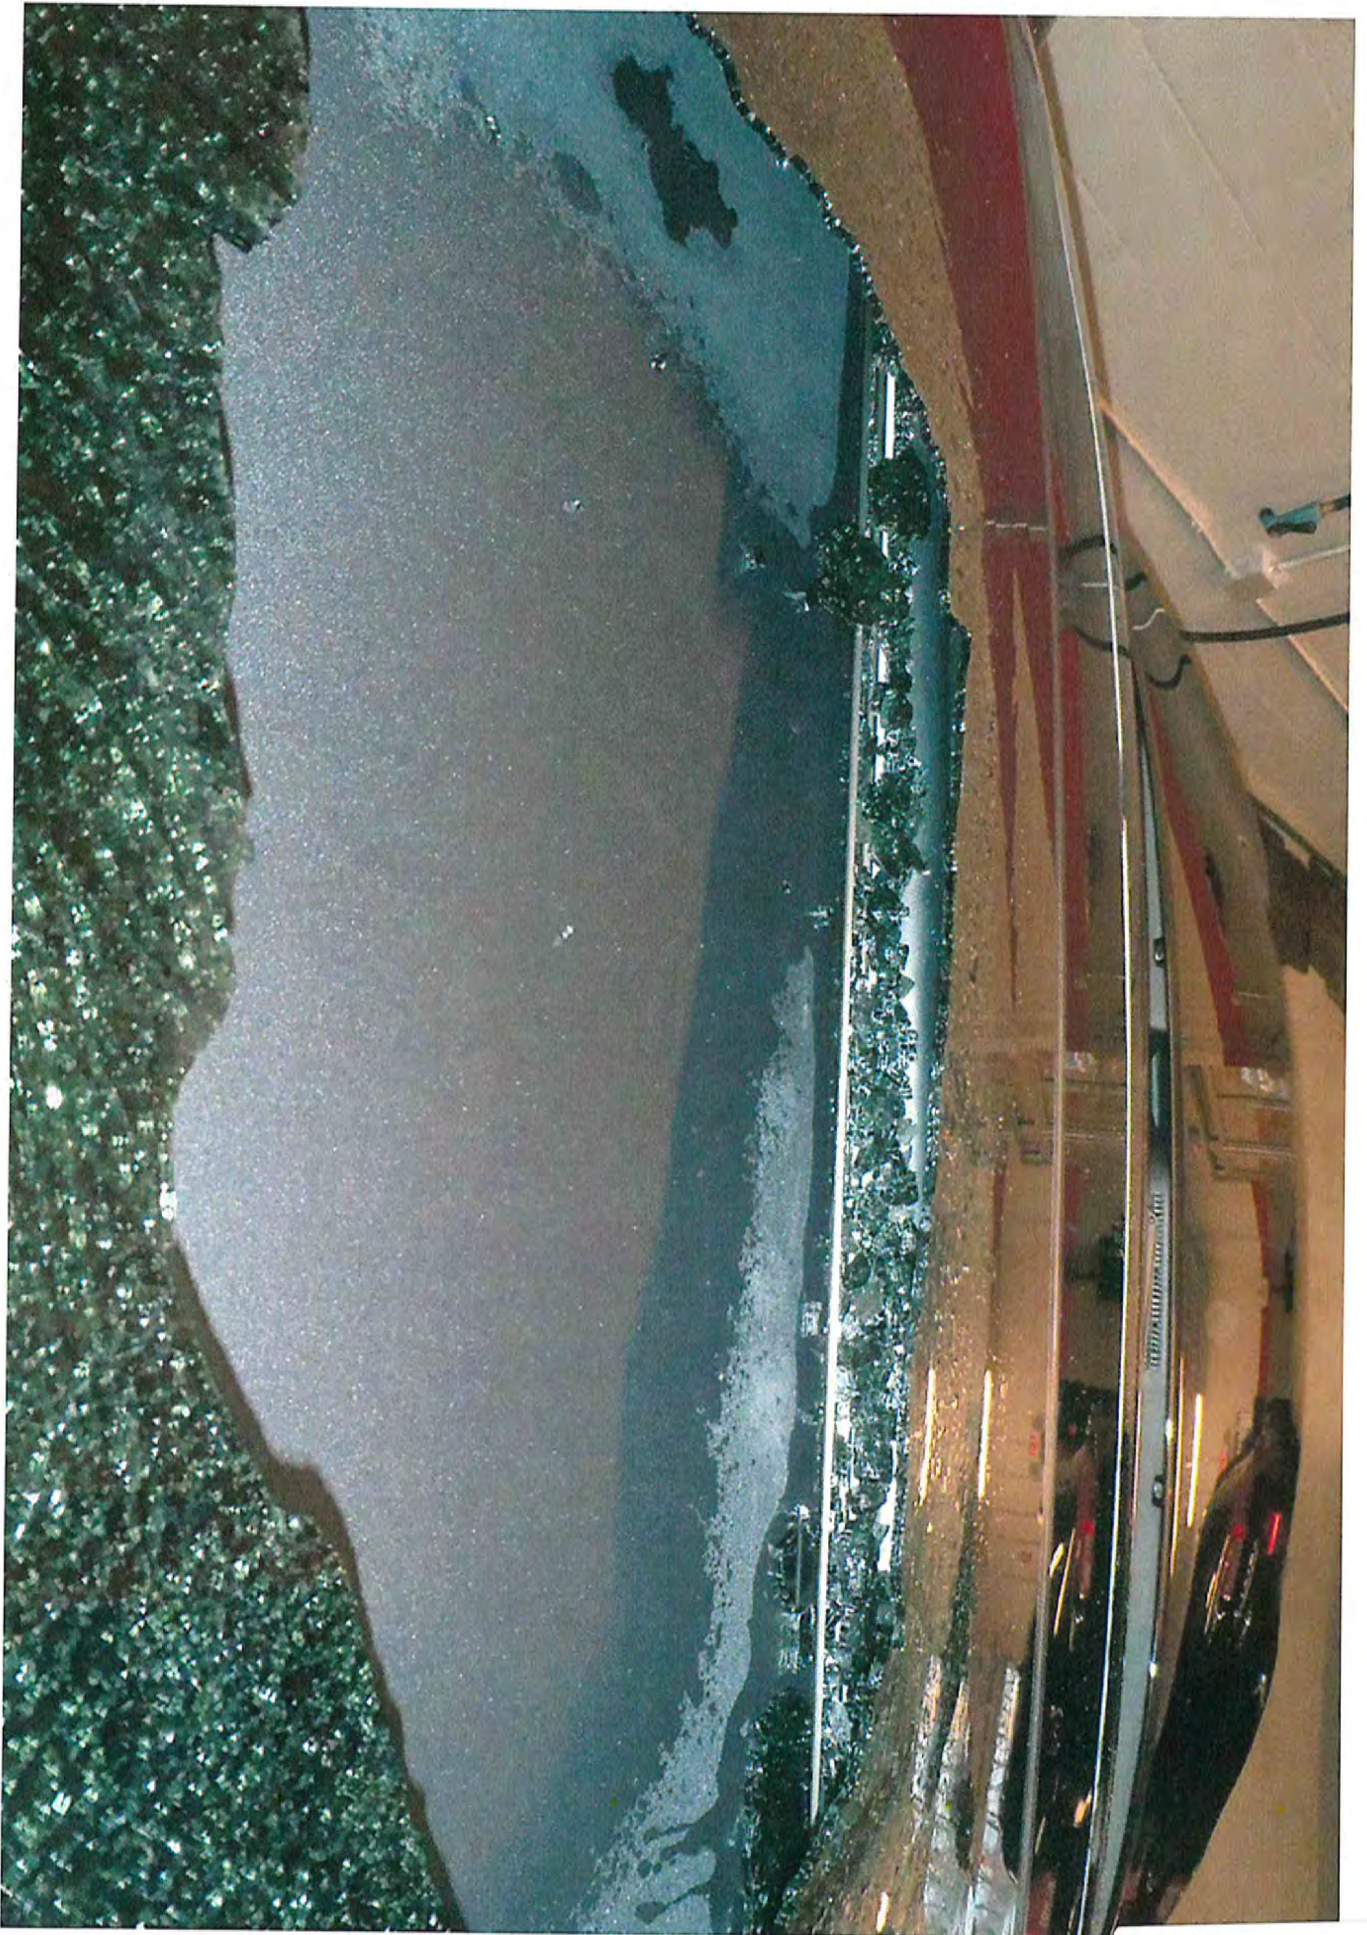
FTR inspected vehicle and found front panel of panoramic roof shattered. The sunroof was closed as well as the sunshade. The glass debris sitting on top of the sunshade.

A hole was in the center of the closed glass sunroof panel. (see photo) An outward crack was at the front of the glass that remained in place and cracks were throughout the rest of the panel. A paint chip was found on the hood down to the metal. No rust was on the exposed metal suggesting the chip was recent. A chip was in the windshield was also found. (see photos attached) other small chips in the paint and windshield were noted as well.

Possible roof glass failure due to impact from outside source resulting in weakening of glass integrity. Signs of impact on hood and windshield was found.

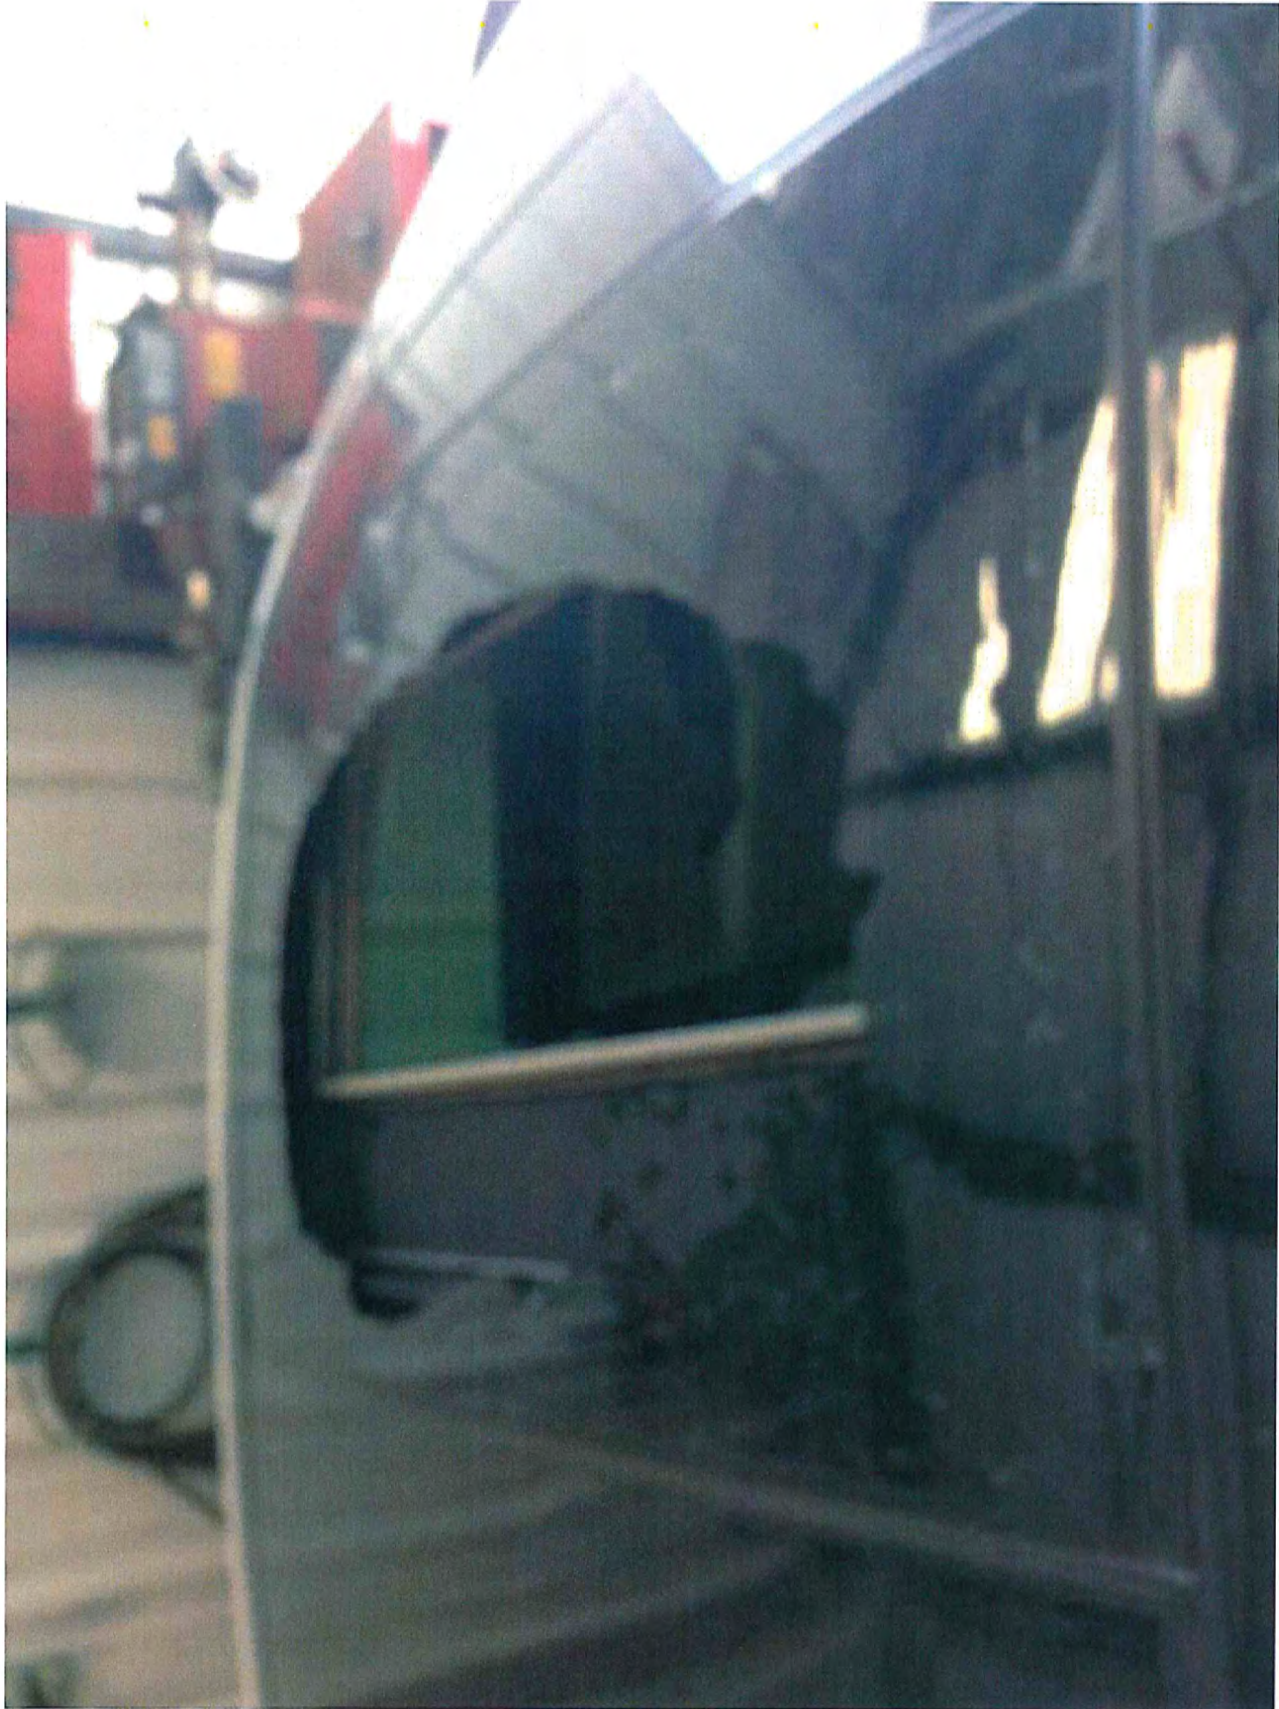
Found no impact marks on the shattered glass

Replace the sunroof glass

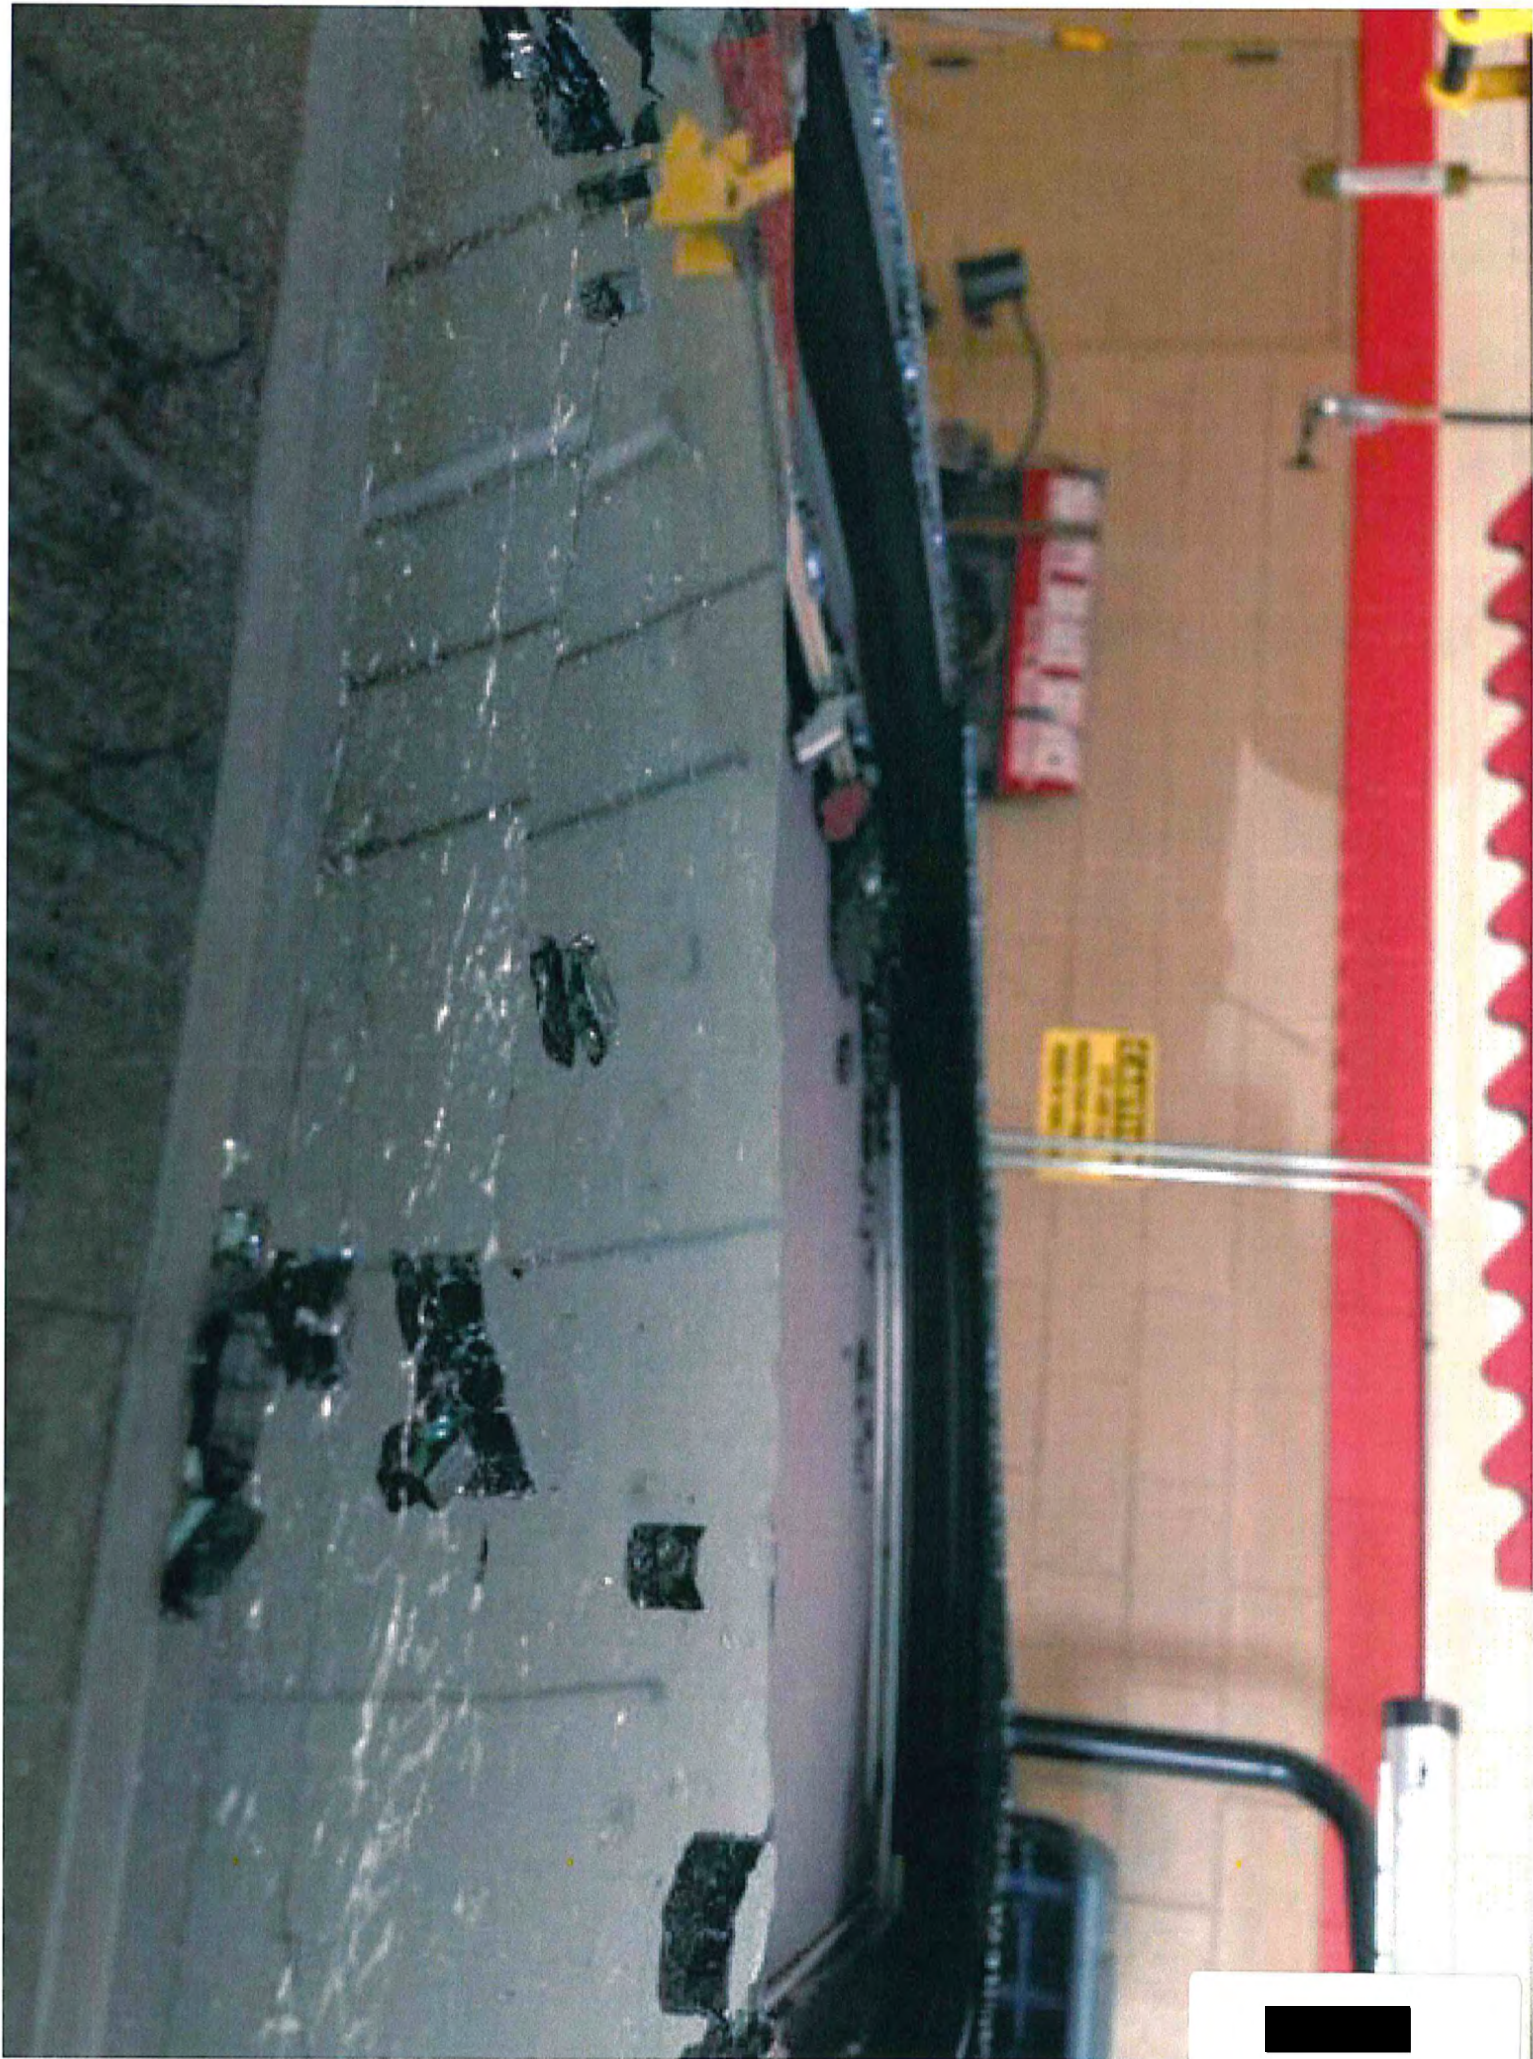
Found no evidence of rock chip in the remaining glass.

Replace the sunroof assy

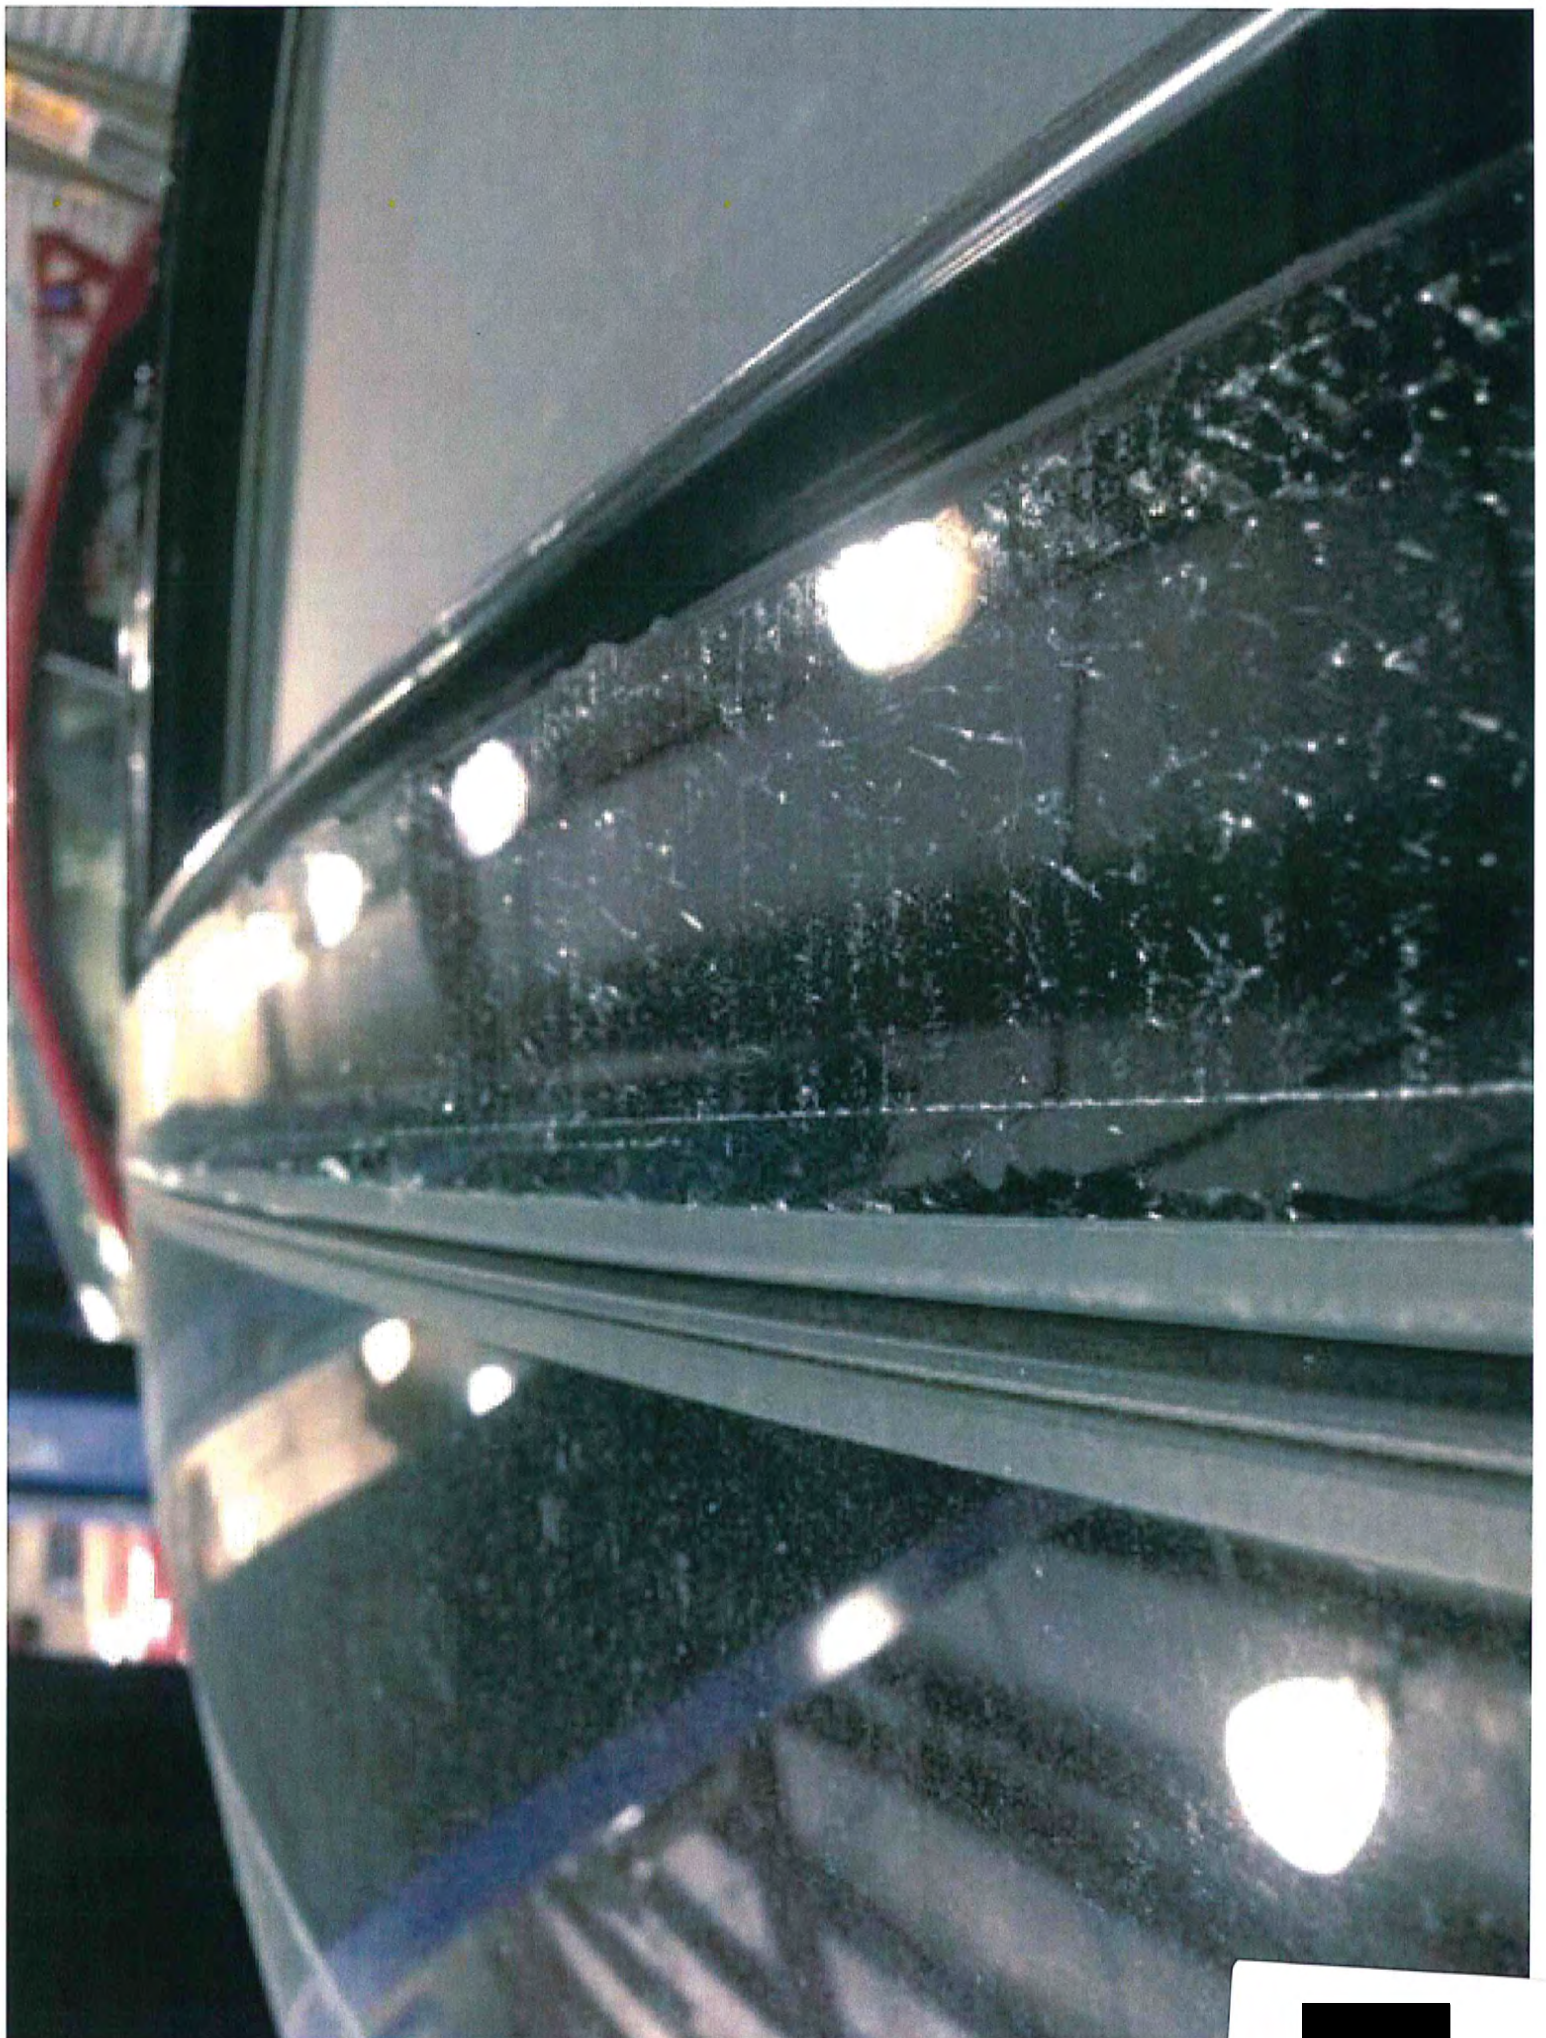
Found no evidence of rock chip. Most of the glass removed by customer.

Replace the sunroof assy.
