Kia Motors America Field Product Quality Report

Subject/Title: Panoramic Sunroof Shattered

Model Desc: OPTIMA EX

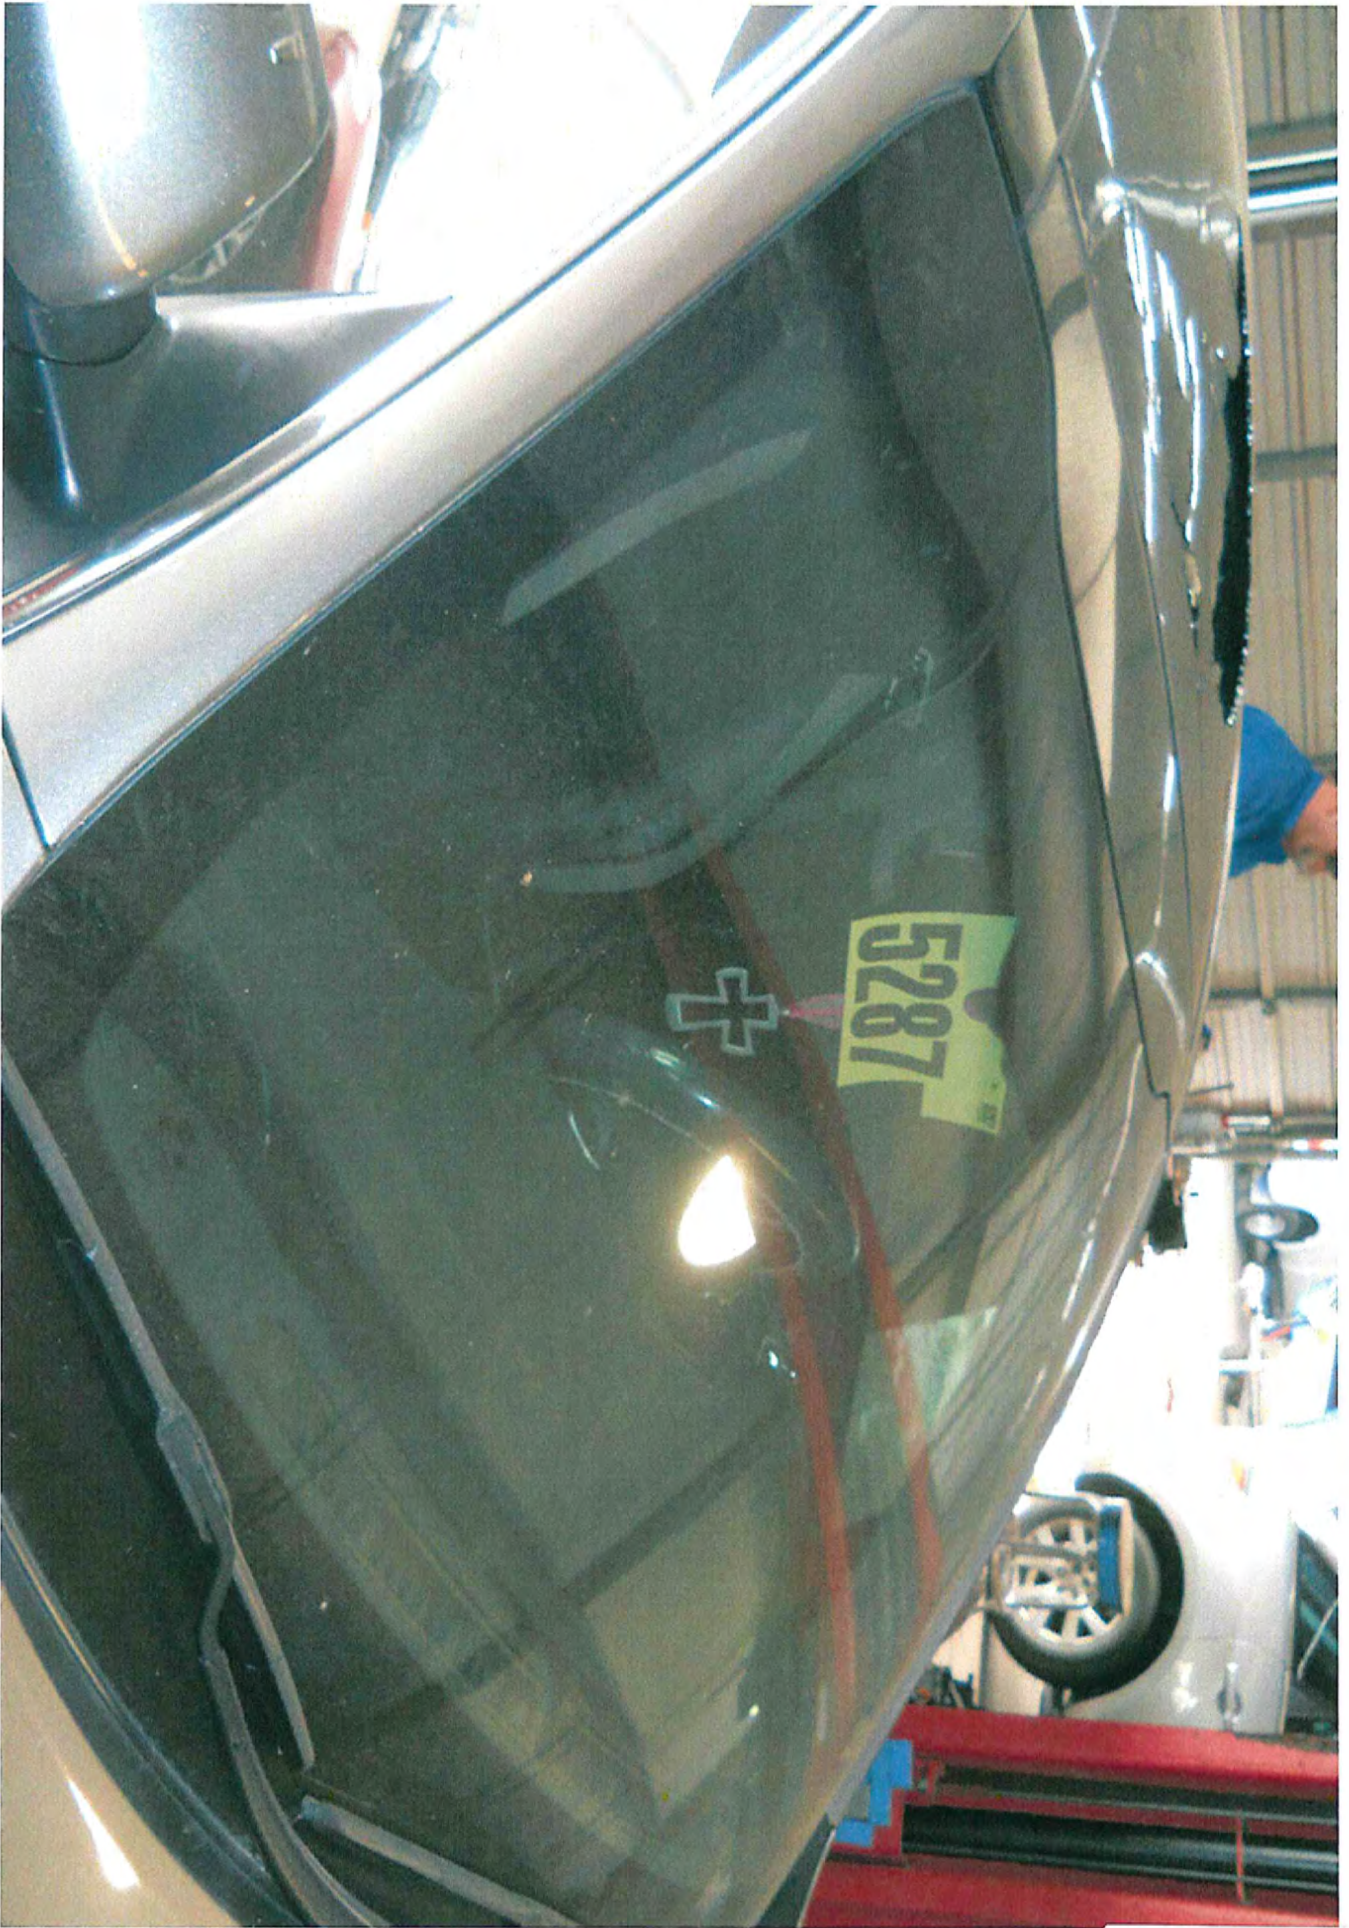
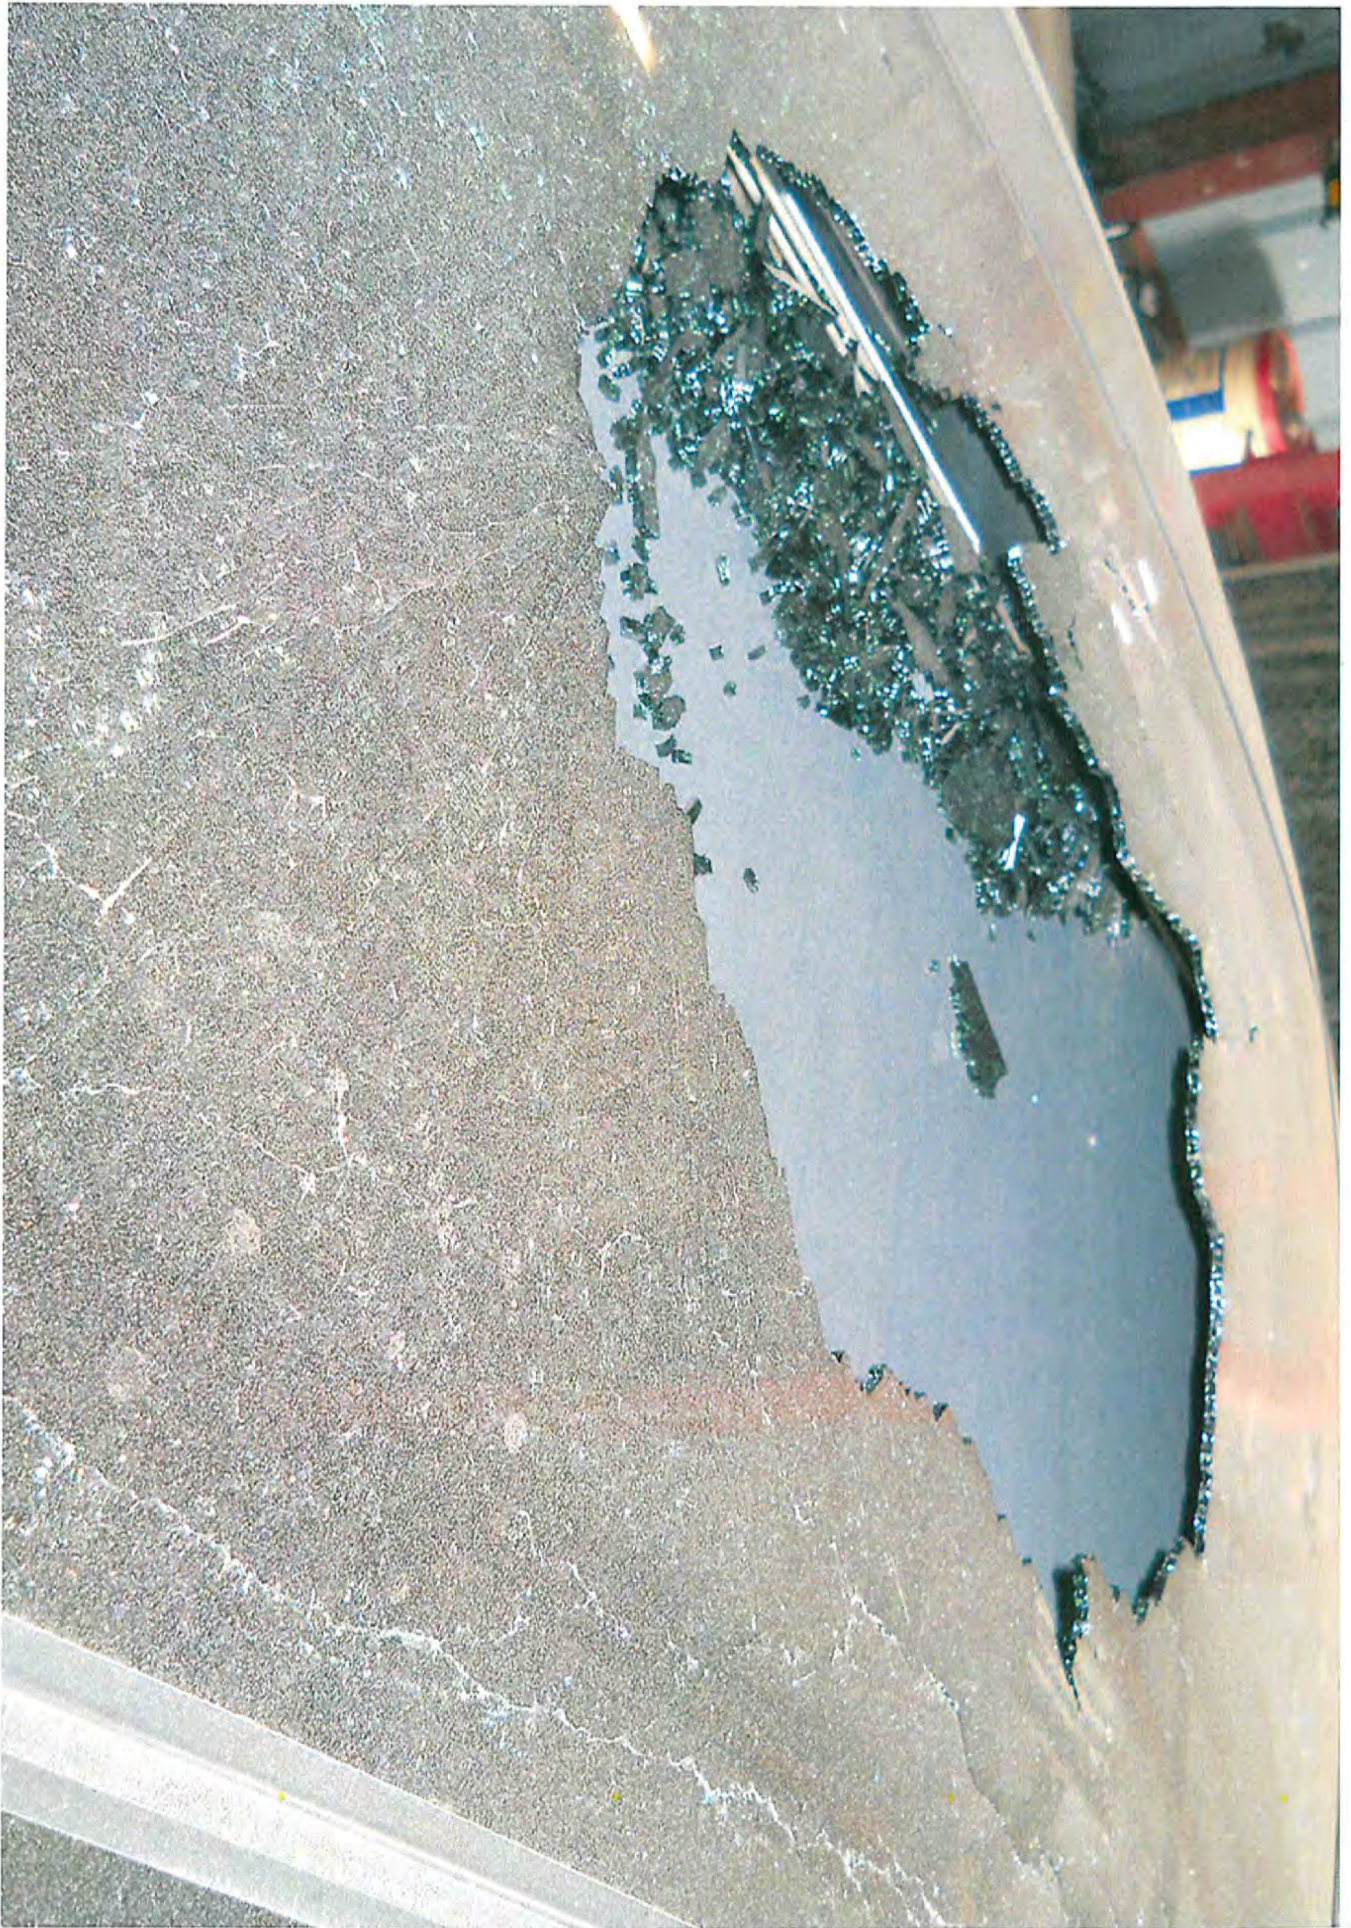
Found no evidence of rock chip.

Replace the sunroof glass

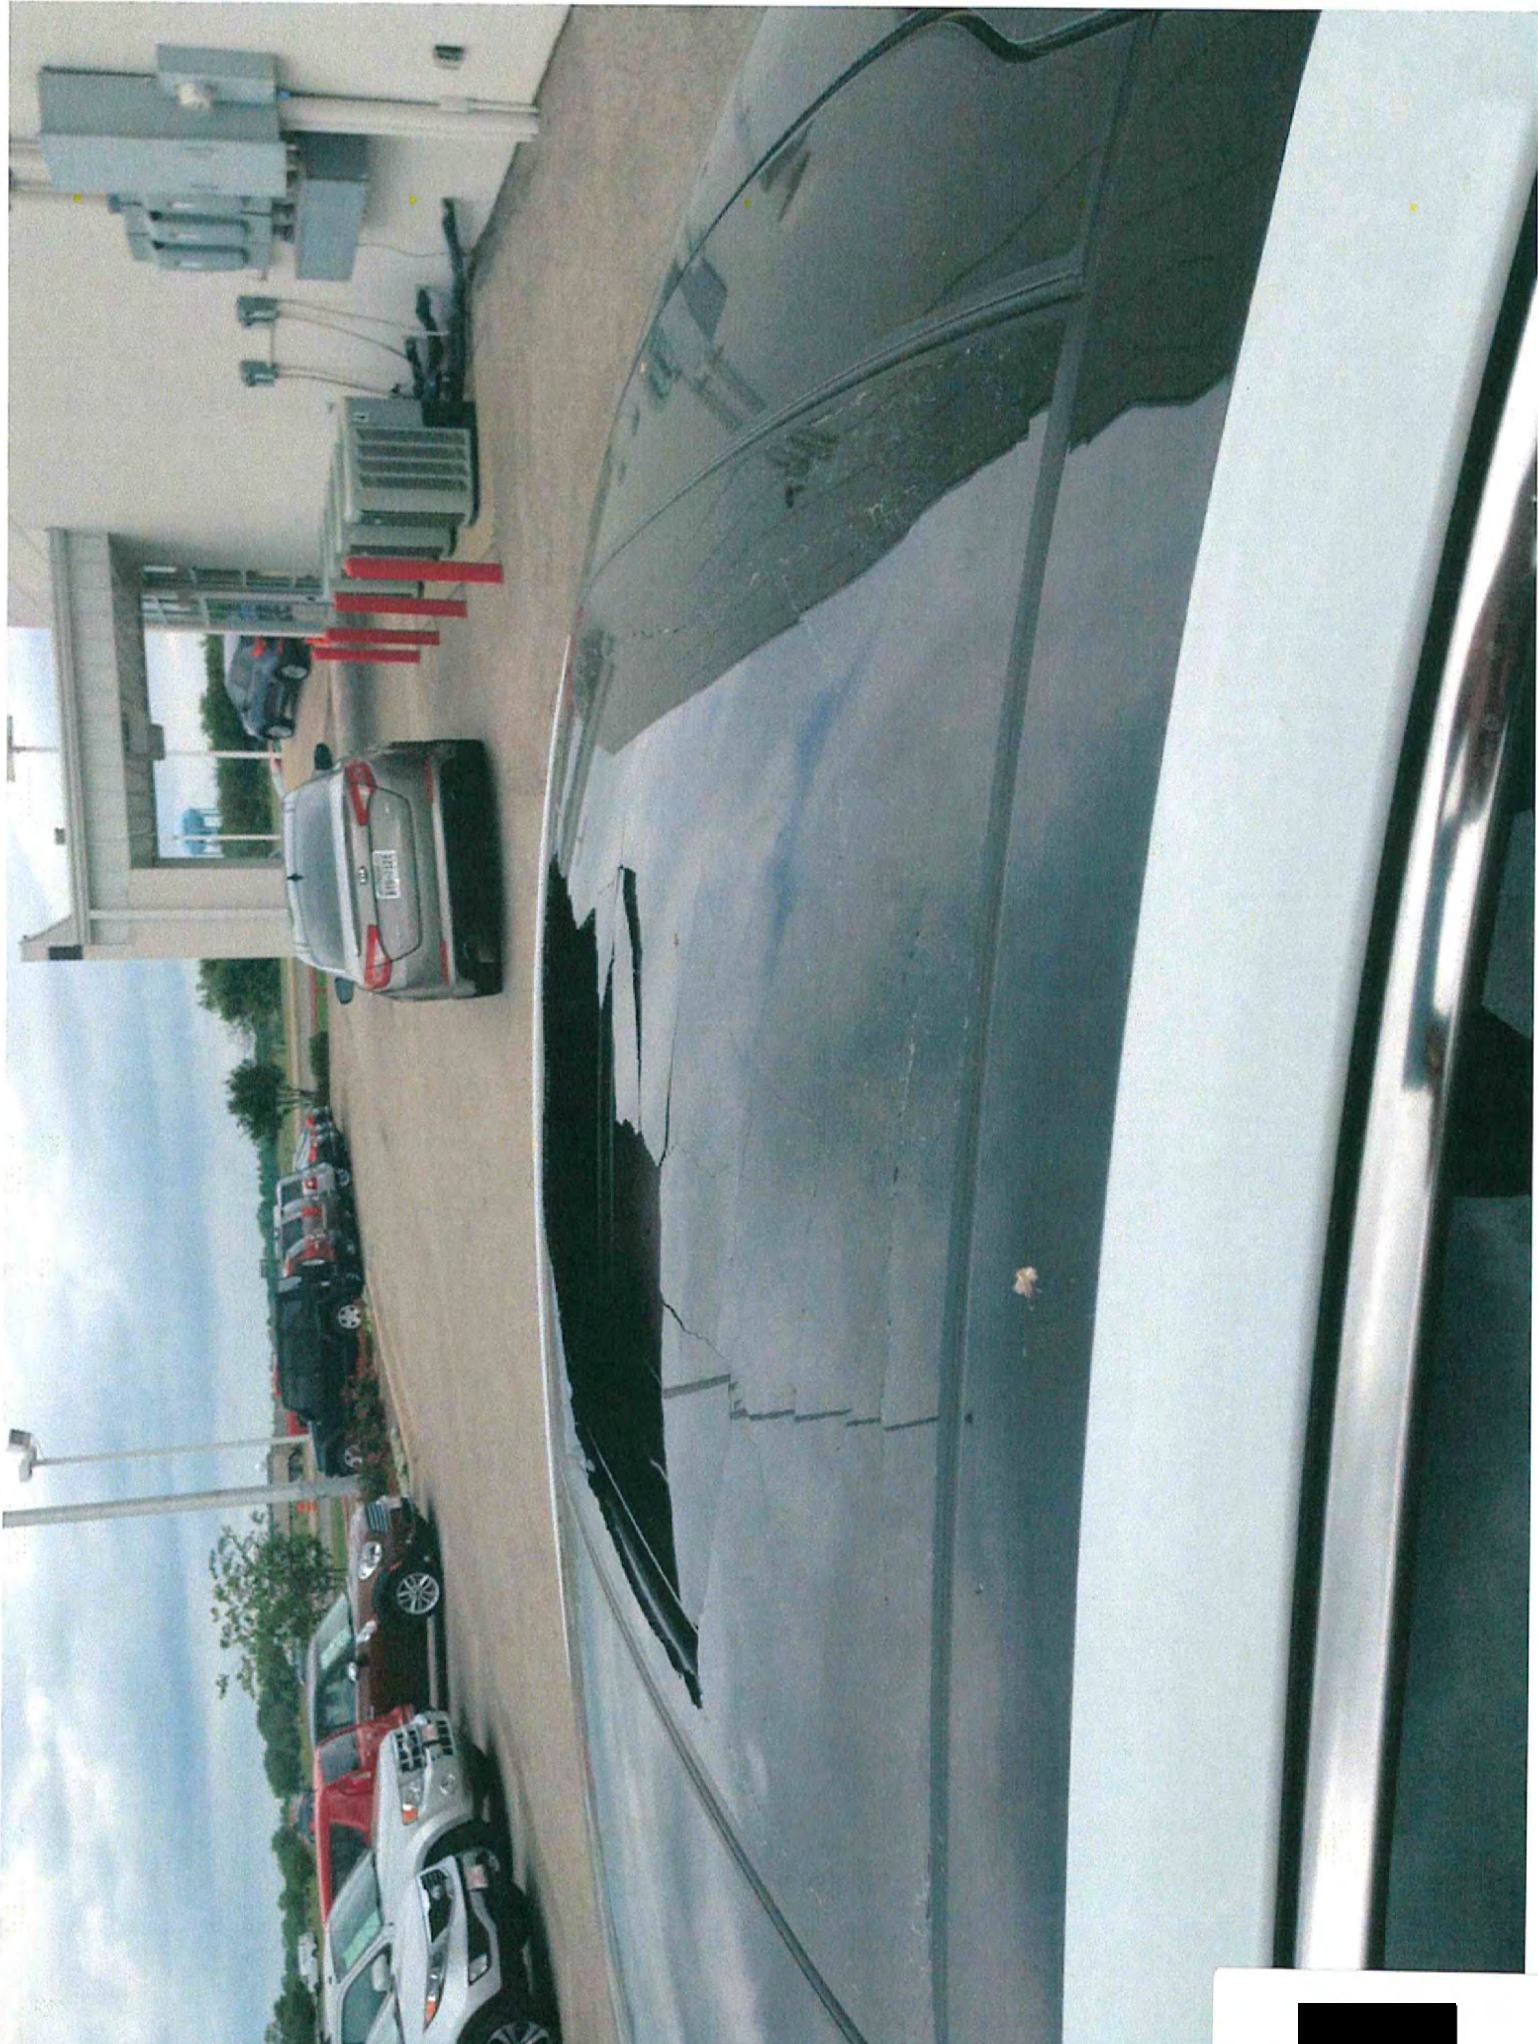
Found no reason why the roof shattered.

Replace the sunroof
