Scope and Prioritise Potential Causes

Intermediate result of KV actuator analysis

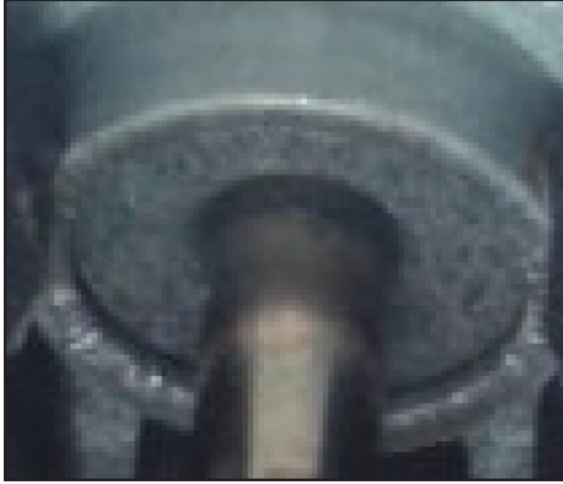
SALWR2WF2EA

Colour comparison of KV sinter bearing

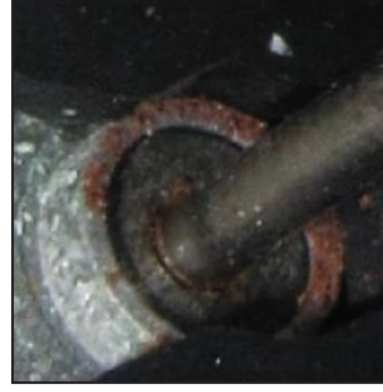
sample A 6 after 480h

OK without short circuit

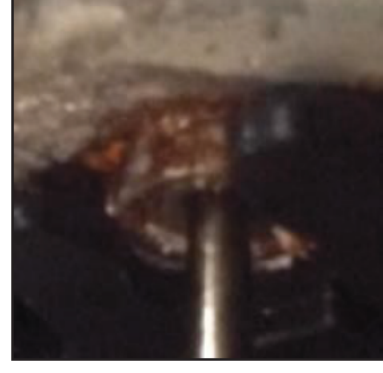
sample A8 after 720h

OK without short circuit

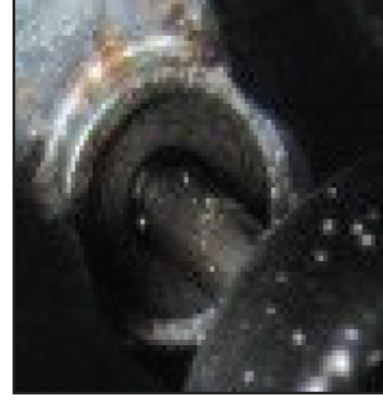
Brose corrosion test (1176h) all ok without SC

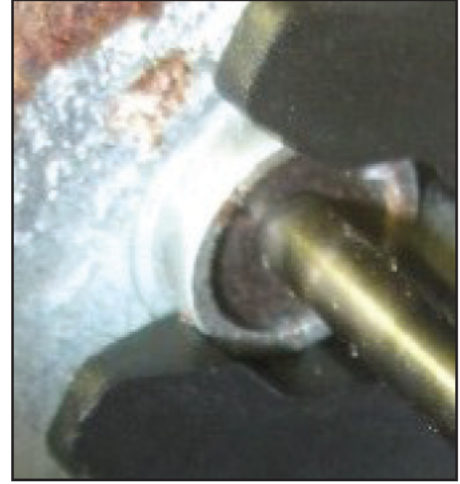
X260 corrosion test

OK without short circuit

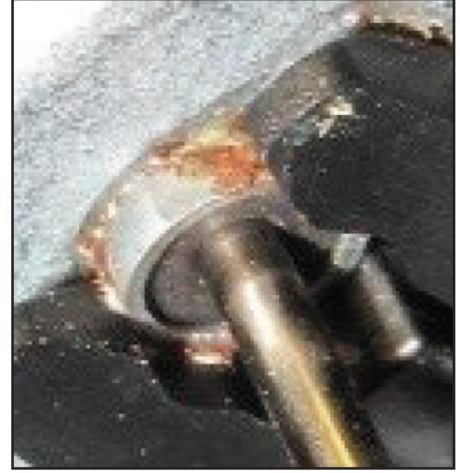
X760 corrosion test ok without SC

OK without short circuit

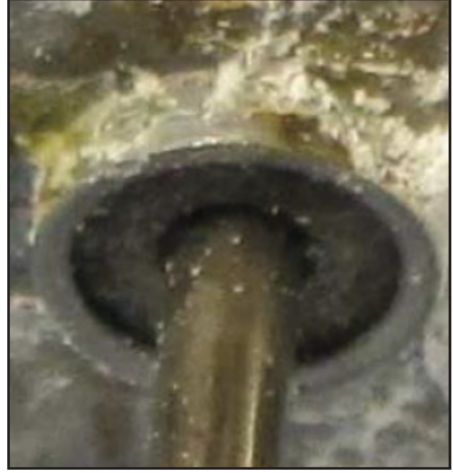
Brose corrosion test (360h)

Conclusion: grey colour of sinter bearing known and no indication of non working KV actuator

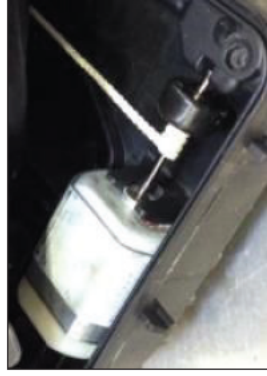
Latch from Critical Concern List / SALWR2WF8EA [REDACTED] UNITED STATES(USA)
“Inadvertent Door Open Post P068 27/07/2015 dbromage”

Latch received with 3 windings left on motor shaft

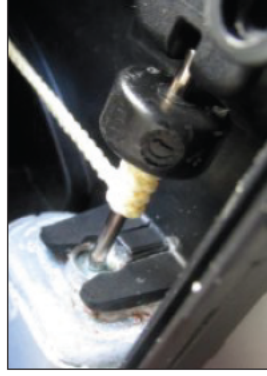
Latch from Critical Concern List /
unknown VIN number

Latch received with 3 windings left on motor shaft

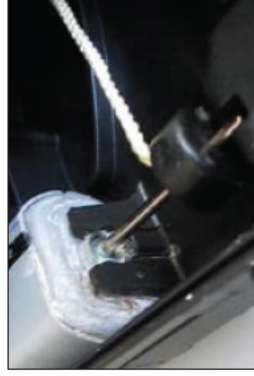
After 3 KV operation at test box with open circuit cord fully unwound
→ **OK**

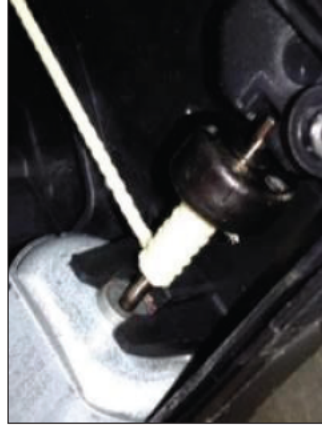
FT RH CL PC KV
18.08.2014

Latch received with 6 windings left on motor shaft

Sinter bearing grey, corrosion at the motor housing
Failure prior to P068 update, P068 didn't resolve issue, latch replaced

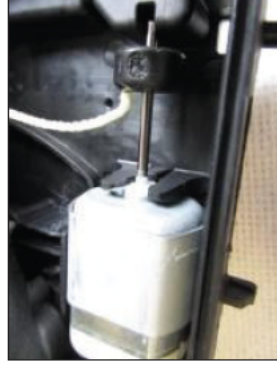
FT RH CL PC KV
07.02.2015

Latch received completely unwound

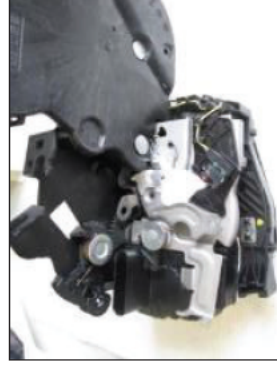
Grease on the sinter bearing

→ ok KV function - cord fully unwound after first operation

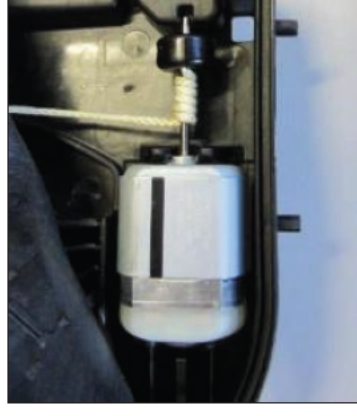
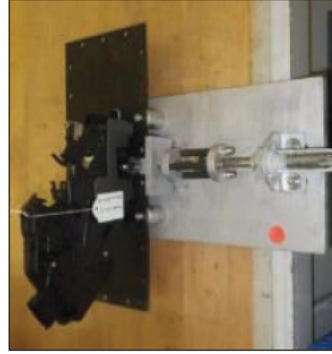
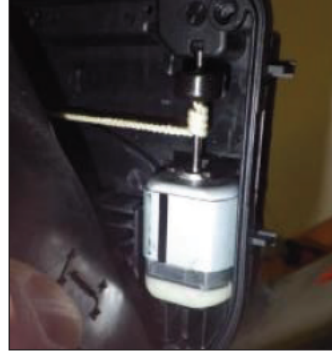
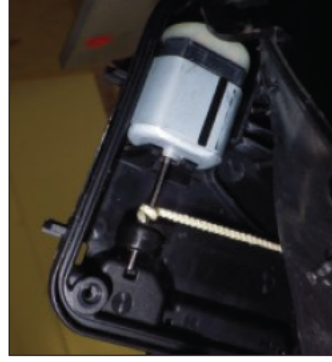
Shake-Test under seal load

1. Start condition: Latch in primary position, seal load 311N, locked
2. KV operation with pulled o/s lever, (with short circuit condition)
3. Latch releases, self return of o/s lever, → KV motor stops with ~4 windings left on motor shaft
4. Close latch to primary position again, applied seal load 311N
5. Shake fixture (also with shocks to simulate pot-holes)

No self release can be provoked, cord rotates in unwinding direction and ends with ~1,5 windings left

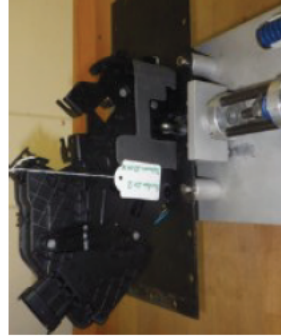
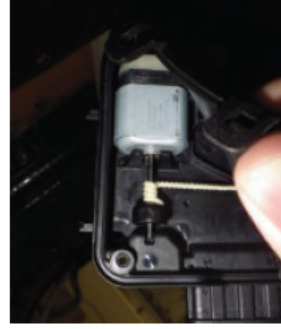
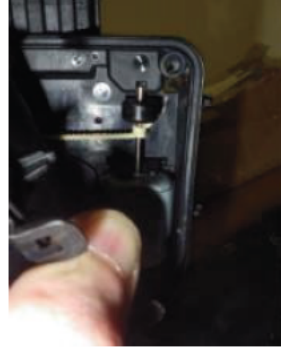
Latch not from Critical Concern List SALGS2VF6FA [REDACTED] // USA

Shake-Test under seal load

No self release can be provoked, cord rotates in unwinding direction and ends with ~2 windings left

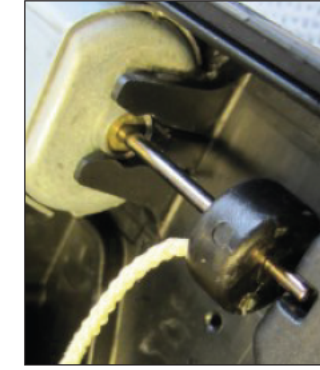
FT LH CL PC KV LB
12.05.2014

Latch received completely unwound

Sinter bearing shiny, no corrosion on motor housing visible

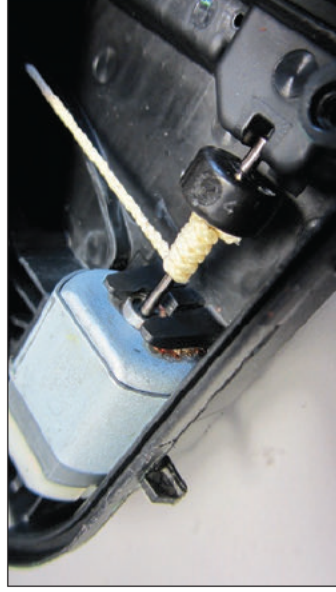
Latch received with 5 windings left on the motor shaft.

Sinter bearing grey, corrosion on housing visible

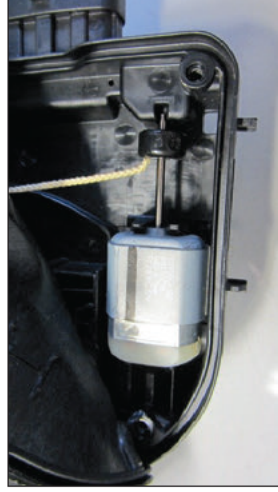
Latch received completely unwound

Sinter bearing shiny, slightly corrosion on motor housing visible

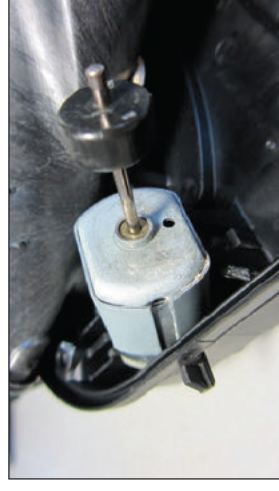
KV motor operation open circuit

→ ok KV function - cord fully unwound after first operation

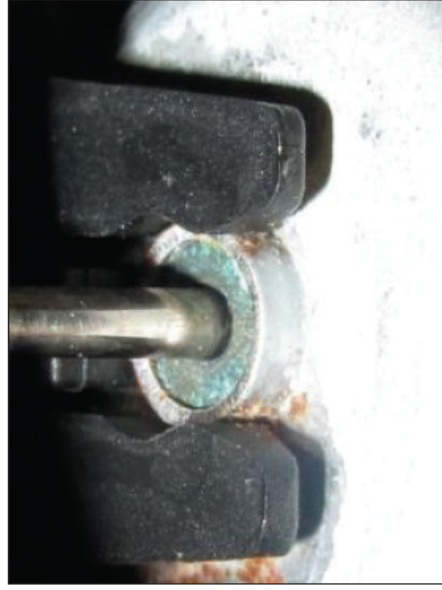
Bearing

Next Steps: Additional storage for another 4 weeks and function check

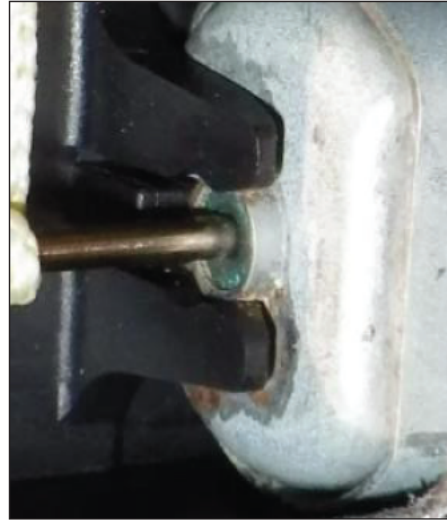
Bearing

Next Steps: Application of 1 water drop onto bearing and additional storage for another 4 weeks and function check (01.12.2015 after 14 weeks in total)

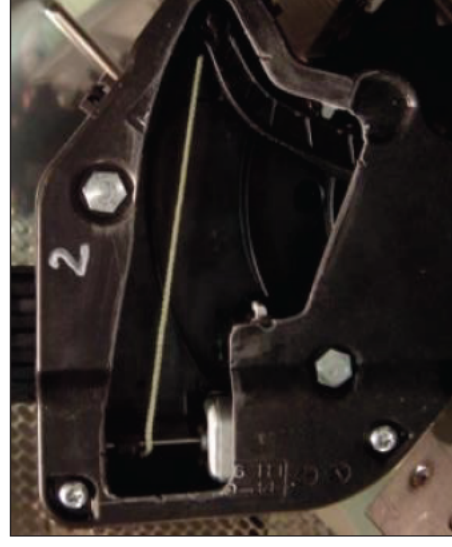
After Open Circuit

No failure reproducible with open circuit condition during more than 3 months storage time.

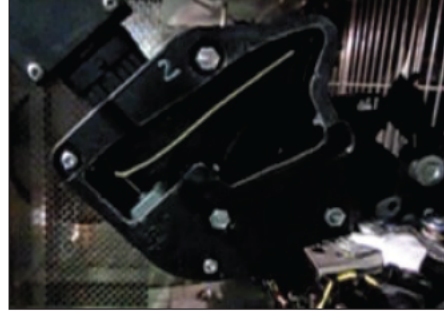
After Open Circuit operation: ok

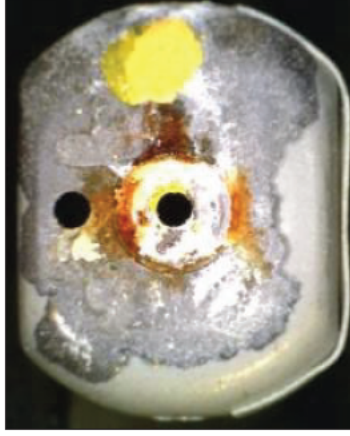
V10571: with radial load on motorshaft (exemplary sample 2):

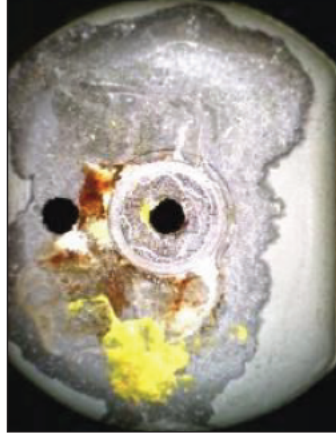
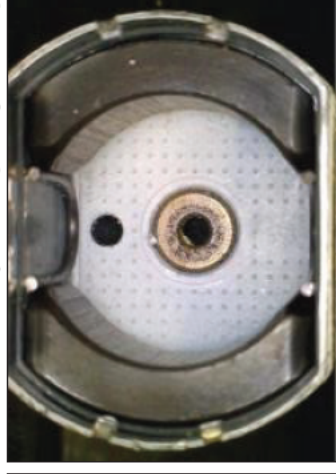
V10572: without load on motorshaft (exemplary sample 4):

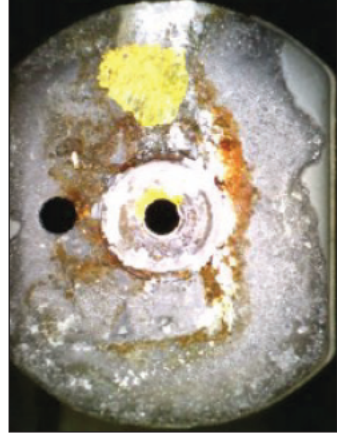
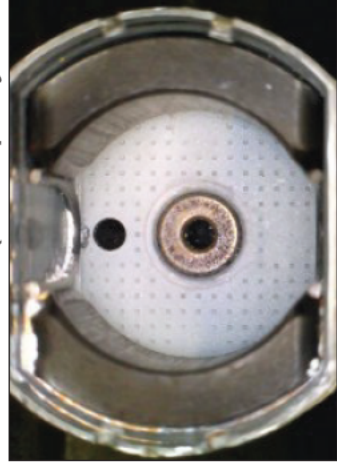
V10573: with axial load on motorshaft (exemplary sample 1):

7	V10.573	360h saltspray test + 168h storage at RT (samples without greaseand sticker) With axial load on motorshaft	2LH/2RH	360h + 168h	28.10.2015	17.11.2015 27.11.2015	17.11.2015: Salt Spray test finished. Storage started 27.11.2015: Test finished, test KV function with first short then open circuit passed ok. → Failure mode in standard salt spray test not reproduceable.
