Separation of 6-panel document on the 15th of September 2017 in two parts for better handling:

Scope and Prioritise Potential Causes

Intermediate result of KV actuator analysis

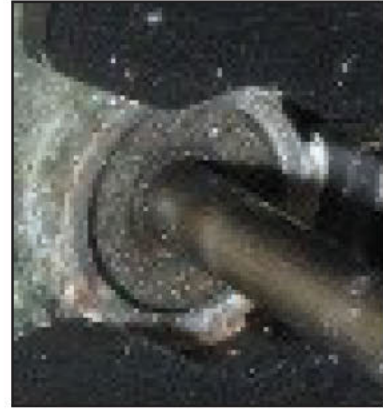
OK without short circuit

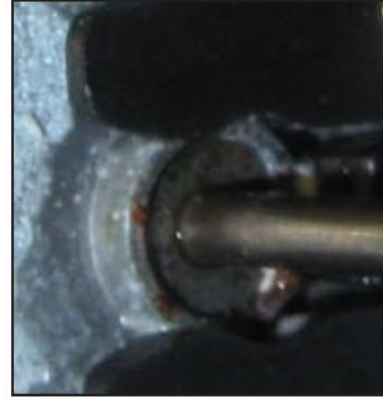
OK without short circuit

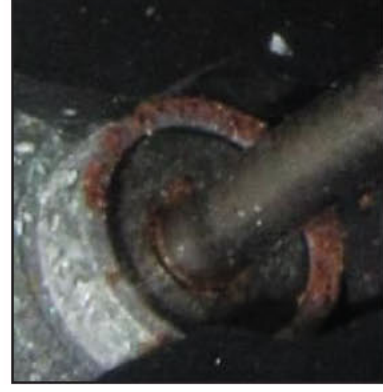
OK without short circuit

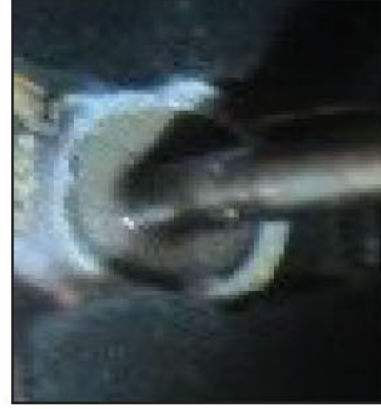
OK without short circuit

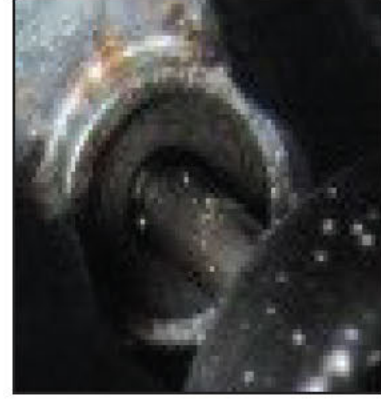
OK without short circuit

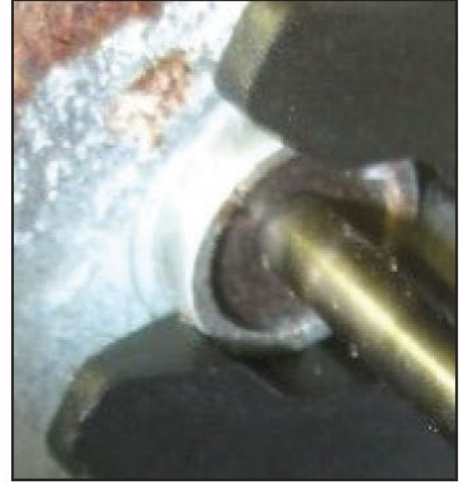
OK without short circuit

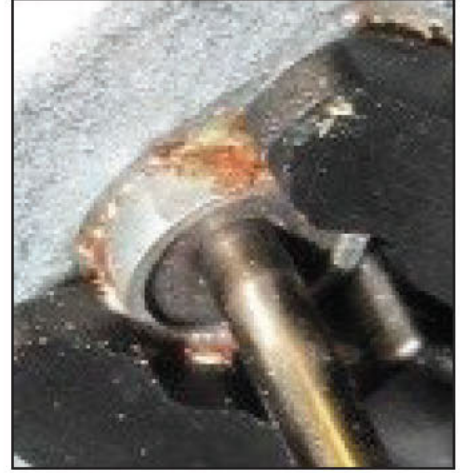
OK without short circuit

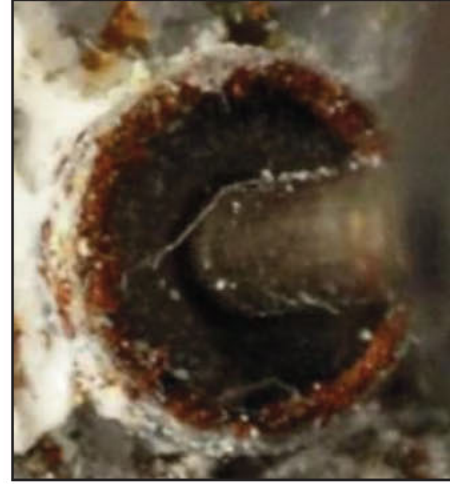
OK without short circuit

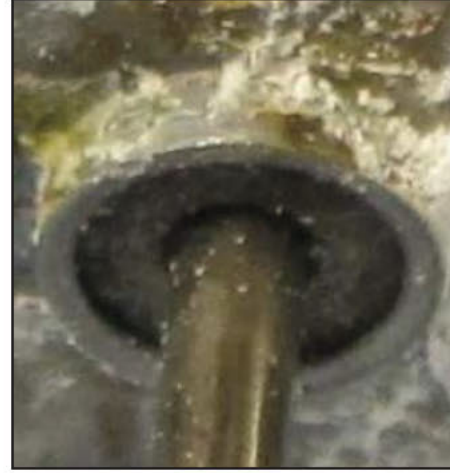
OK without short circuit

Conclusion: grey colour of sinter bearing known and no indication of non working KV actuator

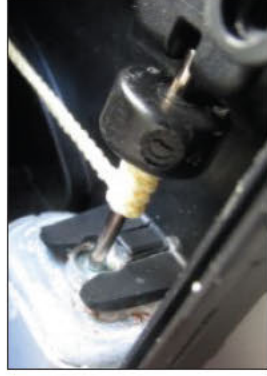
Latch received with 3 windings left on motor shaft

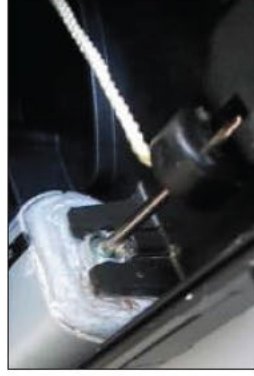
After 3 KV operation at test box with open circuit cord fully unwound
→ OK

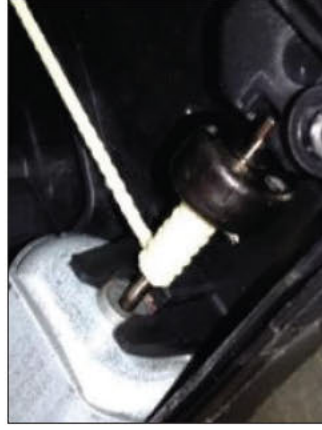
FT RH CL PC KV
18.08.2014

Latch received with 6 windings left on motor shaft

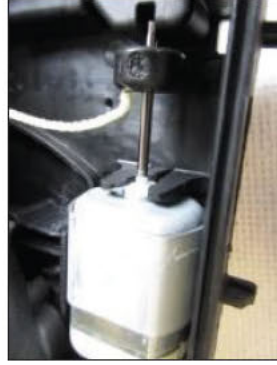
FT RH CL PC KV
07.02.2015

Latch received completely unwound

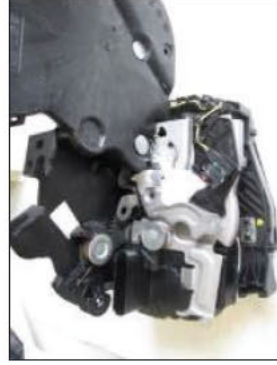
Grease on the sinter bearing

→ ok KV function - cord fully unwound after first operation

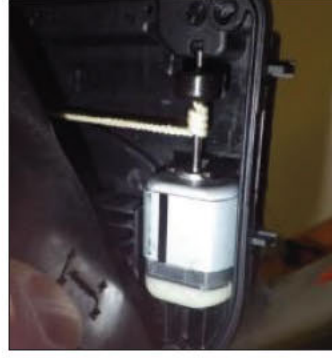
before shaking:

No self release can be provoked, cord rotates in unwinding direction and ends with ~1,5 windings left

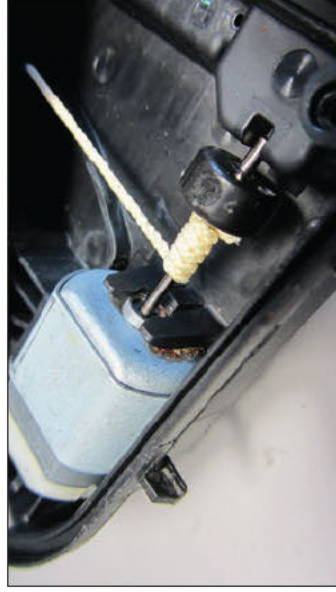
Latch received with 5 windings left on the motor shaft.

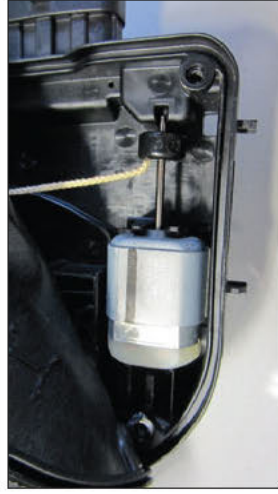
Latch received completely
unwound

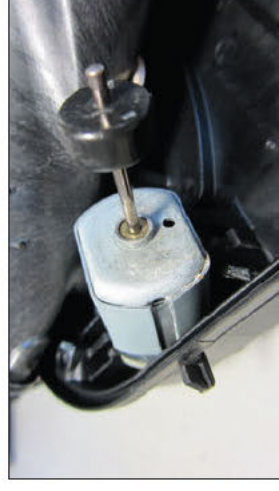
KV motor operation open circuit

→ ok KV function - cord fully unwound after first operation

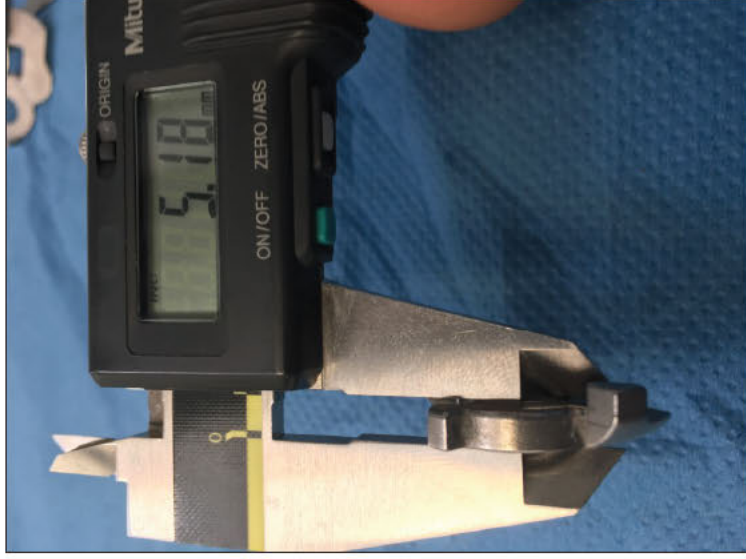
Ft RH CL PC KV
02.04.2013

→ Chamfer from bushing and height of KV transmission lever ok

Investigation completed. Root cause for failure mode can not be detected. Latch passed all tests.

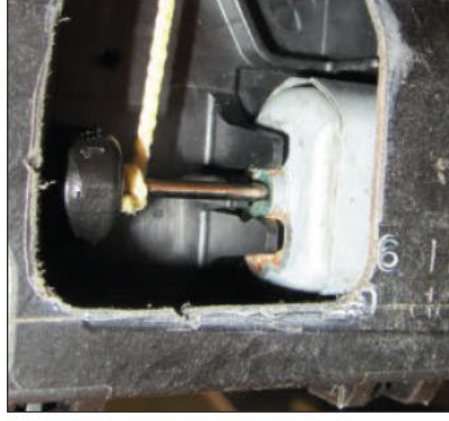
Bearing after 1. short circuit operation: 1 winding left

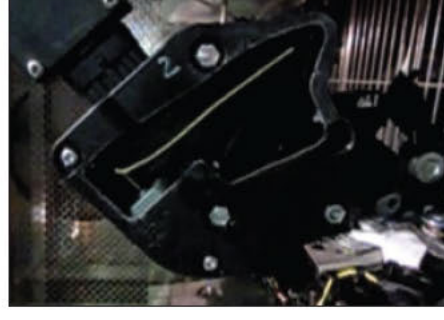
After Open Circuit operation: ok

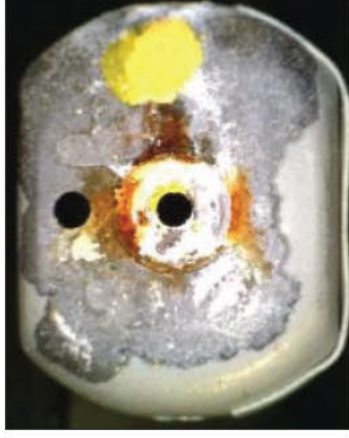
V10571: with radial load on motorshaft (exemplary sample 2):

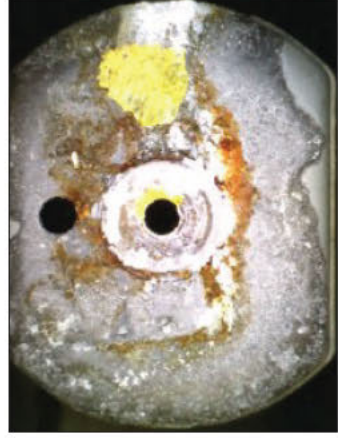
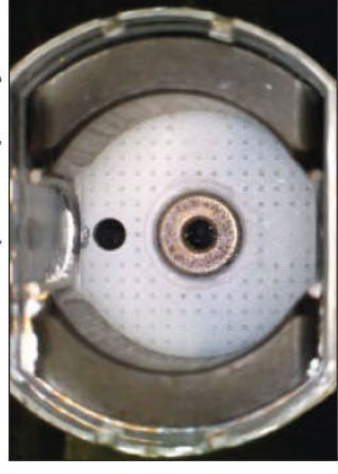
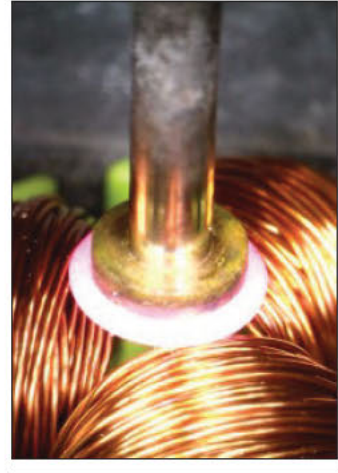
V10573: with axial load on motorshaft (exemplary sample 1):
