Safety Recall

Code: 57J5

Subject	Door Handles															
Document History	<table border="1"><thead><tr><th>Date</th><th>Summary</th></tr></thead><tbody><tr><td>03/22/2024</td><td>Updated claiming and work instructions</td></tr><tr><td>08/25/2023</td><td>Updated instructions for door handles without a port Corrected parts table Additional customer letter examples added</td></tr><tr><td>08/08/2023</td><td>Original publication</td></tr></tbody></table>	Date	Summary	03/22/2024	Updated claiming and work instructions	08/25/2023	Updated instructions for door handles without a port Corrected parts table Additional customer letter examples added	08/08/2023	Original publication							
Date	Summary															
03/22/2024	Updated claiming and work instructions															
08/25/2023	Updated instructions for door handles without a port Corrected parts table Additional customer letter examples added															
08/08/2023	Original publication

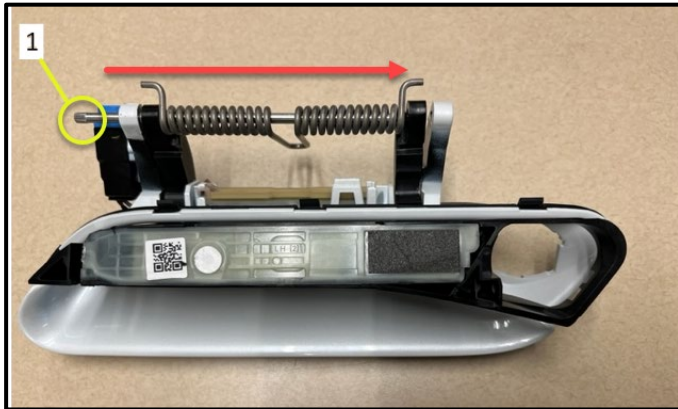
- Incorrect installation of wires <1> shown.
